Expertise

Protocol number: 41753643  
Order number / reference: 25127561  
Inspection date: 29 Sept 2025

Manufacturer: Mercedes-Benz

Model: Vito 111 CDI Lang

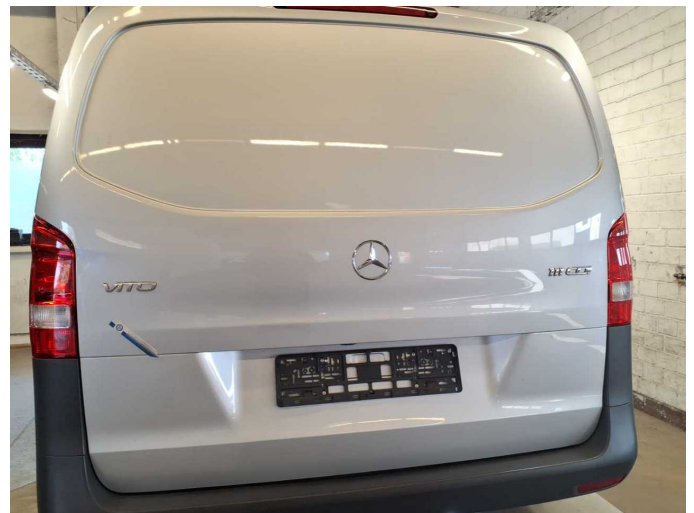
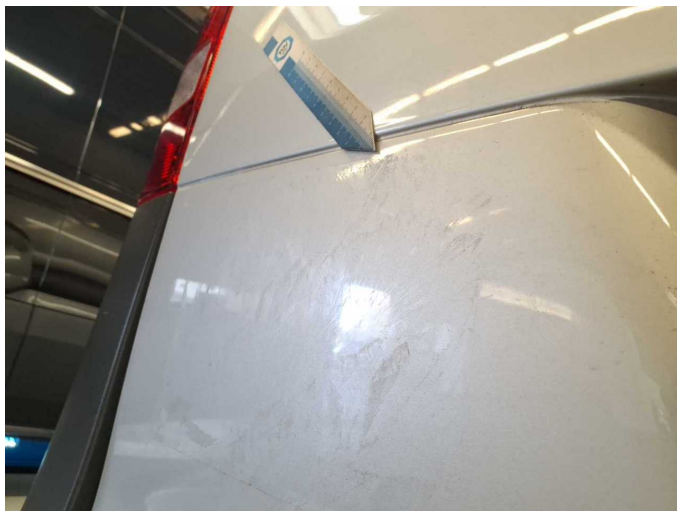
No.	Component group	Description
1	Boot lid / rear door	Boot lid (Klebereste) - Glued / labelled - De-glue / neutralise
2	Mudguard - right side	Mudguard - right side - Glued / labelled - De-glue / neutralise

**Damage 1:** Boot lid / rear door: Boot lid (Klebereste) - Glued / labelled - De-glue / neutralise

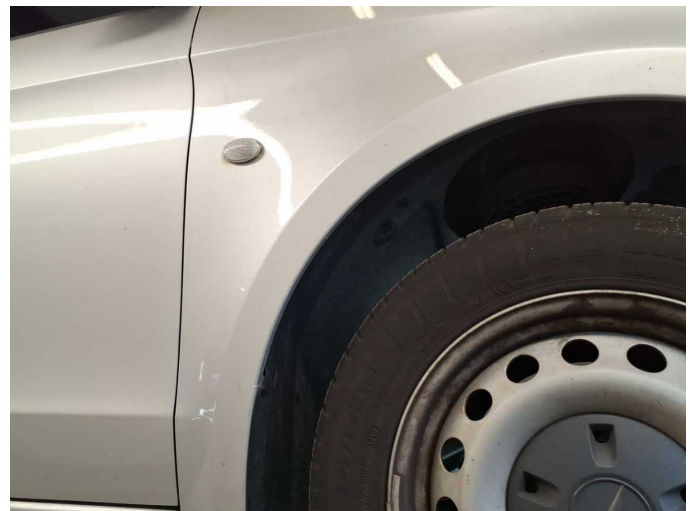
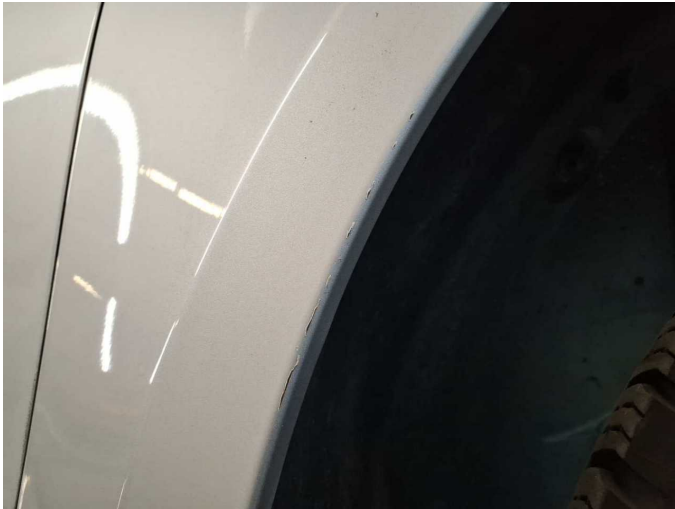
**Damage 2:** Mudguard - right side: Mudguard - right side - Glued / labelled - De-glue / neutralise

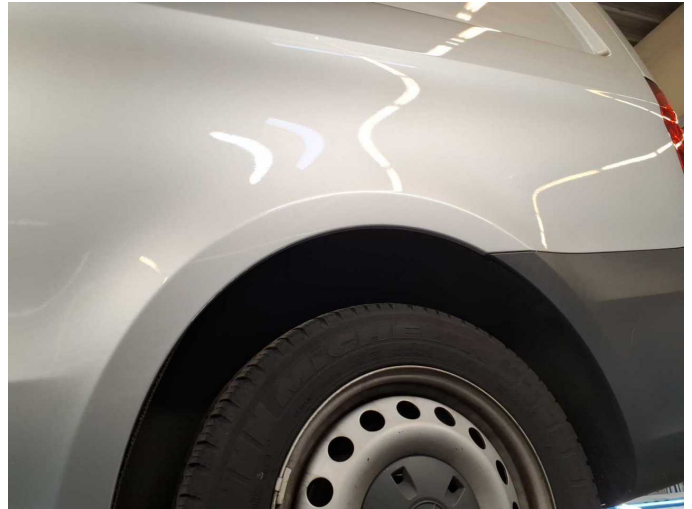
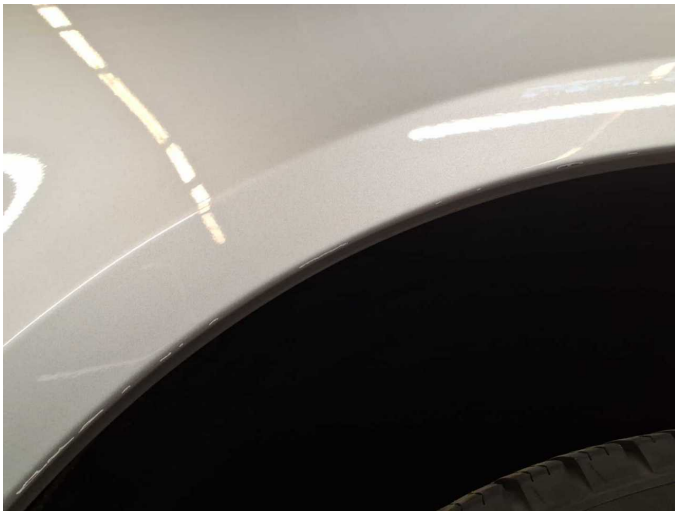
No.	Component group	Description
3	Side panel - rear left side	Side panel (Klebereste) - Glued / labelled - De-glue / neutralise
4	Side panel - rear right side	Side panel (Klebereste) - Glued / labelled - De-glue / neutralise
5	Door - front left side	Door - dent(s) - Smooth repair work
6	Trim / covers	Roof lining - Holes - Smart repair
7	Mudguard - left side	Mudguard - left side - Scratch(es) - Smart repair
8	Boot lid / rear door	Boot lid - dent(s) - Smooth repair work
9	Rear bumper	Rear bumper - Scratch(es) - Loss in value
10	Misc.	Inspection / maintenance - Due - Perform
11	Sliding door, right	Sliding door - Scratch(es) - Paint
12	Sill - left side	Sill - Deformed - Repair and paint

**Damage 3:** Side panel - rear left side: Side panel (Klebereste) - Glued / labelled - De-glue / neutralise

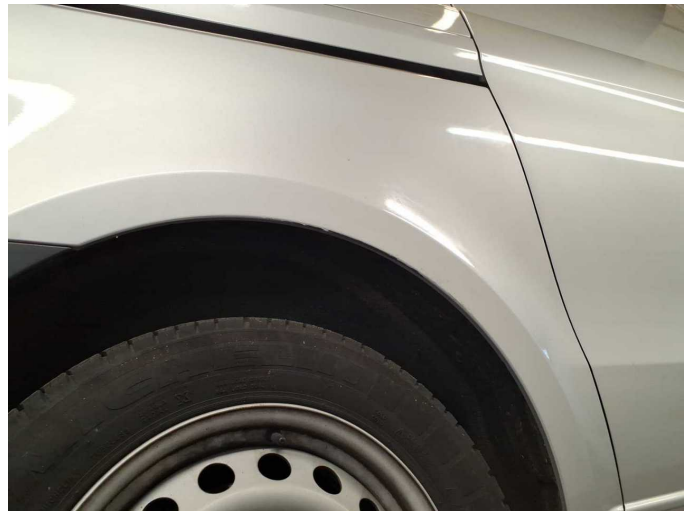
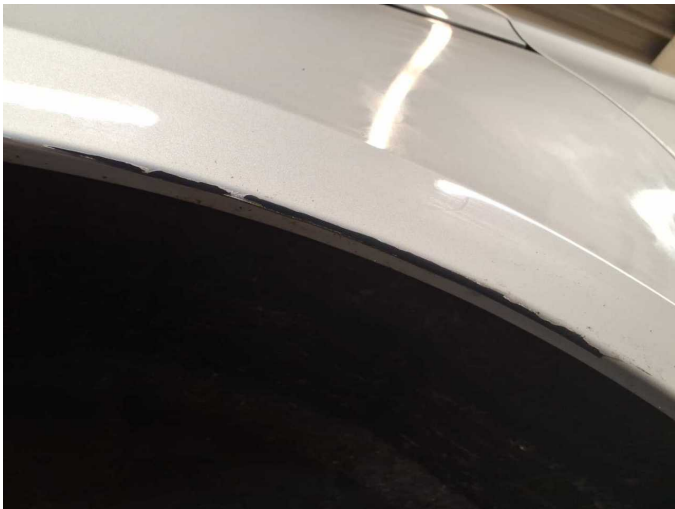
**Damage 4:** Side panel - rear right side: Side panel (Klebereste) - Glued / labelled - De-glue / neutralise

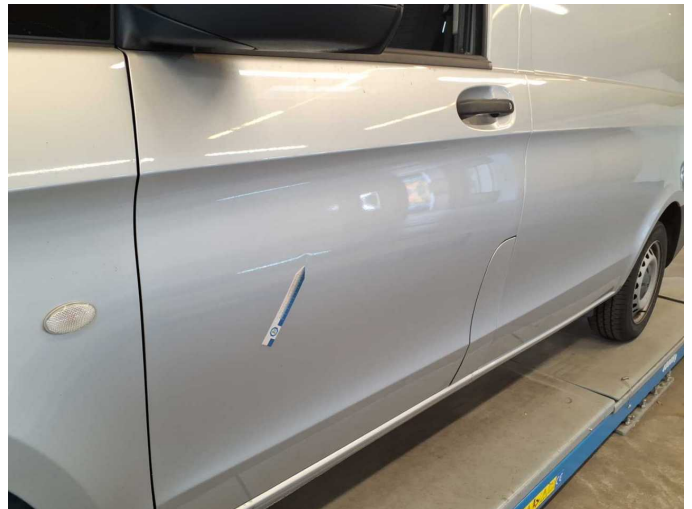
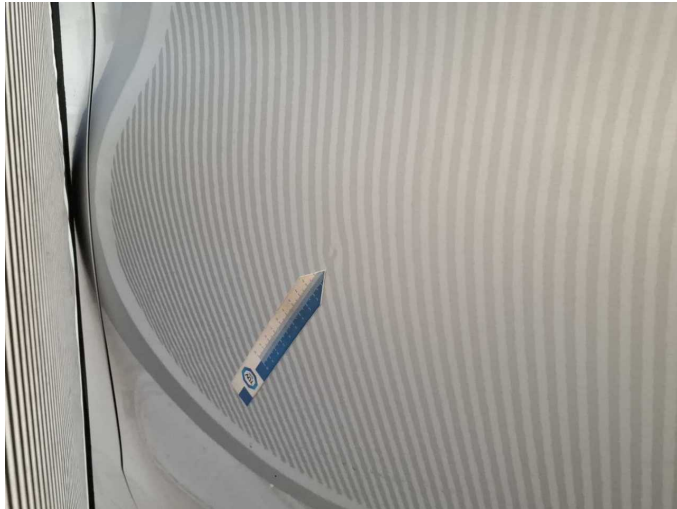
**Damage 5:** Door - front left side: Door - dent(s) - Smooth repair work

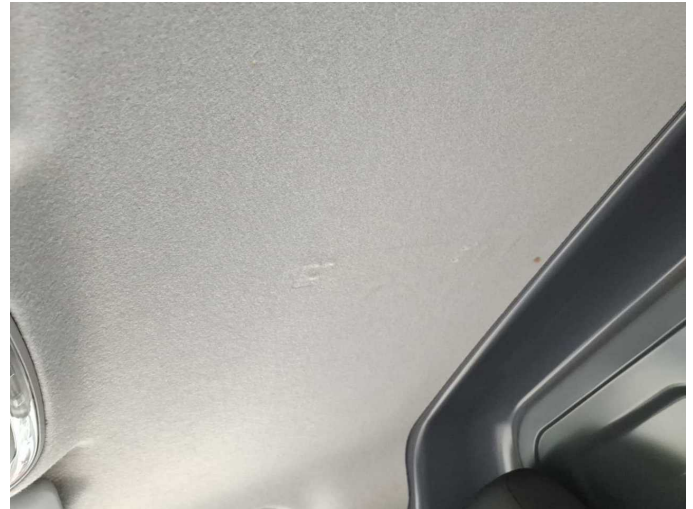
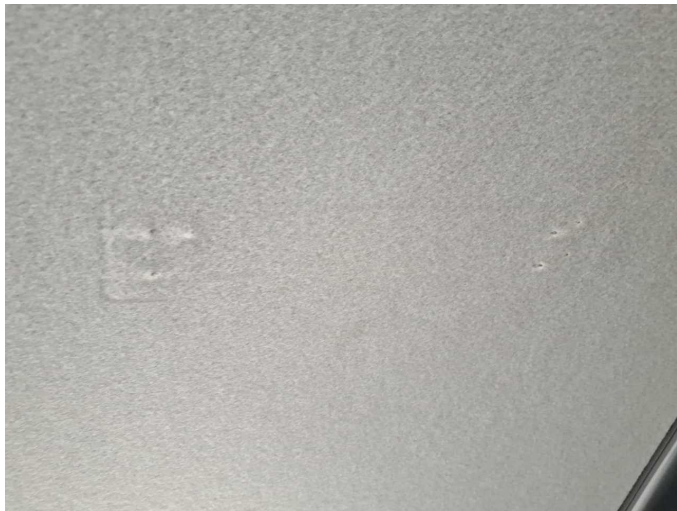
**Damage 6:** Trim / covers: Roof lining - Holes - Smart repair

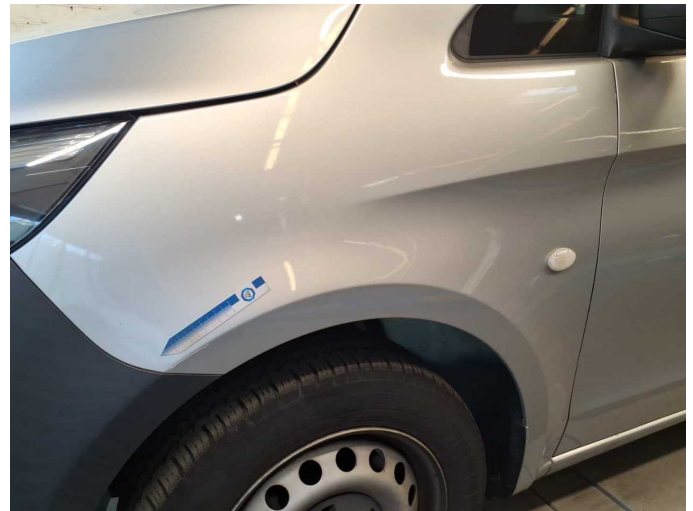
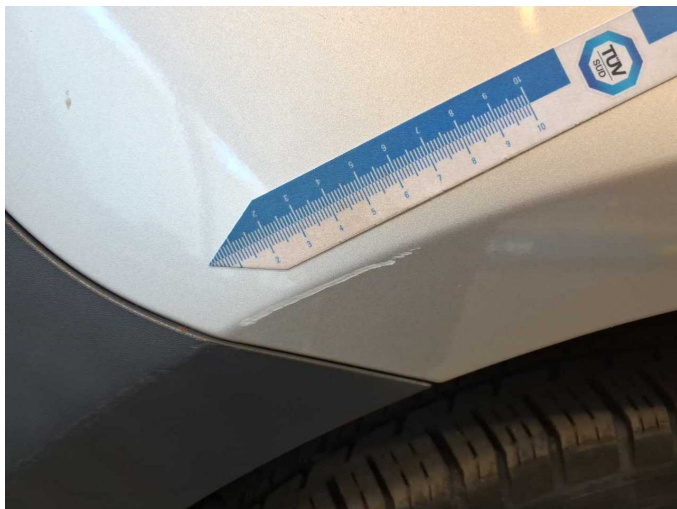
**Damage 7:** Mudguard - left side: Mudguard - left side - Scratch(es) - Smart repair

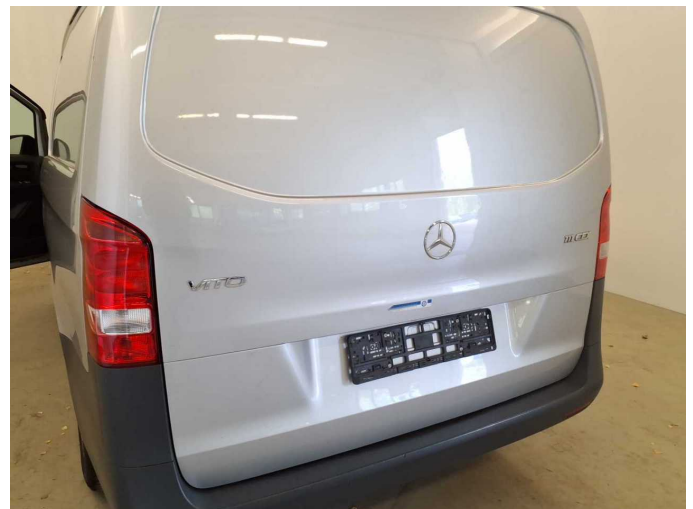
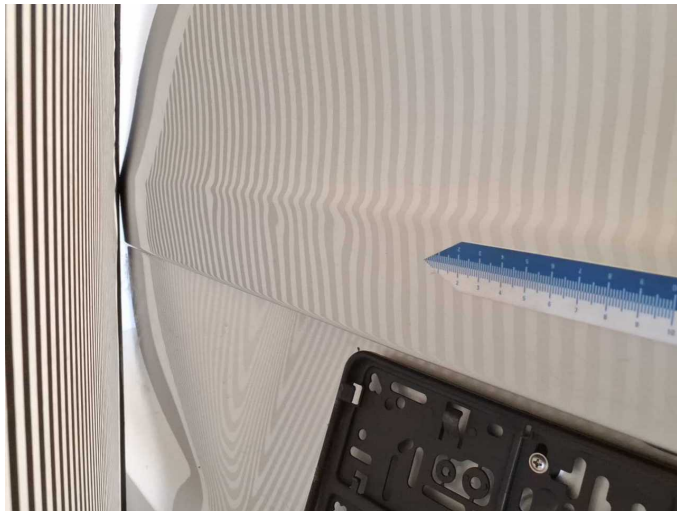
**Damage 8:** Boot lid / rear door: Boot lid - dent(s) - Smooth repair work

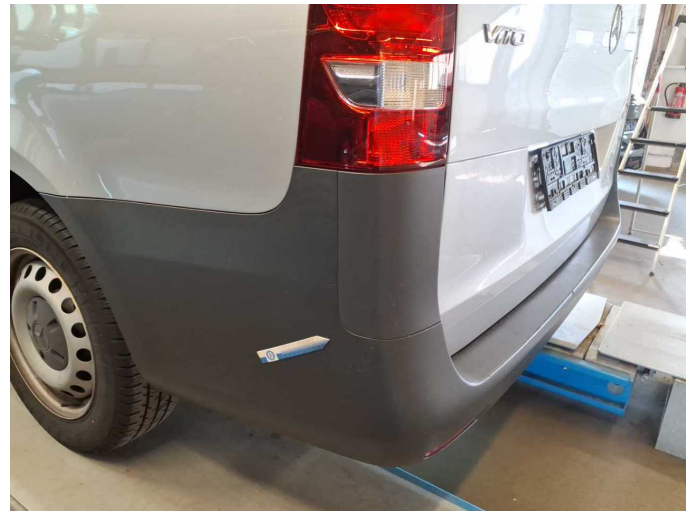
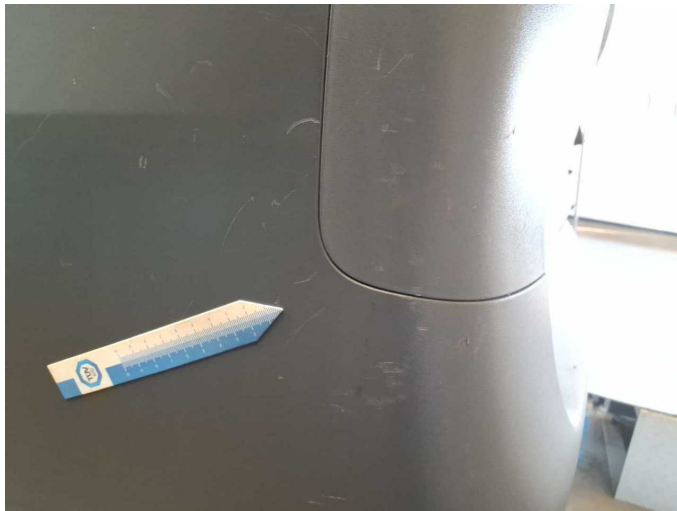
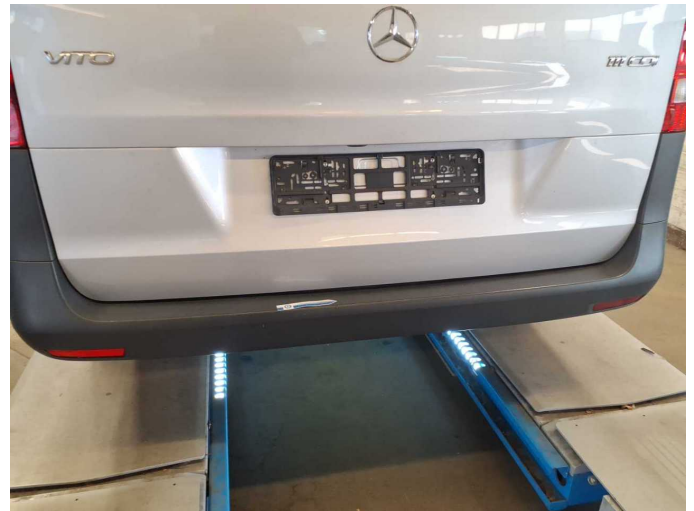
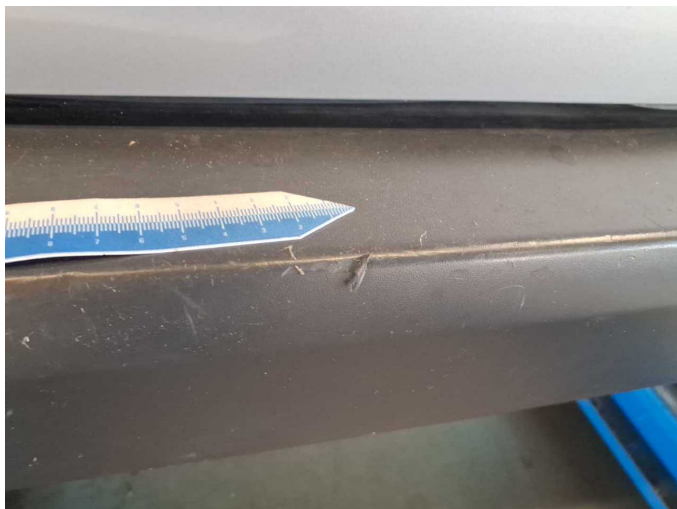
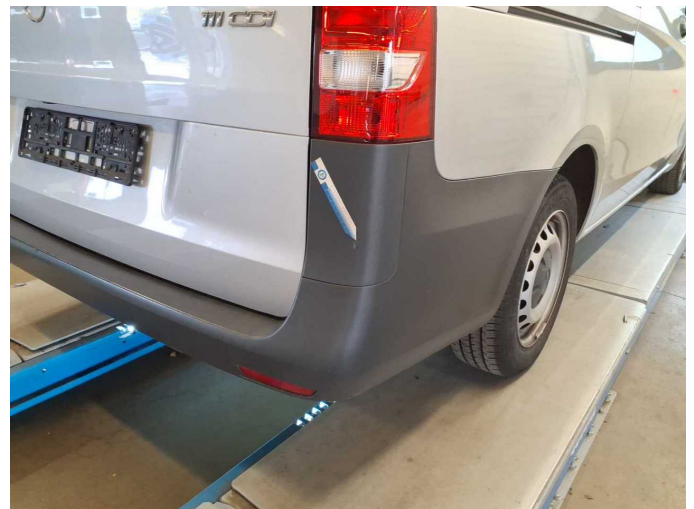
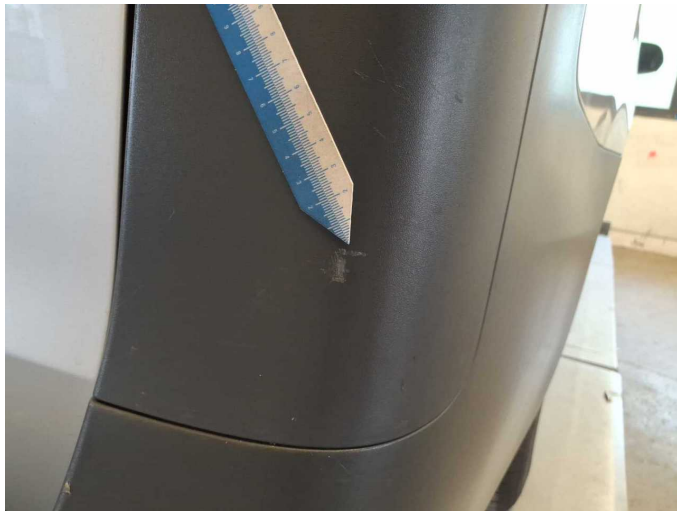
**Damage 9:** Rear bumper: Rear bumper - Scratch(es) - Loss in value

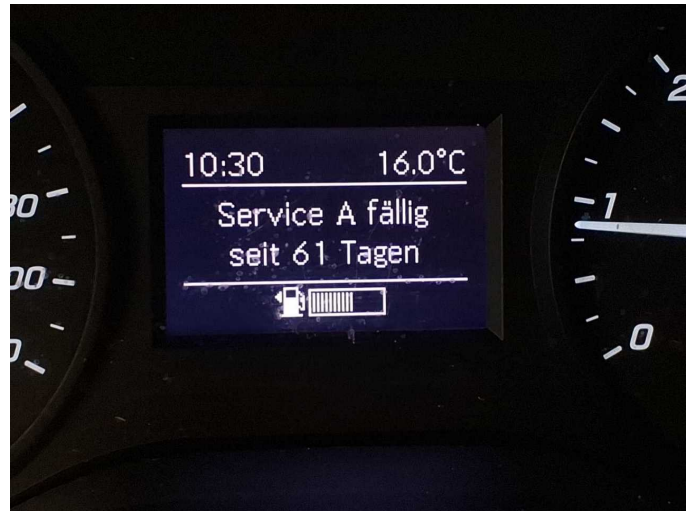
<b>Maintenance booklet / proof</b>	digital proof / complete	<b>Next maintenance in</b>	-61 Tag(e)
<b>Last maintenance on / at</b>	07/2023 at 43,398 km		
<b>Key is / should be</b>	2 / 2	<b>FZG documents</b>	ZB#2 (B) was available (copy), ZB#1 (S) was not available
		<b>Letter No.</b>	FK844629
<b>Previous damage / Accident</b>	None detectable	<b>Repainting</b>	None detectable
<b>Inspection conditions</b>	sufficient	<b>Lifting equipment / pit</b>	yes
<b>Test drive</b>	Not performed	<b>Engine function test</b>	Performed
<b>Manufacturer key number/ type code number</b>	1313 / EKK 01912		
<b>Emission standard</b>	EURO6;Y;PI/CI; N1 III, N2	<b>Fine dust sticker</b>	
<b>Permitted total weight</b>	2,800 kg	<b>Empty weight</b>

**Damage 10:** Misc.: Inspection / maintenance - Due - Perform

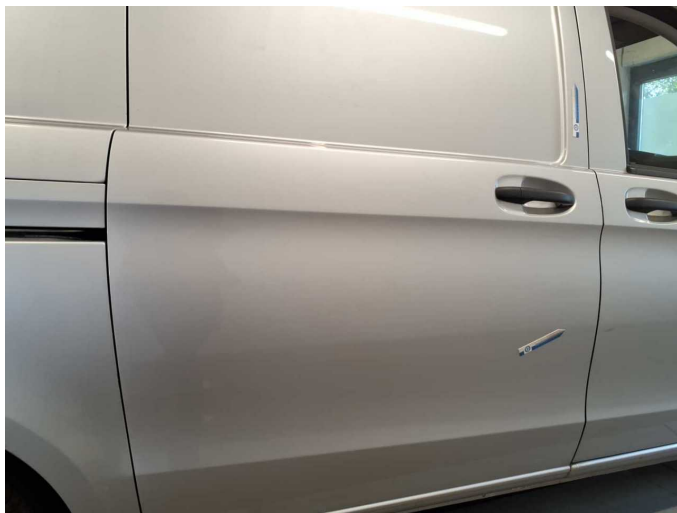
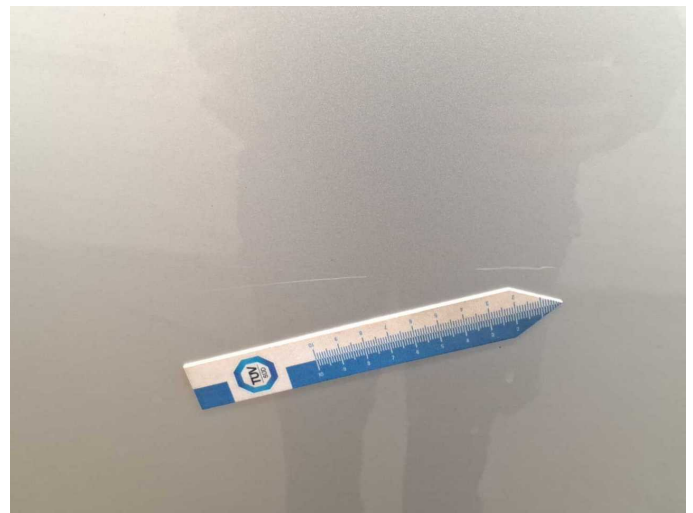
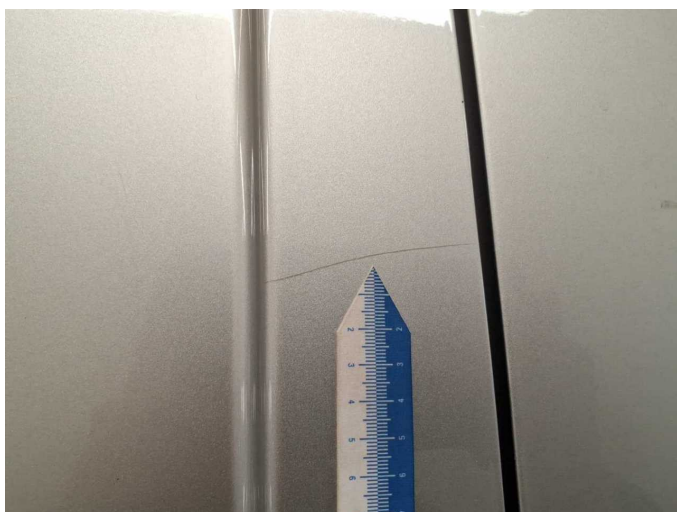
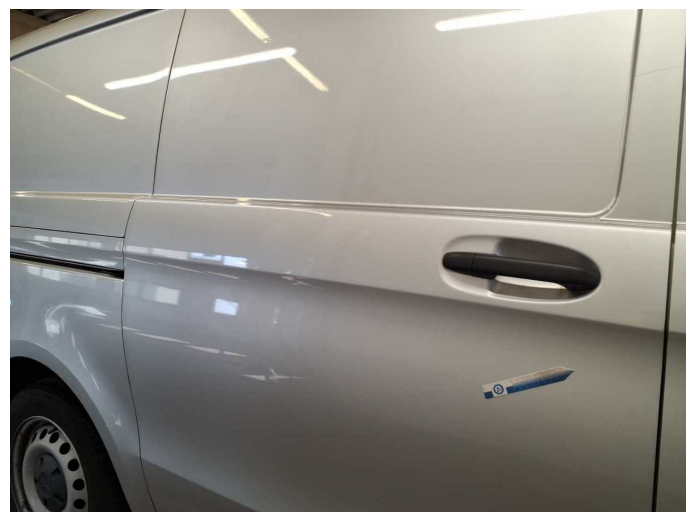
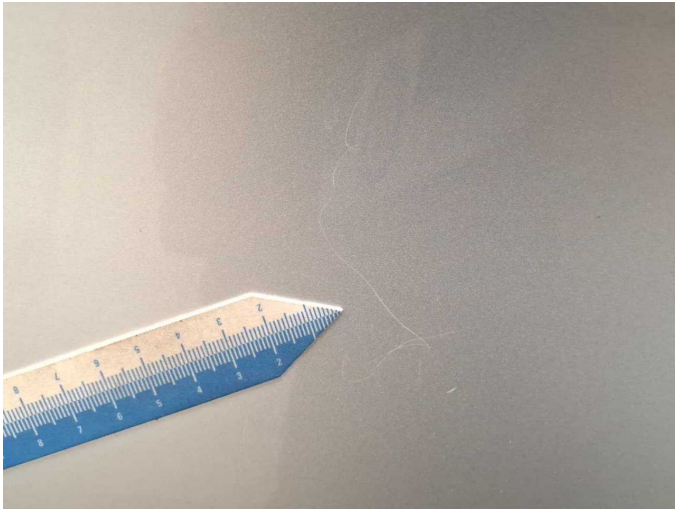
**Damage 11:** Sliding door, right: Sliding door - Scratch(es) - Paint

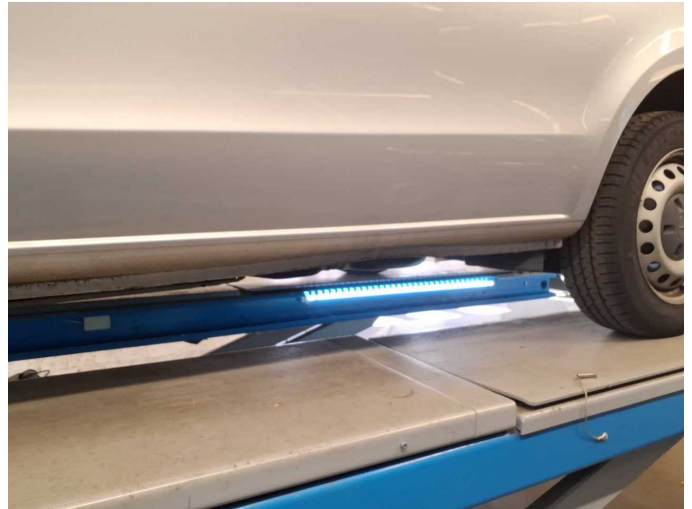
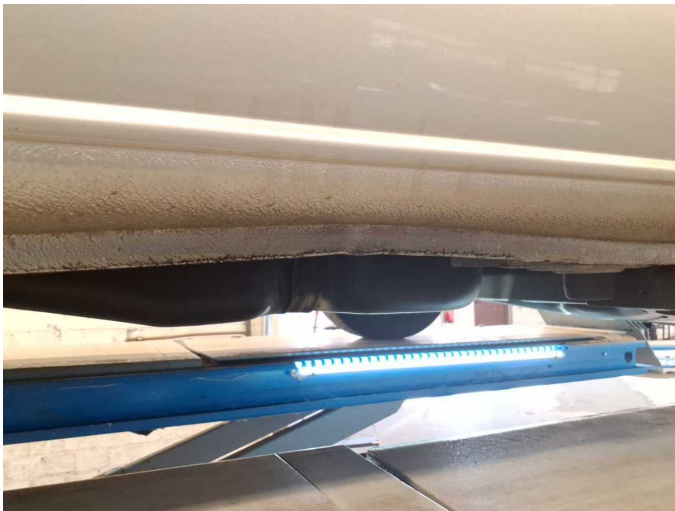
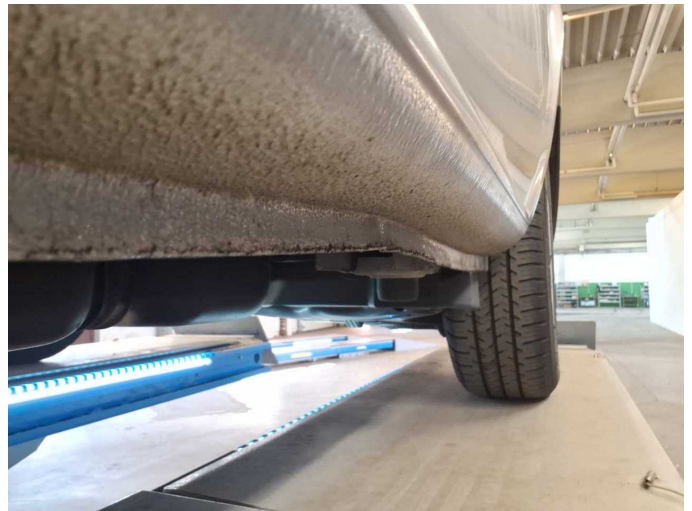
**Damage 12:** Sill - left side: Sill - Deformed - Repair and paint

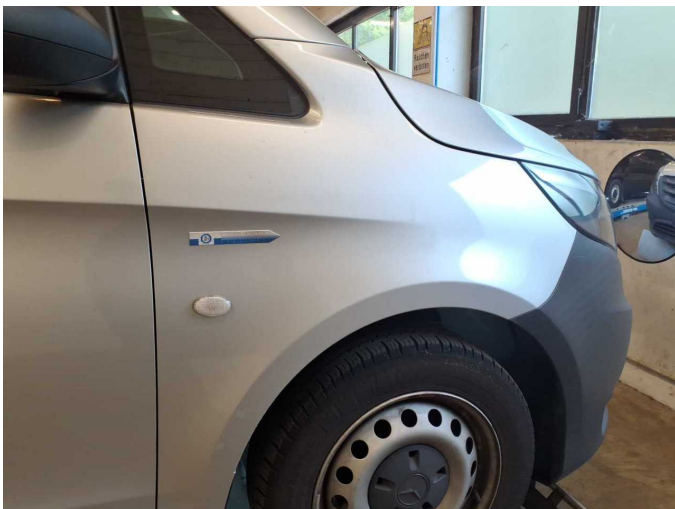
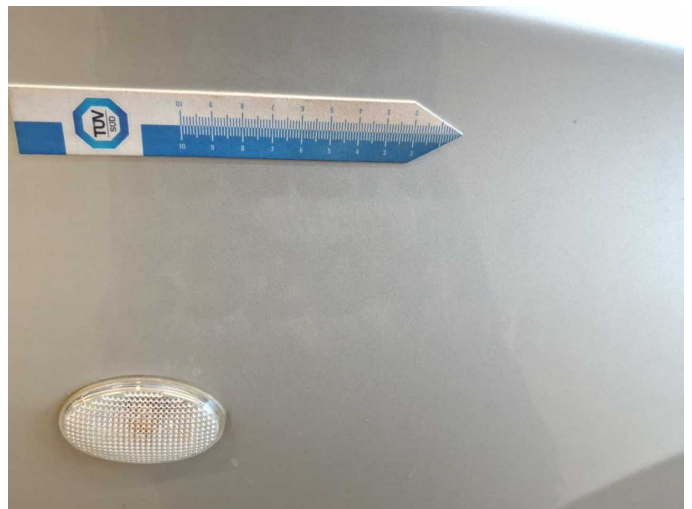
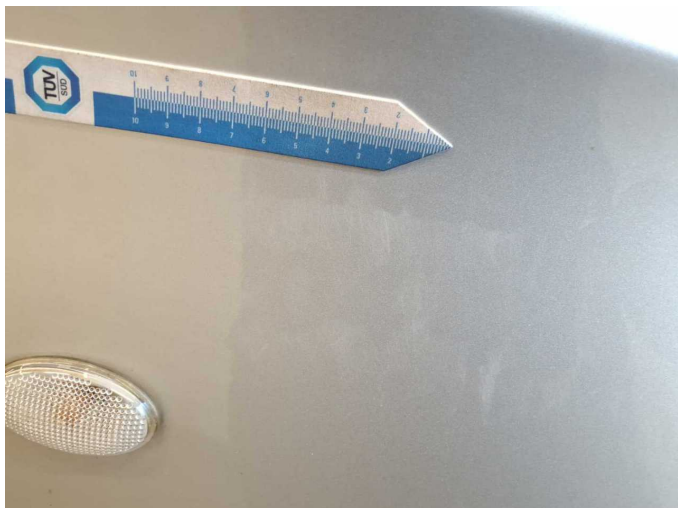
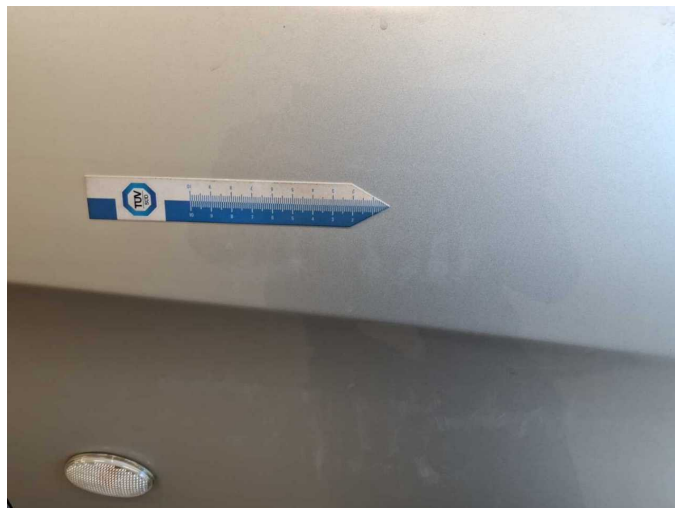
No.	Component group	Description
1	Door - front left side	Door - Scratch(es) - No deduction
2	Side panel - rear left side	Side panel ((Polieren)) - Scratch(es) - No deduction
3	Bonnet	Bonnet - Stone chips - No deduction
4	Boot lid / rear door	Boot lid - Scratch(es) - No deduction
5	Trim / covers	Boot lid - interior trim - Scratch(es) - No deduction
6	Interior	Cargo space division - Scratch(es) - No deduction
7	Engine	Engine cowling lower front - Scratch(es) - No deduction
8	Body	Body (Ausbleichung) - Glued / labelled - No deduction
9	Mudguard - right side	Mudguard - right side - Scratch(es) - Conditioning

**Wear and tear 9:** Mudguard - right side: Mudguard - right side - Scratch(es) - Conditioning

**Wear and tear 9:** Mudguard - right side: Mudguard - right side -  
Scratch(es) - Conditioning
