## status report

#### Ford EcoSport ST-Line

| Vehicle identification number | <b>WF01XXERK1KD17771</b> | mileage read: | <b>112428 km</b> |

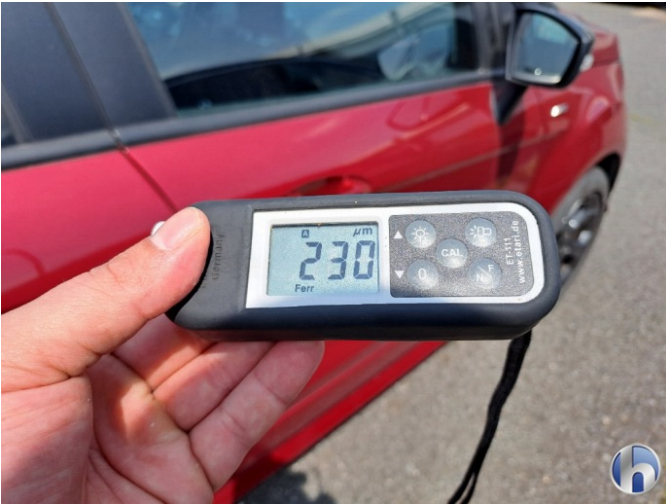
| component | Damage | Rep kind |
|---|---|---|
| 1. Front door - right | Subsequently painted | acceptable |

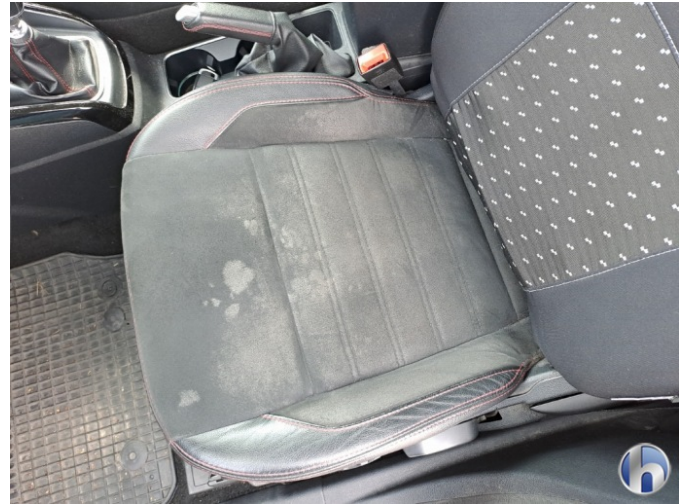
| component | Damage | Rep kind |
|---|---|---|
| 2. | Dirty | |

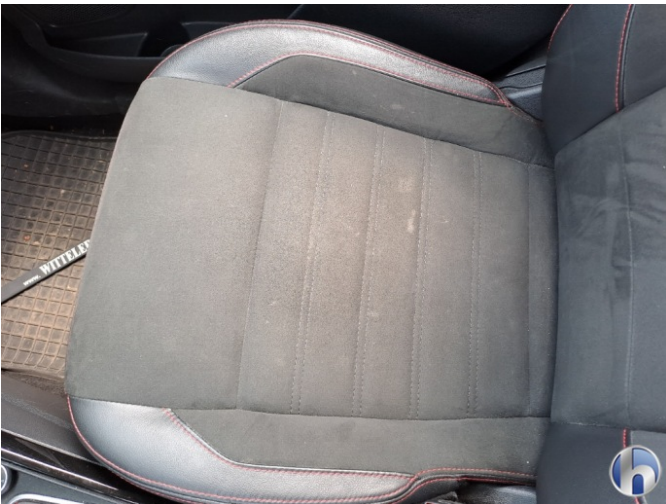
| component | Damage | Rep kind |
|---|---|---|
| 3. | Dirty | |

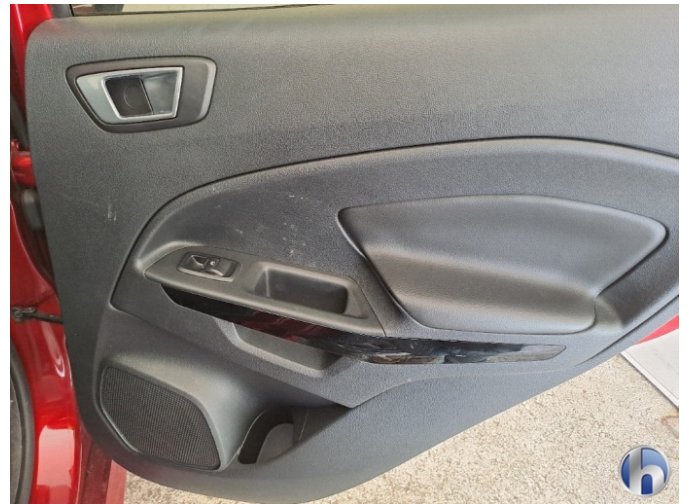
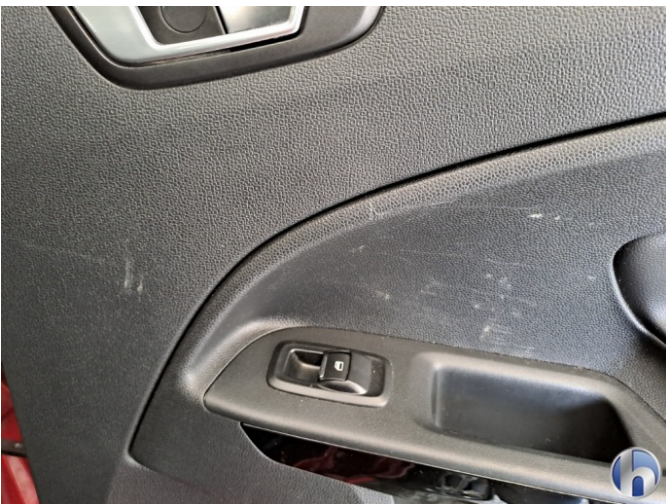
| component | Damage | Rep kind |
|---|---|---|
| 4. Door trim Rear - right | Scratch(es) | Replace |

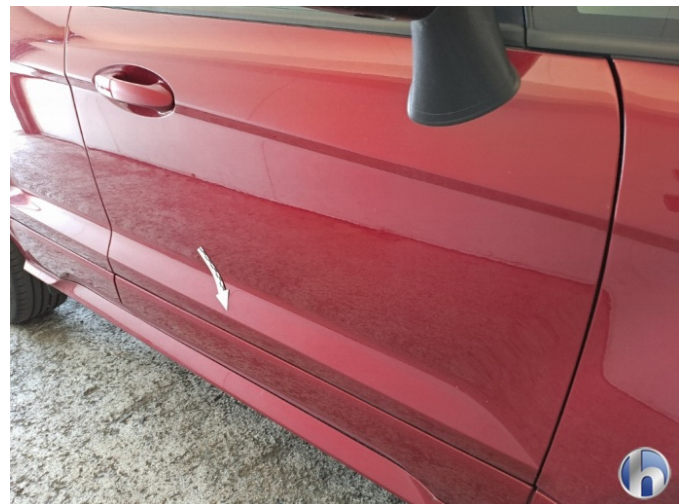
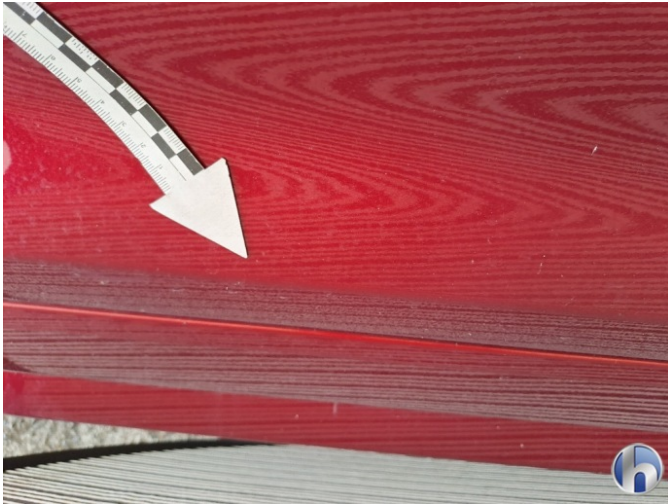
| component | Damage | Rep kind |
|---|---|---|
| 5. Front door - right | Execution defect | Paint |

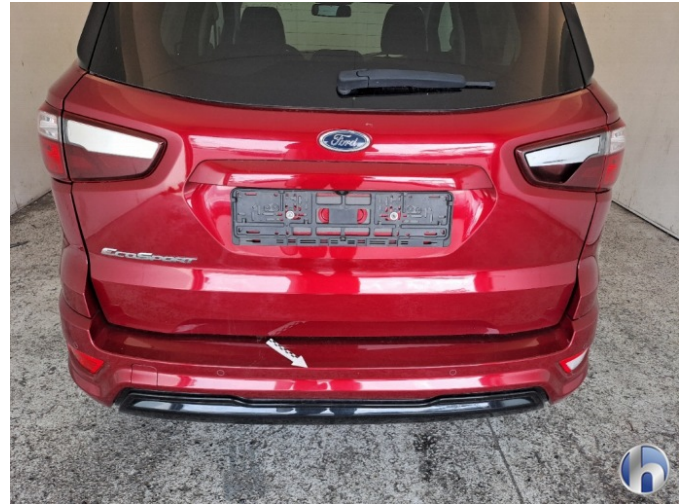
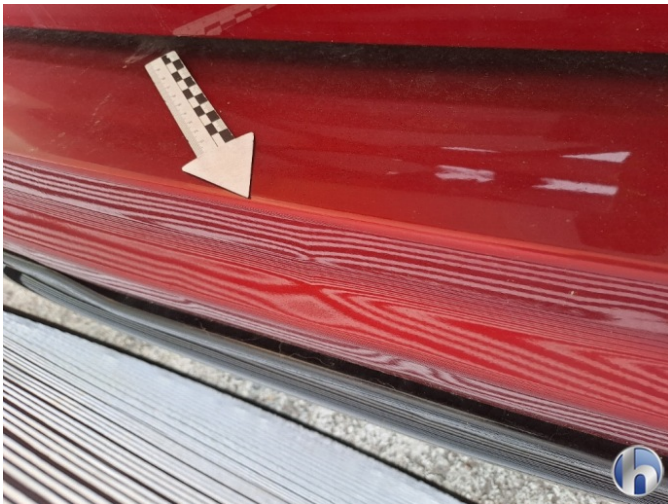
| component | Damage | Rep kind |
|---|---|---|
| 6. Rear bumper | Deformed | Replace |

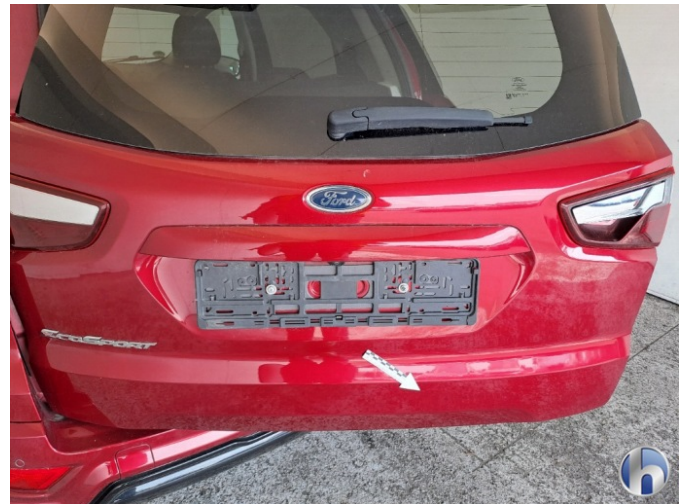
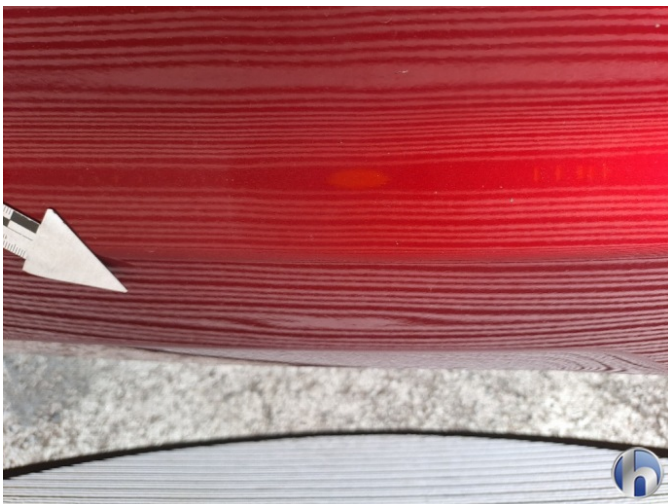
| component | Damage | Rep kind |
|---|---|---|
| 7. tailgate | Deformed | Smart repair |

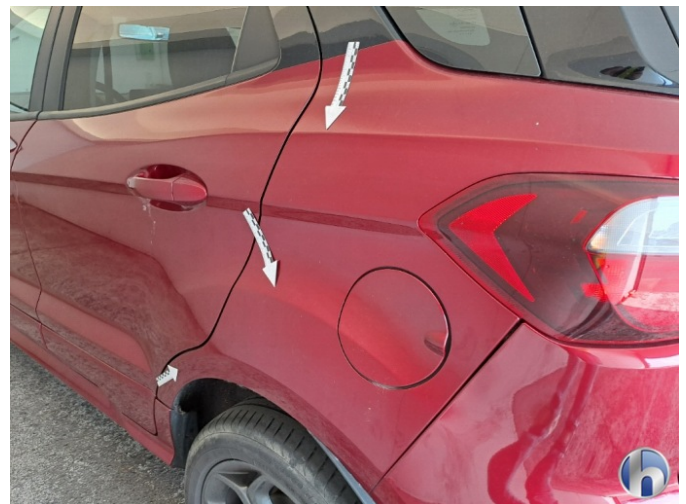
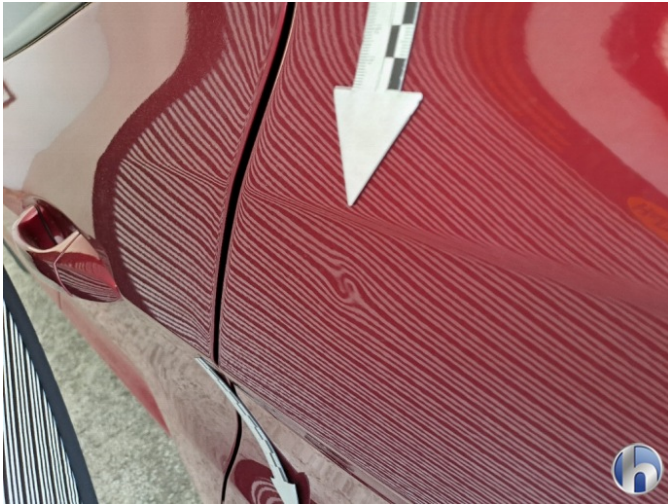
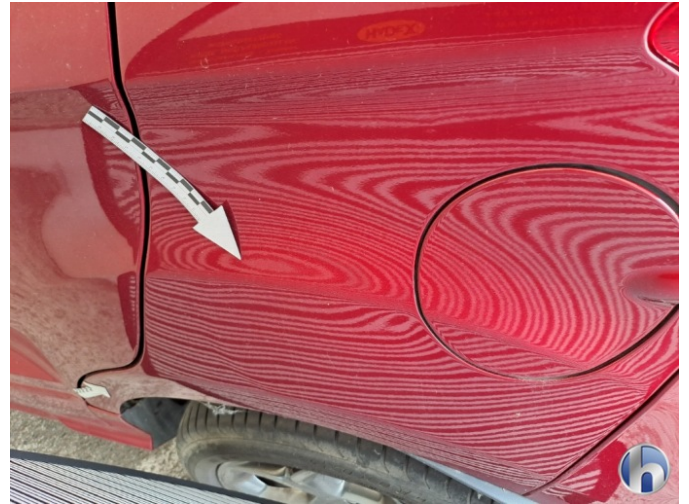
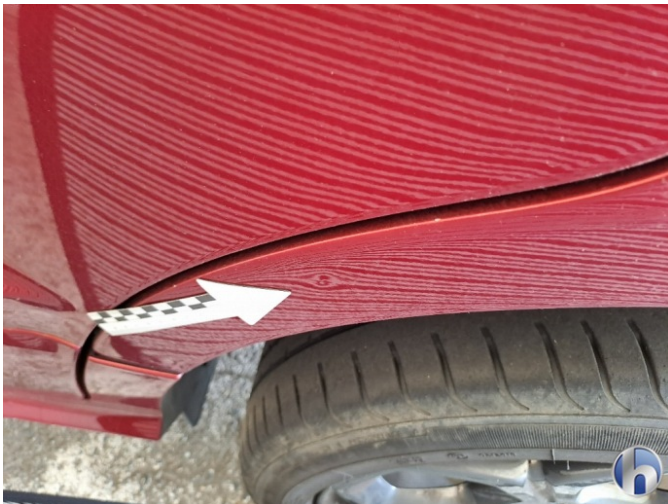
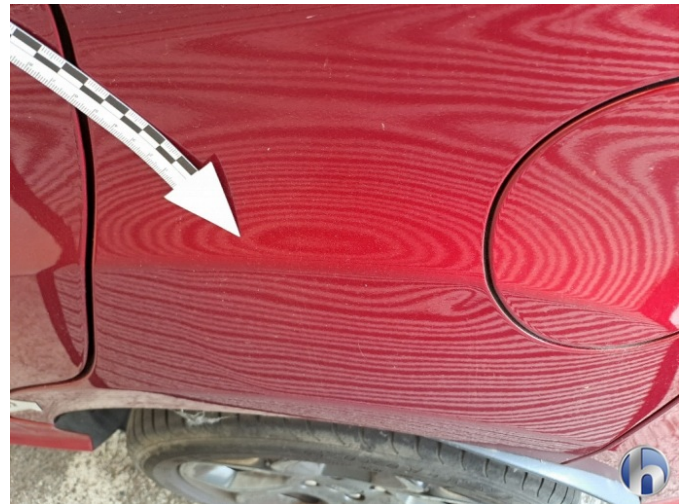
| component | Damage | Rep kind |
|---|---|---|
| 8. Sidewall - Rear - Left | Damaged | Refurbish and paint |

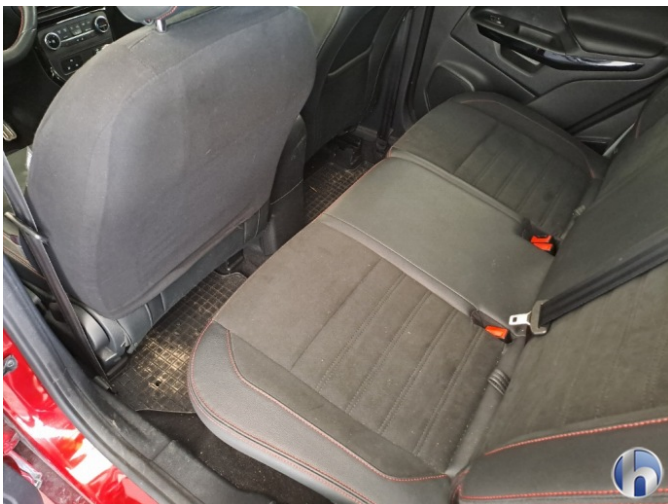
| component | Damage | Rep kind |
|---|---|---|
| 9. | Dirty | |

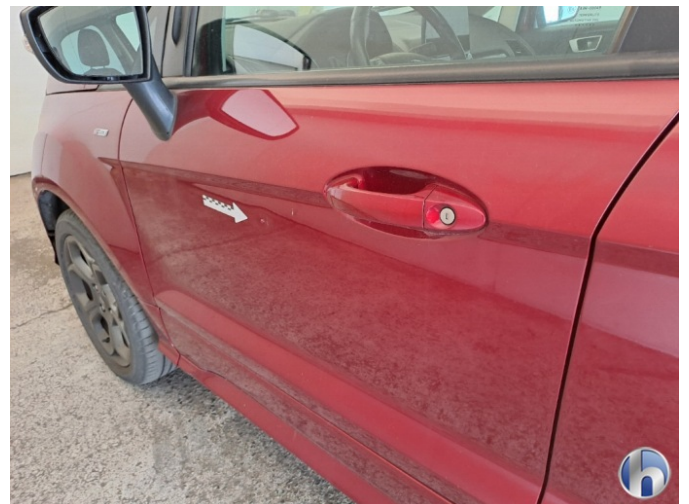
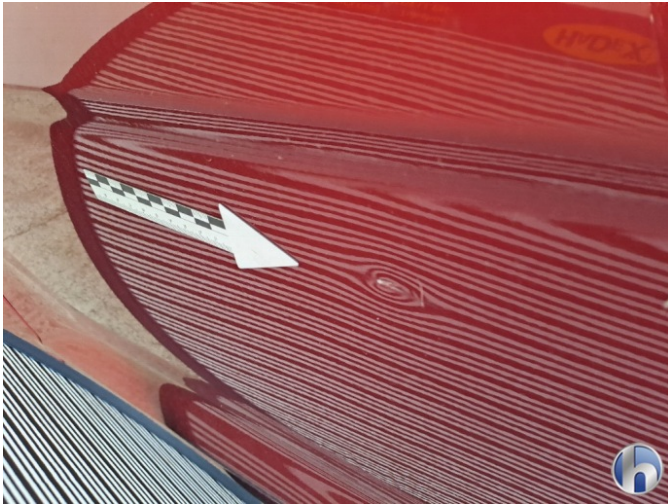
| component | Damage | Rep kind |
|---|---|---|
| 10. Front door - left | | Refurbish and paint |

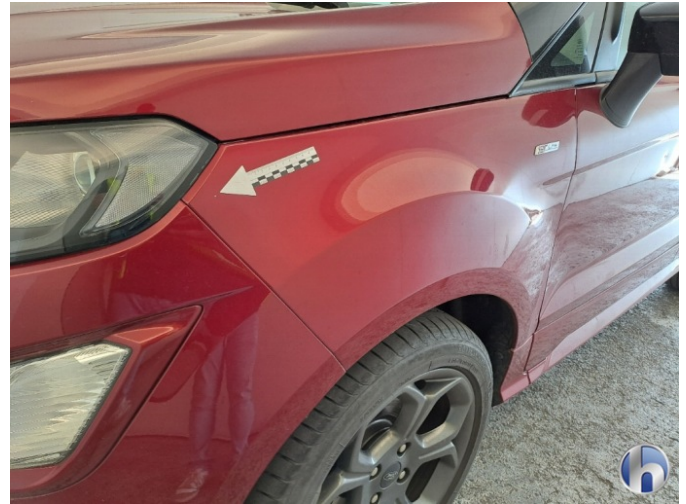
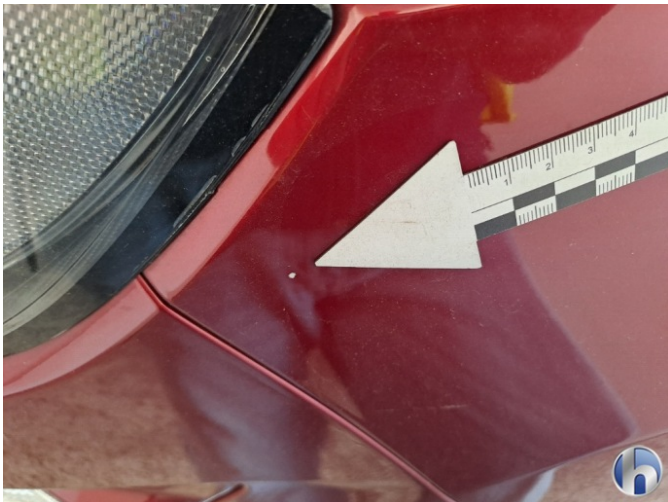
| component | Damage | Rep kind |
|---|---|---|
| 11. Front fender - left | Chipping from stones | Smart repair |

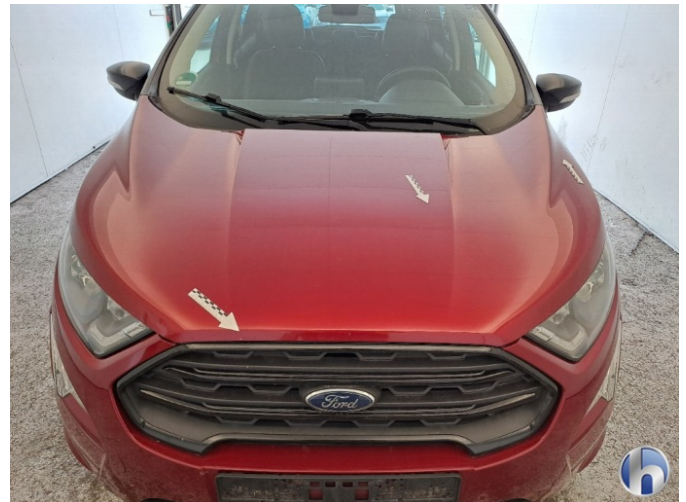
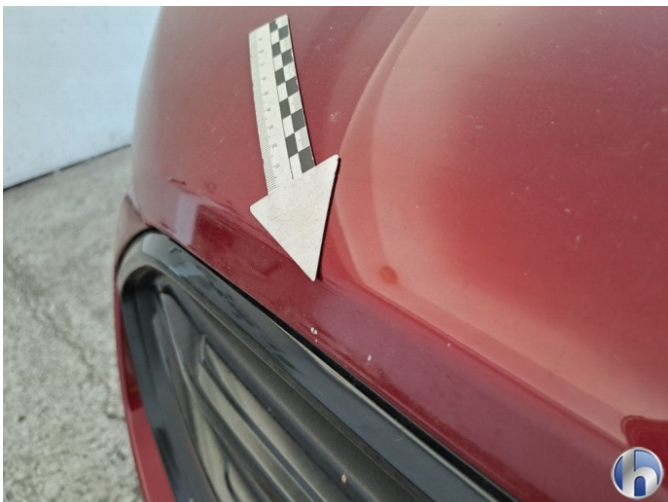
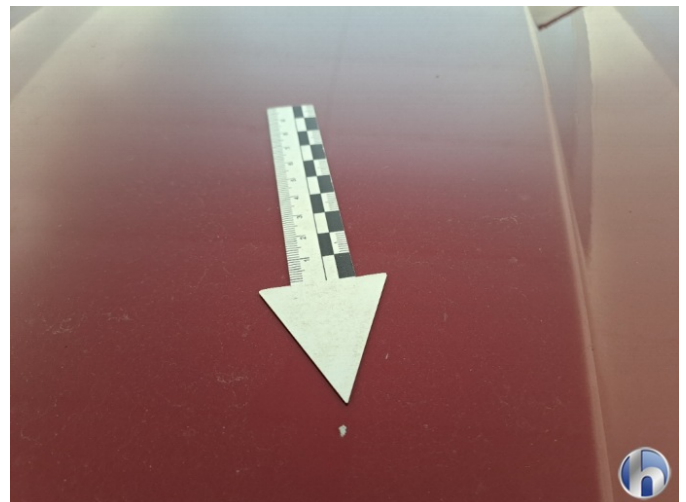
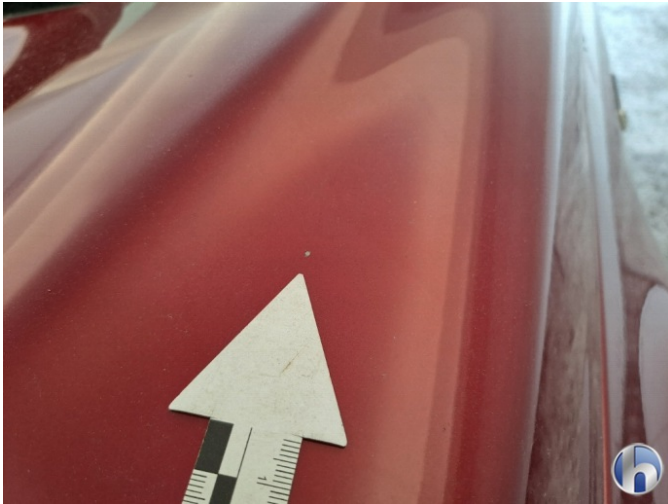
| component | Damage | Rep kind |
|---|---|---|
| 12. hood | Chipping from stones | Paint |
