Expertise

Protocol number: 41850732
Order number / reference: 25245127
Inspection date: 6 Oct 2025

Manufacturer: Ford

Model: Transit Custom Kombi 320 L2H2 VA Trend

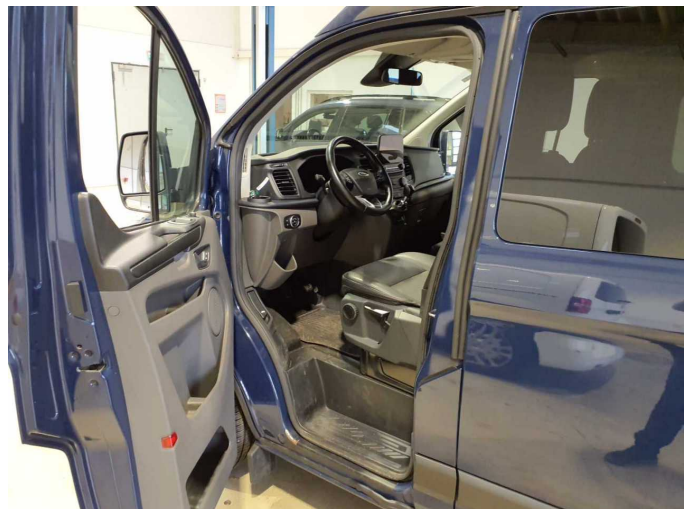
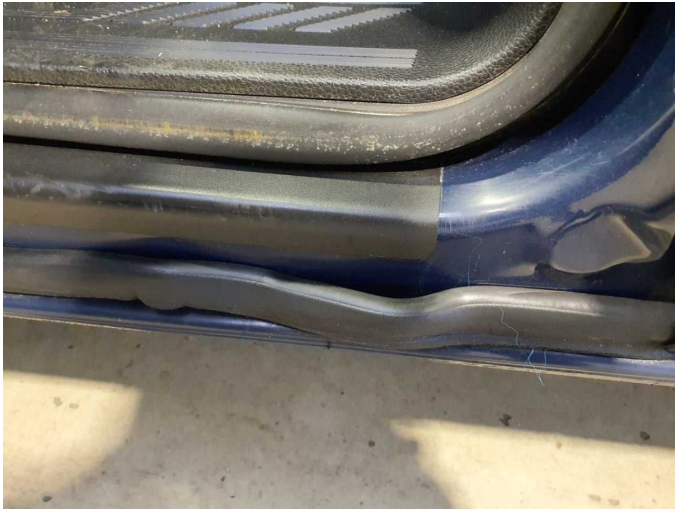
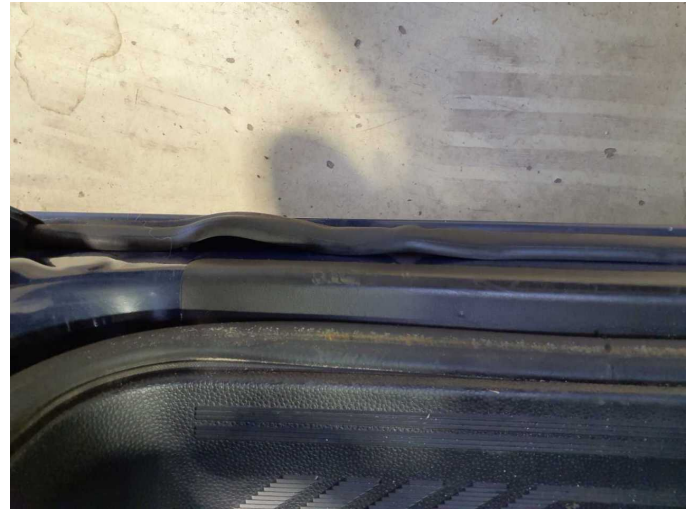
Damage 1: Door - front left side: Door seal - Loose - Un- / install

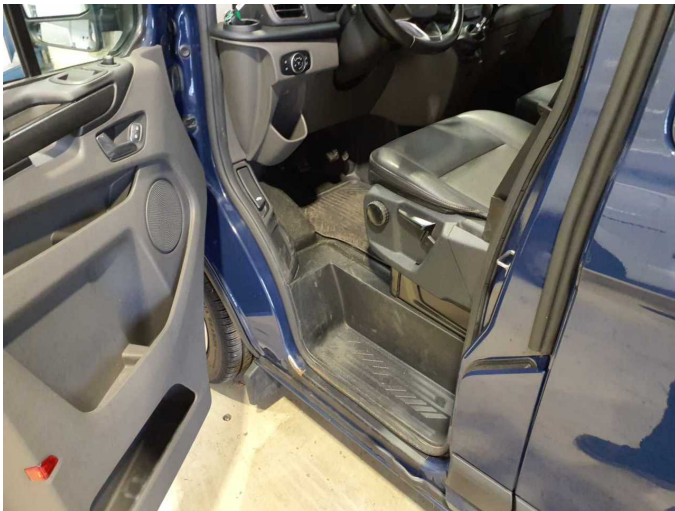
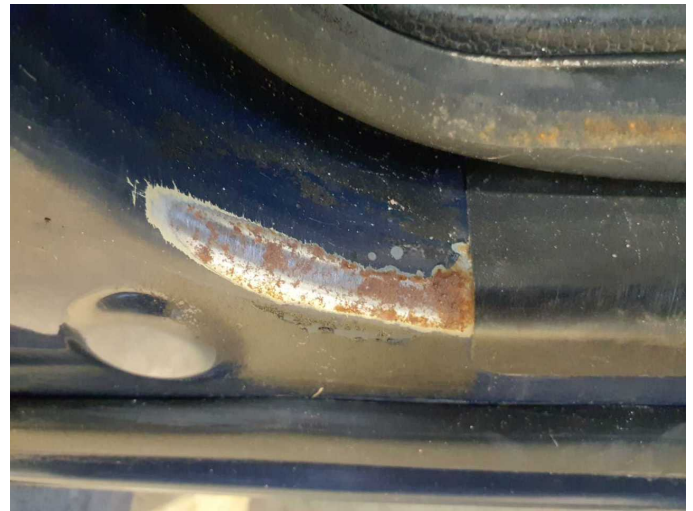
Damage 2: Sill - left side: Sill - Corrosion - Paint

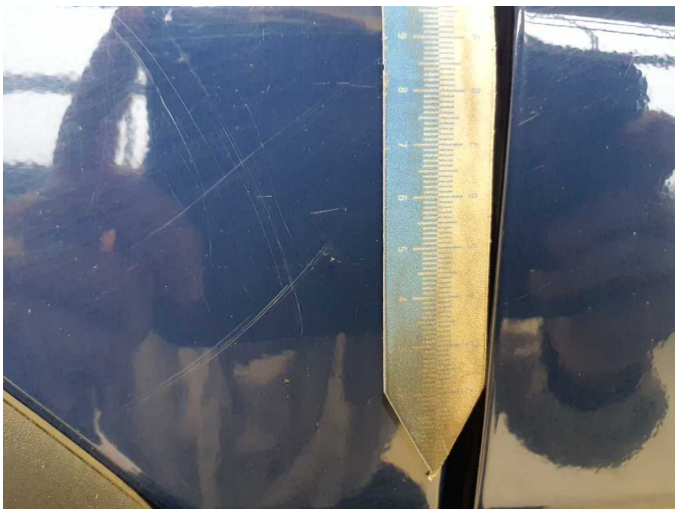
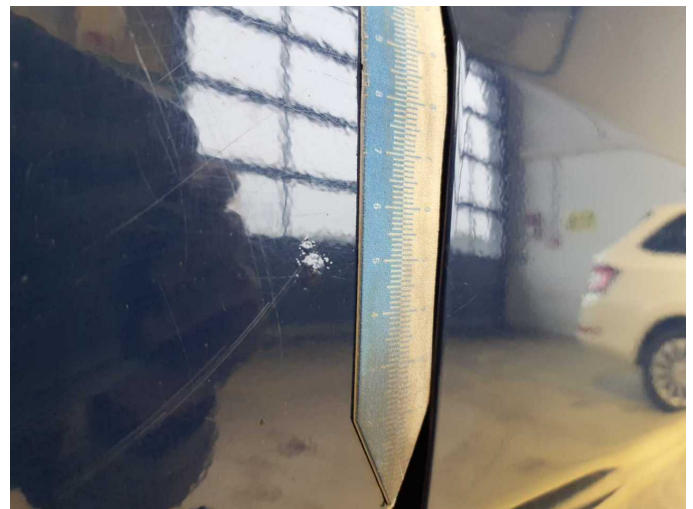
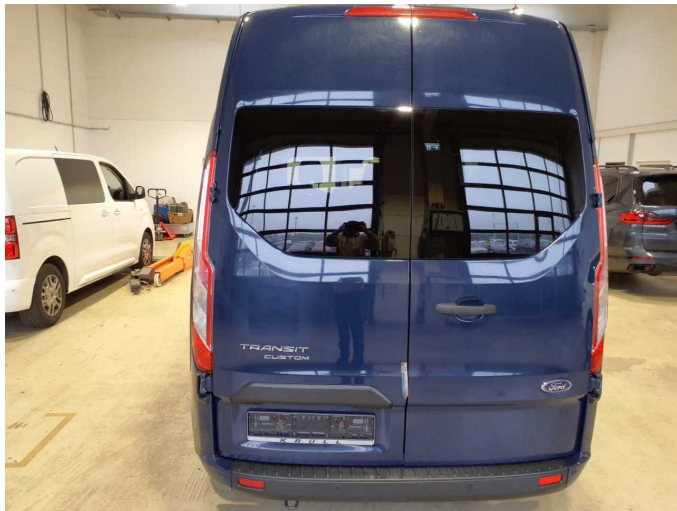
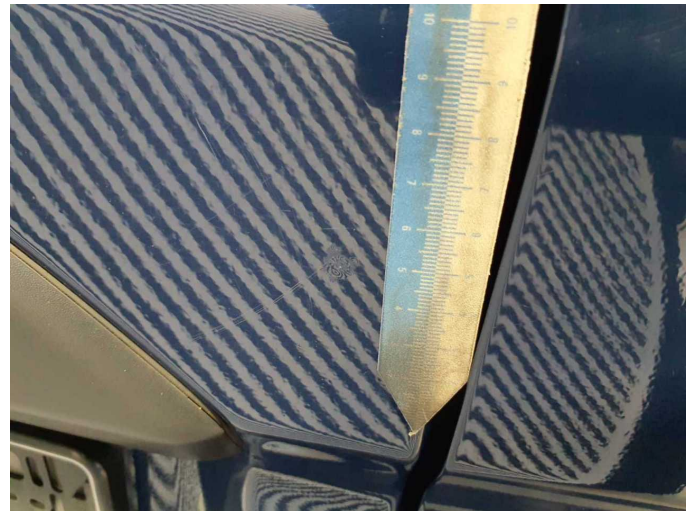
Damage 3: Boot lid / rear door: Rear door - left side - Corrosion - Repair and paint

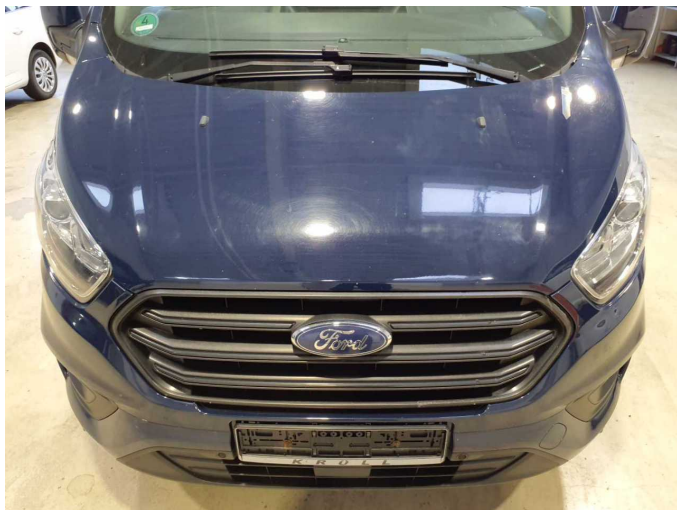
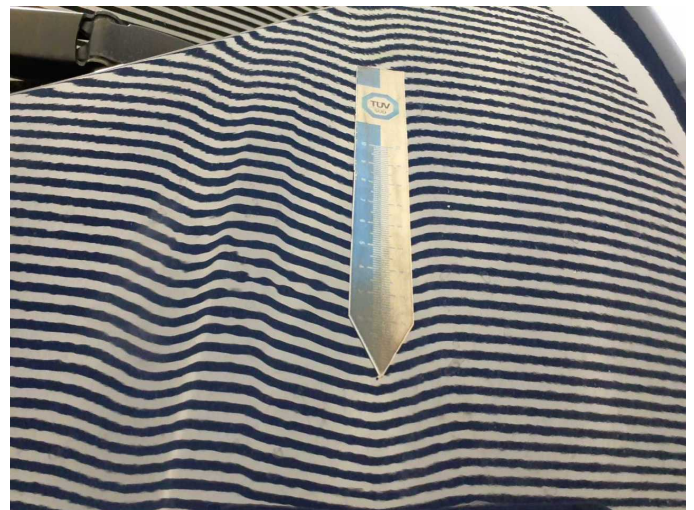
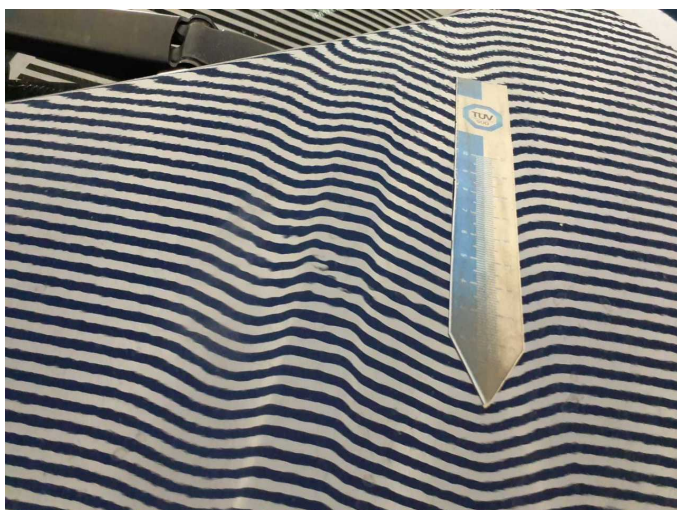
Damage 4: Bonnet: Bonnet (Wellig) - Paint defect - Repair and paint

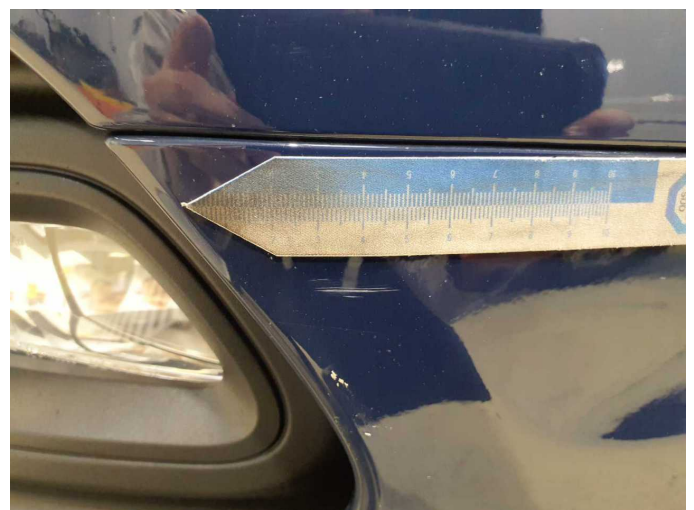
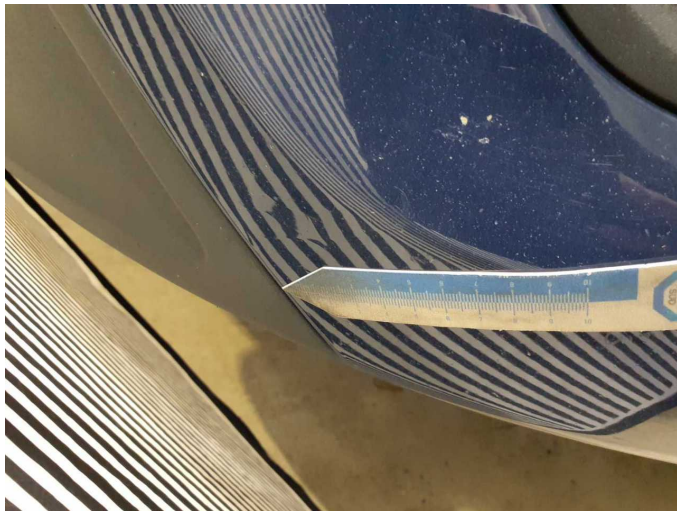
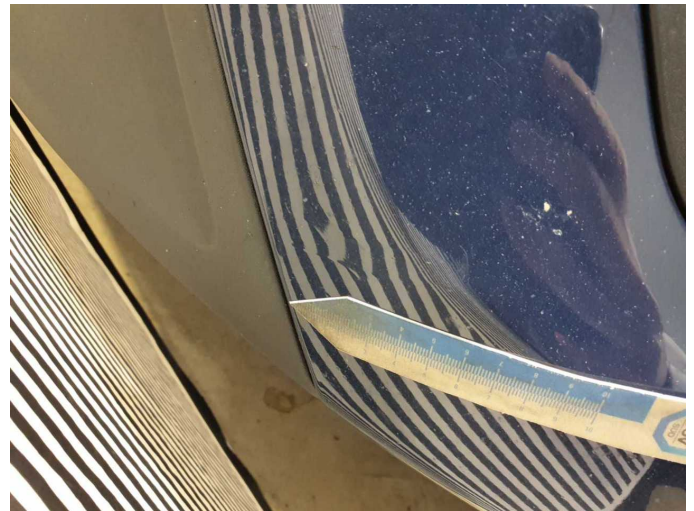
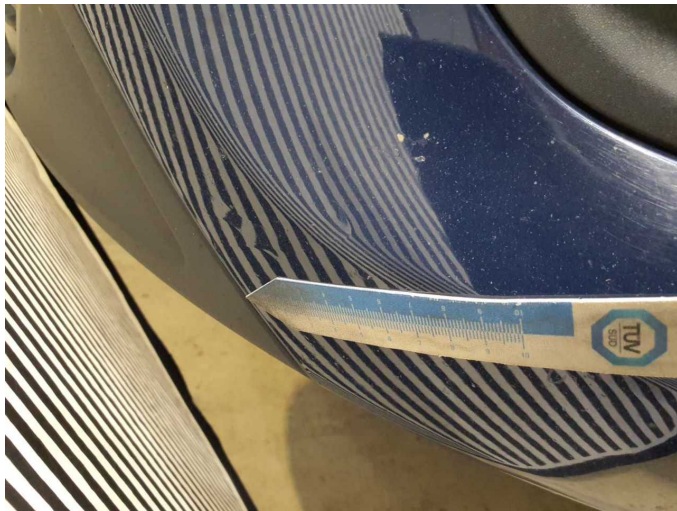
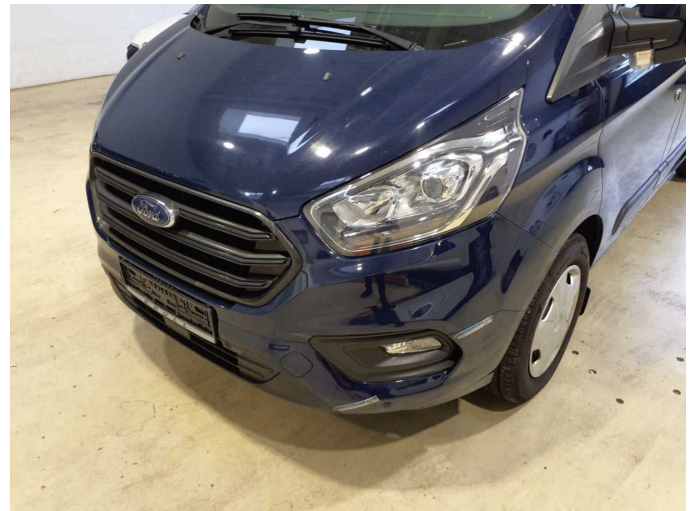
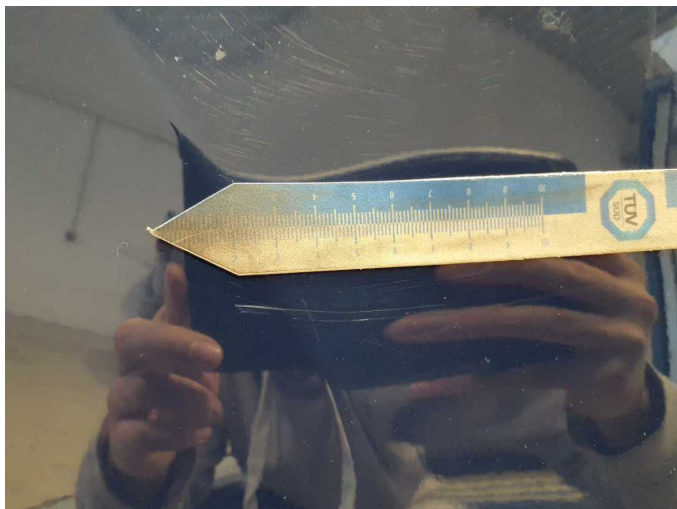
Damage 5: Front bumper: Front bumper - Dent / paintcoat damage - Repair and paint

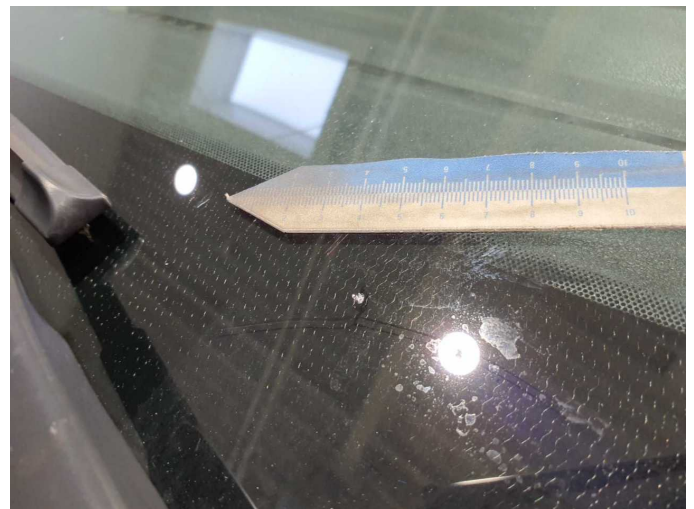
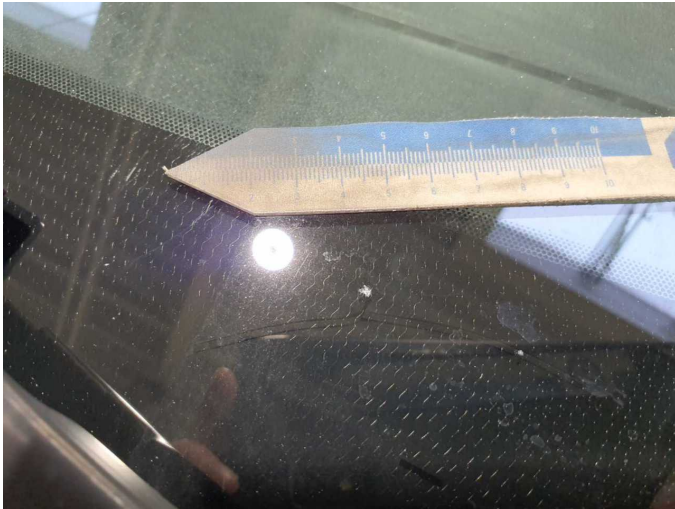
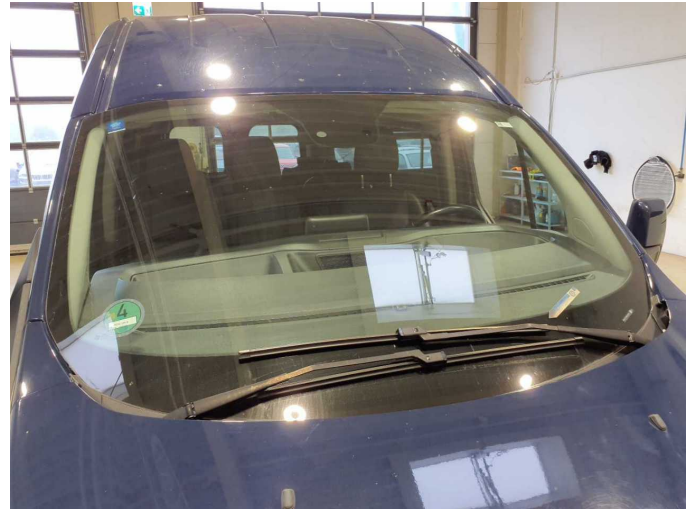
Damage 6: Vehicle glazing: Windscreen - Damaged - Replace

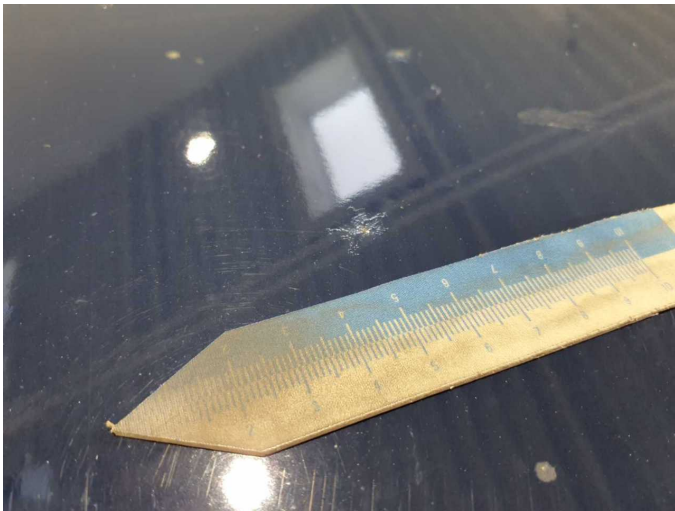
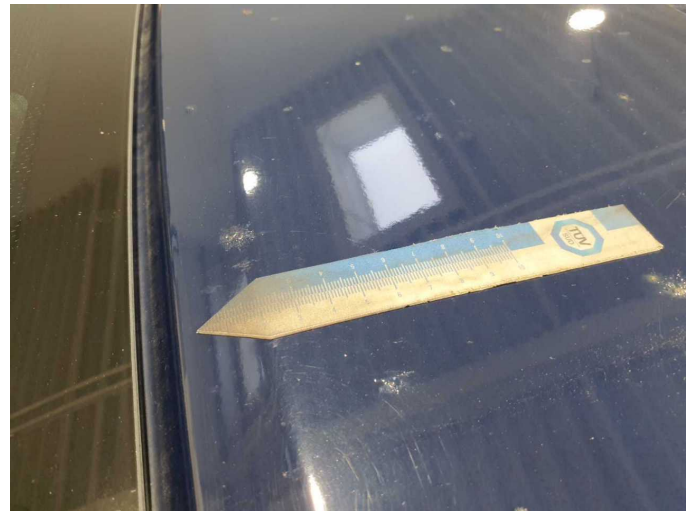
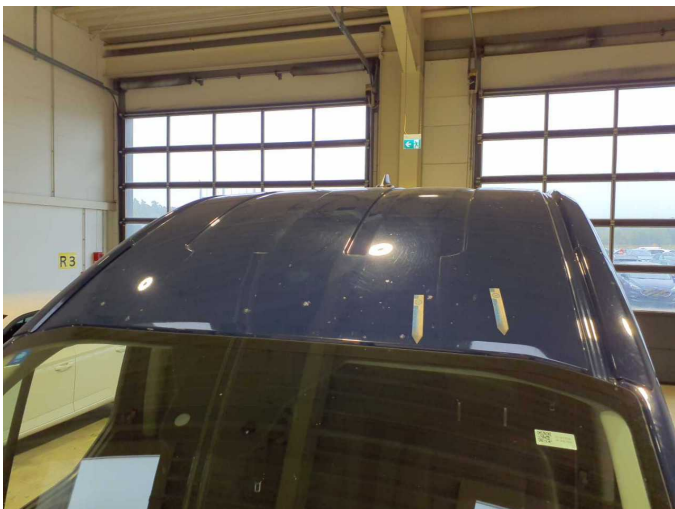
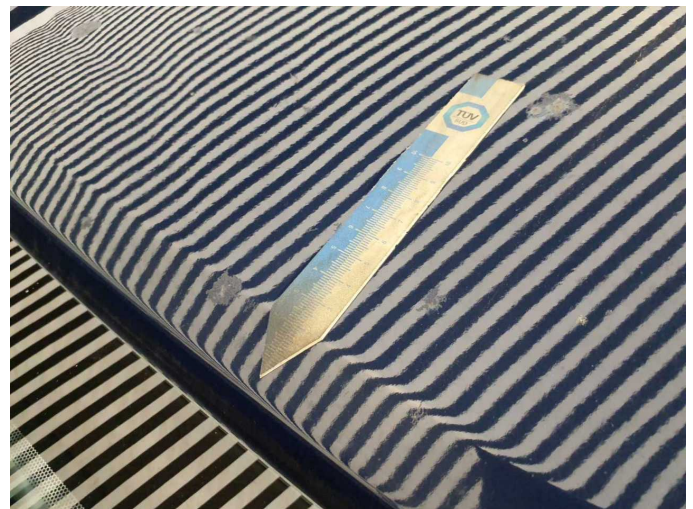
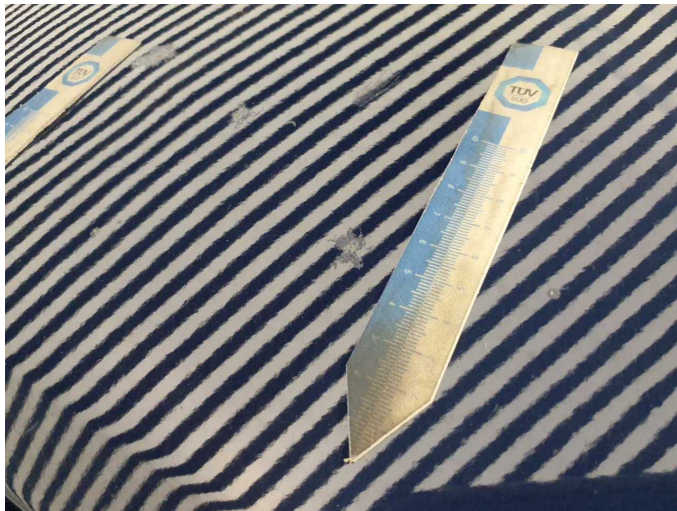
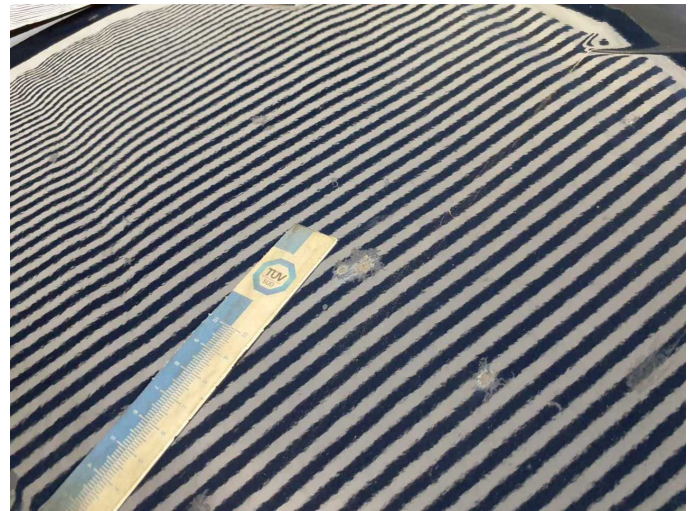
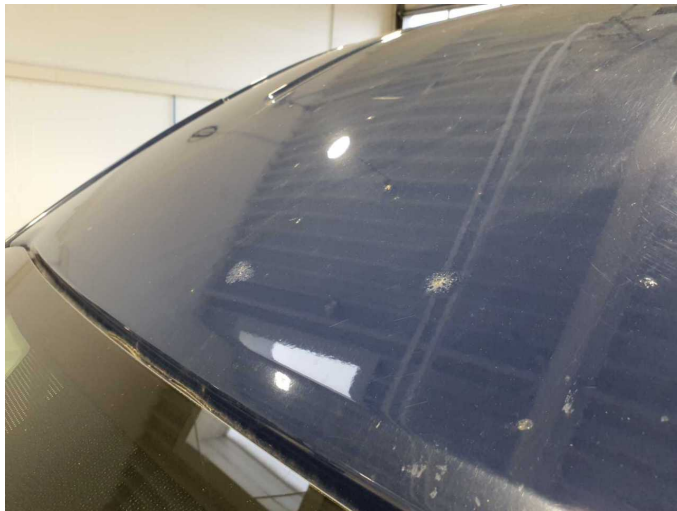
Damage 7: Roof: Roof - Corrosion - Repair and paint

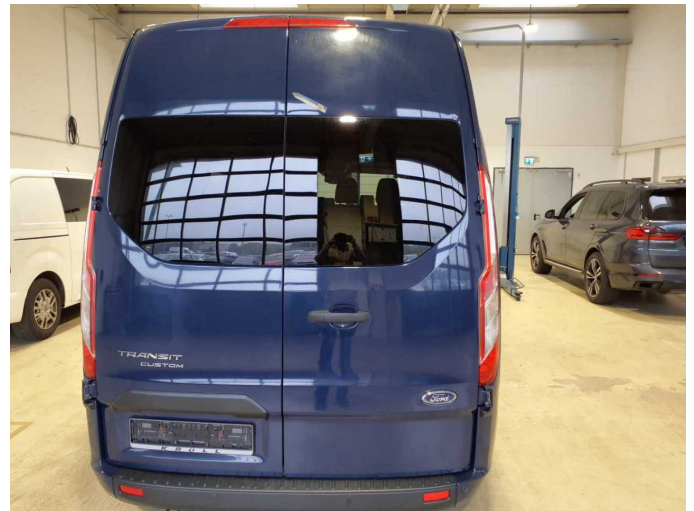
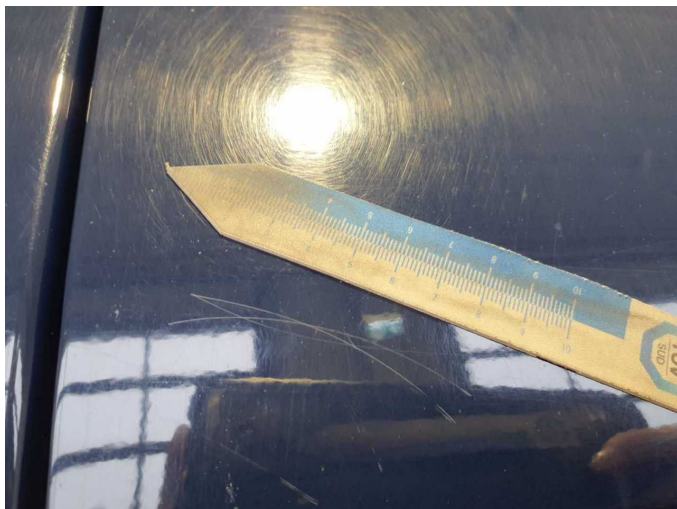
Wear and tear 3: Boot lid / rear door: Rear door - right side - Scratch(es)
- No deduction
