Expertise

Protocol number: 41592922
Order No. / Reference: 25201519
Inspection date: 17 Sept 2025

Manufacturer: Ford

Model: Tourneo Custom 320 L1H1 VA Trend

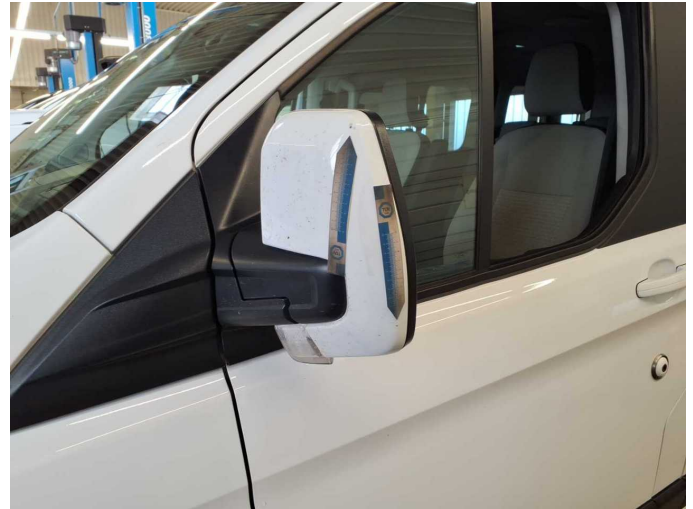
Damage 1: Wing mirror - left side: Cap - Scratch(es) - Paint

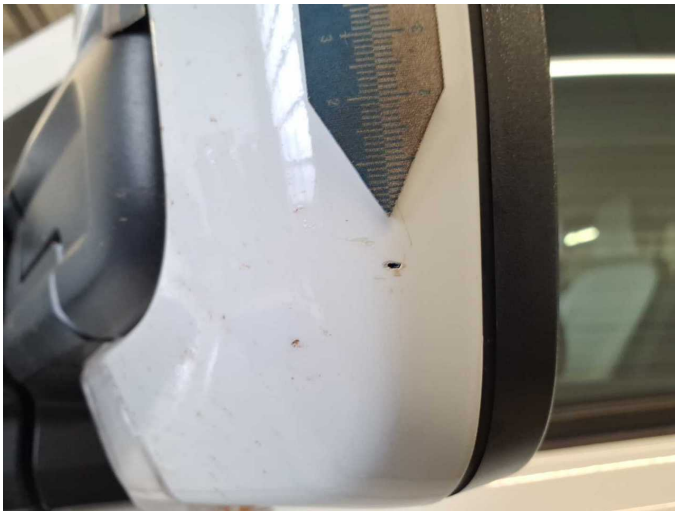
Damage 1: Wing mirror - left side: Cap - Scratch(es) - Paint

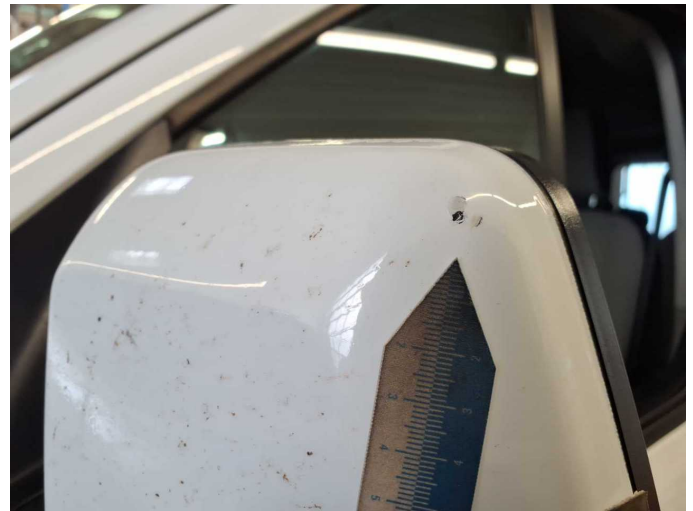
Damage 1: Wing mirror - left side: Cap - Scratch(es) - Paint

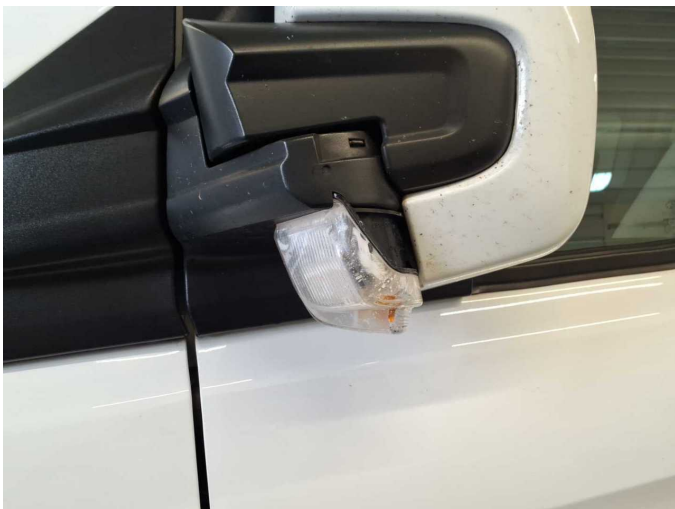
Damage 2: Indicator - front: Mirror - left side - Soiled - Replace

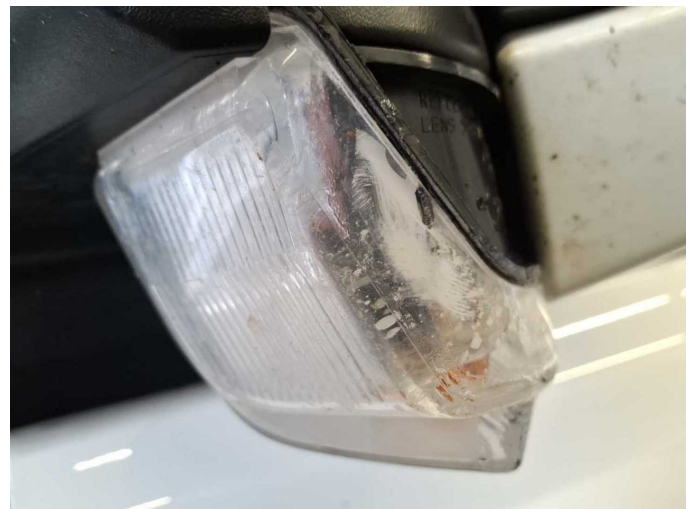
Damage 2: Indicator - front: Mirror - left side - Soiled - Replace

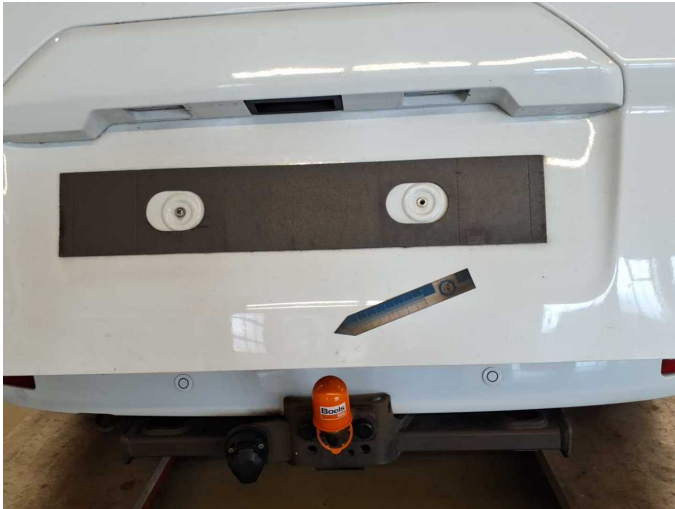
Damage 3: Boot lid / rear door: Boot lid glazed - dent(s) - Smart repair

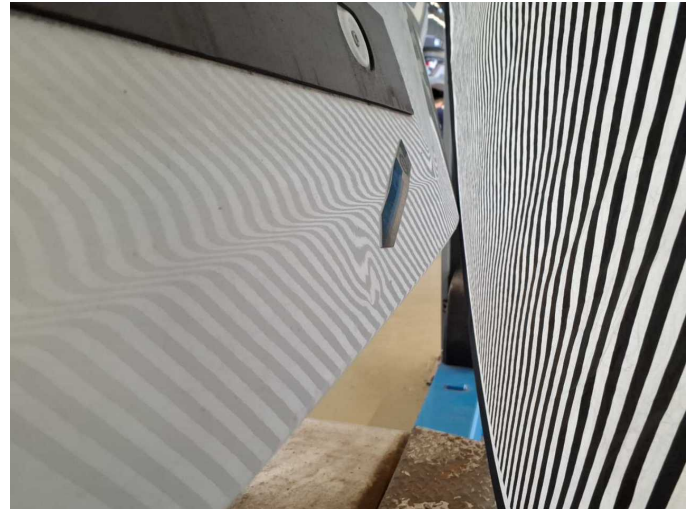
Damage 3: Boot lid / rear door: Boot lid glazed - dent(s) - Smart repair

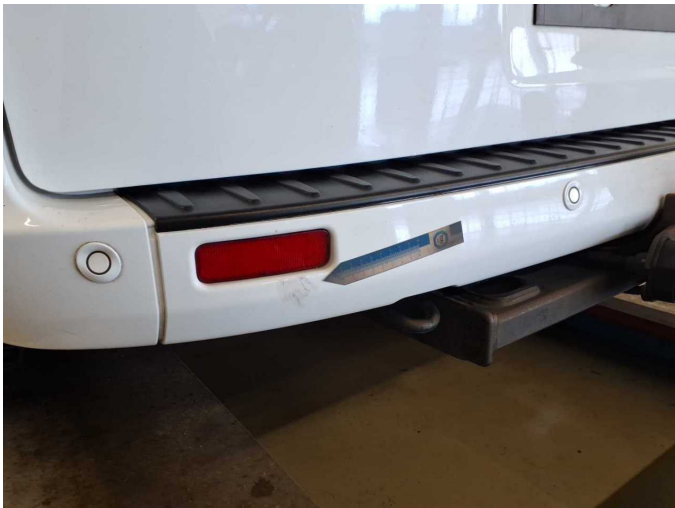
Damage 4: Rear bumper: Bumper with Parktronic - Unprofessionally repaired - Smart repair

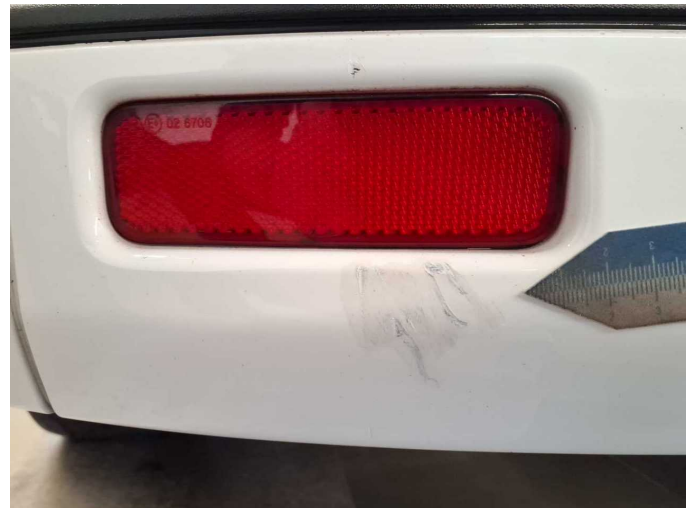
Damage 4: Rear bumper: Bumper with Parktronic - Unprofessionally repaired - Smart repair

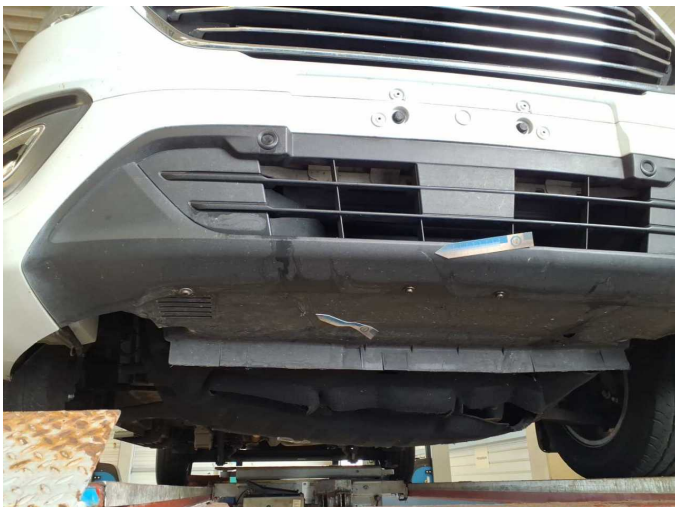
Damage 5: Front bumper: Air-inlet grille - Scratched - Replace

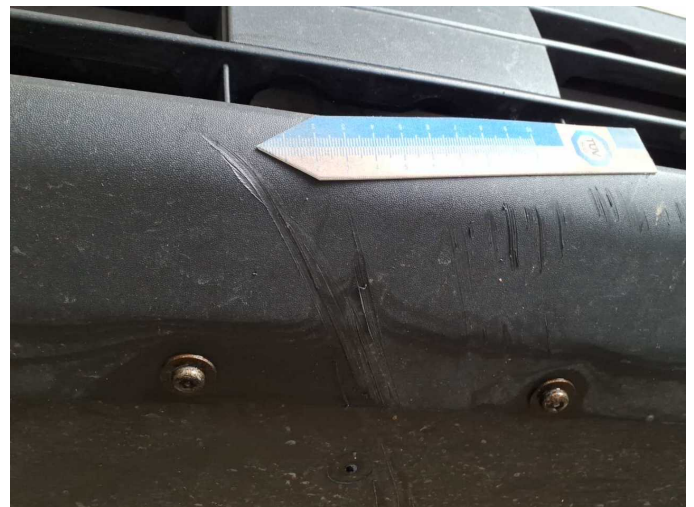
Damage 5: Front bumper: Air-inlet grille - Scratched - Replace

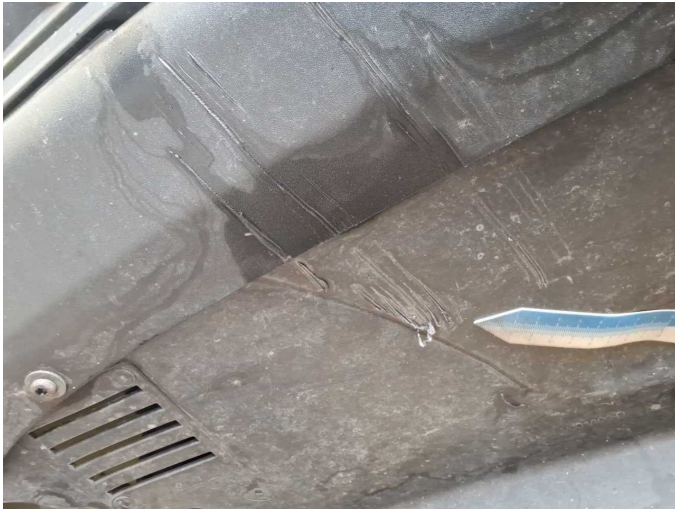
Damage 5: Front bumper: Air-inlet grille - Scratched - Replace

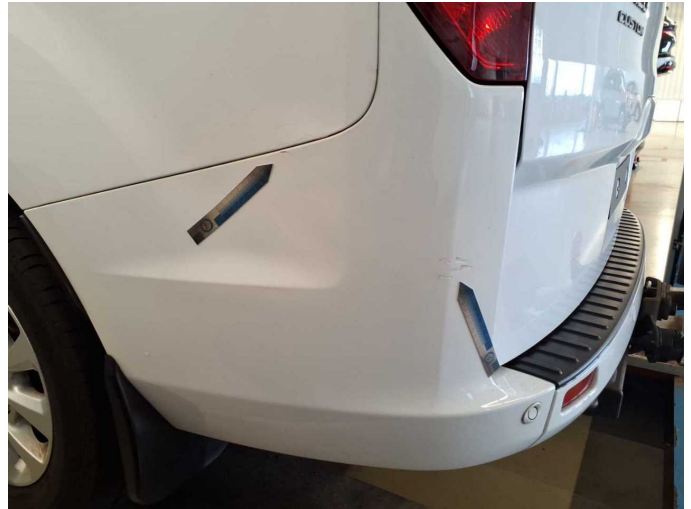
Damage 6: Rear bumper: Bumper - rear left side - Deformed - Replace

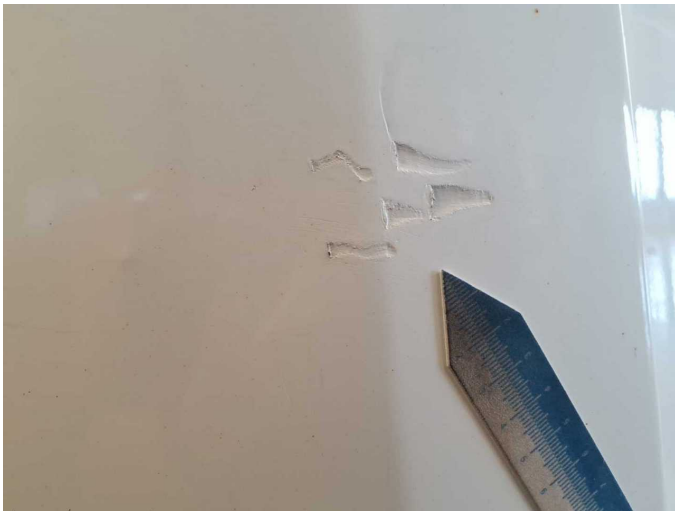
Damage 6: Rear bumper: Bumper - rear left side - Deformed - Replace

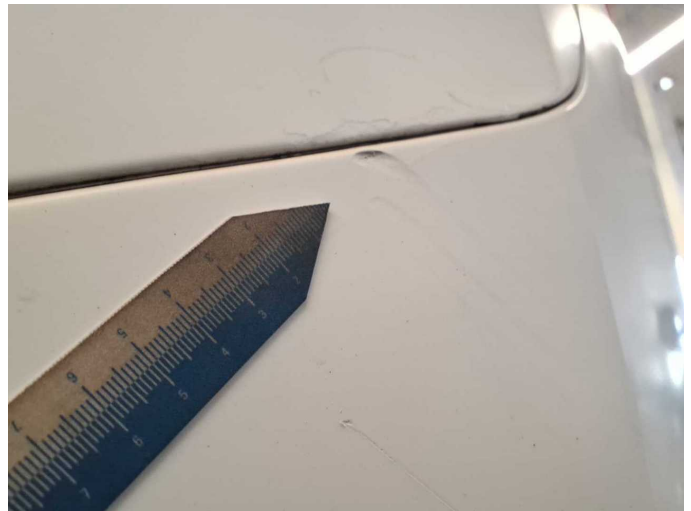
Damage 6: Rear bumper: Bumper - rear left side - Deformed - Replace

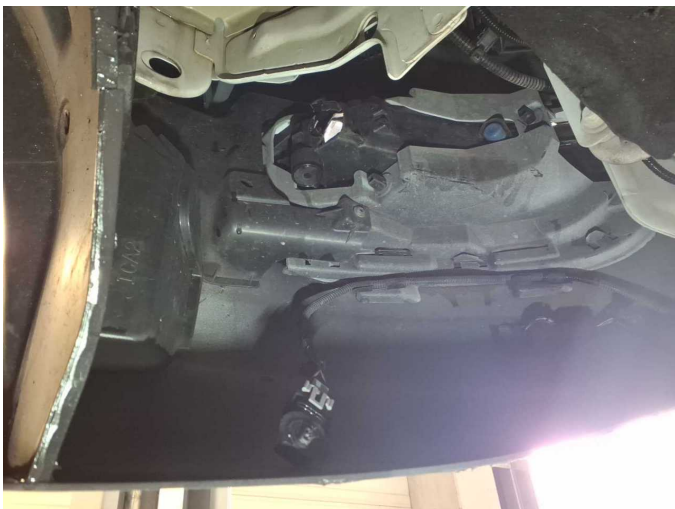
Damage 7: Fog lamp: Fog lamp - front left side - Broken / torn - Replace

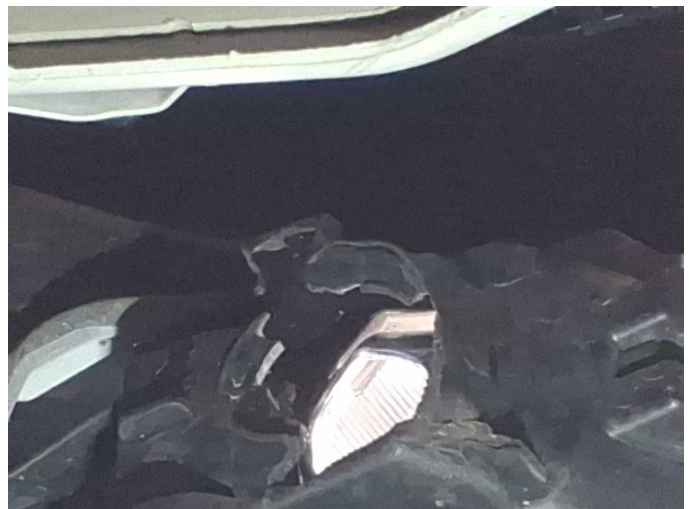
Damage 7: Fog lamp: Fog lamp - front left side - Broken / torn - Replace

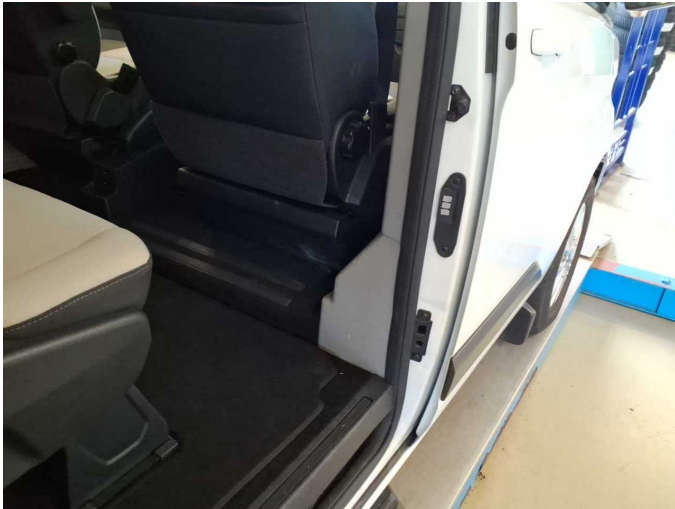
Damage 8: Trim / covers: Trim / covers (Innenraum/Laderaum) - Scratched - Loss in value

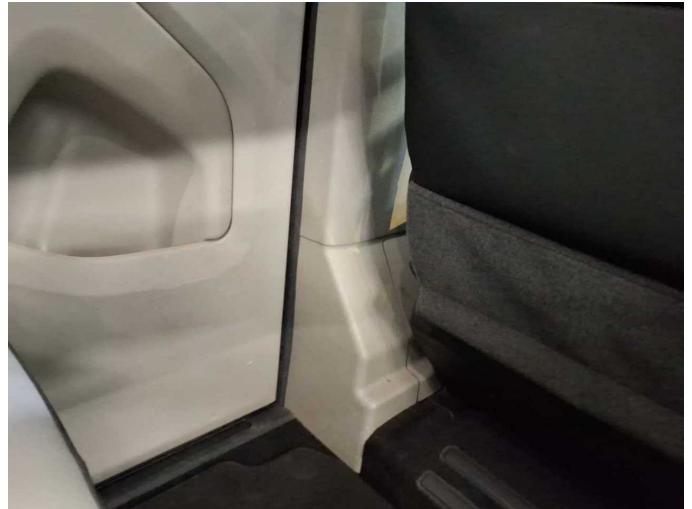
Damage 8: Trim / covers: Trim / covers (Innenraum/Laderaum) - Scratched - Loss in value

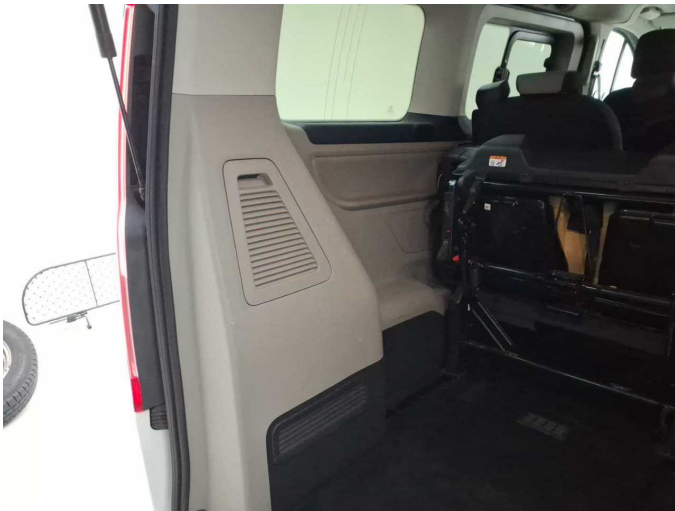
Damage 8: Trim / covers: Trim / covers (Innenraum/Laderaum) - Scratched - Loss in value

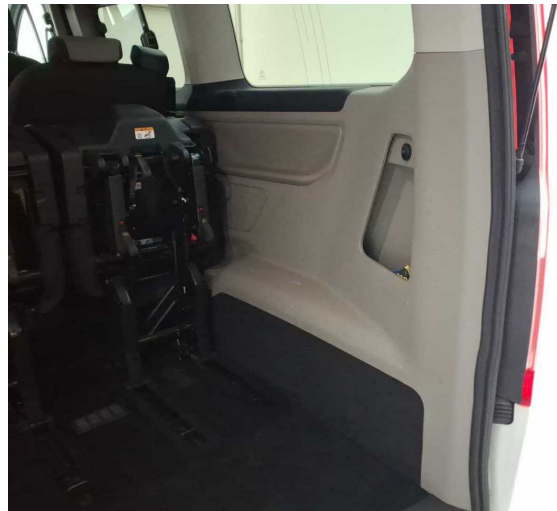
Damage 8: Trim / covers: Trim / covers (Innenraum/Laderaum) - Scratched - Loss in value

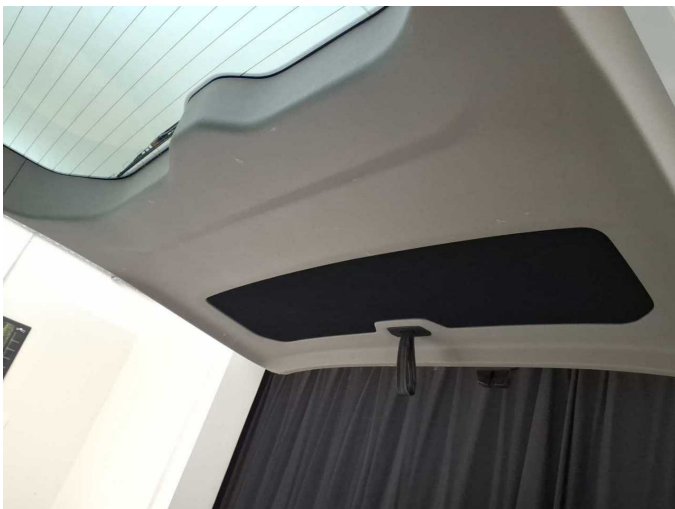
Damage 8: Trim / covers: Trim / covers (Innenraum/Laderaum) - Scratched - Loss in value

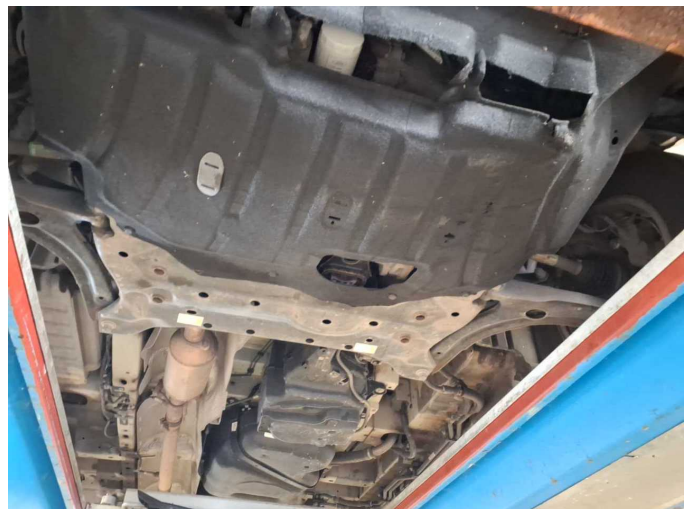
Damage 9: Engine: Engine cowl lower front - Broken / torn - Replace

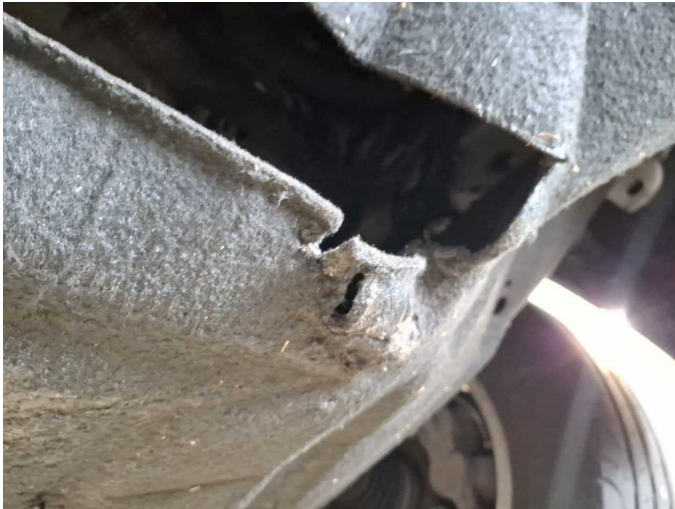
Damage 9: Engine: Engine cowling lower front - Broken / torn - Replace

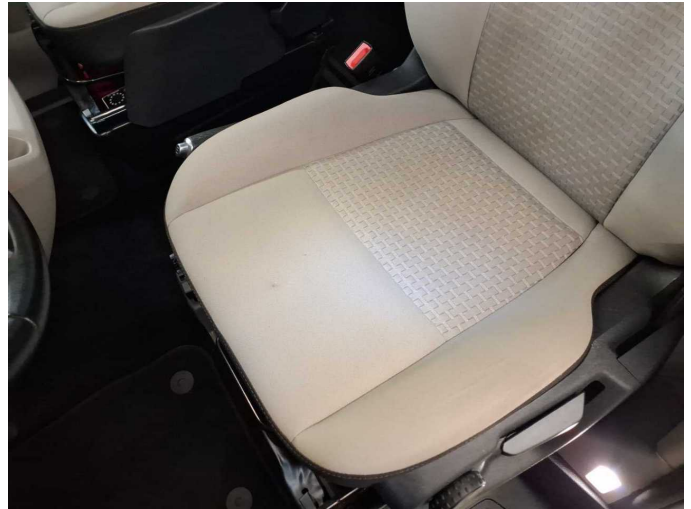
Damage 10: Seat - front: Seat cover - left side (Brandloch) - Unprofessionally repaired - Replace

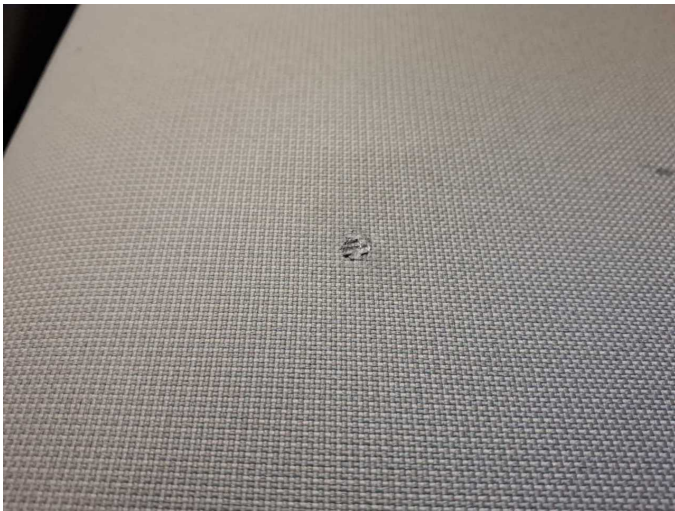
Damage 10: Seat - front: Seat cover - left side (Brandloch) - Unprofessionally repaired - Replace

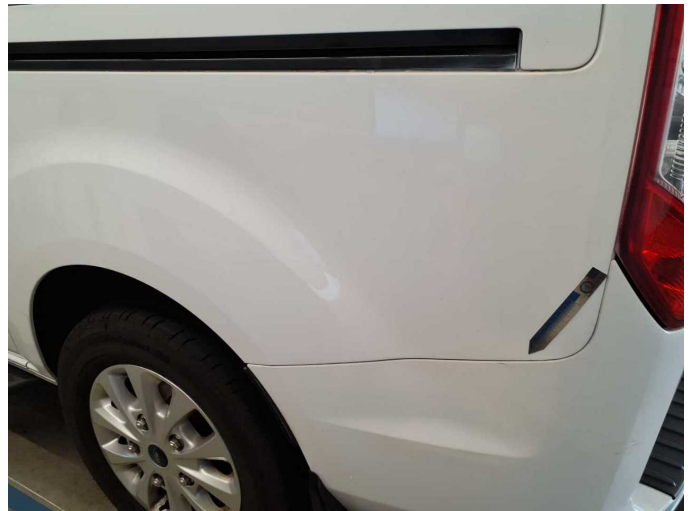
Damage 11: Side panel - rear left side: Side panel - Unprofessionally repaired - Paint

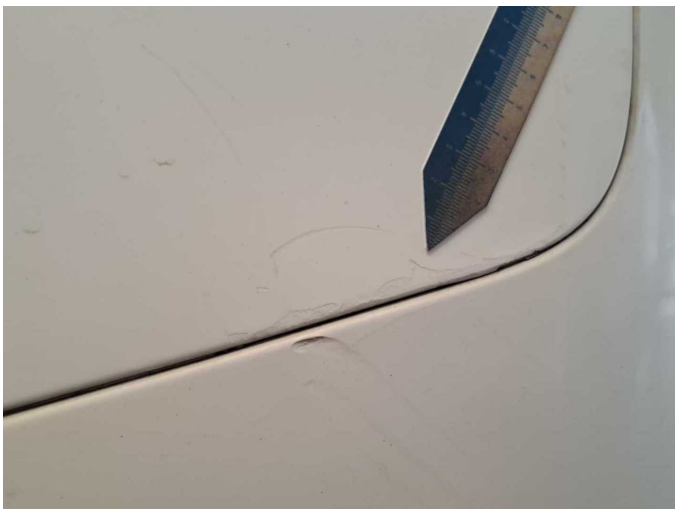
Damage 11: Side panel - rear left side: Side panel - Unprofessionally repaired - Paint

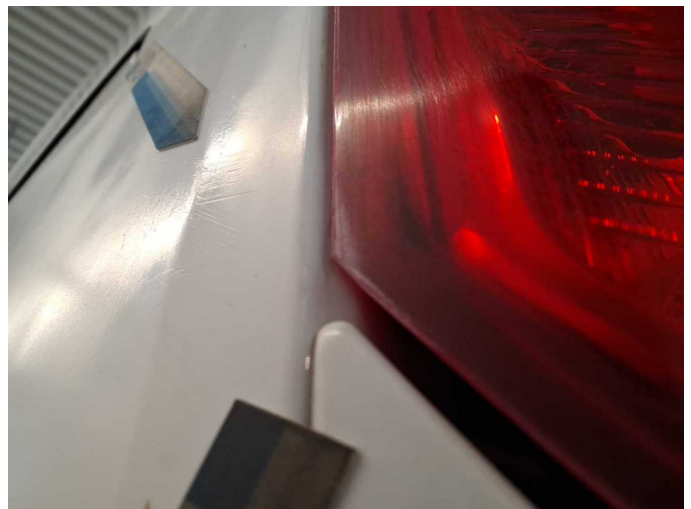
Damage 11: Side panel - rear left side: Side panel - Unprofessionally repaired - Paint

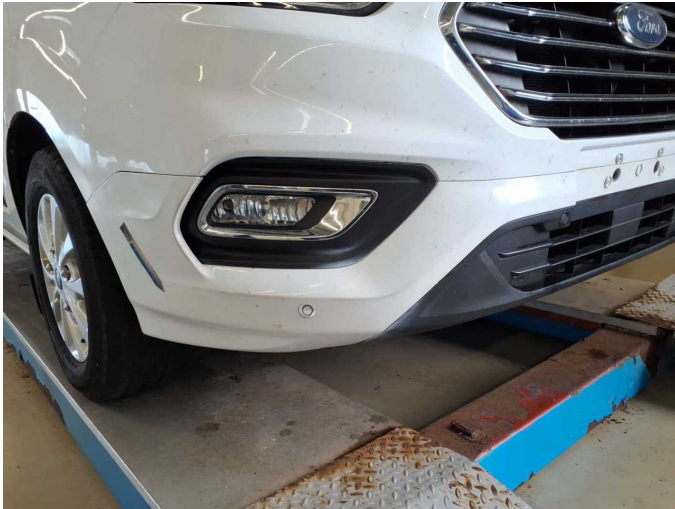
Damage 12: Front bumper: Bumper with Parktronic (Unterteil) - Deformed - Replace

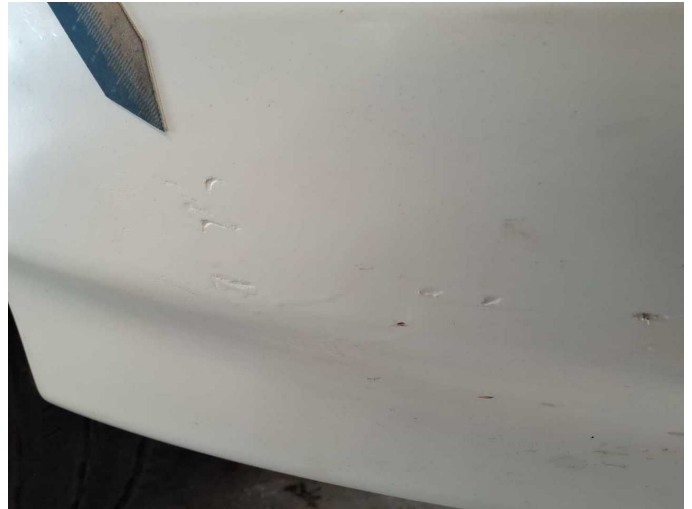
Damage 12: Front bumper: Bumper with Parktronic (Unterteil) - Deformed - Replace

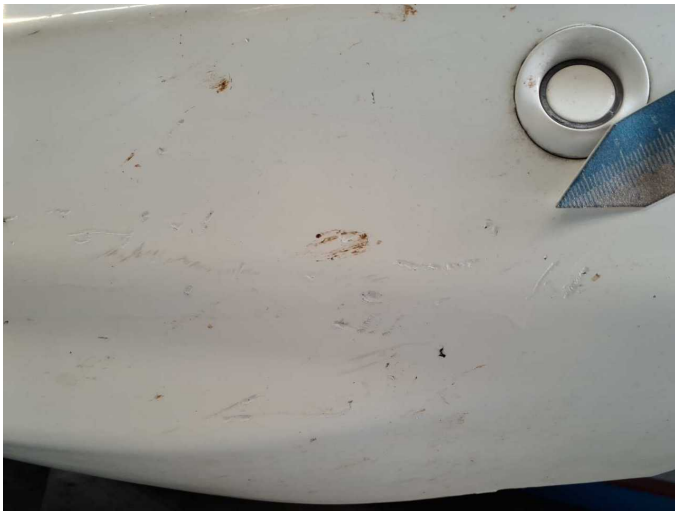
Damage 12: Front bumper: Bumper with Parktronic (Unterteil) - Deformed - Replace

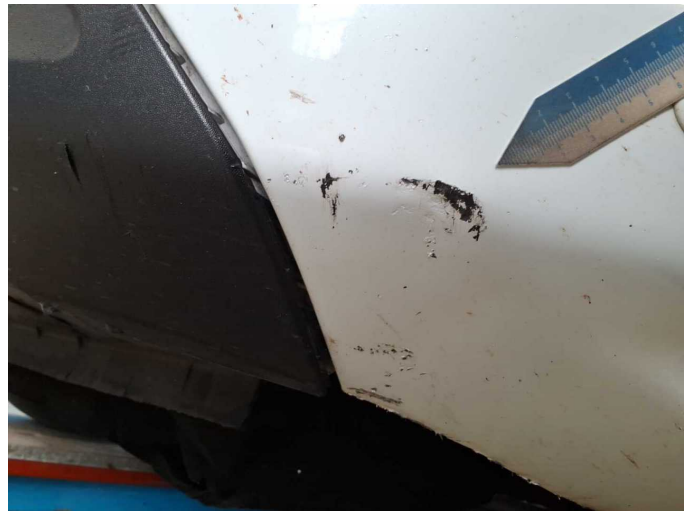
Damage 12: Front bumper: Bumper with Parktronic (Unterteil) - Deformed - Replace

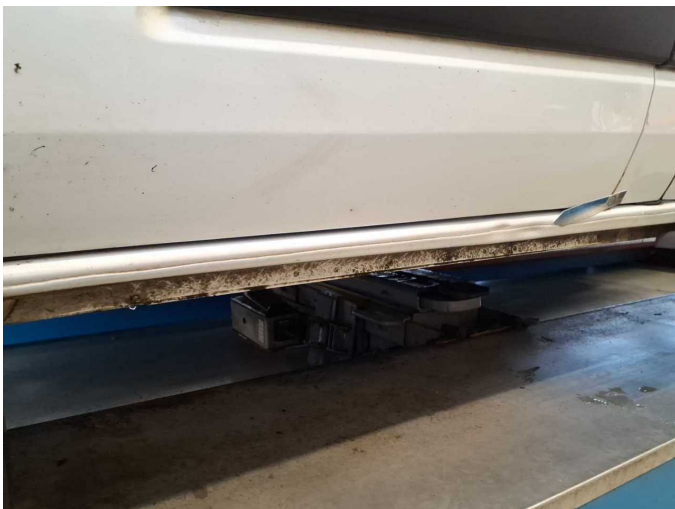
Damage 13: Sill - left side: Sill - dent(s) - Repair and paint

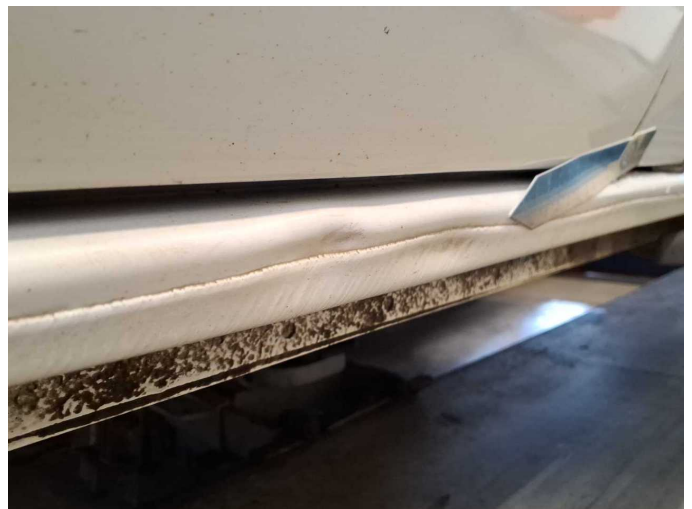
Damage 13: Sill - left side: Sill - dent(s) - Repair and paint

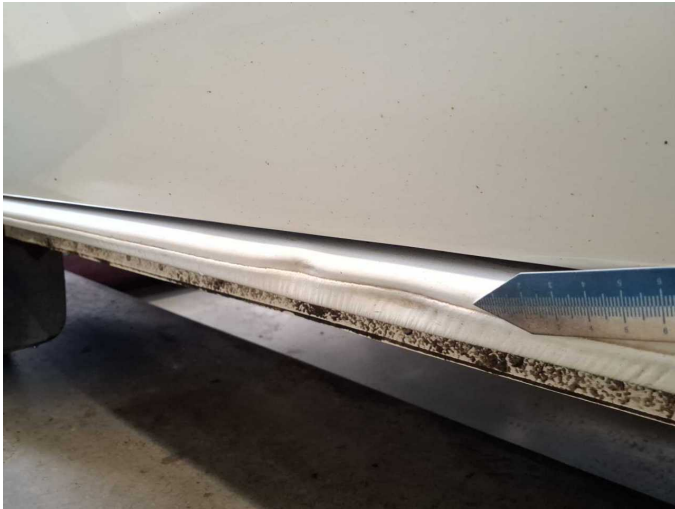
Damage 13: Sill - left side: Sill - dent(s) - Repair and paint

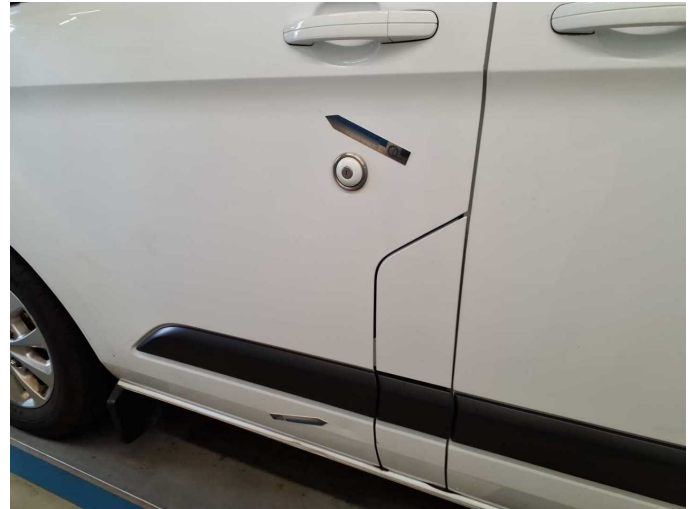
Damage 14: Door - front left side: Door - Dent / paintcoat damage - Repair and paint

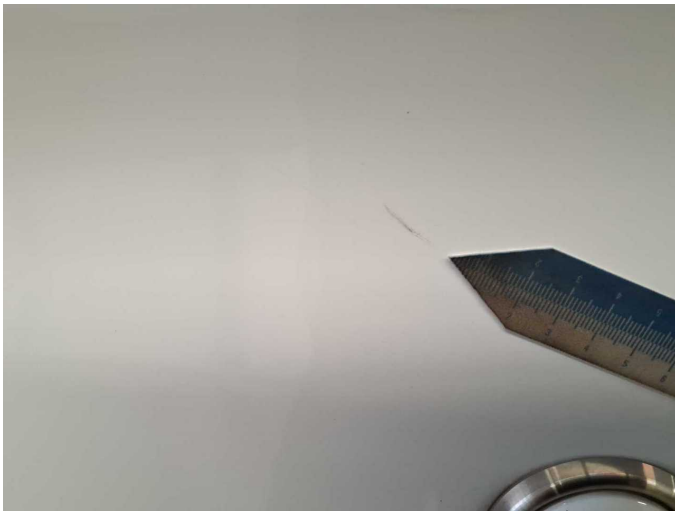
Damage 14: Door - front left side: Door - Dent / paintcoat damage - Repair and paint

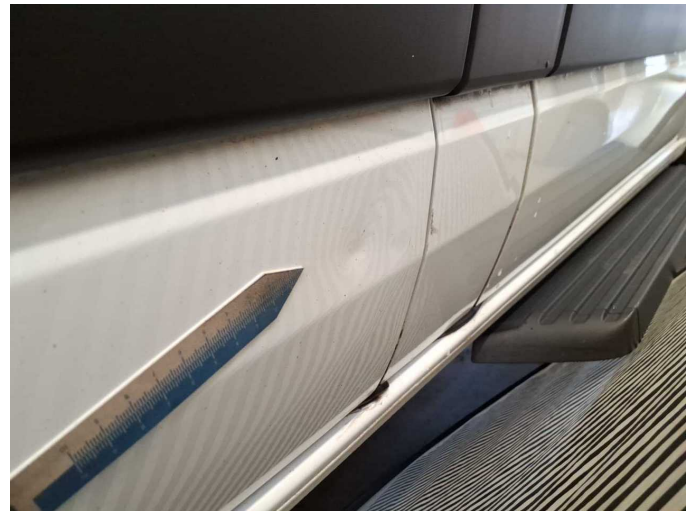
Damage 14: Door - front left side: Door - Dent / paintcoat damage - Repair and paint

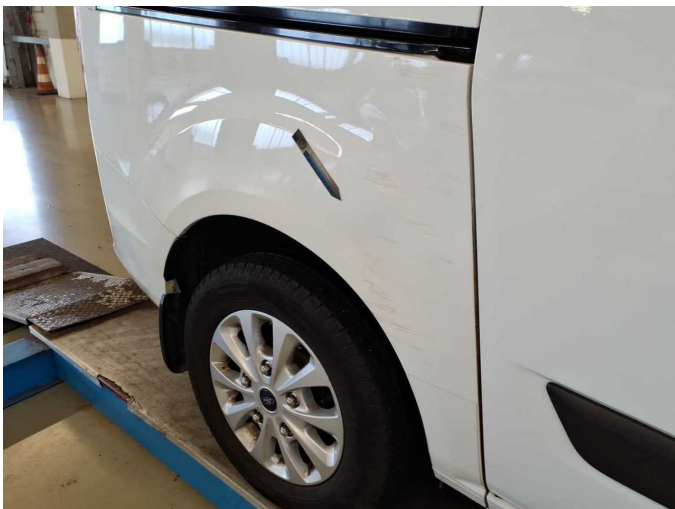
Damage 15: Side panel - rear right side: Side panel - Deformed - Repair and paint

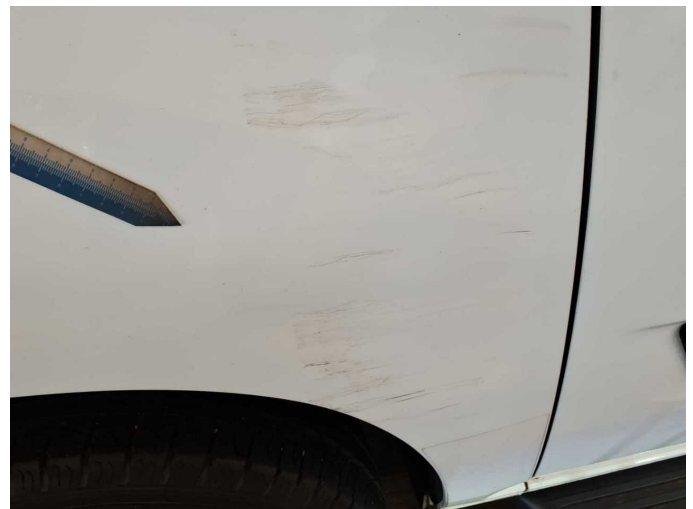
Damage 15: Side panel - rear right side: Side panel - Deformed - Repair and paint

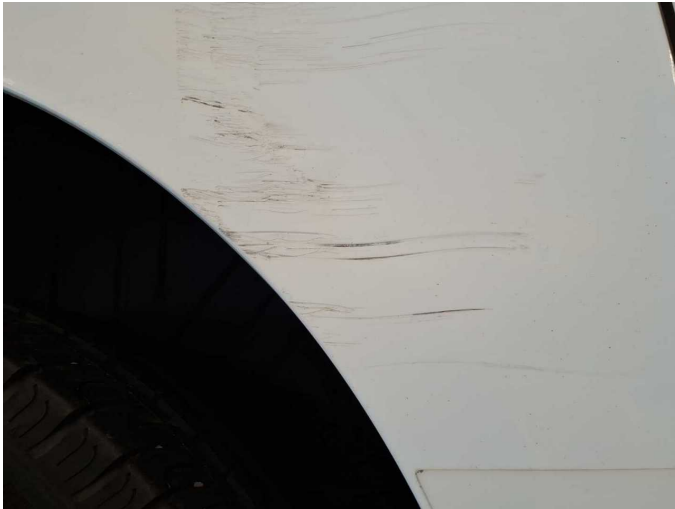
Damage 15: Side panel - rear right side: Side panel - Deformed - Repair and paint

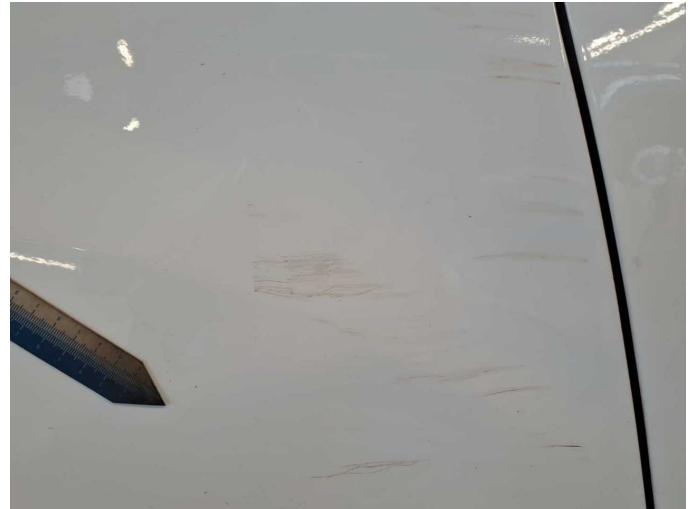
Damage 15: Side panel - rear right side: Side panel - Deformed - Repair and paint

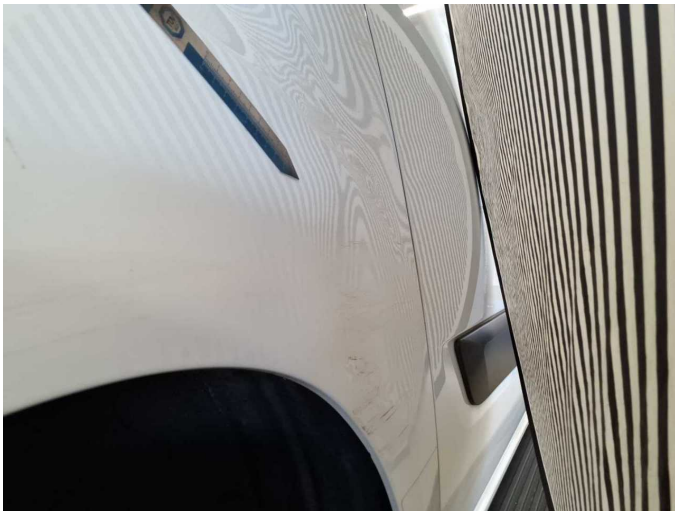
Damage 15: Side panel - rear right side: Side panel - Deformed - Repair and paint

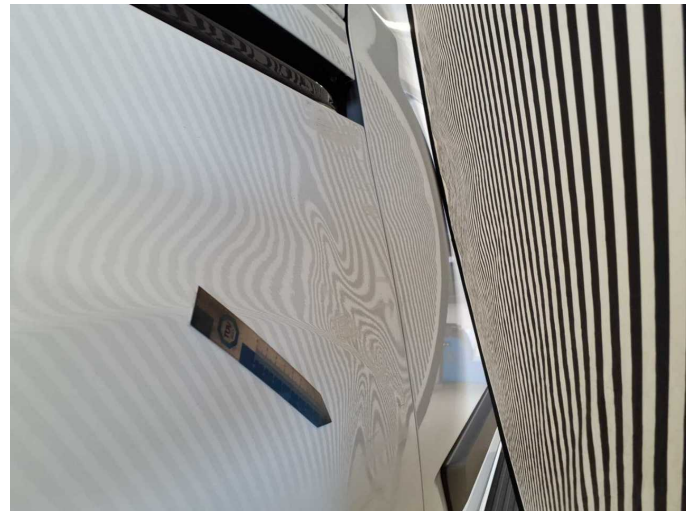
Damage 15: Side panel - rear right side: Side panel - Deformed - Repair and paint

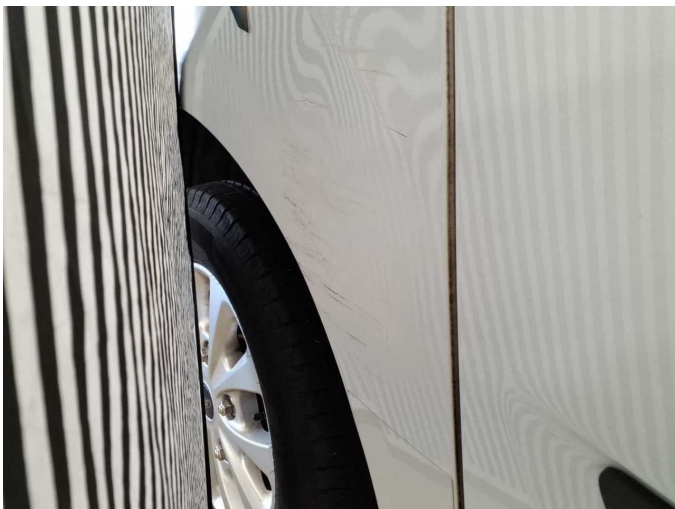
Damage 15: Side panel - rear right side: Side panel - Deformed - Repair and paint

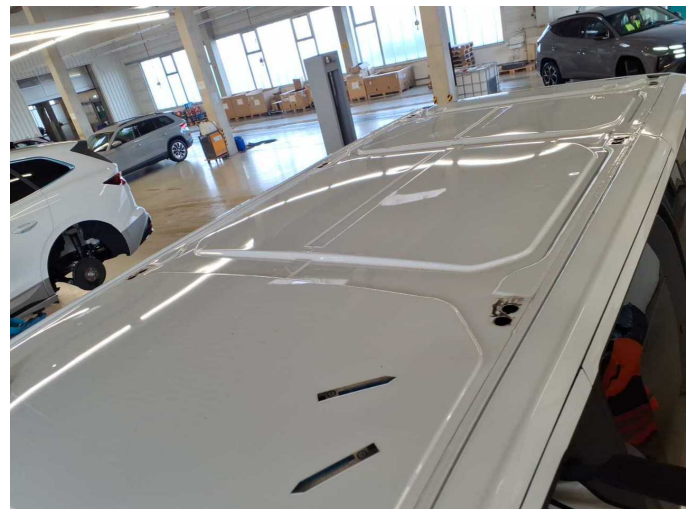
Damage 16: Roof: Roof - dent(s) - Repair and paint

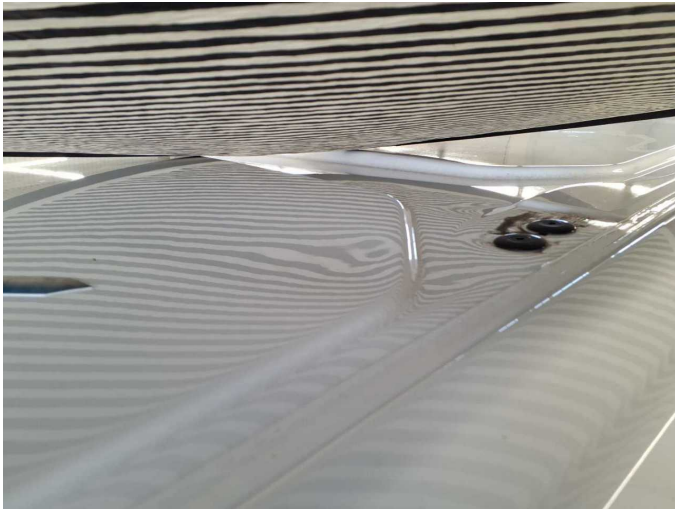
Damage 16: Roof: Roof - dent(s) - Repair and paint

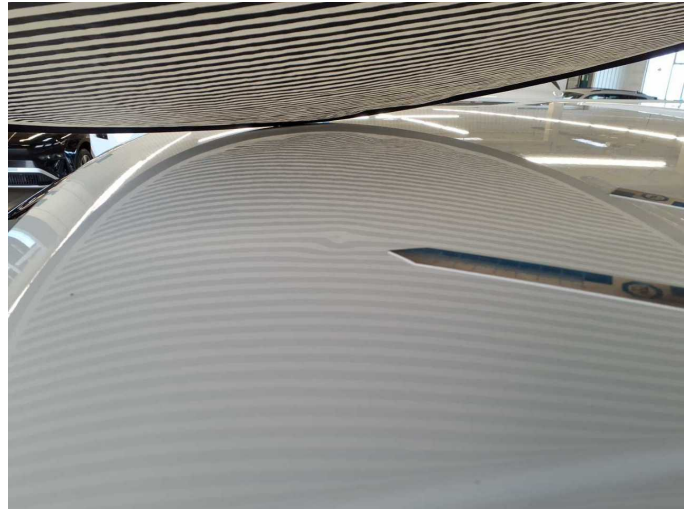
Damage 16: Roof: Roof - dent(s) - Repair and paint

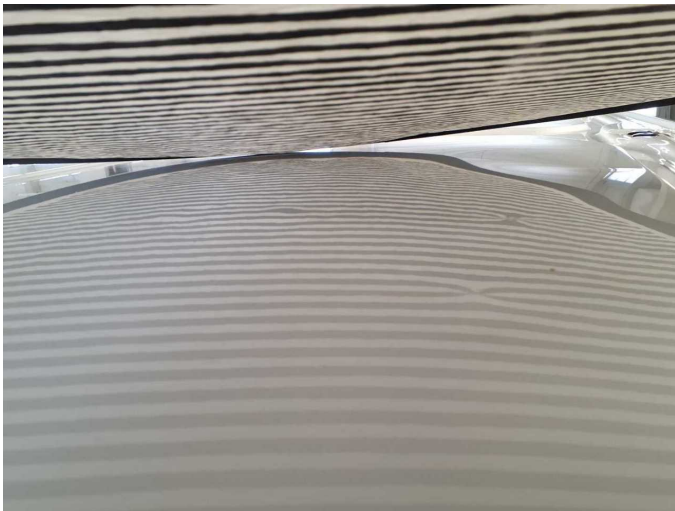
Damage 16: Roof: Roof - dent(s) - Repair and paint

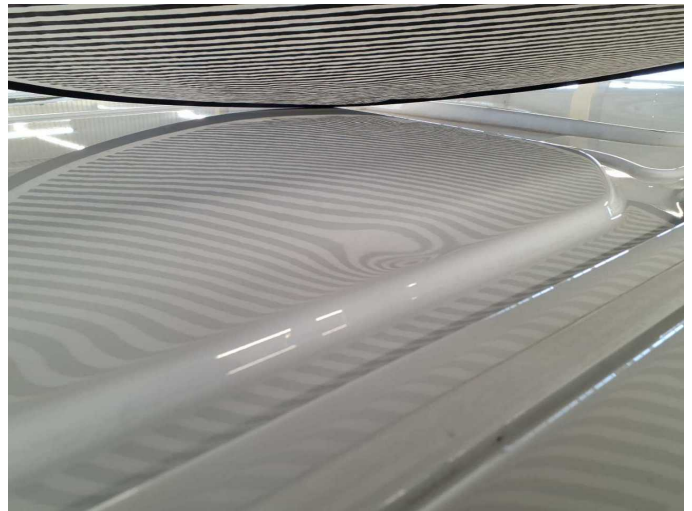
Damage 16: Roof: Roof - dent(s) - Repair and paint

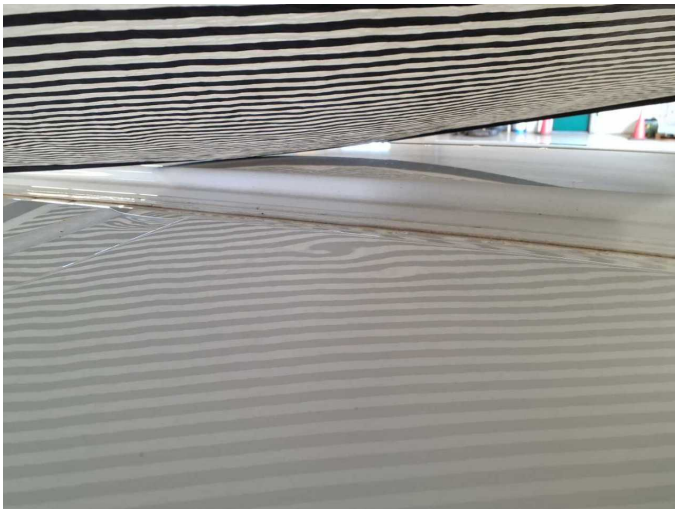
Damage 16: Roof: Roof - dent(s) - Repair and paint

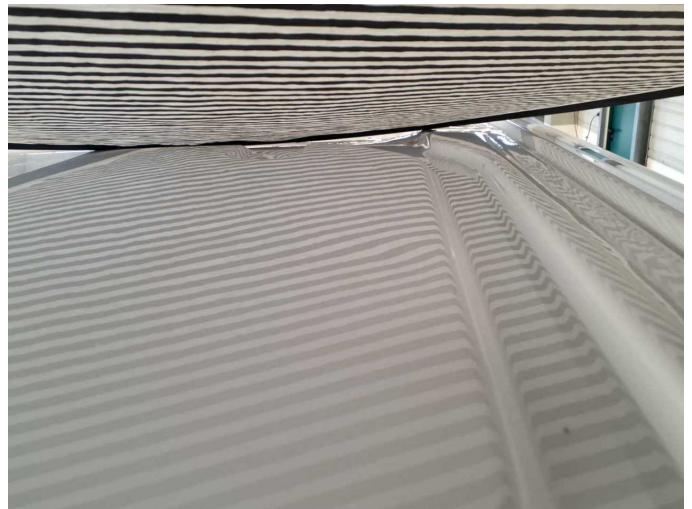
Damage 16: Roof: Roof - dent(s) - Repair and paint

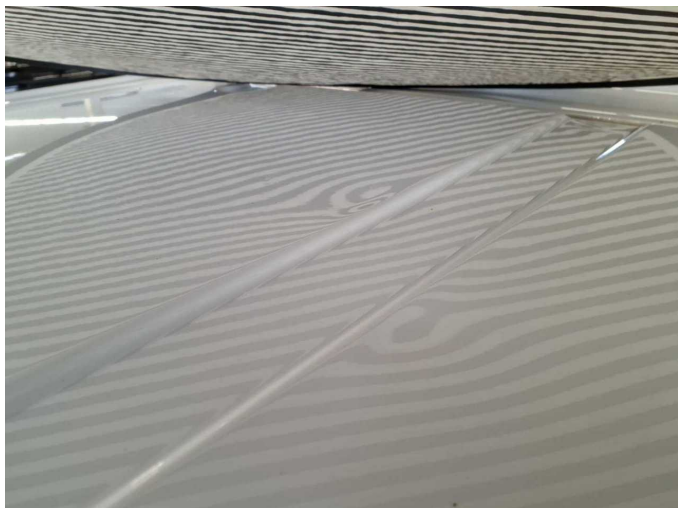
Damage 16: Roof: Roof - dent(s) - Repair and paint

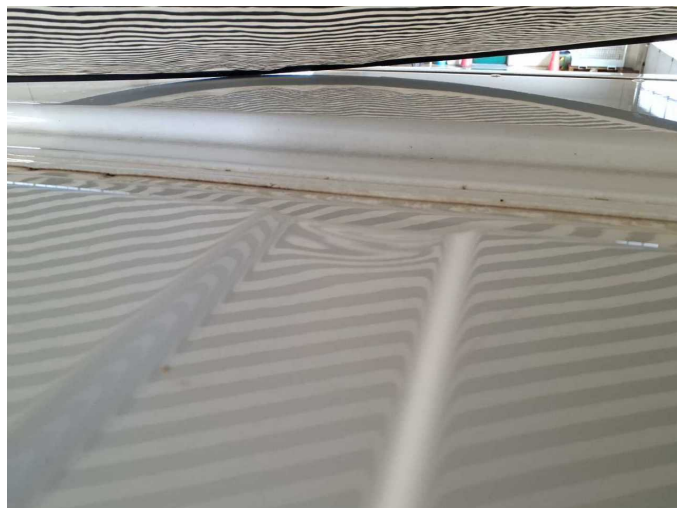
Damage 16: Roof: Roof - dent(s) - Repair and paint
