Expertise

Protocol number: 41657139
Order No. / Reference: 25233557
Inspection date: 23 Sept 2025

Manufacturer: Ford

Model: Transit Connect 240 L2 Trend

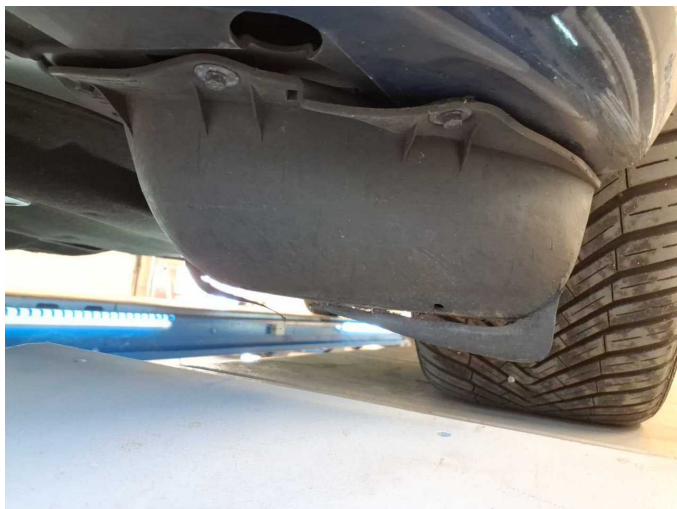
Damage 1: Mudguard - left side: Mud flap - Broken / torn - Loss in value

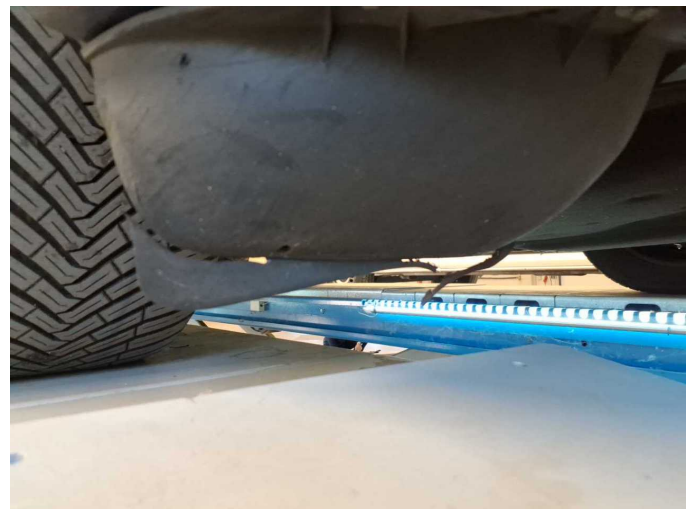
Damage 2: Mudguard - right side: Mud flap - Broken / torn - Loss in value

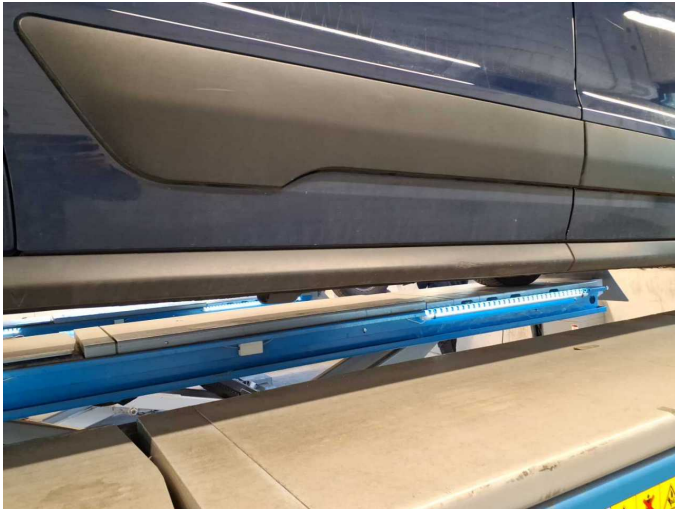
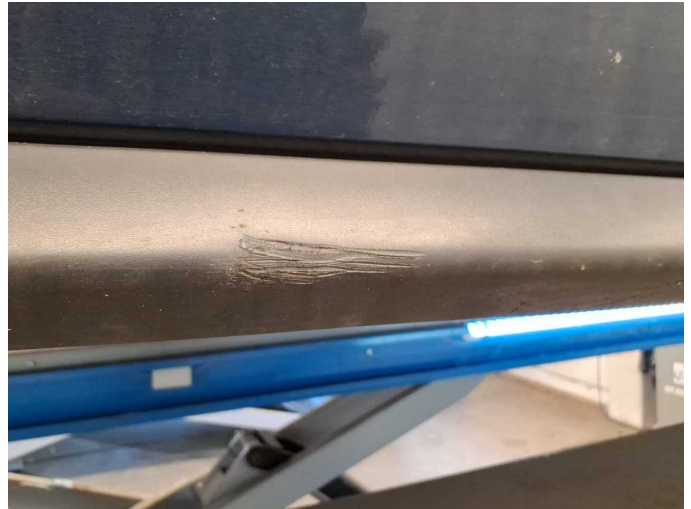
Damage 3: Sill - right side: Trim - Scratch(es) - Loss in value

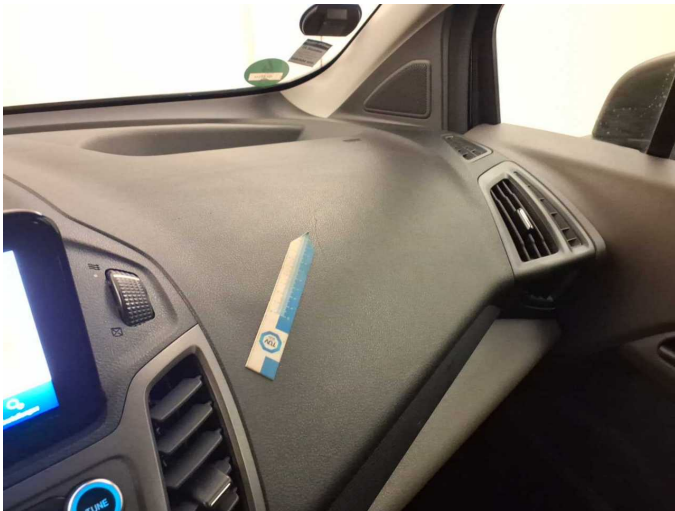
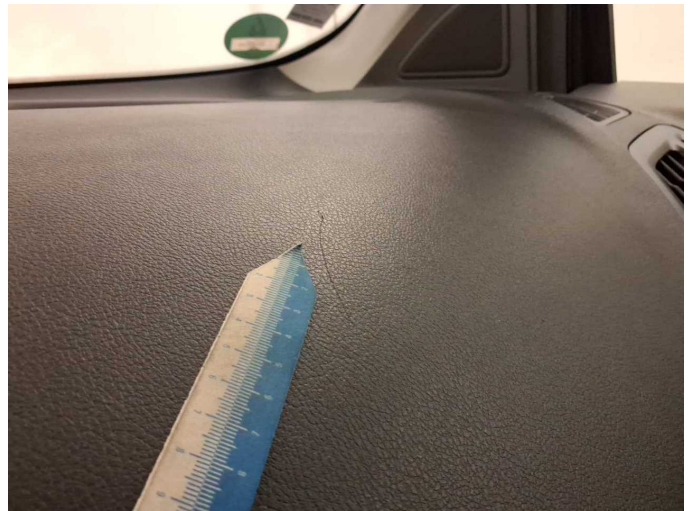
Damage 4: Instrument panel: Instrument panel - Scratch(es) - Smart repair

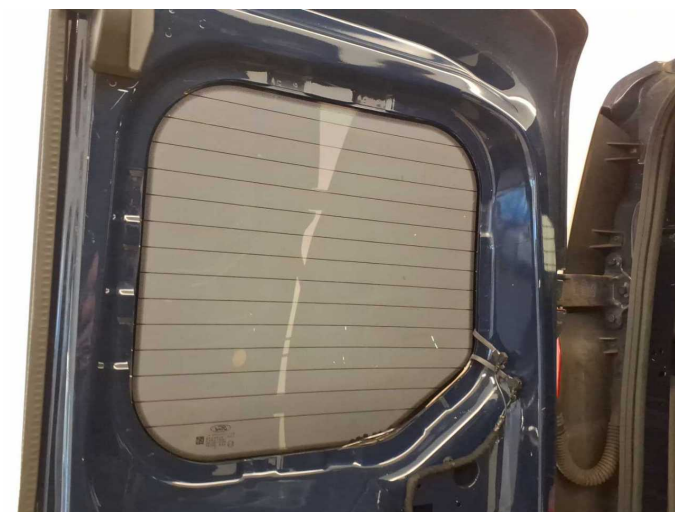
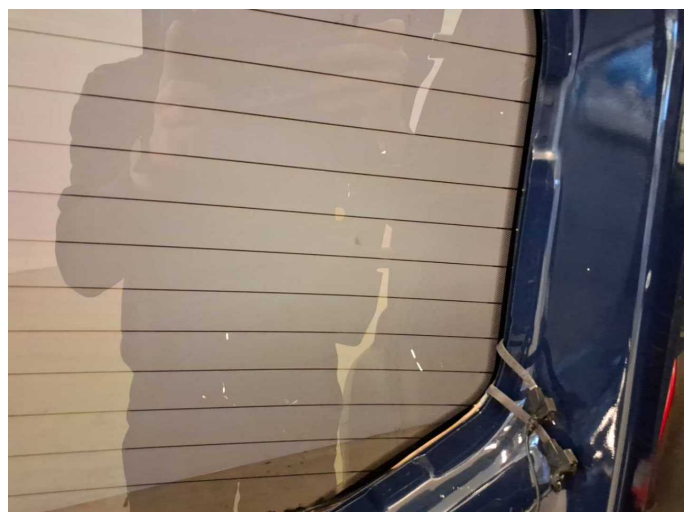
Damage 5: Vehicle glazing: Rear window - Scratch(es) - Loss in value

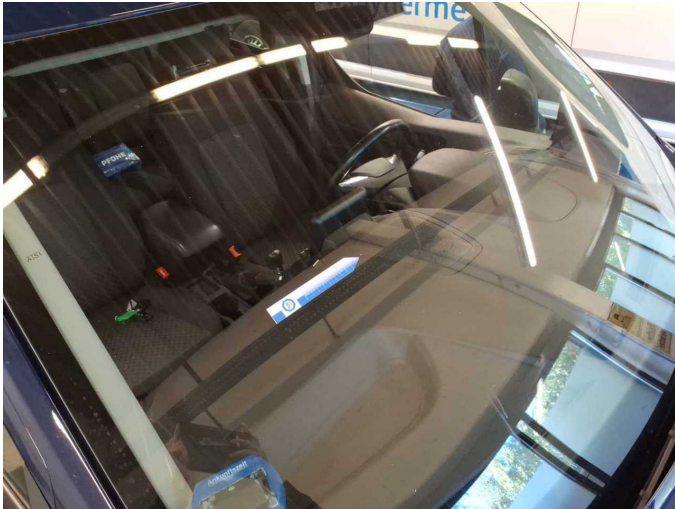
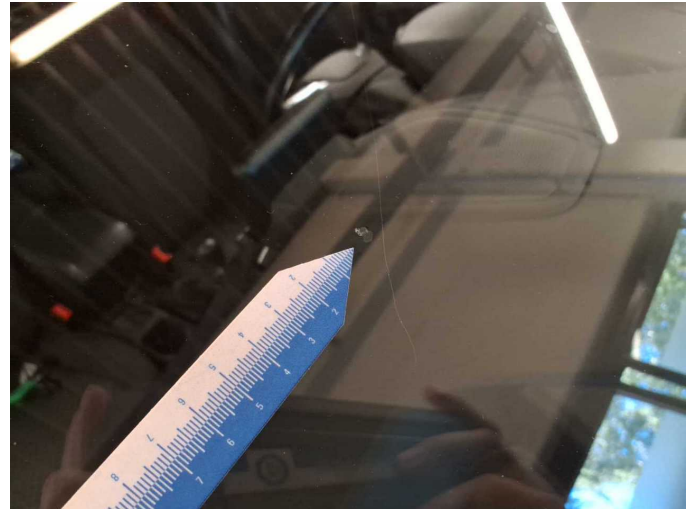
Damage 6: Vehicle glazing: Windscreen - Stone chips - Smart repair

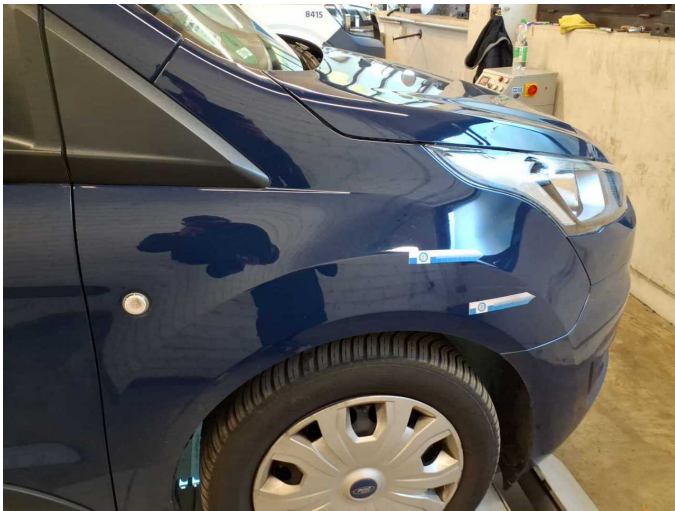
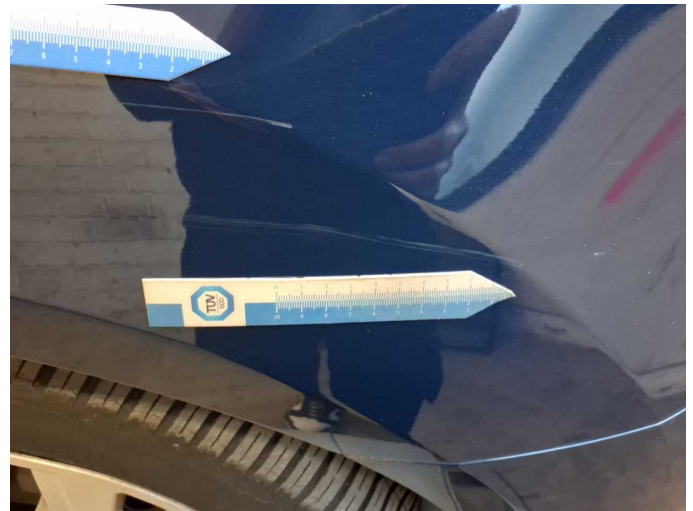
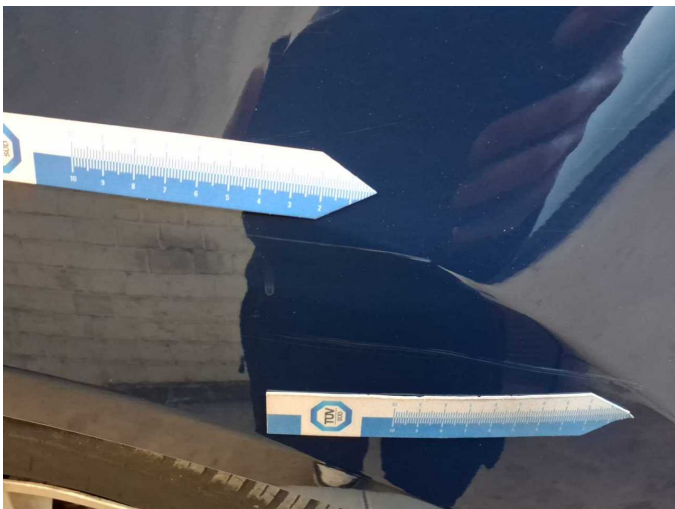
Damage 7: Mudguard - right side: Mudguard - right side - Scratch(es) - Paint

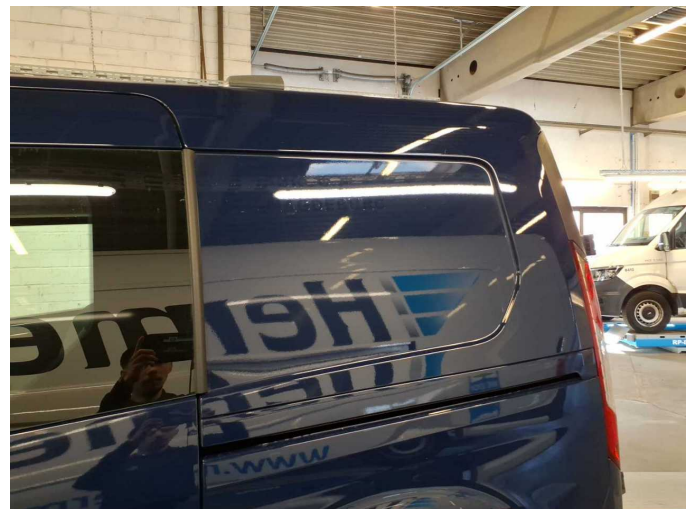
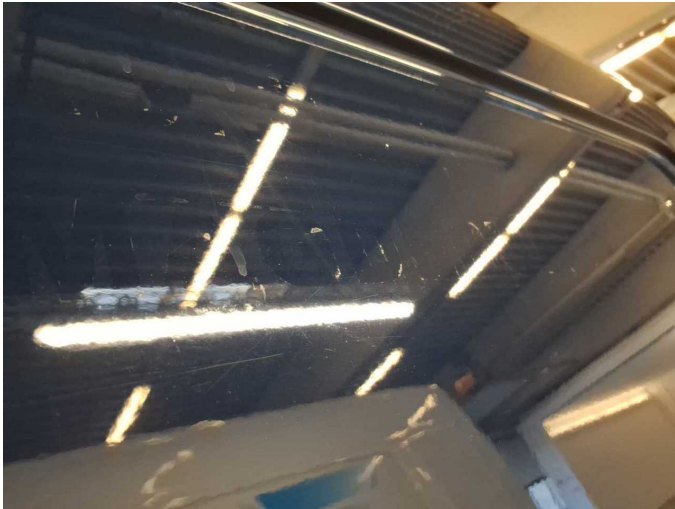
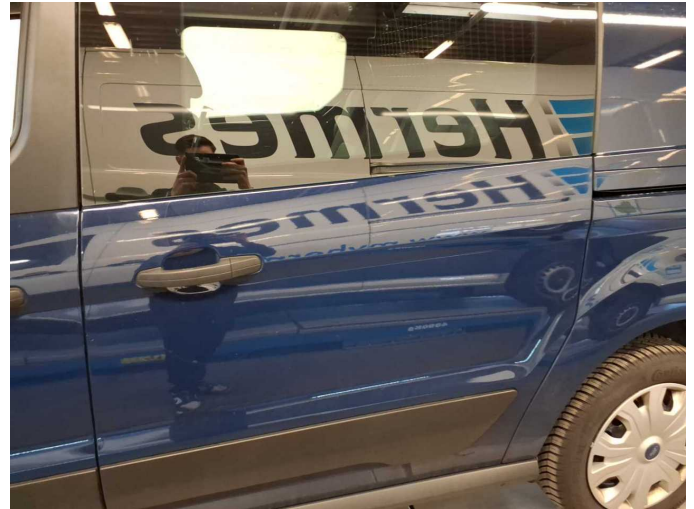
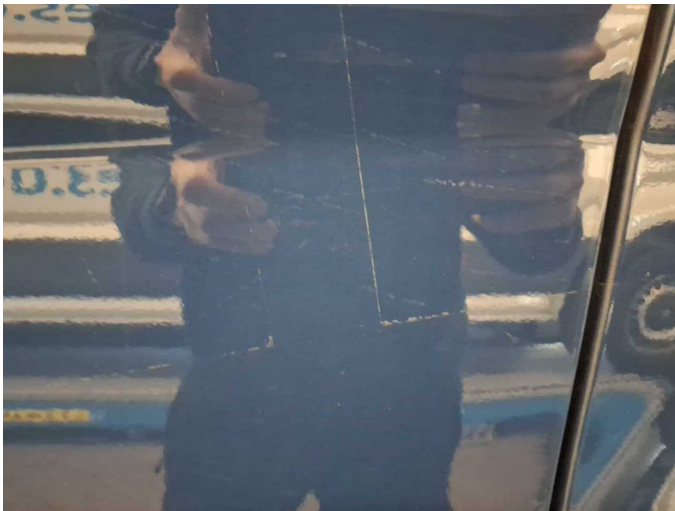
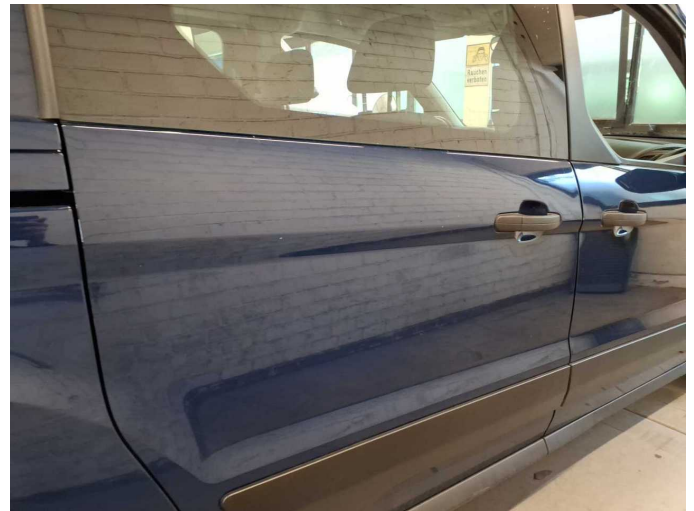
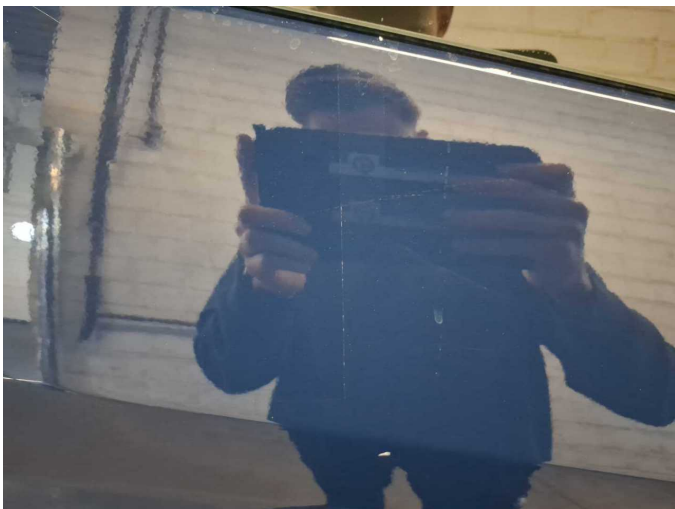
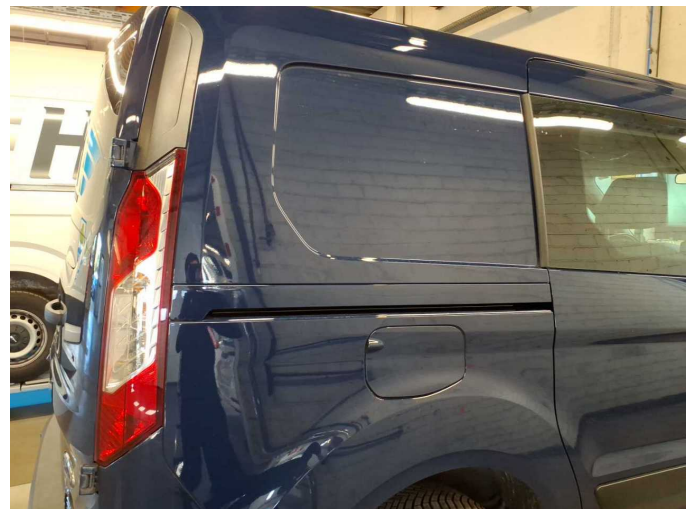
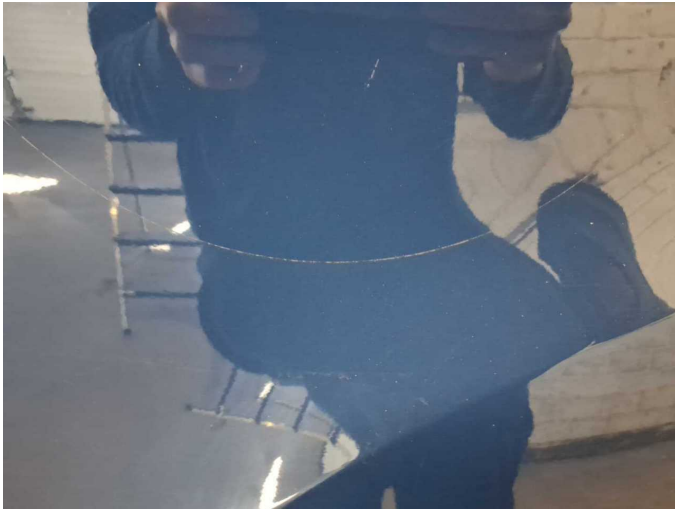
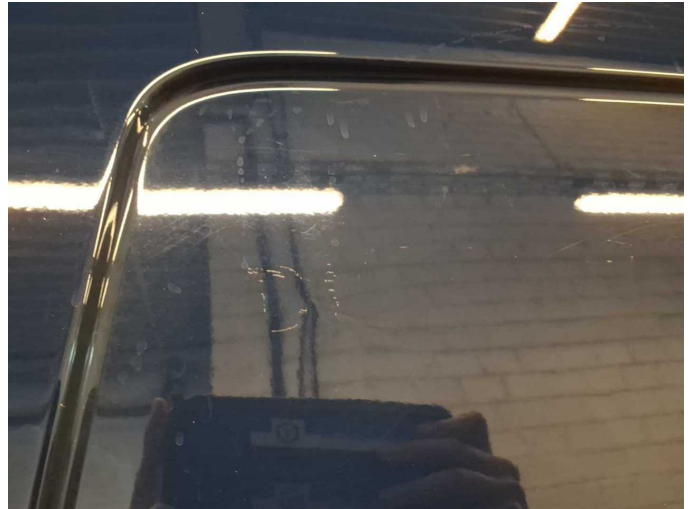
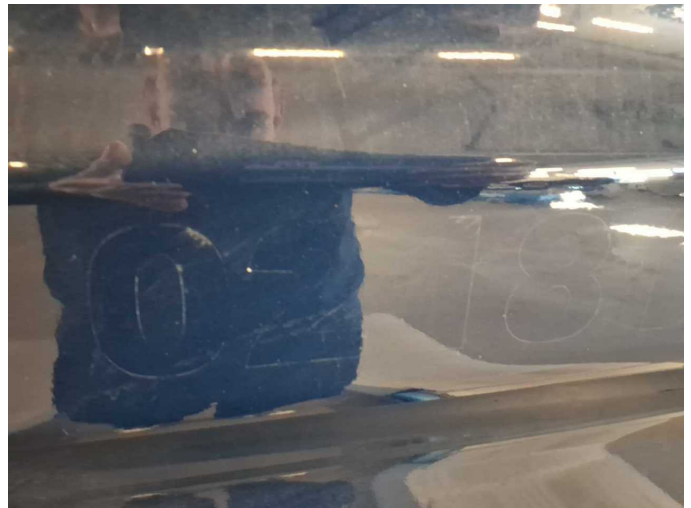
Damage 8: Body: Body (Klebereste) - Glued / labelled - De-glue / neutralise

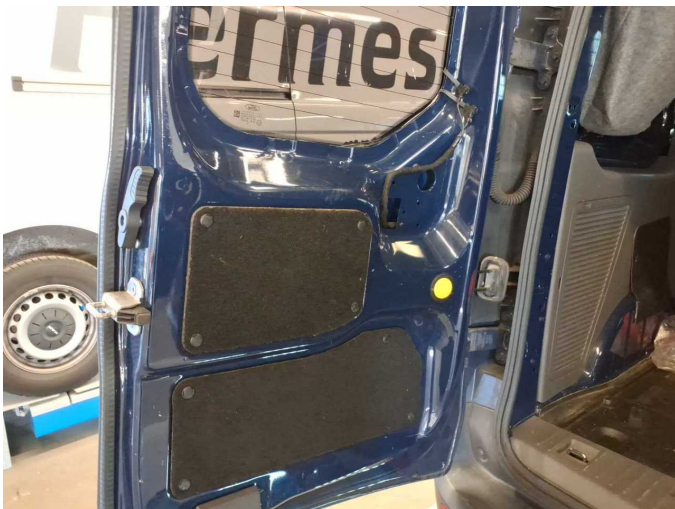
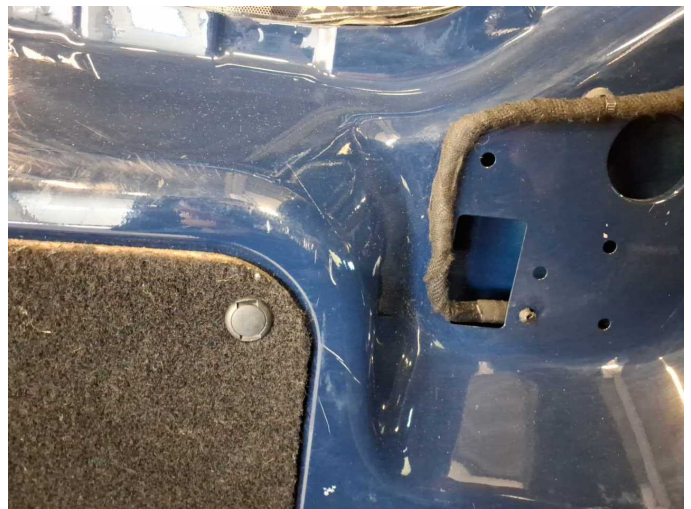
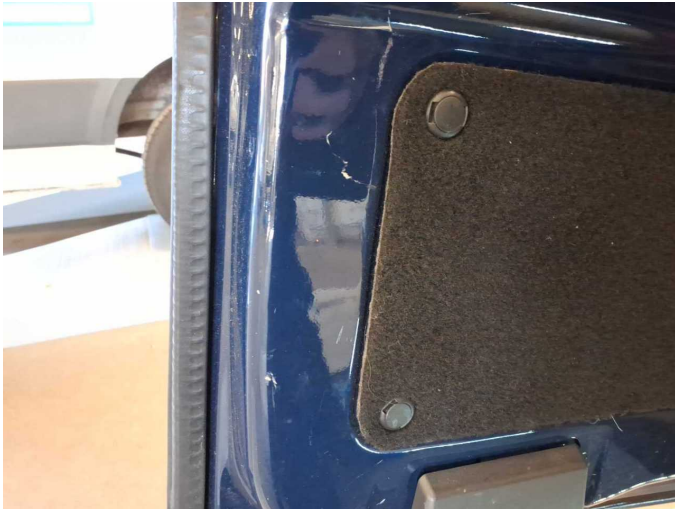
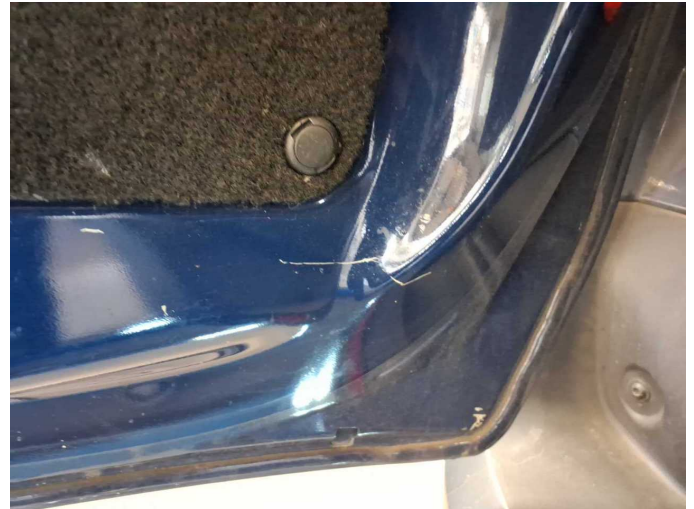
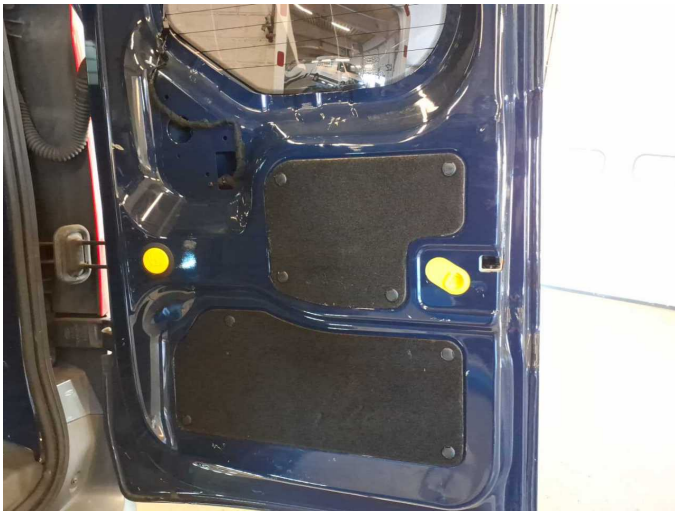
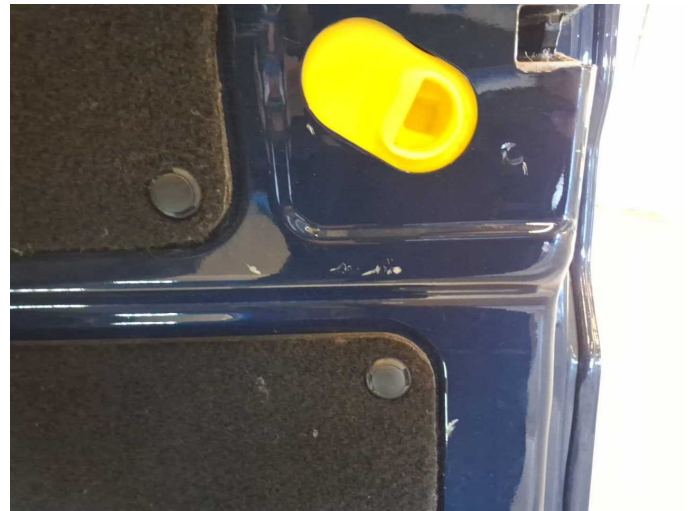
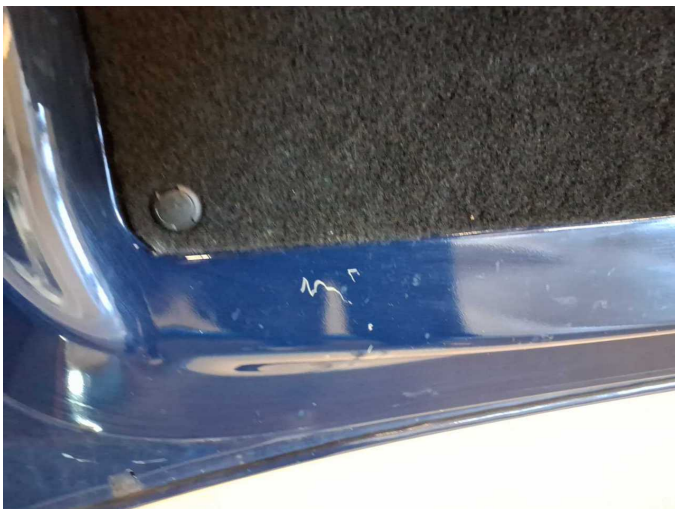
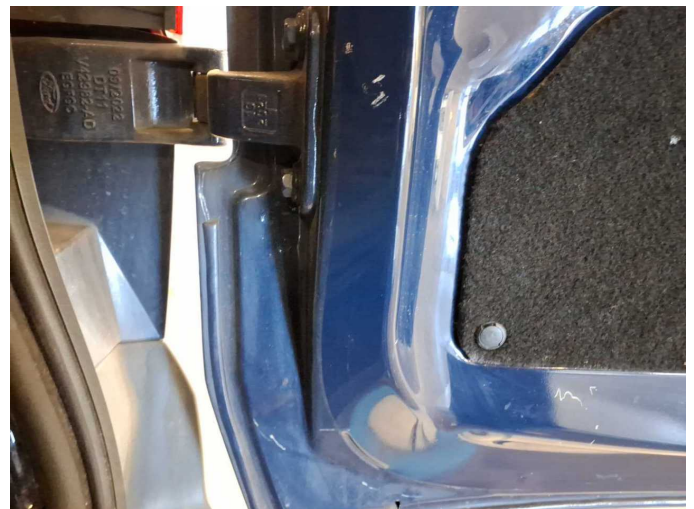
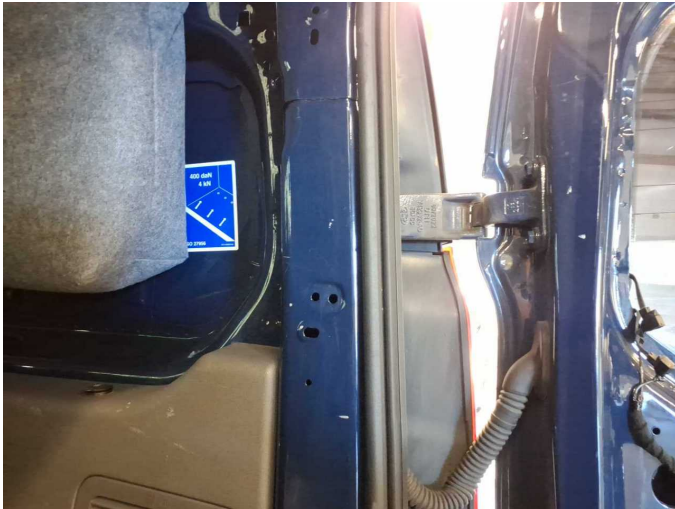
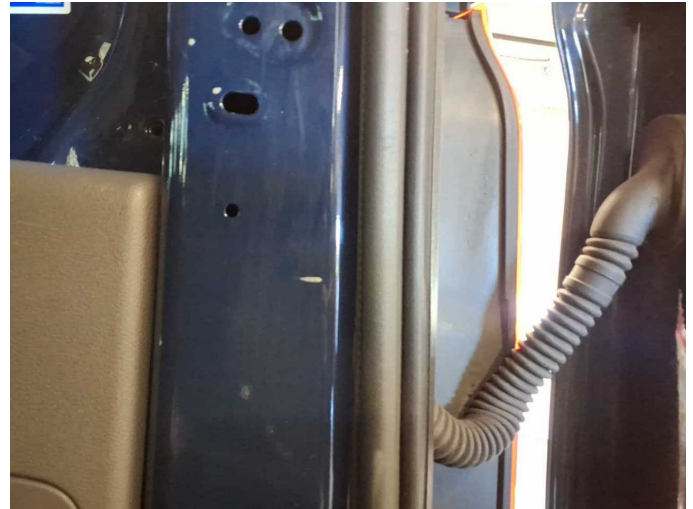
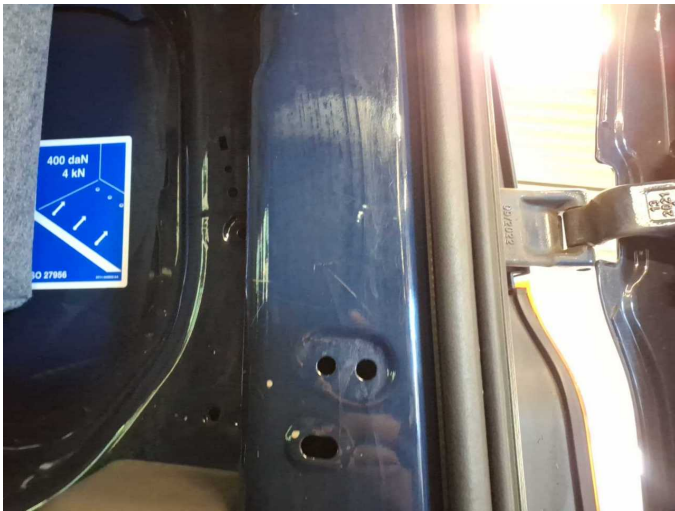
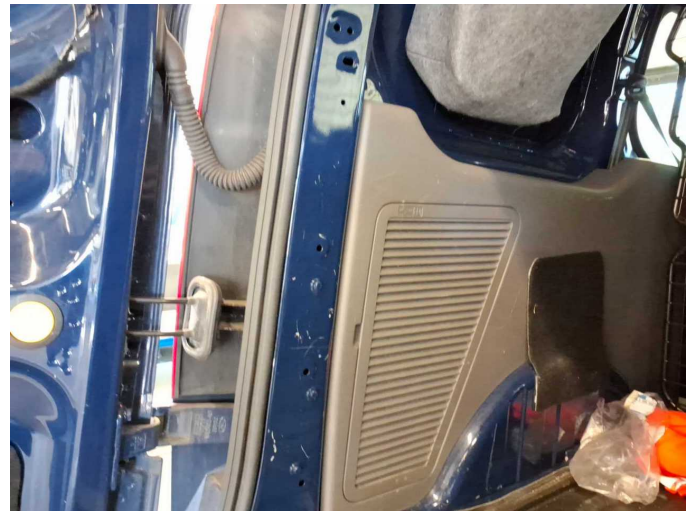
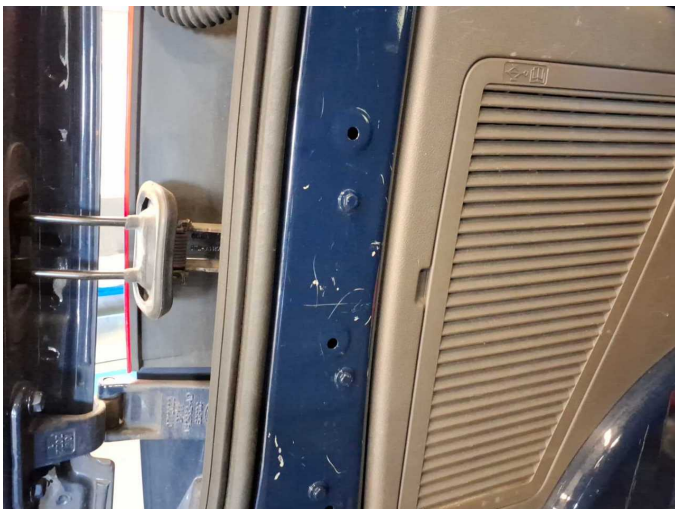
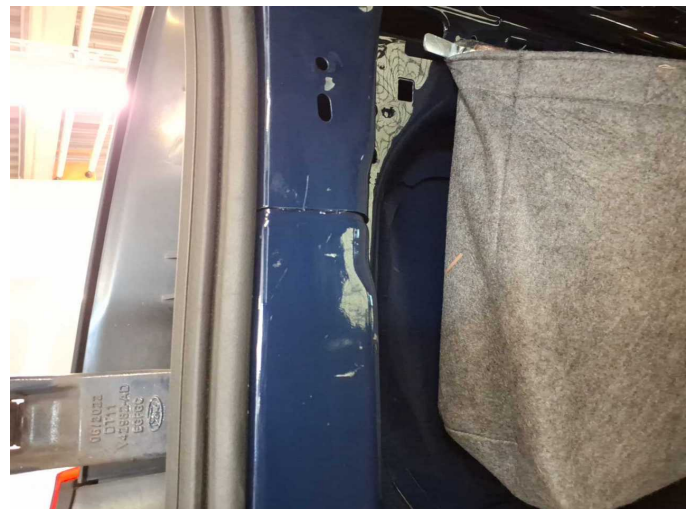
Damage 9: Interior: Cargo space division - Dent / paintcoat damage - Loss in value

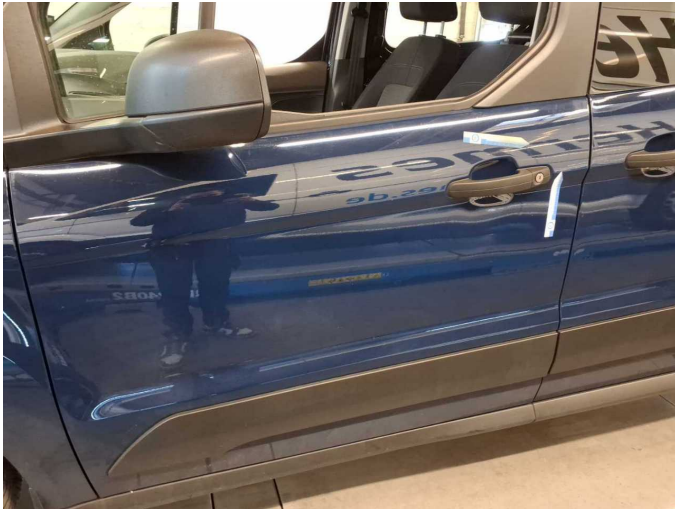
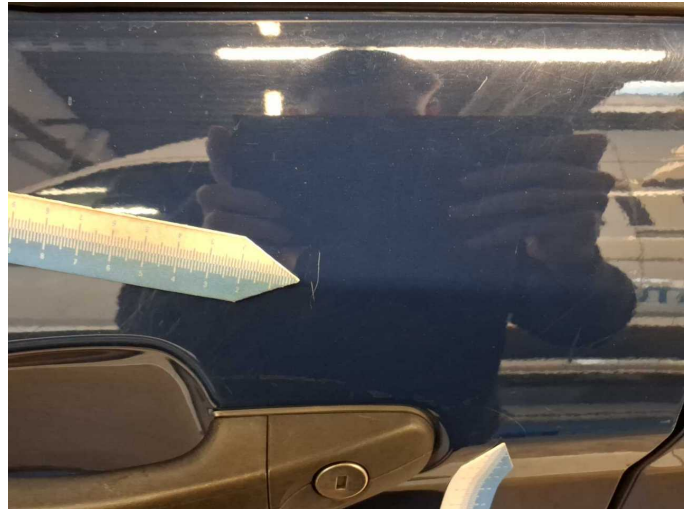
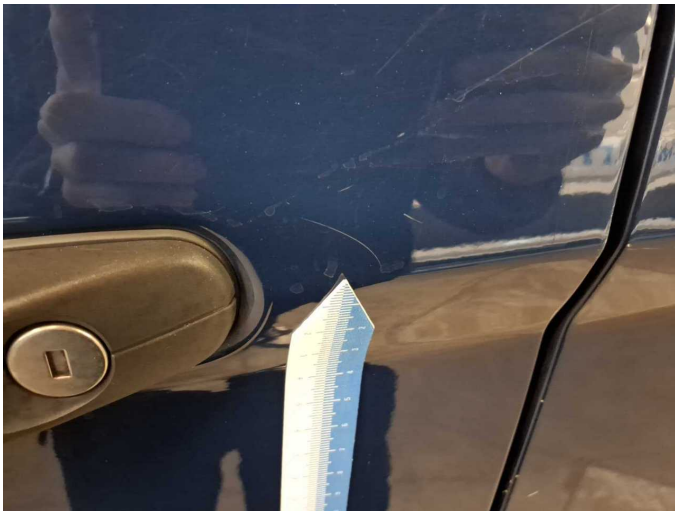
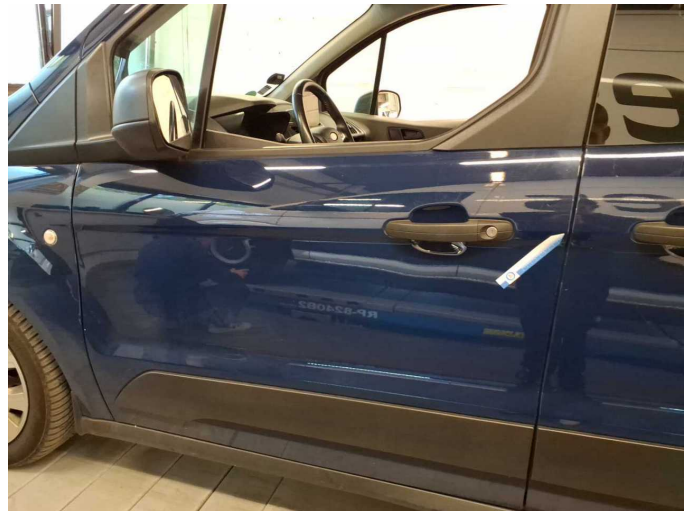
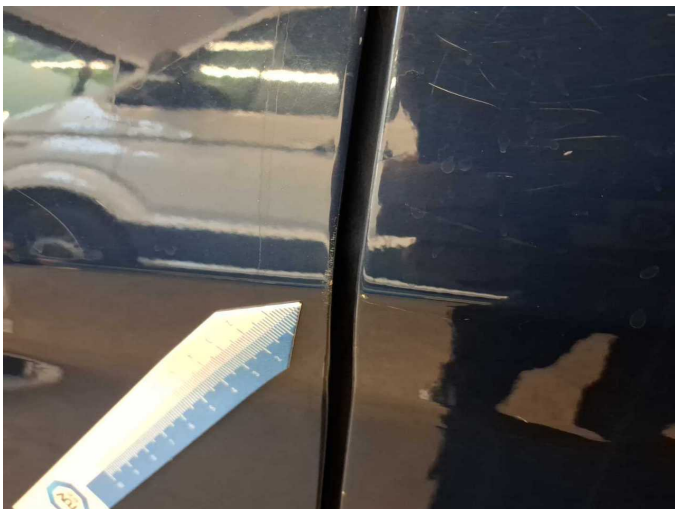
Damage 10: Door - front left side: Door - Scratch(es) - Paint

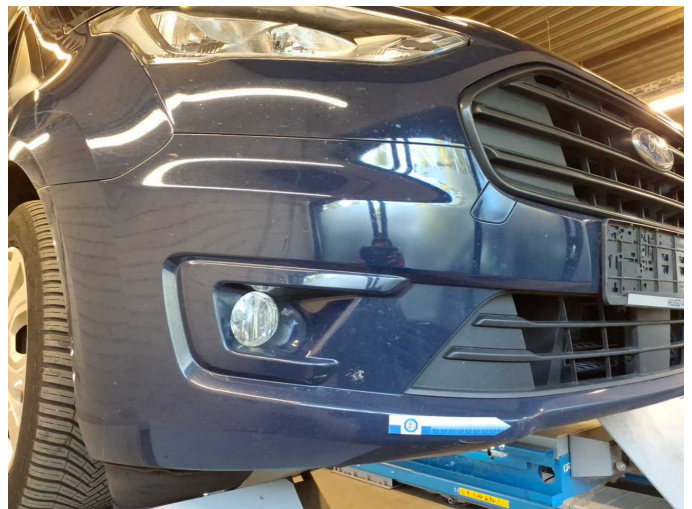
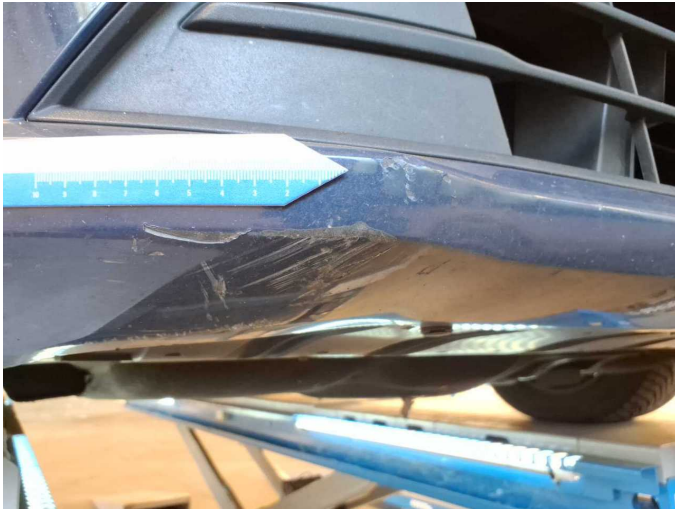
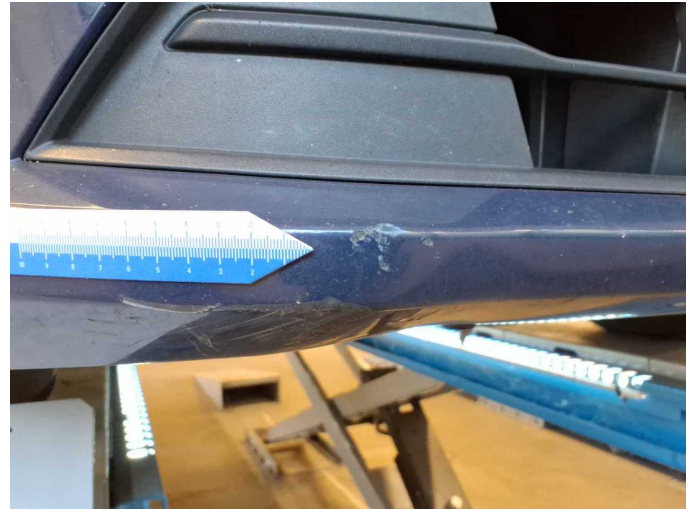
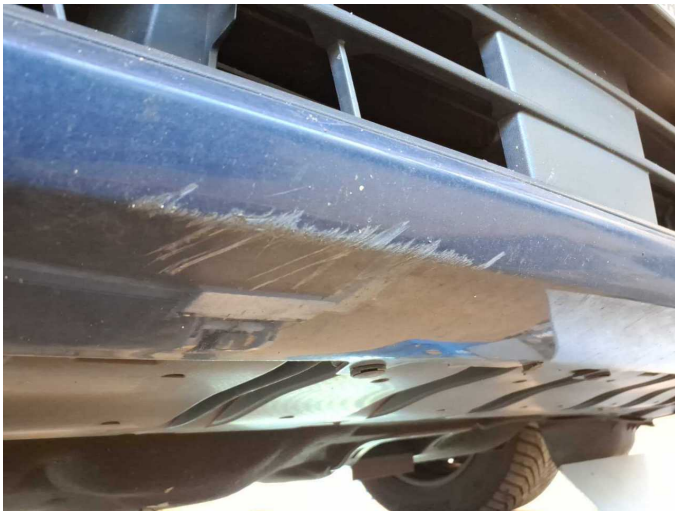
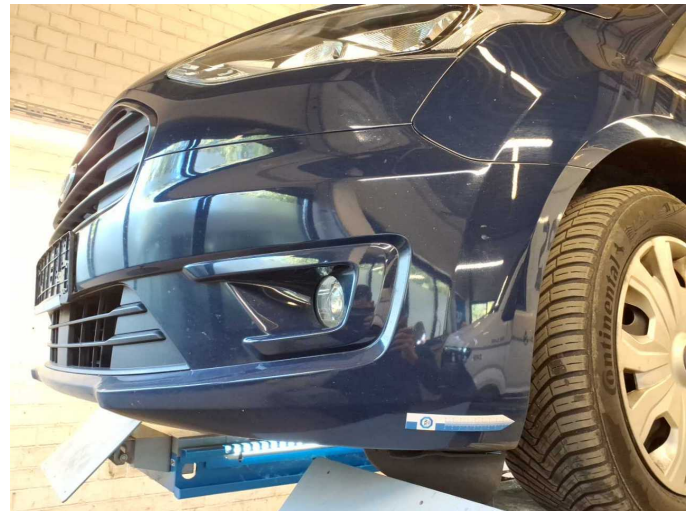
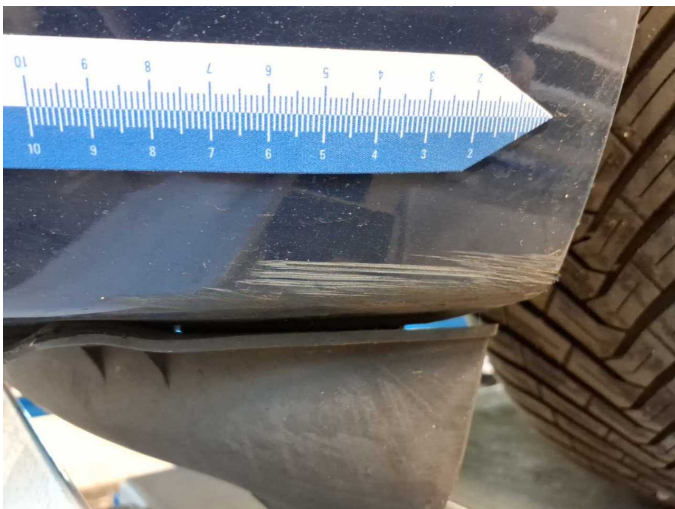
Damage 11: Front bumper: Front bumper - Scratch(es) - Paint

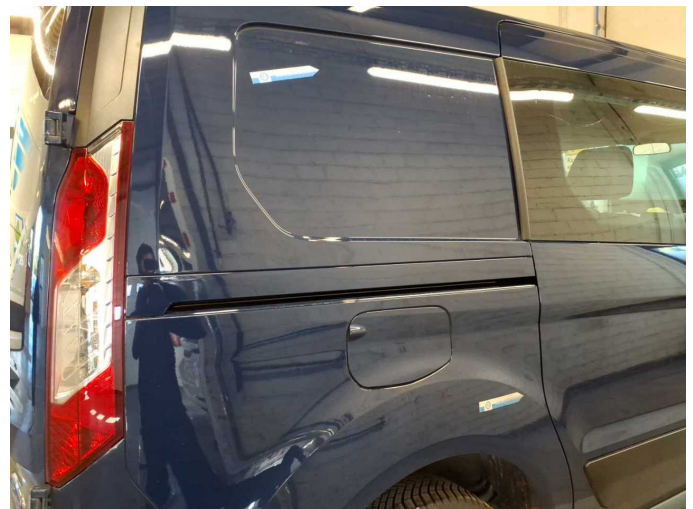
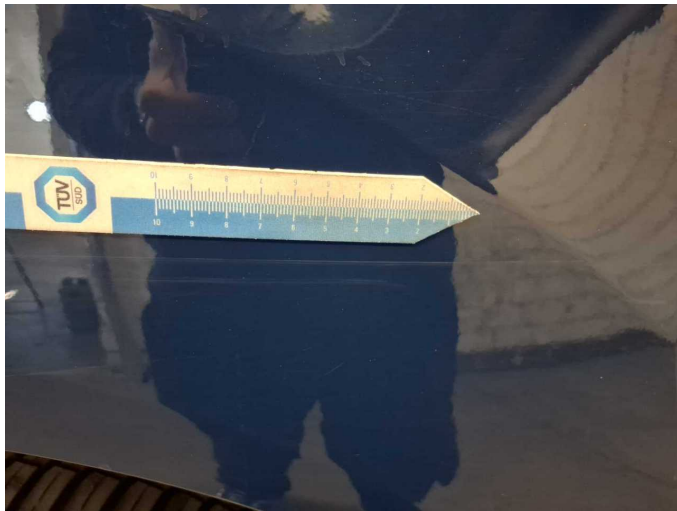
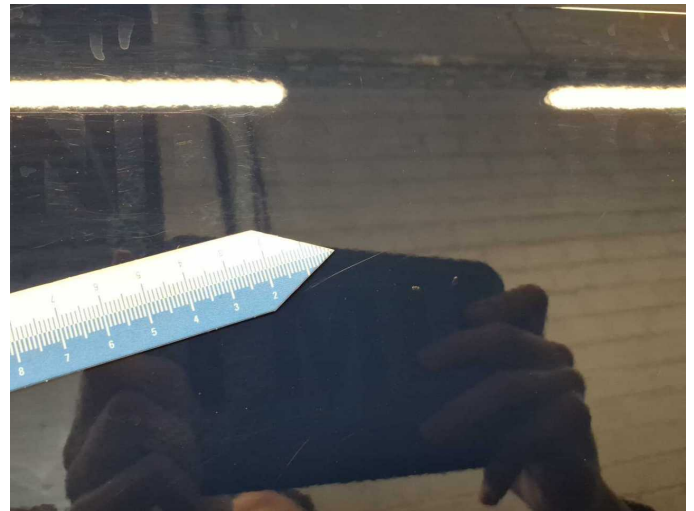
Damage 12: Side panel - rear right side: Side panel - Scratch(es) - Paint

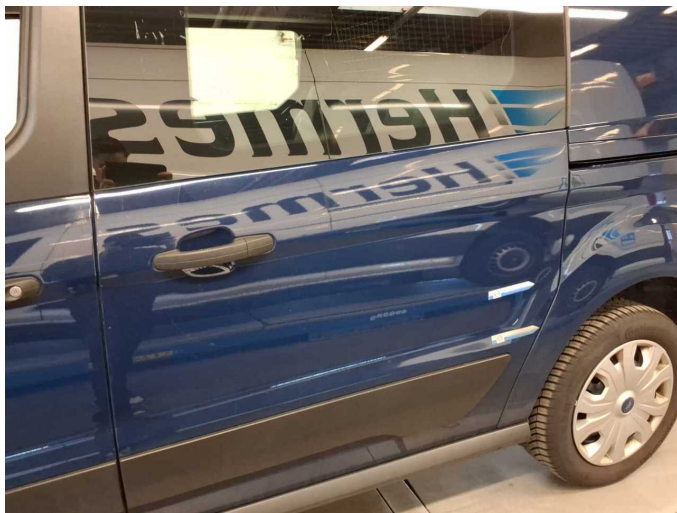
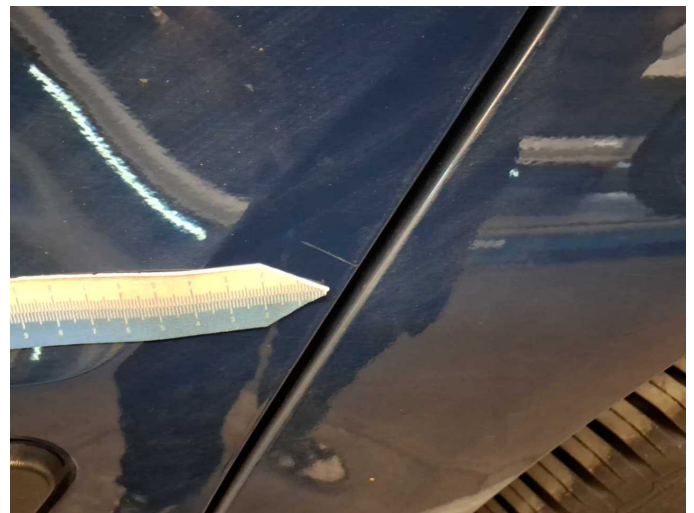
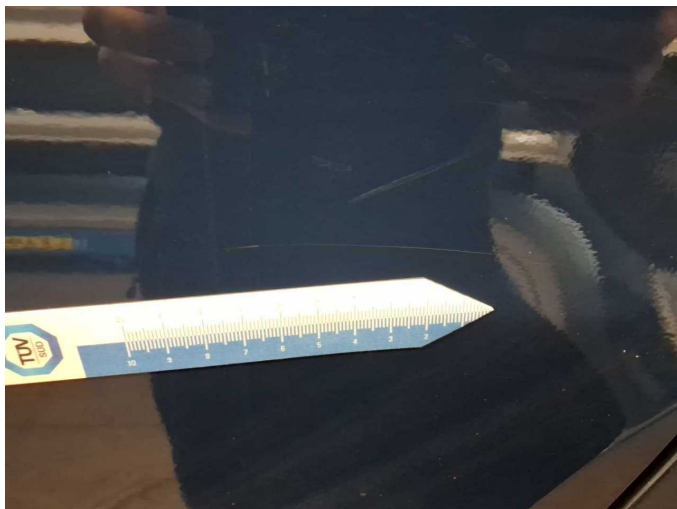
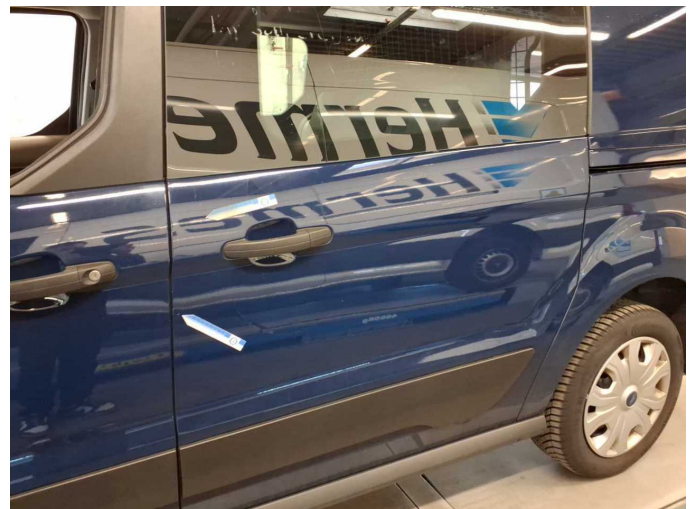
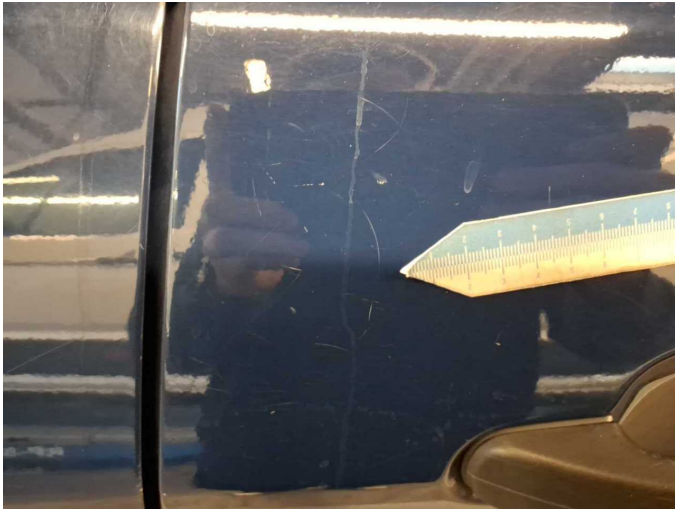
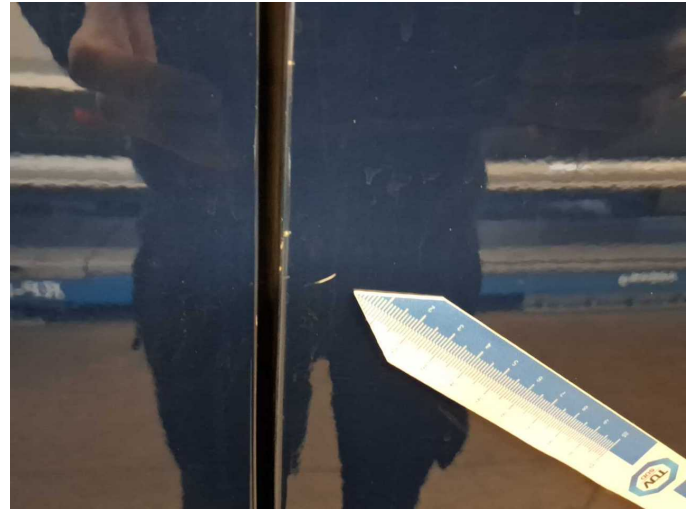
Damage 13: Sliding door - left side: Sliding door with glass panel - Scratch(es) - Paint

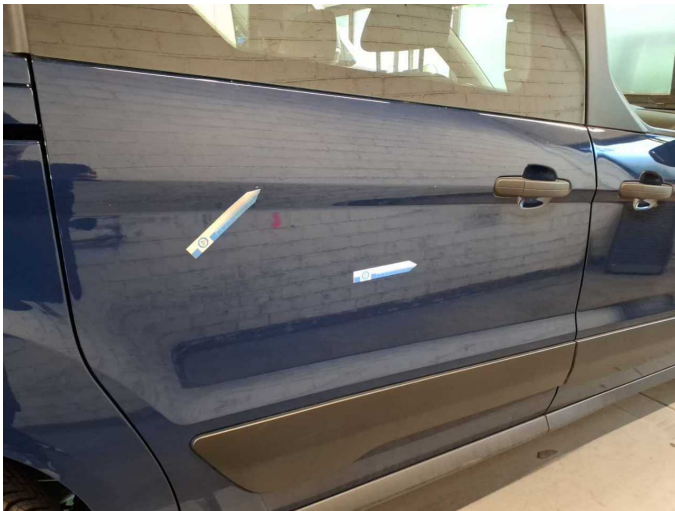
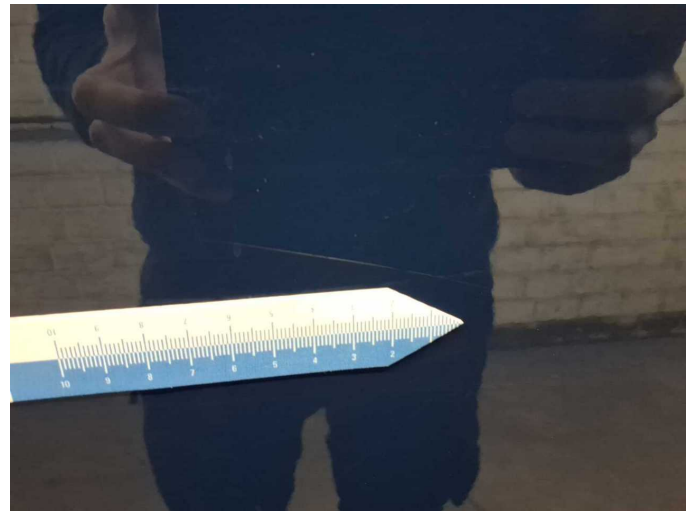
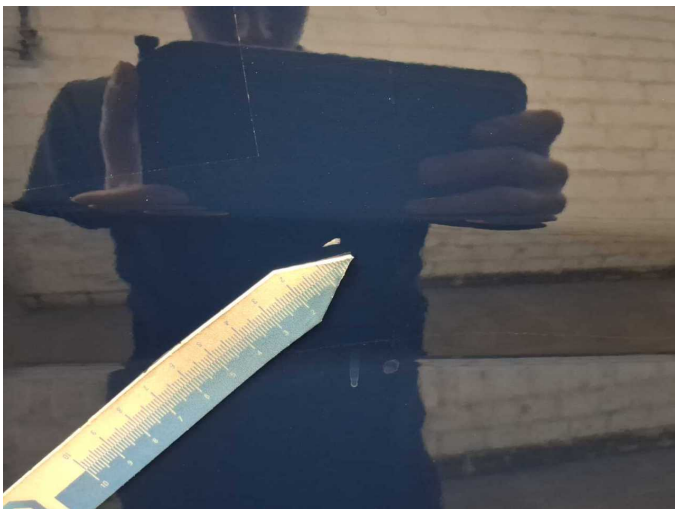
Damage 14: Sliding door, right: Sliding door with glass panel - Scratch(es) - Paint

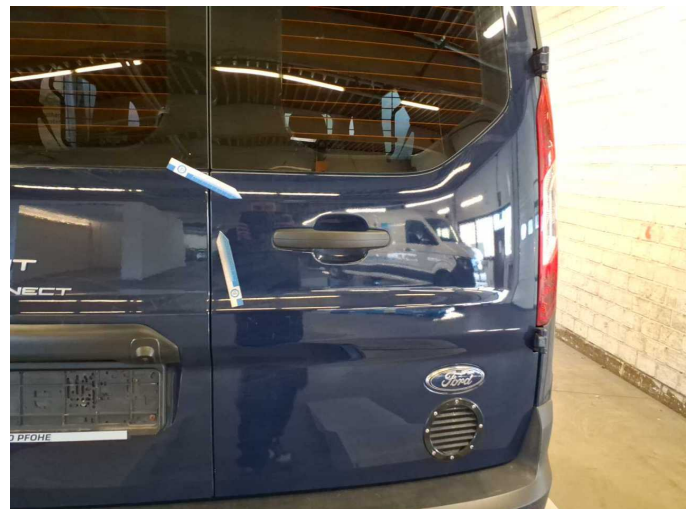
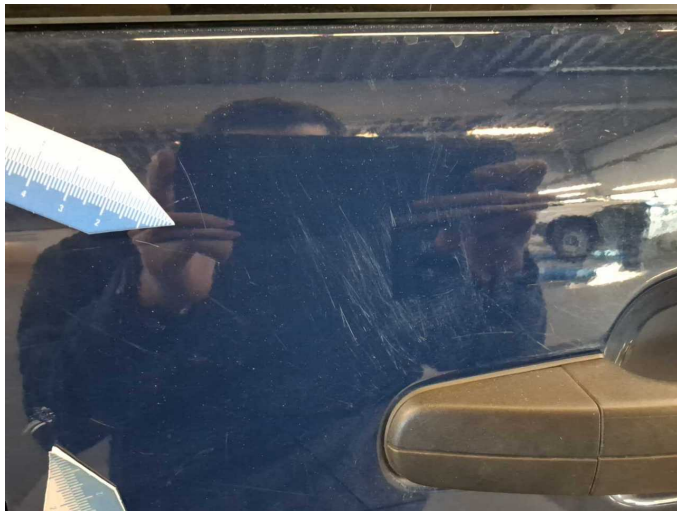
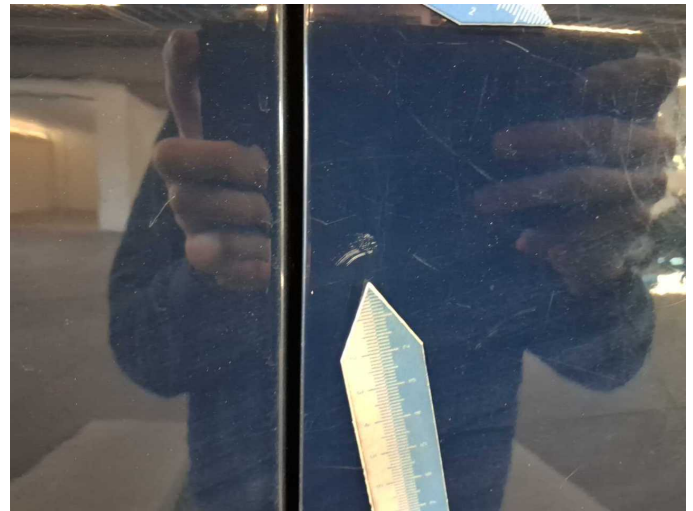
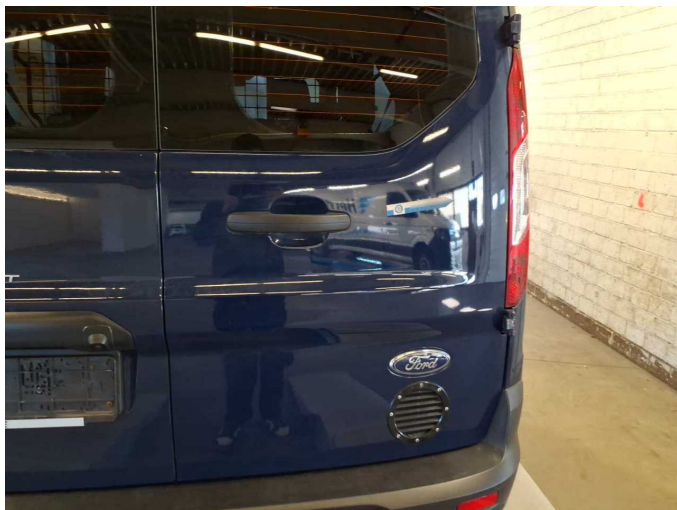
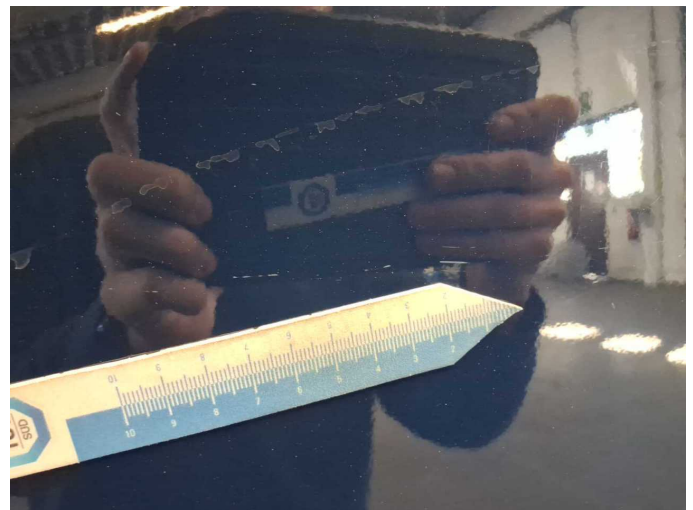
Damage 15: Boot lid / rear door: Rear door - right side - Scratch(es) - Paint
