Expertise

Protocol number: 41657139
Order No. / Reference: 25233557
Inspection date: 23 Sept 2025

Manufacturer: Ford

Model: Transit Connect 240 L2 Trend

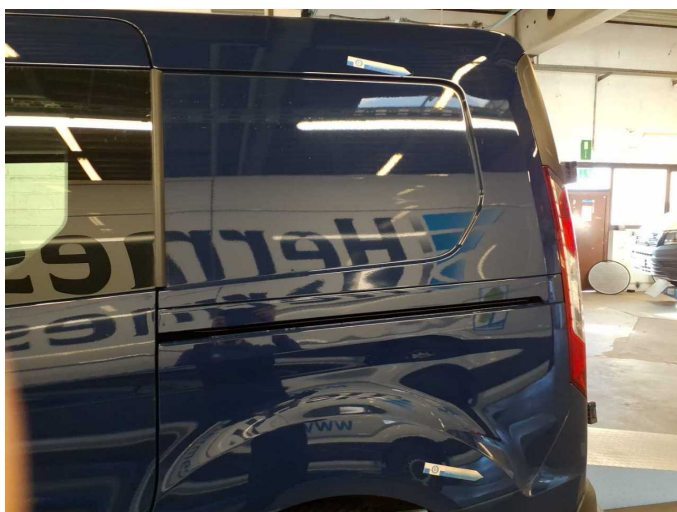
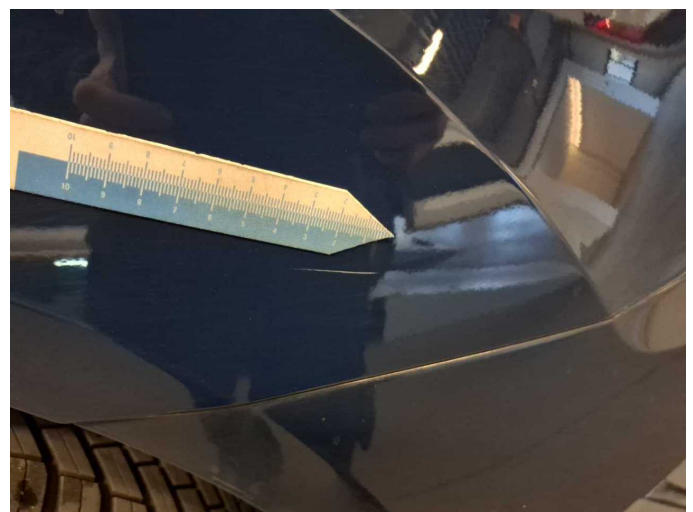
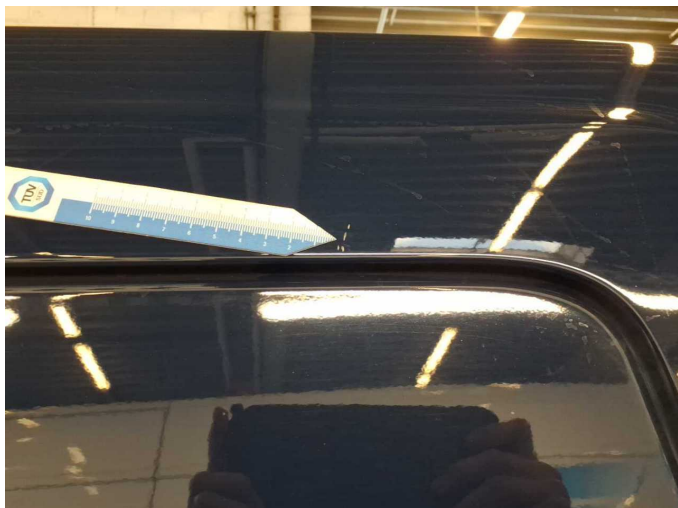
Damage 16: Side panel - rear left side: Side panel - Scratch(es) - Paint

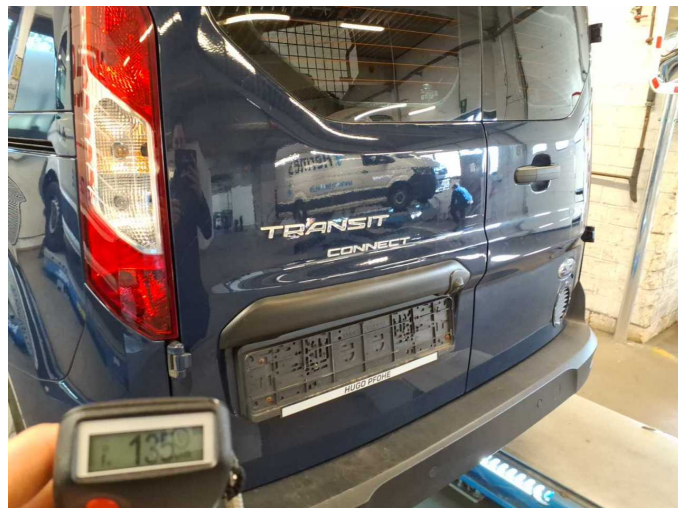
Repainting 1: Boot lid / rear door

1 Boot lid / rear door, Professionally carried out

Boot lid / rear door 135 μm |
