## status report

| <b>customer:</b> | <b>Bank 11, Neuss</b> |
| <b>contract number:</b> | <b>987363530</b> |

| vehicle data | | | |
|---|---|---|---|
| <b>Ford Focus</b> | | | |

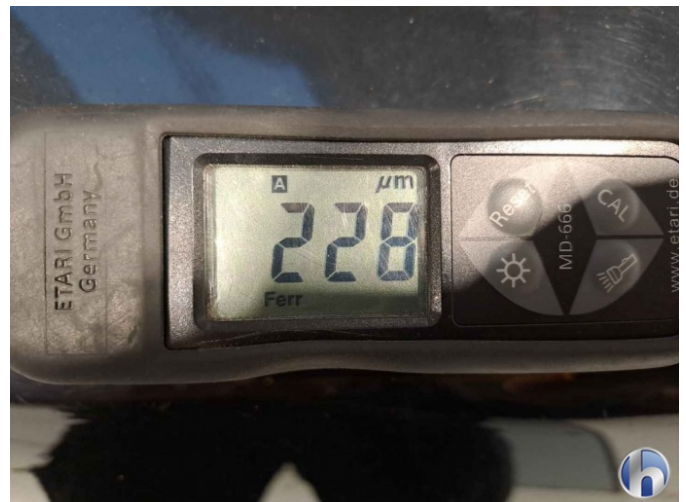
1. Front fender - right

| Performed testing technology | |
|---|---|
| <b>reference:</b> | *Fahrzeug hat Alter und Laufleistungs bedingte Gebrauchsspuren innen und außen VIN Abfrage nicht möglich, Fahrzeugdaten und Ausstattung können abweichen. Kostenerweiterung möglich.<br>Kotflügel VR Nachlackiert Unfallschaden HL Schaden und Kosten Erweiterung möglich |

| | component | Damage | Rep kind |
|---|---|---|---|
| 1. | Front fender - right | Subsequently painted | acceptable |

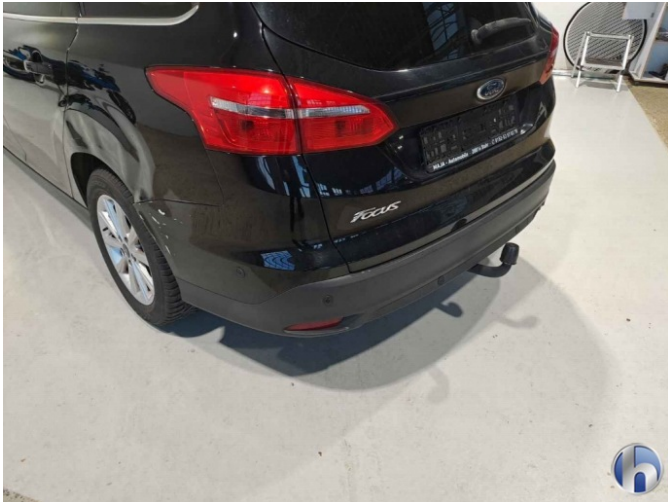
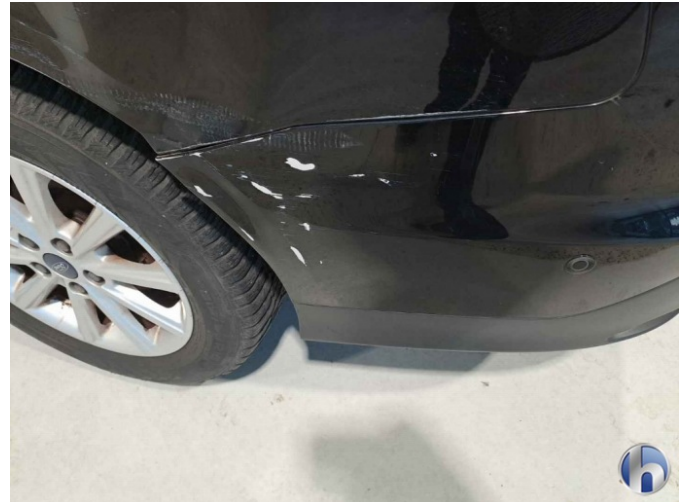
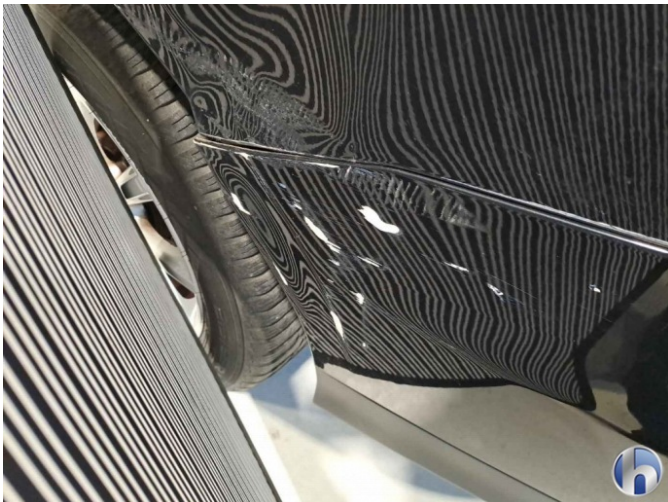
5. Rear bumper

| | component | Damage | Rep kind |
|---|---|---|---|
| 5. | Rear bumper | Accident damage | Replace |

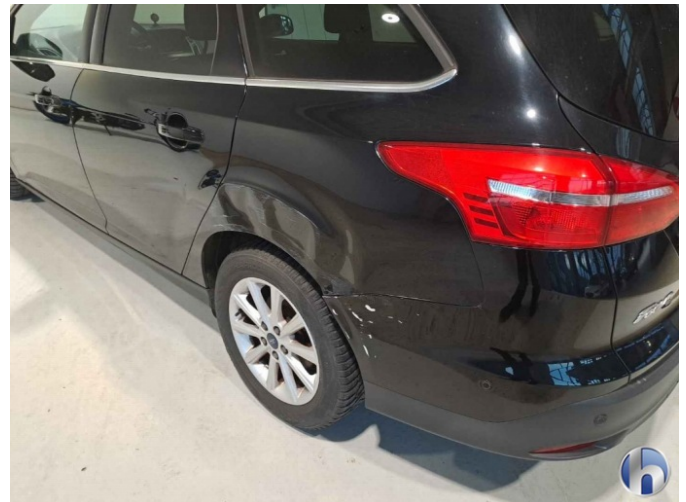
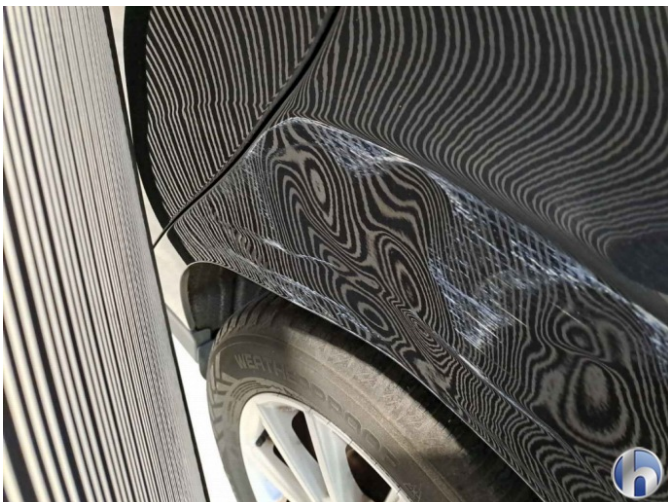
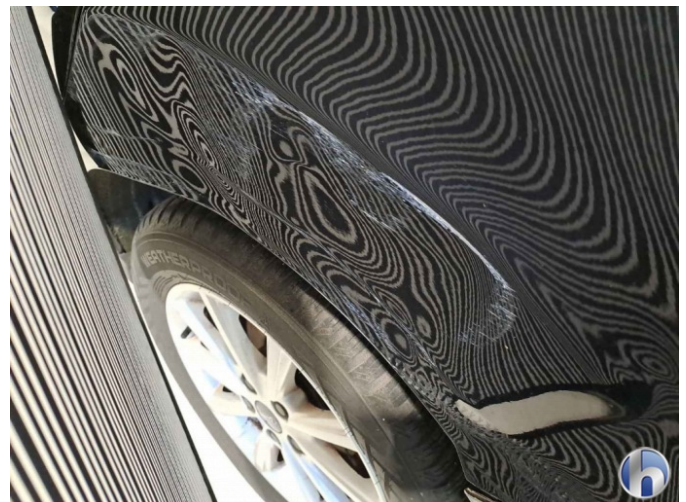
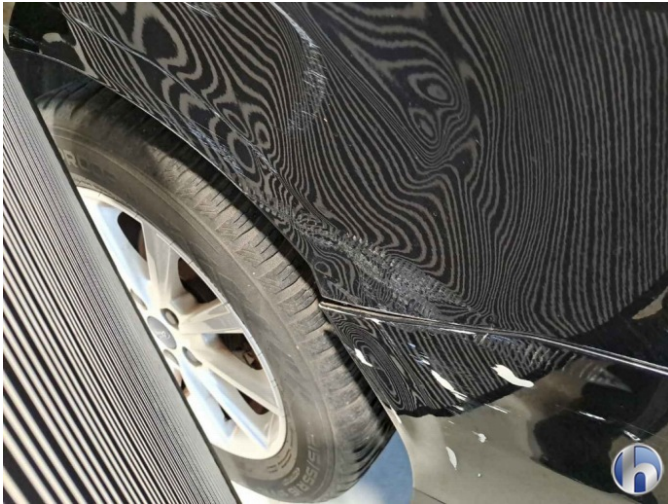
6. Sidewall - Rear - Left

| | component | Damage | Rep kind |
|---|---|---|---|
| 6. | Sidewall - Rear - Left | Accident damage | Replace |

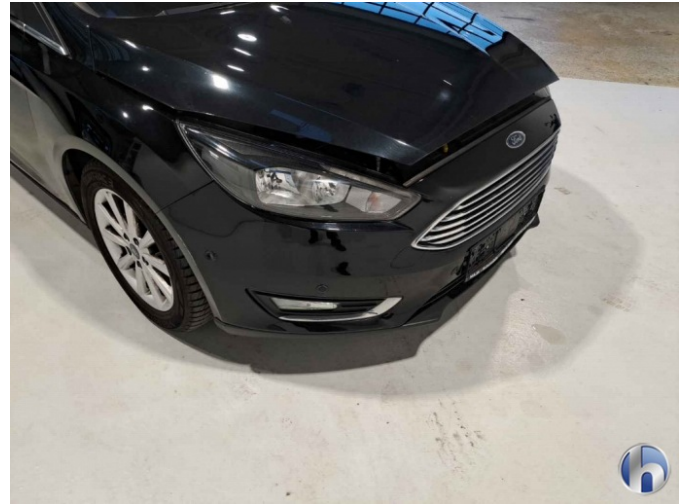
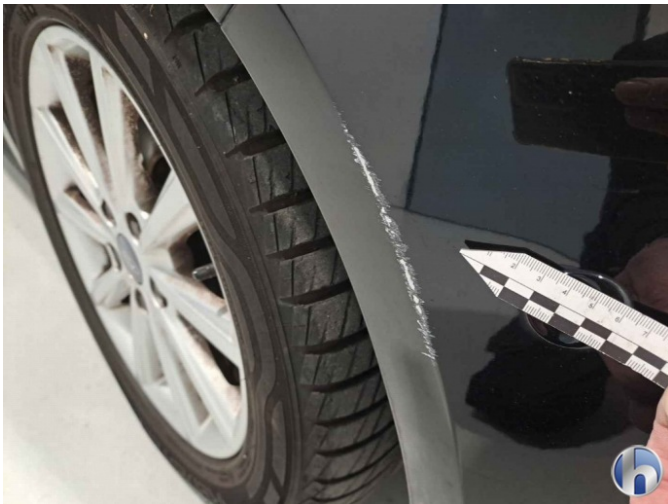
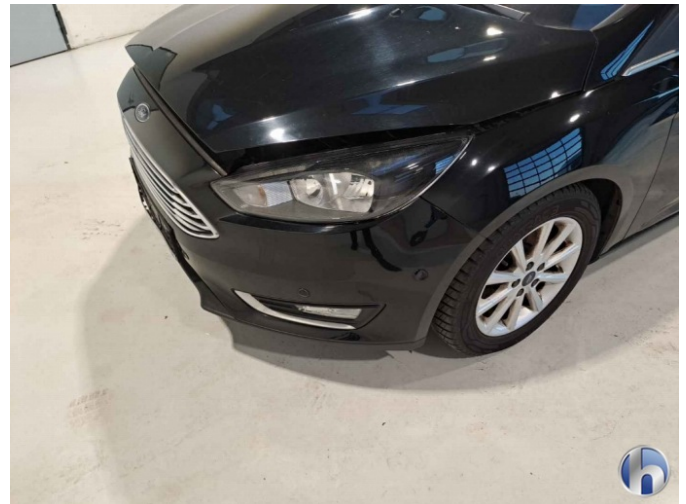
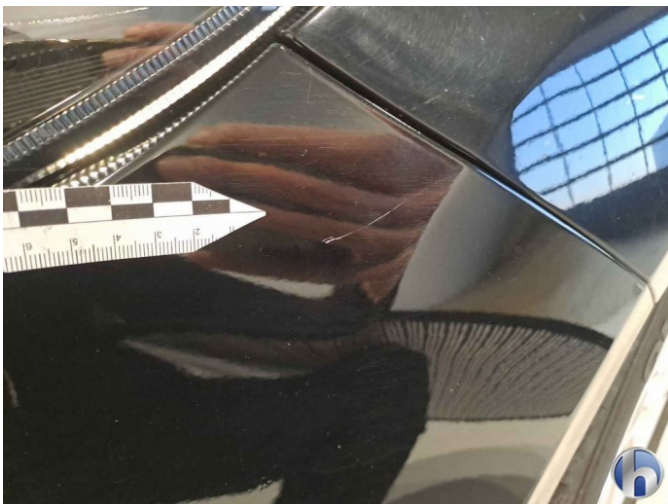
7. Front bumper

| | component | Damage | Rep kind |
|---|---|---|---|
| 7. | Front bumper | Scrape | Smart repair |

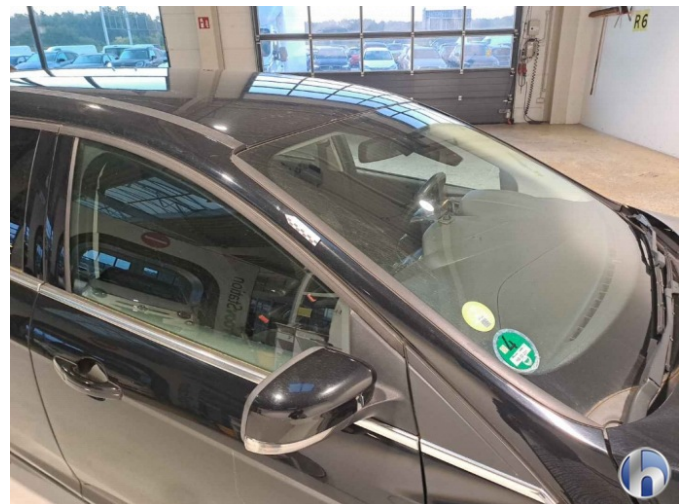
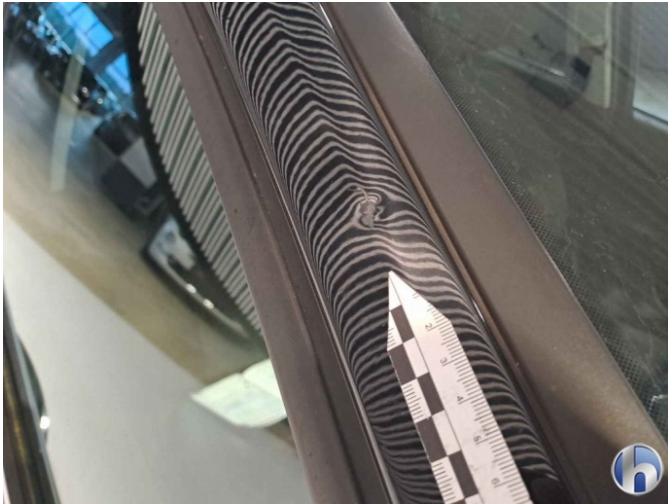
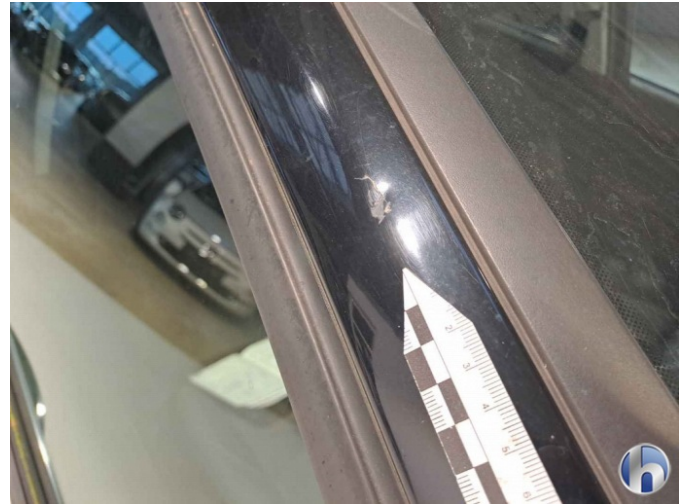
8. A-pillar Front - right

| | component | Damage | Rep kind |
|---|---|---|---|
| 8. | A-pillar Front - right | | Smart repair |

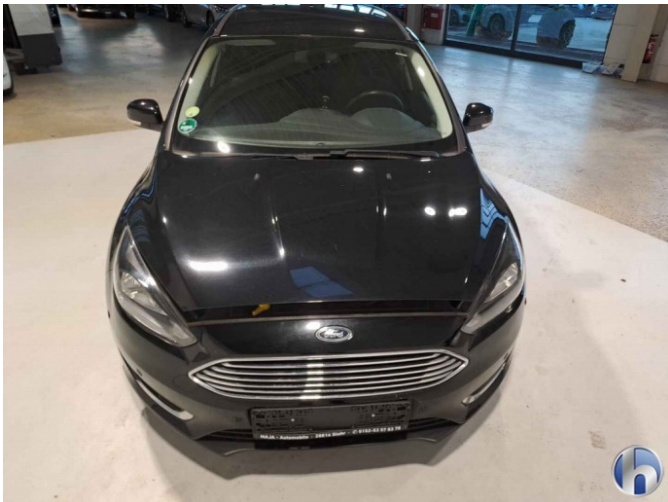
9. exterior body

| | component | Damage | Rep kind |
|---|---|---|---|
| 9. | exterior body | Surface scratch(es) | |

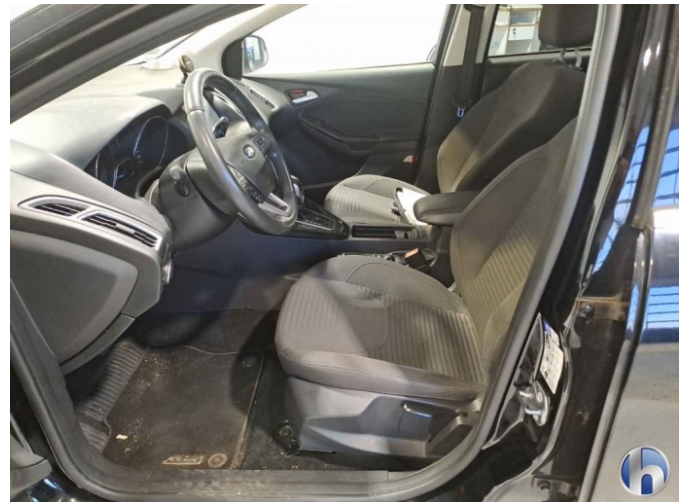
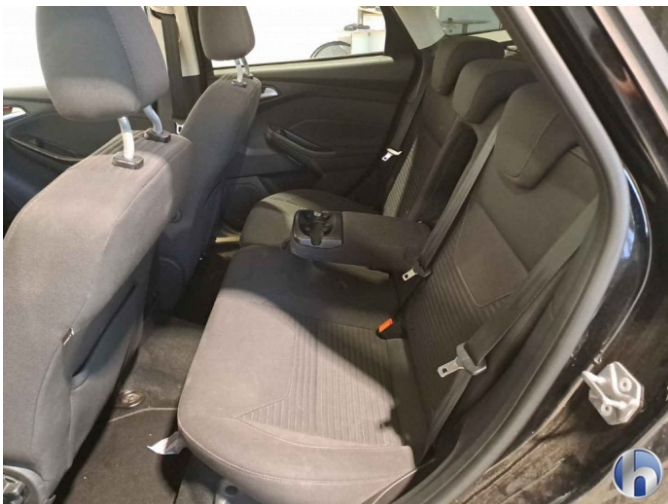
| | component | Damage | Rep kind |
|---|---|---|---|
| 10. | | Wear and tear | acceptable |

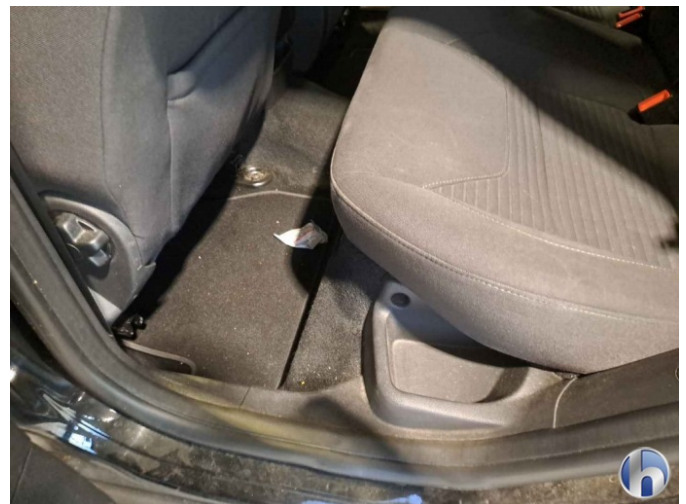
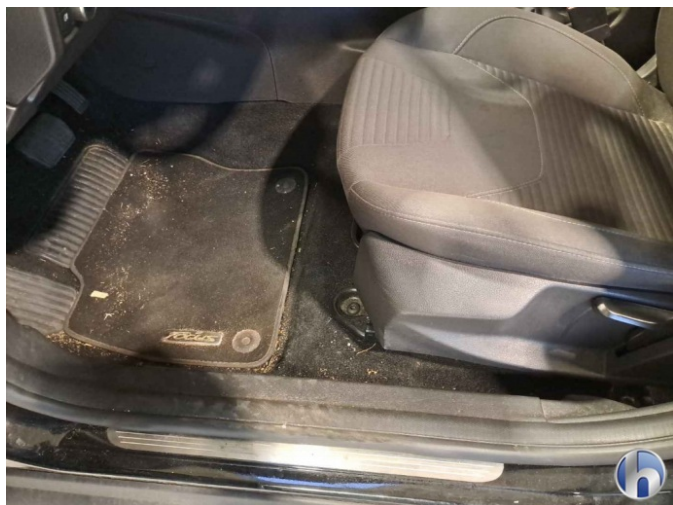
| | component | Damage | Rep kind |
|---|---|---|---|
| 11. | | Dirty | |

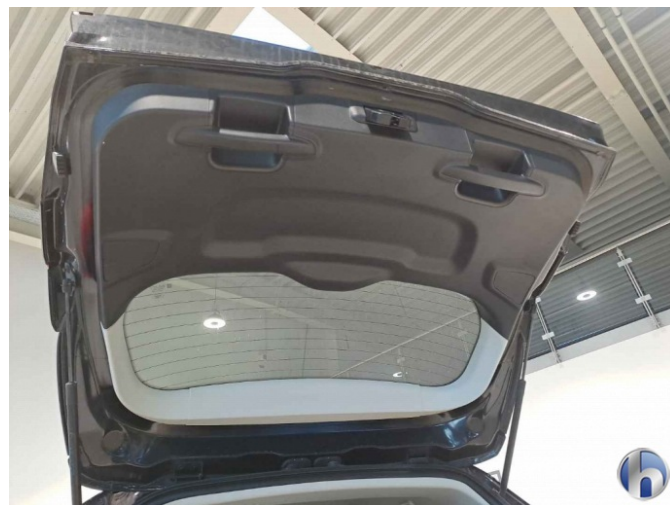
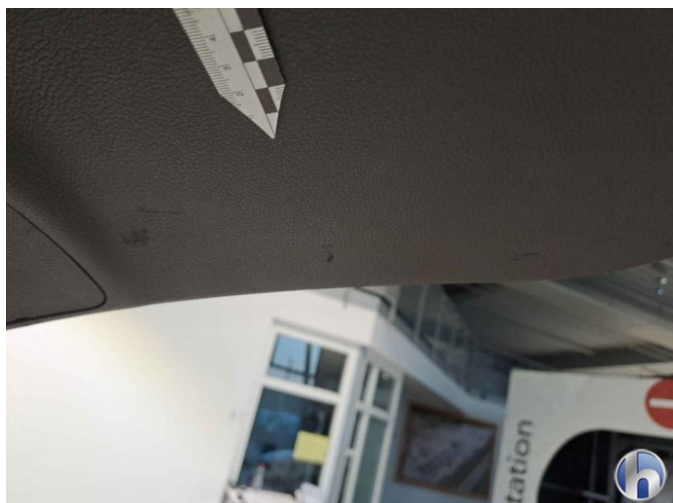
12. tailgate trim

| | component | Damage | Rep kind |
|---|---|---|---|
| 12. | tailgate trim | Scrape | Replace |
