Expertise

Protocol number: 41761050
Order number / reference: 25242481
Inspection date: 30 Sept 2025

Manufacturer: Ford

Model: Transit Connect 220 L1 LKW S&S Autm. Trend

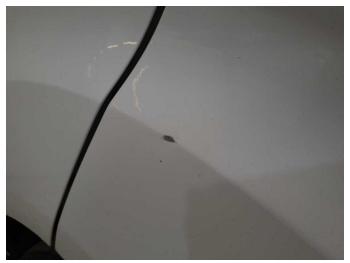
Damage 3: Side panel - rear left side: Side panel - Scratch(es) - Smart repair

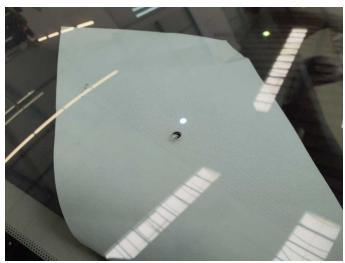
Damage 5: Vehicle glazing: Windscreen (Mit Rissbildung) - Stone chips - Replace
