Expertise

Protocol number: 41742584  
Order number / reference: 25218583  
Inspection date: 26 Sept 2025

Manufacturer: Ford

Model: Transit Connect 230 L2 LKW S&S Trend

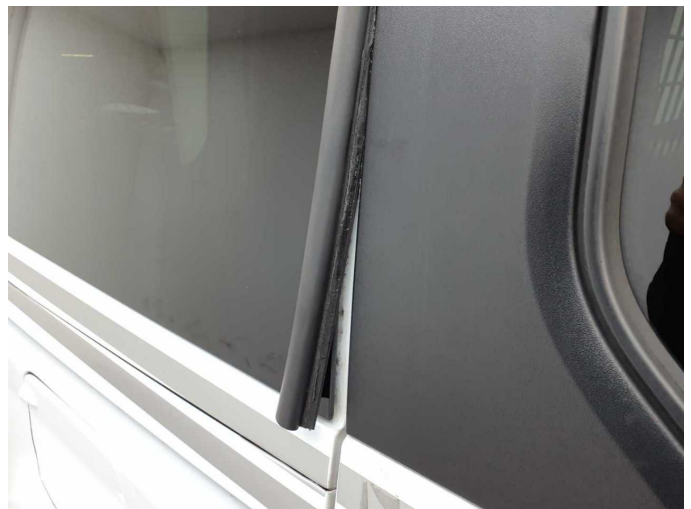
Damage 1: Door - rear right side: Door seal - Damaged - Replace

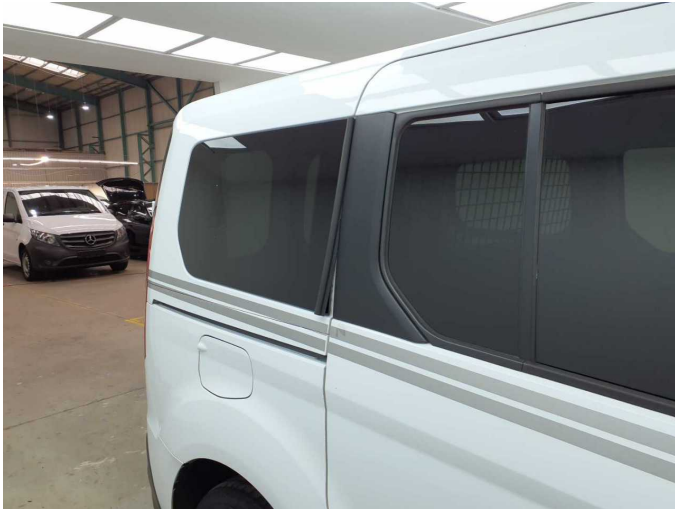
**Damage 1:** Door - rear right side: Door seal - Damaged - Replace

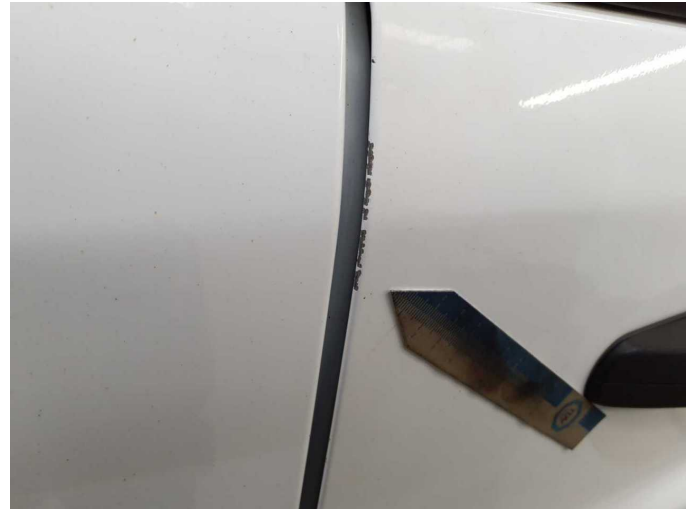
**Damage 2:** Boot lid / rear door: Boot lid - Scratch(es) - Smart repair

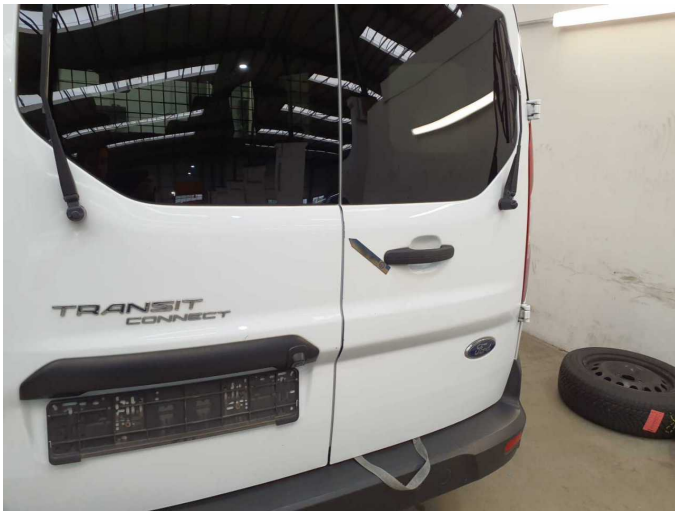
**Damage 2:** Boot lid / rear door: Boot lid - Scratch(es) - Smart repair

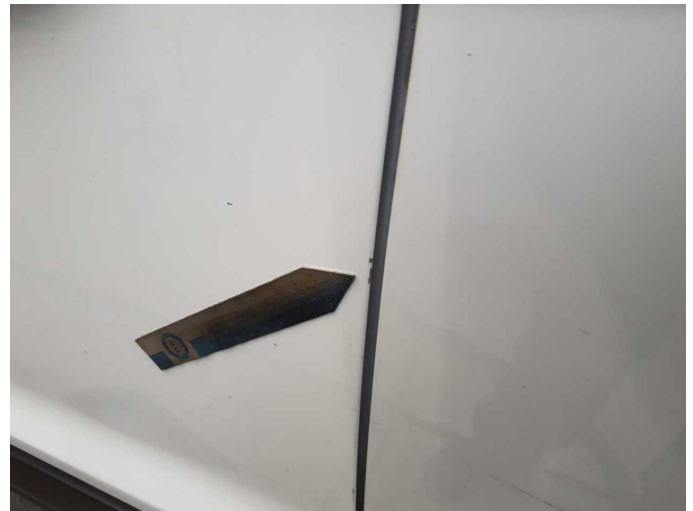
**Damage 3:** Door - front left side: Door edge - Scratch(es) - Smart repair

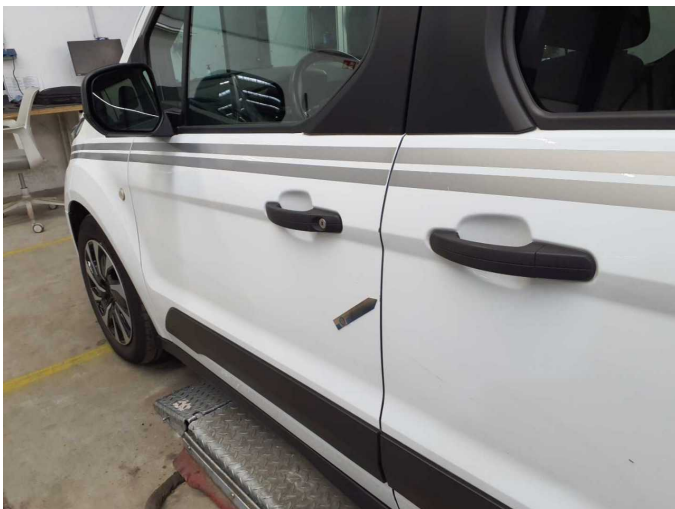
**Damage 3:** Door - front left side: Door edge - Scratch(es) - Smart repair

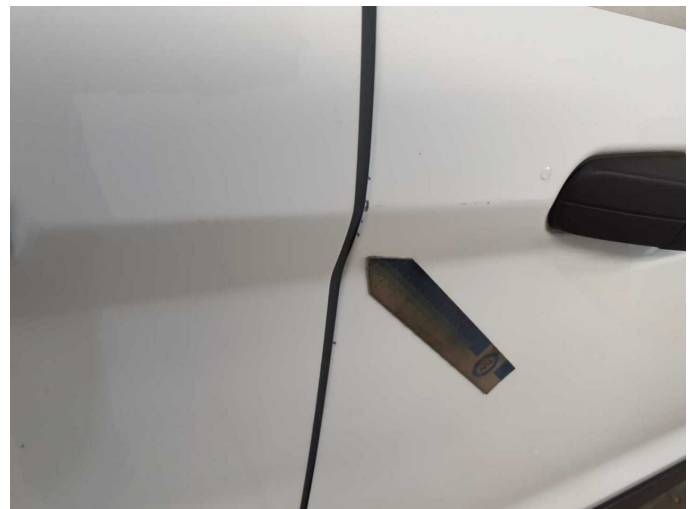
**Damage 4:** Door - front right side: Door edge - Scratch(es) - Smart repair

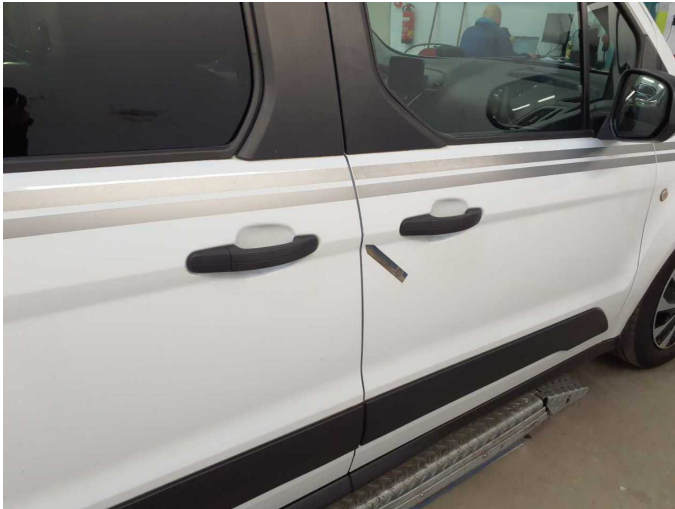
**Damage 4:** Door - front right side: Door edge - Scratch(es) - Smart repair

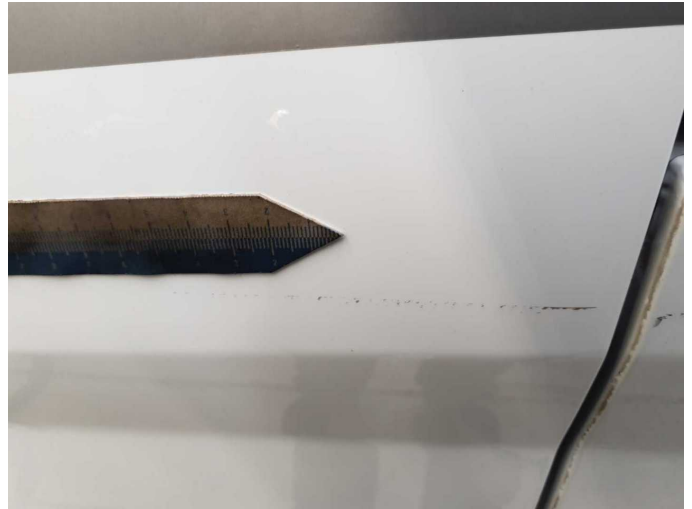
**Damage 5:** Door - rear left side: Door - Scratch(es) - Paint

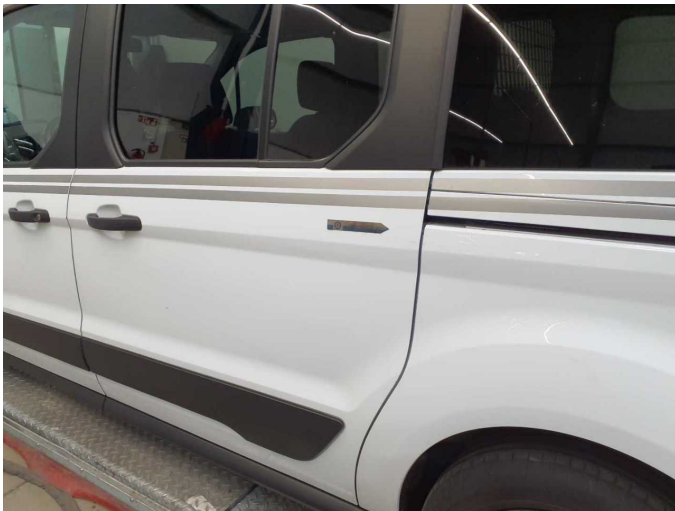
**Damage 5:** Door - rear left side: Door - Scratch(es) - Paint

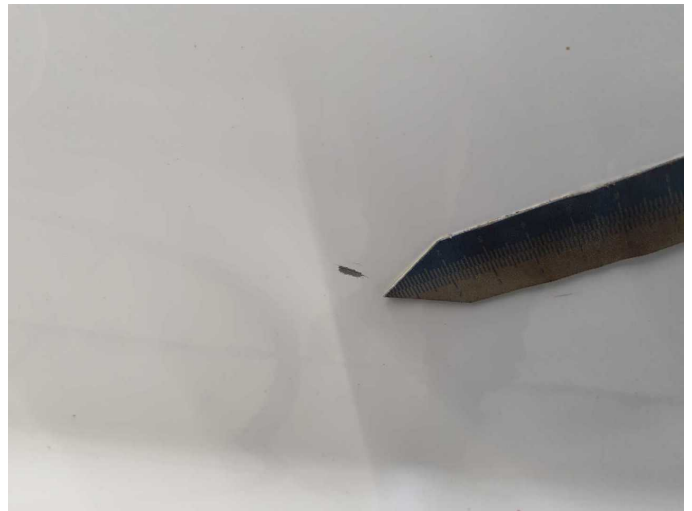
**Damage 5:** Door - rear left side: Door - Scratch(es) - Paint

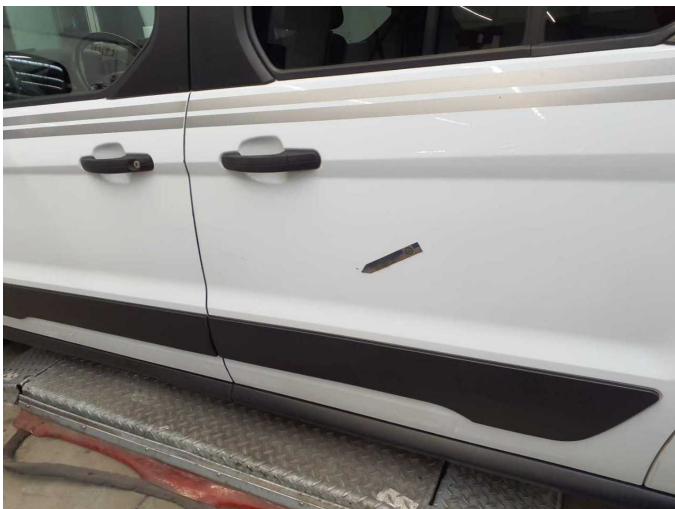
**Damage 5:** Door - rear left side: Door - Scratch(es) - Paint

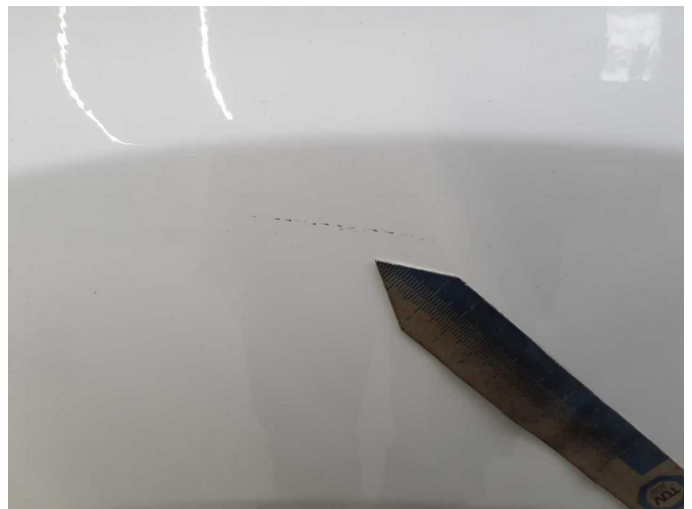
**Wear and tear 1:** Side panel - rear left side: Side panel - Scratch(es) - No deduction

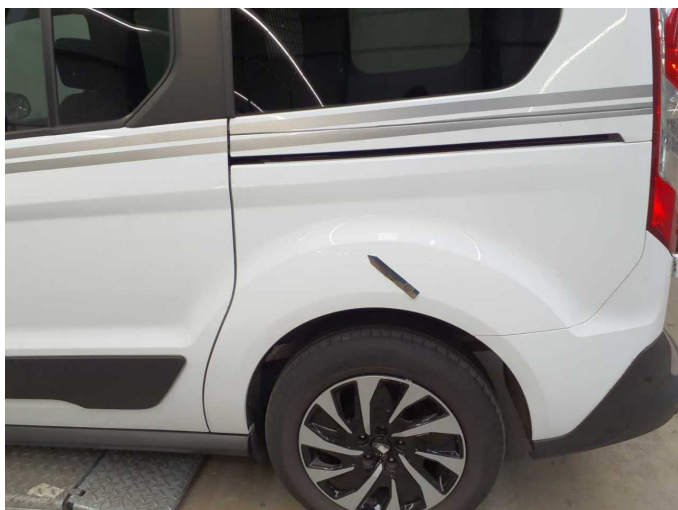
**Wear and tear 1:** Side panel - rear left side: Side panel - Scratch(es) - No deduction

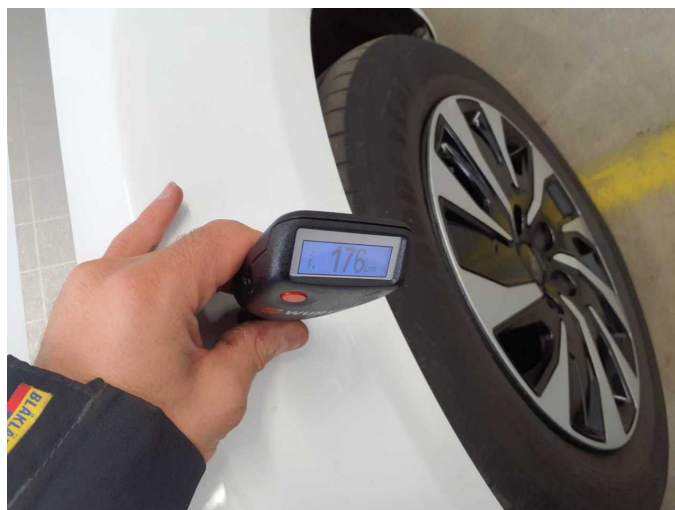
**Repainting 1:** Mudguard - right side

No.	Repainting
1	Mudguard - right side, Professionally carried out, Invoice of repair done Non-existent

Mudguard - right side	176 µm
-----------------------	--------
