Expertise

Protocol number: 41580918  
Order No. / Reference: 25084247  
Inspection date: 16 Sept 2025

| Manufacturer: Ford | Model: Transit Connect 230 L2 S&S Trend |
| VIN: WF07XXWPG7LD27380 | |

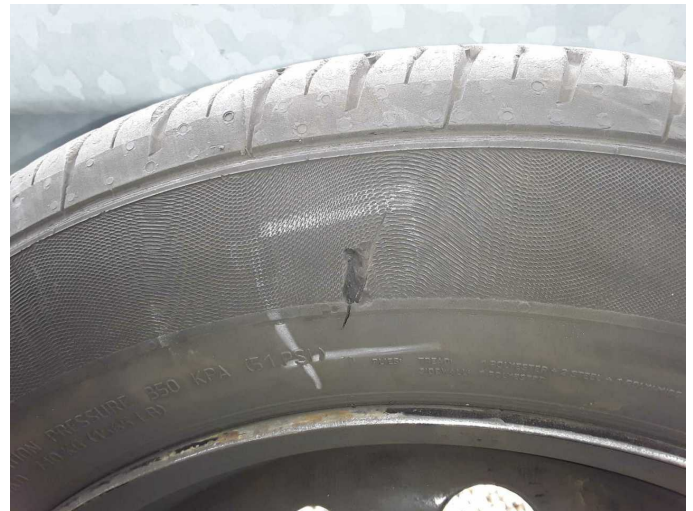
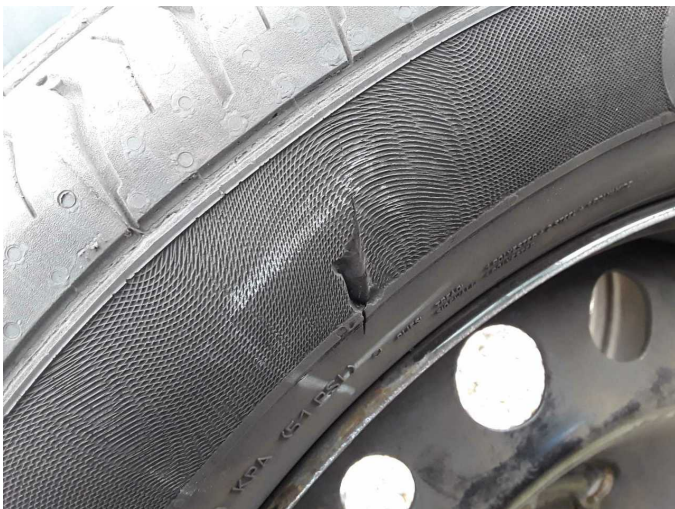
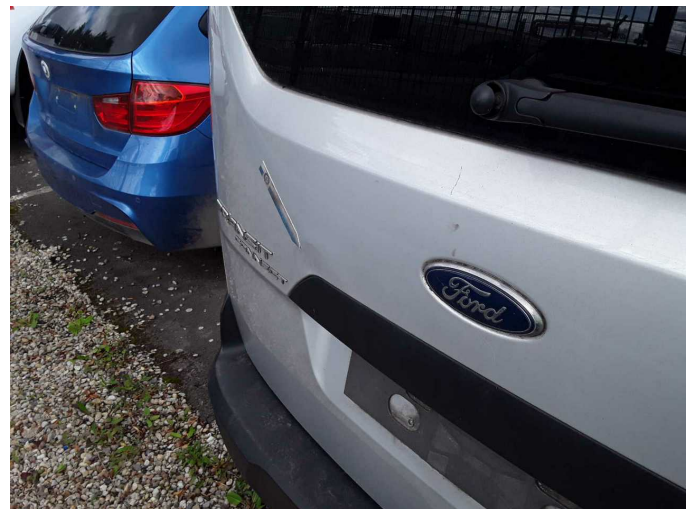
| No. | Component group | Description |
|---|---|--|
| 2 | 2nd wheel set | 1 tyre - Broken / torn - Replace |

**Damage 2:** 2nd wheel set: 1 tyre - Broken / torn - Replace

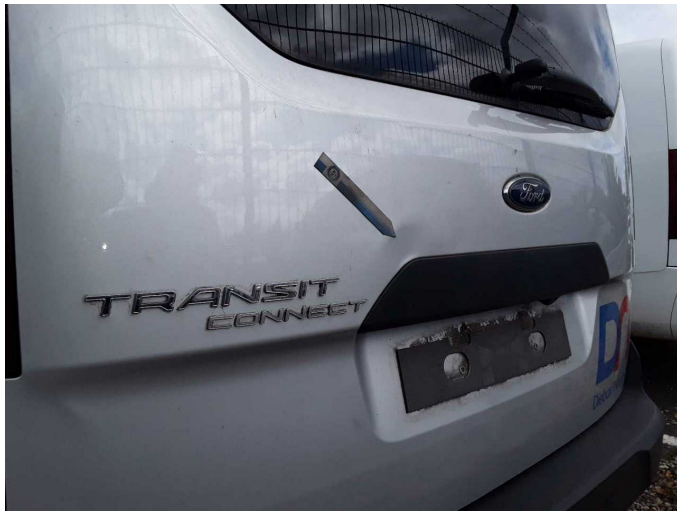
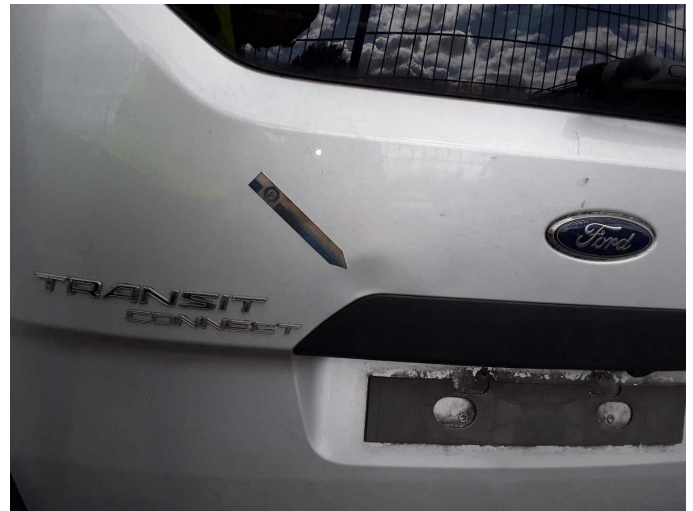
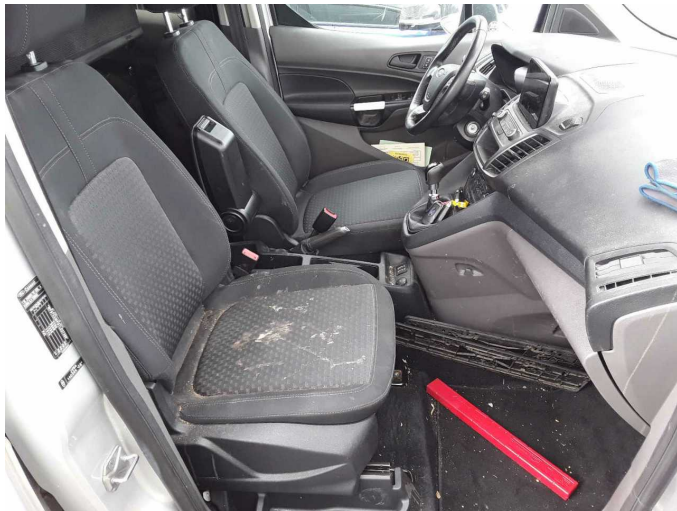
| No. | Component group | Description |
|---|---|--|
| 3 | Boot lid / rear door | Boot lid - dent(s) - Smooth repair work |

**Damage 3:** Boot lid / rear door: Boot lid - dent(s) - Smooth repair work

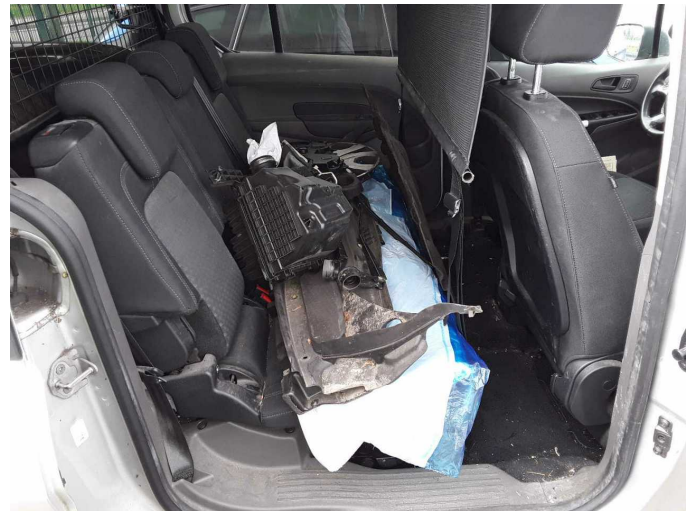
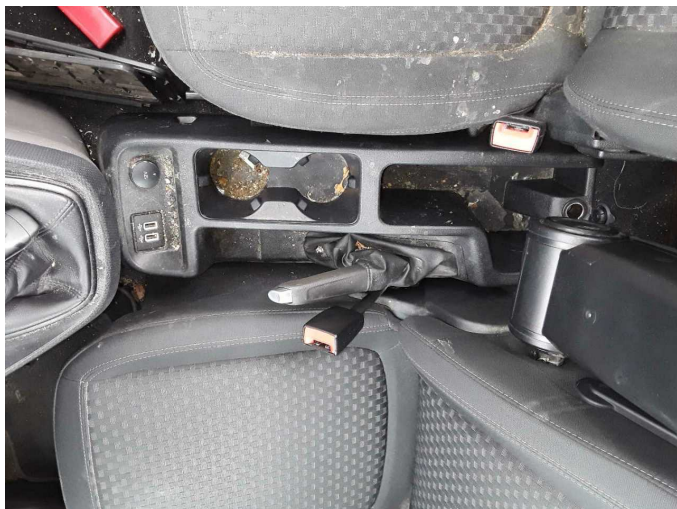
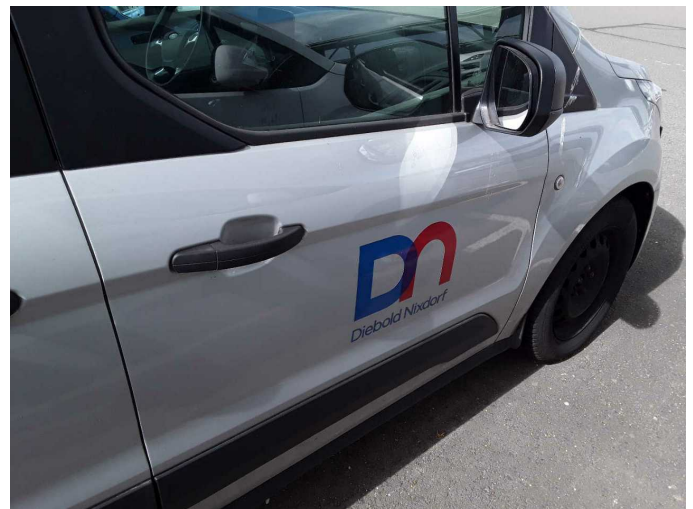
| No. | Component group | Description |
|---|---|--|
| 4 | Interior | Interior - Soiled - Clean |

**Damage 4:** Interior: Interior - Soiled - Clean

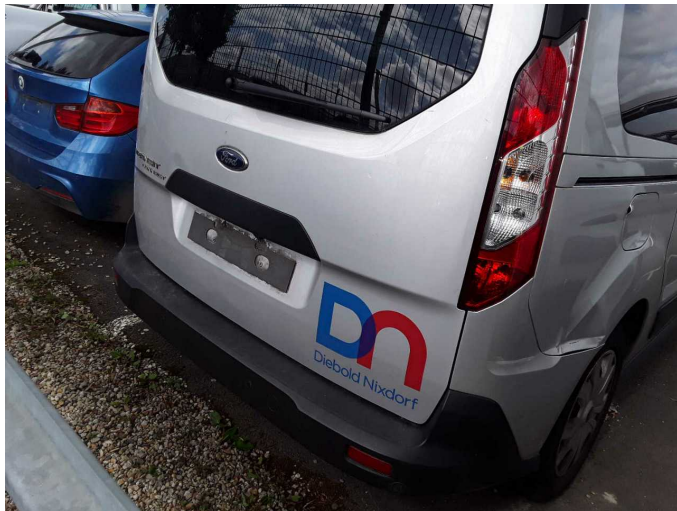
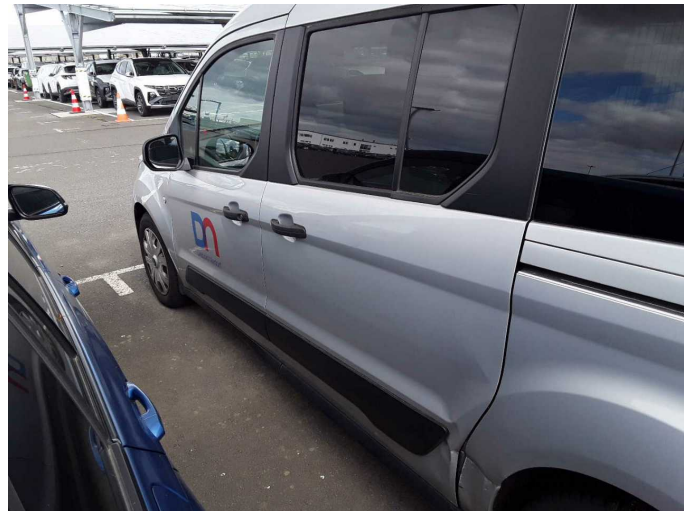
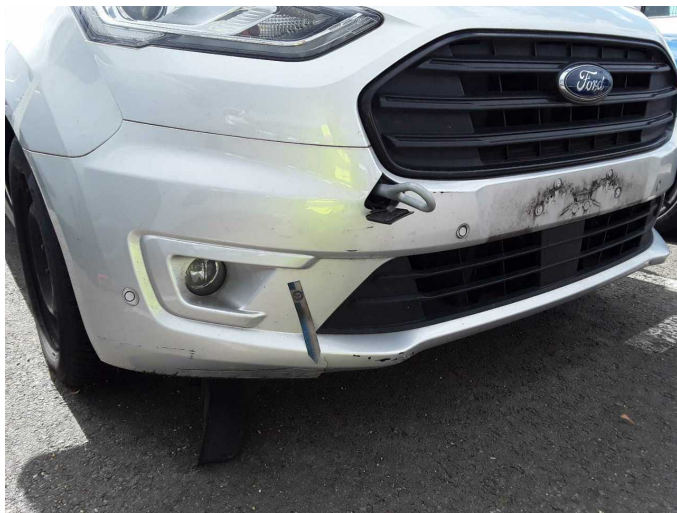
| No. | Component group | Description |
|---|---|--|
| 5 | Body | Body - Glued / labelled - De-glue / neutralise |

**Damage 5:** Body: Body - Glued / labelled - De-glue / neutralise

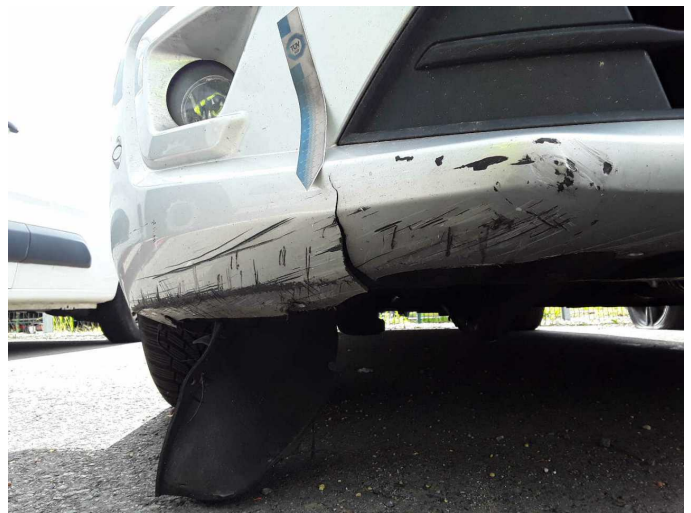
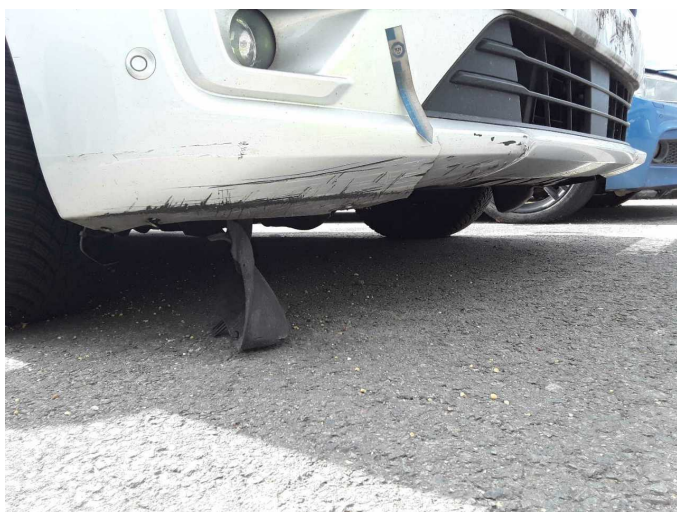
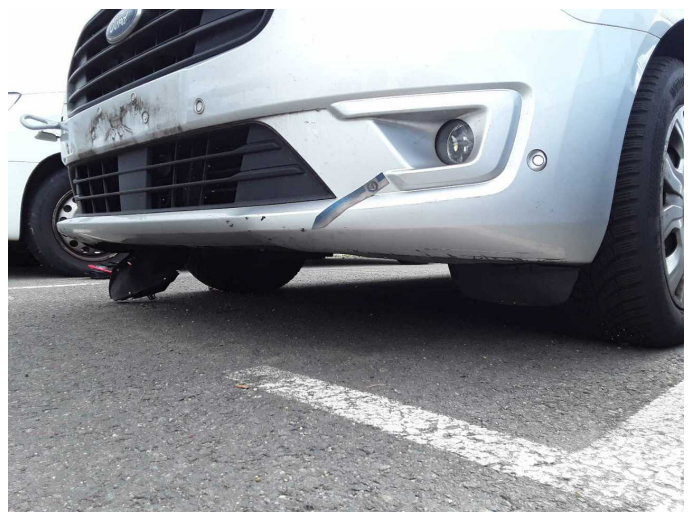
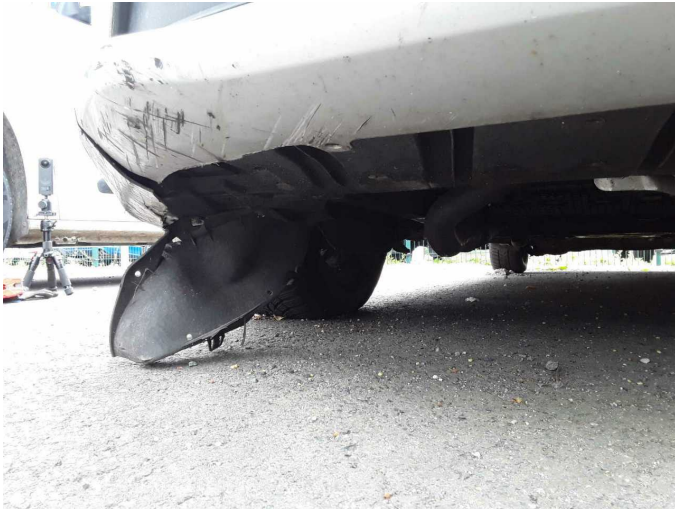
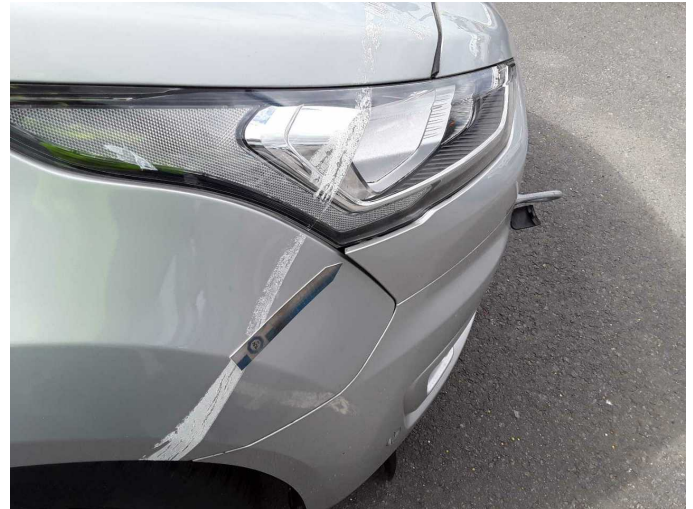
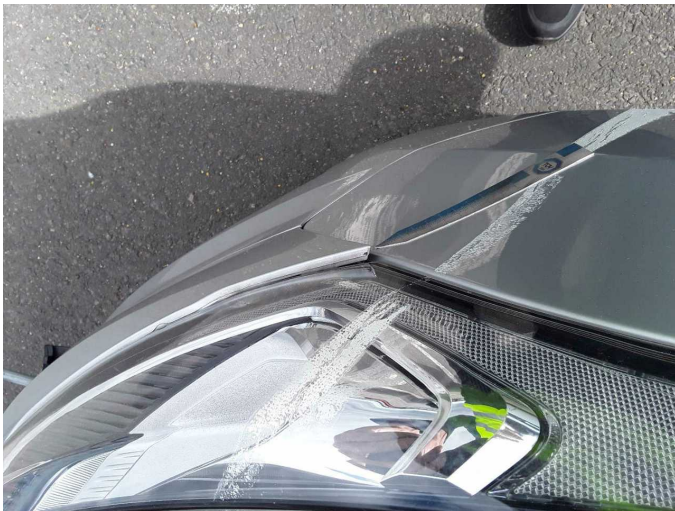
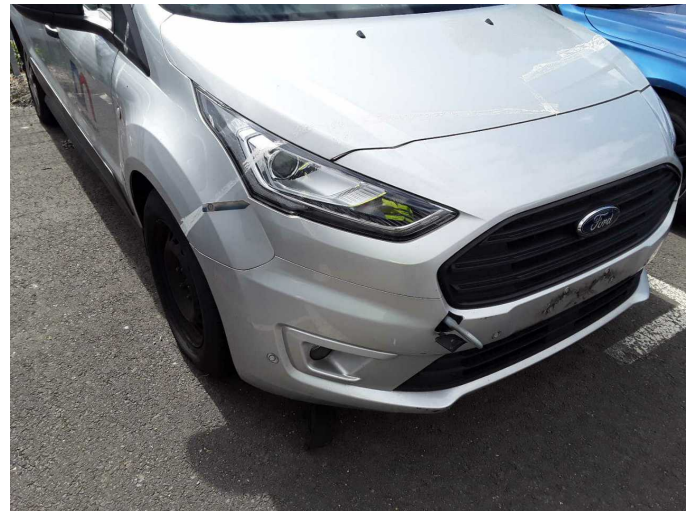
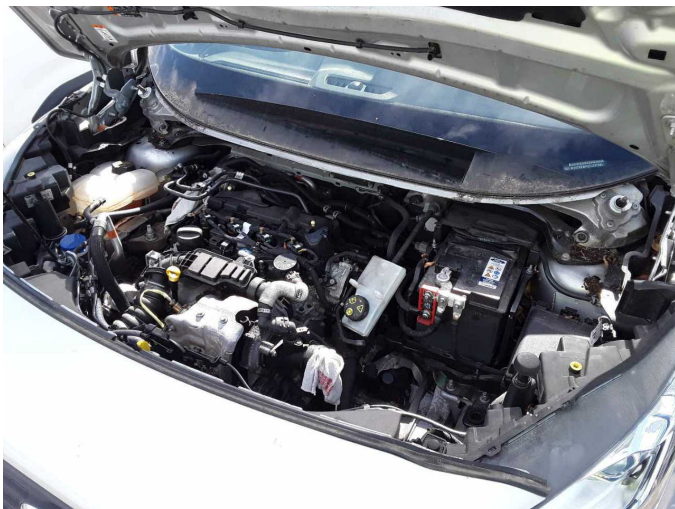
| No. | Component group | Description |
|---|---|--|
| 6 | Front bumper | Front bumper - Damaged - Replace |

**Damage 6:** Front bumper: Front bumper - Damaged - Replace

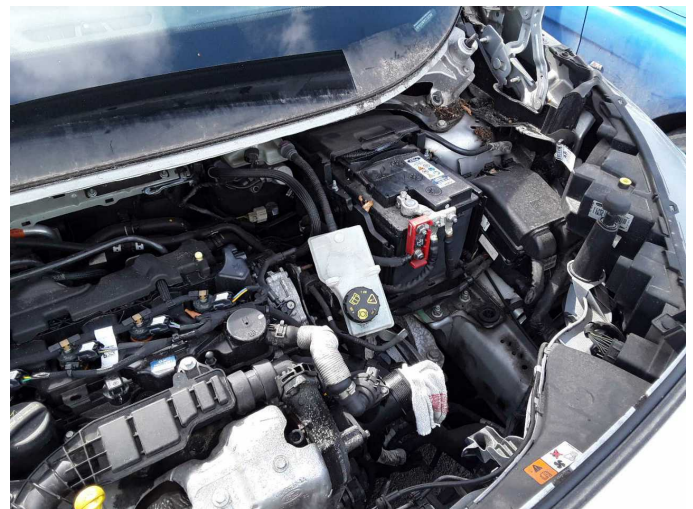
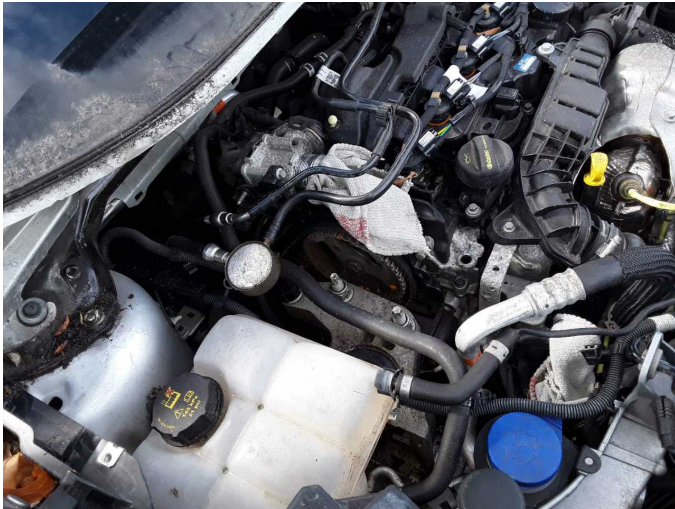
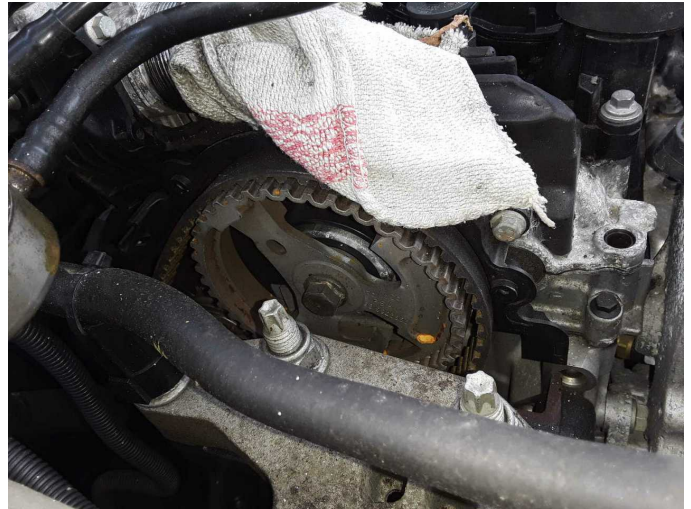
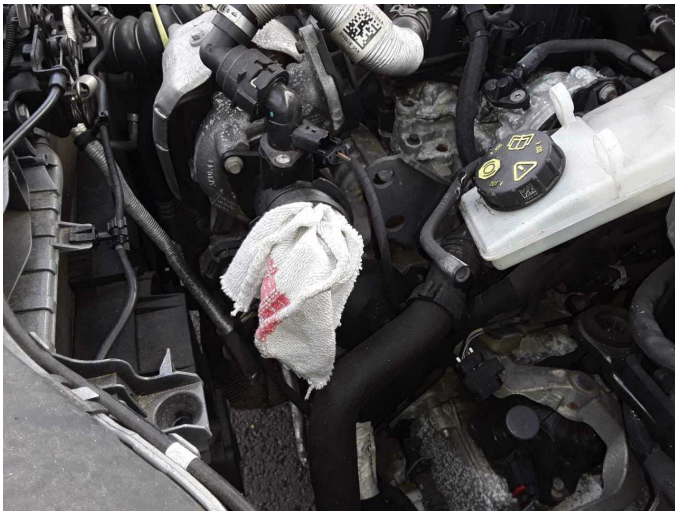
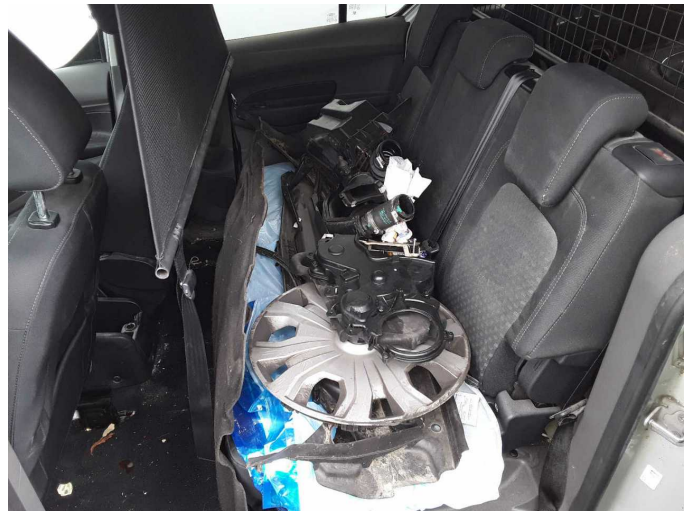
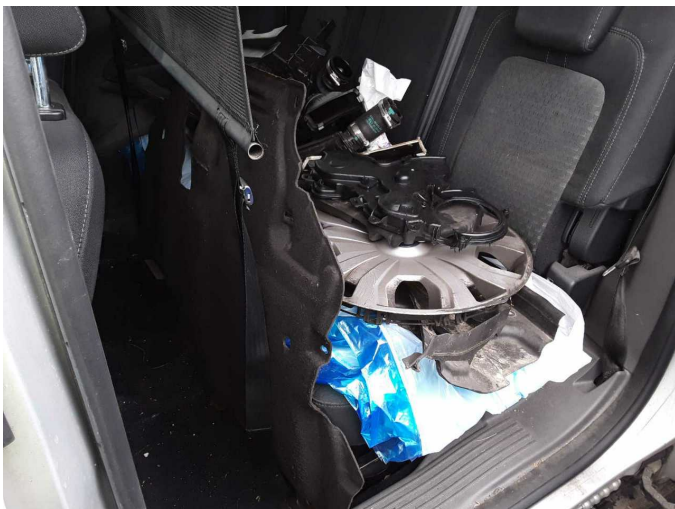
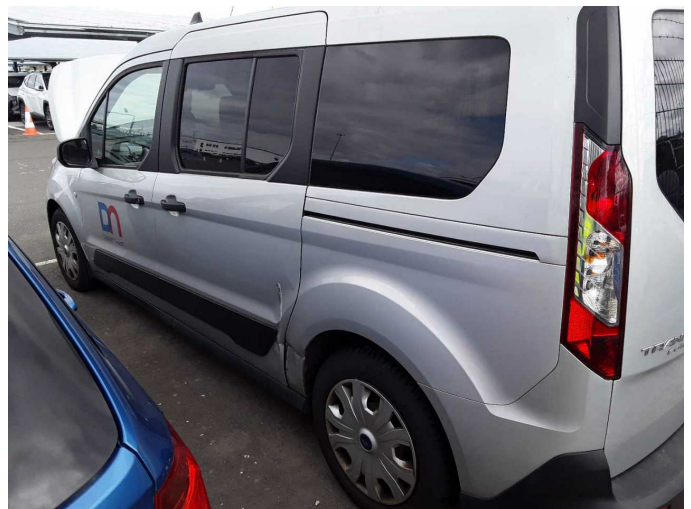
| Engine function test | An engine test run could not be performed.<br>This is due to the following reason:<br>Motorschaden |

| No. | Component group | Description |
|---|---|--|
| 7 | Engine | Engine - Defective - Replace |

**Damage 7:** Engine: Engine - Defective - Replace

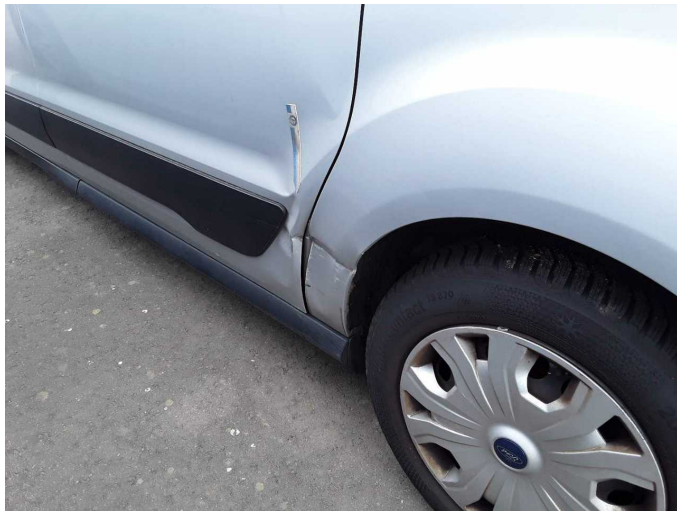
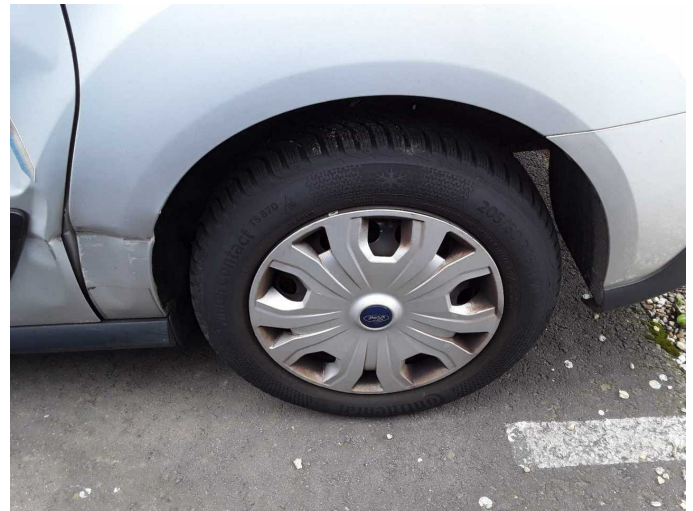
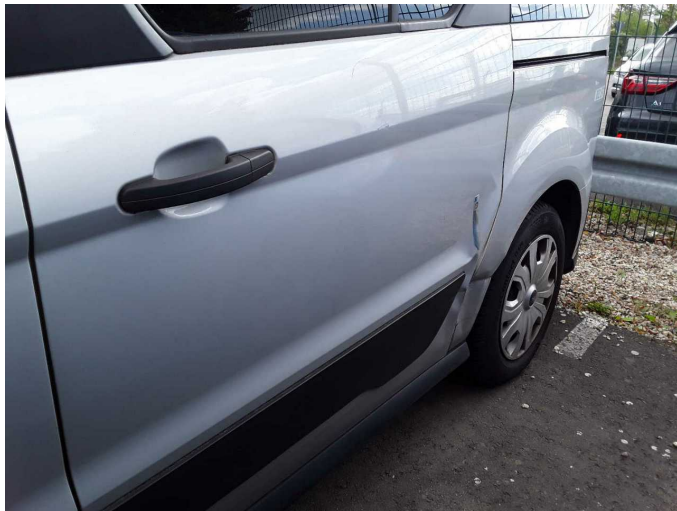
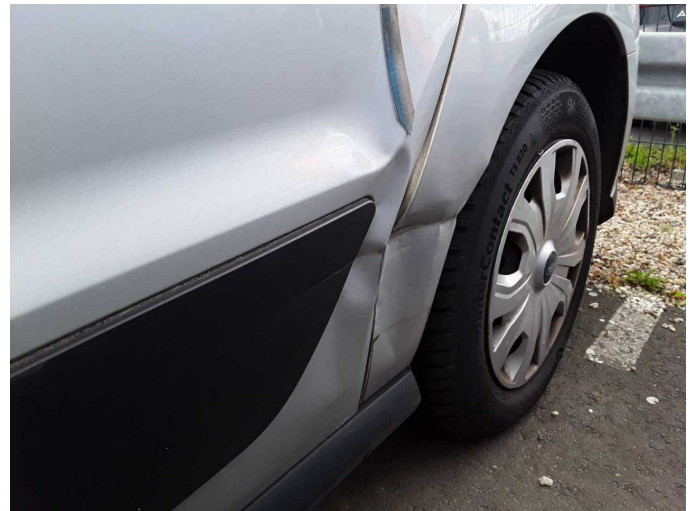
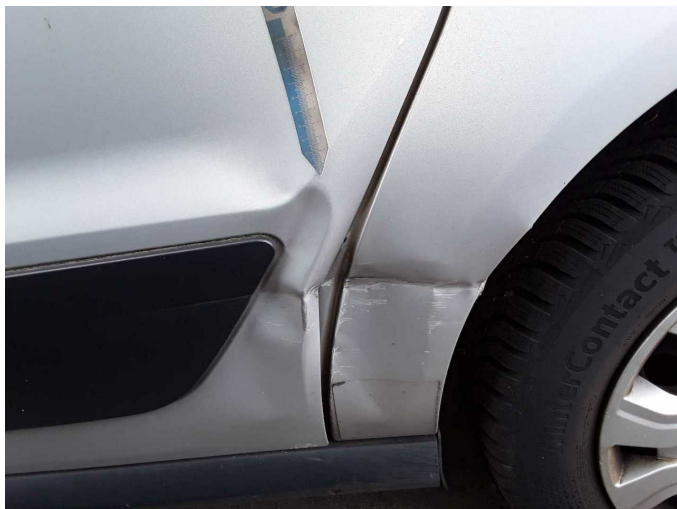
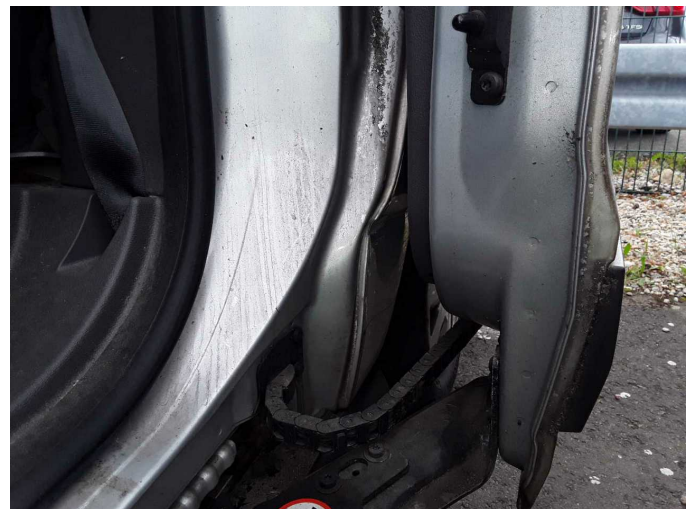
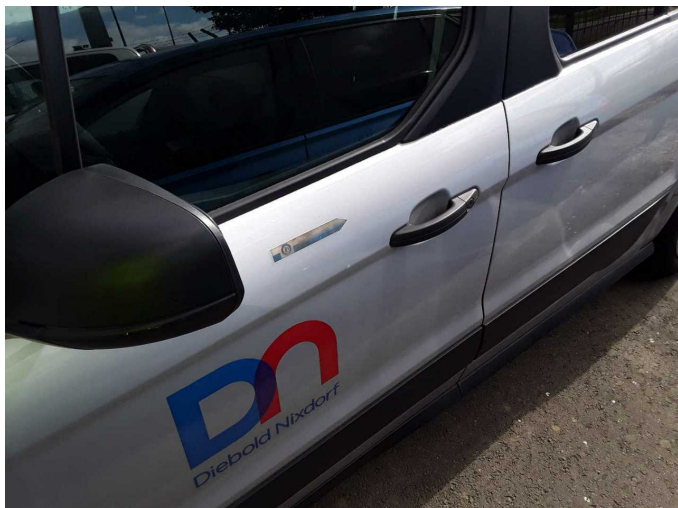
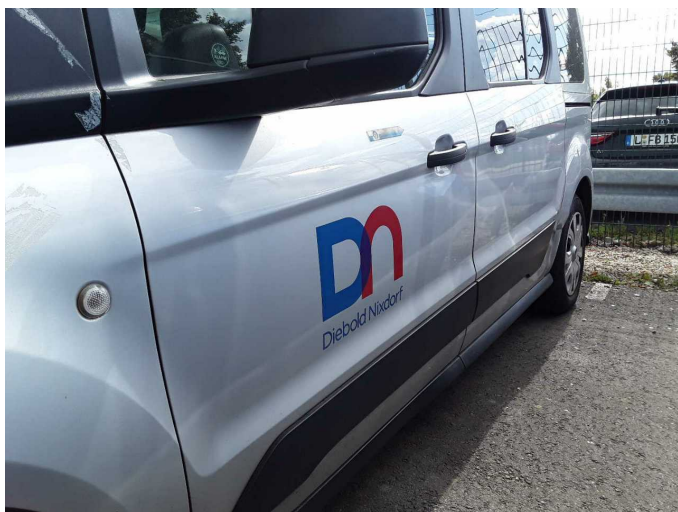
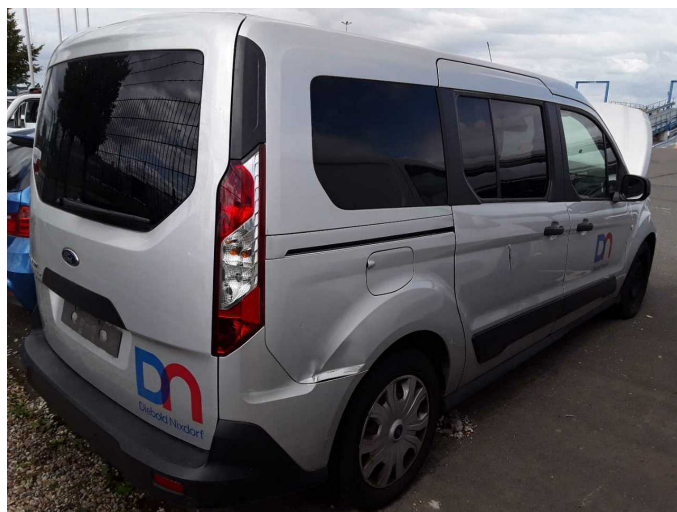
| No. | Accident |
|---|---|
| 1 | Side - left |

**Accident 1:** Side - left

**Accident 1: Side - left**

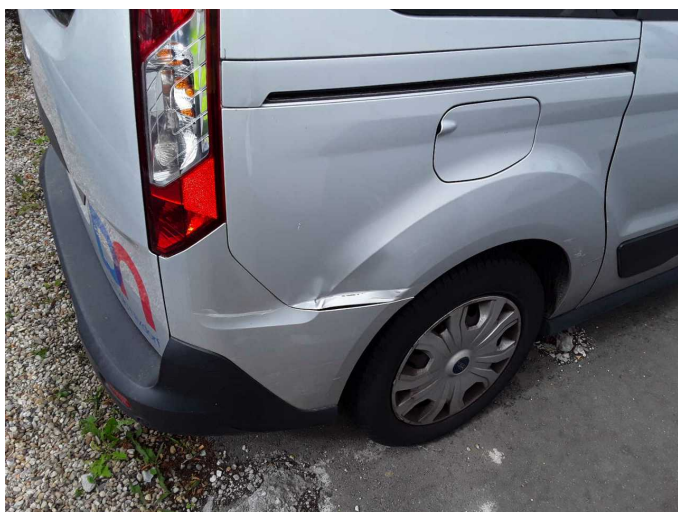
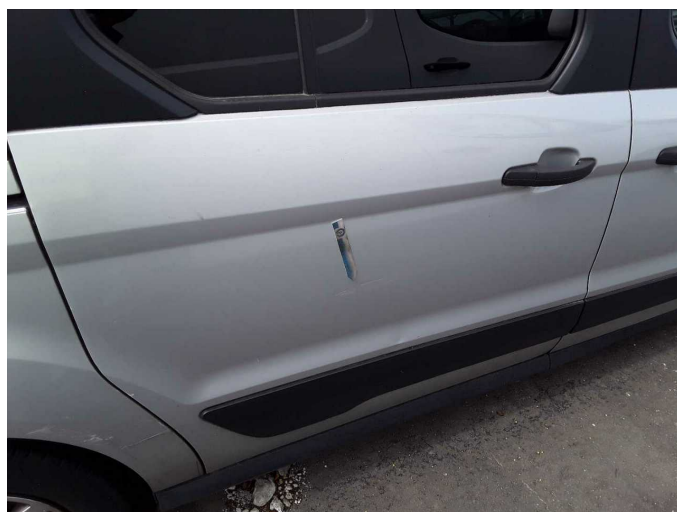
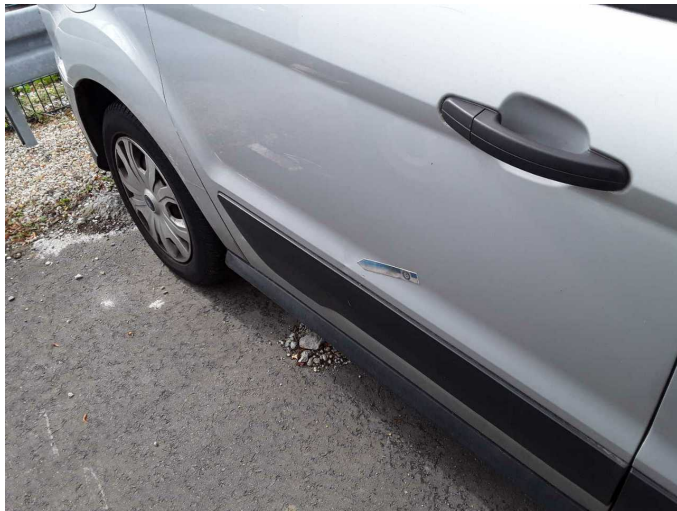
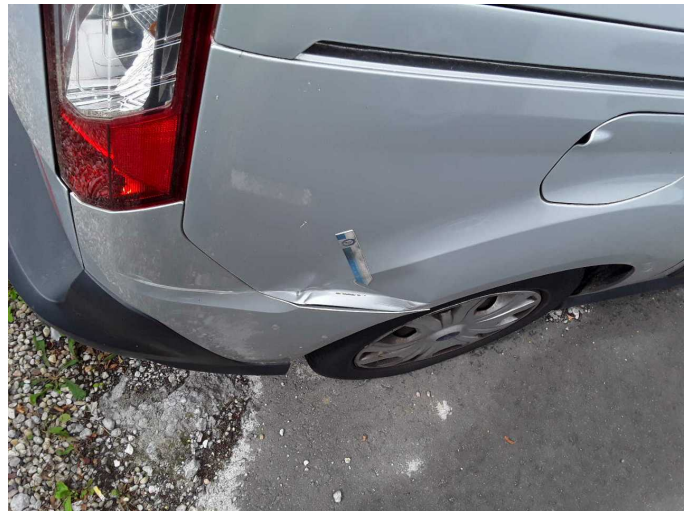
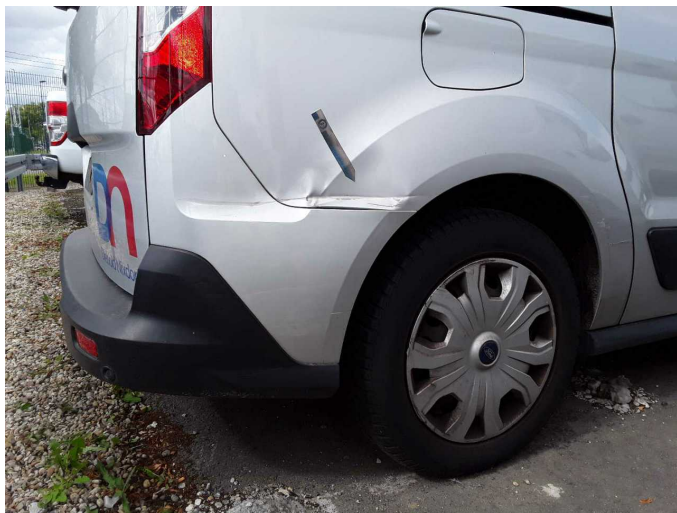
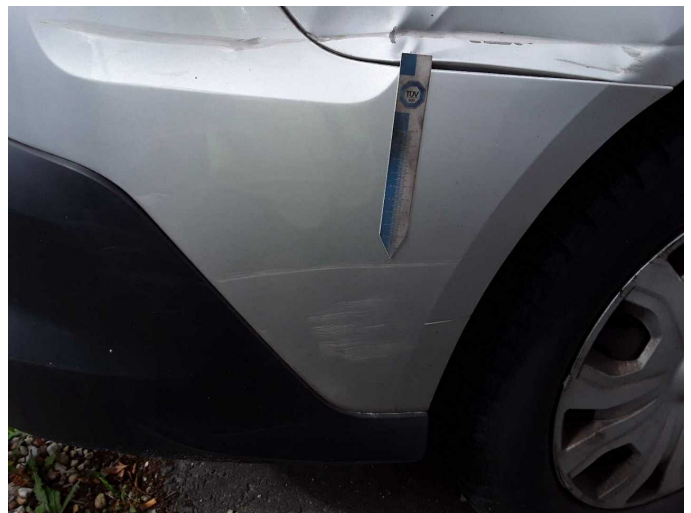
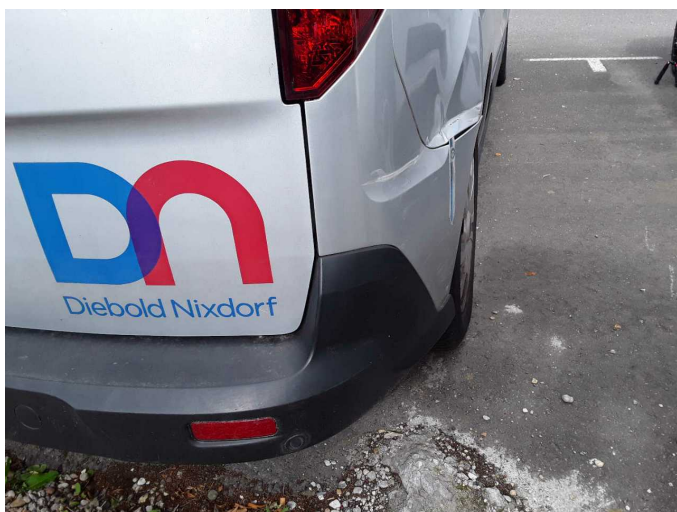
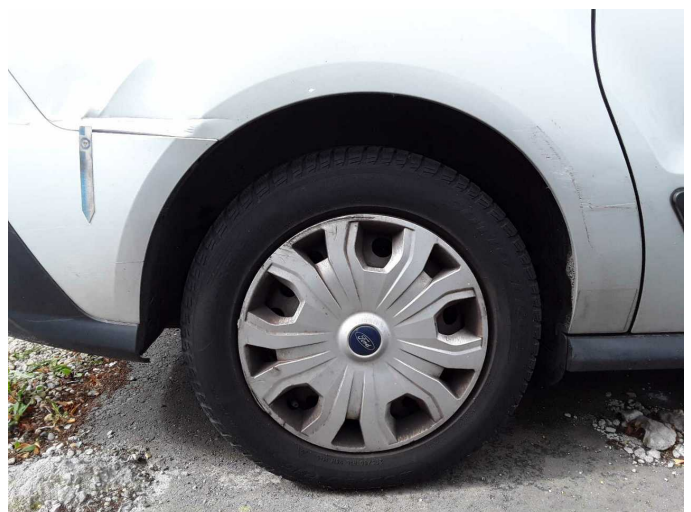
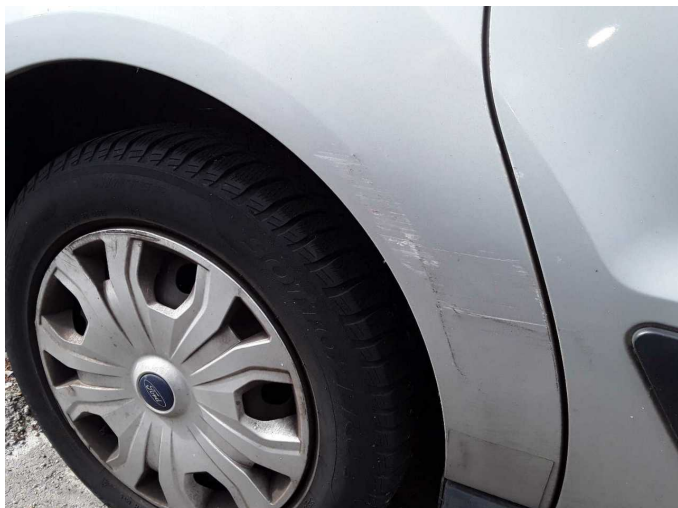
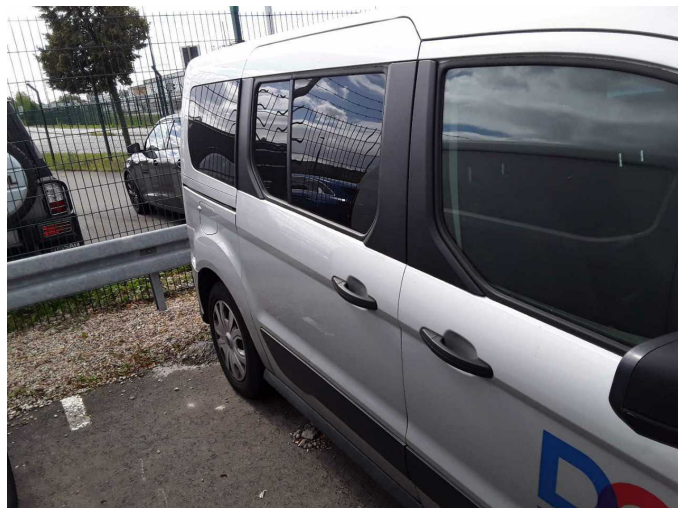
| No. | Accident |
|---|---|
| 2 | Rear, Side right |

**Accident 2: Rear, Side right**

**Accident 2:** Rear, Side right
