Expertise

Protocol number: 41580497  
Order No. / Reference: 25110221  
Inspection date: 15 Sept 2025

Manufacturer: Ford

Model: Transit Connect Kombi 230 L2 LKW S&S Trend

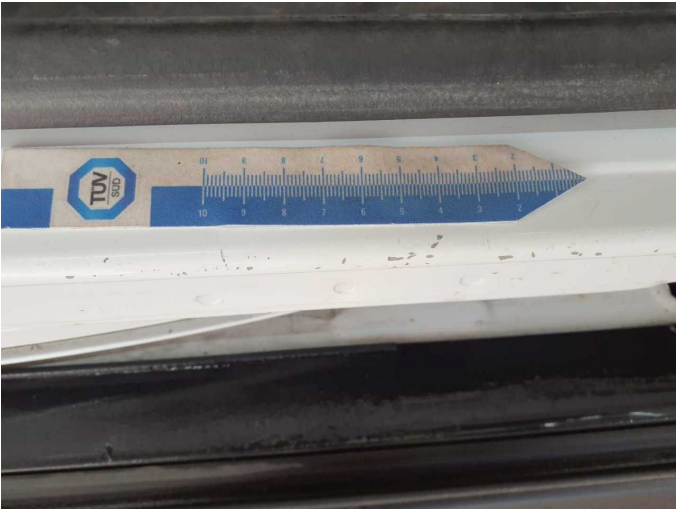
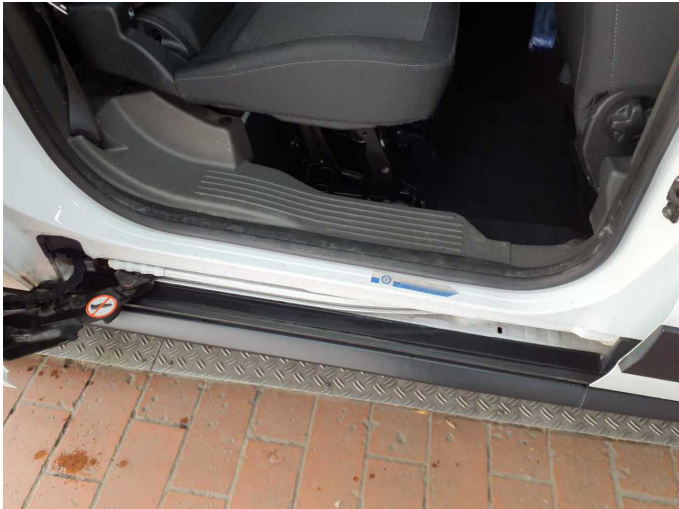
| No. | Component group | Description |
|---|---|---|
| 1 | Side panel - rear right side | Sill - Scratch(es) - Smart repair |

Damage 1: Side panel - rear right side: Sill - Scratch(es) - Smart repair

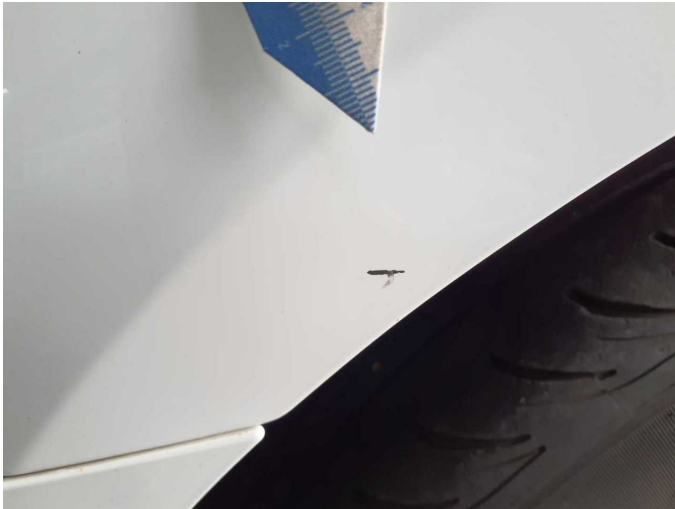
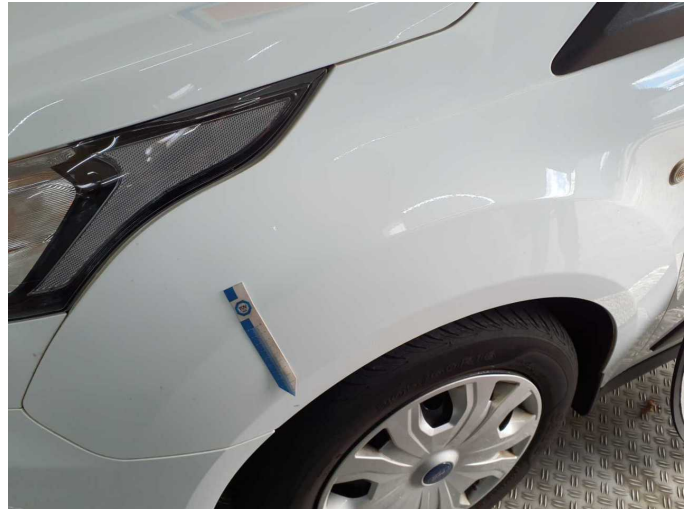
| No. | Component group | Description |
|---|---|---|
| 2 | Mudguard - left side | Mudguard - left side - Scratch(es) - Smart repair |

**Damage 2:** Mudguard - left side: Mudguard - left side - Scratch(es) - Smart repair

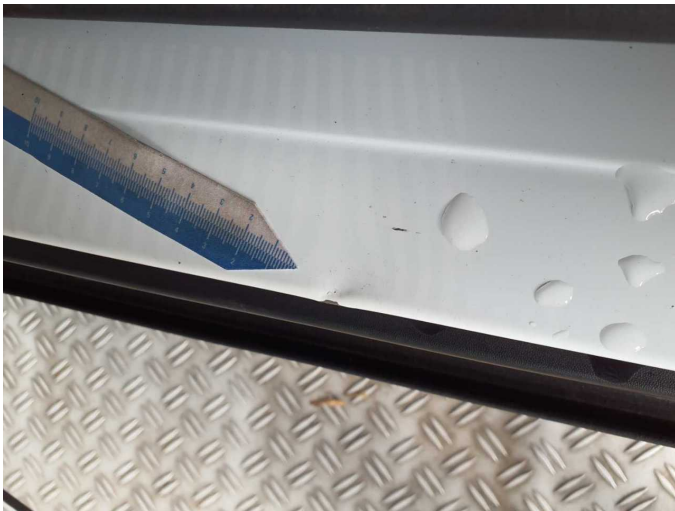
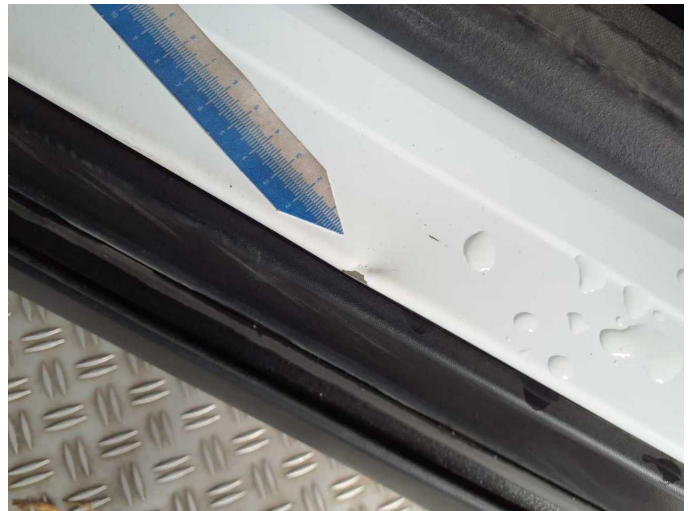
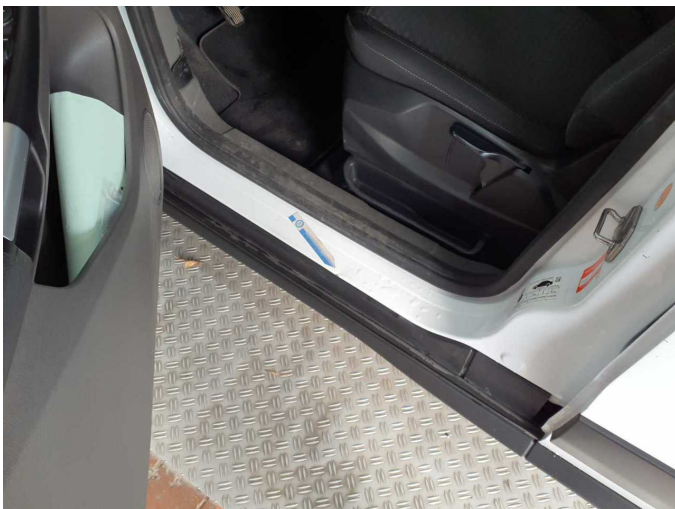
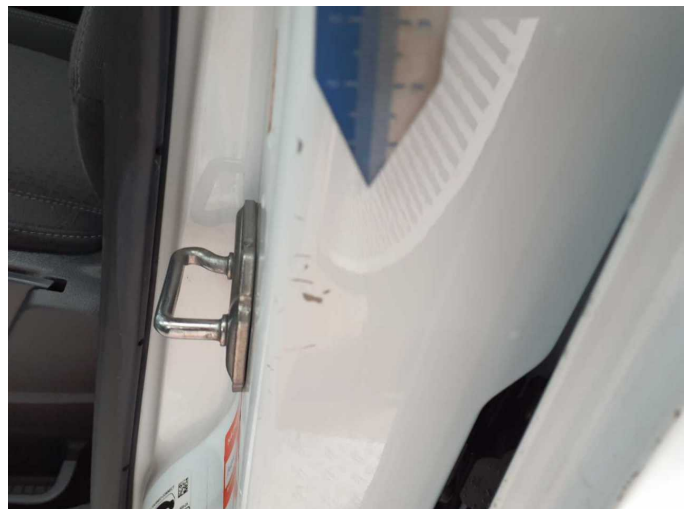
| No. | Component group | Description |
|---|---|---|
| 3 | Sill - left side | Sill - Dent / paintcoat damage - Smart repair |

**Damage 3:** Sill - left side: Sill - Dent / paintcoat damage - Smart repair

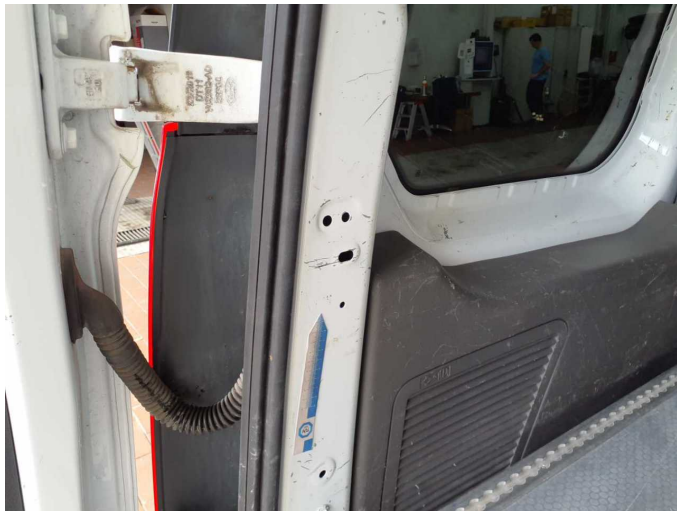
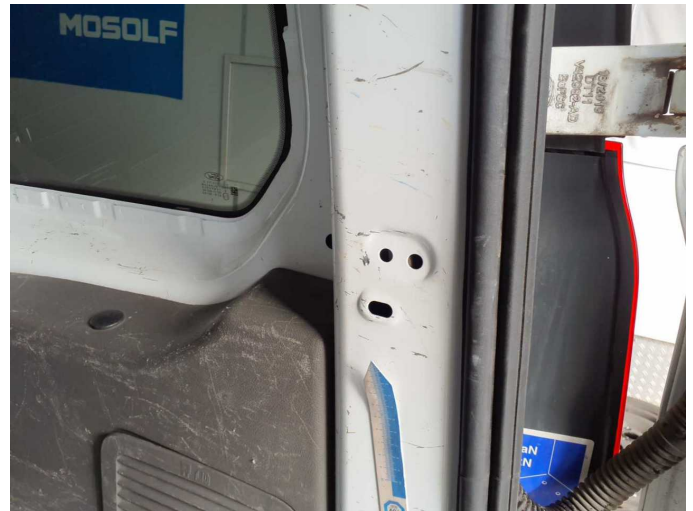
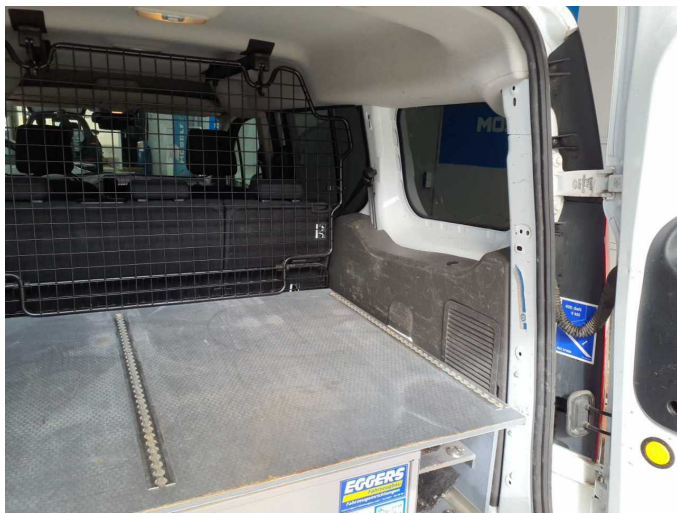
| No. | Component group | Description |
|---|---|---|
| 4 | Interior | Cargo area floor - Scratched - Loss in value |

**Damage 4:** Interior: Cargo area floor - Scratched - Loss in value

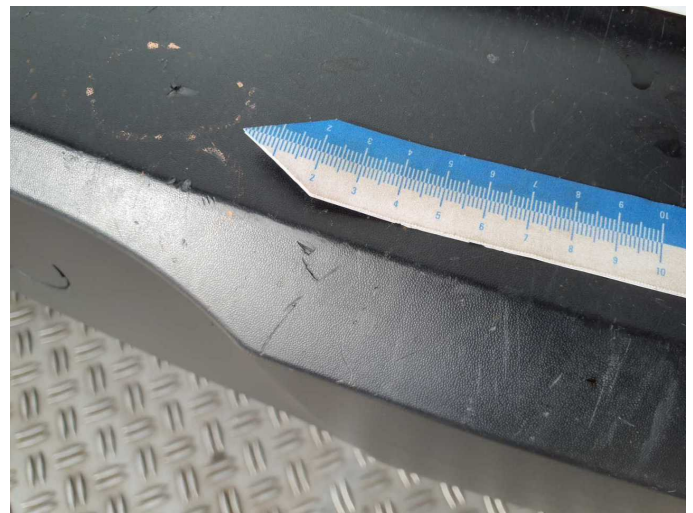
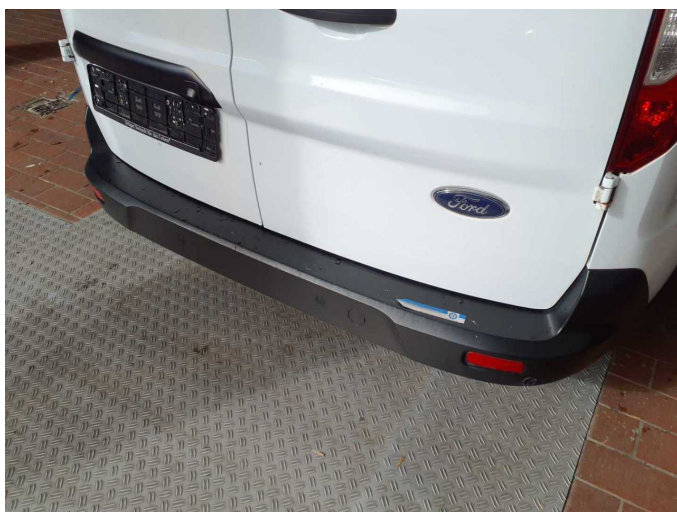
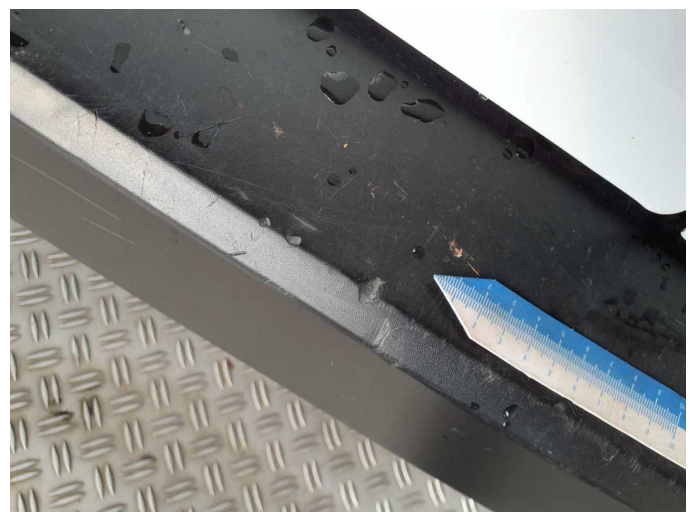
| No. | Component group | Description |
|---|---|---|
| 5 | Rear bumper | Rear bumper (Tiefe Abschürfungen) - Scratch(es) - Replace |

**Damage 5:** Rear bumper: Rear bumper (Tiefe Abschürfungen) - Scratch(es) - Replace

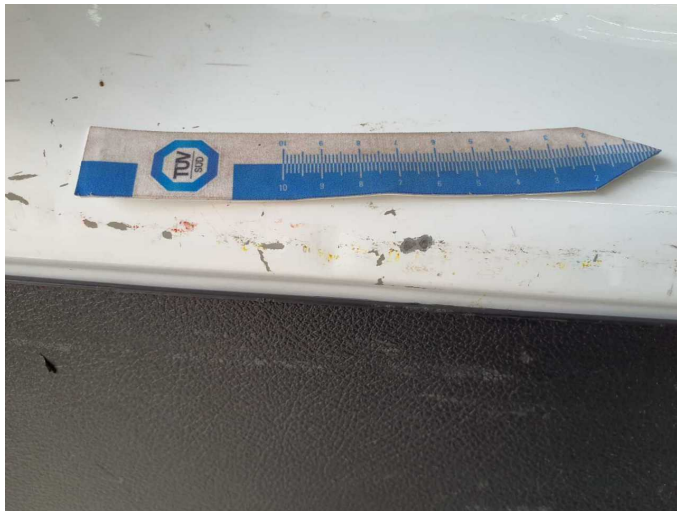
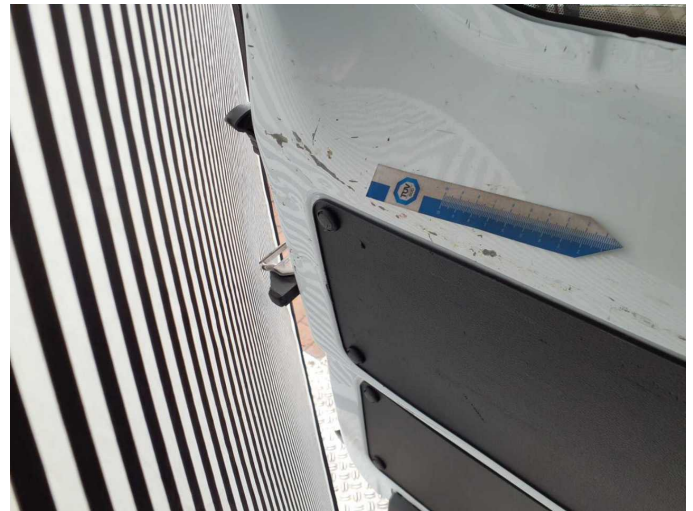
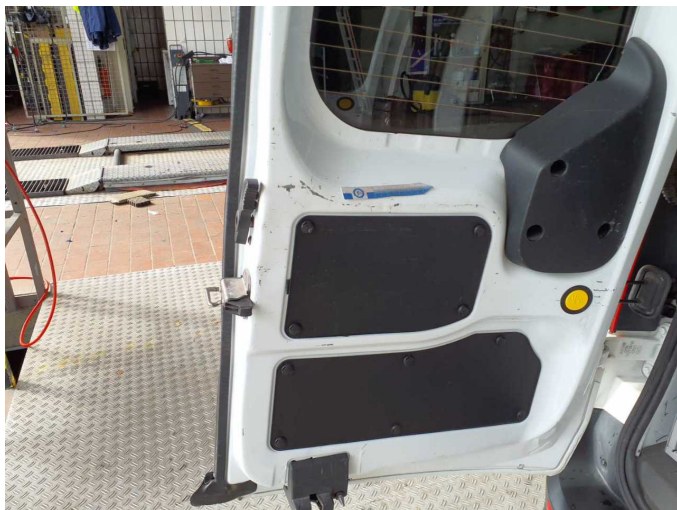
| No. | Component group | Description |
|---|---|---|
| 6 | Boot lid / rear door | Rear door - left side - Dent / paintcoat damage - Repair and paint |

**Damage 6:** Boot lid / rear door: Rear door - left side - Dent / paintcoat damage - Repair and paint

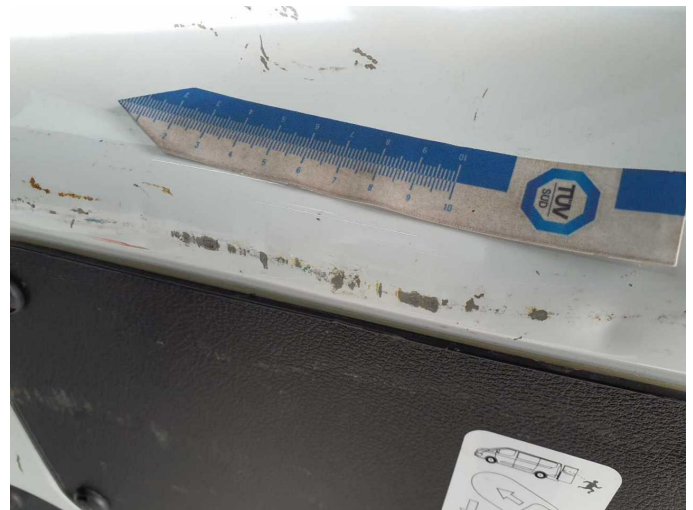
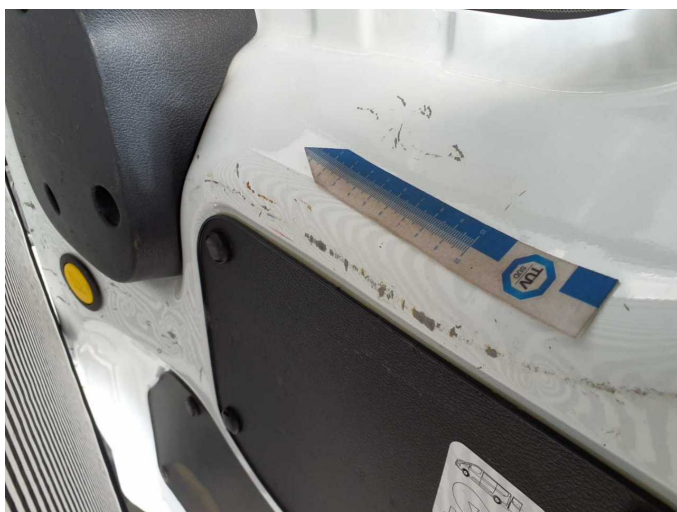
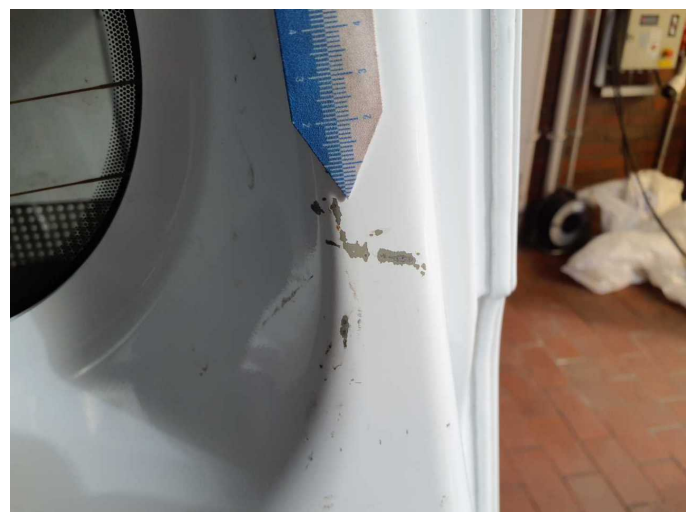
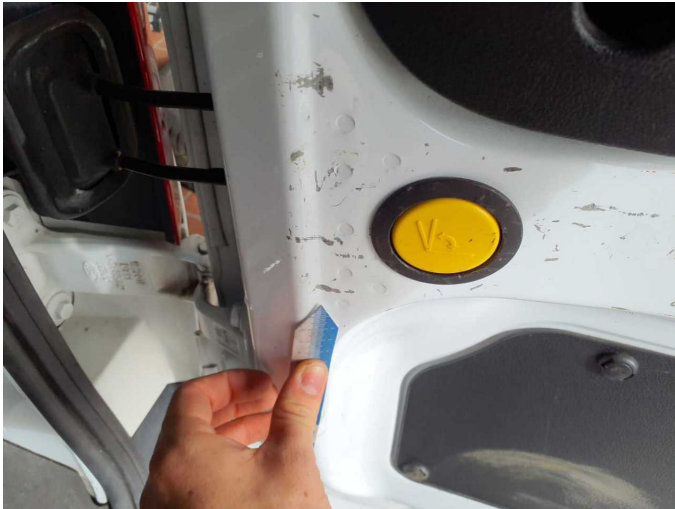
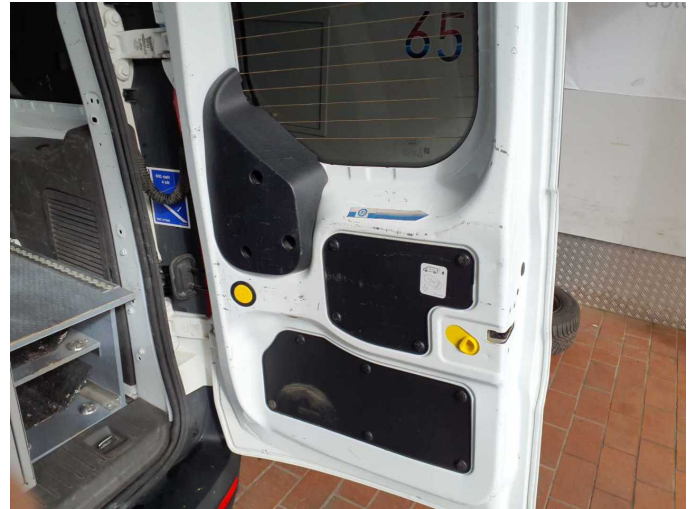
| No. | Component group | Description |
|---|---|---|
| 7 | Boot lid / rear door | Rear door - right side - Dent / paintcoat damage - Repair and paint |

**Damage 7:** Boot lid / rear door: Rear door - right side - Dent / paintcoat damage - Repair and paint

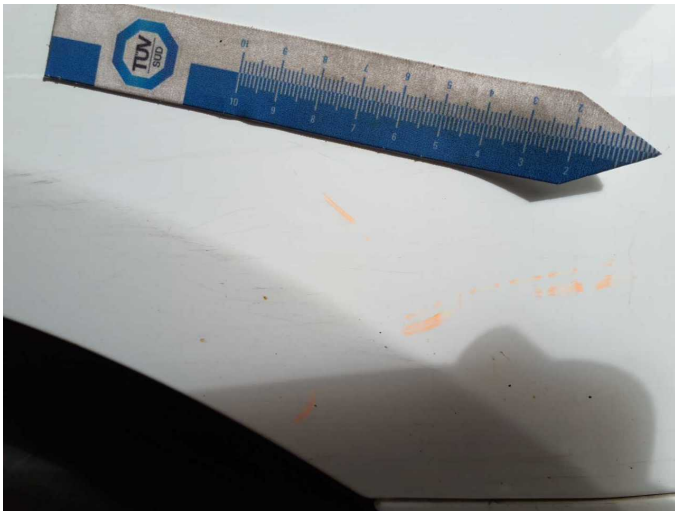
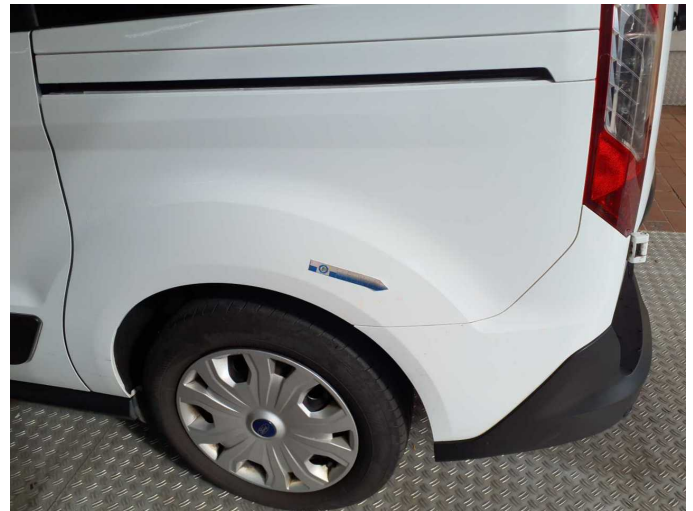
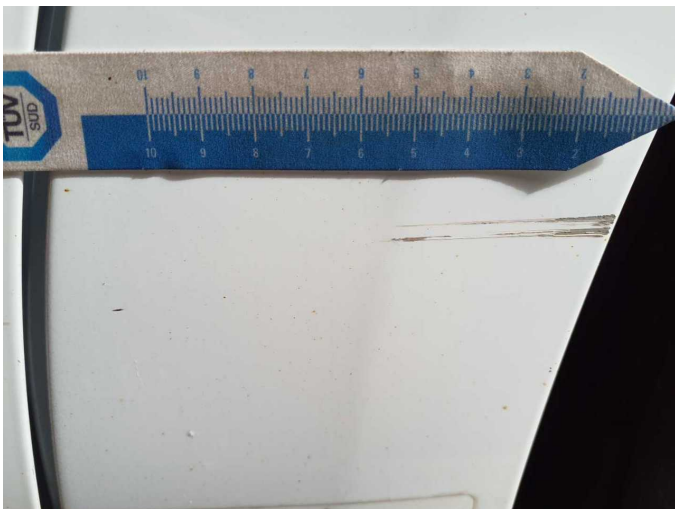
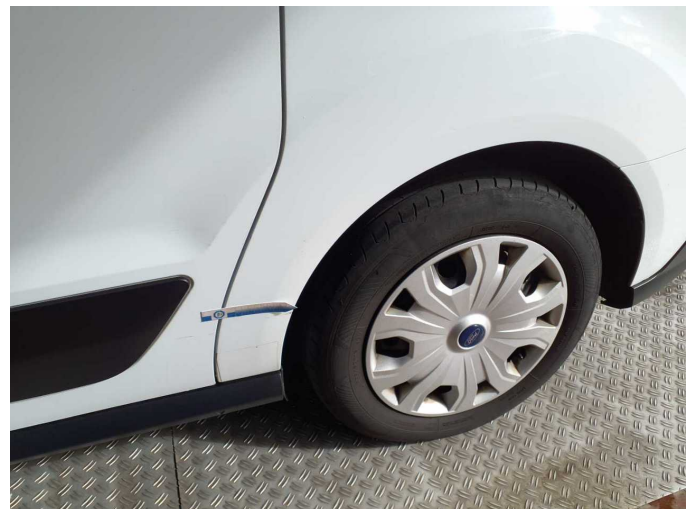
| No. | Component group | Description |
|---|---|---|
| 8 | Side panel - rear left side | Side panel - Scratch(es) - Paint |

**Damage 8:** Side panel - rear left side: Side panel - Scratch(es) - Paint

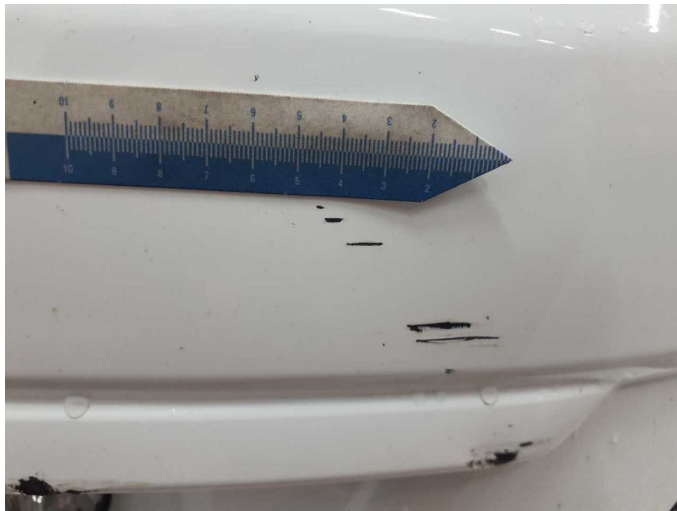
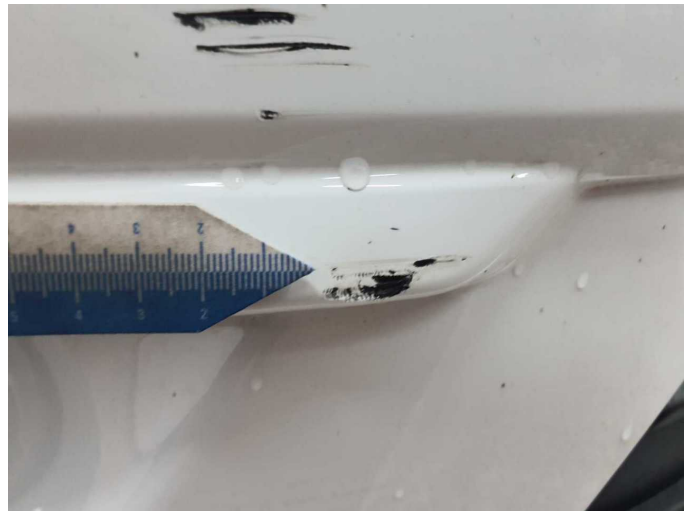
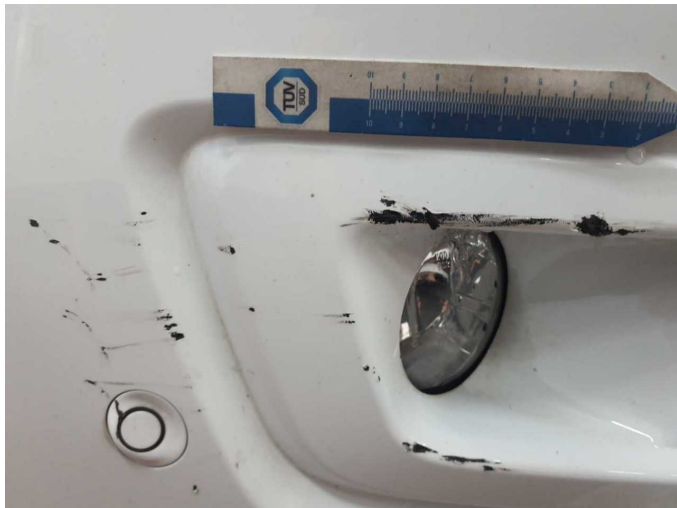
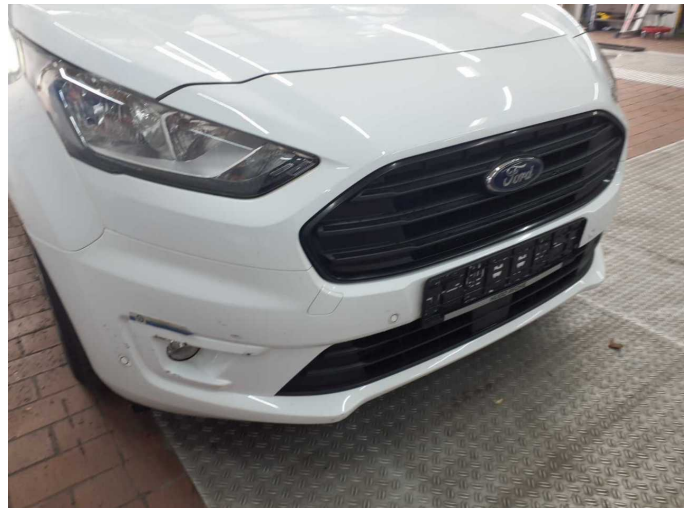
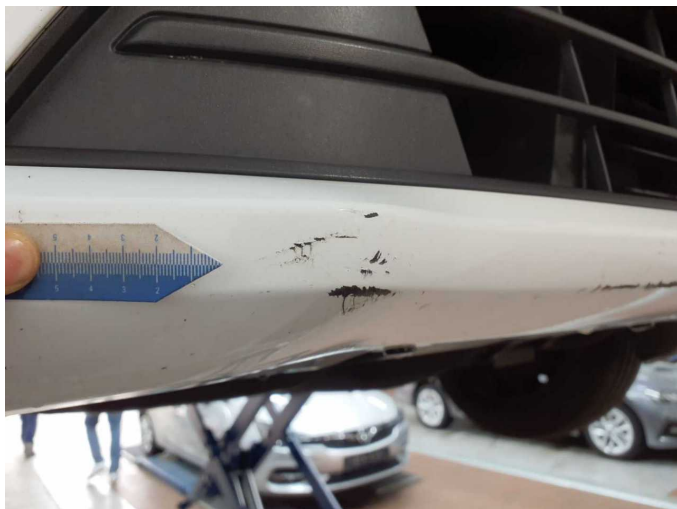
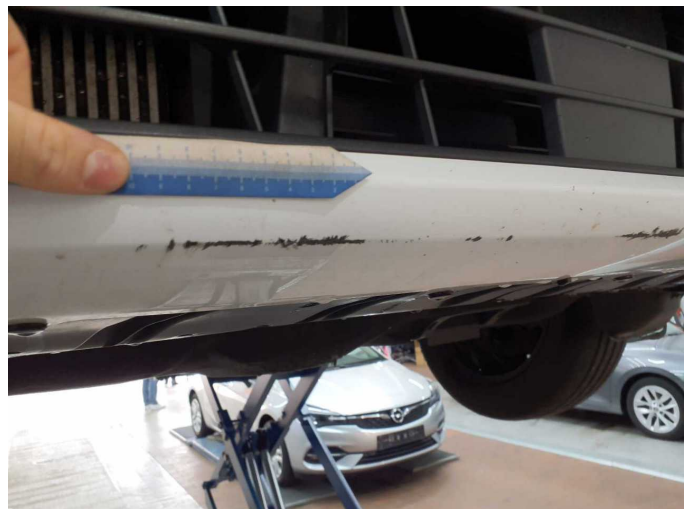
| No. | Component group | Description |
|---|---|---|
| 9 | Front bumper | Front bumper (Materialabtrag) - Scratched - Repair and paint |

**Damage 9:** Front bumper: Front bumper (Materialabtrag) - Scratched - Repair and paint

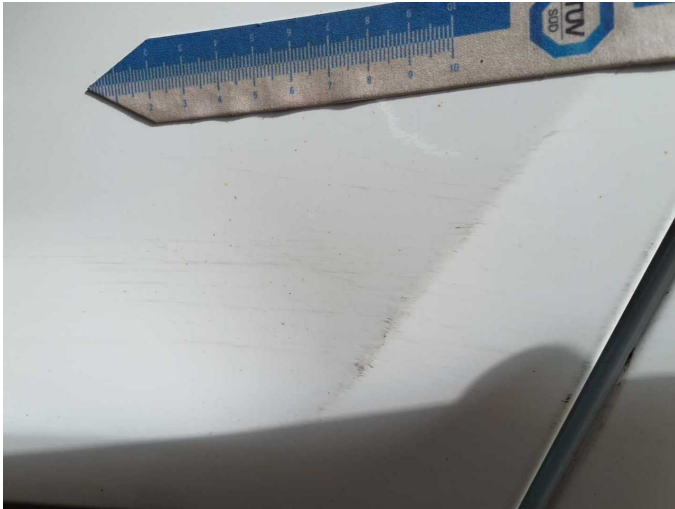
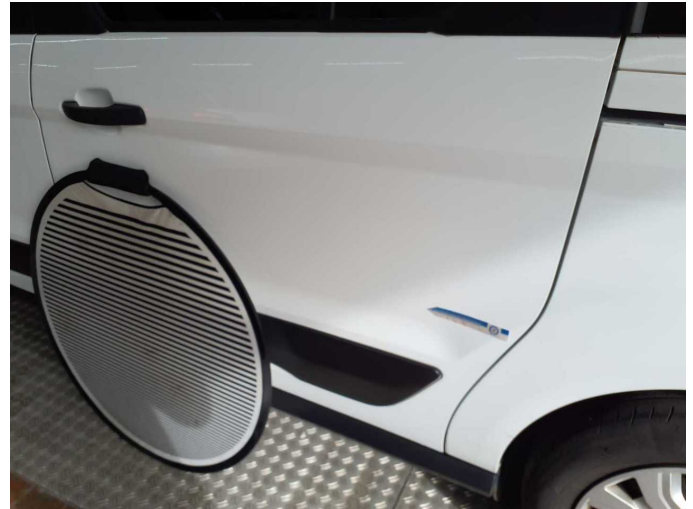
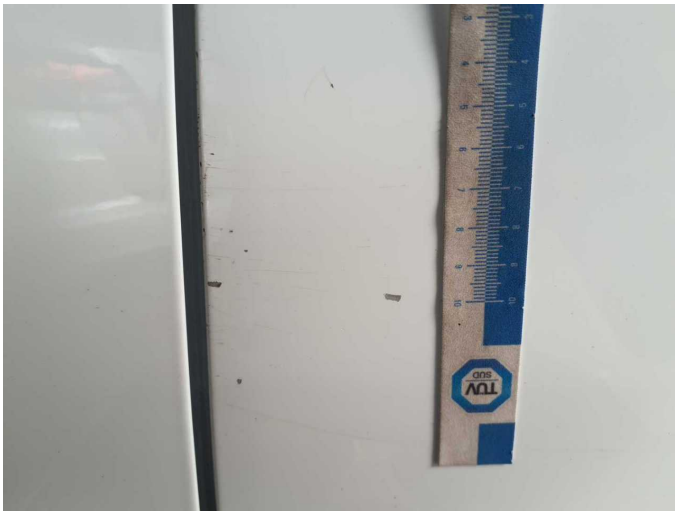
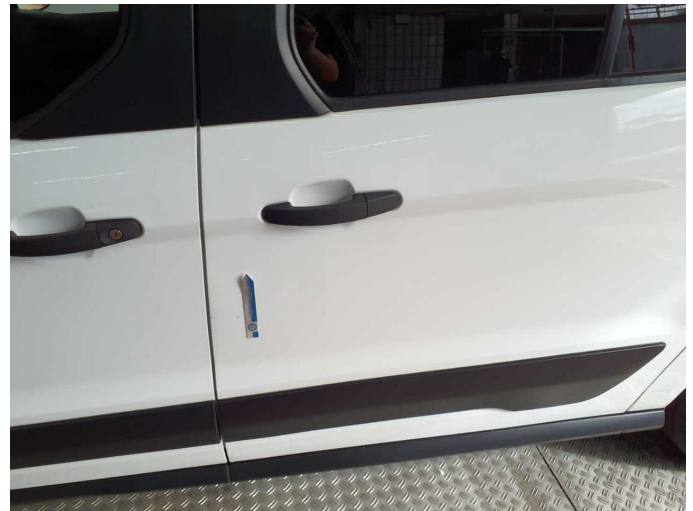
| No. | Component group | Description |
|---|---|---|
| 10 | Door - rear left side | Door - Scratch(es) - Paint |

**Damage 10:** Door - rear left side: Door - Scratch(es) - Paint

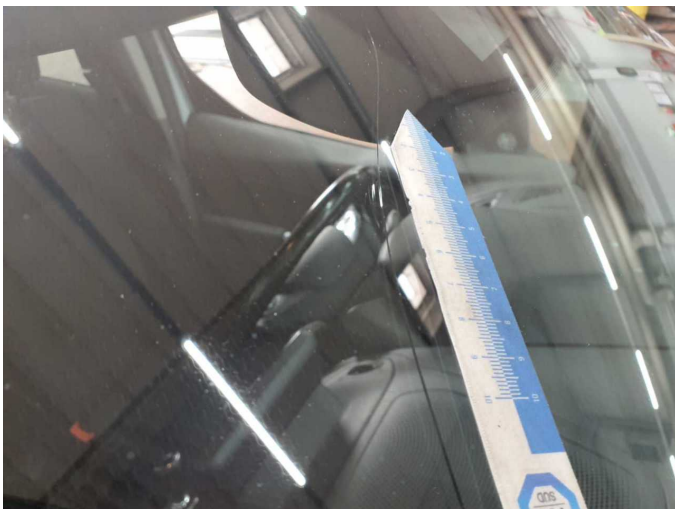
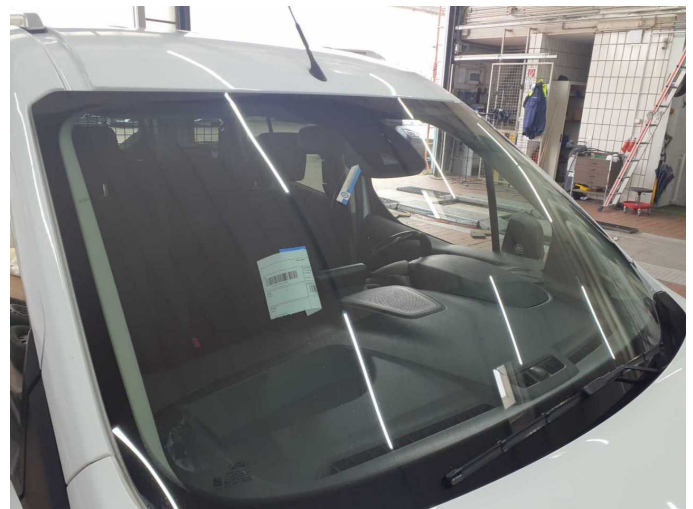
| No. | Component group | Description |
|---|---|---|
| 11 | Vehicle glazing | Windscreen - Broken / torn - Replace |

**Damage 11:** Vehicle glazing: Windscreen - Broken / torn - Replace

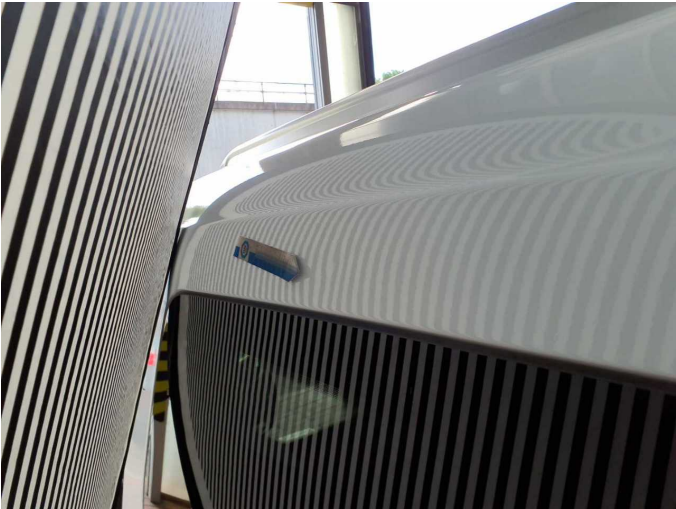
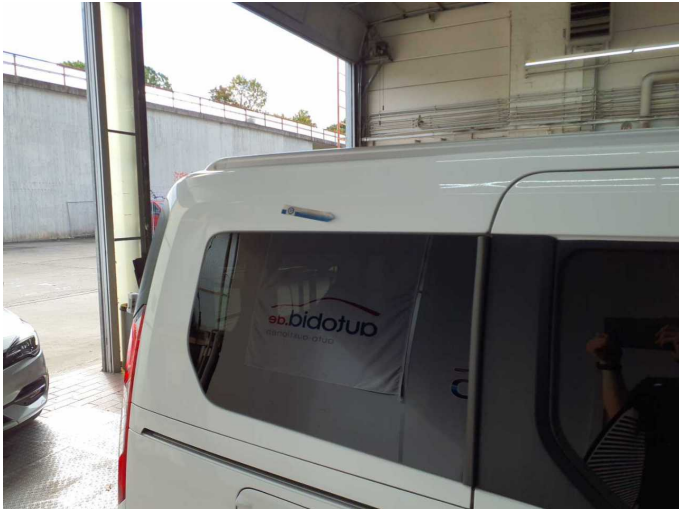
| No. | Component group | Description |
|---|---|--|
| 5 | Side panel - rear right side | Side panel - dent(s) - No deduction |

**Wear and tear 5:** Side panel - rear right side: Side panel - dent(s) - No deduction
