Expertise

Protocol number: 41461680  
Order No. / Reference: 25128751  
Inspection date: 10 Sept 2025

| Manufacturer: Ford | Model: Transit 350 L2 VA Basis |
| VIN: WF0AXXTTRAKM13497 | |

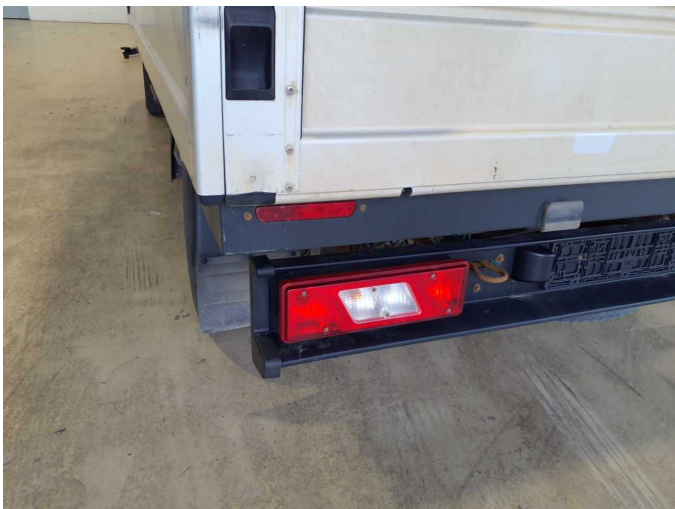
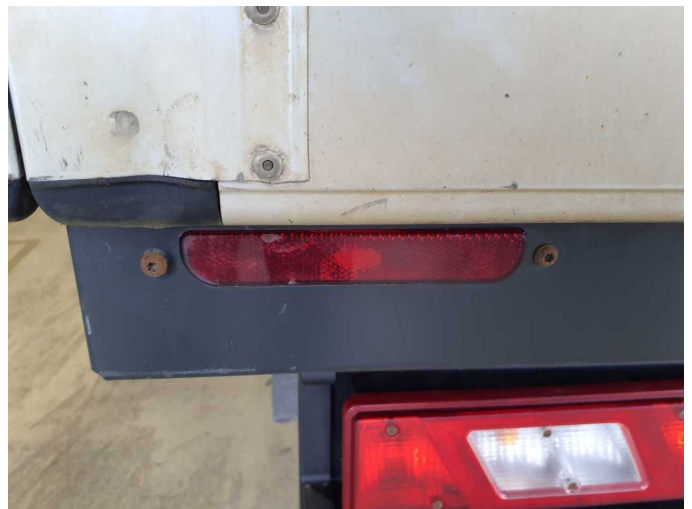
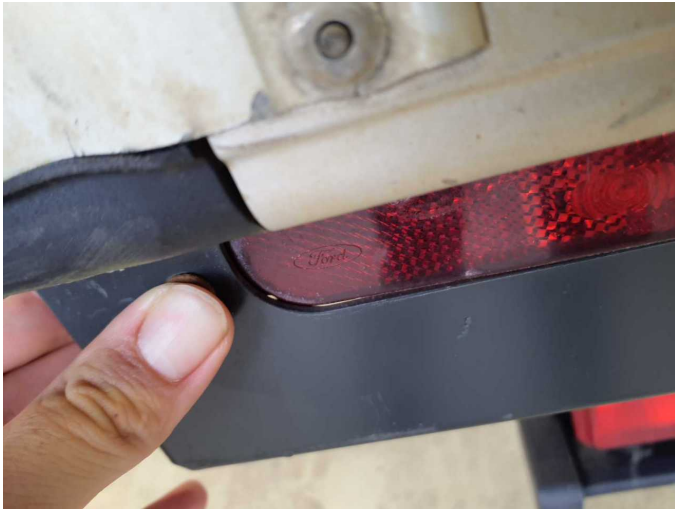
| No. | Component group | Description |
|---|---|---|
| 1 | Boot lid / rear door | Reflectors - Loose - Un- / install |

Damage 1: Boot lid / rear door: Reflectors - Loose - Un- / install

**Damage 1:** Boot lid / rear door: Reflectors - Loose - Un- / install

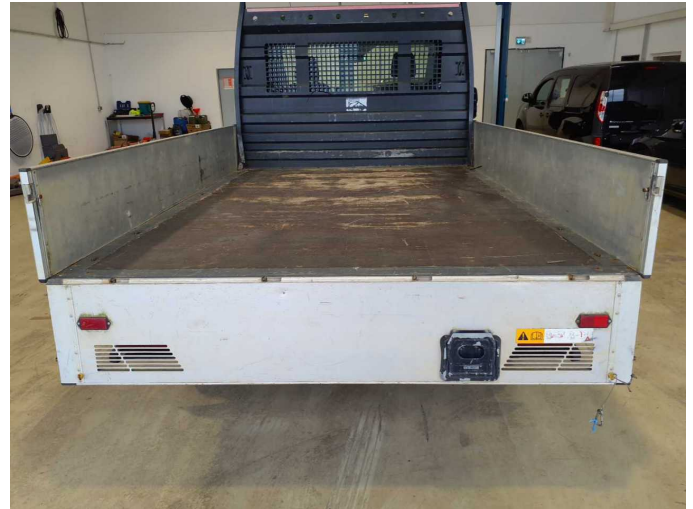
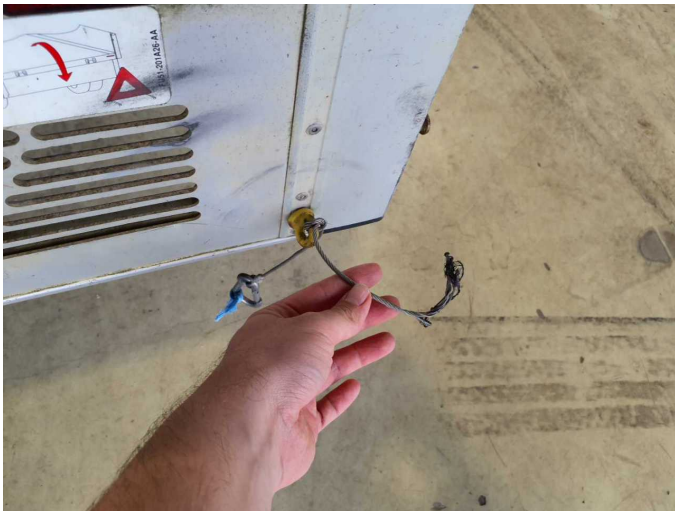
| No. | Component group | Description |
|---|---|---|
| 2 | Boot lid / rear door | Boot lid (Fangband) - Damaged - Replace |

**Damage 2:** Boot lid / rear door: Boot lid (Fangband) - Damaged - Replace

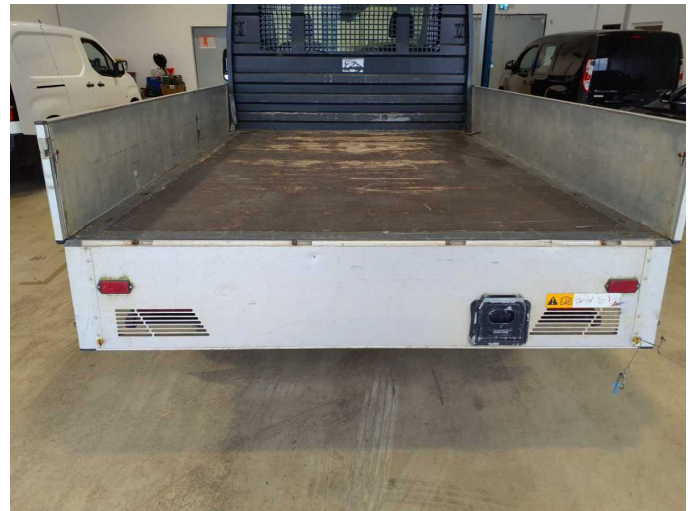
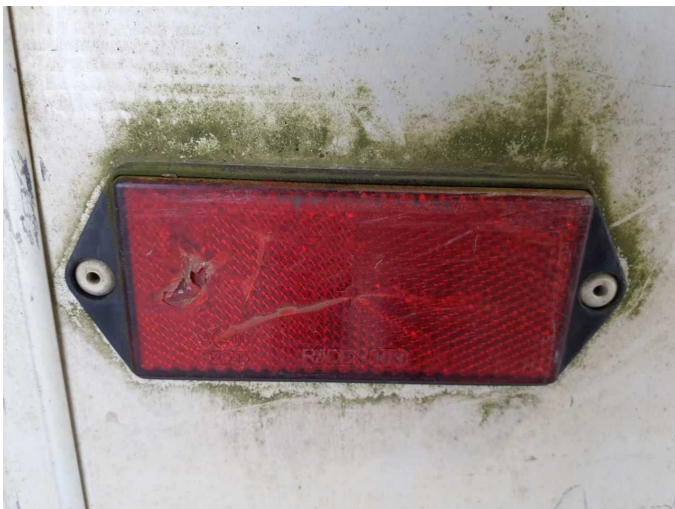
| No. | Component group | Description |
|---|---|---|
| 3 | Boot lid / rear door | Boot lid (Reflektor links innen) - Damaged - Replace |

**Damage 3:** Boot lid / rear door: Boot lid (Reflektor links innen) - Damaged - Replace

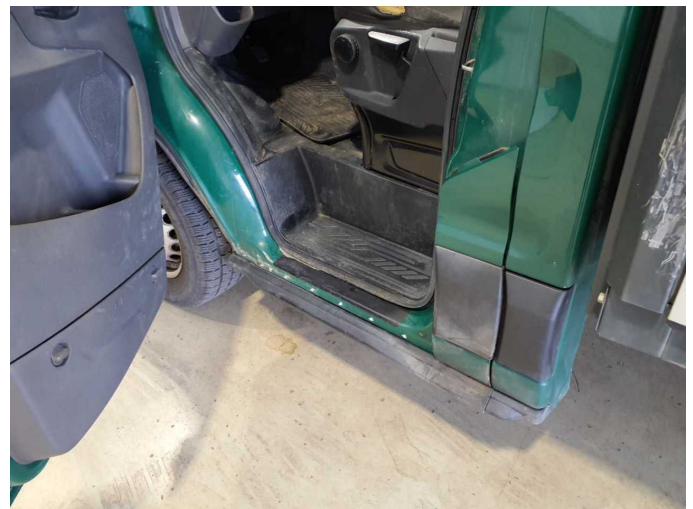
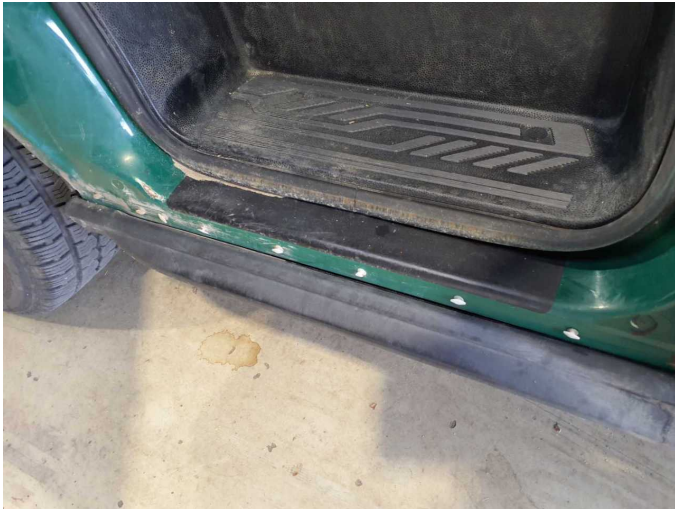
| No. | Component group | Description |
|---|---|---|
| 4 | Door - front left side | Door seal - Missing - Replace |

**Damage 4:** Door - front left side: Door seal - Missing - Replace

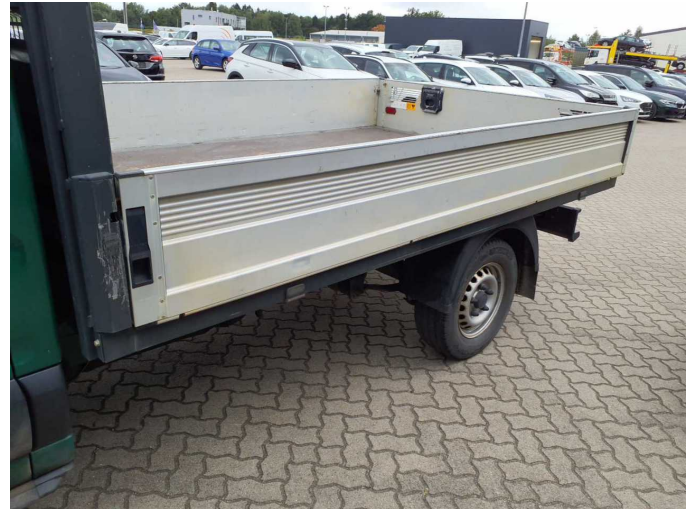
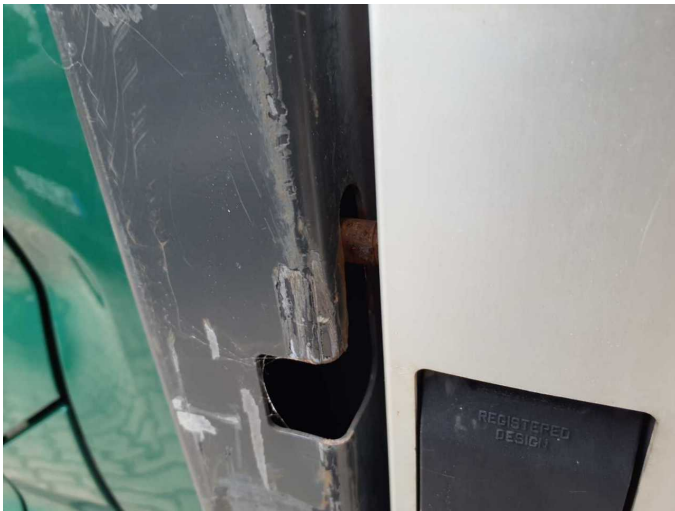
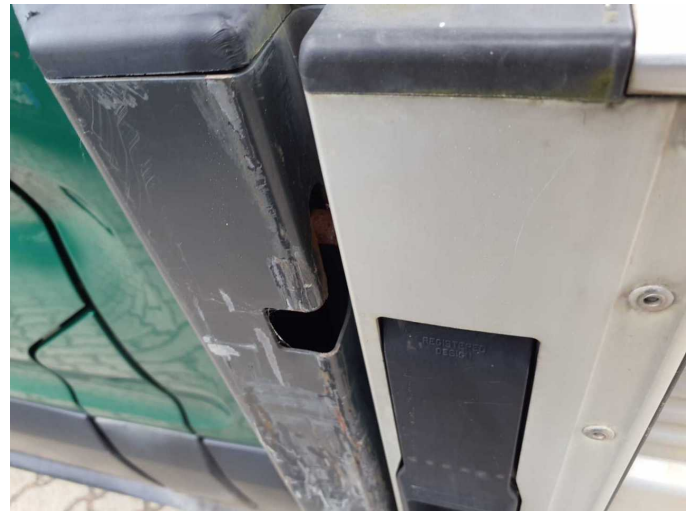
| No. | Component group | Description |
|---|---|---|
| 6 | Trim / covers | Cargo area - lining -left side (Außen) - Loose - Un- / install |

**Damage 6:** Trim / covers: Cargo area - lining -left side (Außen) - Loose - Un- / install

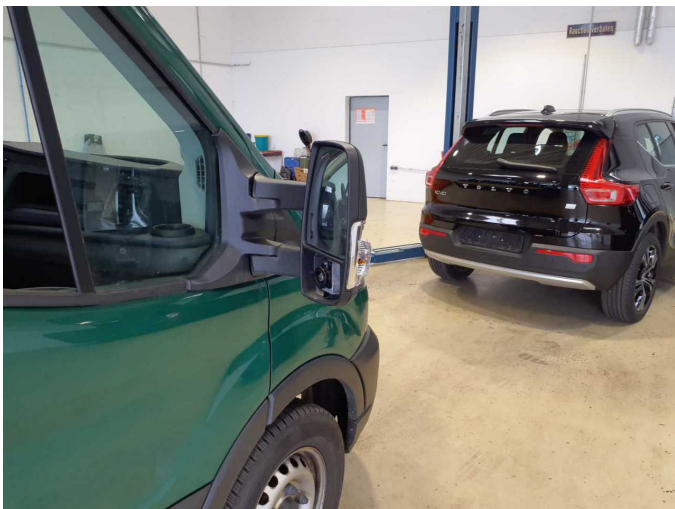
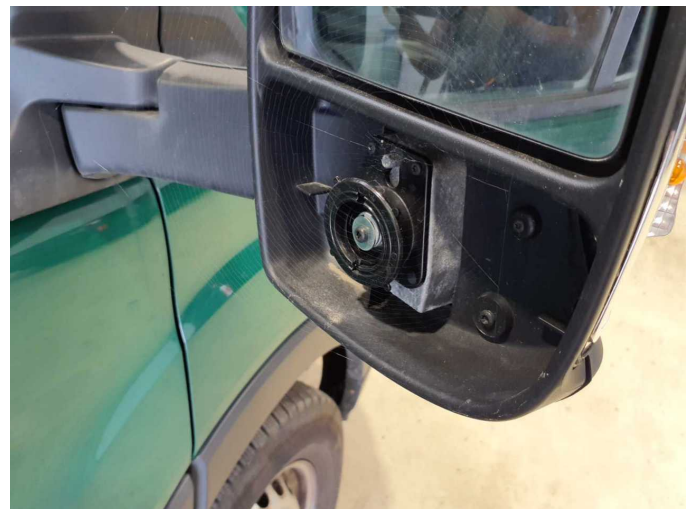
| No. | Component group | Description |
|---|---|---|
| 7 | Wing mirror - right side | Mirror glass - Missing - Replace |

**Damage 7:** Wing mirror - right side: Mirror glass - Missing - Replace

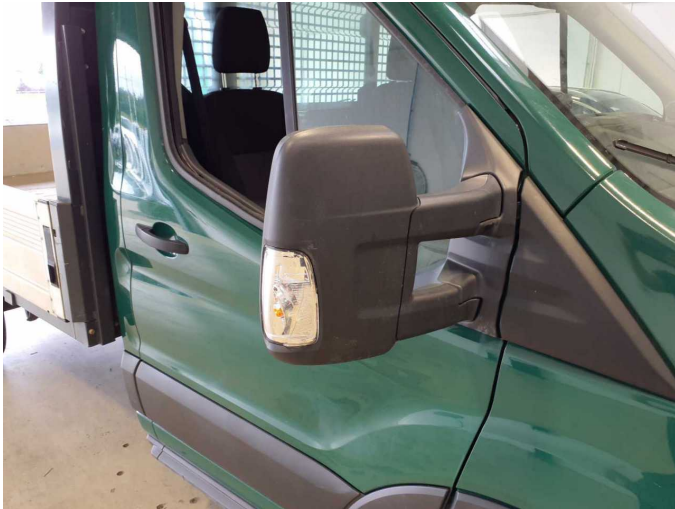
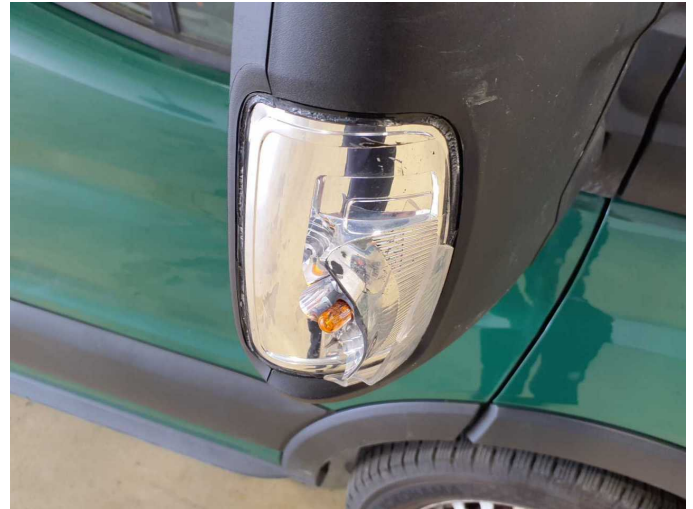
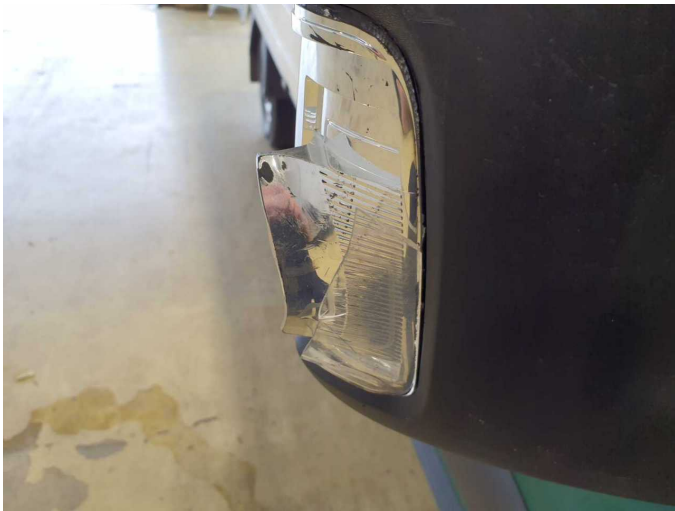
| No. | Component group | Description |
|---|---|---|
| 8 | Indicator - front | Mirror - right side - Damaged - Replace |

**Damage 8:** Indicator - front: Mirror - right side - Damaged - Replace

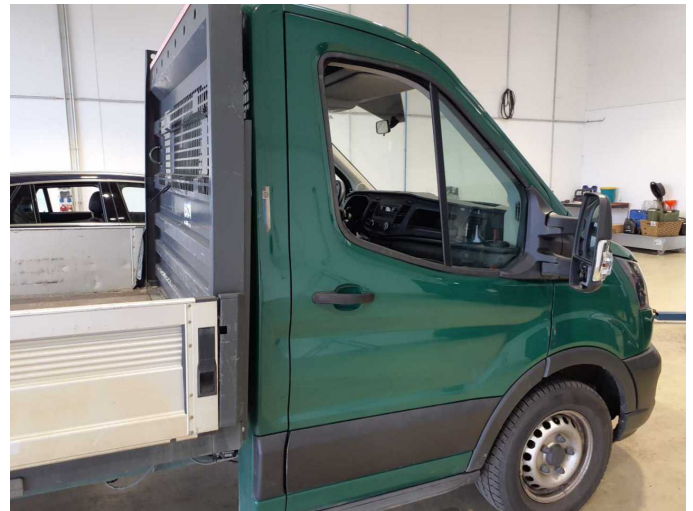
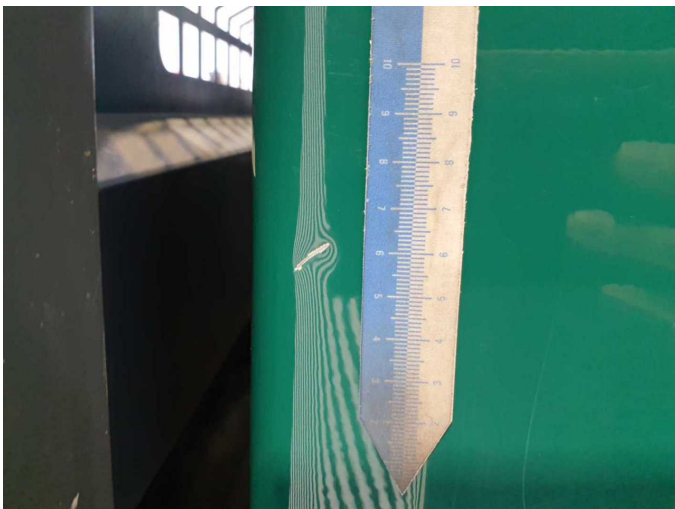
| No. | Component group | Description |
|---|---|---|
| 9 | Side panel - rear right side | Side panel - Dent / paintcoat damage - Smart repair |

**Damage 9:** Side panel - rear right side: Side panel - Dent / paintcoat damage - Smart repair

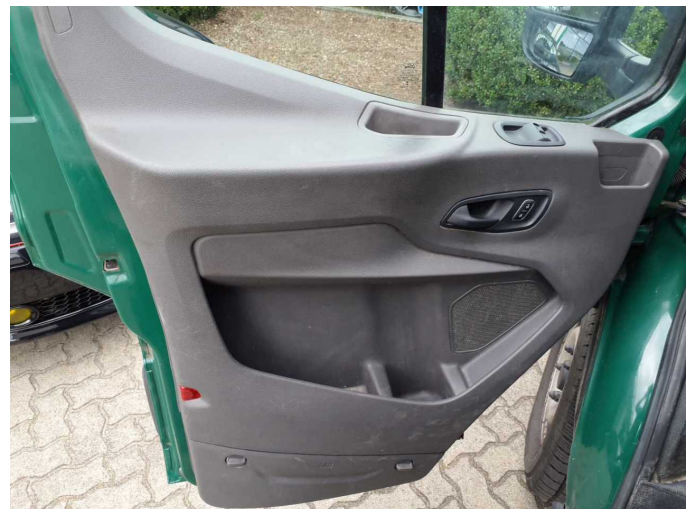
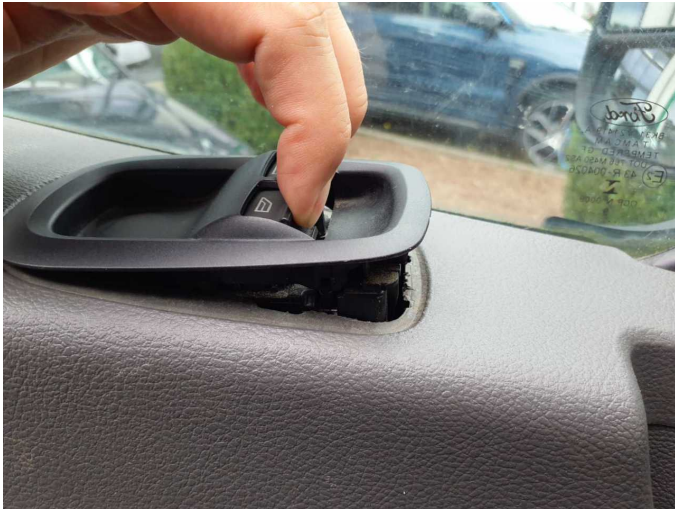
| No. | Component group | Description |
|---|---|---|
| 10 | Trim / covers | Door trim - front left side (Fensterheberschalter) - Loose - Replace |

**Damage 10:** Trim / covers: Door trim - front left side (Fensterheberschalter) - Loose - Replace

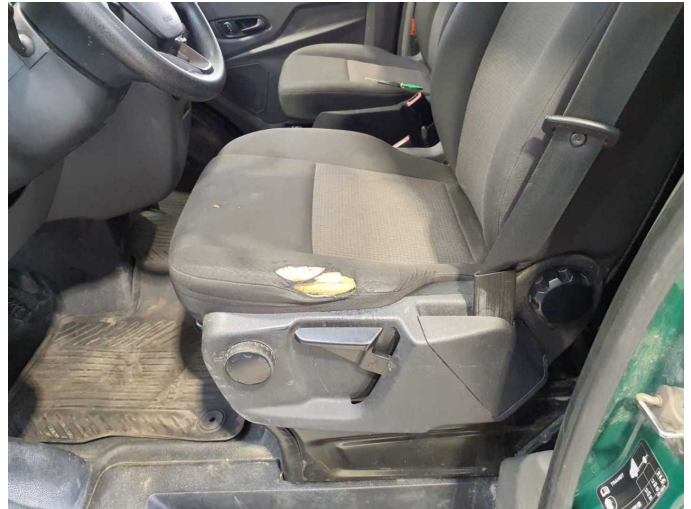
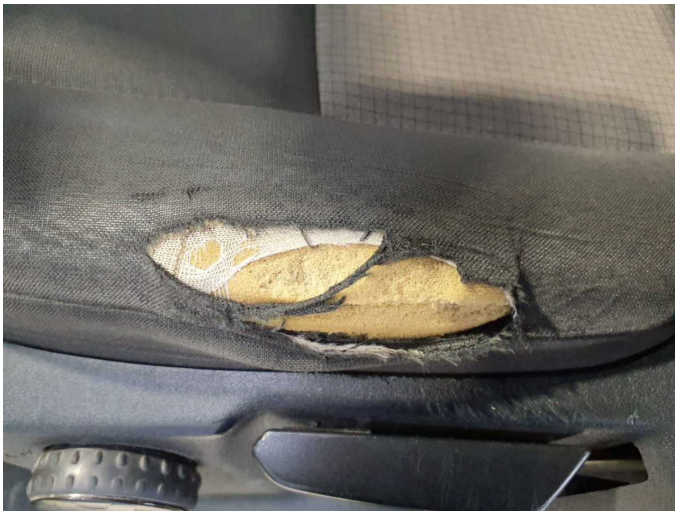
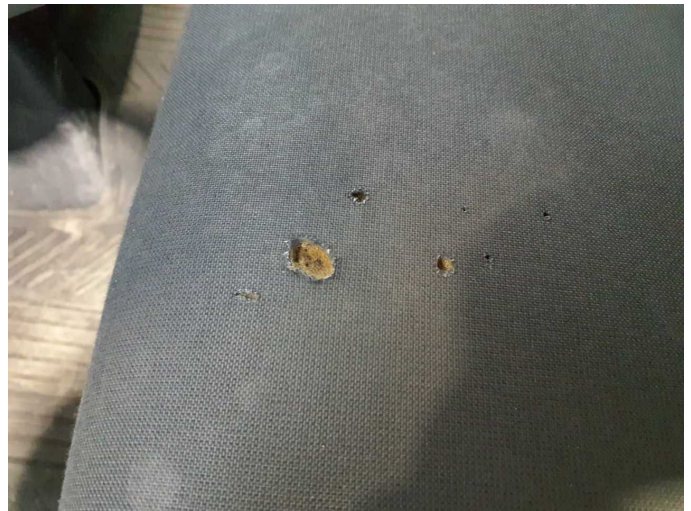
| No. | Component group | Description |
|---|---|---|
| 11 | Seat - front | Seat cover - left side (+ Polster) - Damaged - Replace |

**Damage 11:** Seat - front: Seat cover - left side (+ Polster) - Damaged - Replace

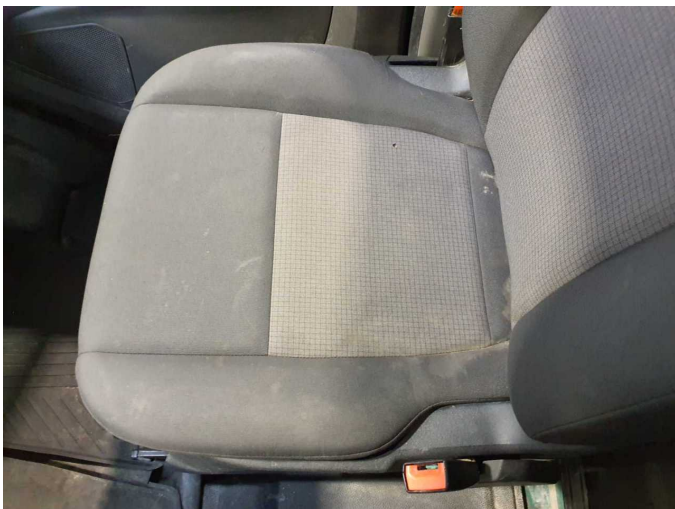
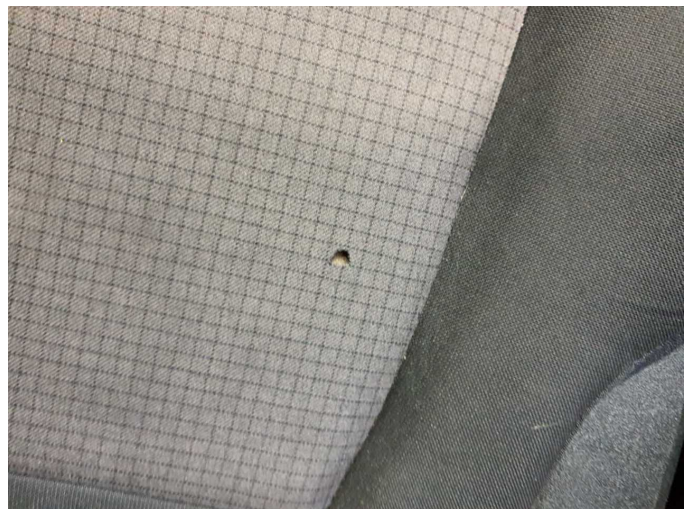
| No. | Component group | Description |
|---|---|---|
| 12 | Seat - front | Seat cover - right side - Burn hole (cigarettes) - Replace |

**Damage 12:** Seat - front: Seat cover - right side - Burn hole (cigarettes) - Replace

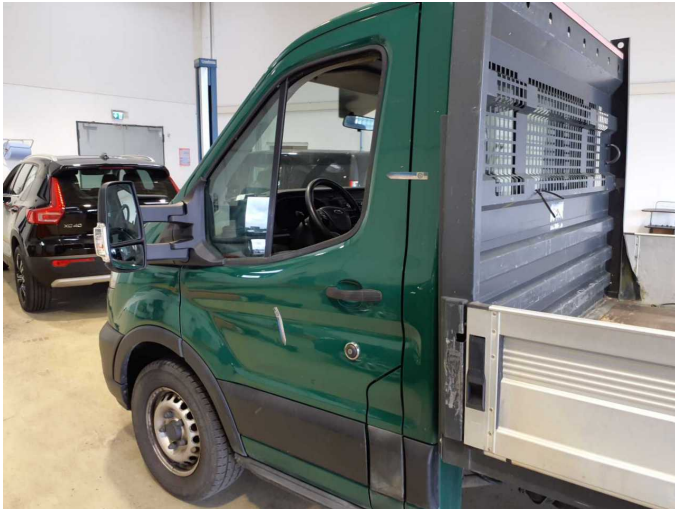
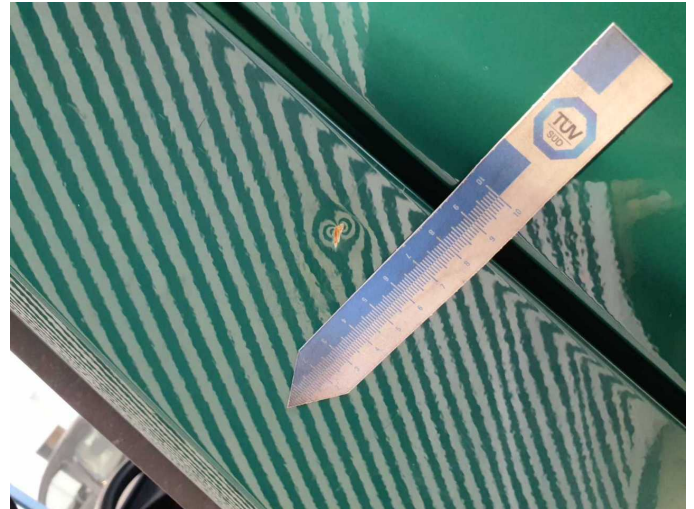
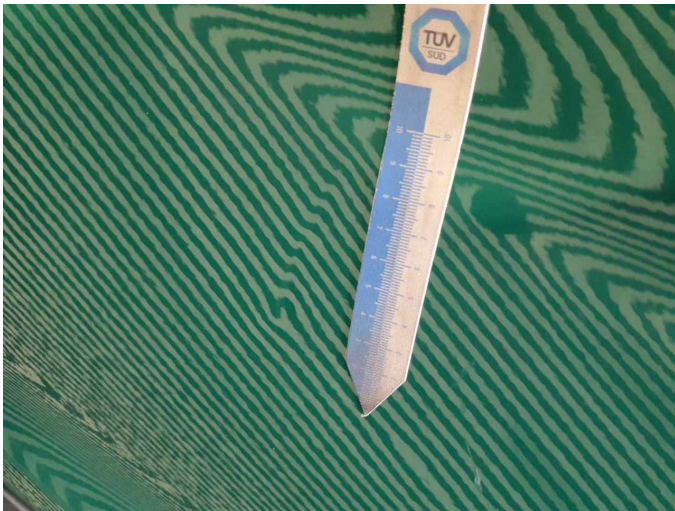
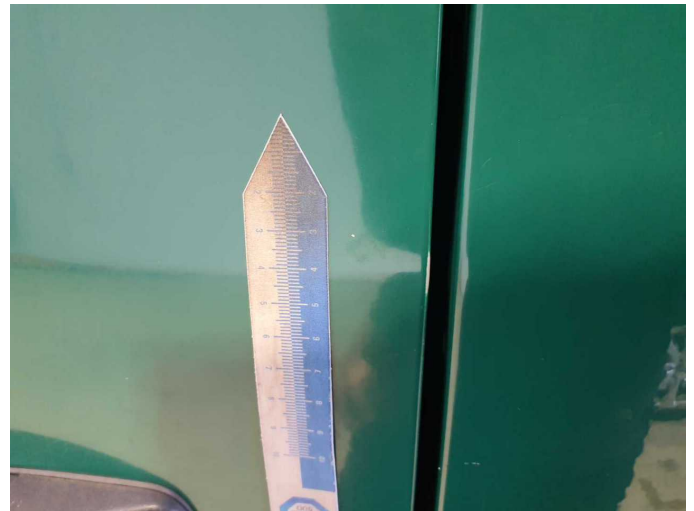
| No. | Component group | Description |
|---|---|---|
| 13 | Door - front left side | Door - Corrosion - Repair and paint |

**Damage 13:** Door - front left side: Door - Corrosion - Repair and paint

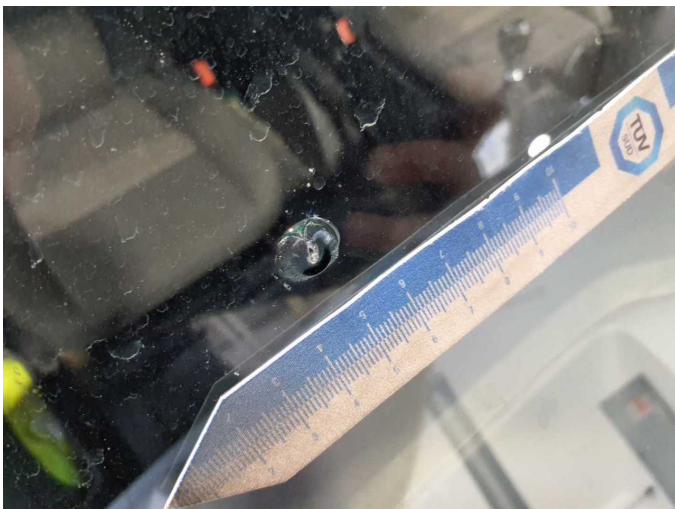
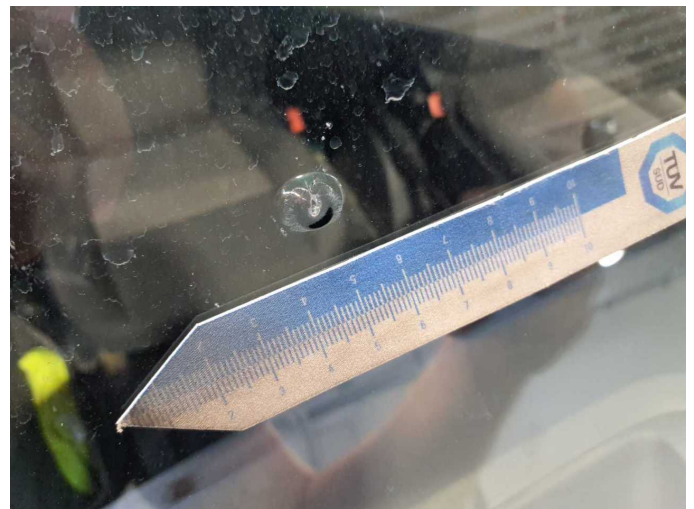
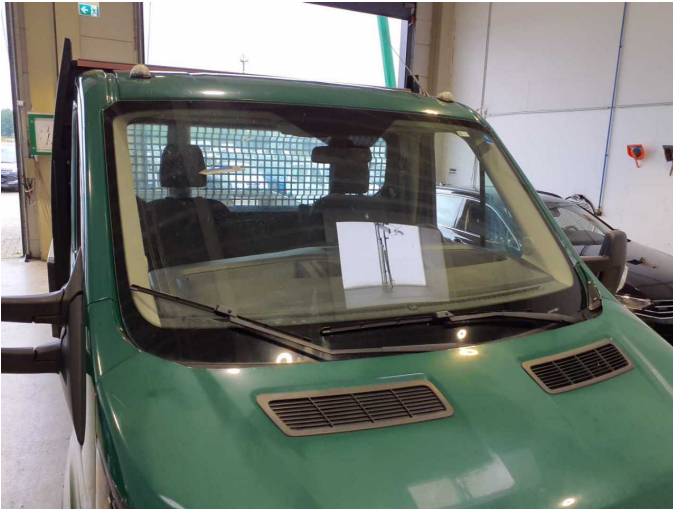
| No. | Component group | Description |
|---|---|---|
| 14 | Vehicle glazing | Windscreen - Damaged - Replace |

**Damage 14:** Vehicle glazing: Windscreen - Damaged - Replace

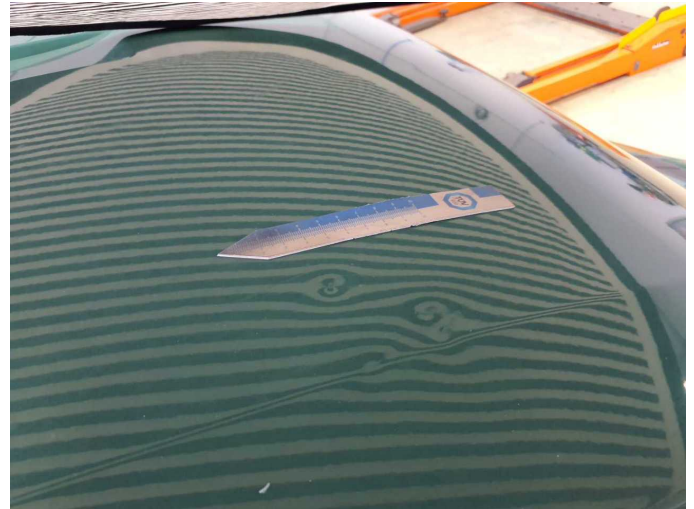
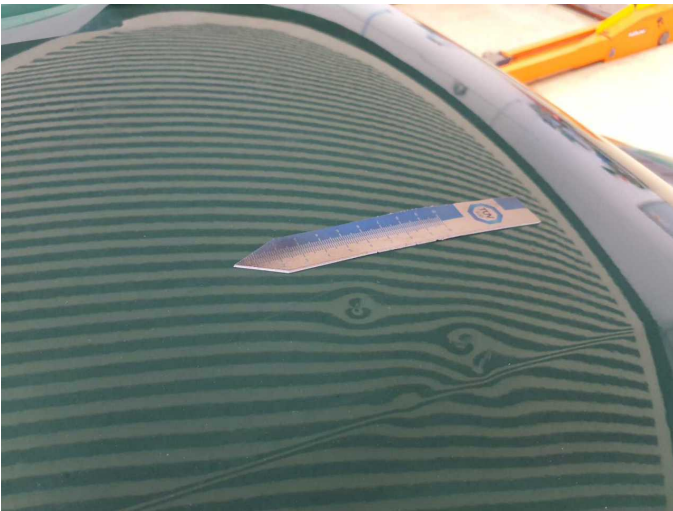
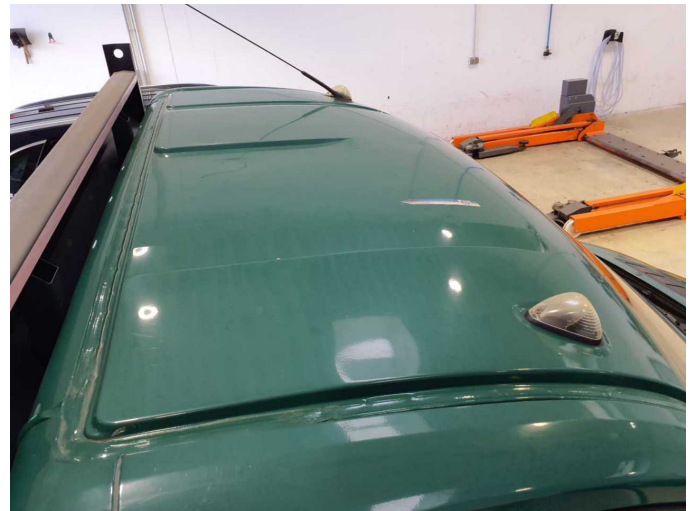
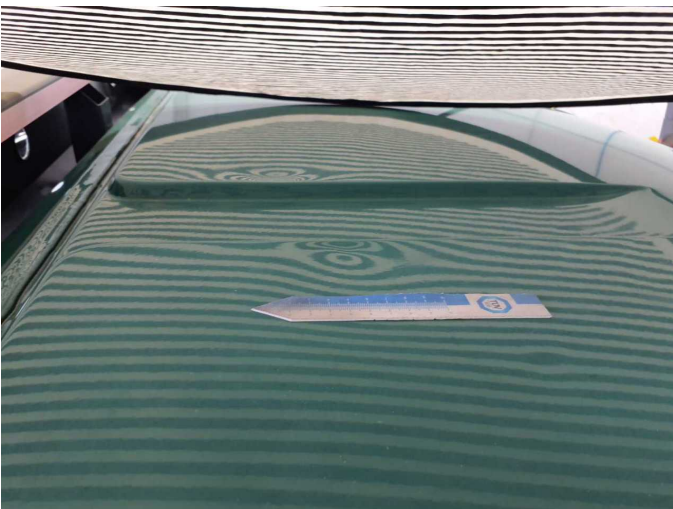
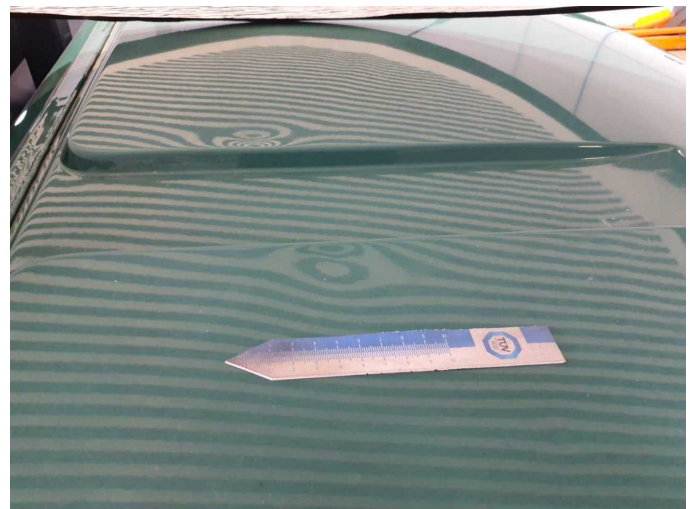
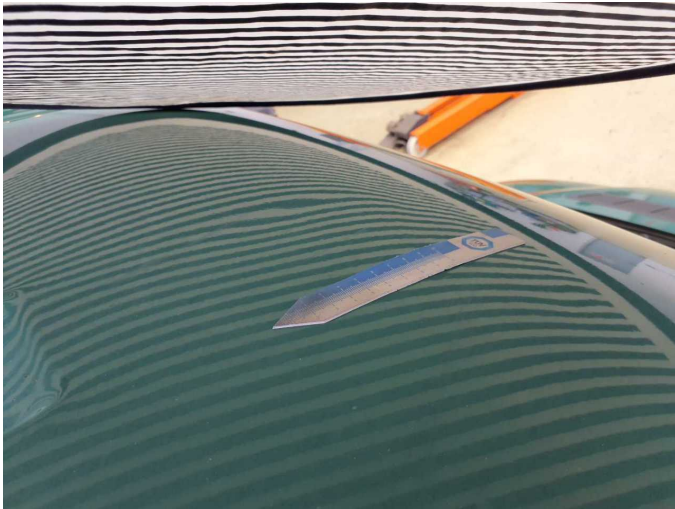
| No. | Component group | Description |
|---|---|---|
| 15 | Roof | Roof - Deformed - Repair and paint |

**Damage 15:** Roof: Roof - Deformed - Repair and paint

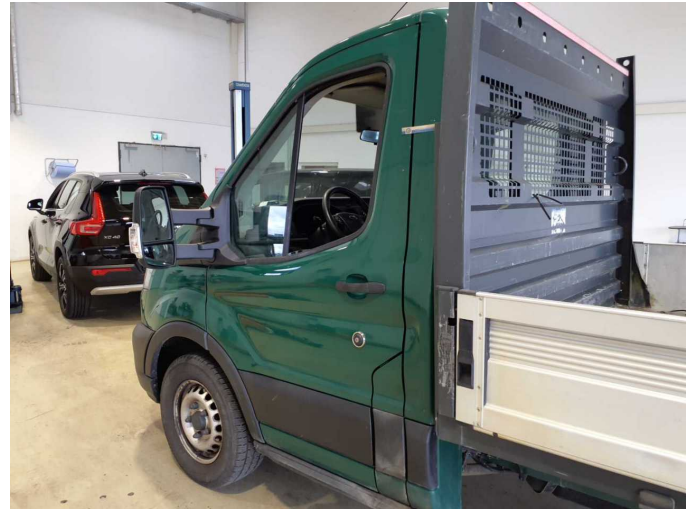
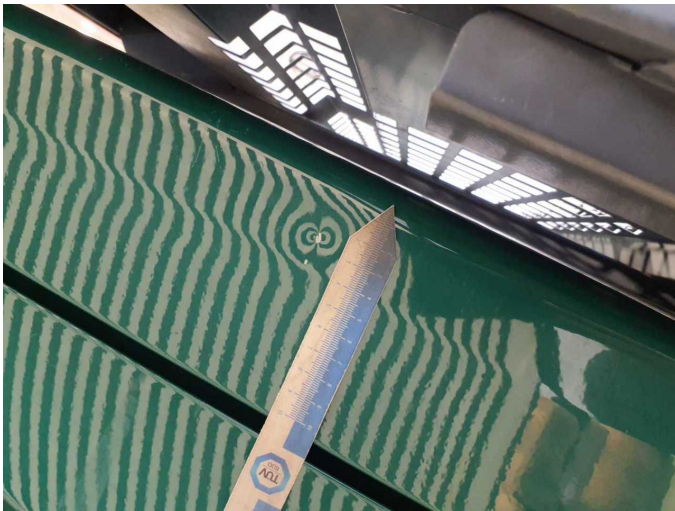
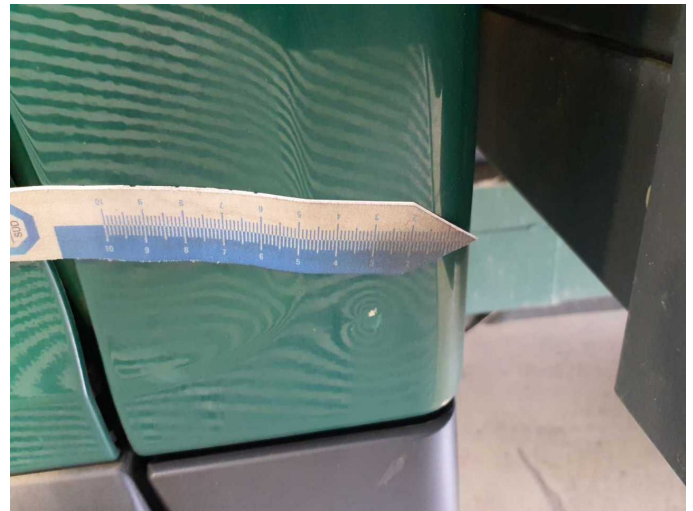
| No. | Component group | Description |
|---|---|---|
| 4 | Side panel - rear left side | Side panel - Dent / paintcoat damage - No deduction |

**Wear and tear 4:** Side panel - rear left side: Side panel - Dent / paintcoat damage - No deduction

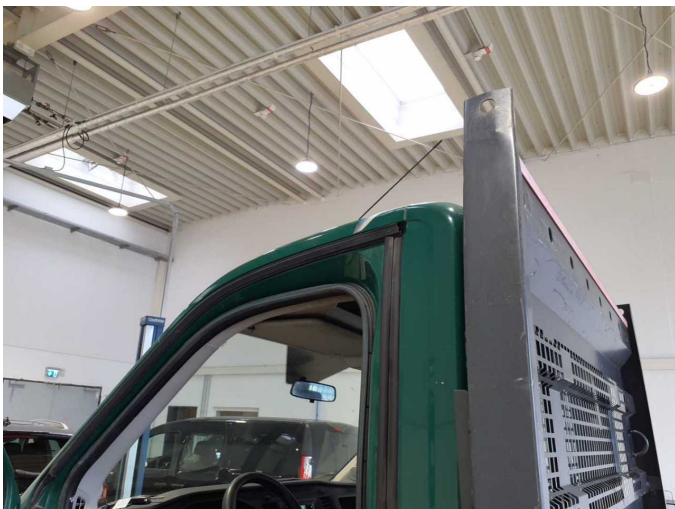
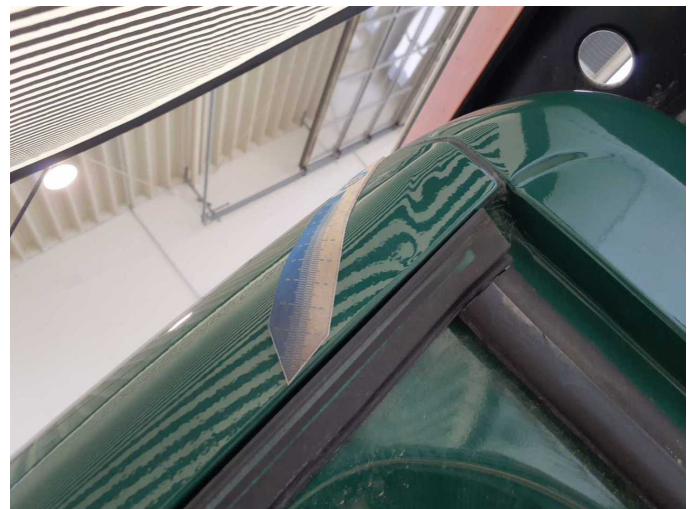
| No. | Component group | Description |
|---|---|---|
| 5 | Roof | Roof rail - left side - dent(s) - No deduction |

**Wear and tear 5:** Roof: Roof rail - left side - dent(s) - No deduction

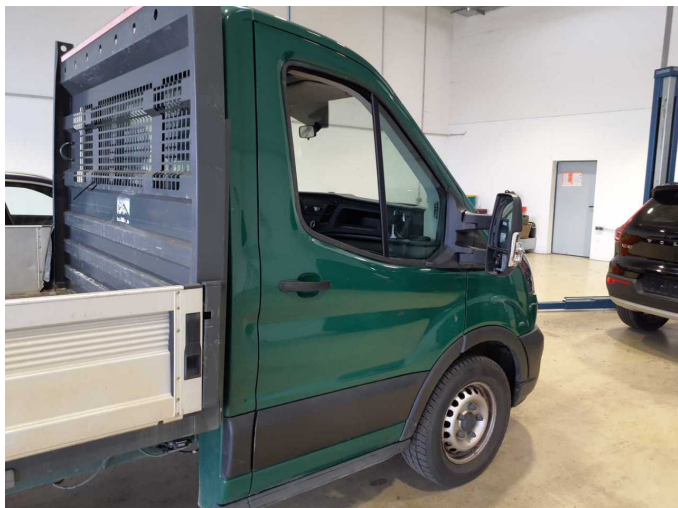
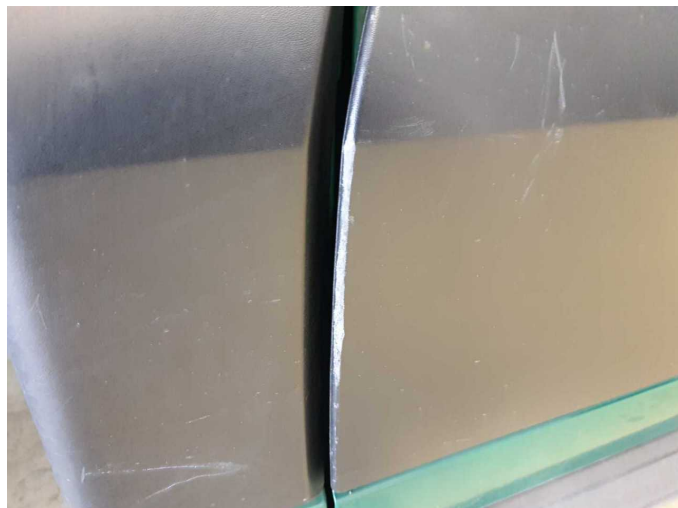
| No. | Component group | Description |
|---|---|---|
| 6 | Door - front right side | Door edge (Zierleiste) - Scratch(es) - No deduction |

**Wear and tear 6:** Door - front right side: Door edge (Zierleiste) -  
Scratch(es) - No deduction
