FORD Kuga II 2013 Diesel Kuga 2.0 tdci Titanium 4wd s&s 150cv powershift E6

VIN NO WF0AXXWPMAER85145 Registration Number EX285ED

Inspection Report Summary

Customer	BCA Lodi	Report Number	P20250804142537
Inspection Date / Place	2025-08-04 / BCA Lodi	Cosmetic Grade	5

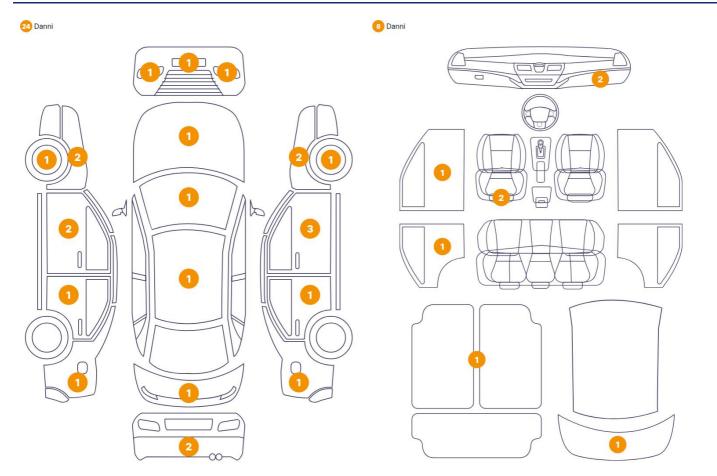
Cosmetic Damage

Component	Damage	Comments
1	Dashboard / Front	Interior / Warning Light ON	
2	Dashboard / Front	Interior / Worn - out	
3	Panel Filling / Front Left	Interior / Scratched	
4	Seat / Front Left	Interior / Worn - out	
5	Seat / Front Left	Interior / Worn - out	
6	Floor Carpet	Interior / Worn - out	
7	Panel Filling / Back Left	Interior / Scratched	
8	Tailgate Upholstery / Back	Interior / Scratched	
9	Rim / Front Right	Out of Bodywork / Scratch	
10	Wing Expander / Front Right	Bodywork / Breakage	
11	Fender / Front Right	Bodywork / Poor Previous Repair	
12	Mirror Shell / Front Right	Bodywork / Breakage	
13	Bumper / Front	Bodywork / Dent

14	Hood	Bodywork / Poor Previous Repair
15	Wing Expander / Front Left	Paint / Scratch / Line
16	Fender / Front Left	Paint / Scratch / Scuff
17	Rim / Front Left	Out of Bodywork / Scratch
18	Windshield / Front	Glass Break / Impact
19	Door / Front Left	Bodywork / Dent
20	Door / Back Left	Bodywork / Dent
21	Fender / Back Left	Bodywork / Poor Previous Repair
22	Pillar / Front Left	Bodywork / Dent / Hail Area
23	Bumper / Back	Bodywork / Dent
24	Bumper / Back	Paint / Scratch / Line
25	Tailgate	Bodywork / Poor Previous Repair
26	Roof	Bodywork / Dent / Hail Area
27	Pillar / Front Right	Bodywork / Dent / Hail Area
28	Fender / Back Right	Bodywork / Poor Previous Repair
29	Door / Back Right	Bodywork / Poor Previous Repair
30	Door / Front Right	Paint / Scratch / Line
31	Front Light / Front Right	Bodywork / Breakage
32	Front Light / Front Left	Bodywork / Breakage

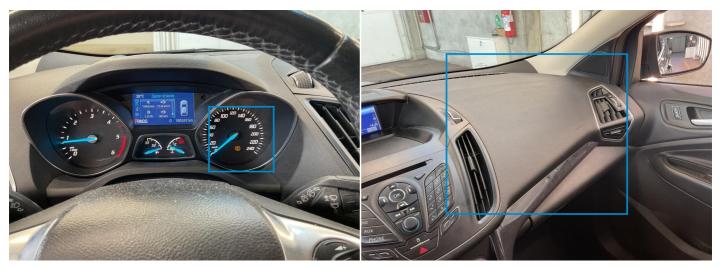
1. Dashboard / Front Interior / Warning Light ON -

2. Dashboard / Front Interior / Worn - out -

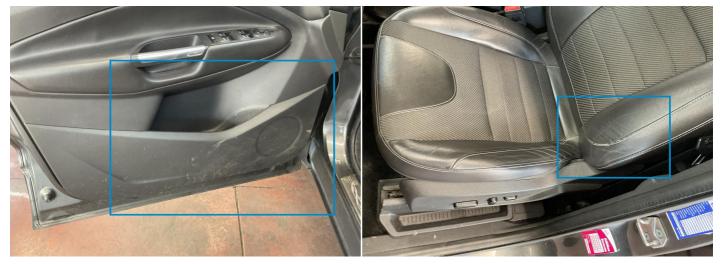
3. Panel Filling / Front Left Interior / Scratched -

4. Seat / Front Left Interior / Worn - out -

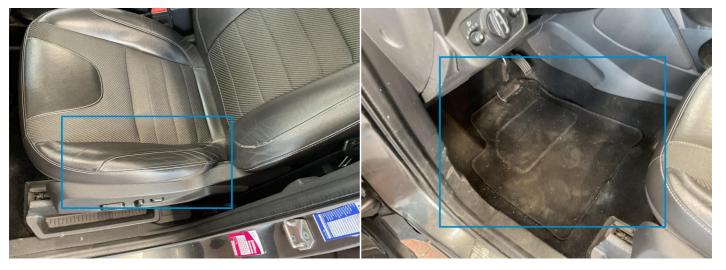
5. Seat / Front Left Interior / Worn - out -

6. Floor Carpet Interior / Worn - out -

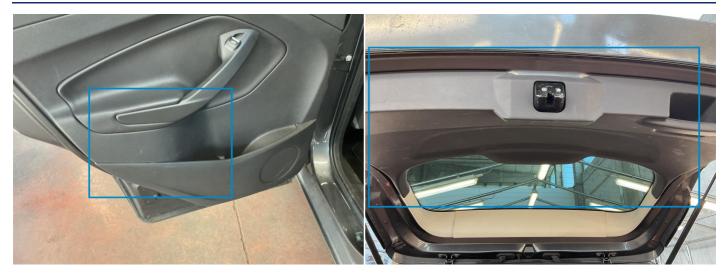
7. Panel Filling / Back Left Interior / Scratched -

8. Tailgate Upholstery / Back Interior / Scratched -

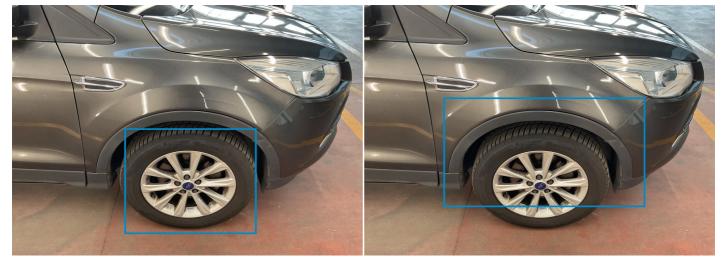
9. Rim / Front Right Out of Bodywork / Scratch -

10. Wing Expander / Front Right Bodywork / Breakage -

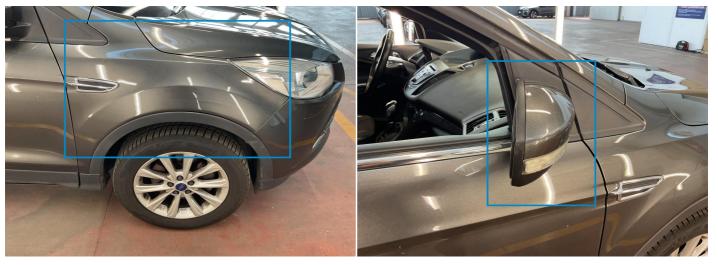
11. Fender / Front Right Bodywork / Poor Previous Repair -

12. Mirror Shell / Front Right Bodywork / Breakage -

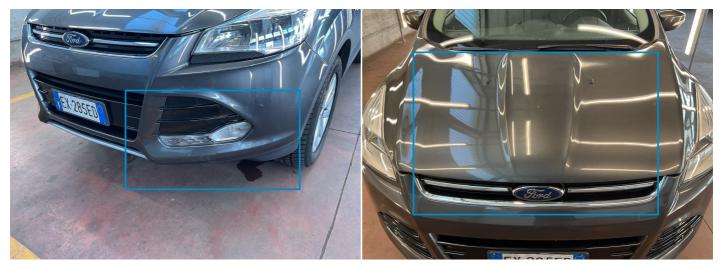
13. Bumper / Front Bodywork / Dent -

14. Hood Bodywork / Poor Previous Repair -

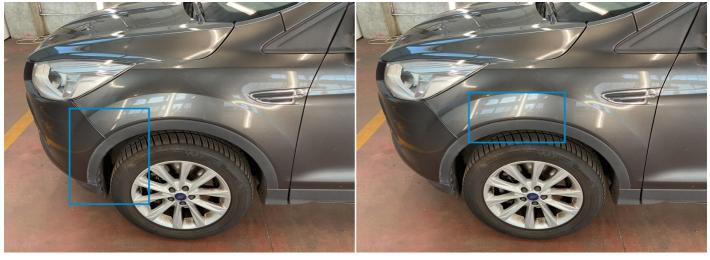
15. Wing Expander / Front Left Paint / Scratch / Line -

16. Fender / Front Left Paint / Scratch / Scuff -

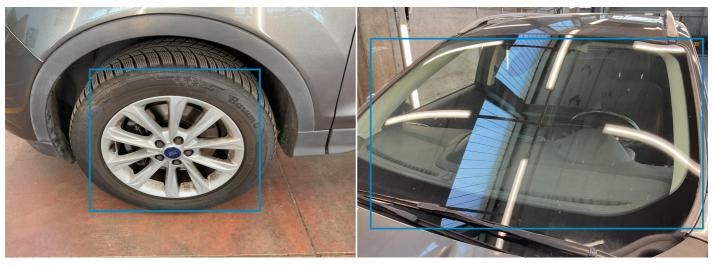
17. Rim / Front Left
Out of Bodywork / Scratch -

18. Windshield / Front Glass Break / Impact -

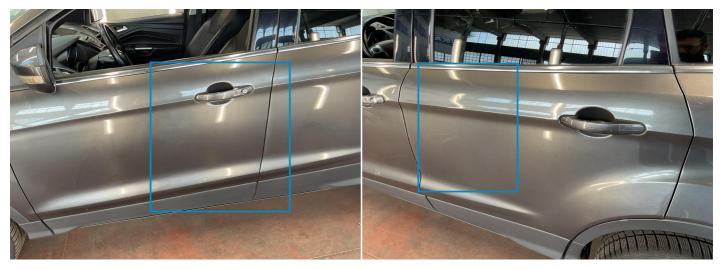
19. Door / Front Left Bodywork / Dent -

20. Door / Back Left Bodywork / Dent -

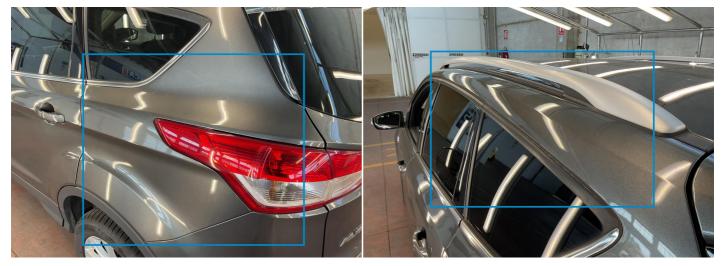
21. Fender / Back Left Bodywork / Poor Previous Repair -

22. Pillar / Front Left Bodywork / Dent / Hail Area -

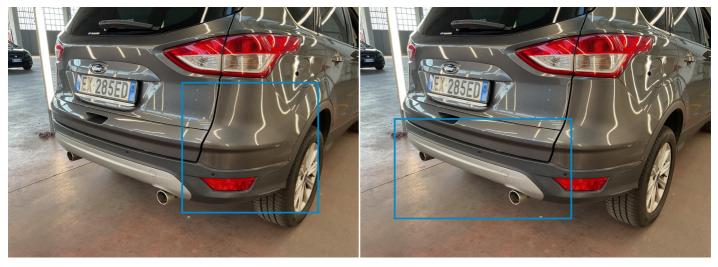
23. Bumper / Back Bodywork / Dent -

24. Bumper / Back Paint / Scratch / Line -

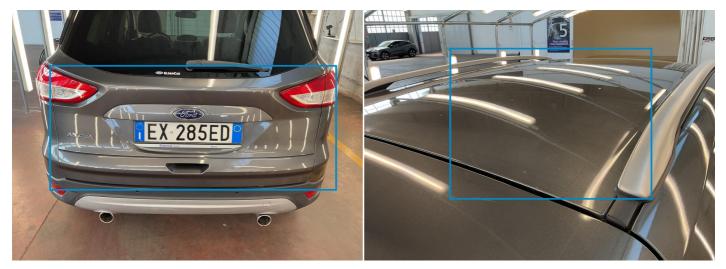
25. Tailgate Bodywork / Poor Previous Repair -

26. Roof Bodywork / Dent / Hail Area -

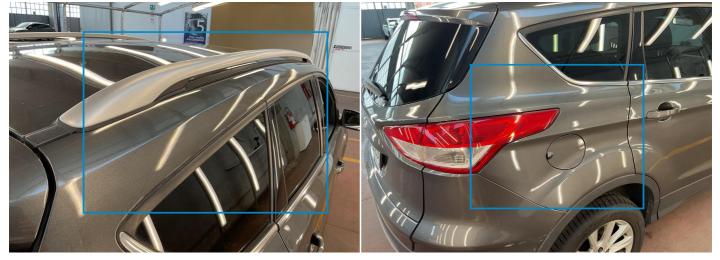
27. Pillar / Front Right Bodywork / Dent / Hail Area -

28. Fender / Back Right Bodywork / Poor Previous Repair -

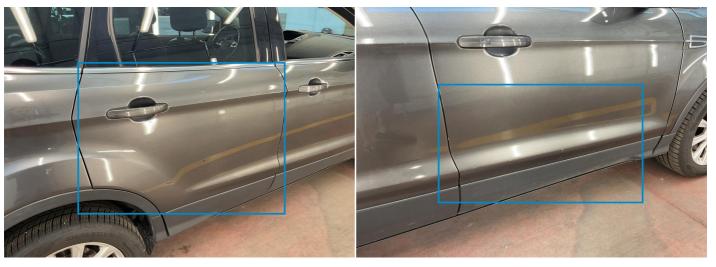
29. Door / Back Right Bodywork / Poor Previous Repair -

30. Door / Front Right Paint / Scratch / Line -

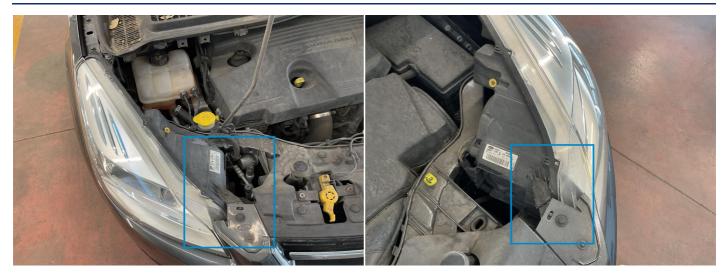
31. Front Light / Front Right Bodywork / Breakage -

32. Front Light / Front Left Bodywork / Breakage -
