## status report

**customer:** Bank 11, Neuss  
**contract number:** 1010833530  
**reference:**

#### Ford Kuga Cool

| Vehicle identification number | <b>WF0AXXWPMJU61034</b> | mileage read: | <b>60452 km</b> |

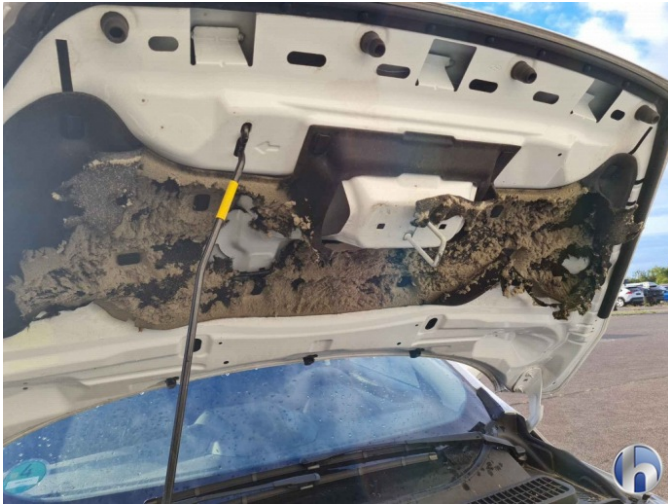
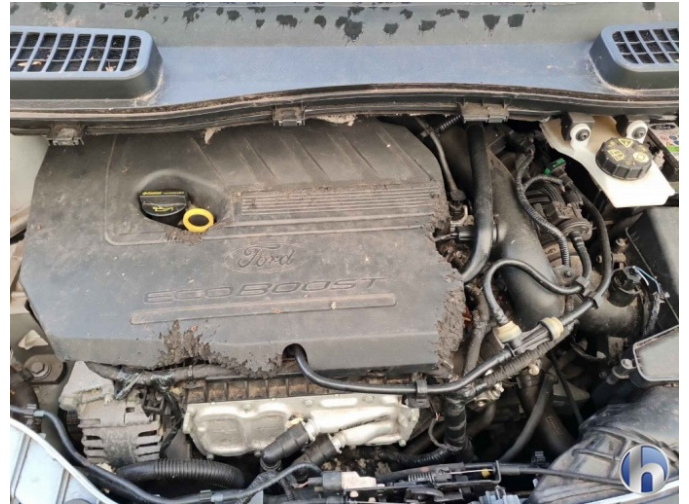
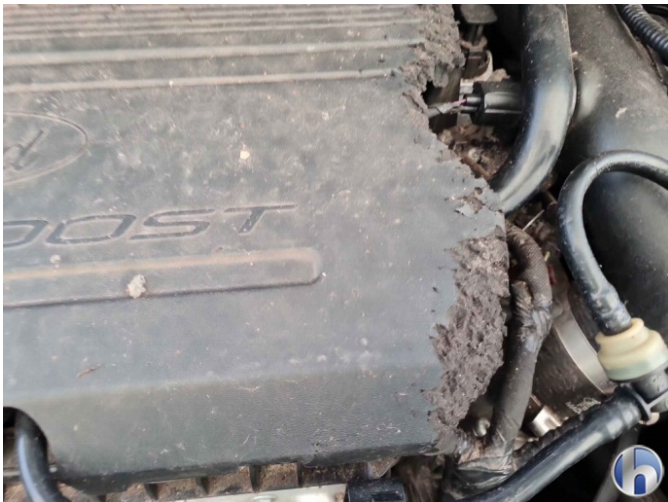
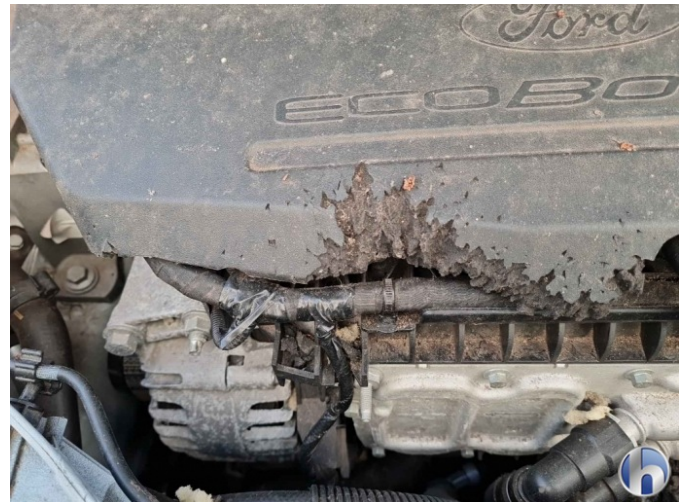
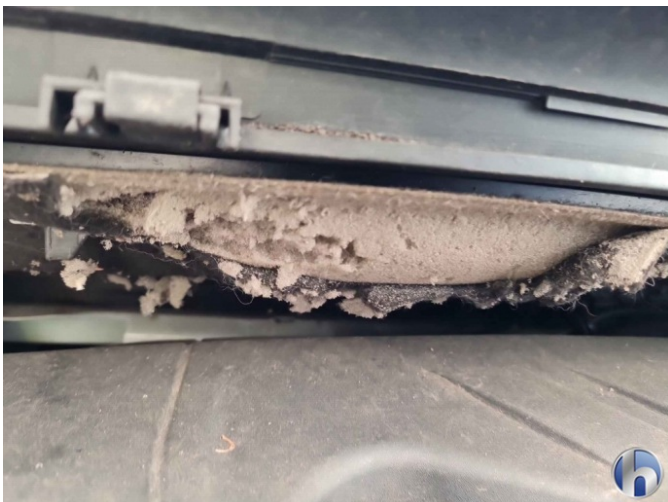
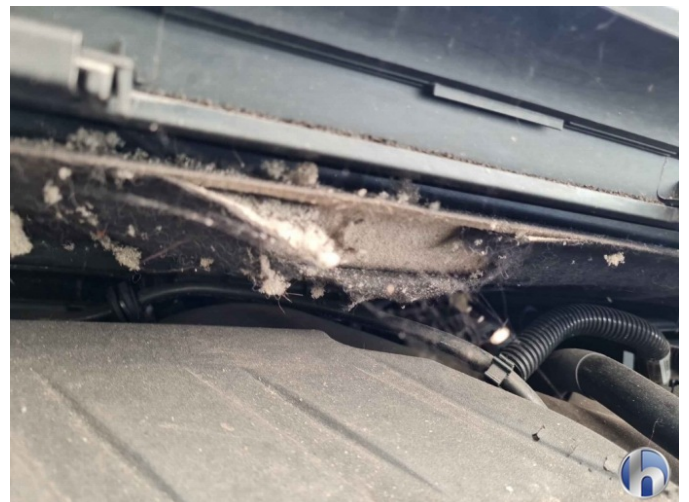
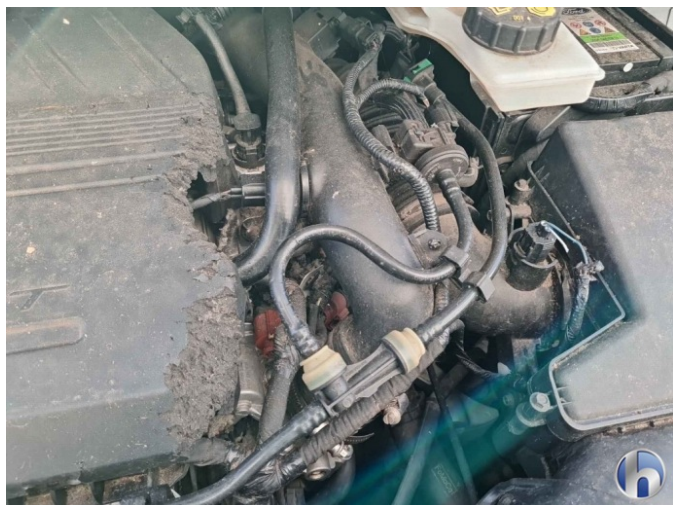
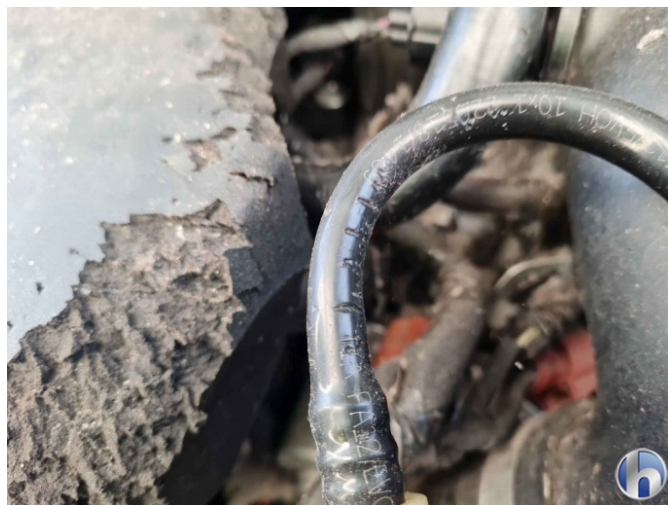
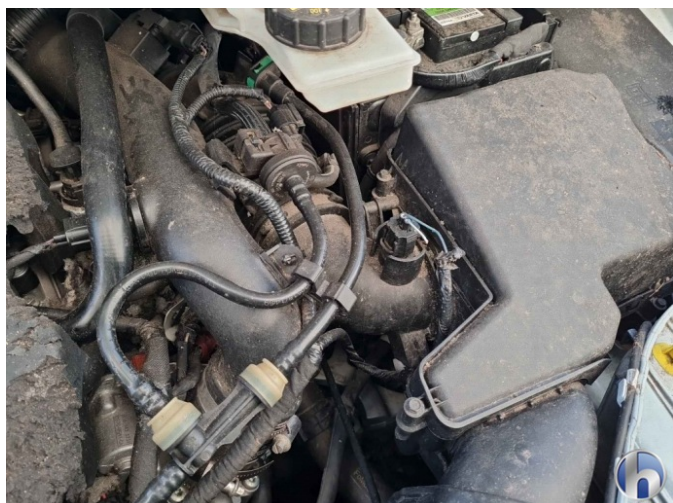
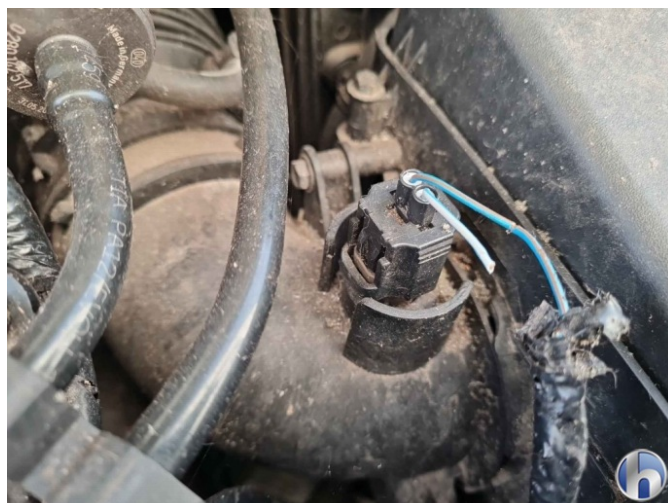
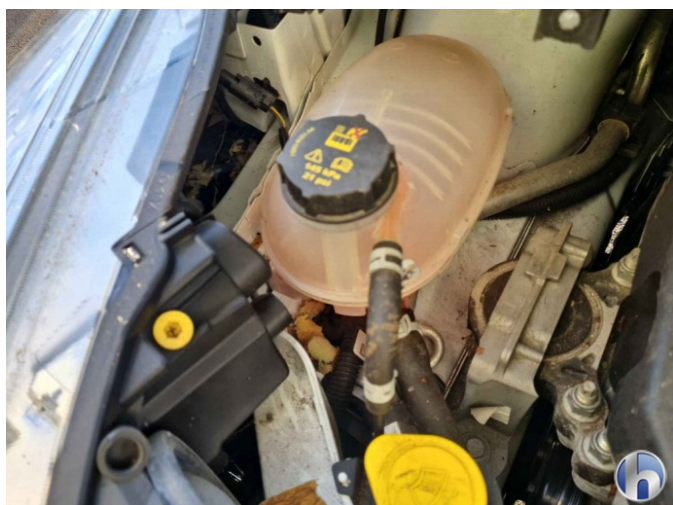
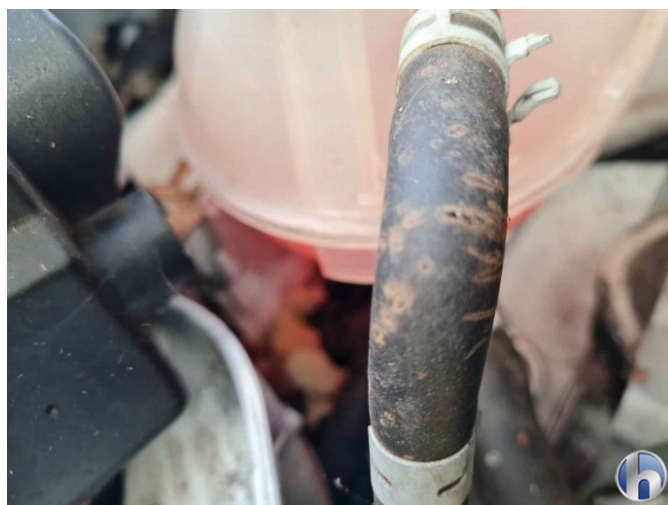
| | component | Damage | Rep kind |
|---|---|---|---|
| 2. | Motorraum | | Replace |

2. Motorraum

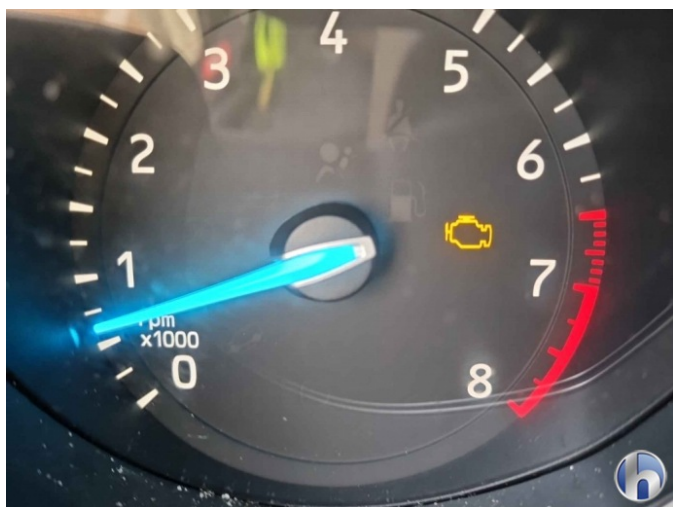
| Performed testing technology | |
|---|---|
| <b>engine running:</b> | A field test of the engine had to acoustic or visual defects for visiting time .<br>**Engine warning light. Engine run out of round. |

| | component | Damage | Rep kind |
|---|---|---|---|
| 4. | Motor | Error message | Carry out a fault diagnosis |

4. Motor

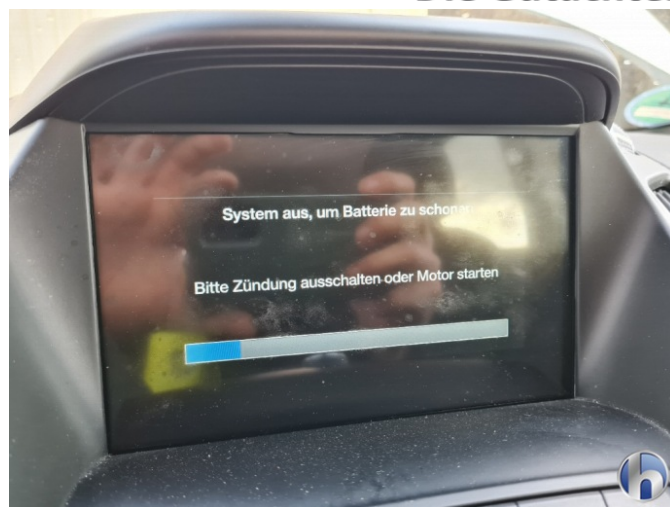
| | component | Damage | Rep kind |
|---|---|---|---|
| 5. | Radio | | Carry out a fault diagnosis |

5. Radio

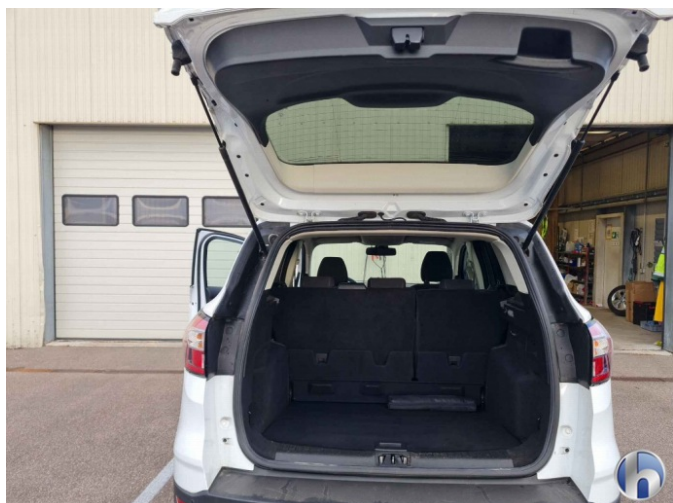
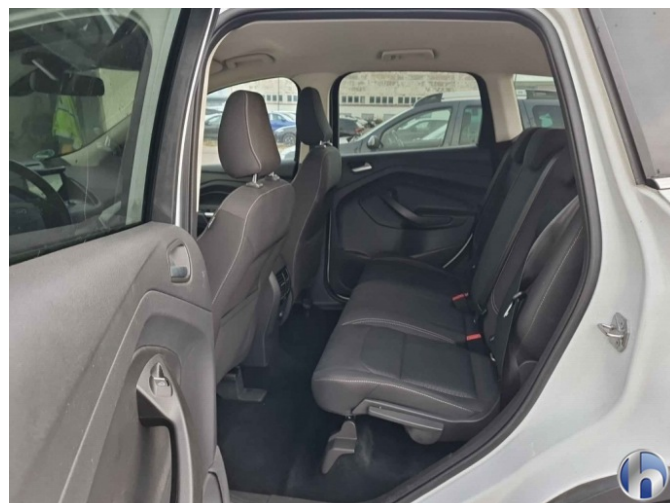
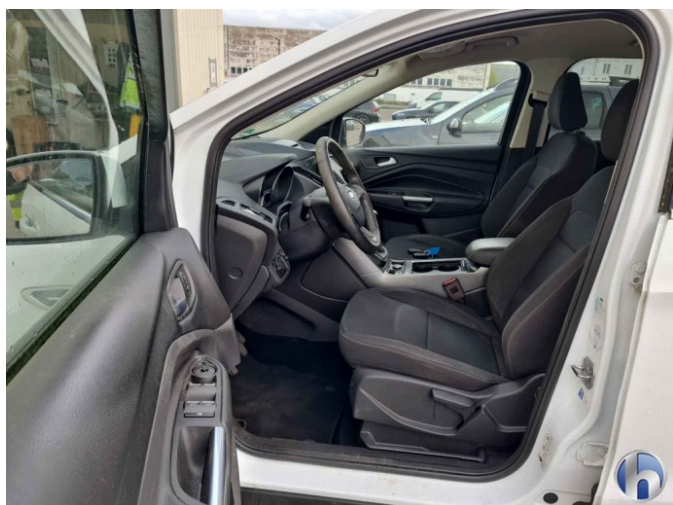
| | component | Damage | Rep kind |
|---|---|---|---|
| 8. | Kofferraum und Innenraum | Wear and tear | acceptable |

8. Kofferraum und Innenraum

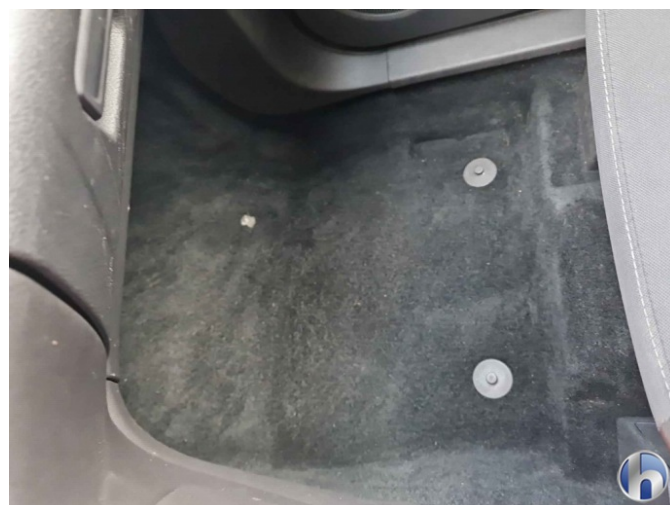
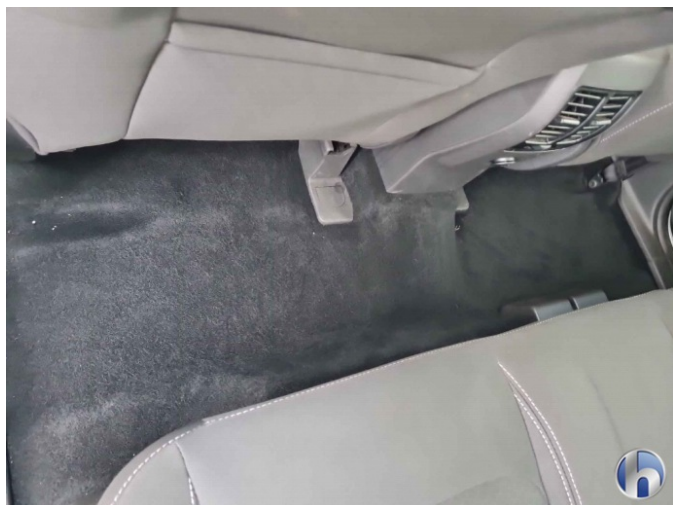
| | component | Damage | Rep kind |
|---|---|---|---|
| 9. | Fußmatten Hinten Vorne Rechts | Missing | Replace |

9. Fußmatten Hinten Vorne Rechts

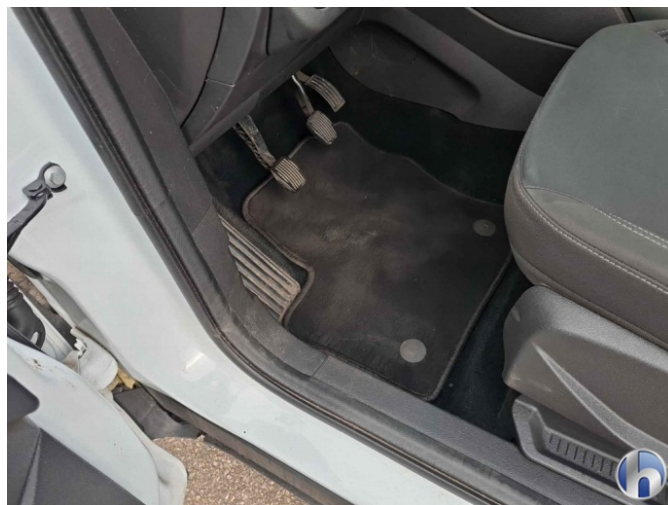
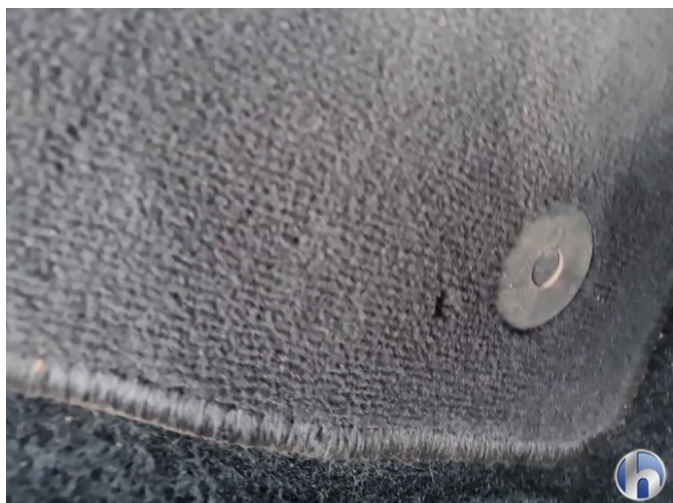
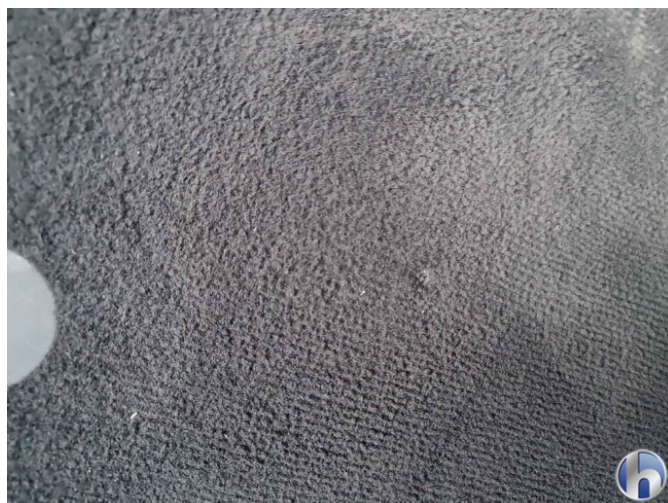
| | component | Damage | Rep kind |
|---|---|---|---|
| 10. | | Burn hole | Replace |

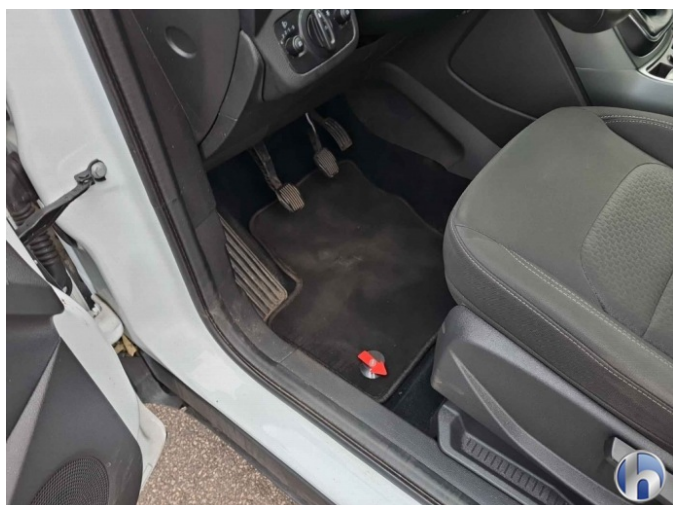
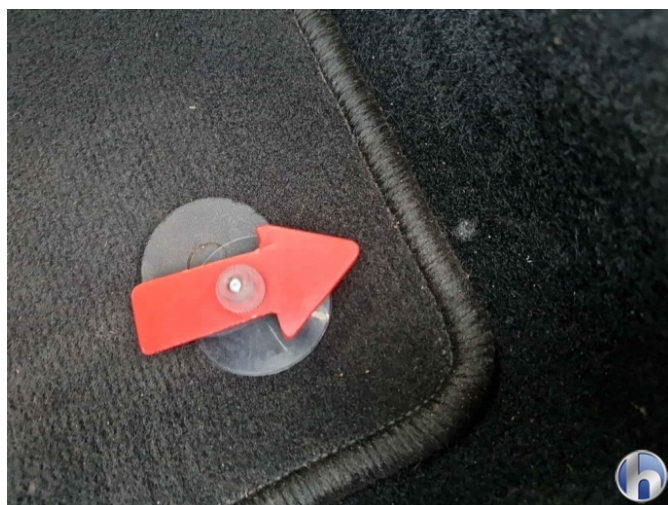
| | component | Damage | Rep kind |
|---|---|---|---|
| 11. | Bodenbelag | Burn hole | Smart repair |

11. Bodenbelag

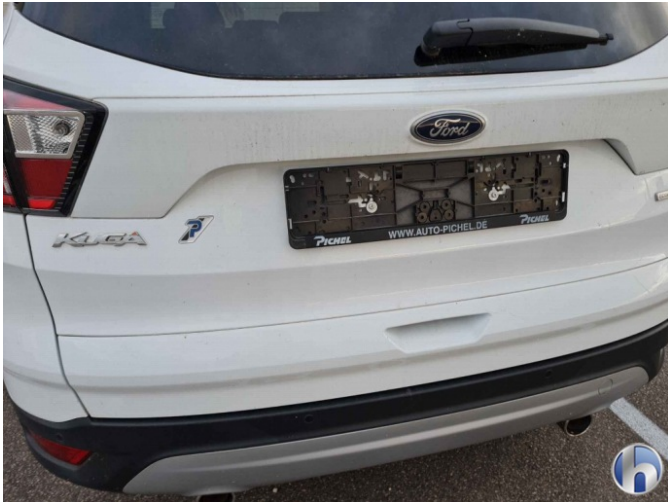
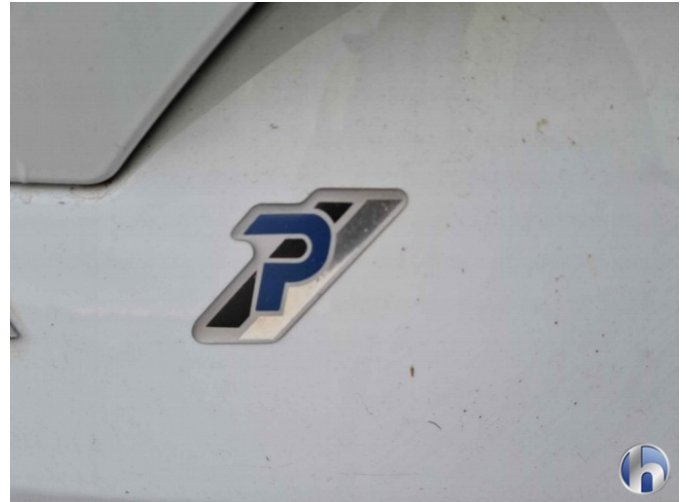
| | component | Damage | Rep kind |
|---|---|---|---|
| 12. | tailgate | Sticker | |

12. tailgate

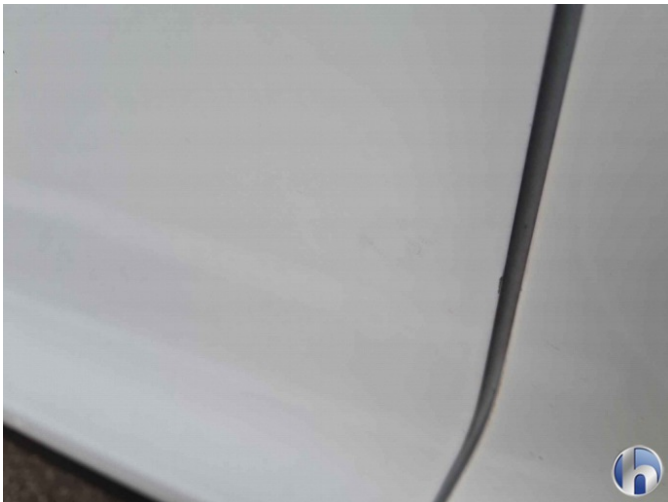
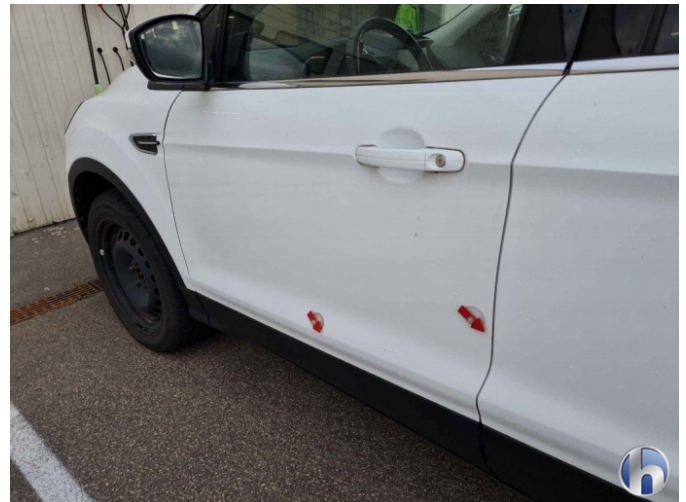
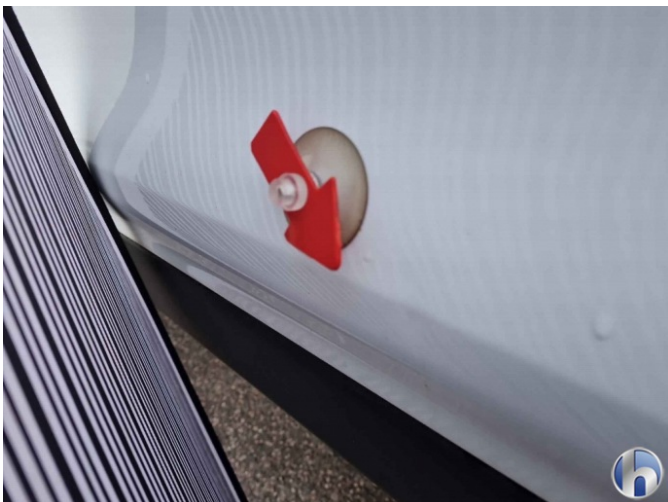
| | component | Damage | Rep kind |
|---|---|---|---|
| 13. | Front door - left | Damaged | Smart repair |

13. Front door - left

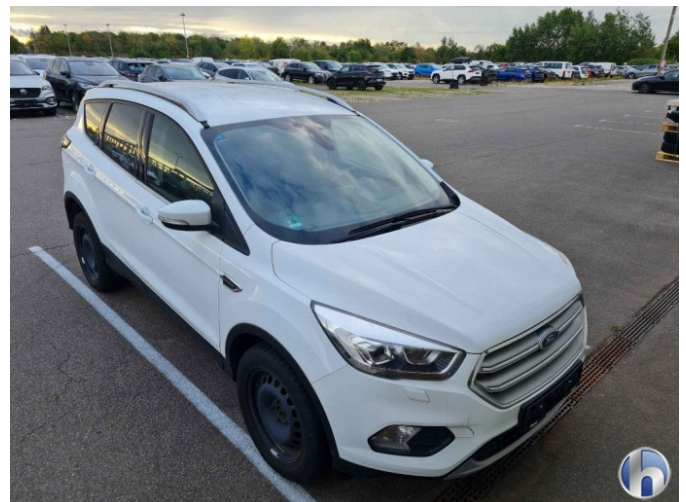
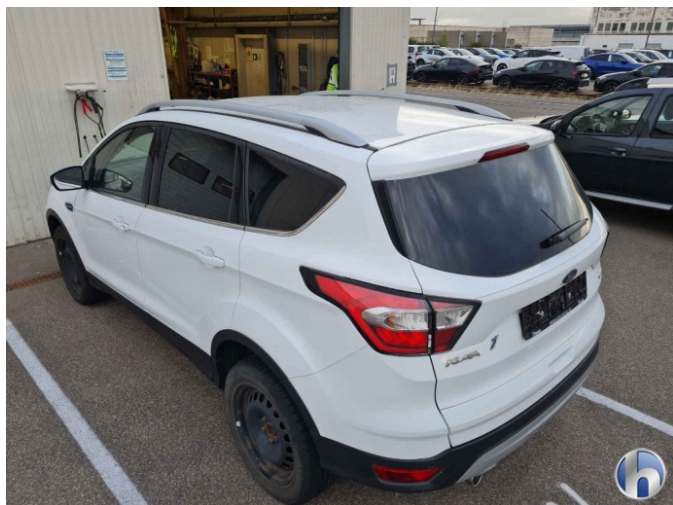
| | component | Damage | Rep kind |
|---|---|---|---|
| 14. | Fahrzeug (Kratzer, Harz-/Säureeinwirkung, Verschmutzungen, Flugrost) | Not okay | |

14. Fahrzeug (Kratzer, Harz-/Säureeinwirkung, Verschmutzungen, Flugrost)

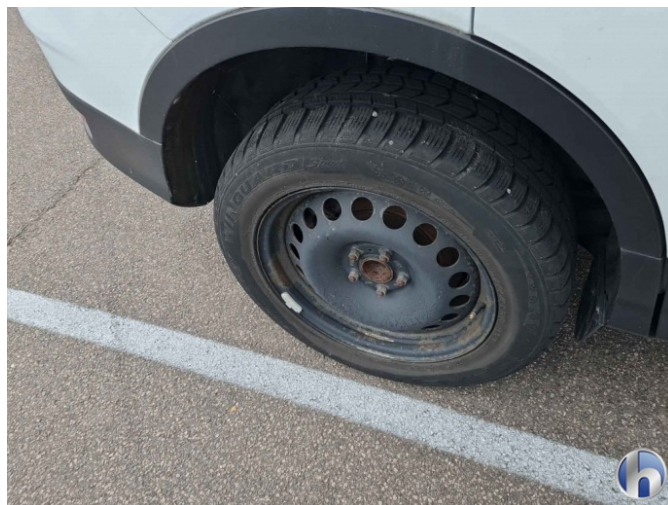
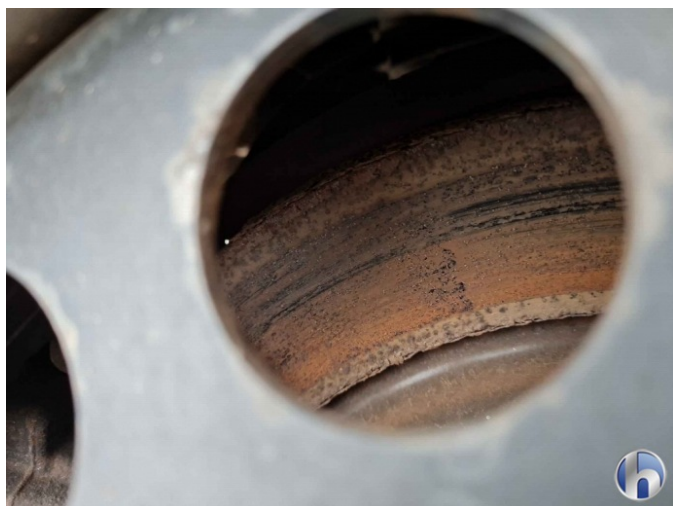
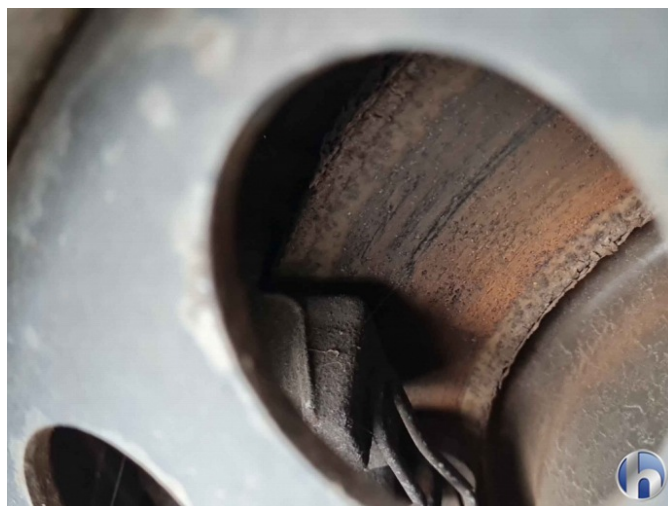
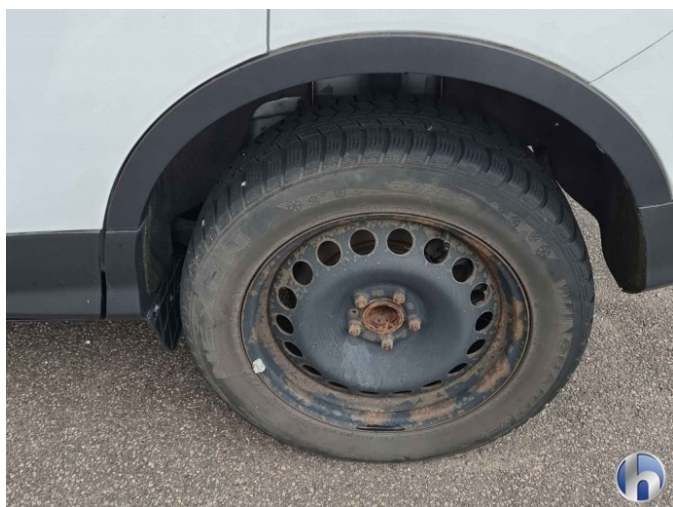
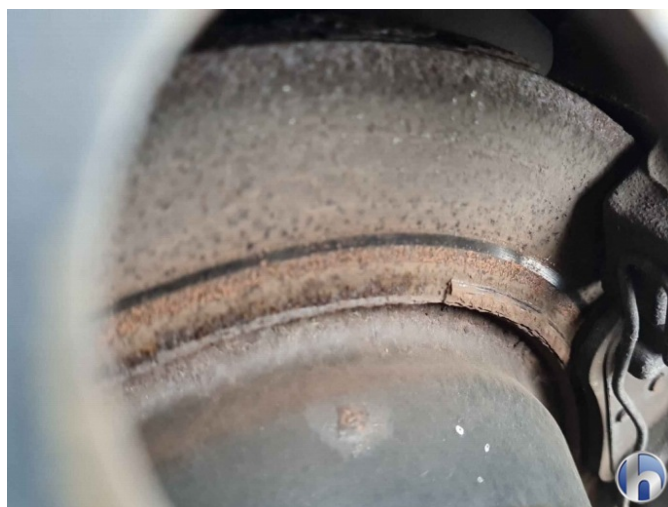
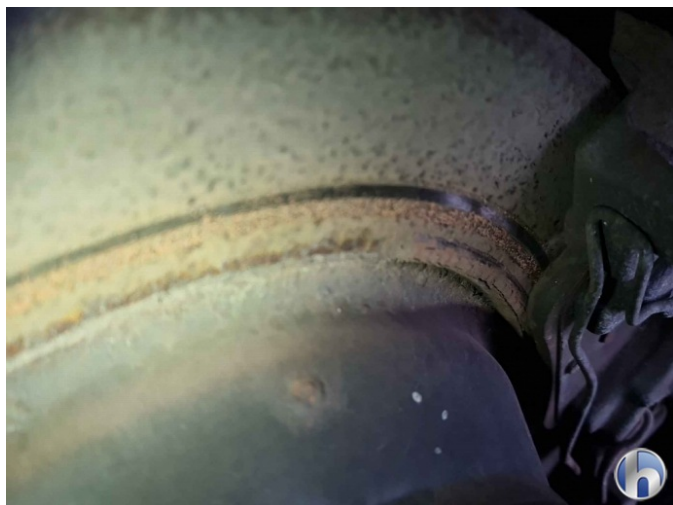
| | component | Damage | Rep kind |
|---|---|---|---|
| 17. | | Not okay | Replace |

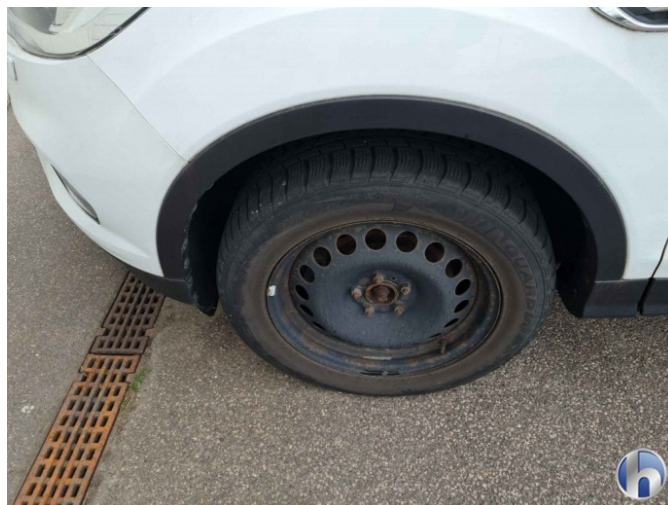
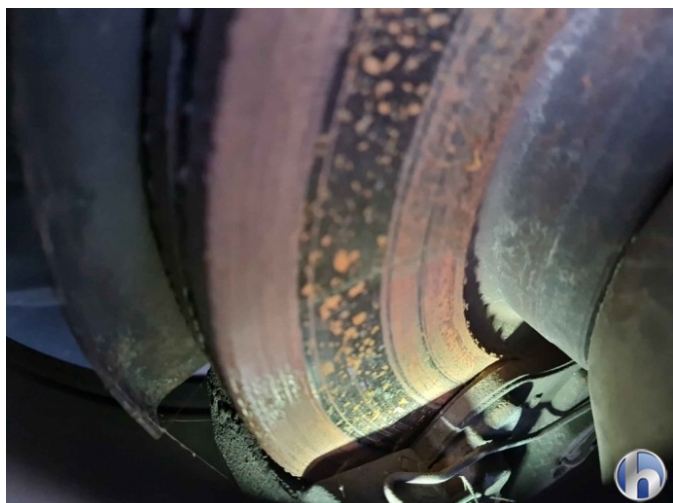
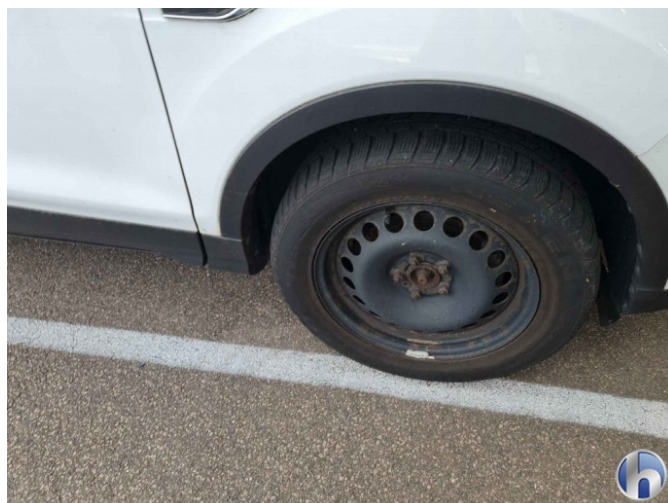
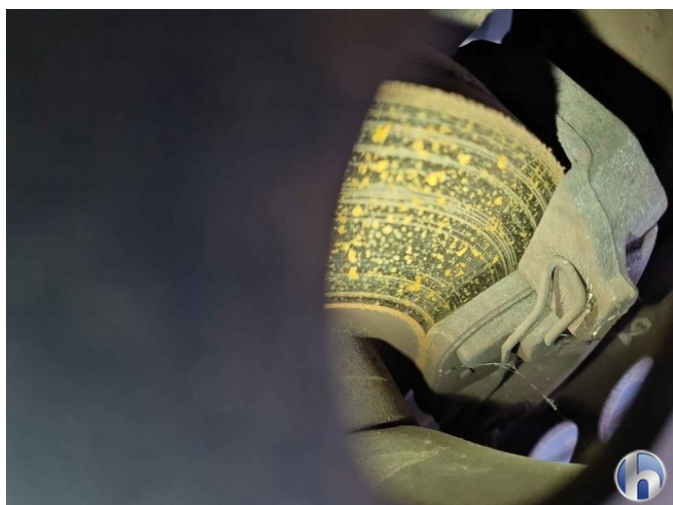
| | component | Damage | Rep kind |
|---|---|---|---|
| 18. | | Not okay | Replace |
