Expertise

Protocol number: 40679948  
Order No. / Reference: 24887905  
Inspection date: 21 Jul 2025

Manufacturer: Ford

Model: Transit 350 L3 VA Trend

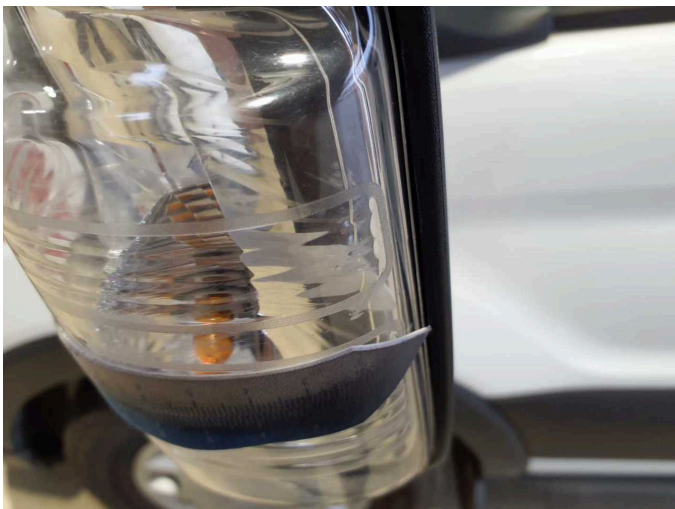
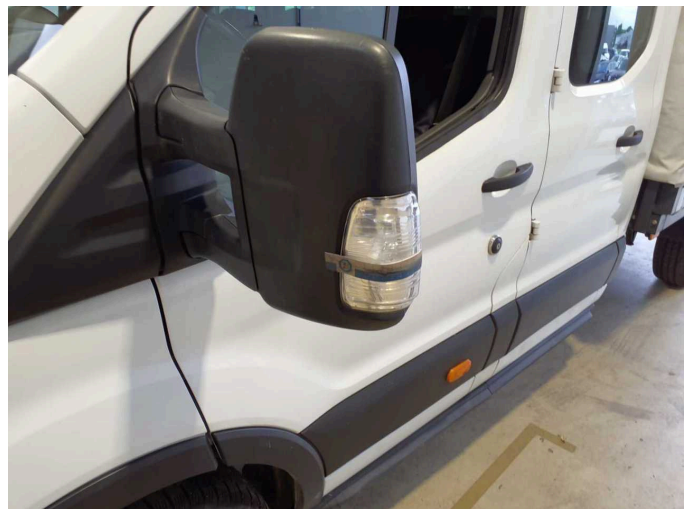
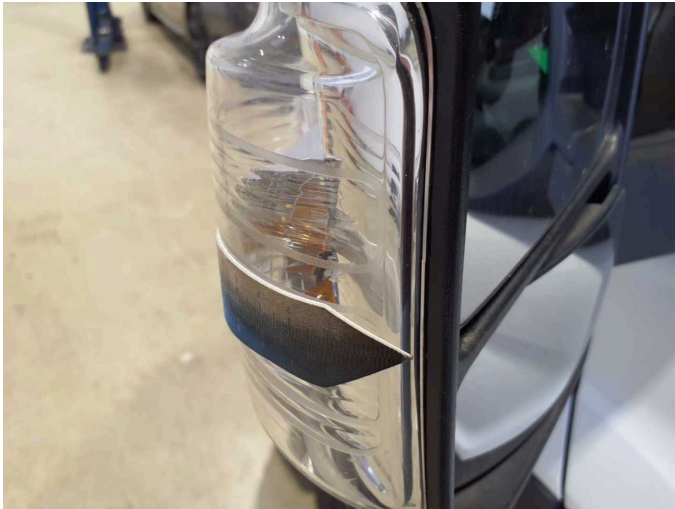
Damage 1: Indicator - front: Mirror - left side - Scratch(es) - Replace

**Damage 1:** Indicator - front: Mirror - left side - Scratch(es) - Replace

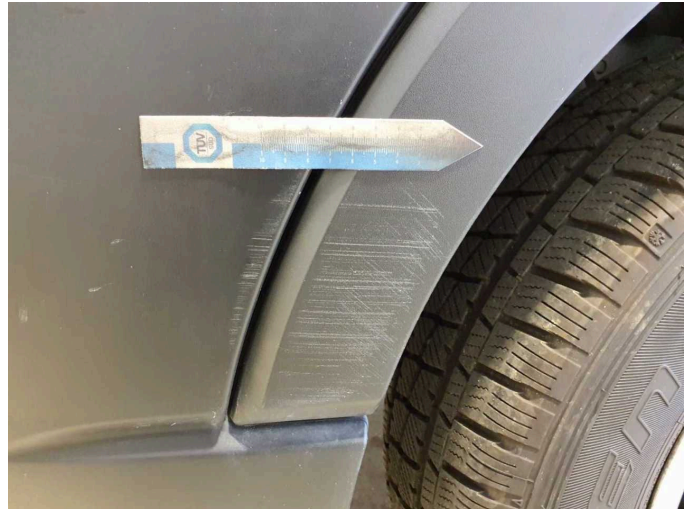
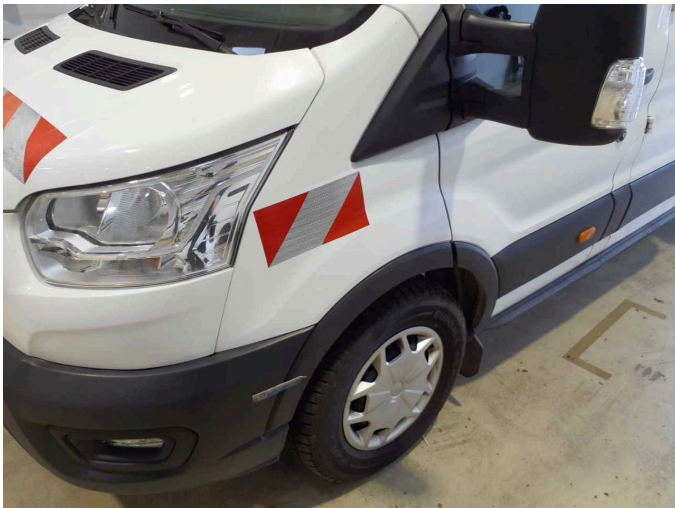
**Damage 2:** Mudguard - left side: Wheel well extension - Scratch(es) - Loss in value

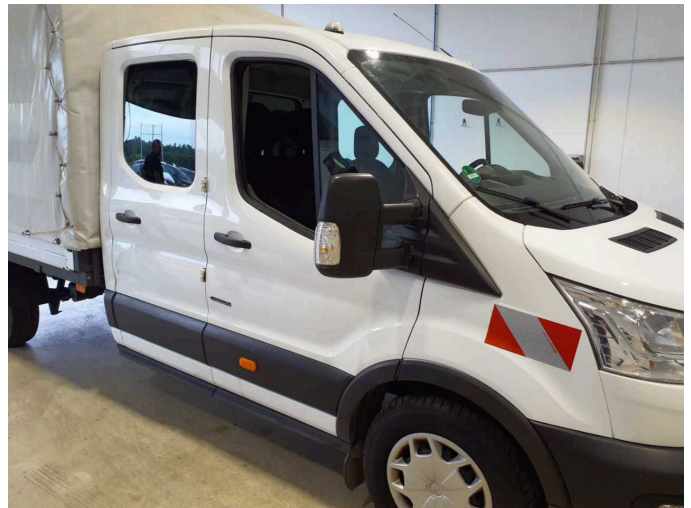
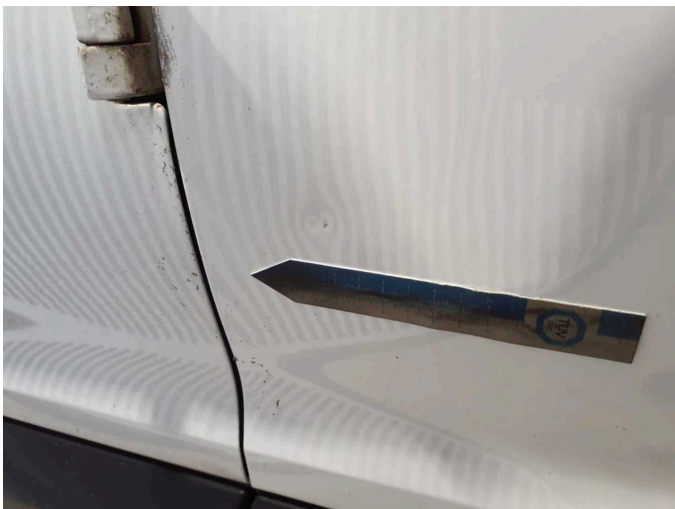
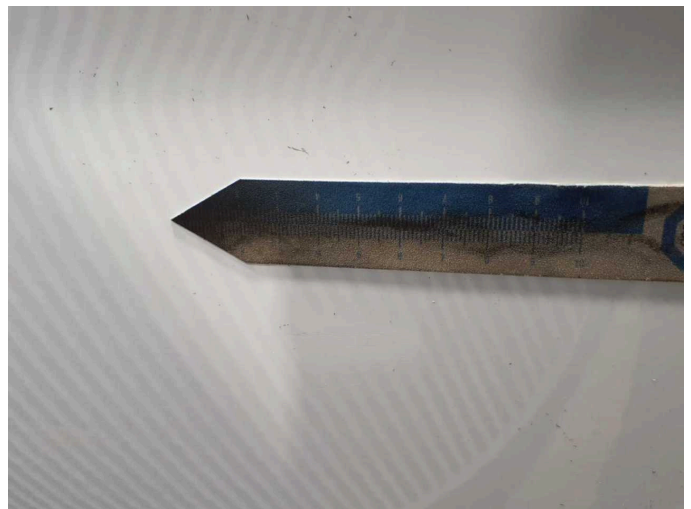
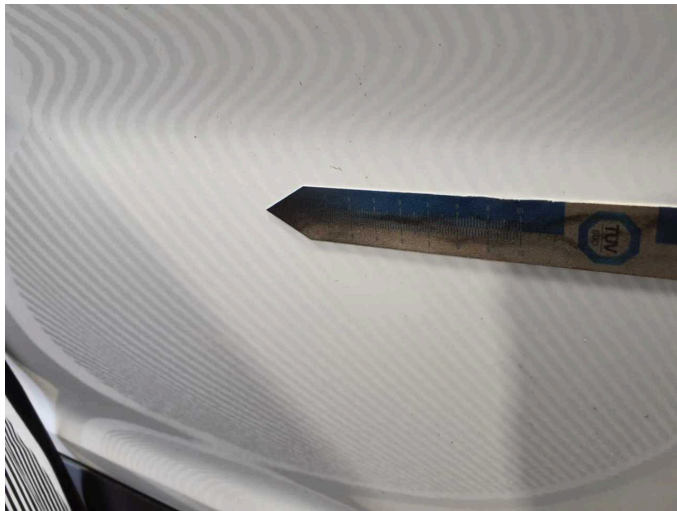
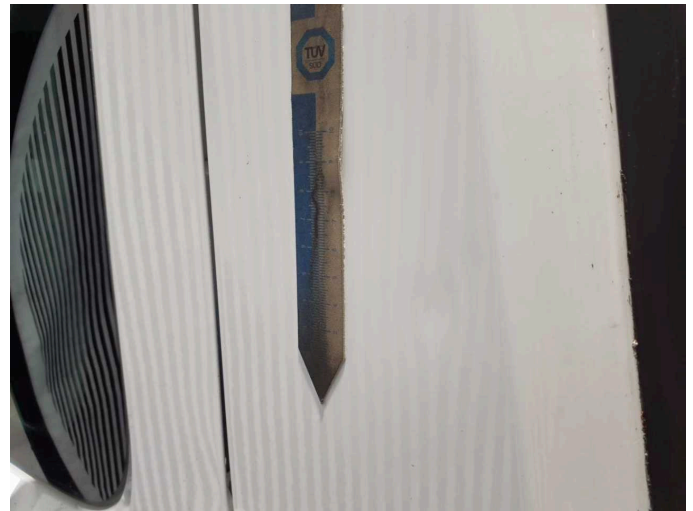
**Damage 3:** Door - front right side: Door - Dent / paintcoat damage - Smart repair

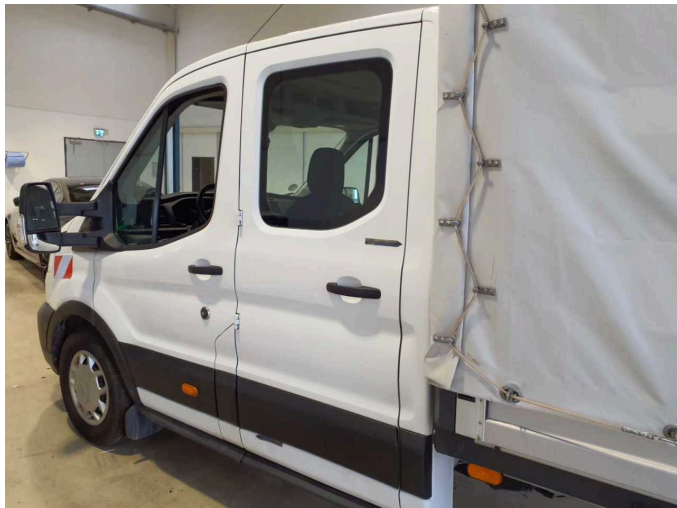
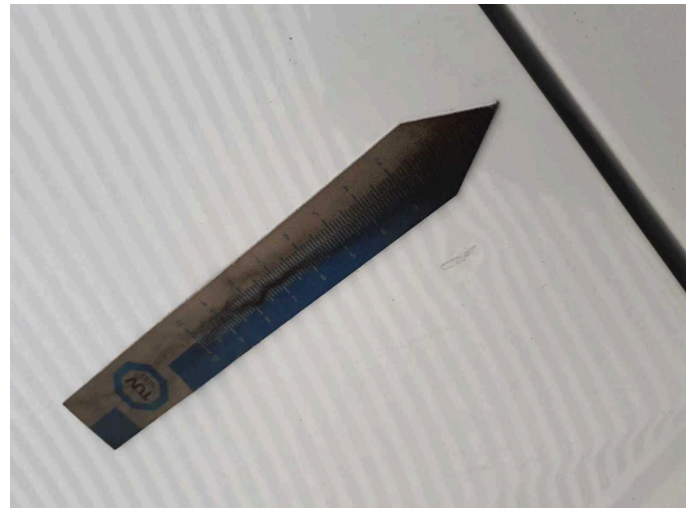
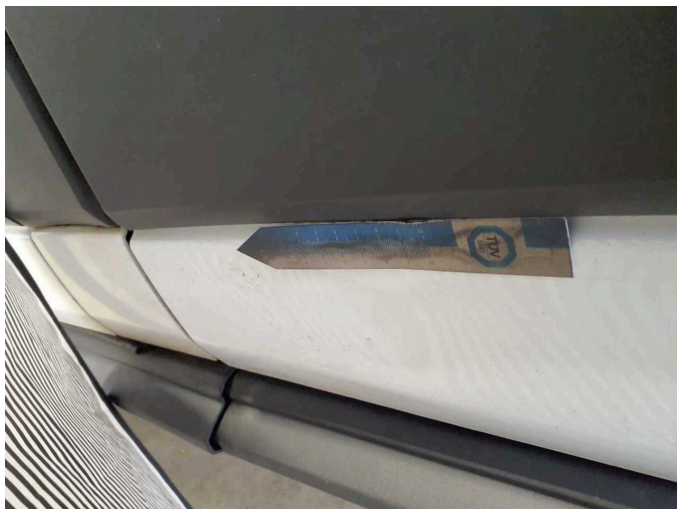
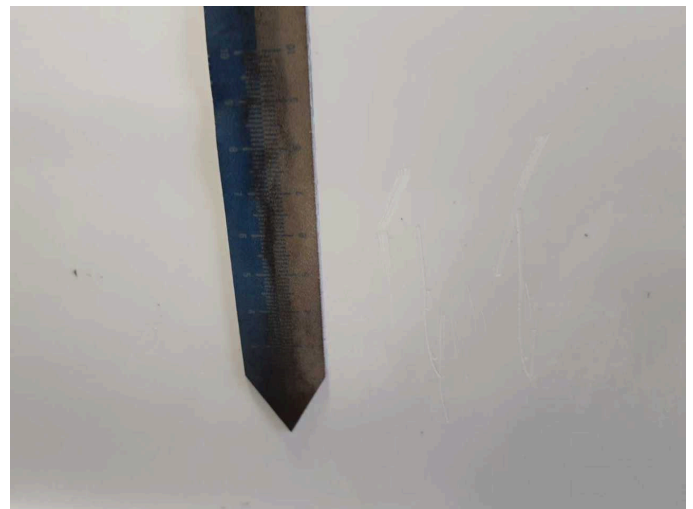
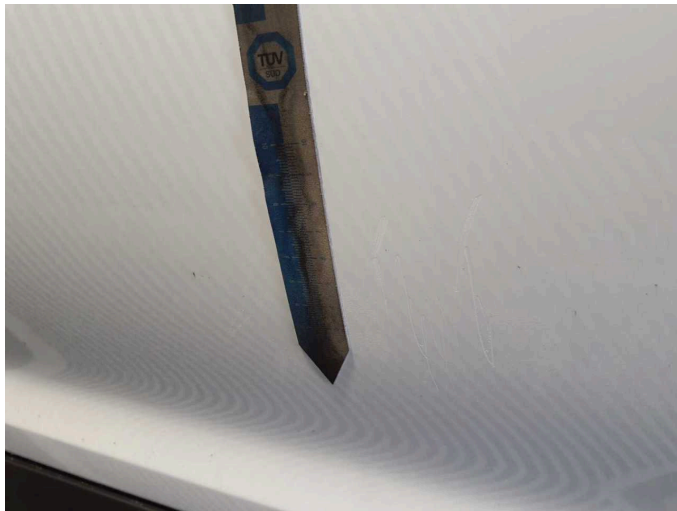
**Damage 4:** Door - rear left side: Door - Dent / paintcoat damage - Smart repair

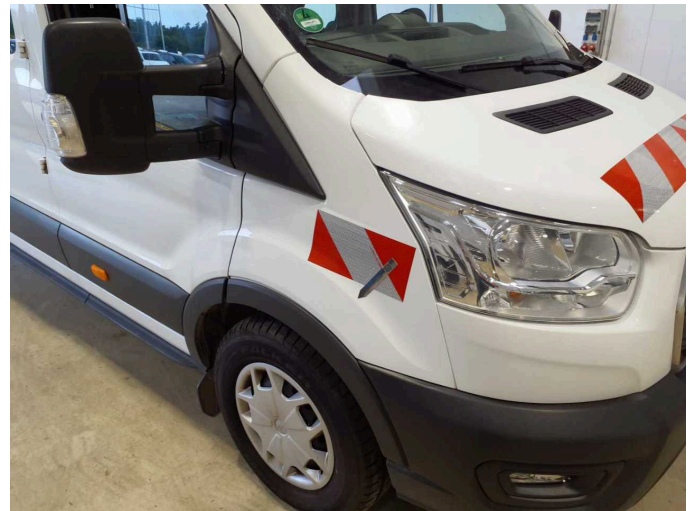
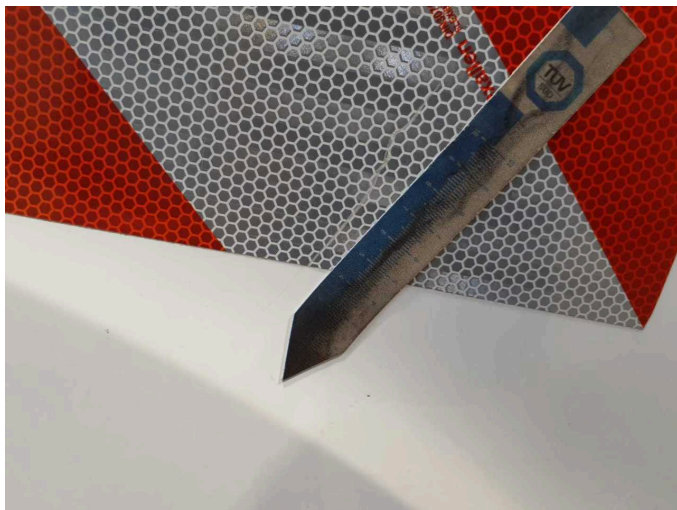
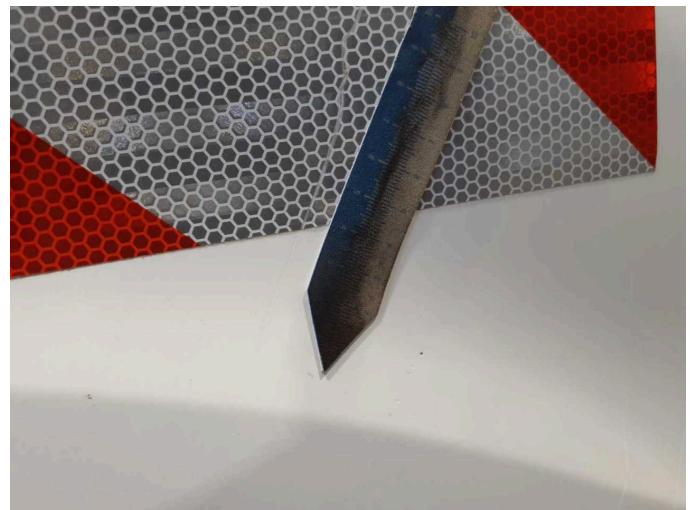
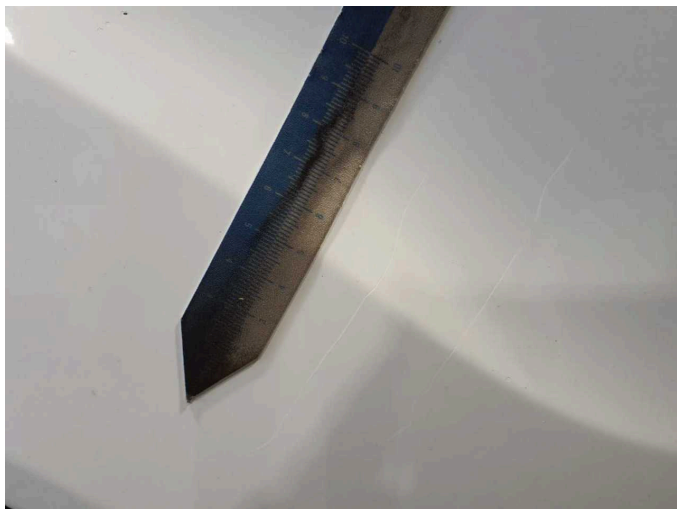
**Damage 5:** Mudguard - right side: Mudguard - right side - Scratch(es) - Lacquer

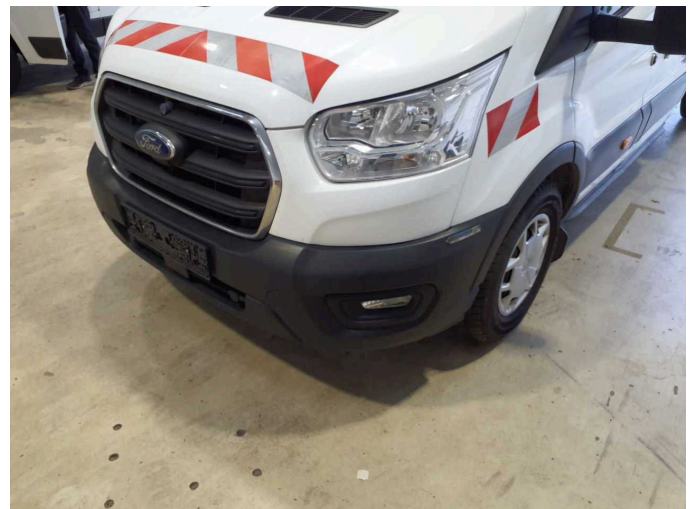
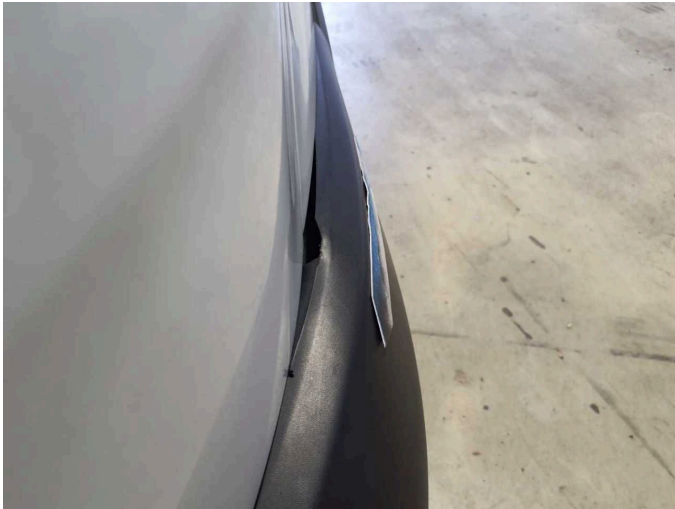
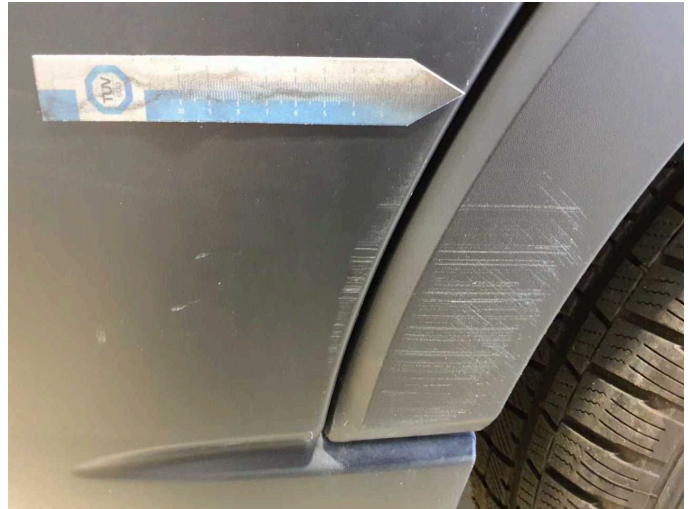
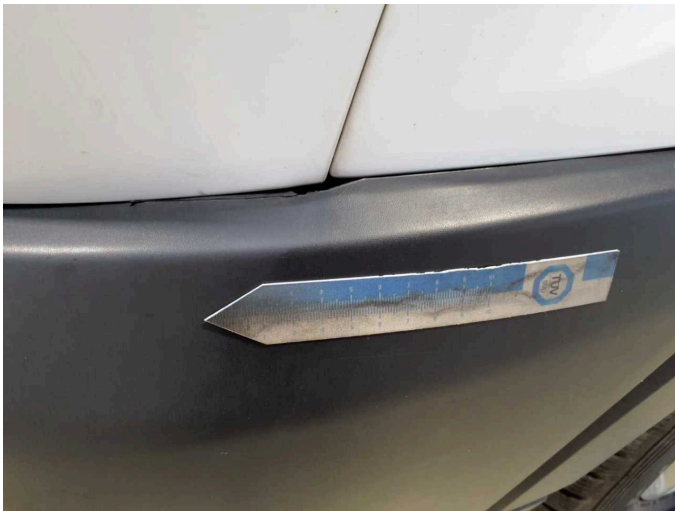
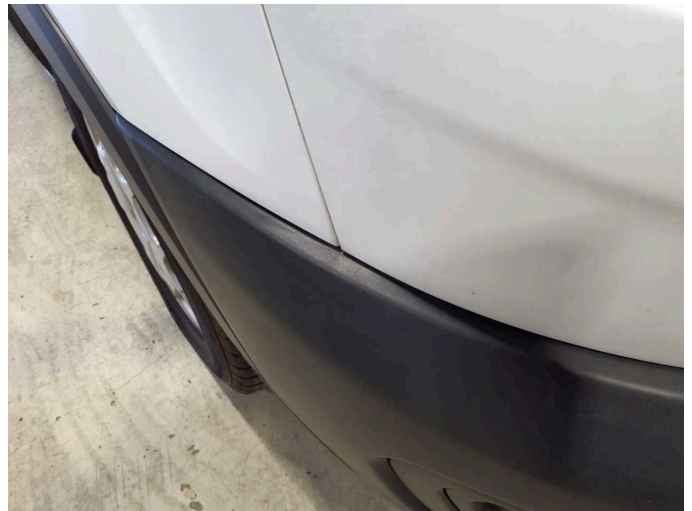
**Damage 6:** Front bumper: Front bumper (unpainted) - Deformed - Replace

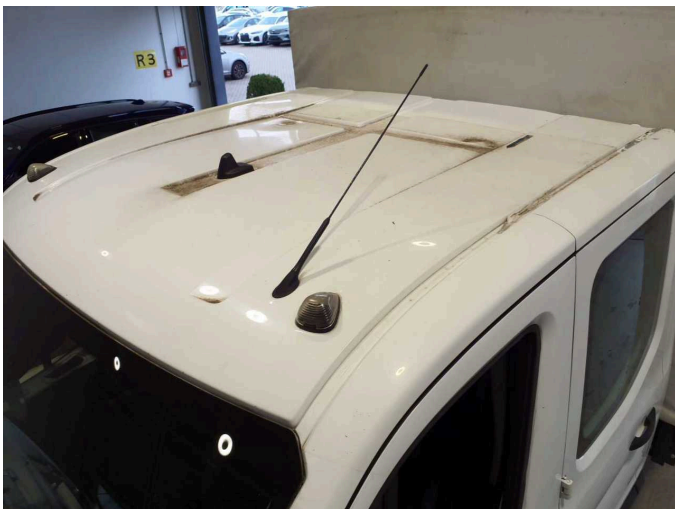
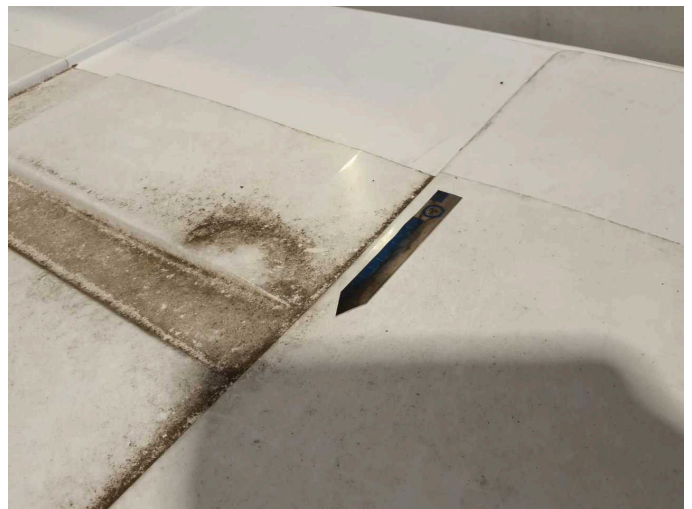
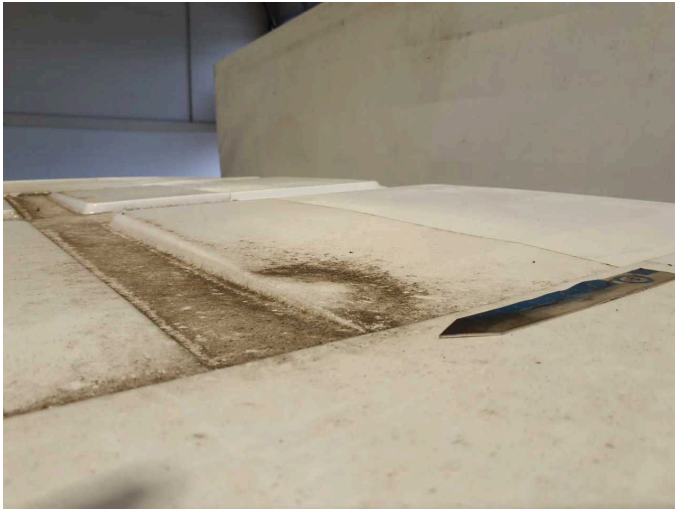
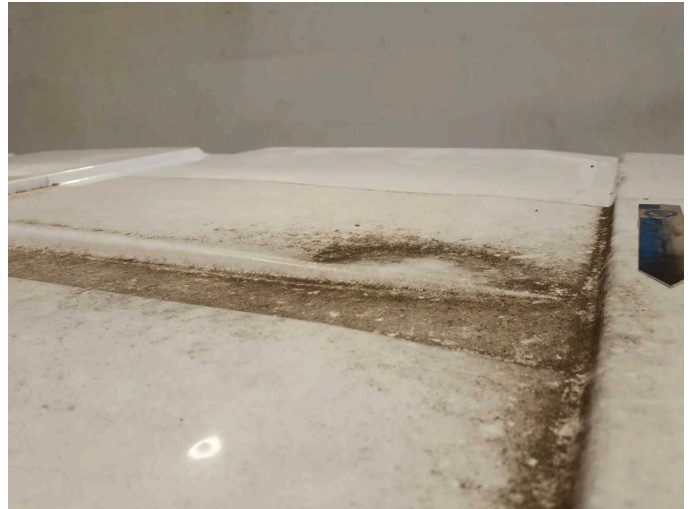
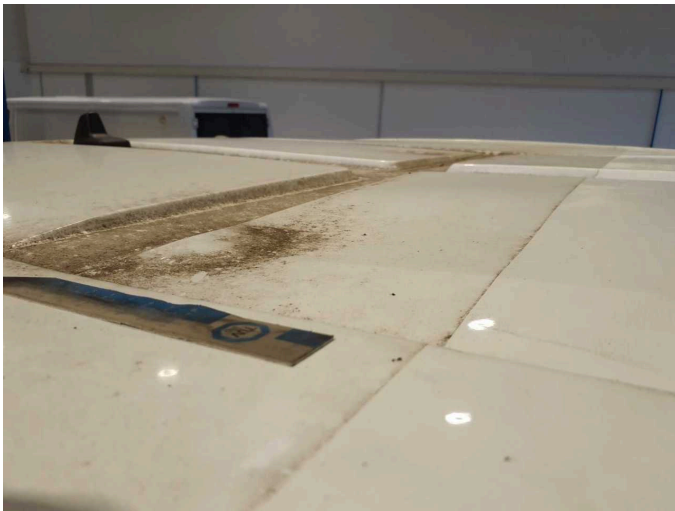
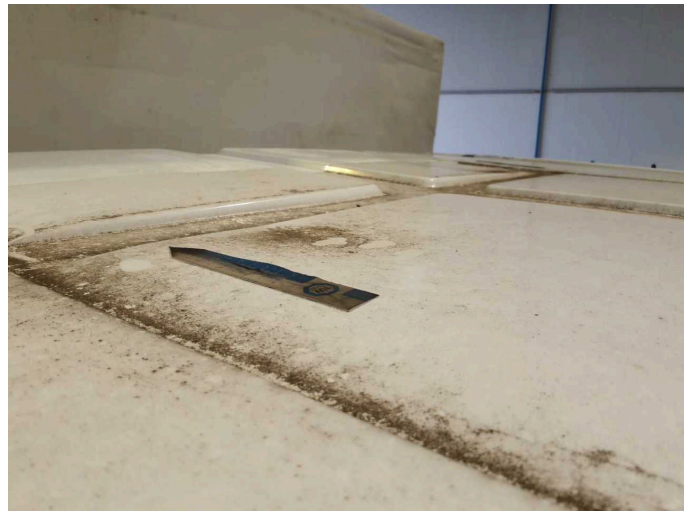
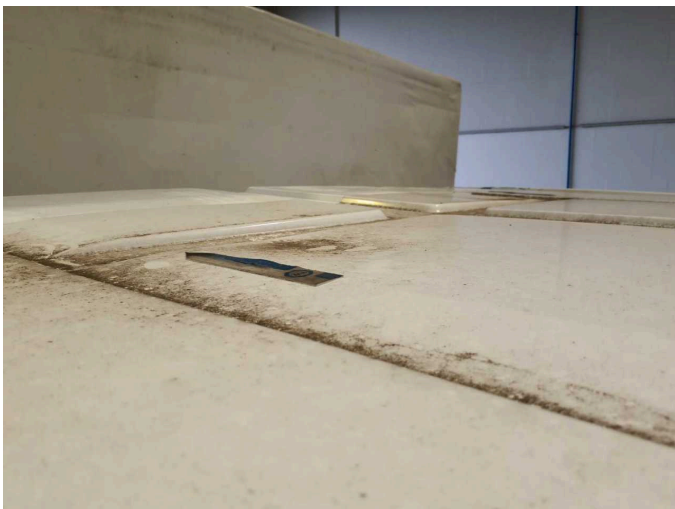
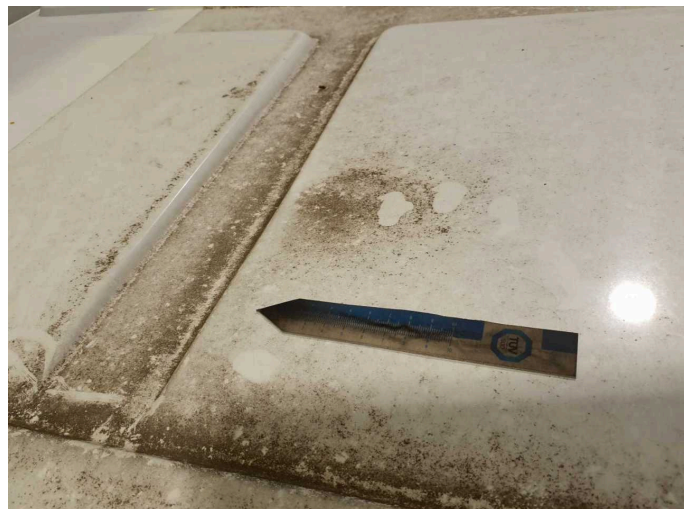
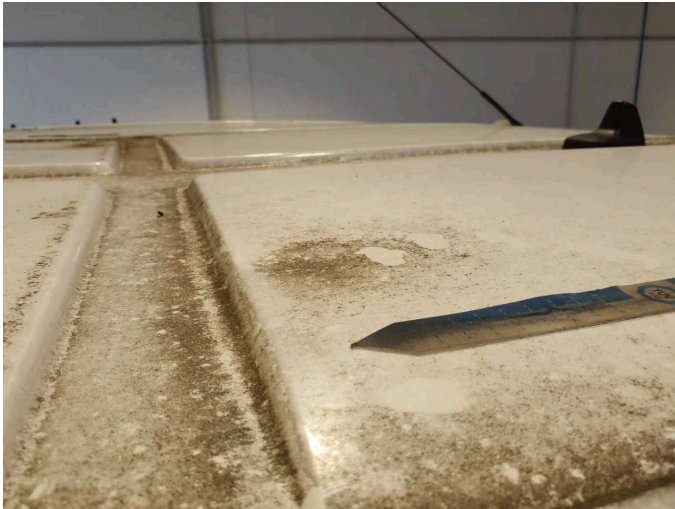
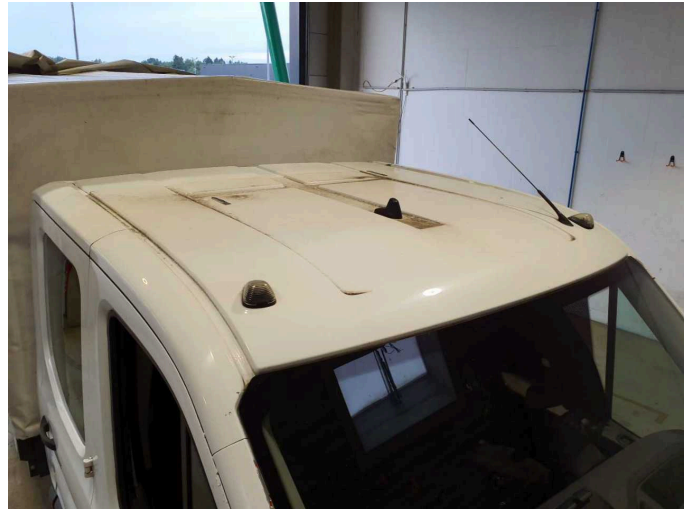
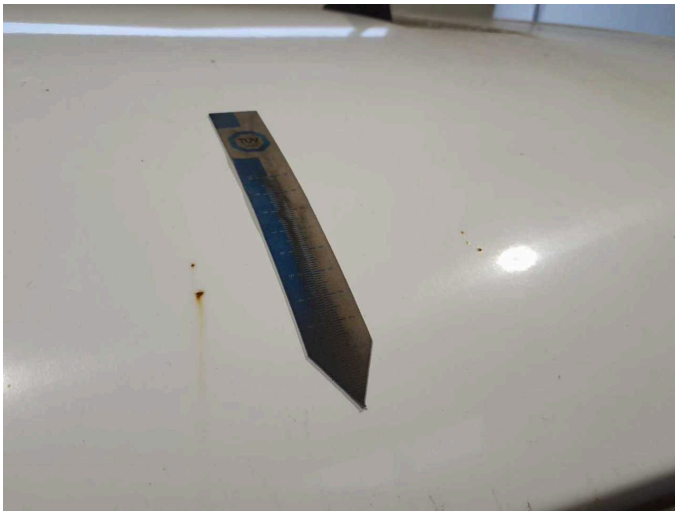
**Damage 7:** Roof: Roof - Corrosion - Repair and paint

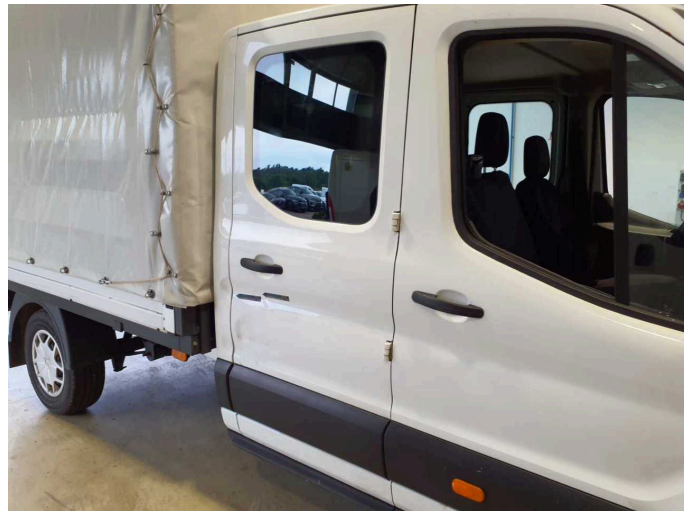
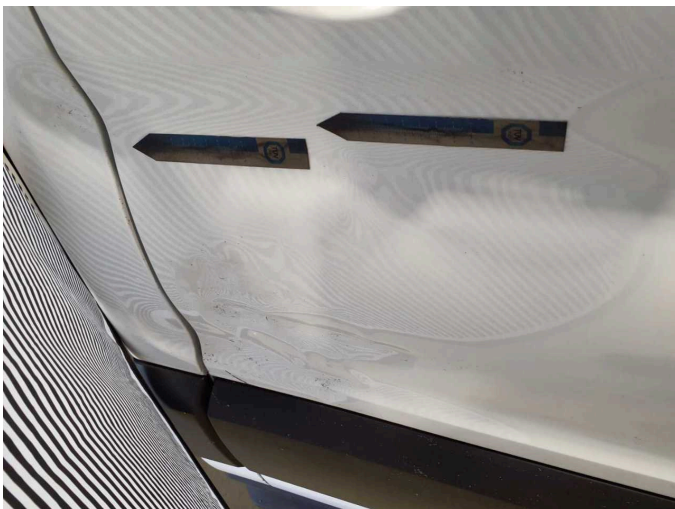
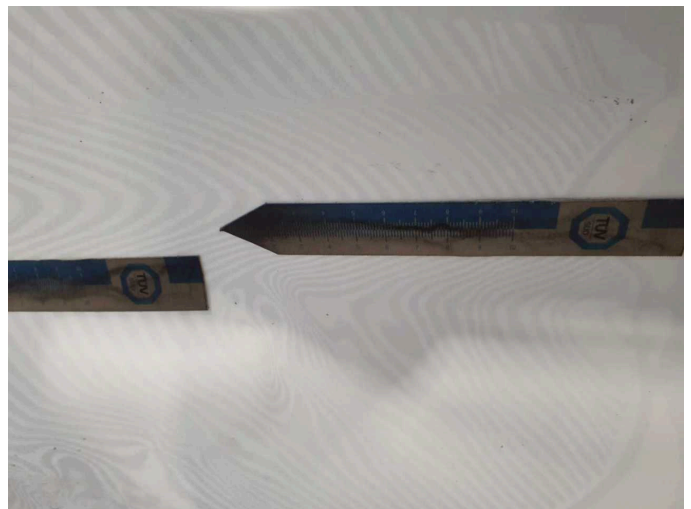
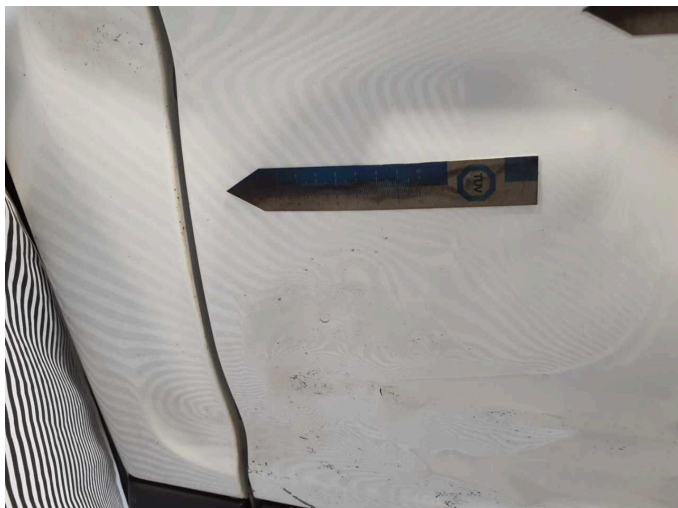
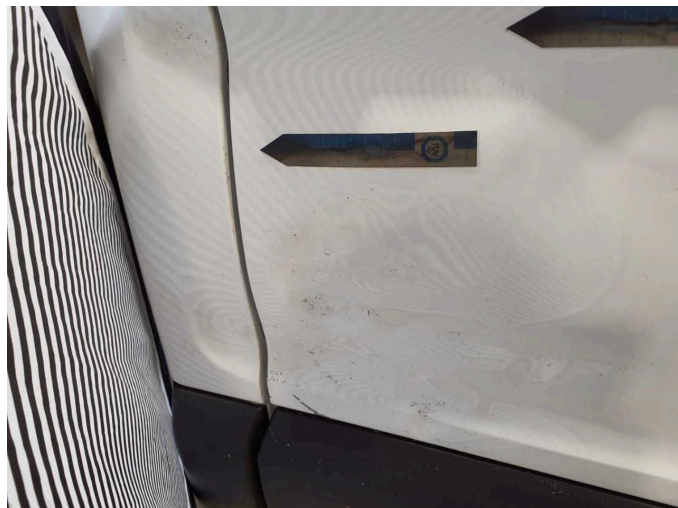
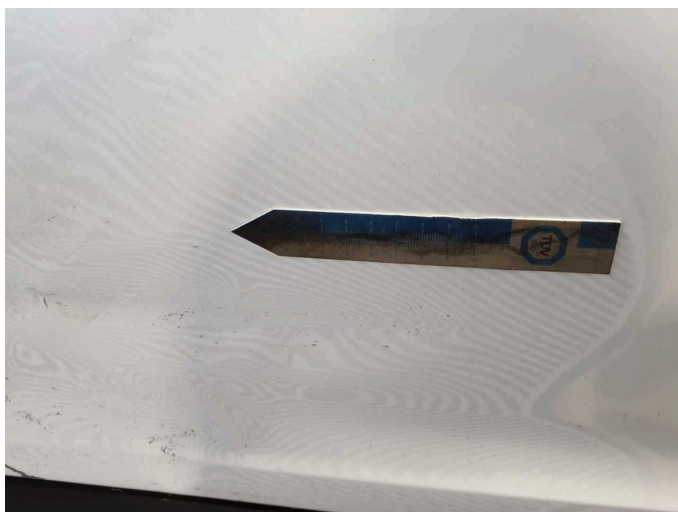
**Damage 8:** Door - rear right side: Door (Außenblech) - Deformed - Replace
