Expertise

Protocol number: 40984352
Order No. / Reference: MW2558533
Inspection date: 21 Jul 2025

Manufacturer: Ford

Model: Transit 350 L3 VA Trend

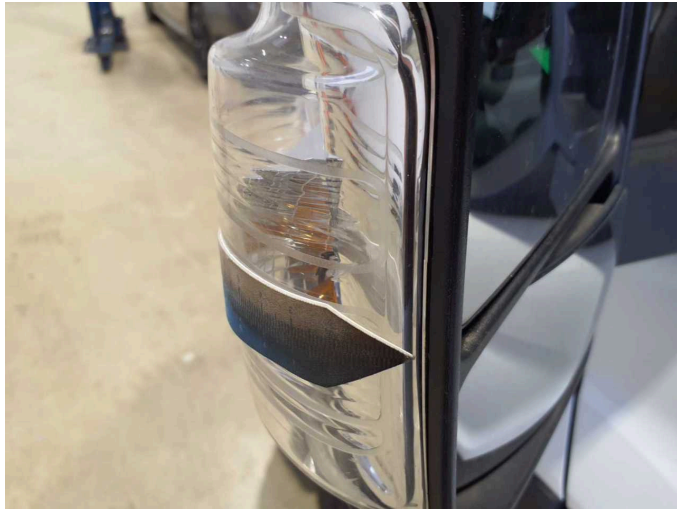
Damage 1: Indicator - front: Mirror - left side - Scratch(es) - Replace

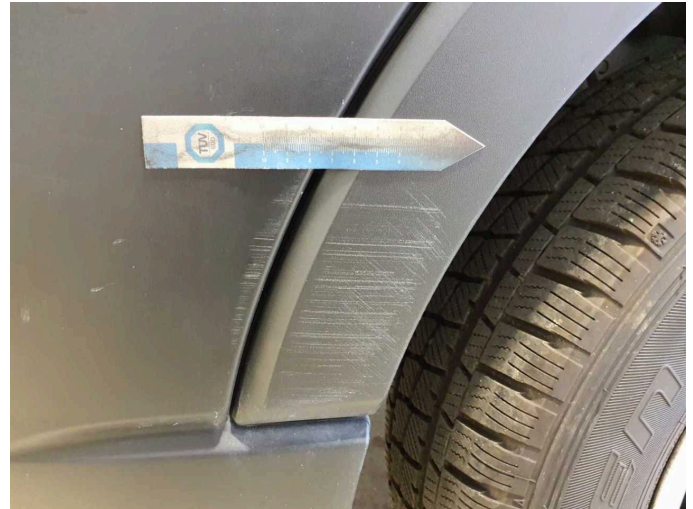
Damage 2: Mudguard - left side: Wheel well extension - Scratch(es) - Loss in value

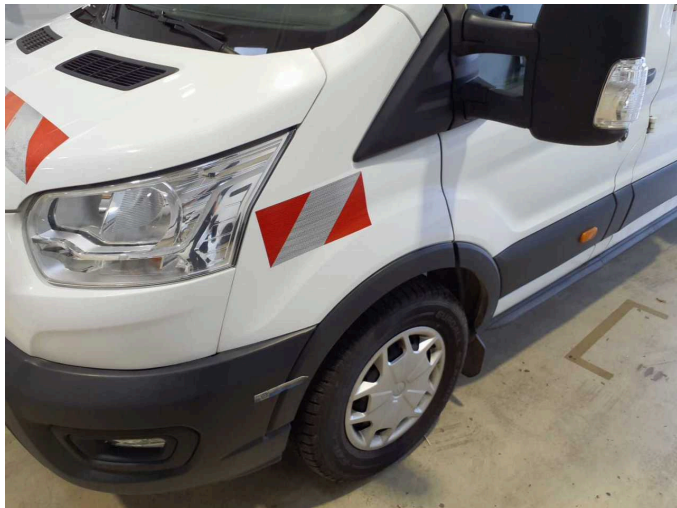
Damage 2: Mudguard - left side: Wheel well extension - Scratch(es) - Loss in value

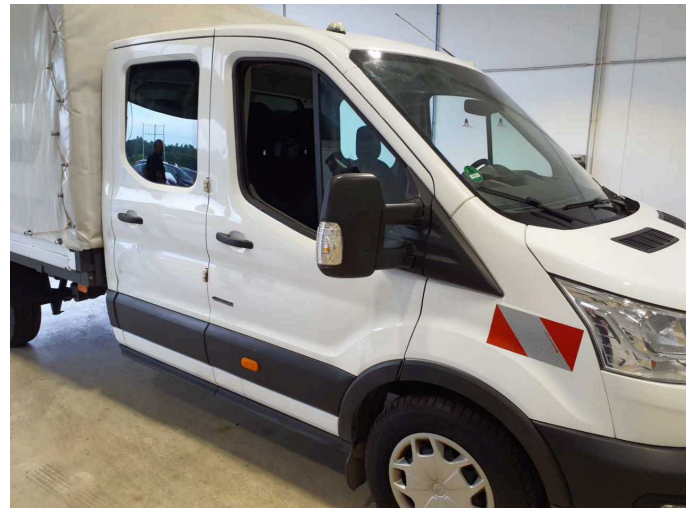
No.	Component group	Description
3	Door - front right side	Door - Dent / paintcoat damage - Smart repair
4	Door - rear left side	Door - Dent / paintcoat damage - Smart repair
5	Mudguard - right side	Mudguard - right side - Scratch(es) - Lacquer
6	Front bumper	Front bumper (unpainted) - Deformed - Replace
7	Roof	Roof - Corrosion - Repair and paint
8	Door - rear right side	Door (Außenblech) - Deformed - Replace

Damage 3: Door - front right side: Door - Dent / paintcoat damage - Smart repair

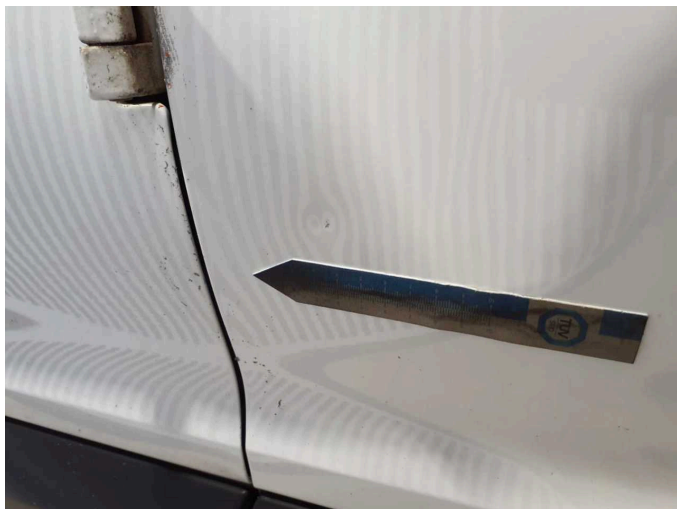
Damage 3: Door - front right side: Door - Dent / paintcoat damage - Smart repair

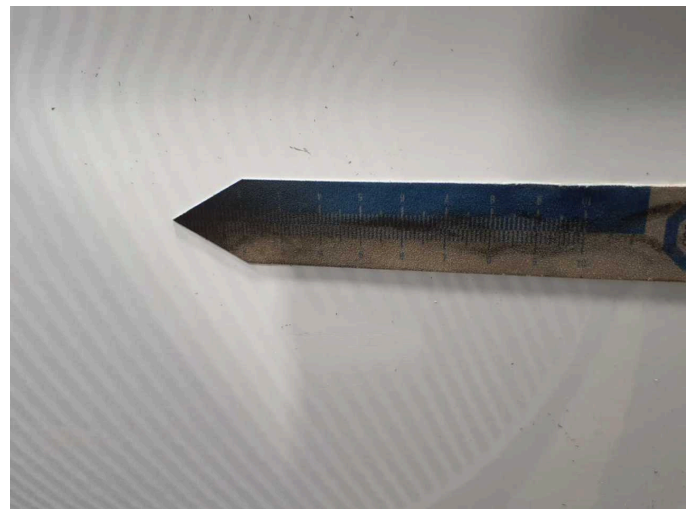
Damage 3: Door - front right side: Door - Dent / paintcoat damage - Smart repair

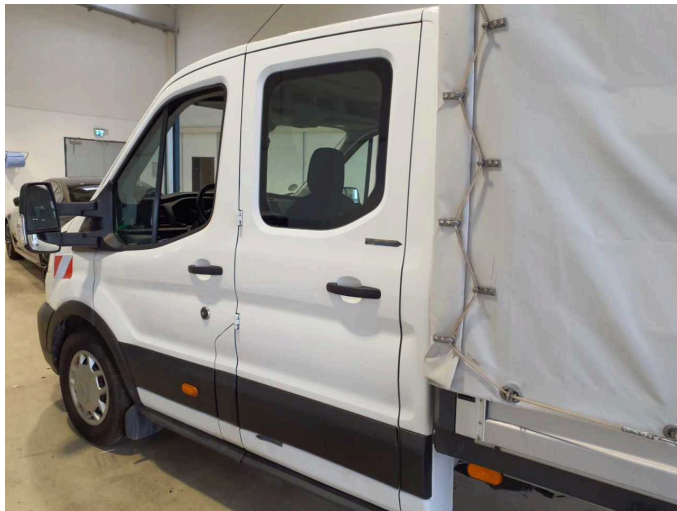
Damage 4: Door - rear left side: Door - Dent / paintcoat damage - Smart repair

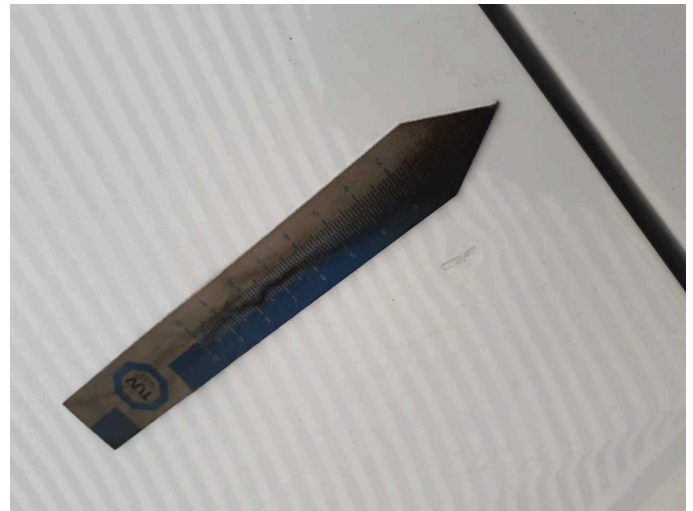
Damage 4: Door - rear left side: Door - Dent / paintcoat damage - Smart repair

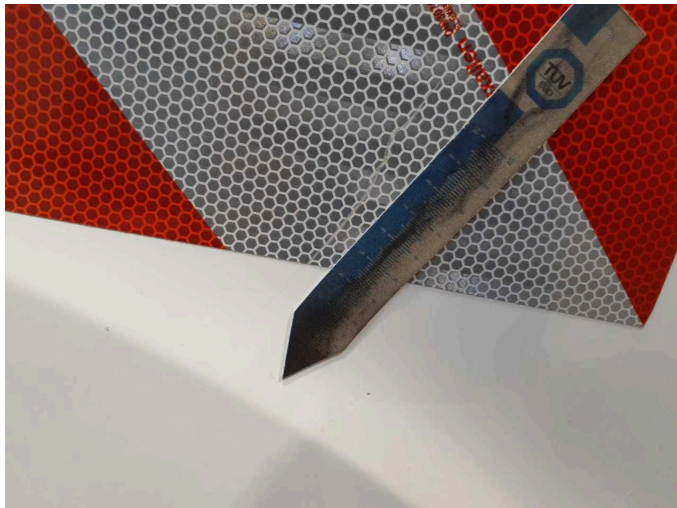
Damage 5: Mudguard - right side: Mudguard - right side - Scratch(es) - Lacquer

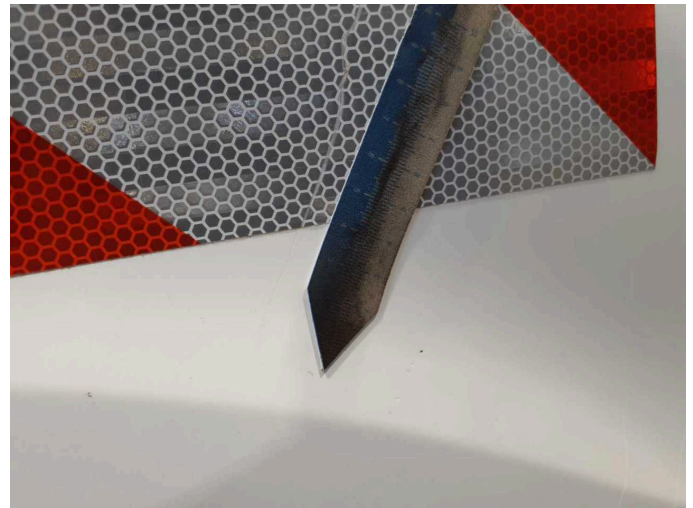
Damage 5: Mudguard - right side: Mudguard - right side - Scratch(es) - Lacquer

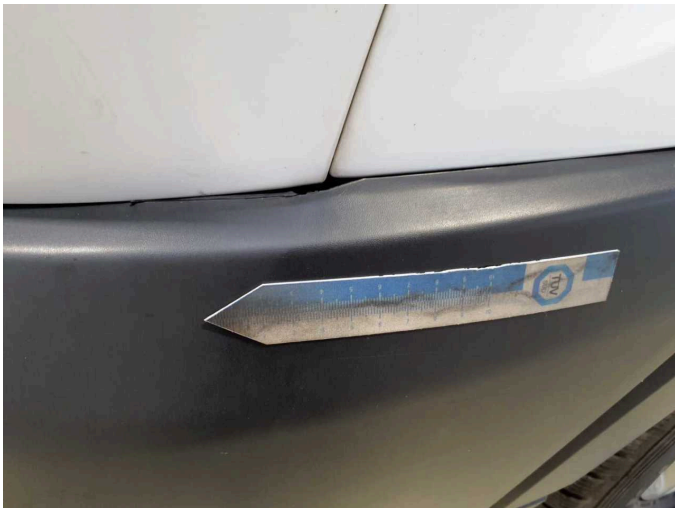
Damage 6: Front bumper: Front bumper (unpainted) - Deformed - Replace

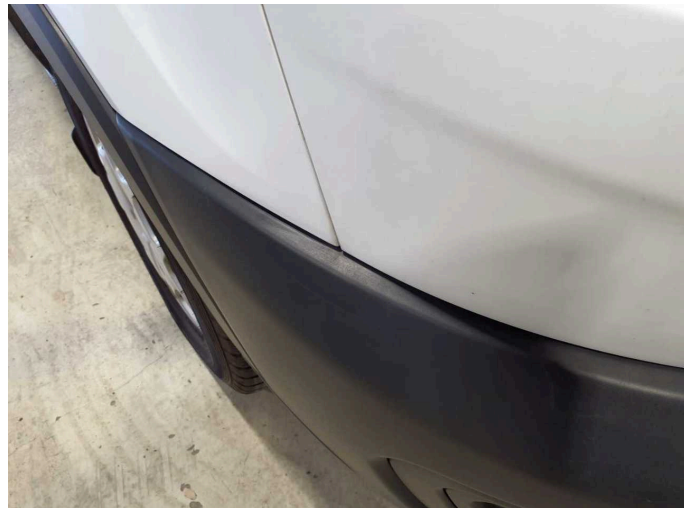
Damage 6: Front bumper: Front bumper (unpainted) - Deformed - Replace

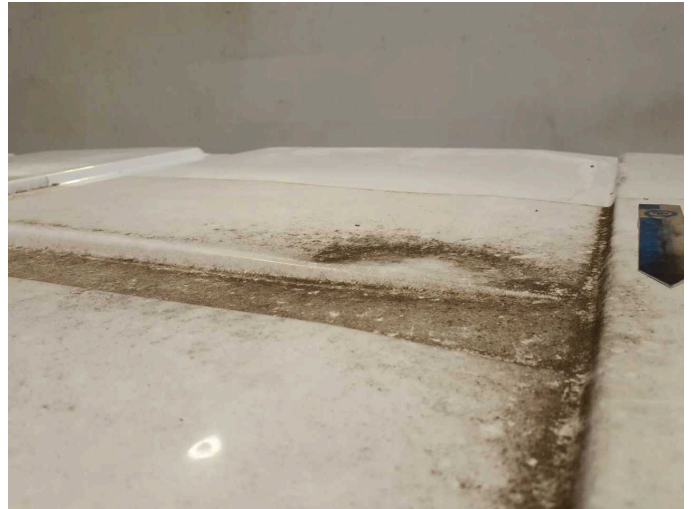
Damage 7: Roof: Roof - Corrosion - Repair and paint

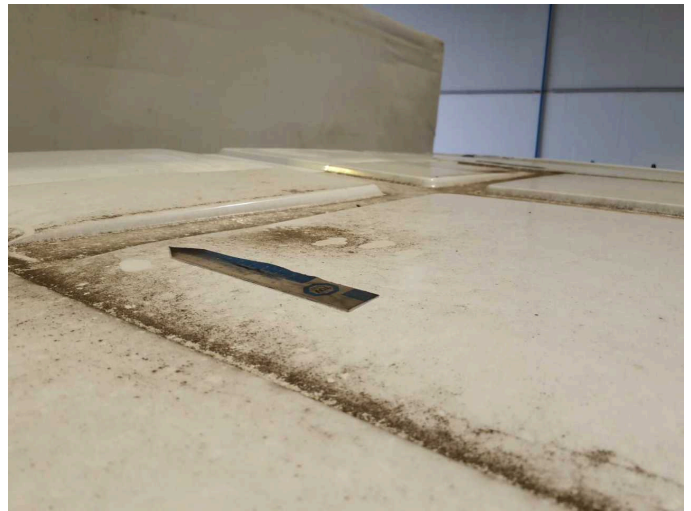
Damage 7: Roof: Roof - Corrosion - Repair and paint

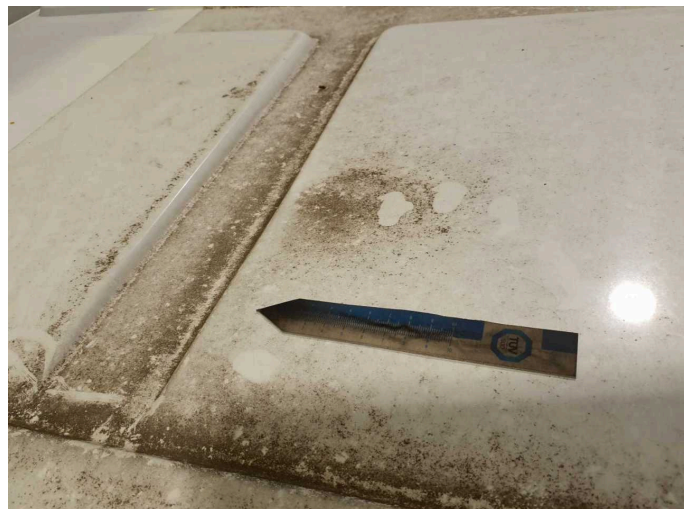
Damage 7: Roof: Roof - Corrosion - Repair and paint
