Expertise

Protocol number: 41635971  
Order No. / Reference: MW2558533-1  
Inspection date: 21 Jul 2025

Manufacturer: Ford

Model: Transit 350 L3 VA Trend

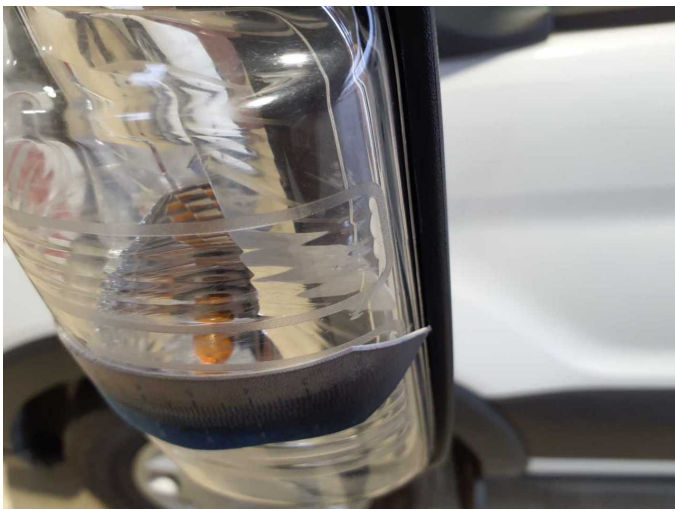
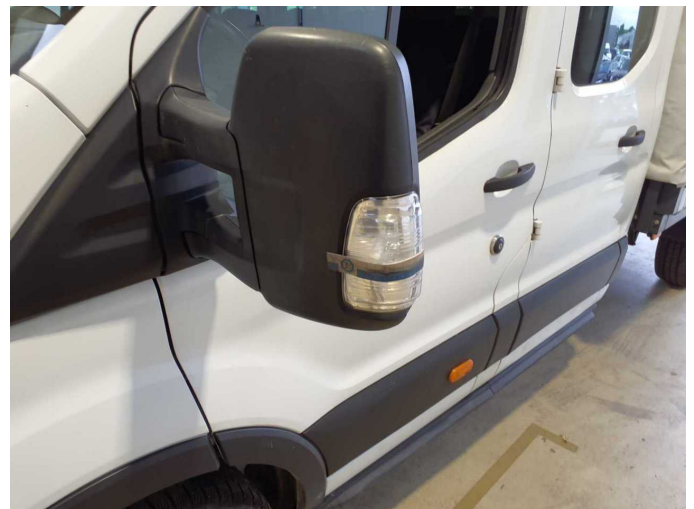
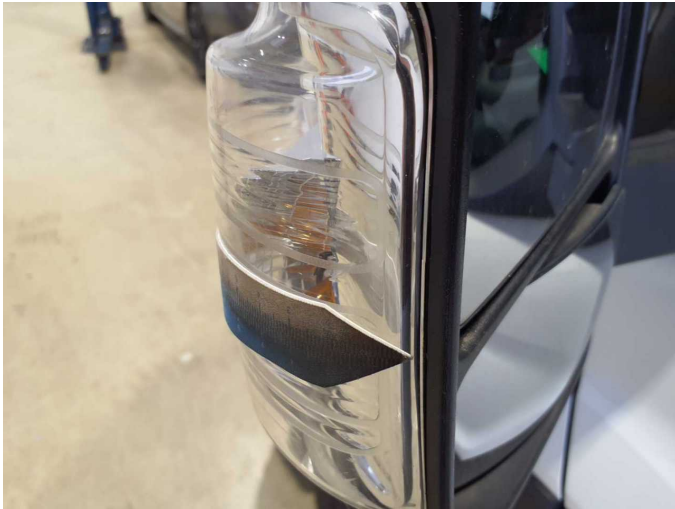
| No. | Component group | Description |
|---|---|---|
| 1 | Indicator - front | Mirror - left side - Scratch(es) - Replace |

Damage 1: Indicator - front: Mirror - left side - Scratch(es) - Replace

**Damage 1:** Indicator - front: Mirror - left side - Scratch(es) - Replace

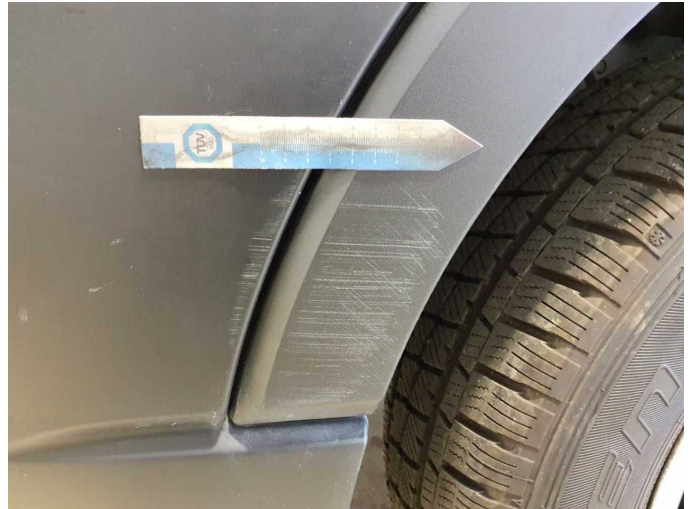
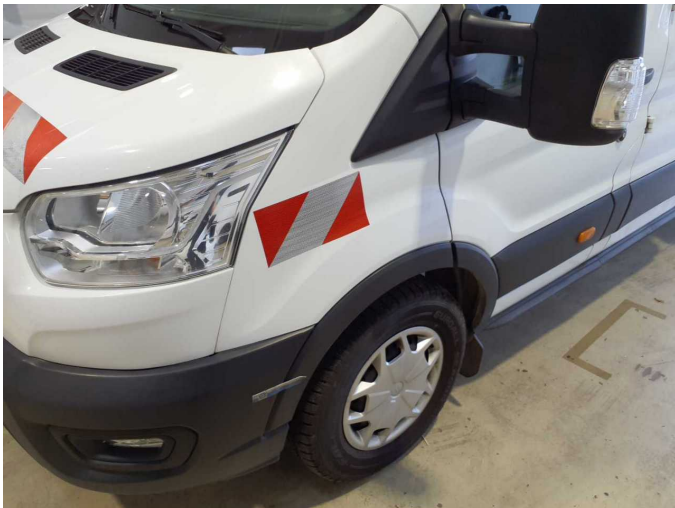
| No. | Component group | Description |
|---|---|---|
| 2 | Mudguard - left side | Wheel well extension - Scratch(es) - Loss in value |

**Damage 2:** Mudguard - left side: Wheel well extension - Scratch(es) - Loss in value

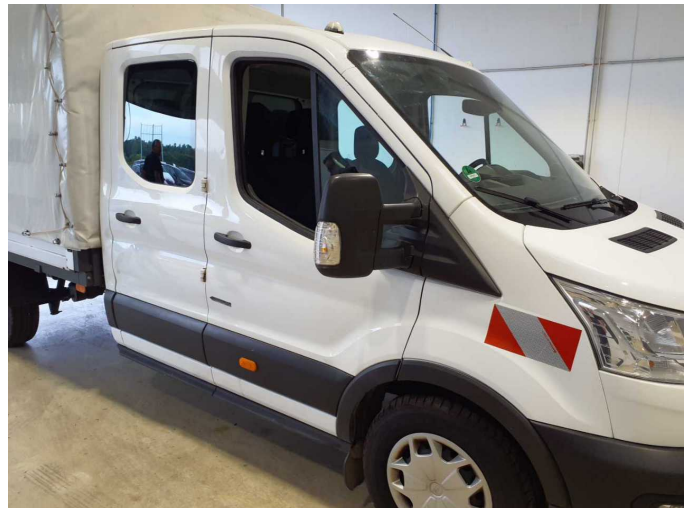
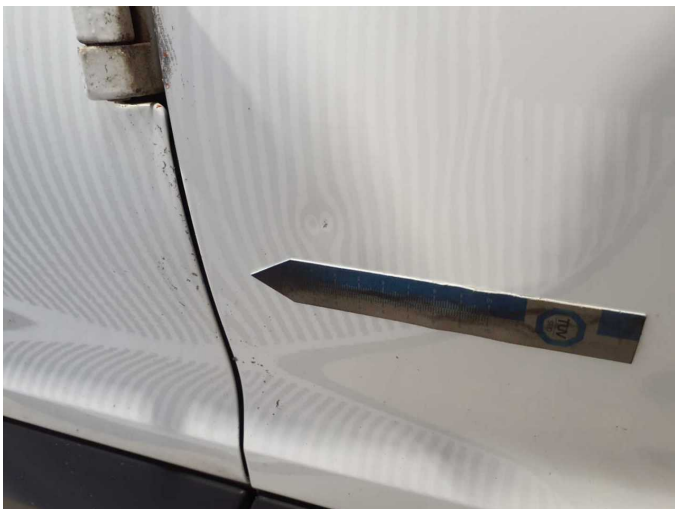
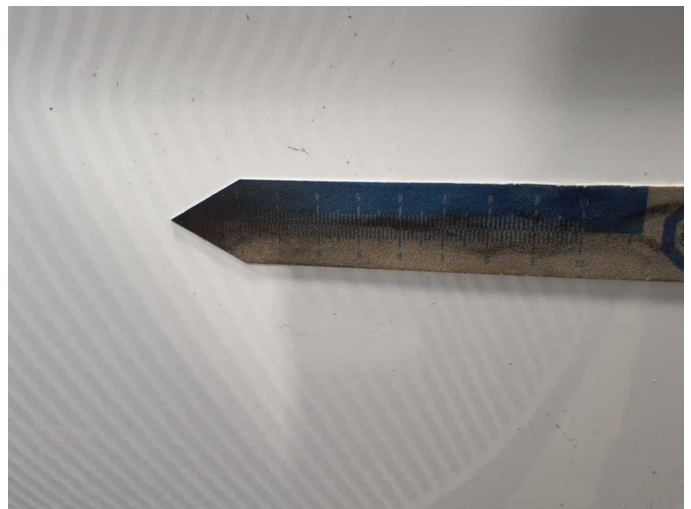
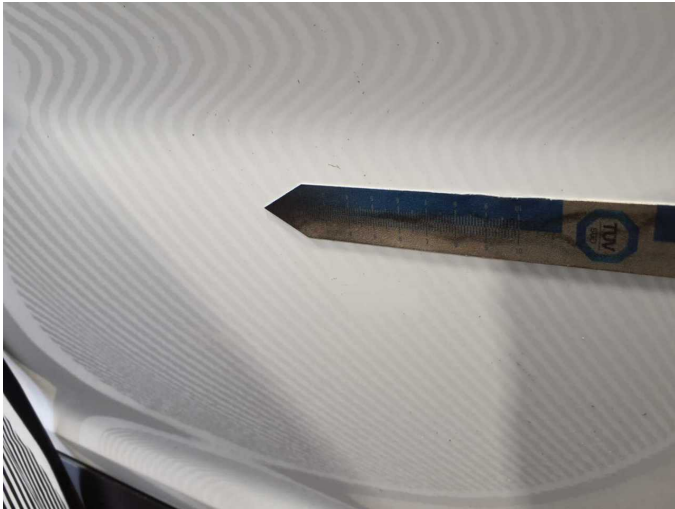
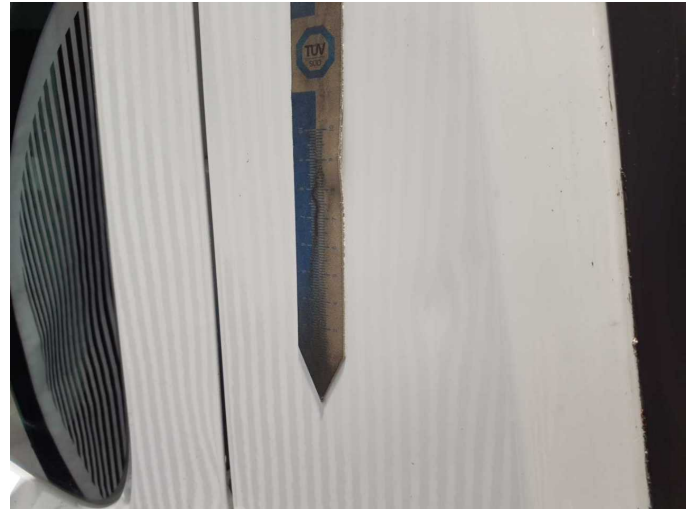
| No. | Component group | Description |
|---|---|---|
| 3 | Door - front right side | Door - Dent / paintcoat damage - Smart repair |

**Damage 3:** Door - front right side: Door - Dent / paintcoat damage - Smart repair

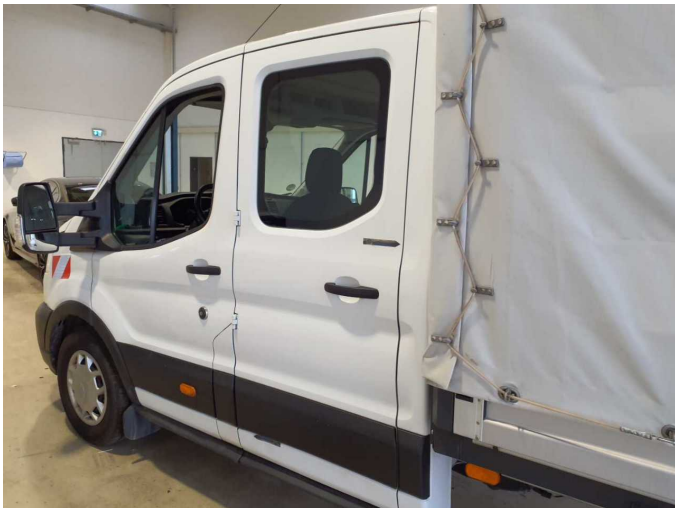
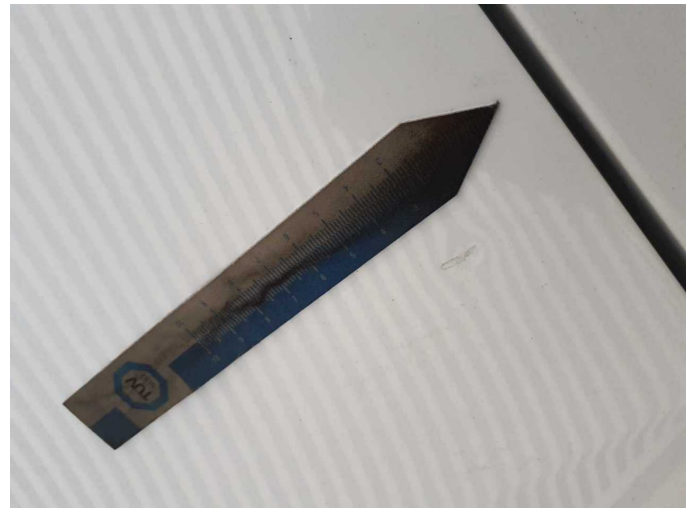
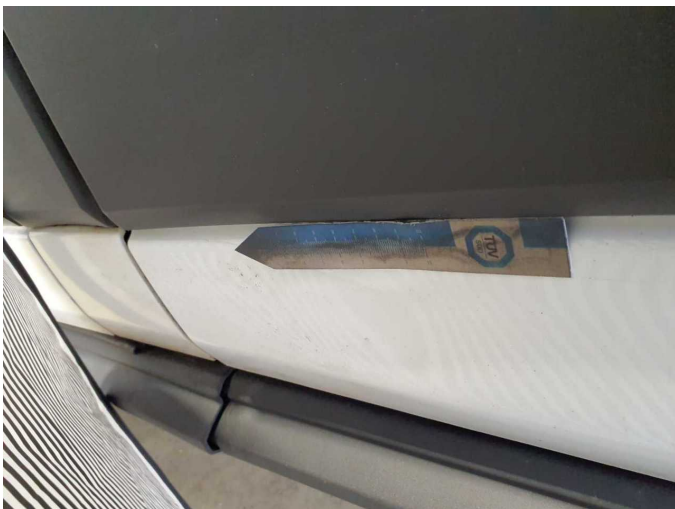
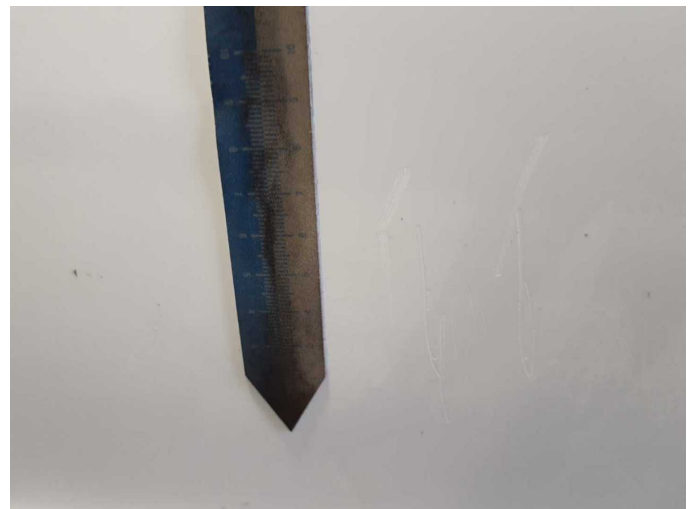
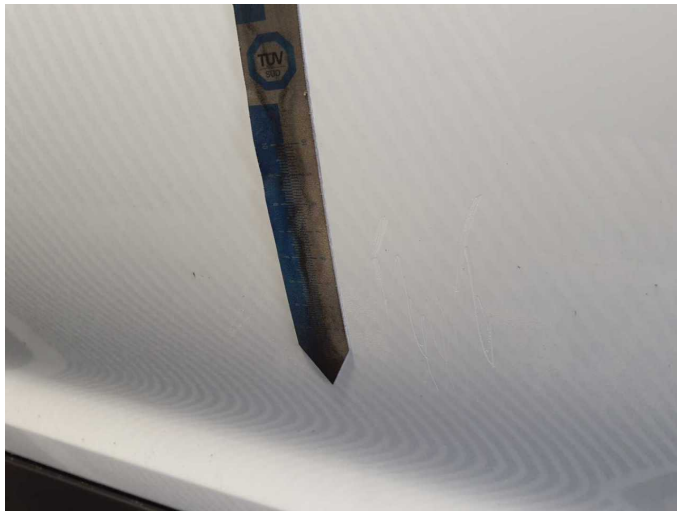
| No. | Component group | Description |
|---|---|---|
| 4 | Door - rear left side | Door - Dent / paintcoat damage - Smart repair |

**Damage 4:** Door - rear left side: Door - Dent / paintcoat damage - Smart repair

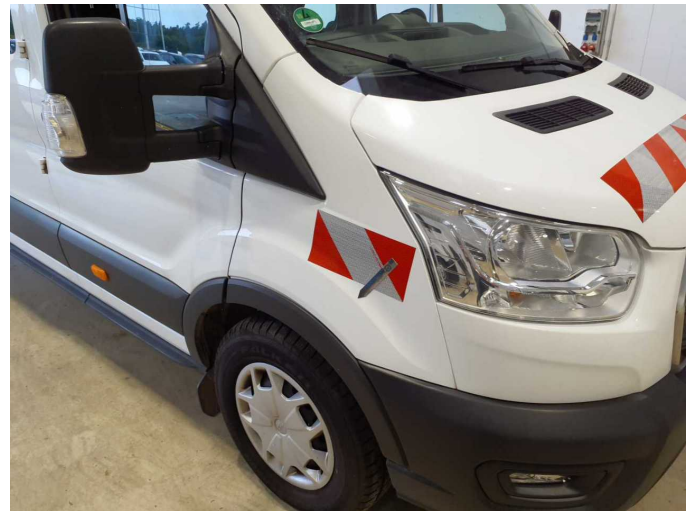
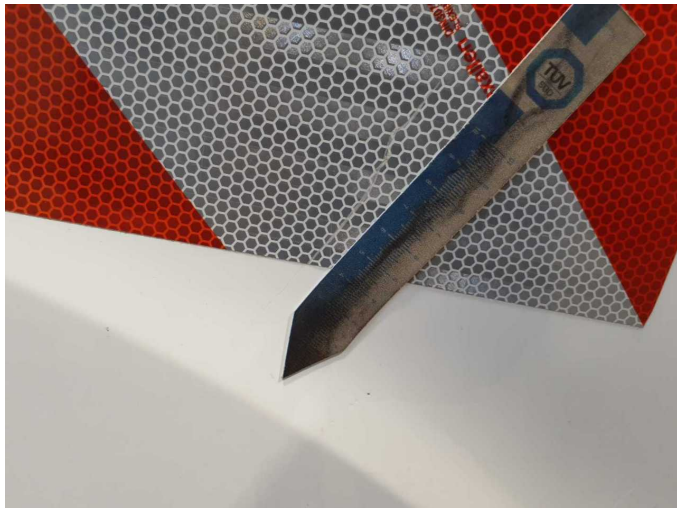
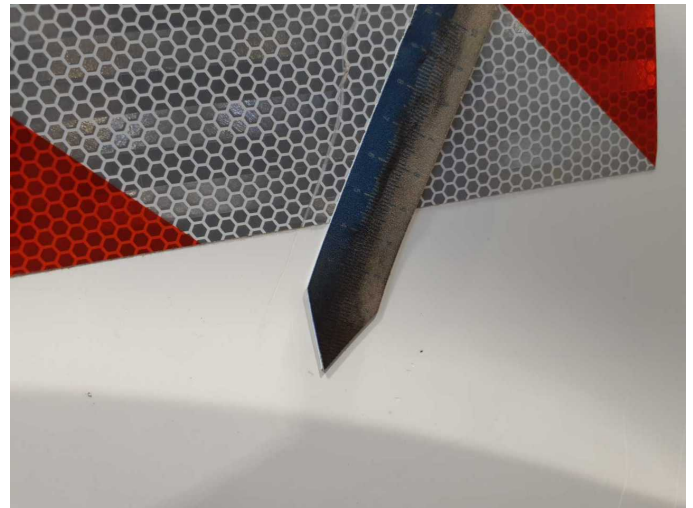
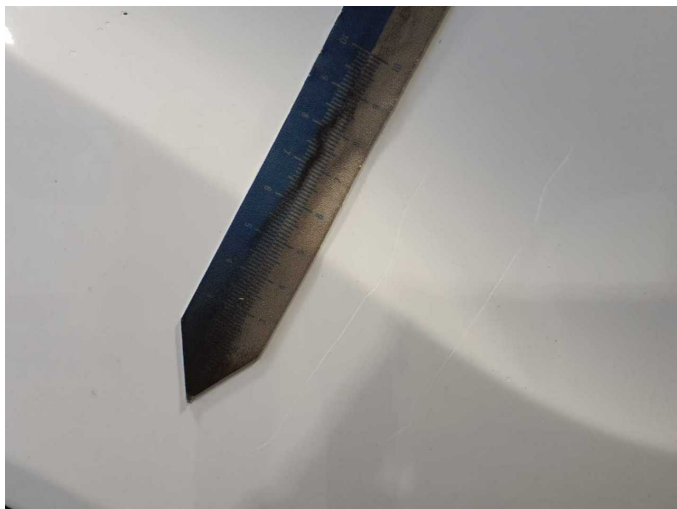
| No. | Component group | Description |
|---|---|---|
| 5 | Mudguard - right side | Mudguard - right side - Scratch(es) - Lacquer |

**Damage 5:** Mudguard - right side: Mudguard - right side - Scratch(es) - Lacquer

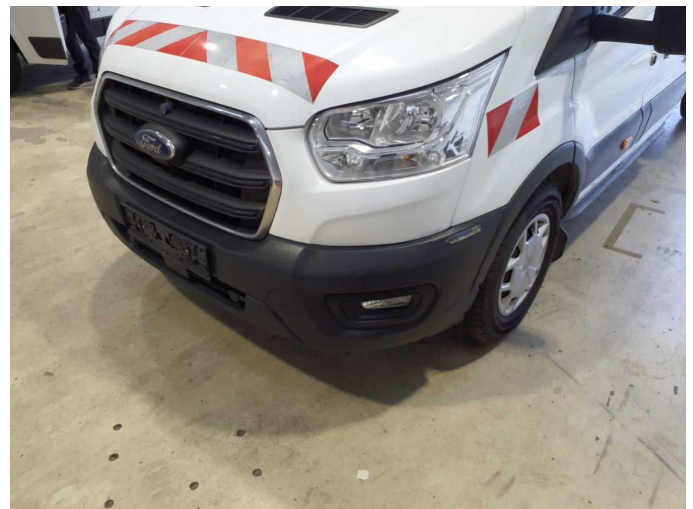
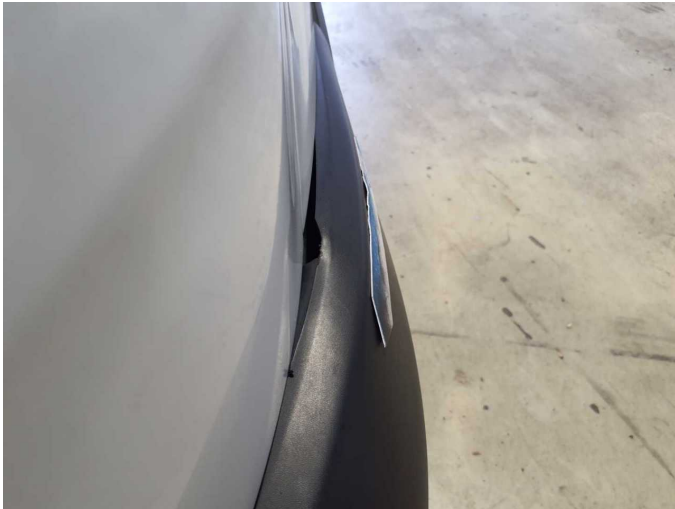
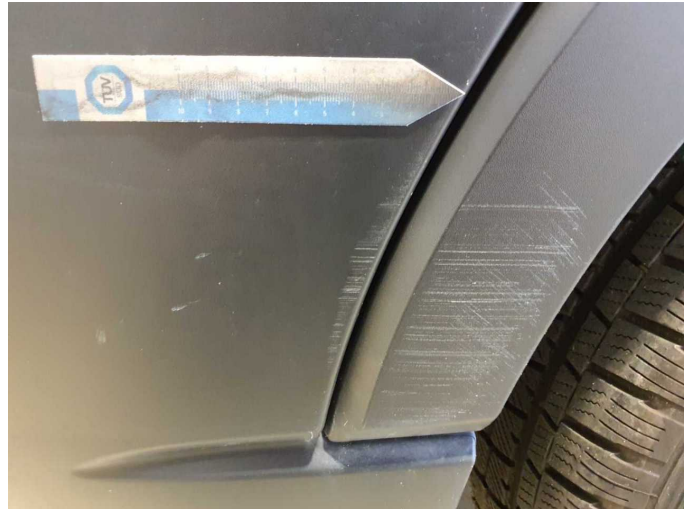
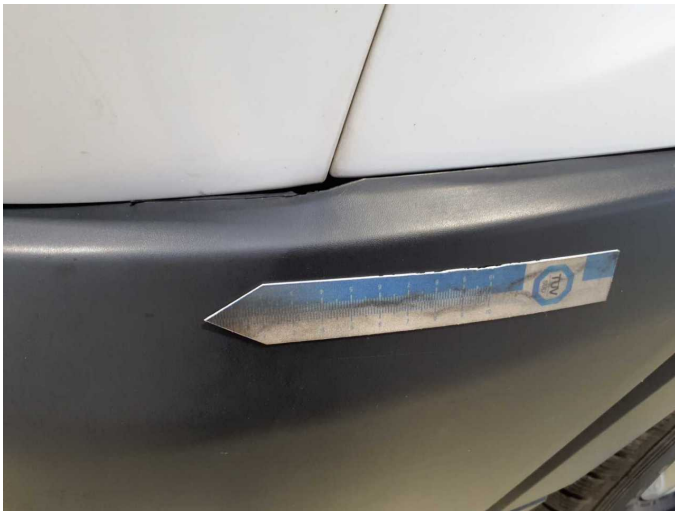
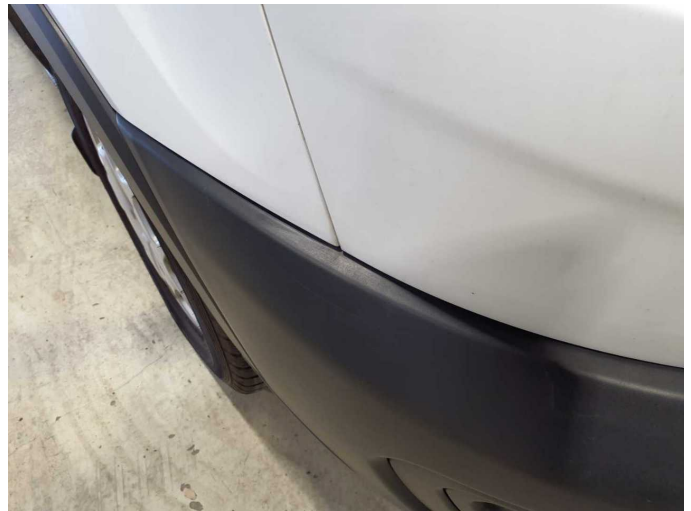
| No. | Component group | Description |
|---|---|---|
| 6 | Front bumper | Front bumper (unpainted) - Deformed - Replace |

**Damage 6:** Front bumper: Front bumper (unpainted) - Deformed - Replace

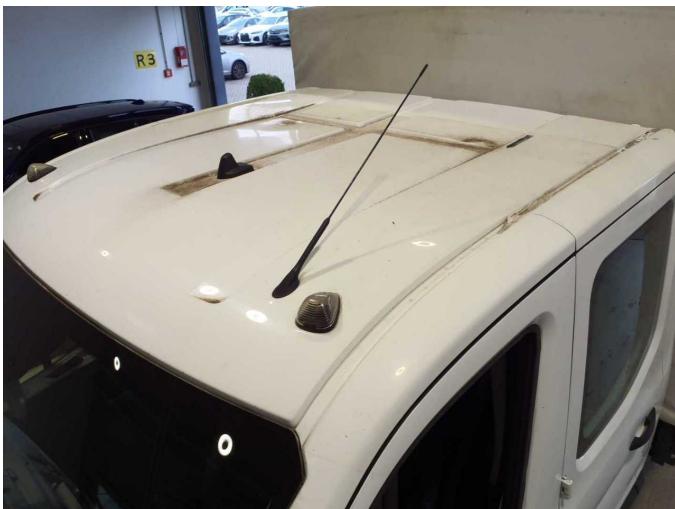
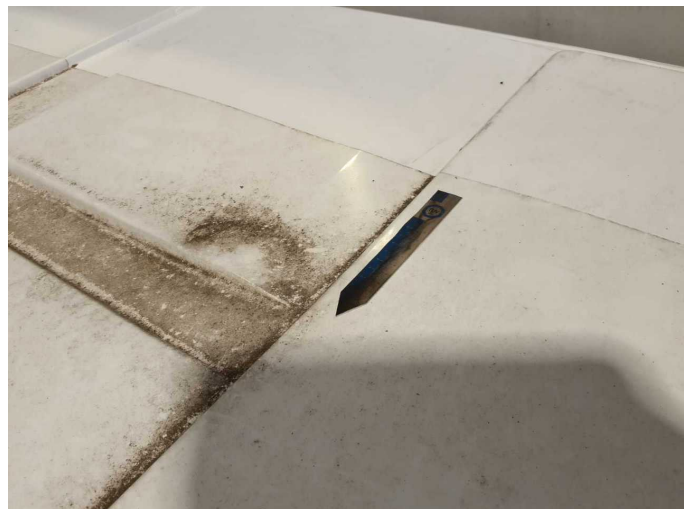
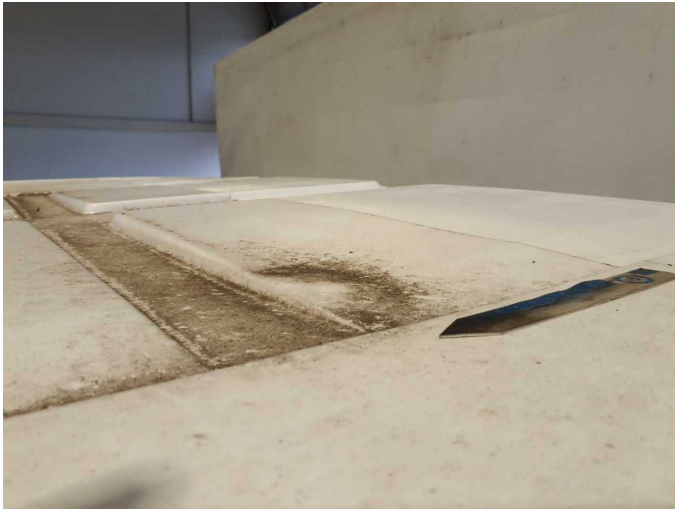
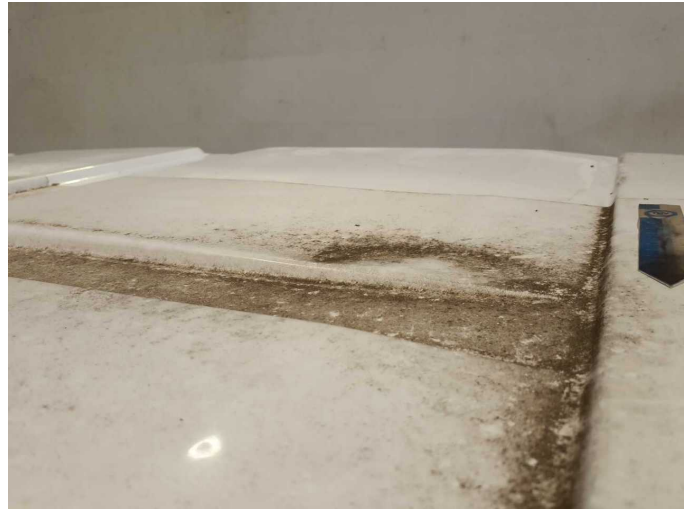
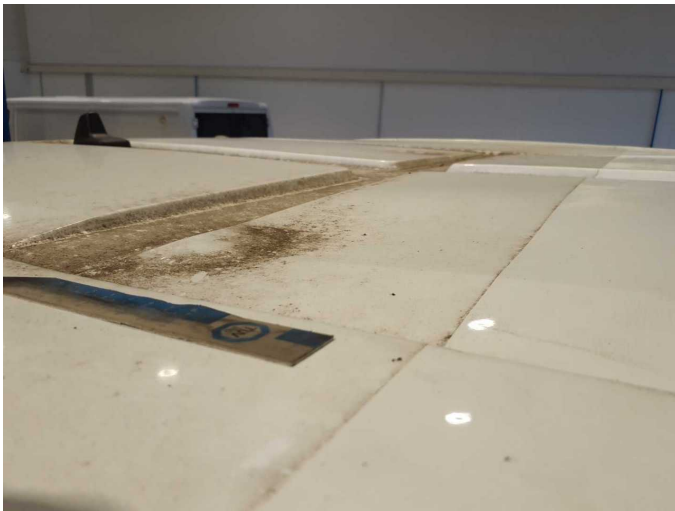
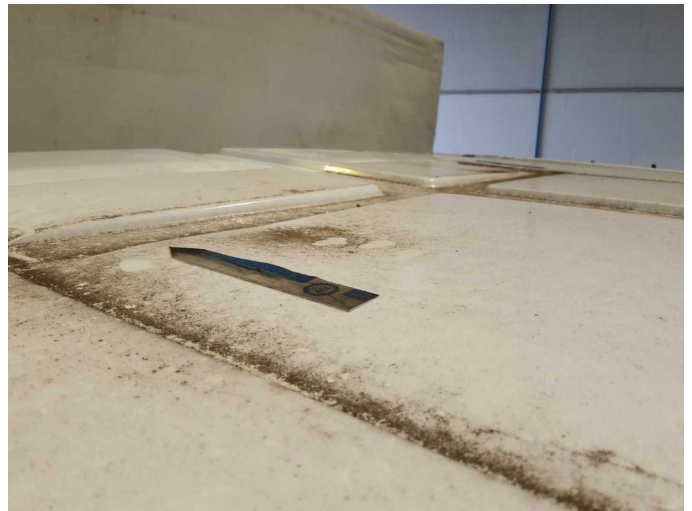
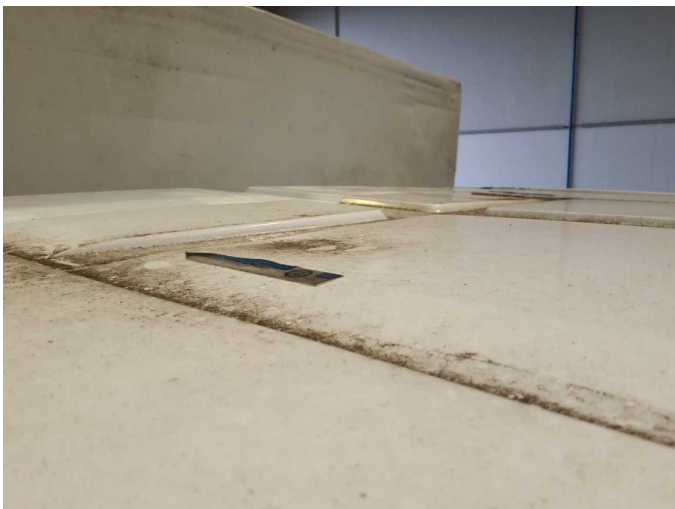
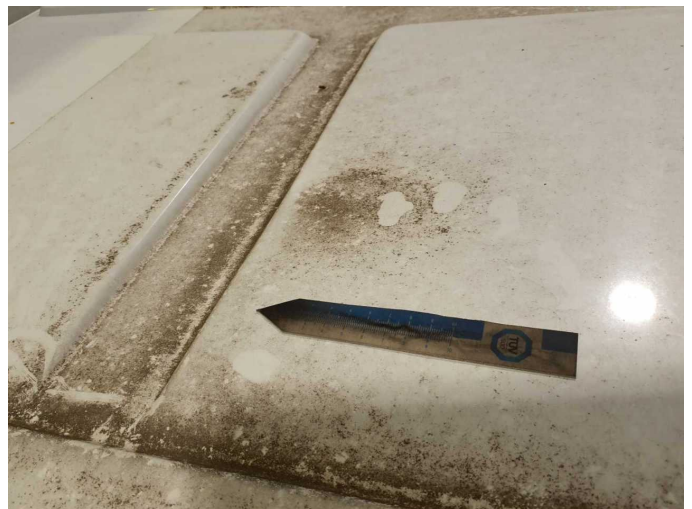
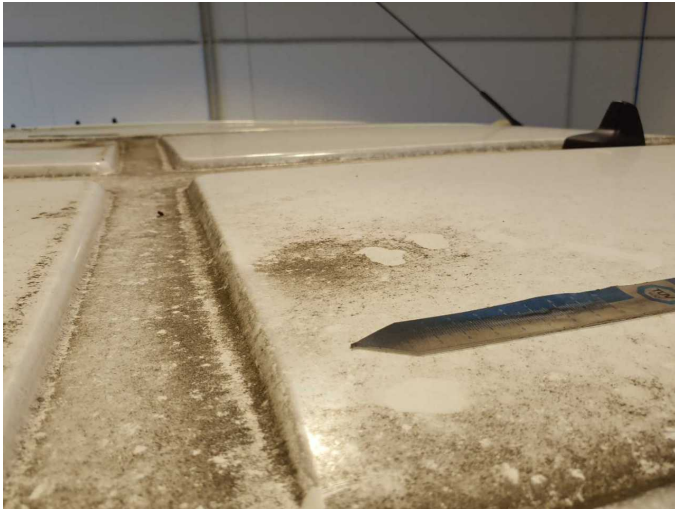
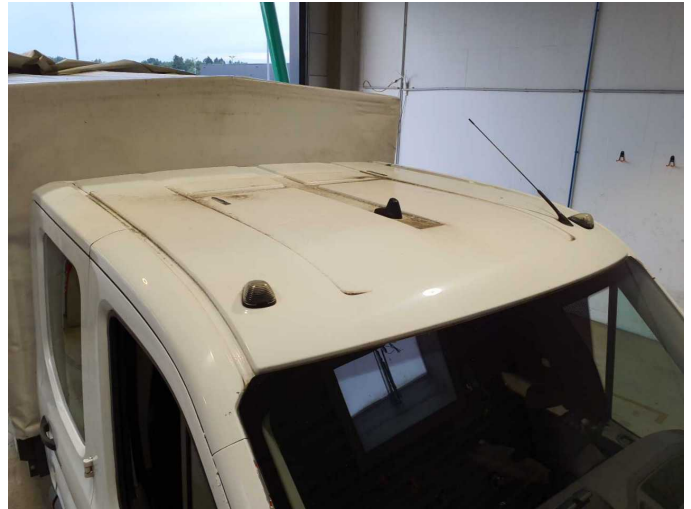
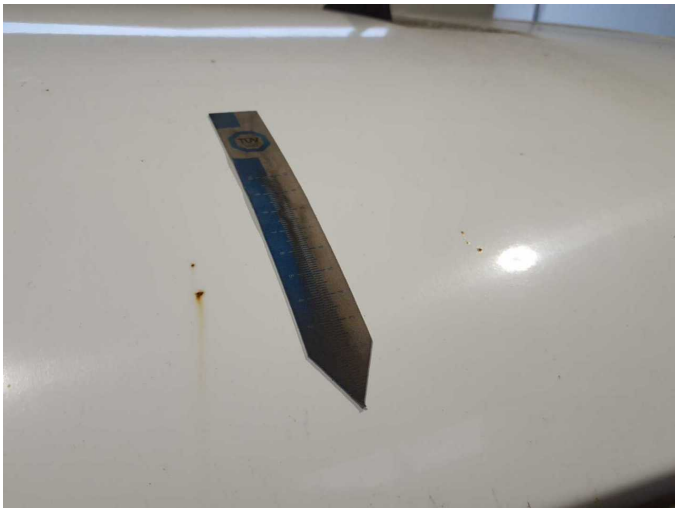
| No. | Component group | Description |
|---|---|---|
| 7 | Roof | Roof - Corrosion - Repair and paint |

**Damage 7:** Roof: Roof - Corrosion - Repair and paint

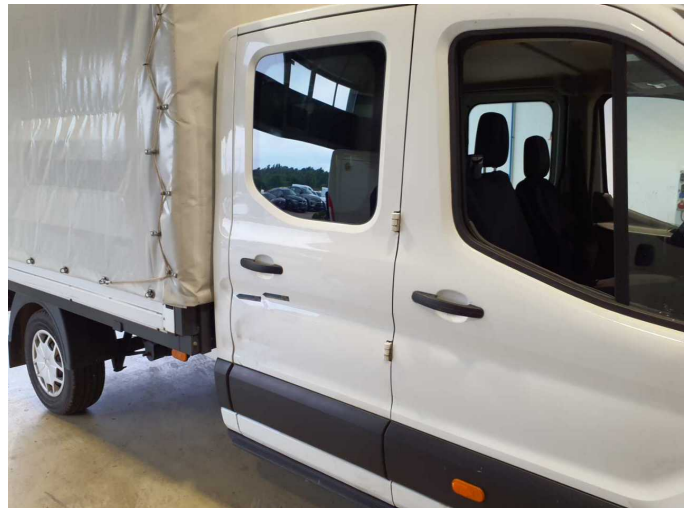
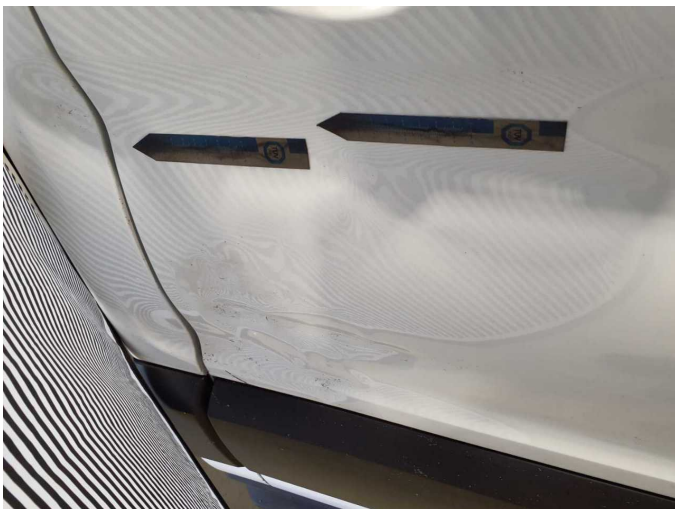
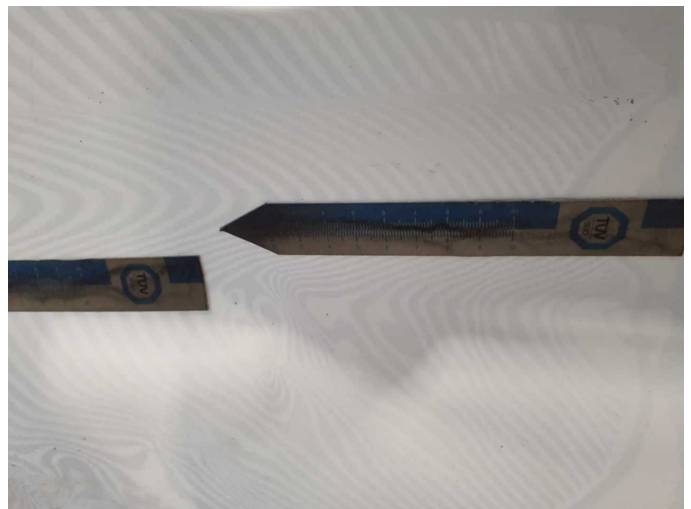
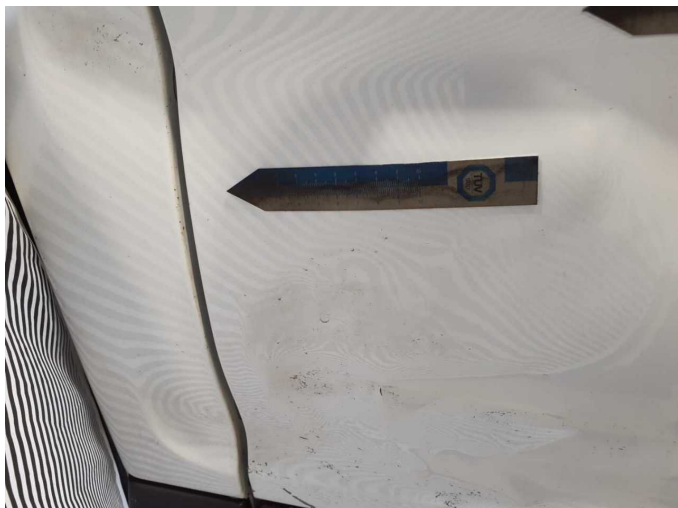
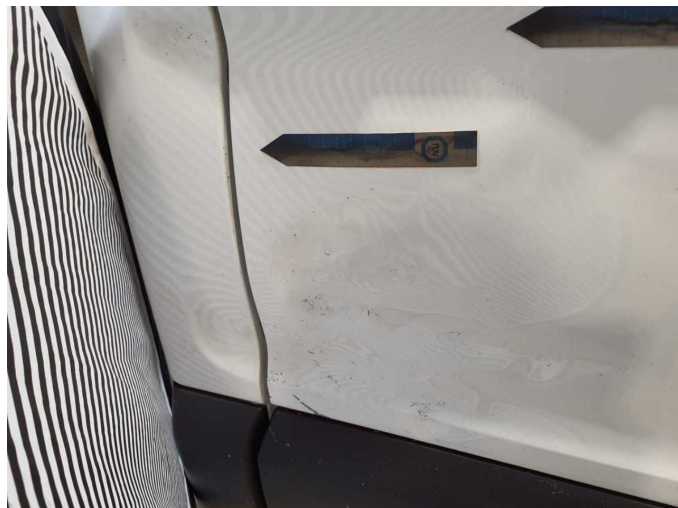
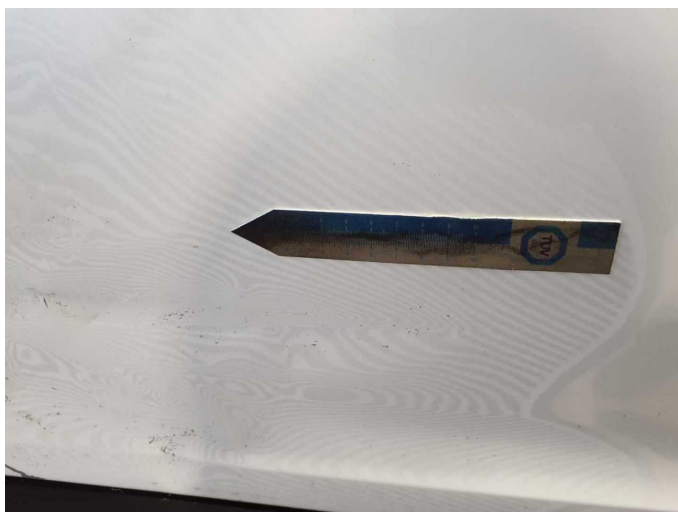
| No. | Component group | Description |
|---|---|---|
| 8 | Door - rear right side | Door (Außenblech) - Deformed - Replace |

**Damage 8:** Door - rear right side: Door (Außenblech) - Deformed - Replace
