Expertise

Protocol number: 41565907  
Order No. / Reference: 25137373  
Inspection date: 12 Sept 2025

Manufacturer: Ford

Model: Transit 350 L4 Einzelkabine Trend Koffer LBW

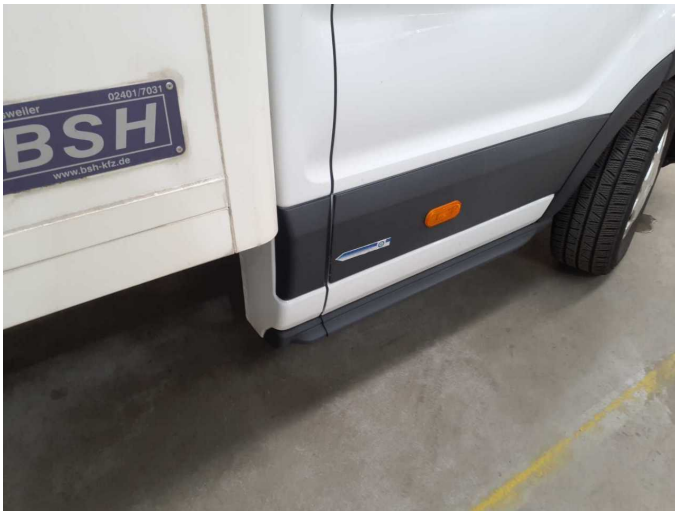
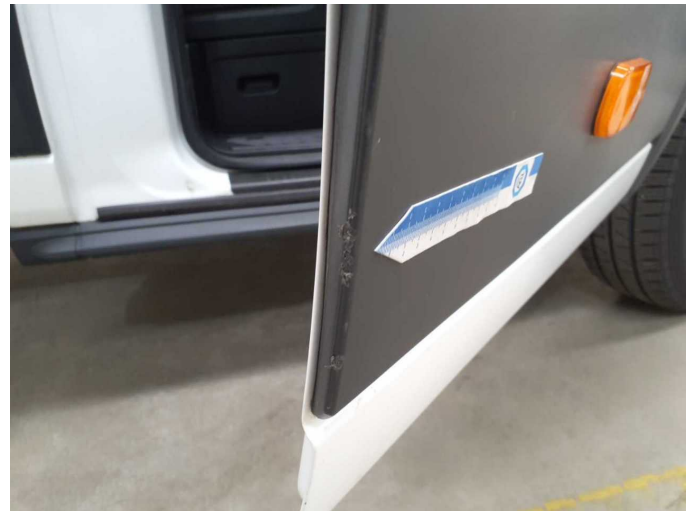
| No. | Component group | Description |
|---|---|---|
| 2 | Door - front right side | Brightware - lower - Scratched - Loss in value |

**Damage 2:** Door - front right side: Brightware - lower - Scratched - Loss in value

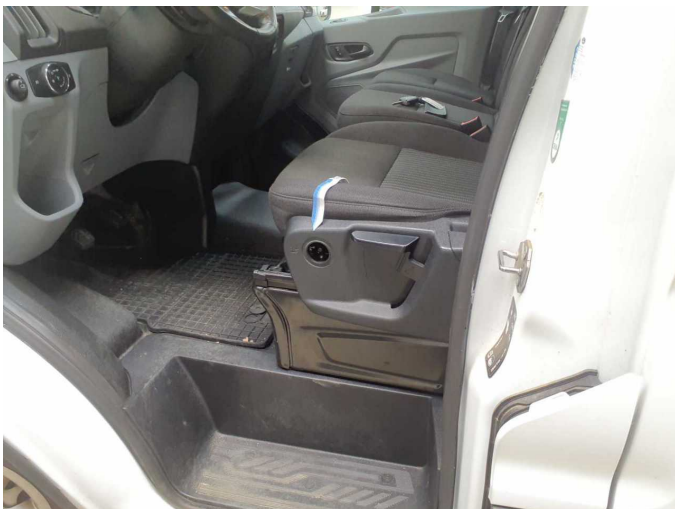
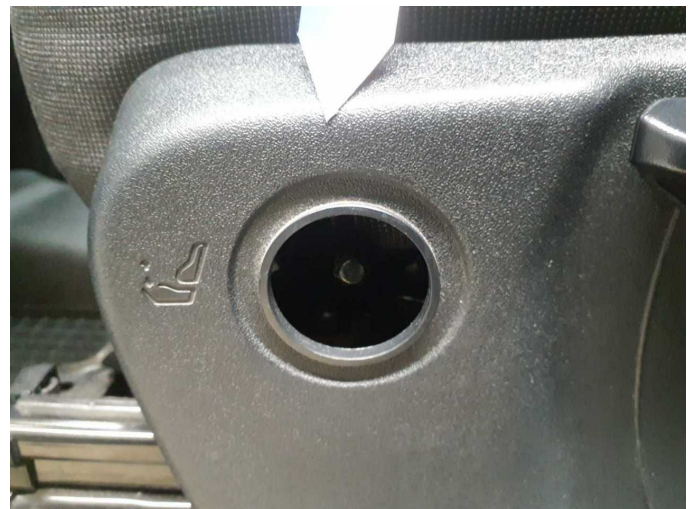
| No. | Component group | Description |
|---|---|---|
| 3 | Seat - front | Seat base trim - left side (Blende Sitzverstellung) - Missing - Replace |

**Damage 3:** Seat - front: Seat base trim - left side (Blende Sitzverstellung) - Missing - Replace

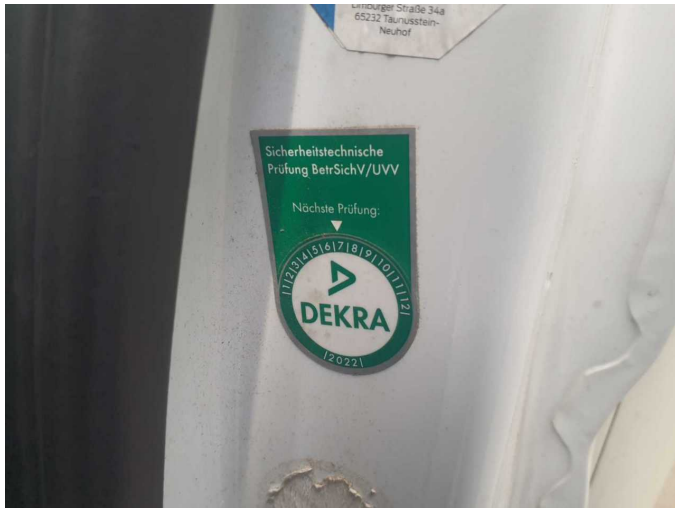
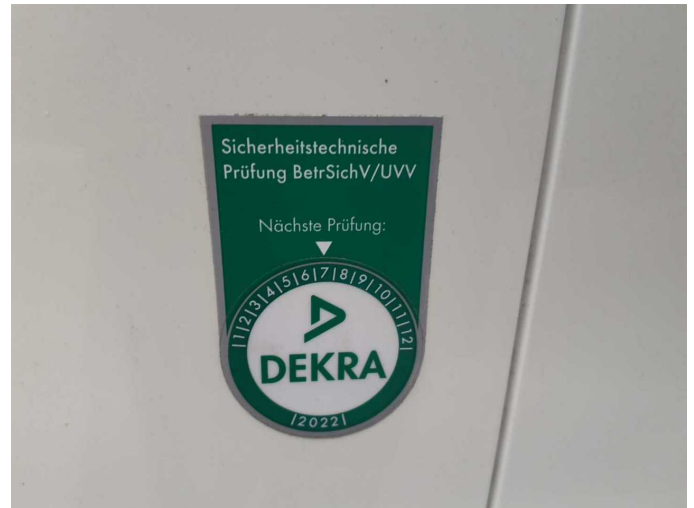
| No. | Component group | Description |
|---|---|---|
| 4 | Misc. | Accident prevention regulations tail lift - Expired - Perform |

**Damage 4:** Misc.: Accident prevention regulations tail lift - Expired - Perform

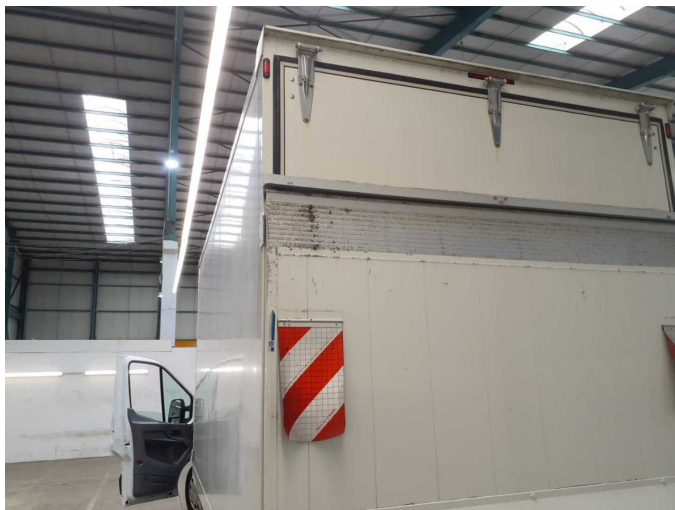
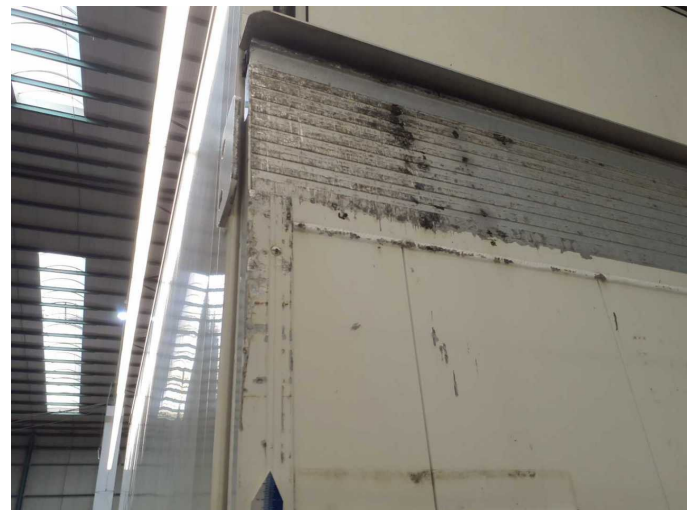
| No. | Component group | Description |
|---|---|---|
| 5 | Boot lid / rear door | Boot lid (LBW Korrosionsschutz erforderlich) - Scratched - Smart repair |

**Damage 5:** Boot lid / rear door: Boot lid (LBW Korrosionsschutz erforderlich) - Scratched - Smart repair

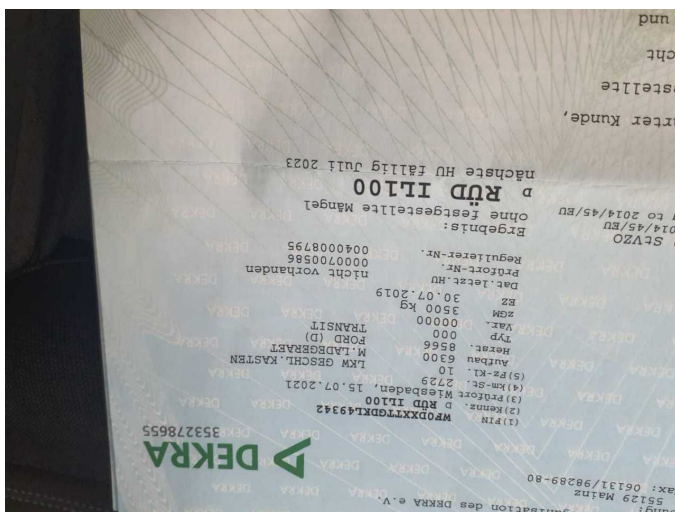
| No. | Component group | Description |
|---|---|---|
| 6 | Misc. | Main inspection - Due - Perform |

**Damage 6:** Misc.: Main inspection - Due - Perform

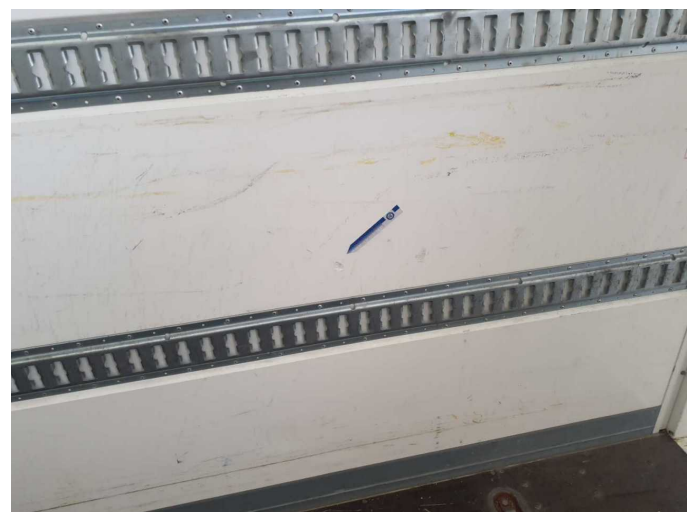
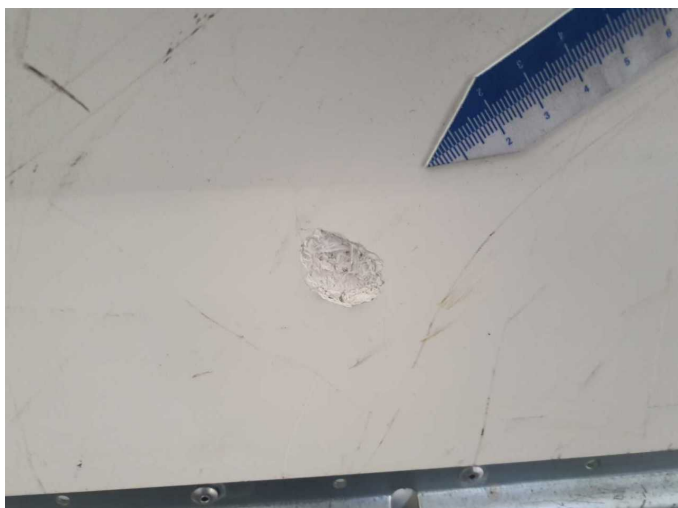
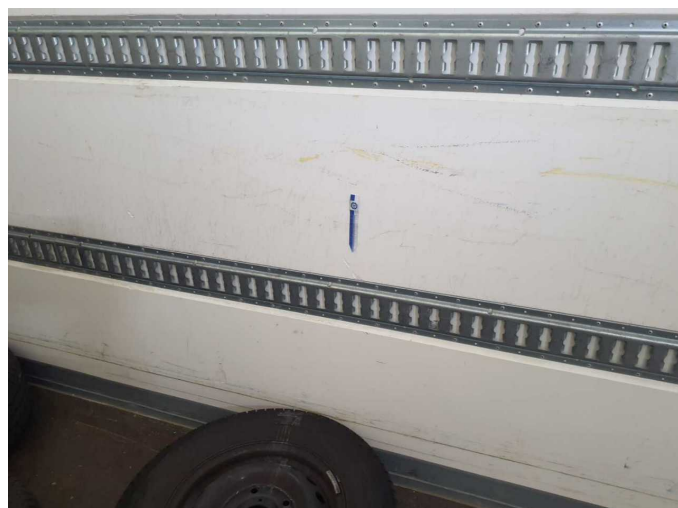
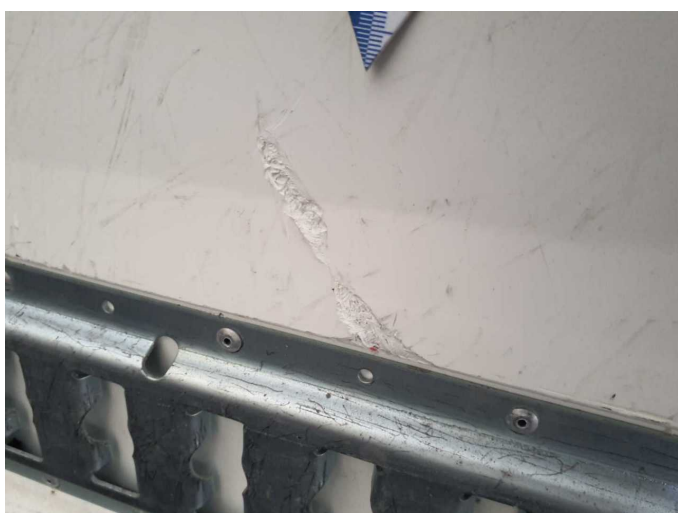
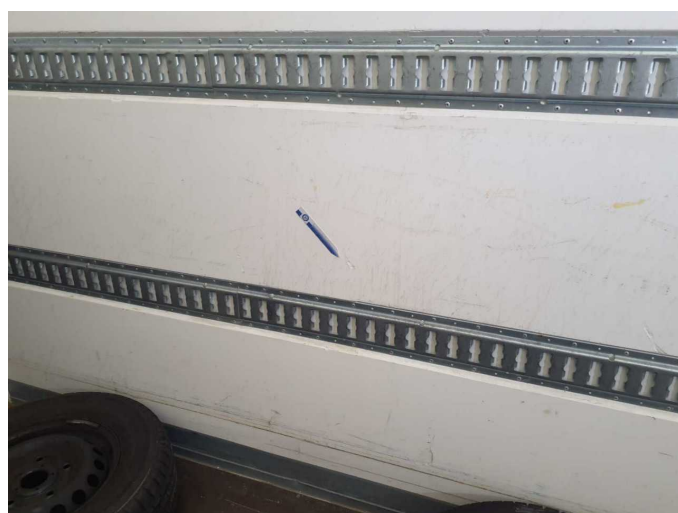
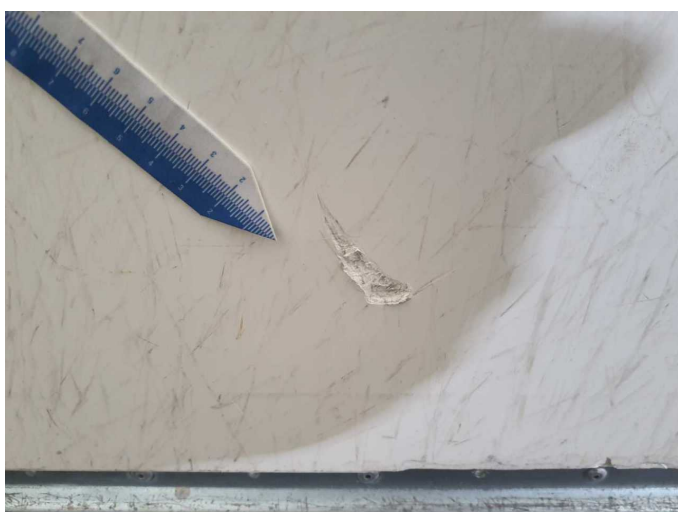
| No. | Component group | Description |
|---|---|---|
| 7 | Trim / covers | Cargo area - lining - right side - Scratched - Smart repair |

**Damage 7:** Trim / covers: Cargo area - lining - right side - Scratched - Smart repair

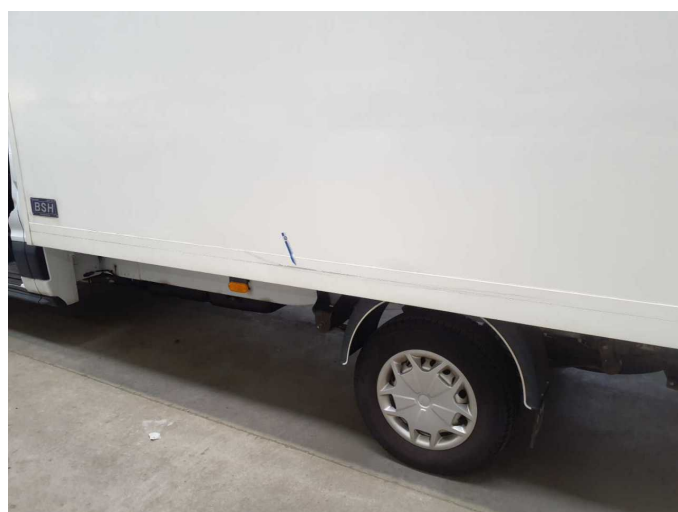
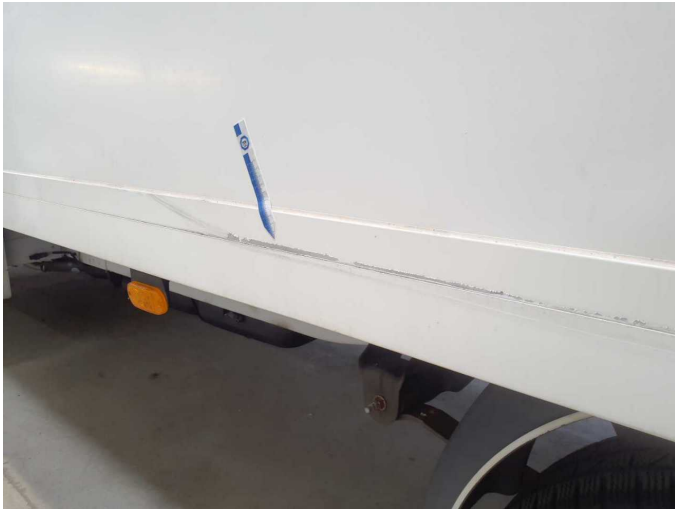
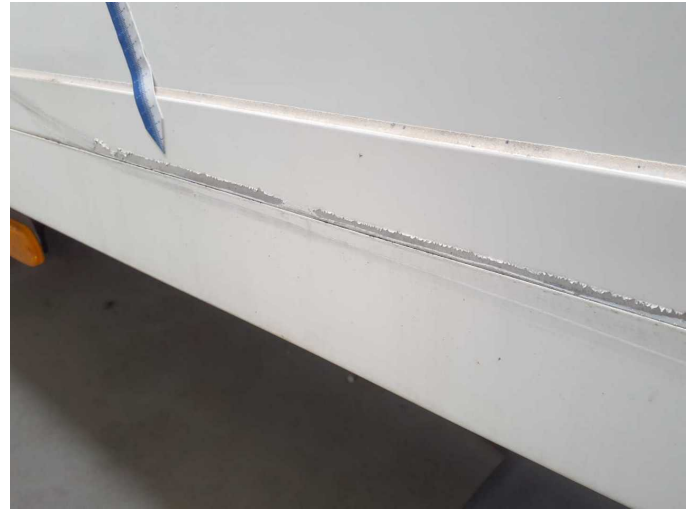
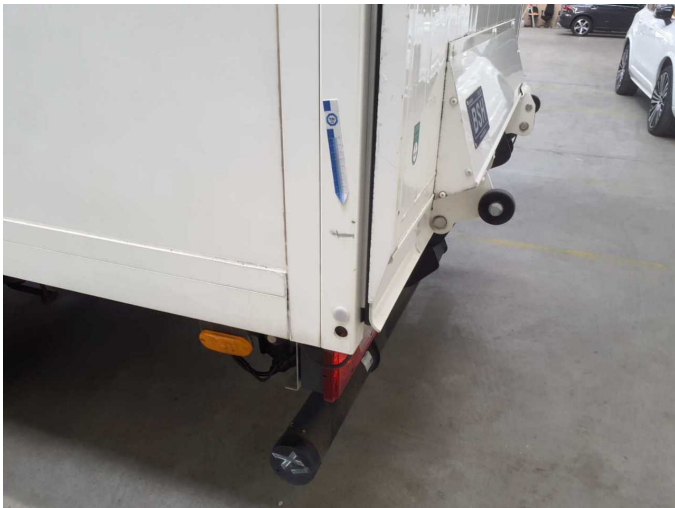
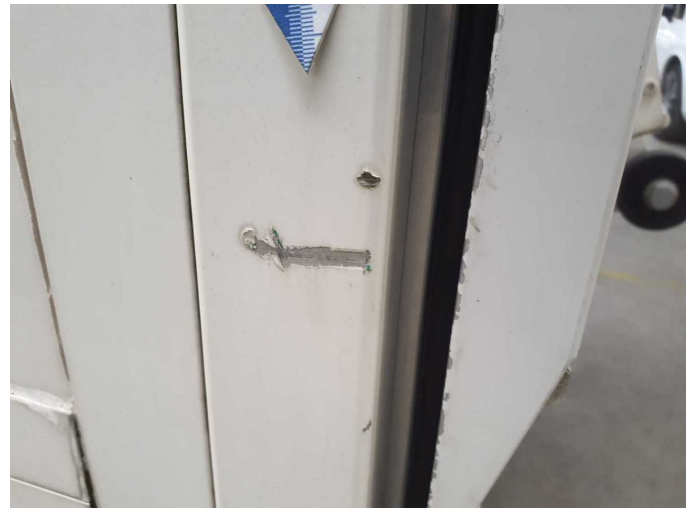
| No. | Component group | Description |
|---|---|---|
| 8 | Side panel - rear left side | Side panel (Kofferaufbau inkl. Portalrahmen) - Scratched - Paint |

**Damage 8:** Side panel - rear left side: Side panel (Kofferaufbau inkl. Portalrahmen) - Scratched - Paint

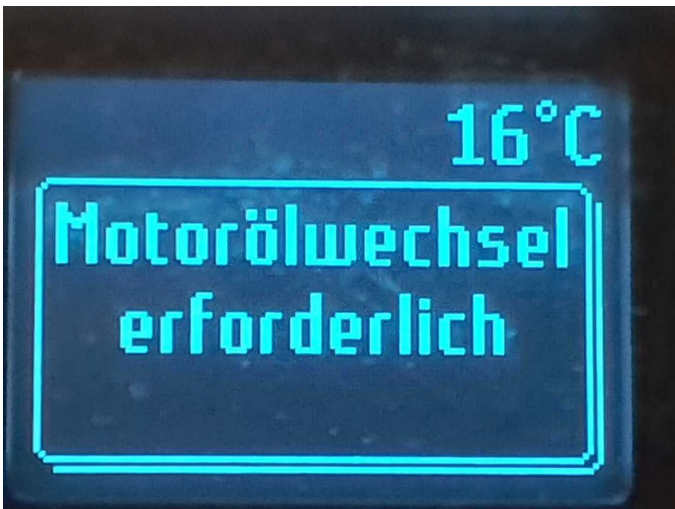
| No. | Component group | Description |
|---|---|---|
| 9 | Misc. | Inspection / maintenance - Due - Perform |

**Damage 9:** Misc.: Inspection / maintenance - Due - Perform

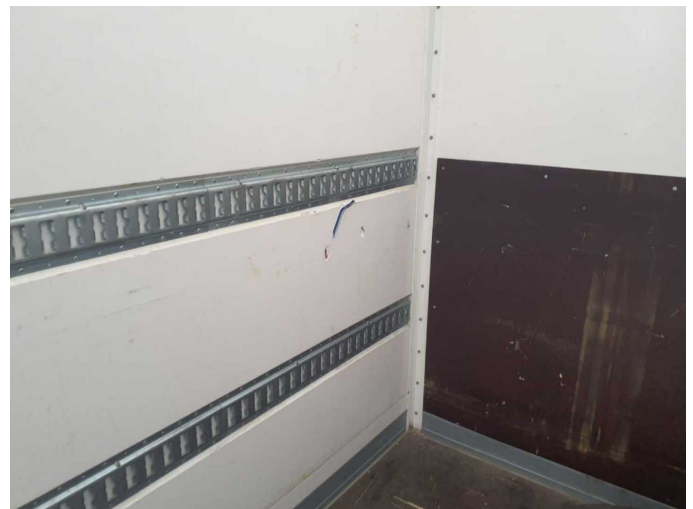
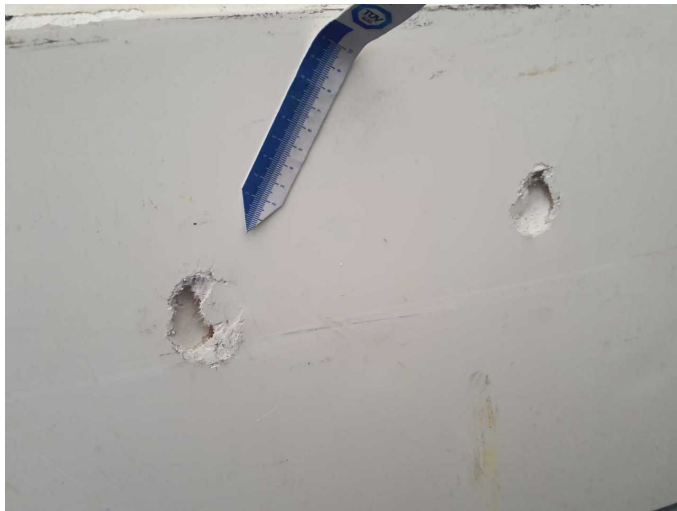
| No. | Component group | Description |
|---|---|---|
| 10 | Trim / covers | Cargo area - lining -left side (Teilersatz) - Broken / torn - Repair |

**Damage 10:** Trim / covers: Cargo area - lining -left side (Teilersatz) - Broken / torn - Repair

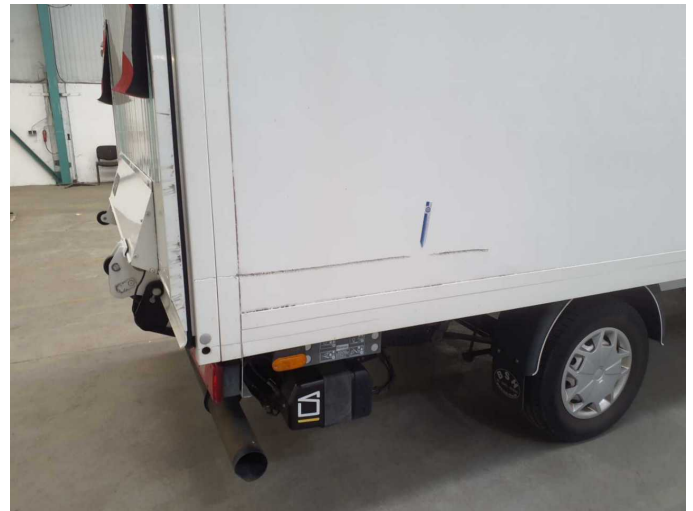
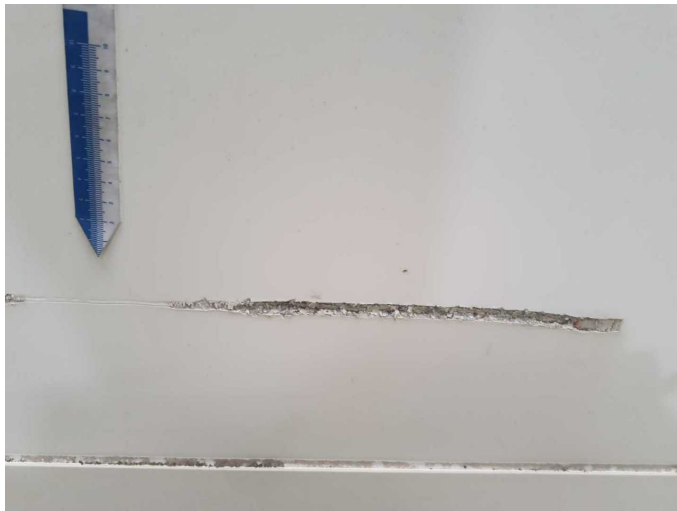
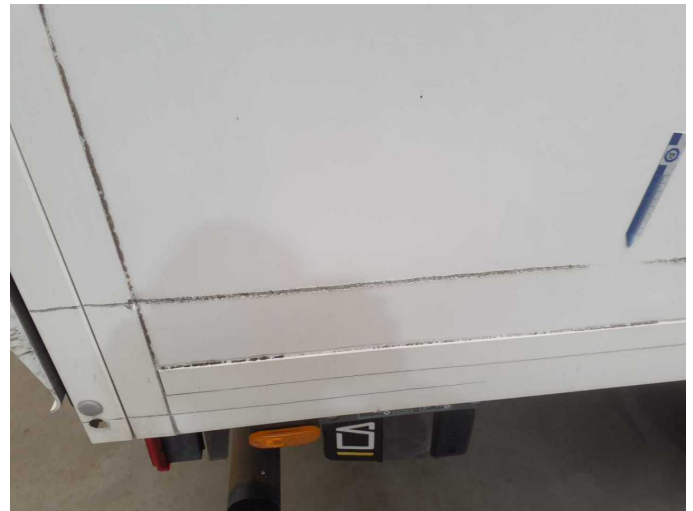
| No. | Component group | Description |
|---|---|---|
| 11 | Side panel - rear right side | Side panel (Kofferrwand inkl. Portalrahmen hinten) - Scratched - Repair and paint |

**Damage 11:** Side panel - rear right side: Side panel (Kofferwand inkl. Portalrahmen hinten) - Scratched - Repair and paint

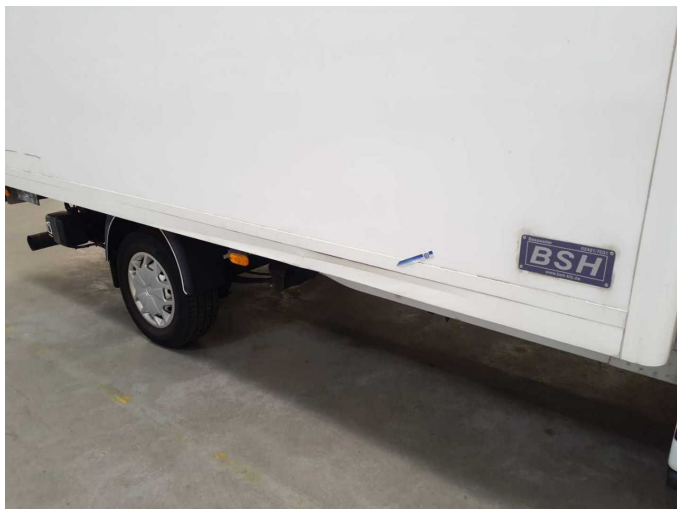
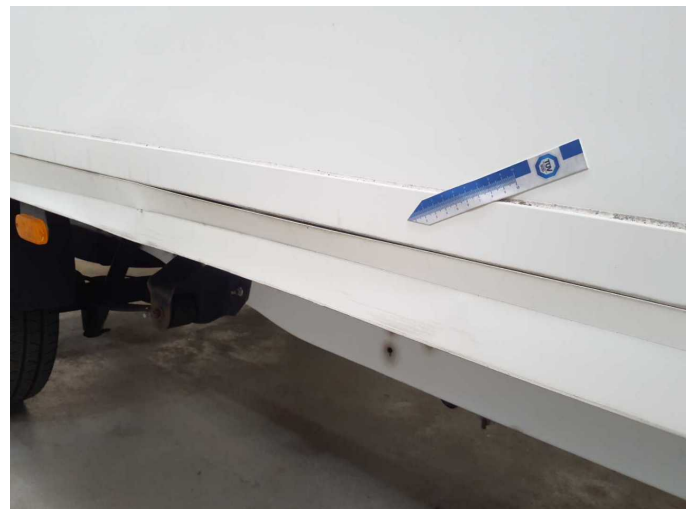
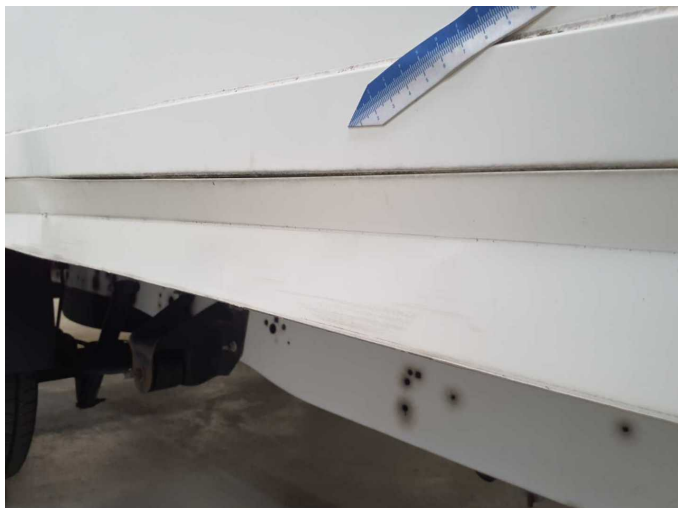
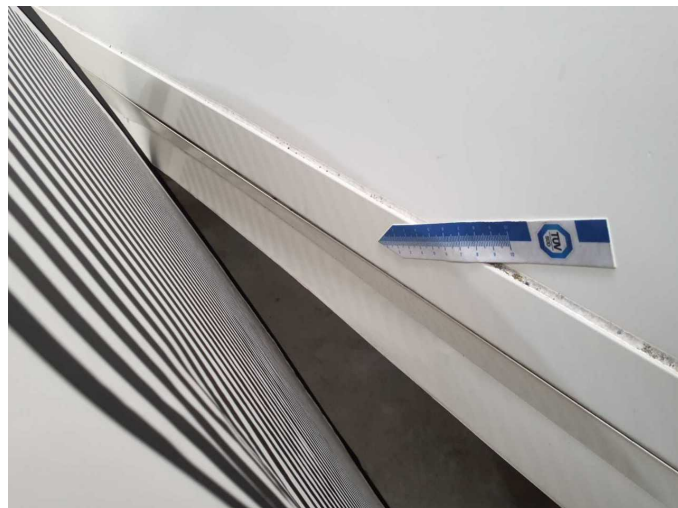
| No. | Component group | Description |
|---|---|---|
| 12 | Side panel - rear right side | Side panel (Kofferaufbau unten, Unterzug) - Deformed - Replace |

**Damage 12:** Side panel - rear right side: Side panel (Kofferaufbau unten, Unterzug) - Deformed - Replace

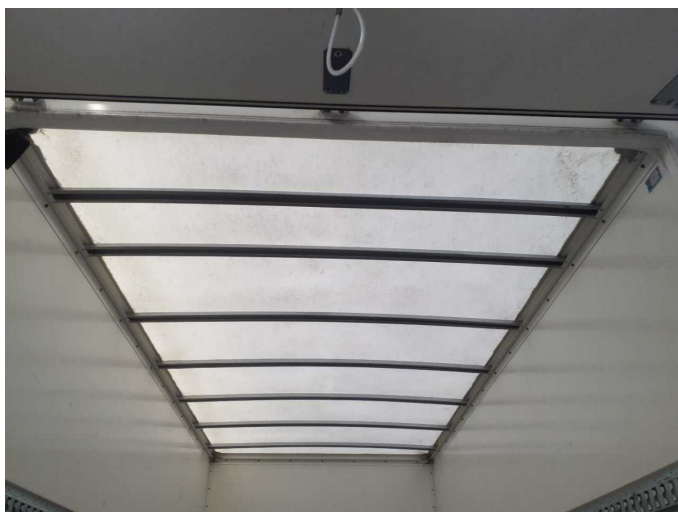
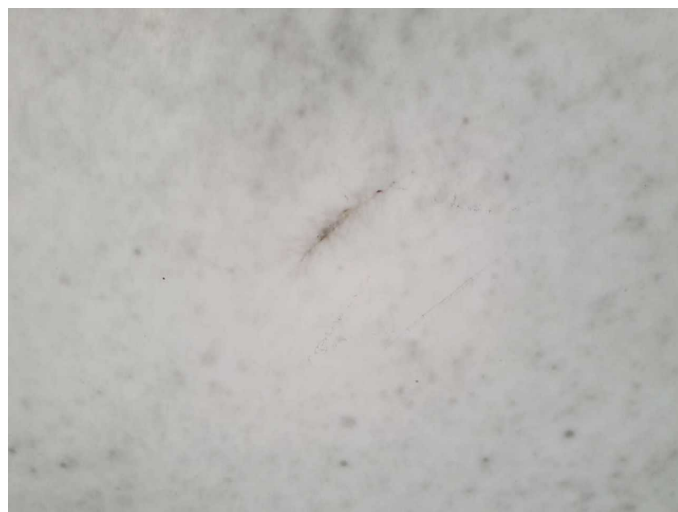
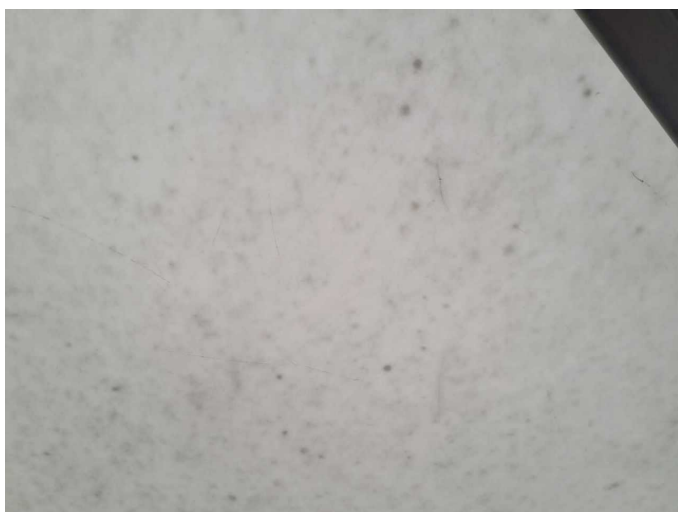
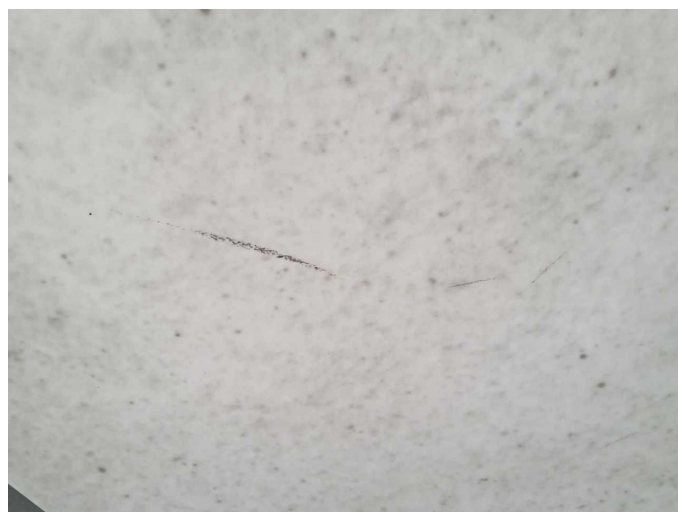
| No. | Component group | Description |
|---|---|---|
| 6 | Roof | Roof (Kofferaufbau, von innen sichtbar) - Scratch(es) - No deduction |

**Wear and tear 6:** Roof: Roof (Kofferaufbau, von innen sichtbar) - Scratch(es) - No deduction
