# FORD C-MAX

## C-MAX 1.6 TDCi - 90 Ghia

VIN NO WF0EXXGCDE9R04269  
Registration Number AC727FK

### Inspection Report Summary

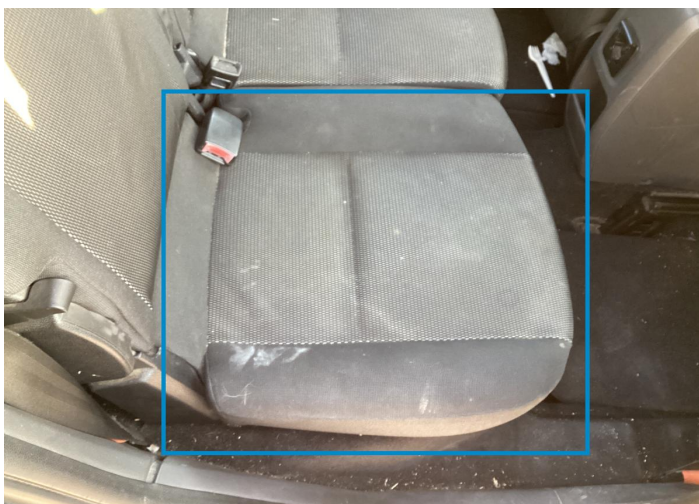
| Component | | Damage | Comments |
|---|---|---|---|
| 1 | Seat Cushion / Back Right | Interior / Dirty | |

1. Seat Cushion / Back Right  
Interior / Dirty -

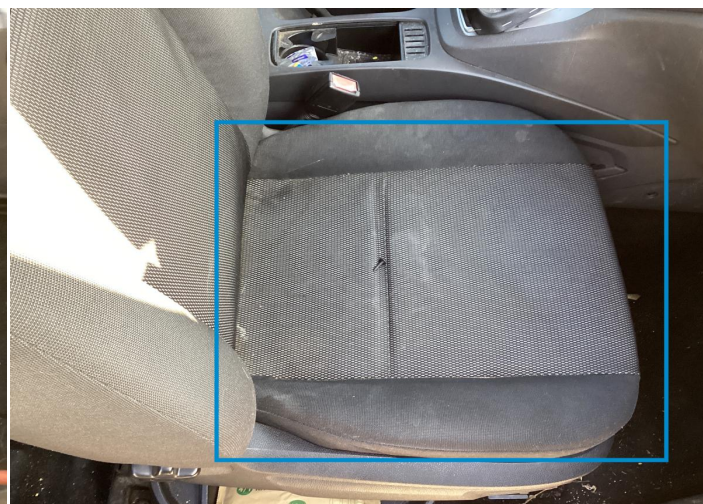
| Component | | Damage | Comments |
|---|---|---|---|
| 2 | Seat Cushion / Front Right | Interior / Dirty | |

2. Seat Cushion / Front Right  
Interior / Dirty -

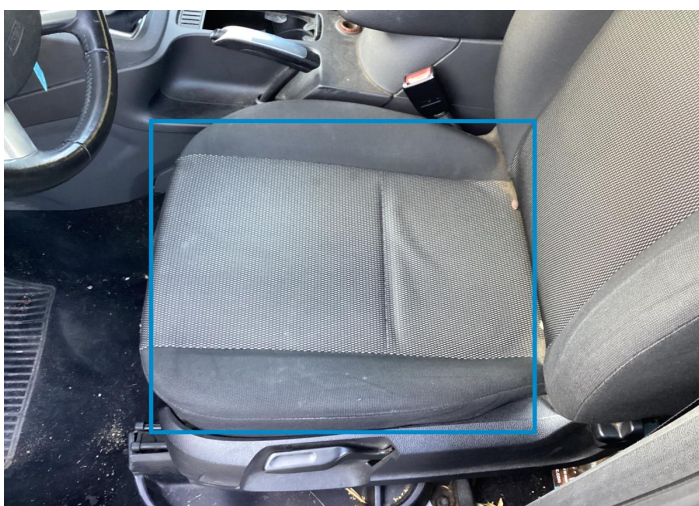
| Component | | Damage | Comments |
|---|---|---|---|
| 3 | Seat Cushion / Front Left | Interior / Dirty | |

3. Seat Cushion / Front Left  
Interior / Dirty -

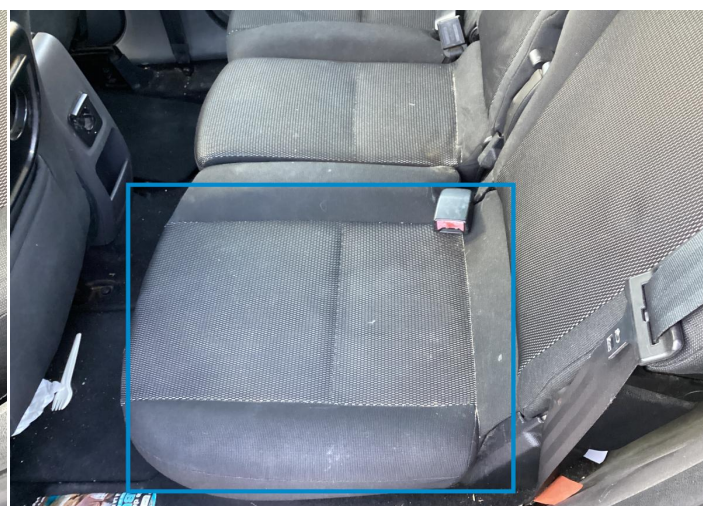
| Component | | Damage | Comments |
|---|---|---|---|
| 4 | Seat Cushion / Back Left | Interior / Dirty | |

4. Seat Cushion / Back Left  
Interior / Dirty -

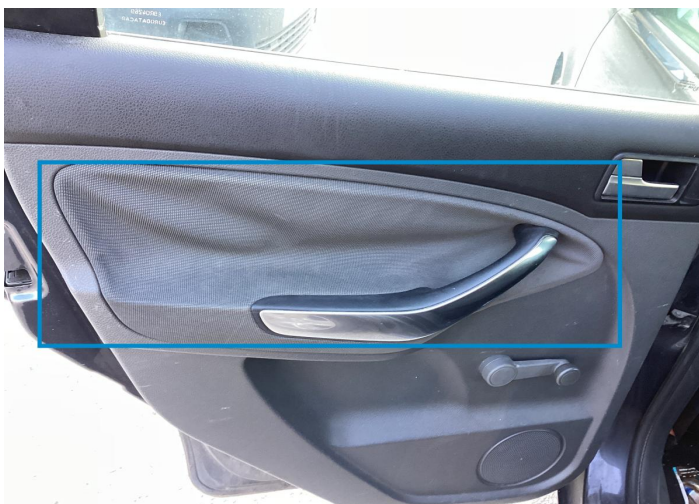
| Component | | Damage | Comments |
|---|---|---|---|
| 5 | Panel Filling / Back Left | Interior / Loose | |

5. Panel Filling / Back Left  
Interior / Loose -

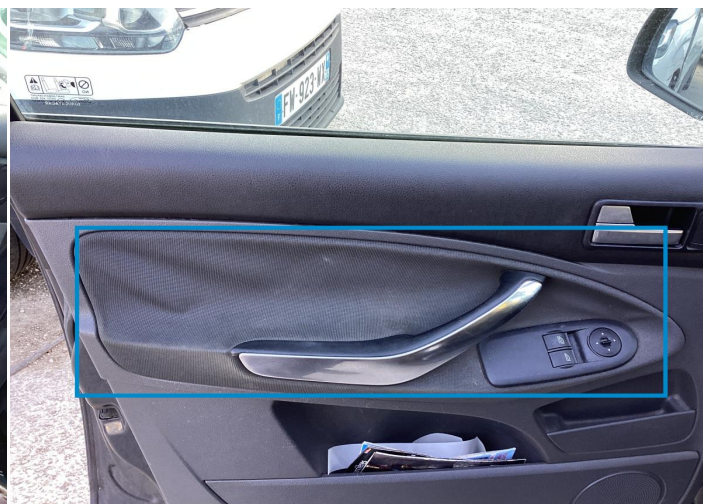
| Component | | Damage | Comments |
|---|---|---|---|
| 6 | Panel Filling / Front Left | Interior / Loose | |

6. Panel Filling / Front Left  
Interior / Loose -

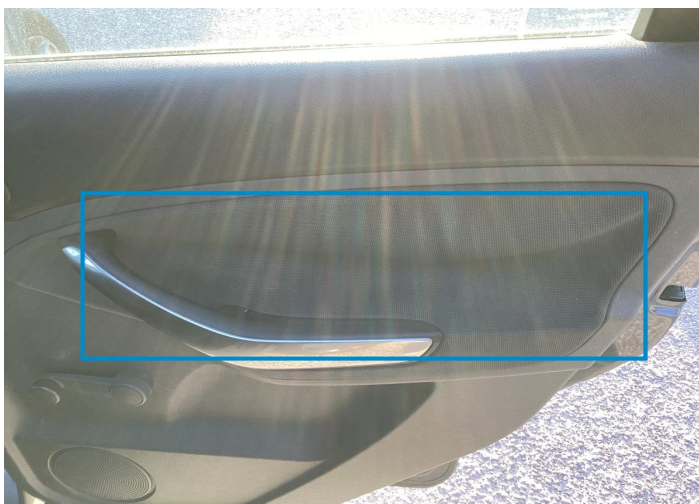
| Component | | Damage | Comments |
|---|---|---|---|
| 7 | Panel Filling / Back Right | Interior / Loose | |

7. Panel Filling / Back Right  
Interior / Loose -

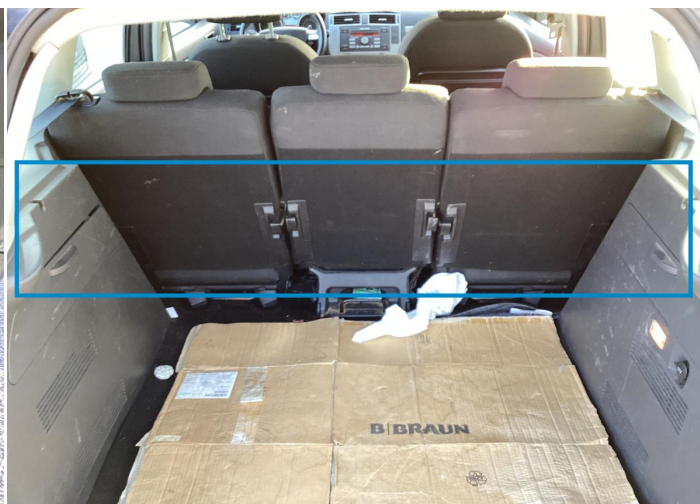
| Component | | Damage | Comments |
|---|---|---|---|
| 8 | Luggage Space Cover / Back | Interior / Missing | |

8. Luggage Space Cover / Back  
Interior / Missing -

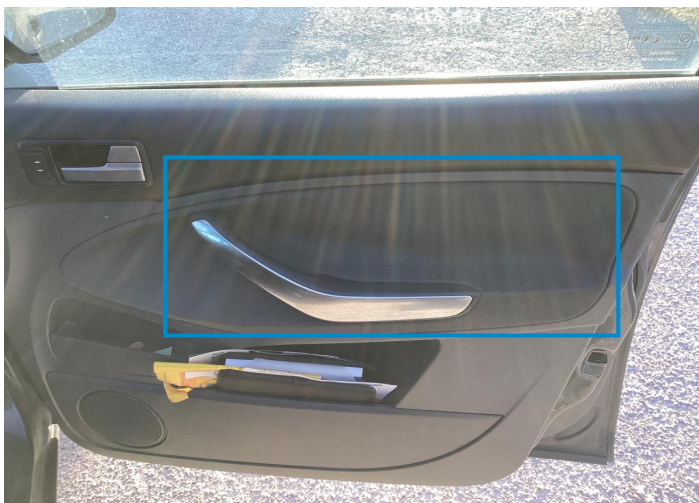
| Component | | Damage | Comments |
|---|---|---|---|
| 9 | Panel Filling / Front Right | Interior / Loose | |

9. Panel Filling / Front Right  
Interior / Loose -

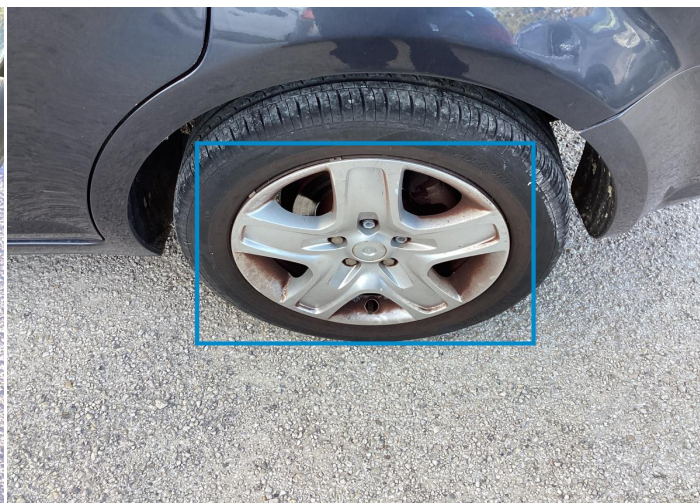
| Component | | Damage | Comments |
|---|---|---|---|
| 10 | Hubcap / Back Left | Out of Bodywork / Scratch | |

10. Hubcap / Back Left  
Out of Bodywork / Scratch -

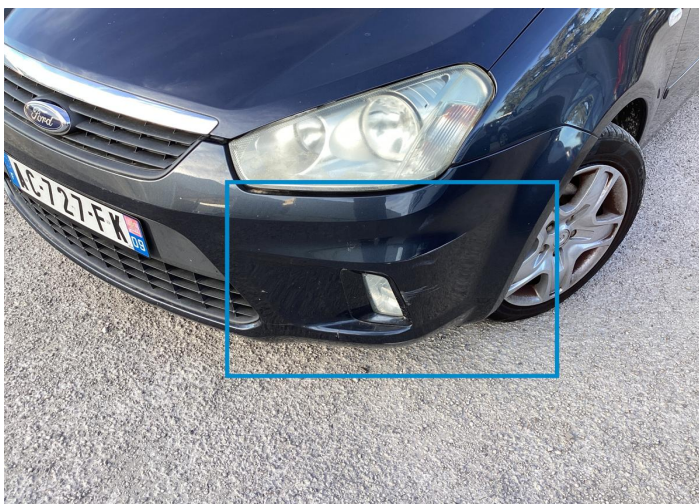
| Component | | Damage | Comments |
|---|---|---|---|
| 11 | Shield / Front | Paint / Scratch / Line | |

11. Shield / Front  
Paint / Scratch / Line -

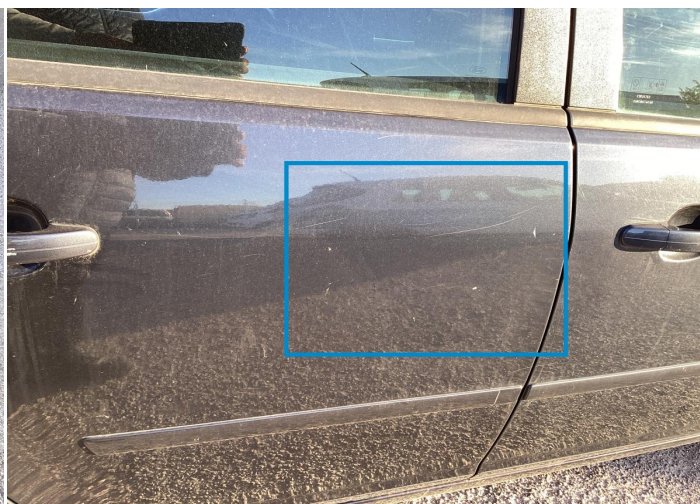
| Component | | Damage | Comments |
|---|---|---|---|
| 12 | Door / Back Right | Paint / Scratch / Line | |

12. Door / Back Right  
Paint / Scratch / Line -

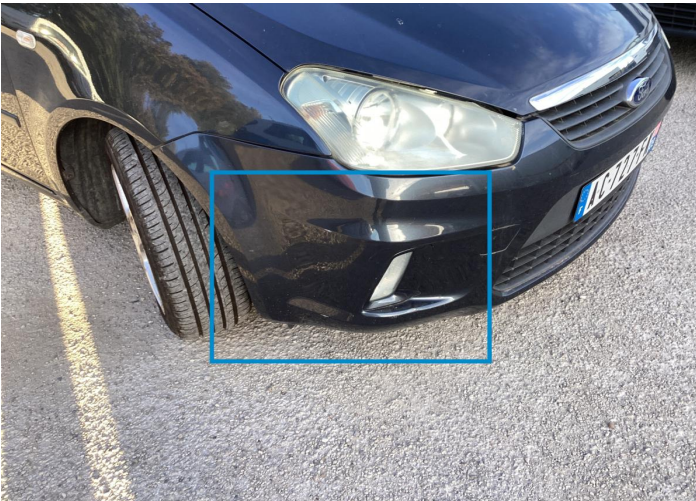
| 13 | Shield / Front | Paint / Scratch / Line |

13. Shield / Front  
Paint / Scratch / Line -

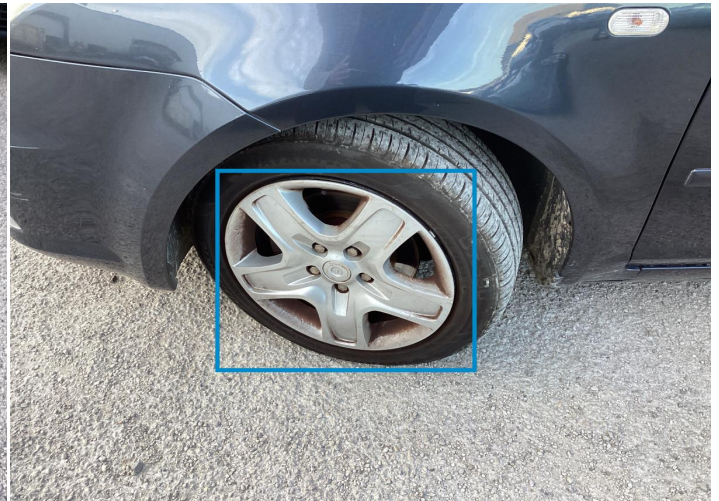
| 14 | Hubcap / Front Left | Out of Bodywork / Scratch |

14. Hubcap / Front Left  
Out of Bodywork / Scratch -

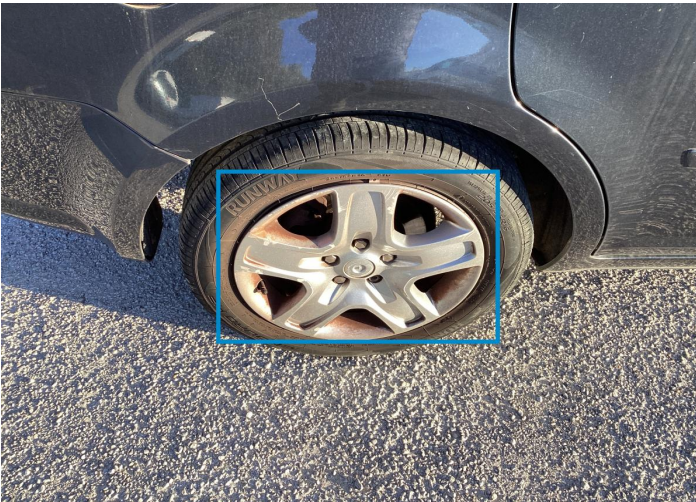
| 15 | Hubcap / Back Right | Out of Bodywork / Scratch |

15. Hubcap / Back Right  
Out of Bodywork / Scratch -

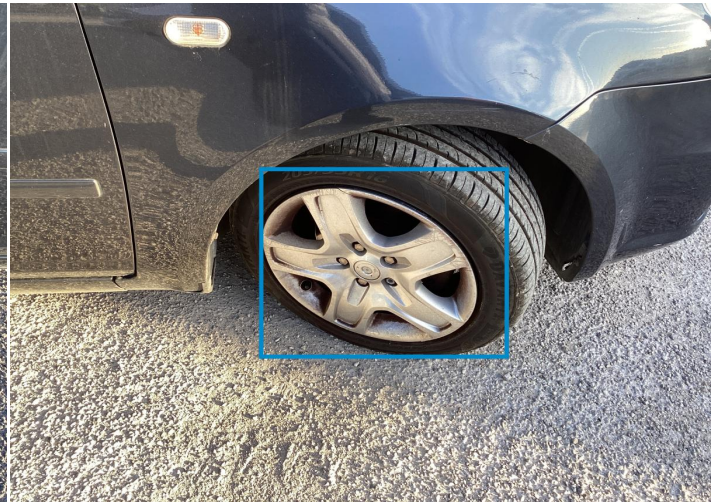
| 16 | Hubcap / Front Right | Out of Bodywork / Breakage |

16. Hubcap / Front Right  
Out of Bodywork / Breakage -

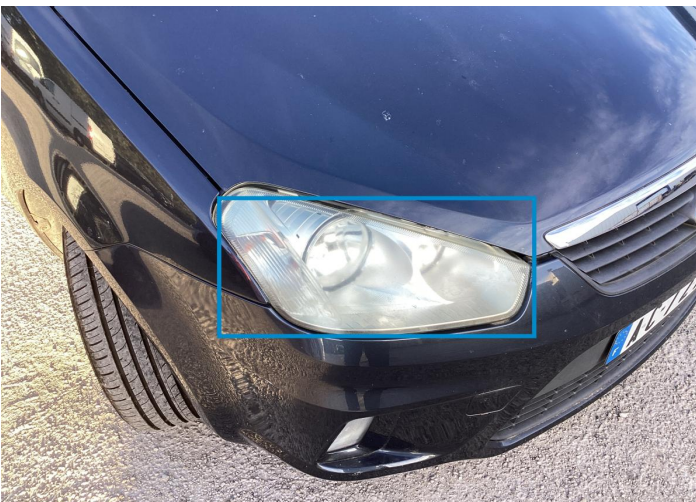
| 17 | Front Light / Front Right | Glass Break |

17. Front Light / Front Right  
Glass Break -

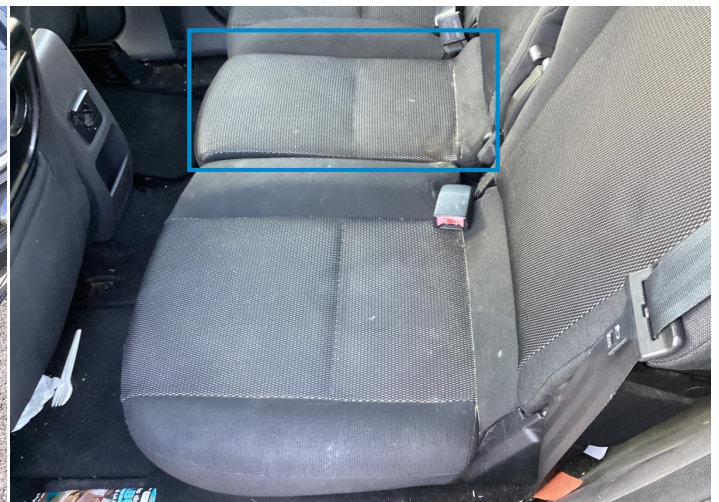
| 18 | Seat Cushion / Back Left | Interior / Dirty |

18. Seat Cushion / Back Left  
Interior / Dirty -

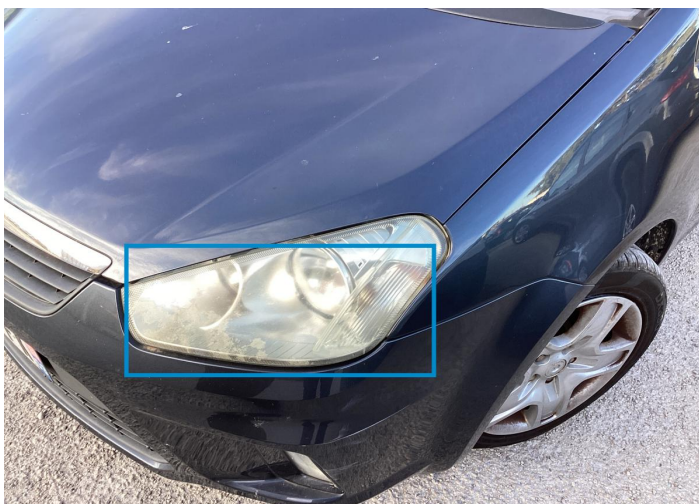
| 19 | Front Light / Front Left | Glass Break |

19. Front Light / Front Left  
Glass Break -

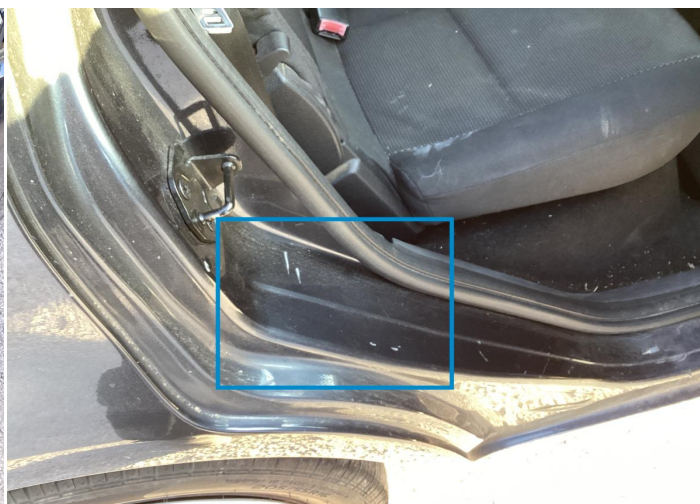
| 20 | Door Step / Back Right | Interior / Distorted |

20. Door Step / Back Right  
Interior / Distorted -

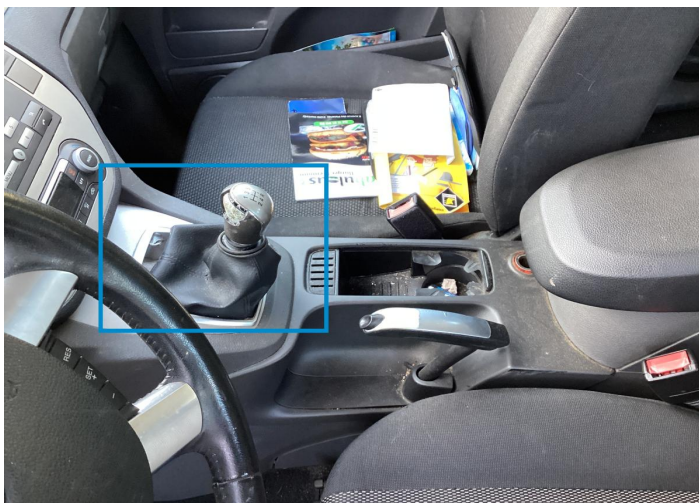
| 21 | Gear Knob | Interior / Broken |

21. Gear Knob  
Interior / Broken -

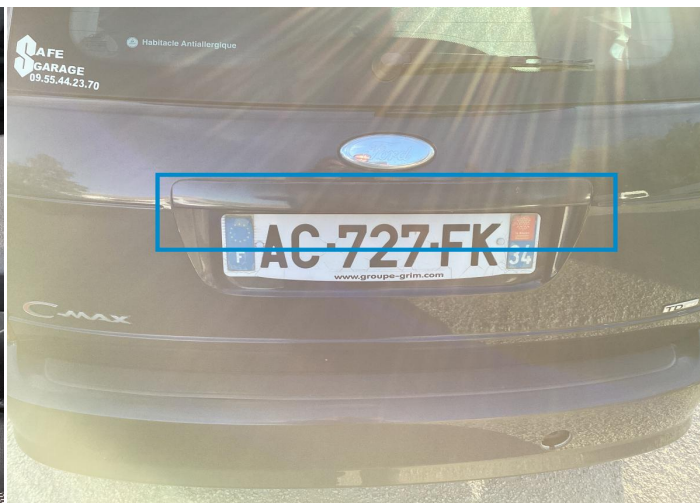
| 22 | Trunk Stick | Paint / Poor Previous Repair |

22. Trunk Stick  
Paint / Poor Previous Repair -

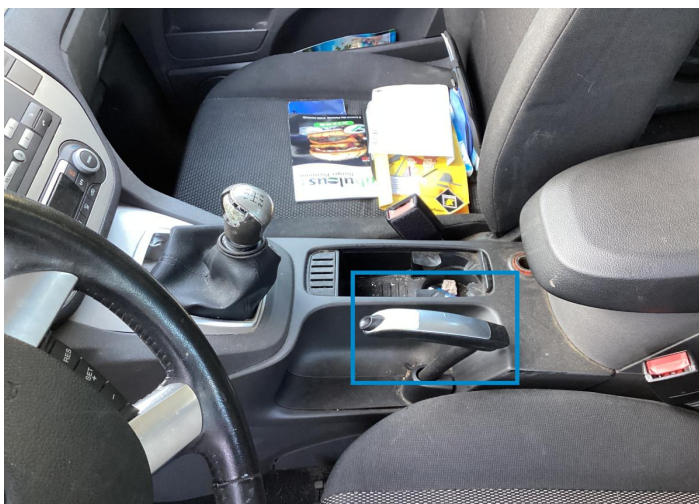
| 23 | Gear Knob | Interior / Worn - out |

23. Gear Knob  
Interior / Worn - out -

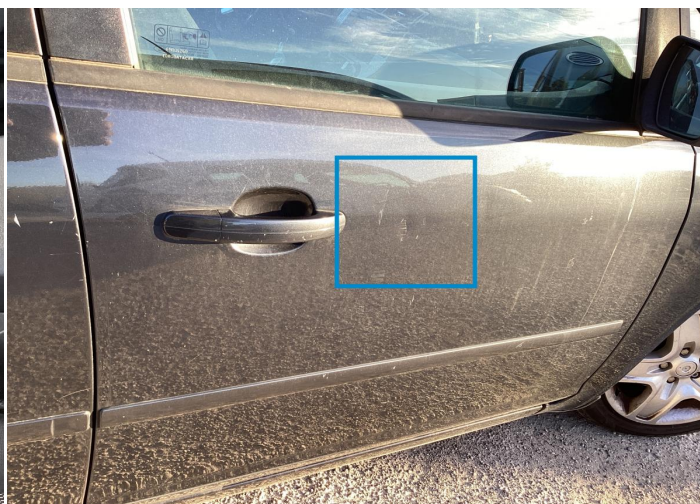
| 24 | Door / Front Right | Bodywork / Dent / Deformation |

24. Door / Front Right  
Bodywork / Dent / Deformation -

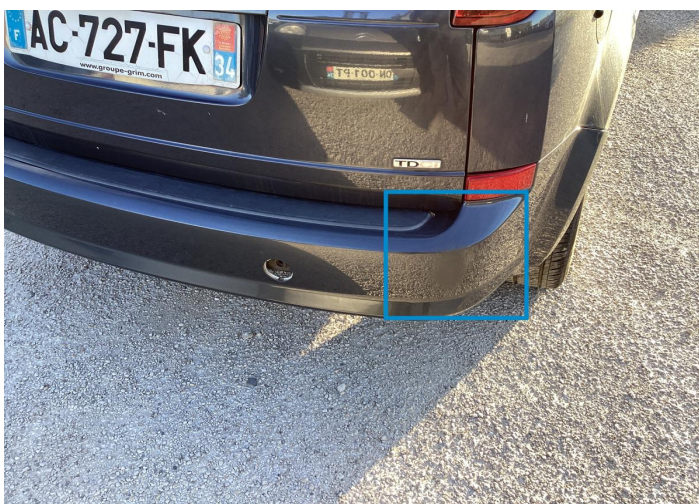
| 25 | Shield / Back | Paint / Scratch / Line |

25. Shield / Back  
Paint / Scratch / Line -

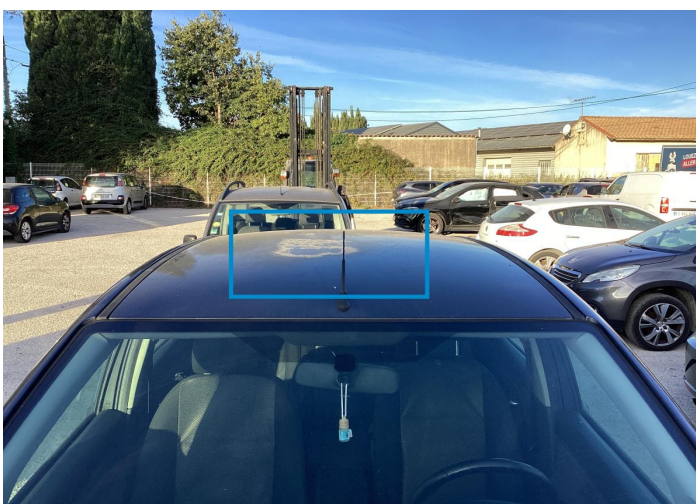
| 26 | Roof | Paint / Poor Previous Repair |

26. Roof  
Paint / Poor Previous Repair -

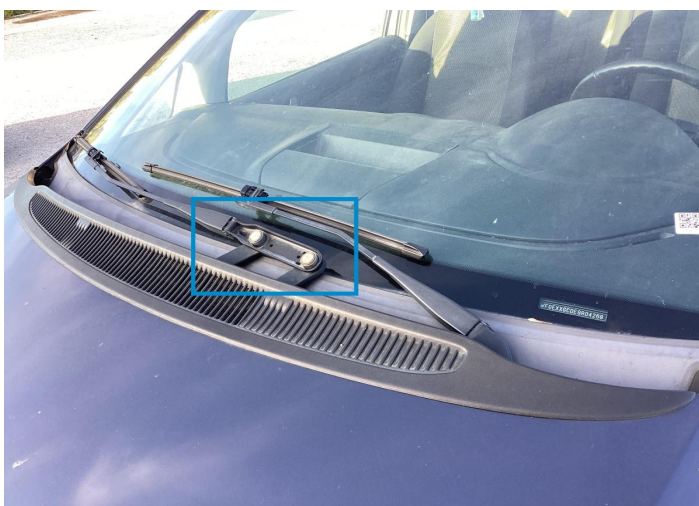
| 27 | Windshield Wiper Blade / Front Right | Missing Part |

27. Windshield Wiper Blade / Front Right  
Missing Part -

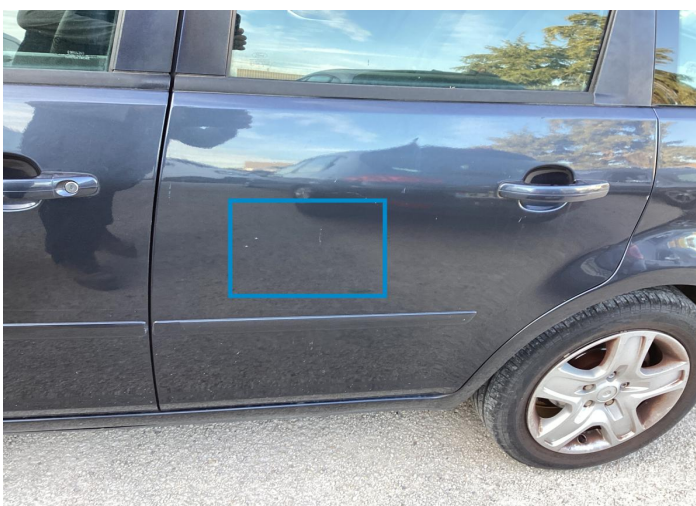
| 28 | Door / Back Left | Paint / Scratch / Line |

28. Door / Back Left  
Paint / Scratch / Line -

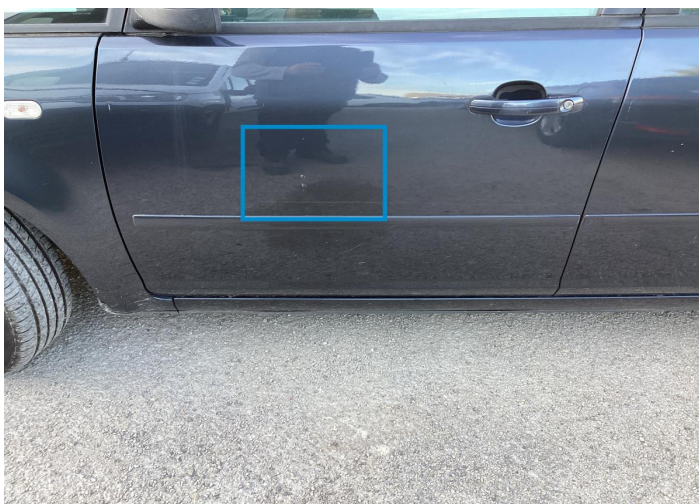
| 29 | Door / Front Left | Paint / Scratch / Line |

29. Door / Front Left  
Paint / Scratch / Line -

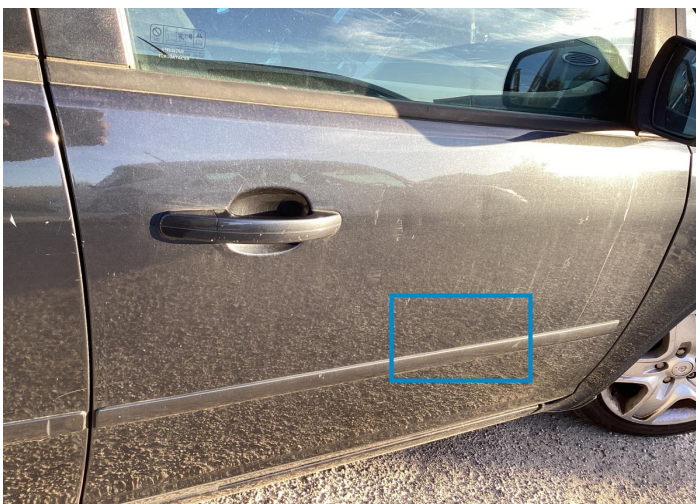
| 30 | Door / Front Right | Bodywork / Dent / Deformation |

30. Door / Front Right  
Bodywork / Dent / Deformation -

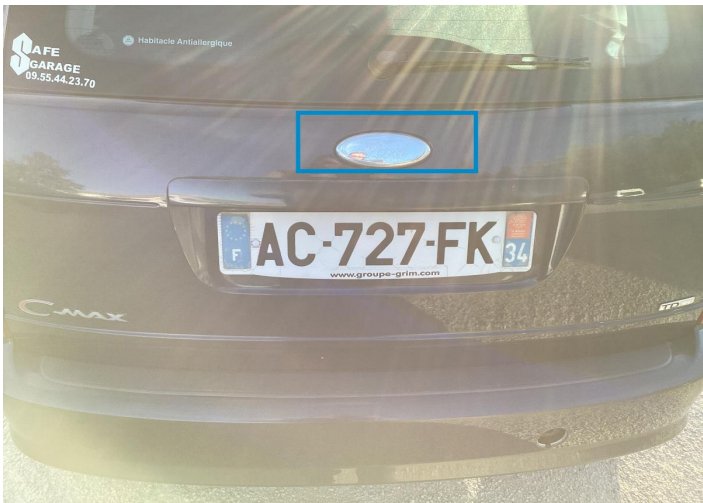
| 31 | Trunk Stick | Paint / Poor Previous Repair |

31. Trunk Stick  
Paint / Poor Previous Repair -

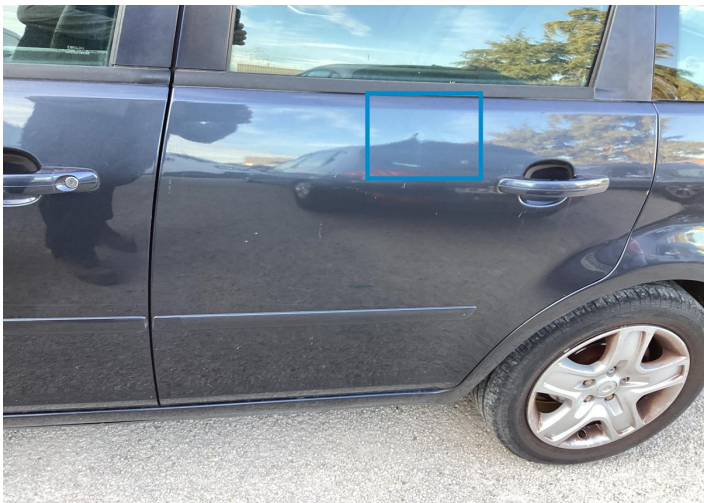
| 32 | Door / Back Left | Bodywork / Dent / Deformation |

32. Door / Back Left  
Bodywork / Dent / Deformation -

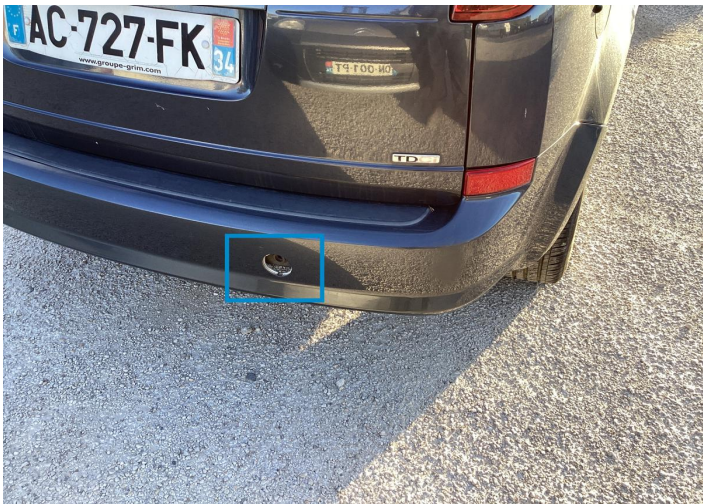
| 33 | Shield / Back | Missing Part |

33. Shield / Back  
Missing Part -

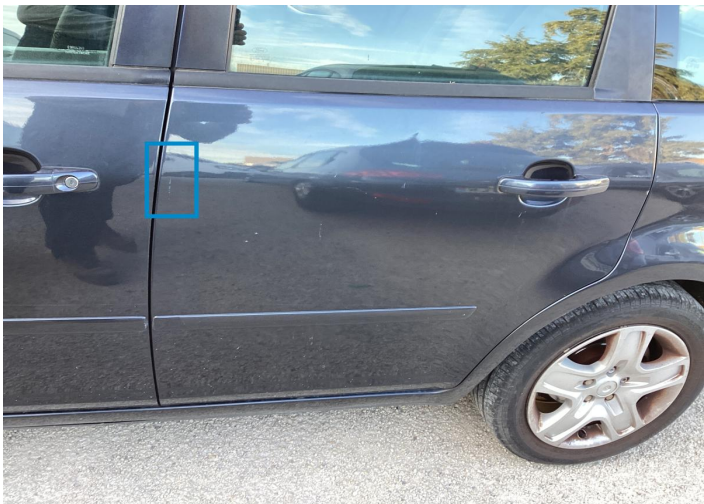
| 34 | Door / Back Left | Paint / Scratch / Line |

34. Door / Back Left  
Paint / Scratch / Line -
