Expertise

Protocol number: 41825225
Order number / reference: 25118792
Inspection date: 26 Sept 2025

Manufacturer: Ford	Model: Transit 350 L3H3 VA Kasten LKW Trend
VIN: WF0EXXTTREKS27432

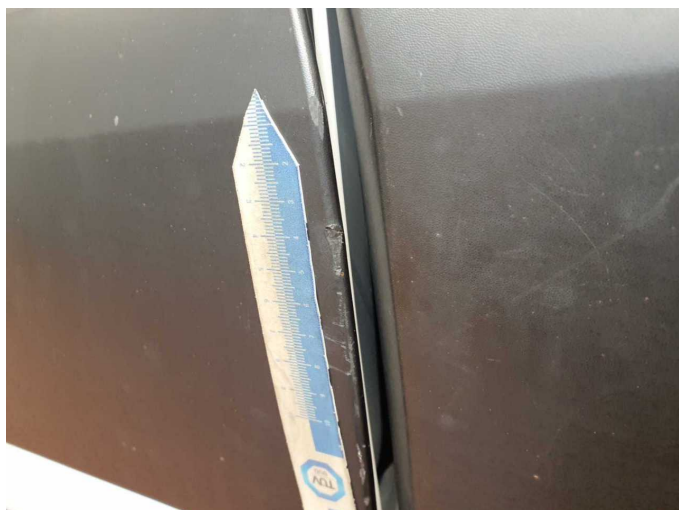
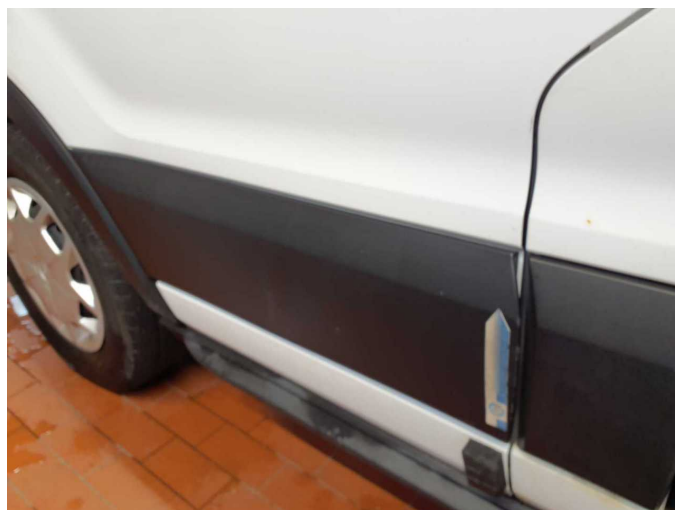
Damage 2: Door - front left side: Brightware - lower - Scratch(es) - Loss in value

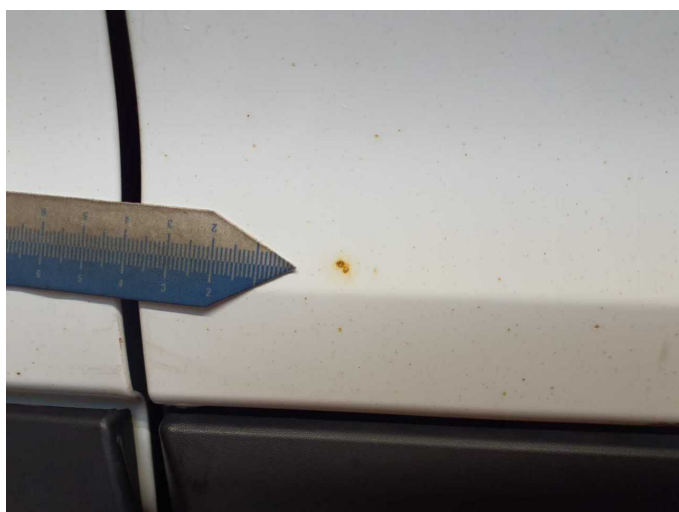
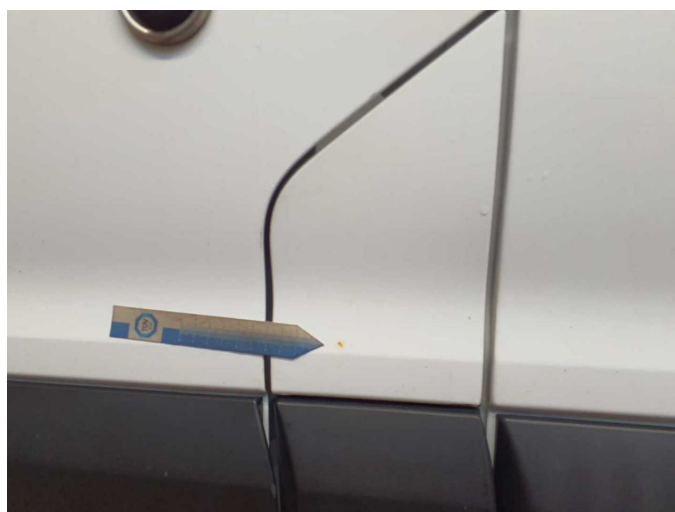
Damage 3: Fuel system: Tank cap (Rost) - Paint defect - Smart repair

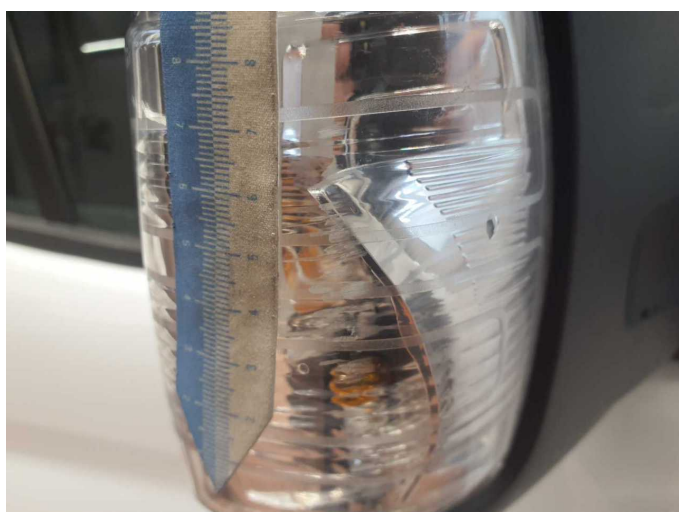
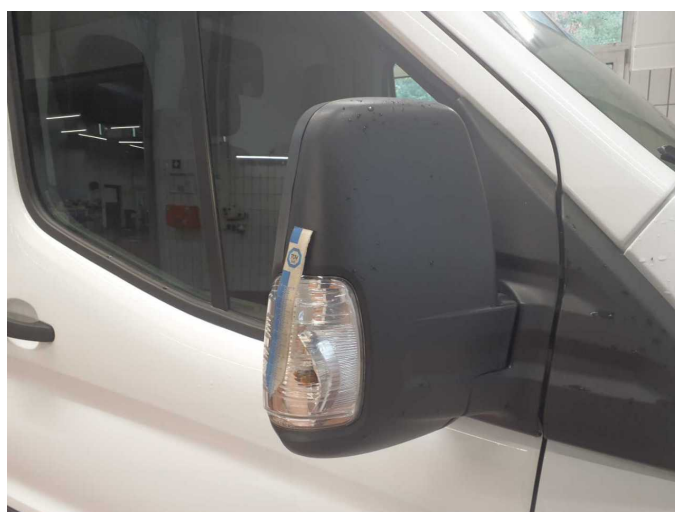
Damage 4: Indicator - front: Mirror - right side - Scratch(es) - Replace

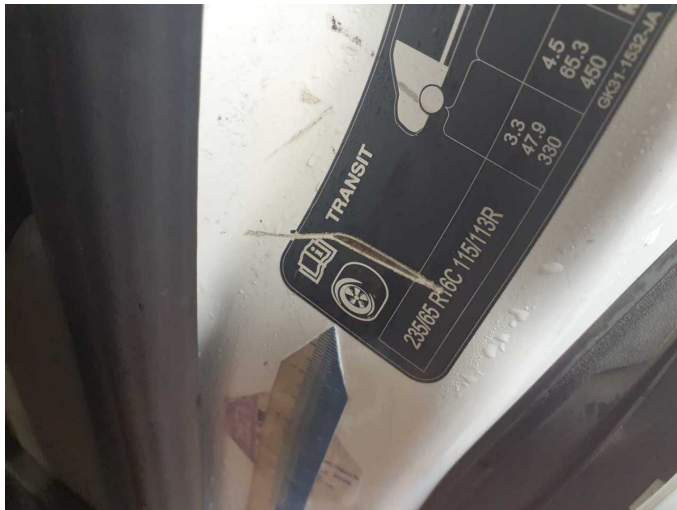
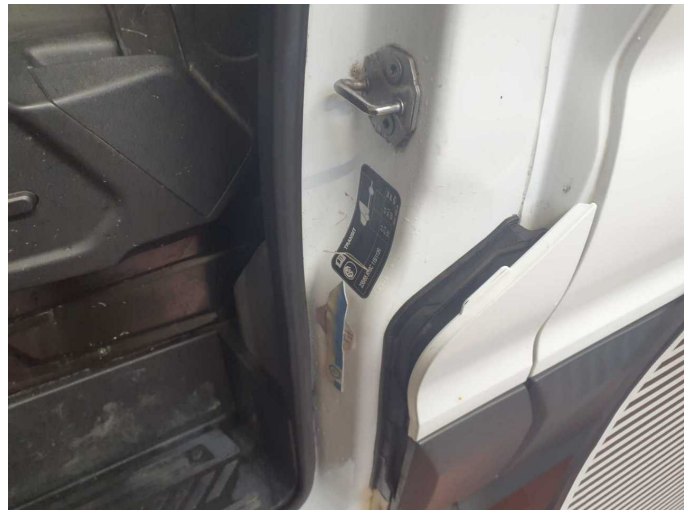
Damage 5: Sill - left side: Sill - Scratch(es) - Smart repair

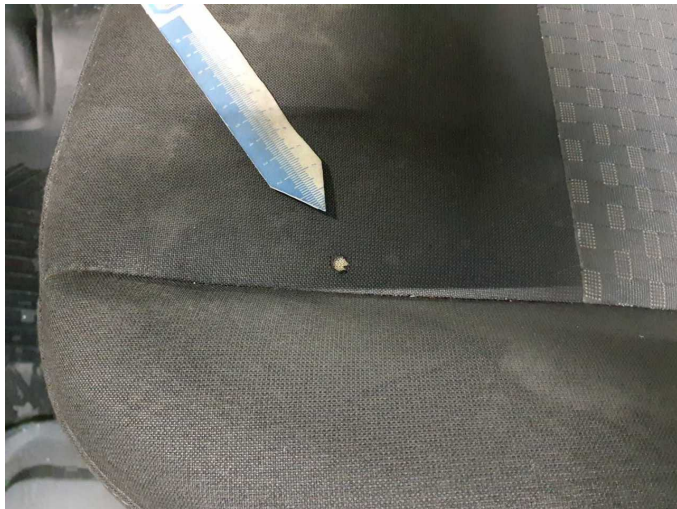
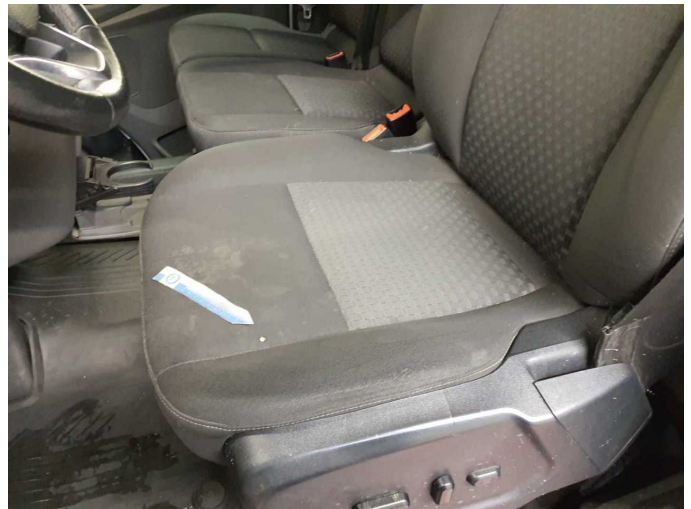
Damage 6: Seat - front: Seat cover - left side - Burn hole (cigarettes) - Loss in value

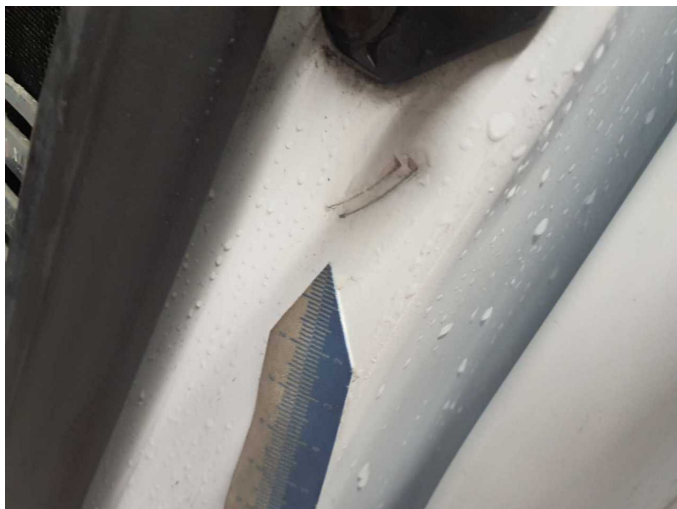
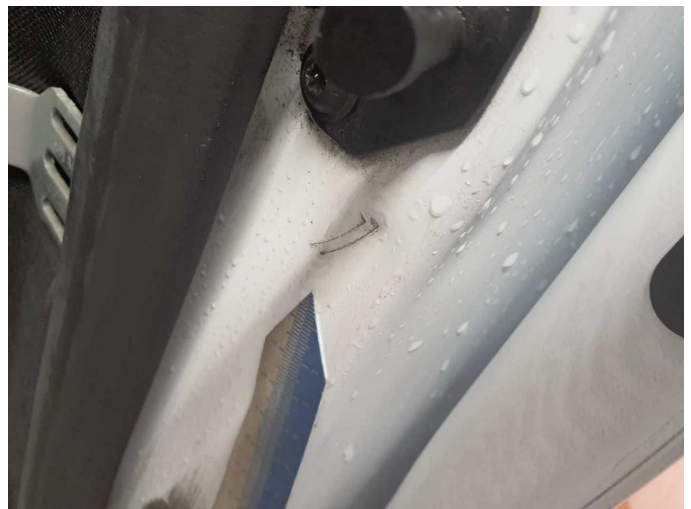
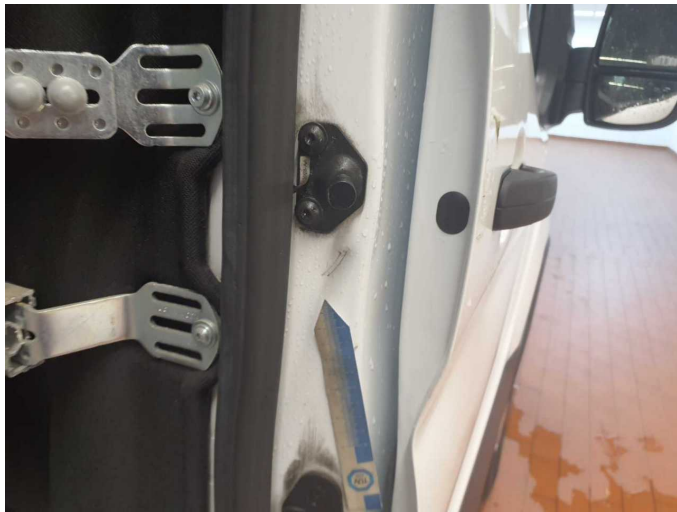
Damage 7: Body: B-pillar - right side - Dent / paintcoat damage - Smart repair

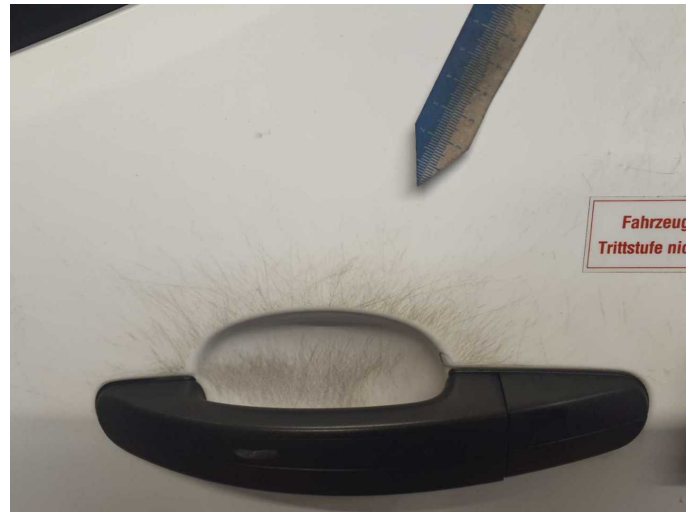
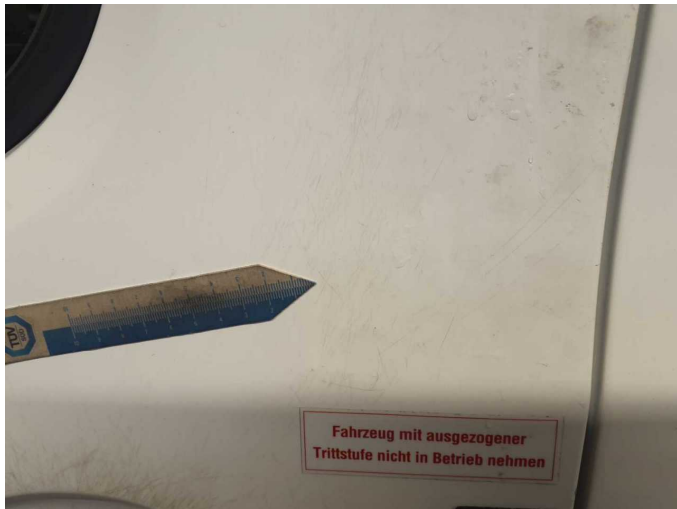
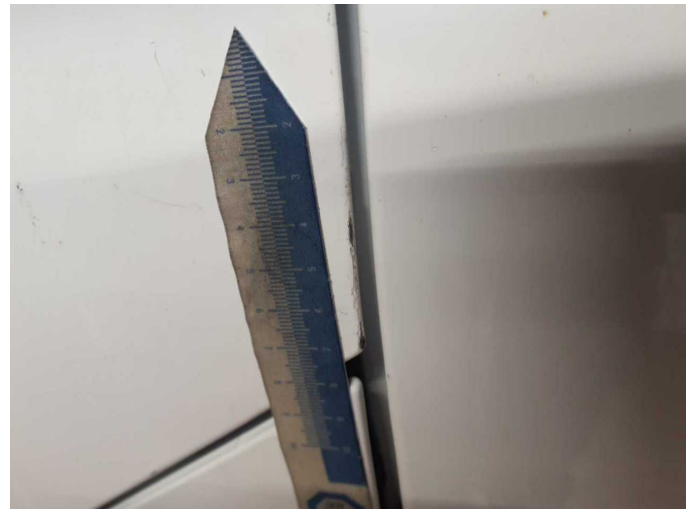
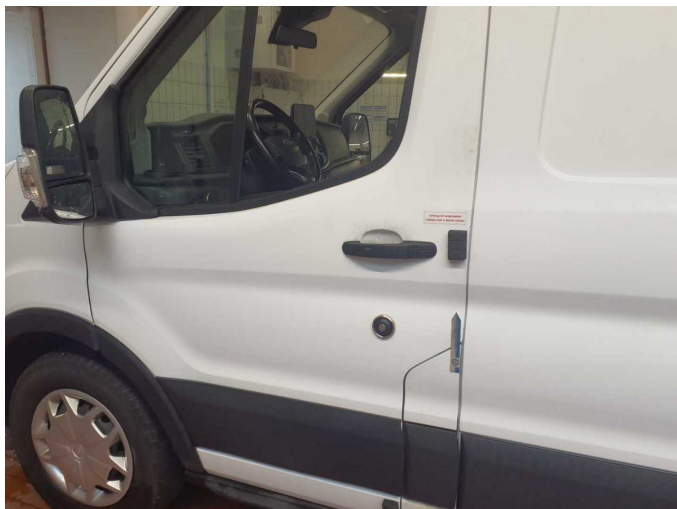
Damage 8: Door - front left side: Door - Scratched - Smart repair

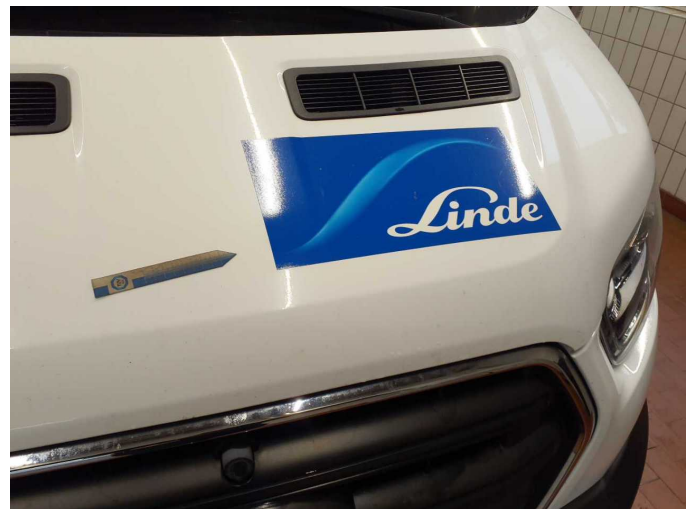
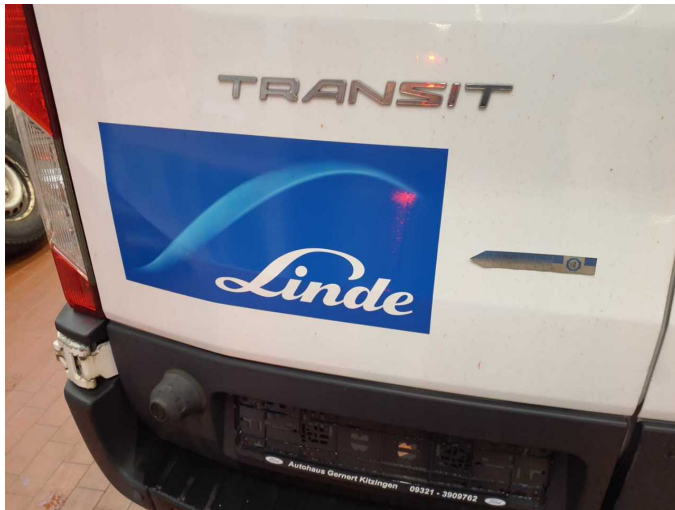
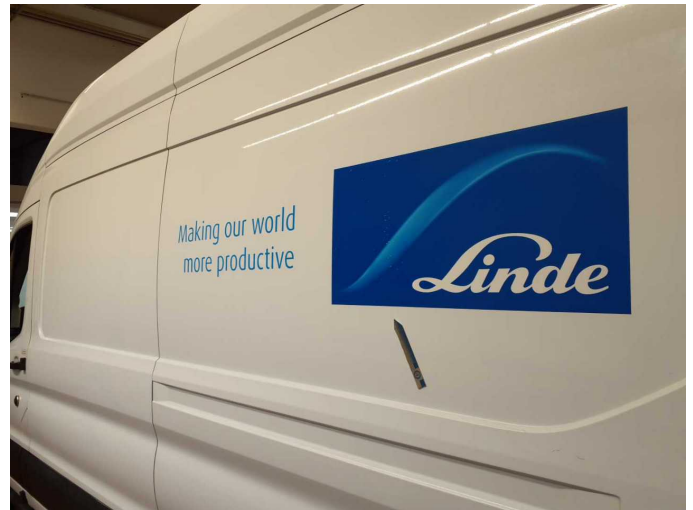
Damage 9: Body: Body - Glued / labelled - Remove

Damage 9: Body - Body - Glued / labelled - Remove

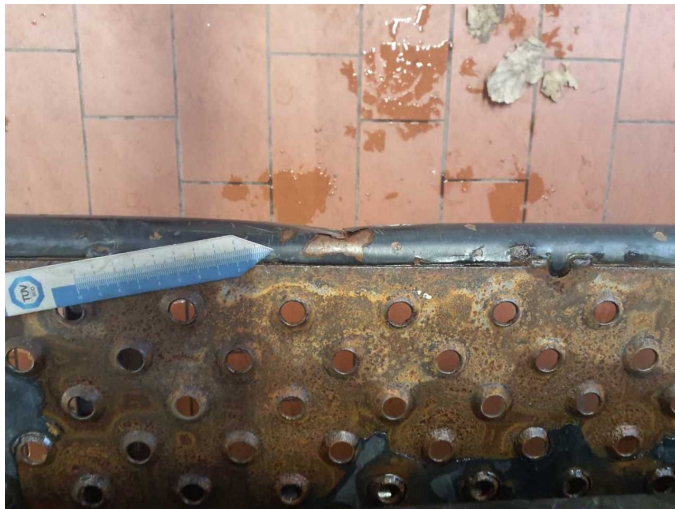
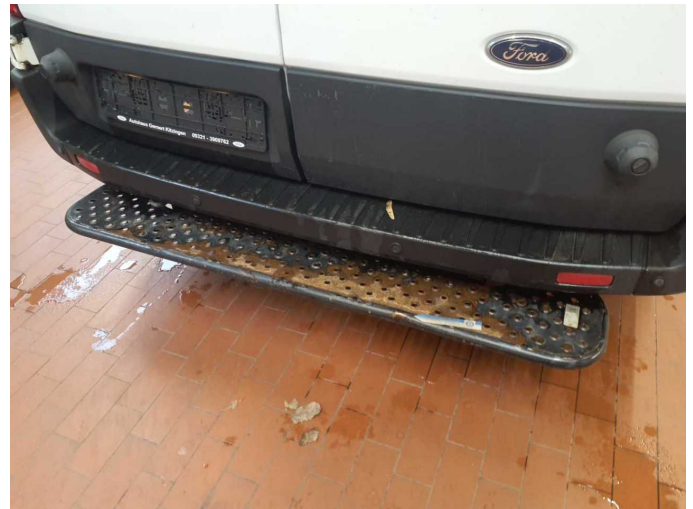
Damage 10: Rear of vehicle: Foot plate - Deformed - Loss in value

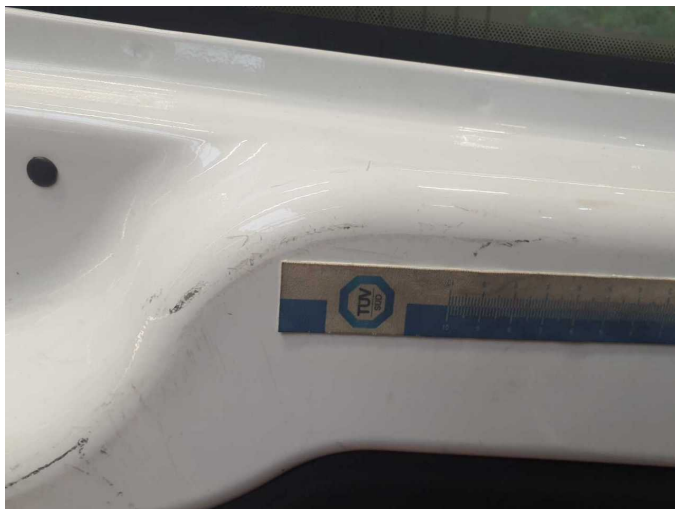
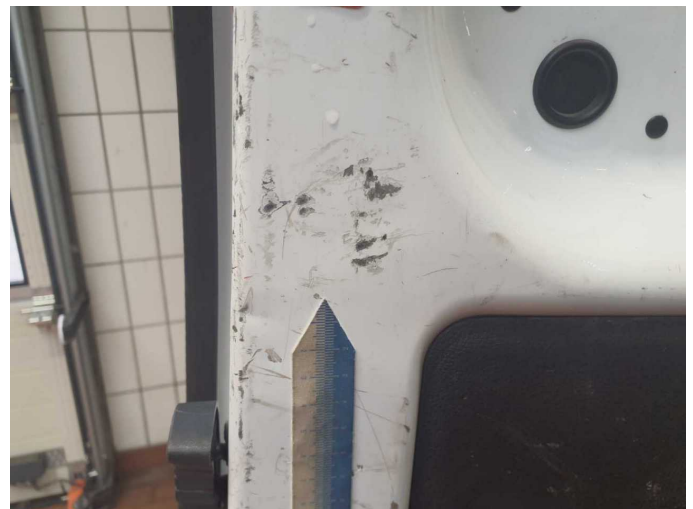
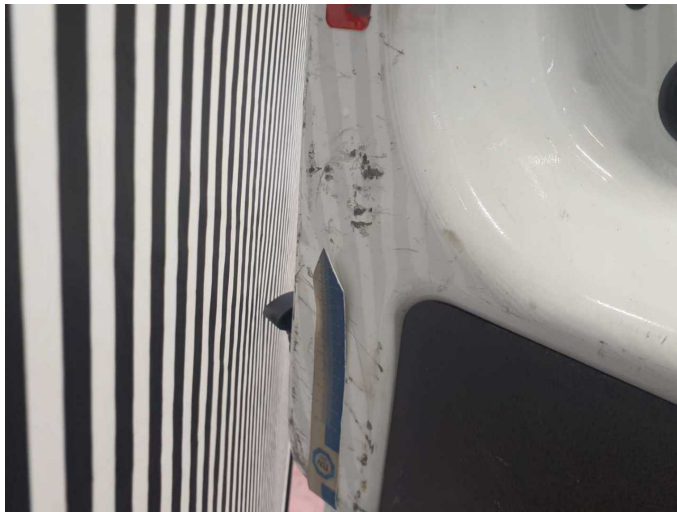
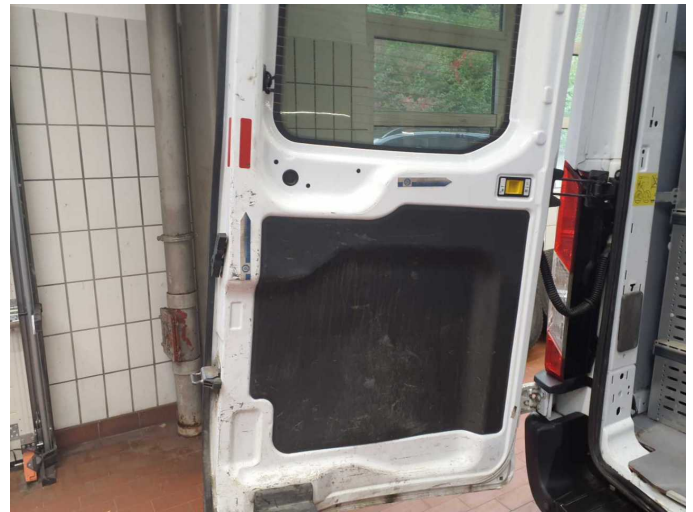
Damage 11: Boot lid / rear door: Rear door - left side - Dent / paintcoat damage - Repair and paint

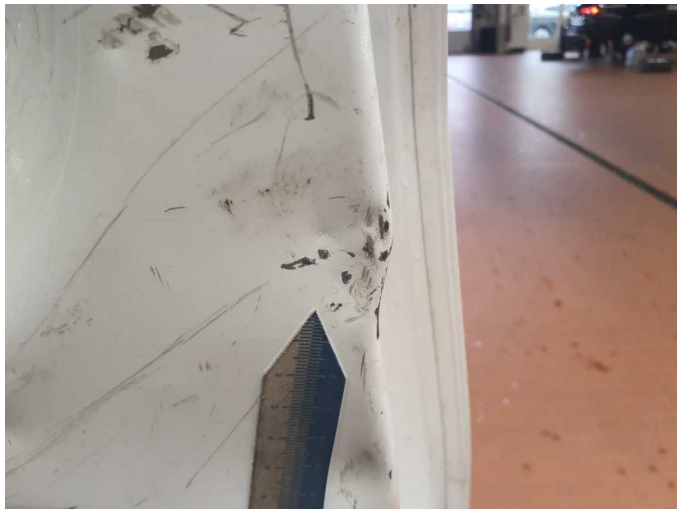
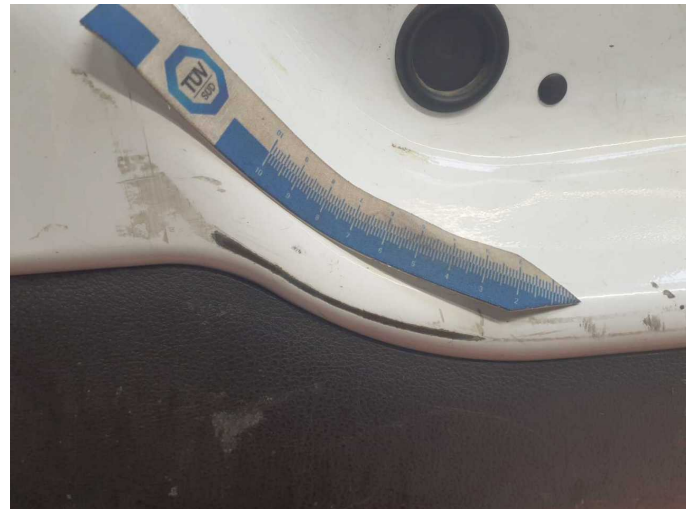
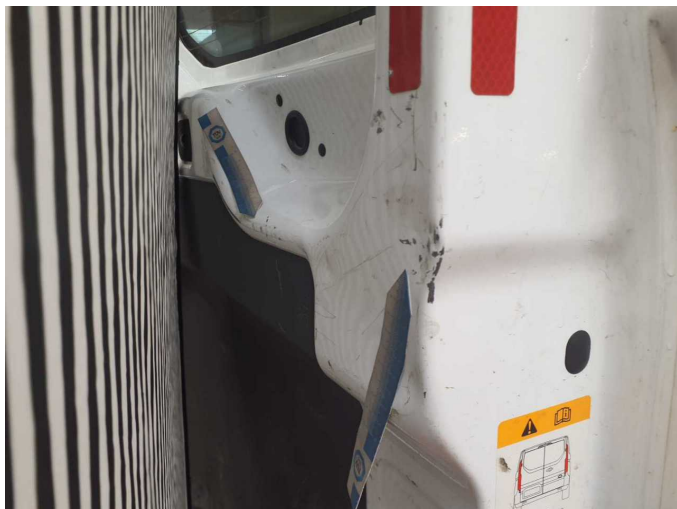
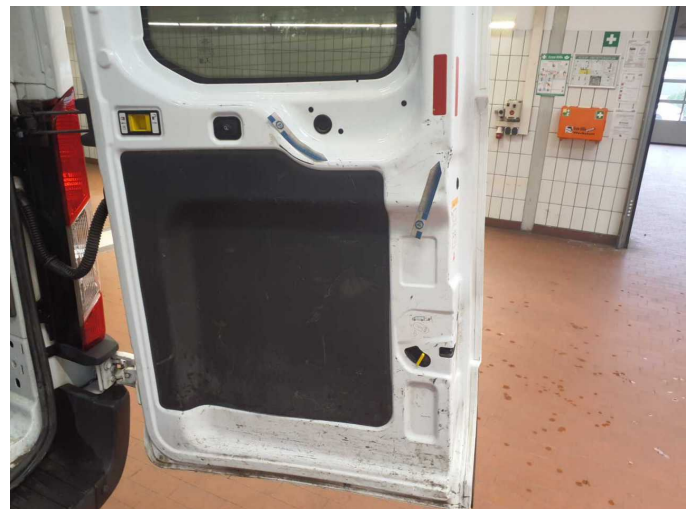
Damage 12: Boot lid / rear door: Rear door - right side - Dent / paintcoat damage - Repair and paint

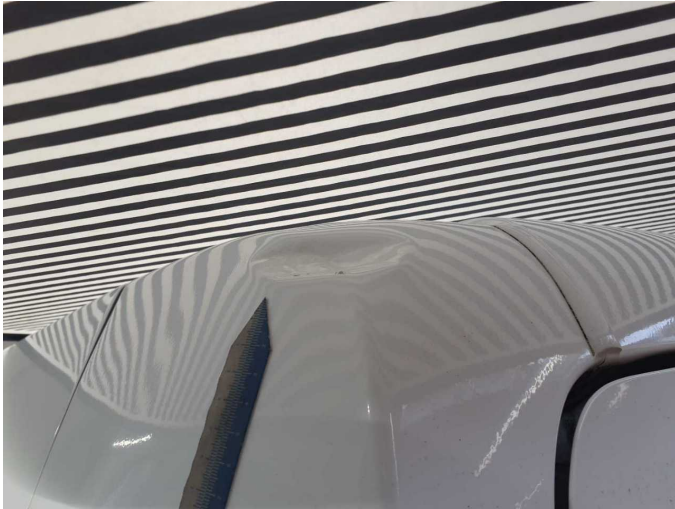
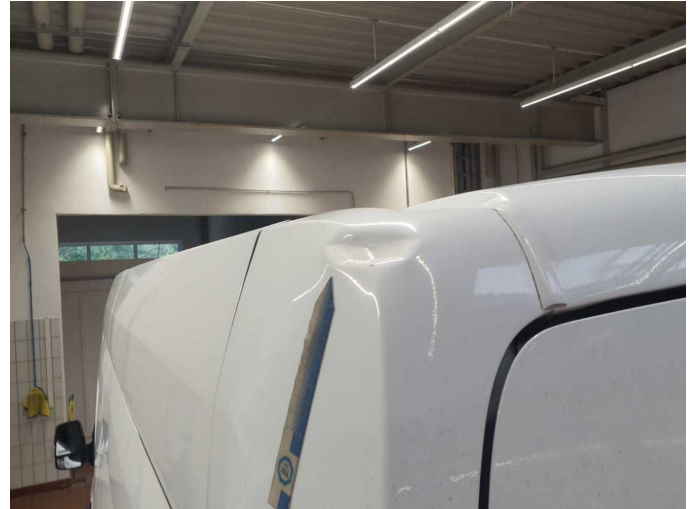
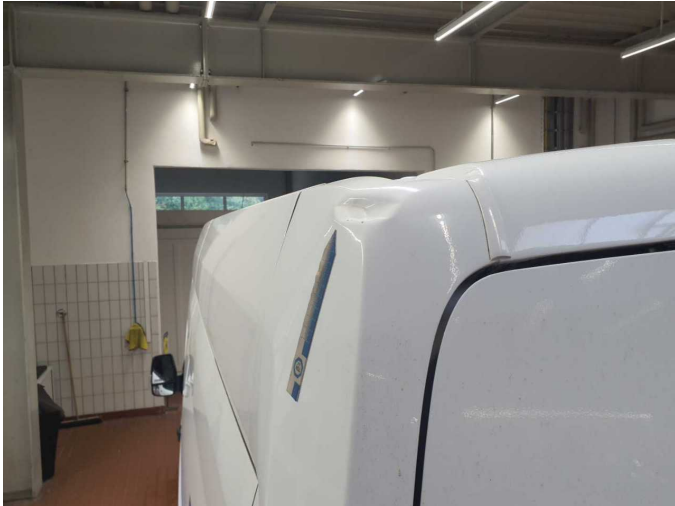
Damage 13: Body: D-pillar - left side (Eingedrückt) - Deformed - Repair and paint

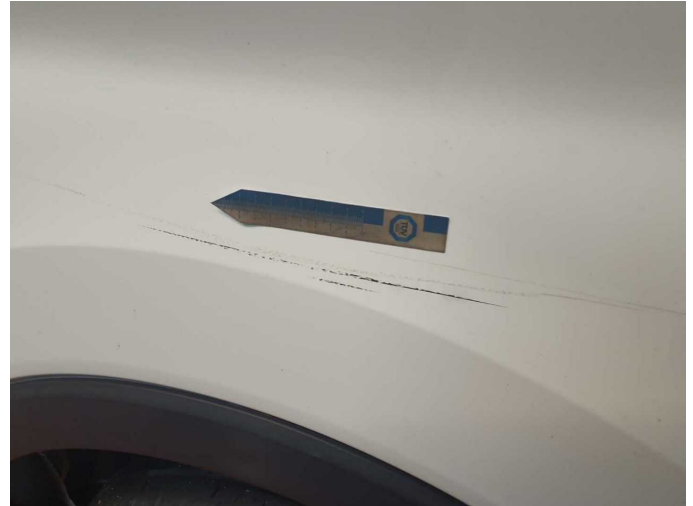
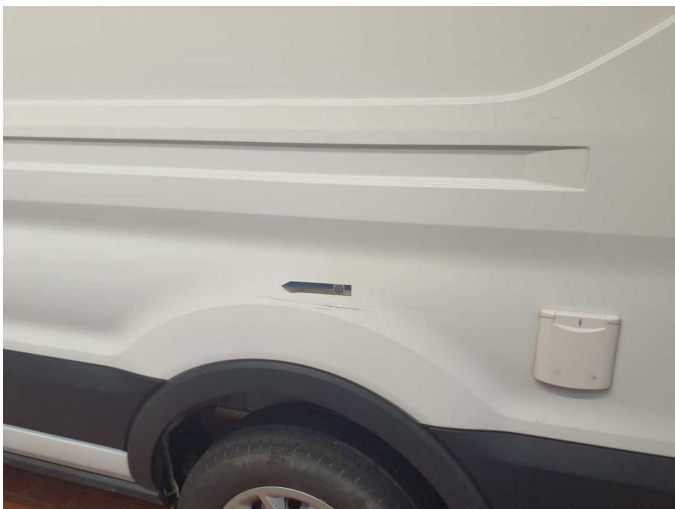
Damage 14: Side panel - rear left side: Side panel - Scratch(es) - Paint

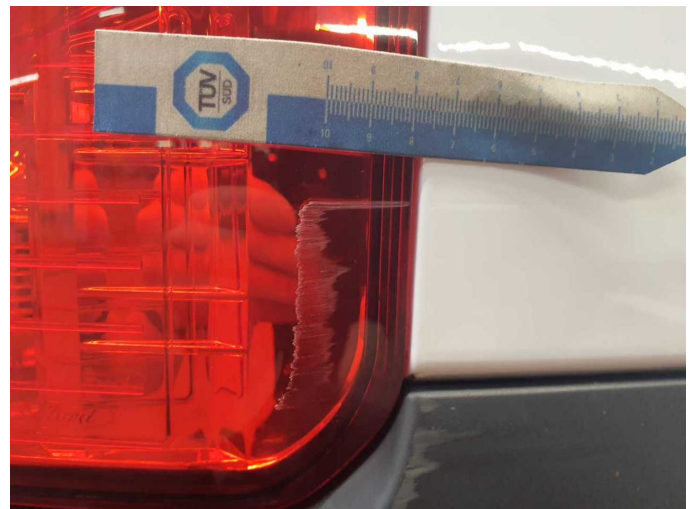
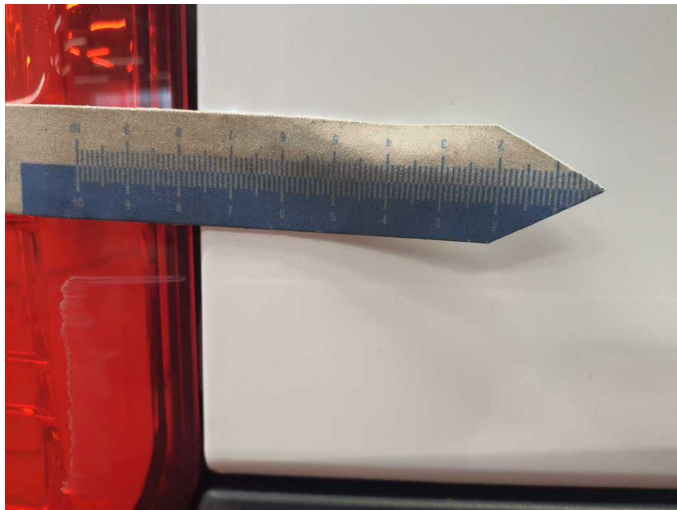
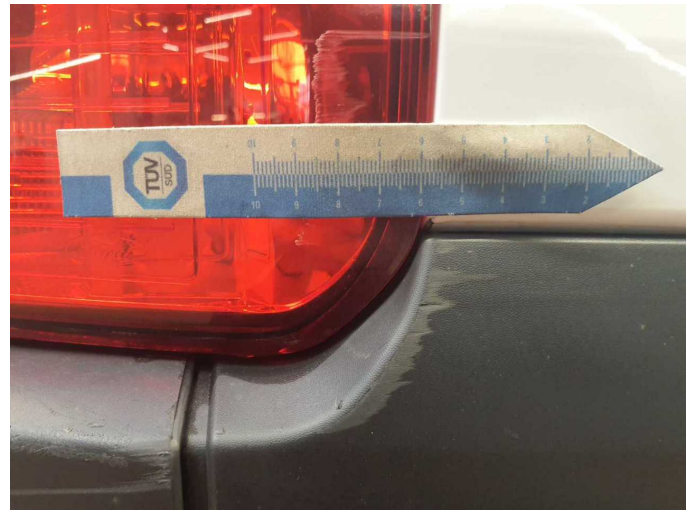
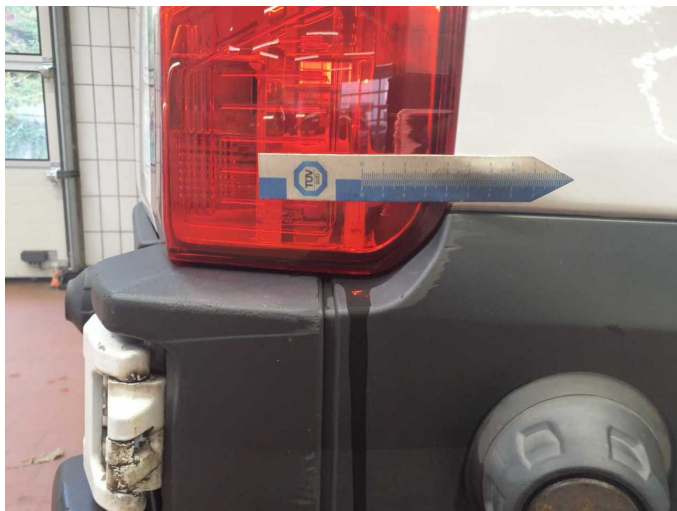
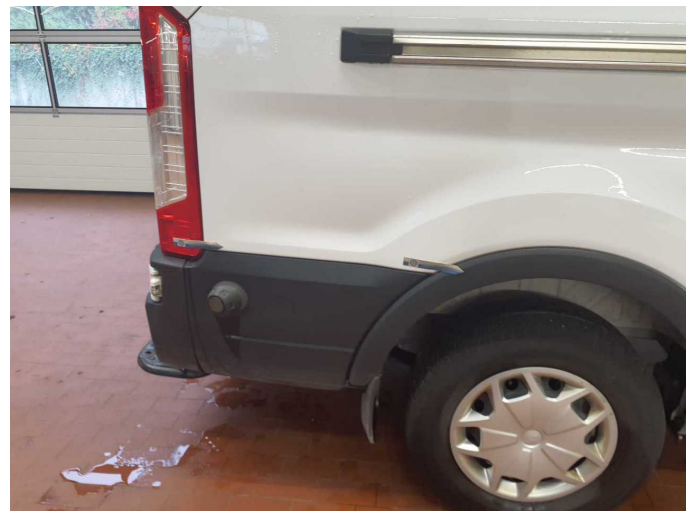
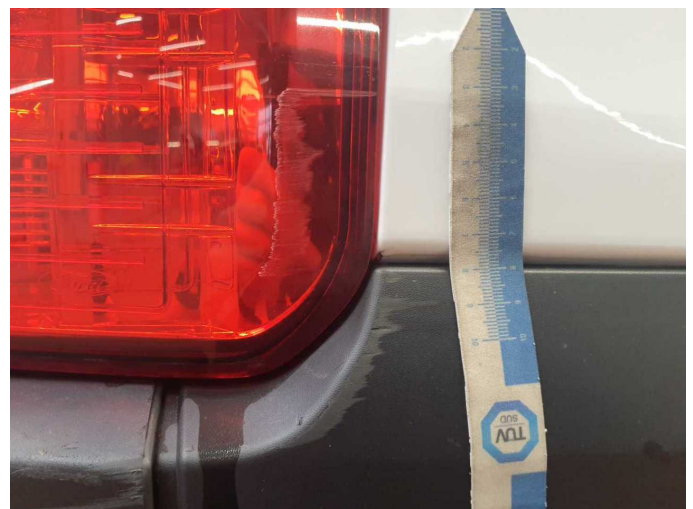
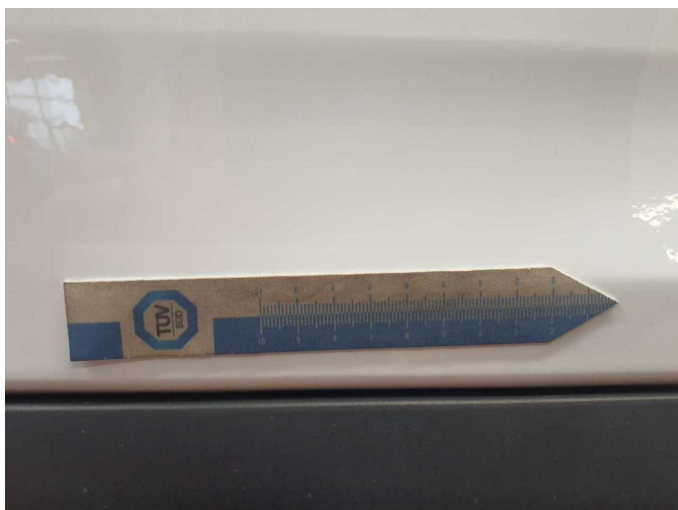
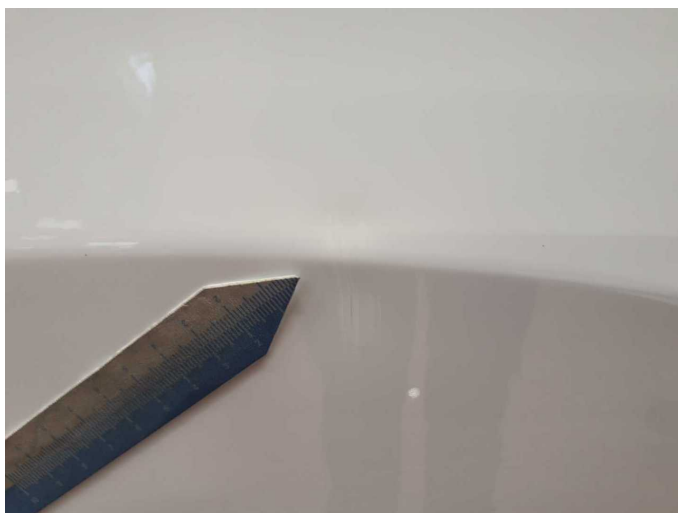
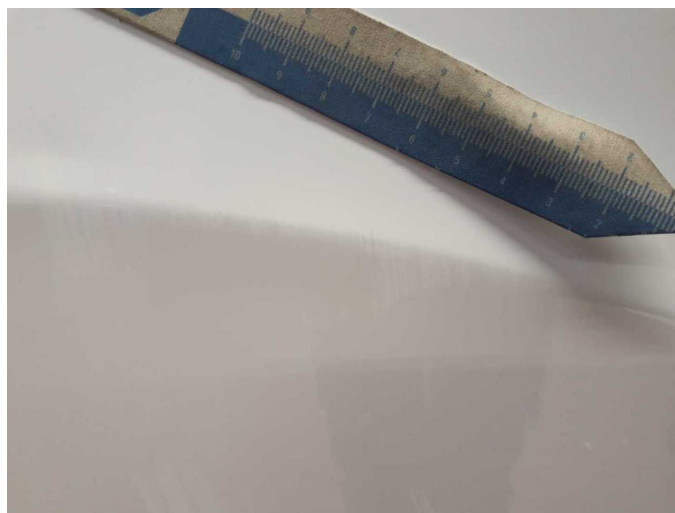
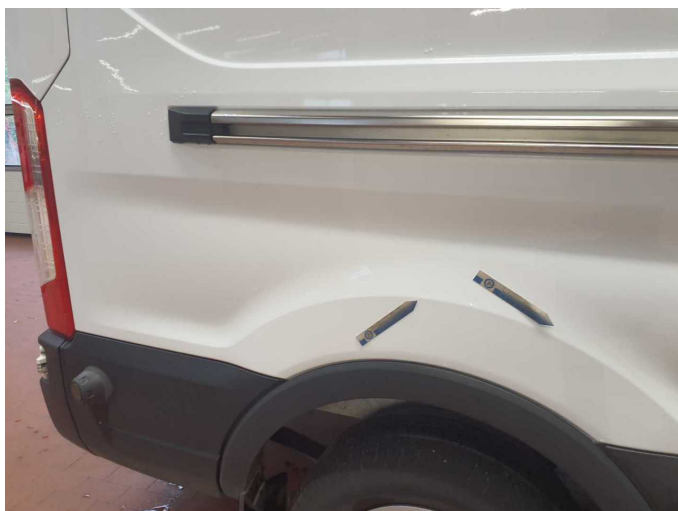
1 Rear, Side right

Accident 1: Rear, Side right

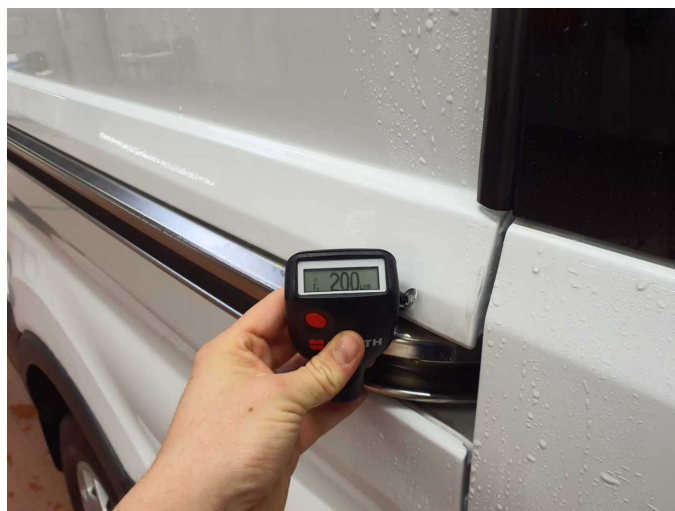
- Side panel - rear right side, Professionally carried out, Invoice of repair done Non-existent
- Door - rear right side, Professionally carried out, Invoice of repair done Non-existent

Side panel - rear right side	200 µm	Door - rear right side	204 µm
------------------------------	--------	------------------------	--------

Repainting 1: Side panel - rear right side
