Expertise

Protocol number: 41489908
Order No. / Reference: 25212949
Inspection date: 10 Sept 2025

Manufacturer: Ford	Model: Transit 350 L2H2 Lkw VA Trend
VIN: WF0EXXTTREKS27705

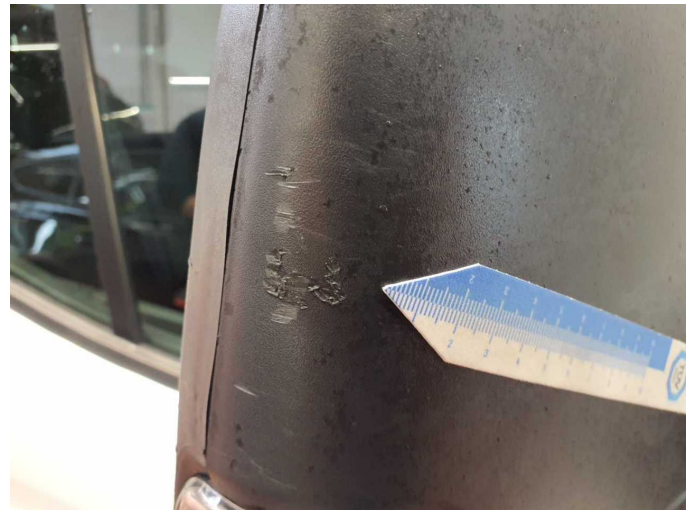
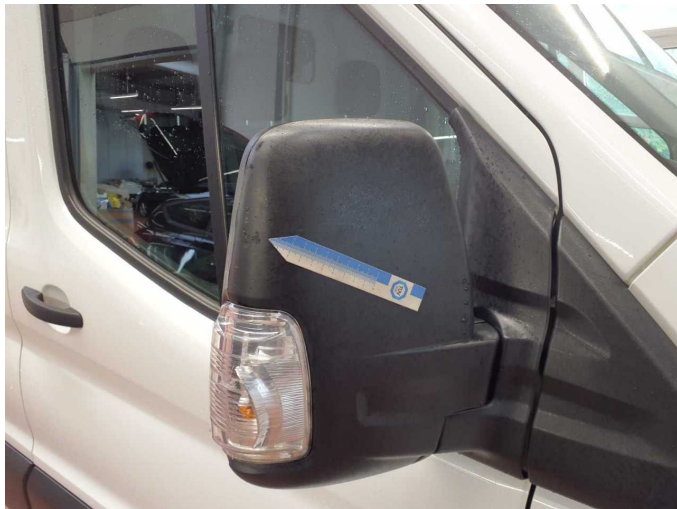
Damage 1: Wing mirror - right side: Cap - Scratch(es) - Replace

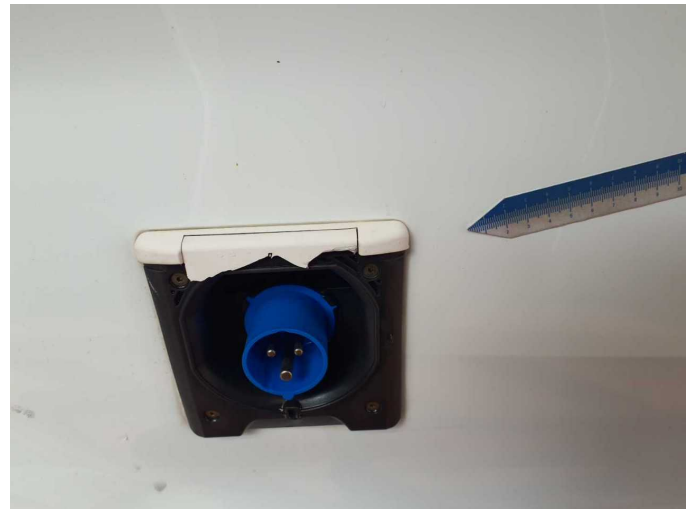
Damage 2: Electrical system: Power socket (Deckel) - Damaged - Replace

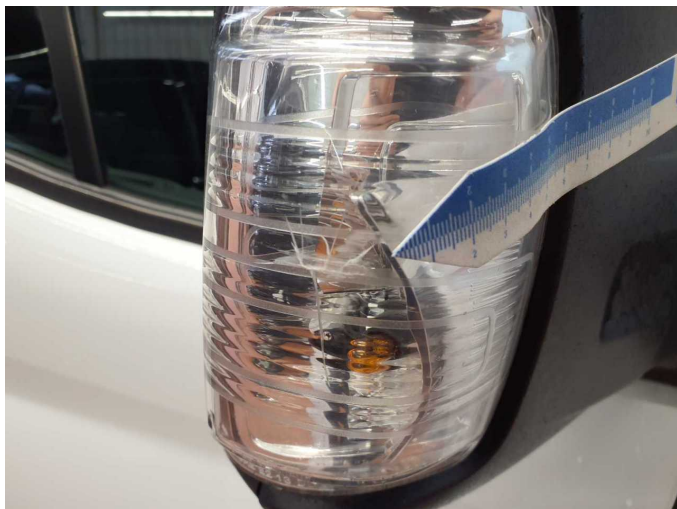
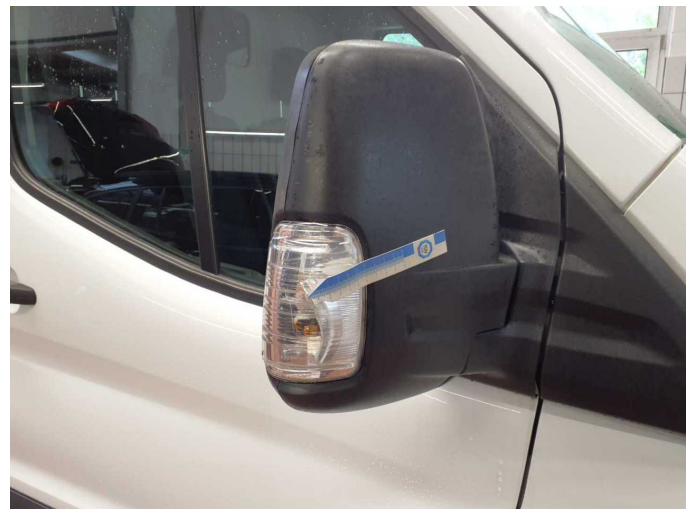
Damage 3: Indicator - front: Mirror - right side - Broken / torn - Replace

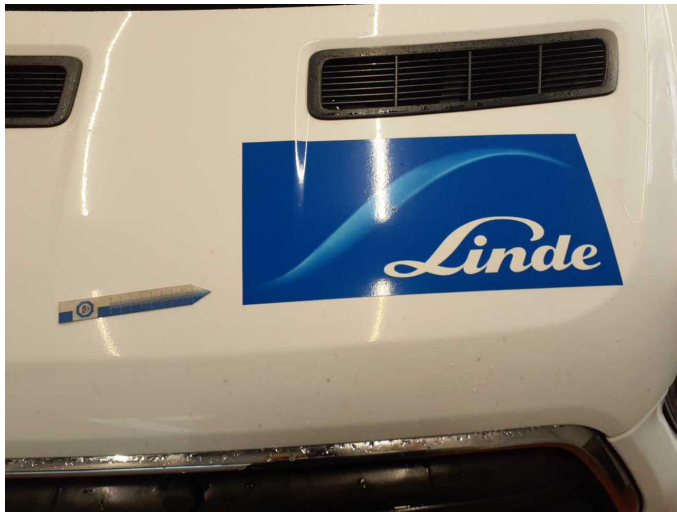
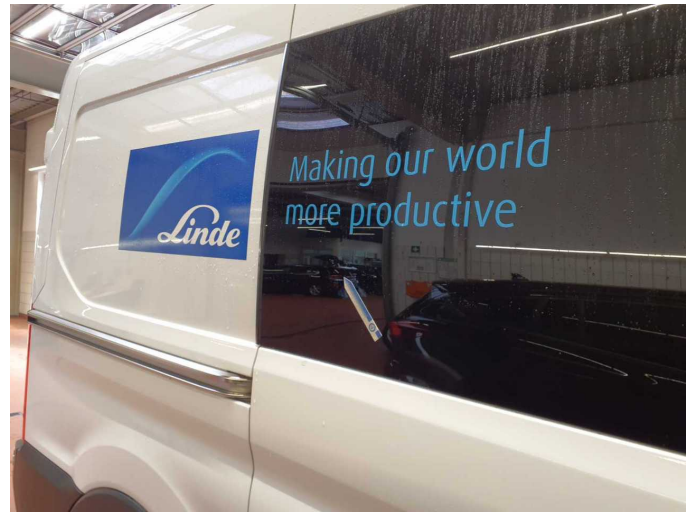
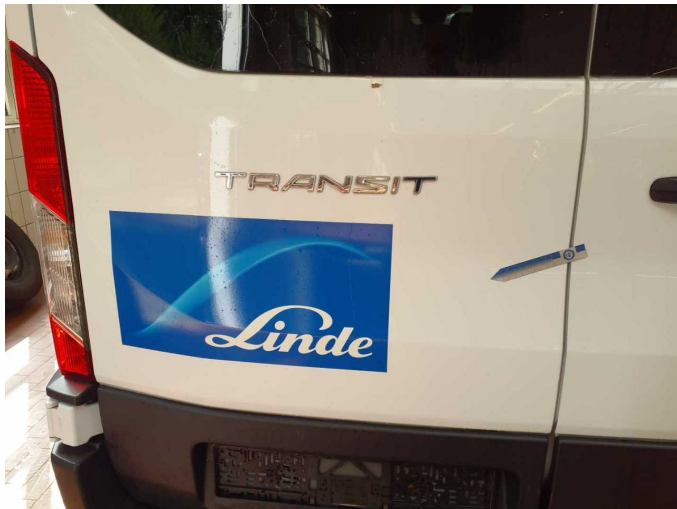
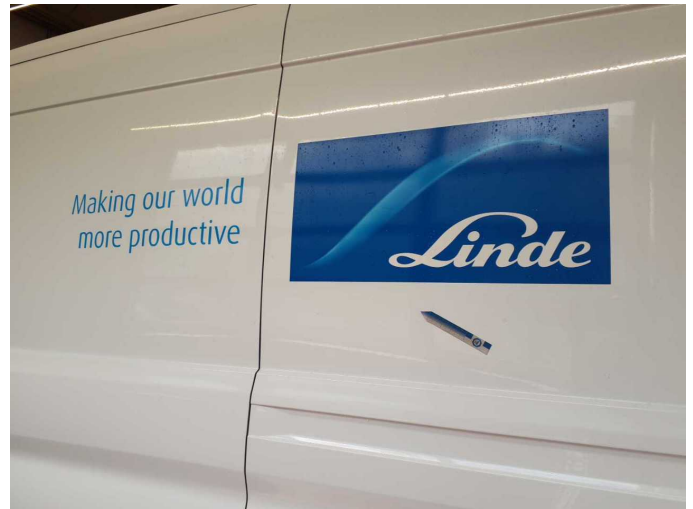
Damage 4: Body: Body - Glued / labelled - Remove

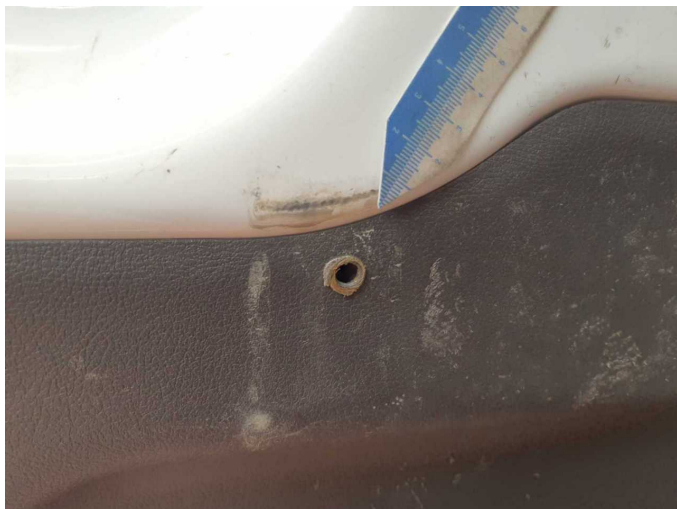
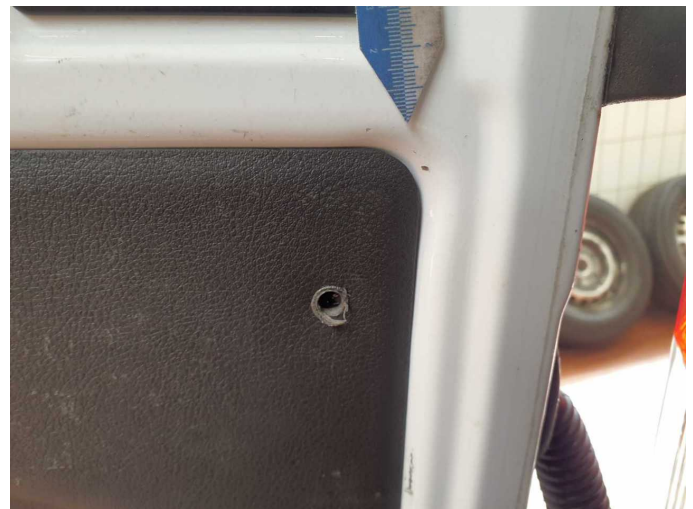
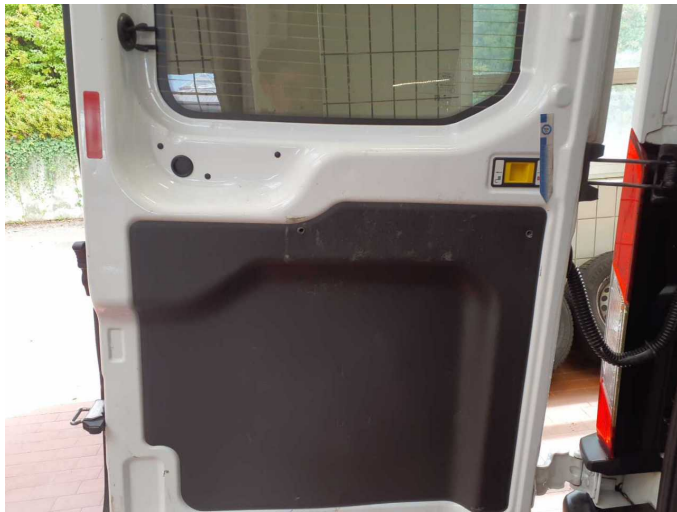
Damage 5: Boot lid / rear door: Trim - standard - lower - Holes - Replace

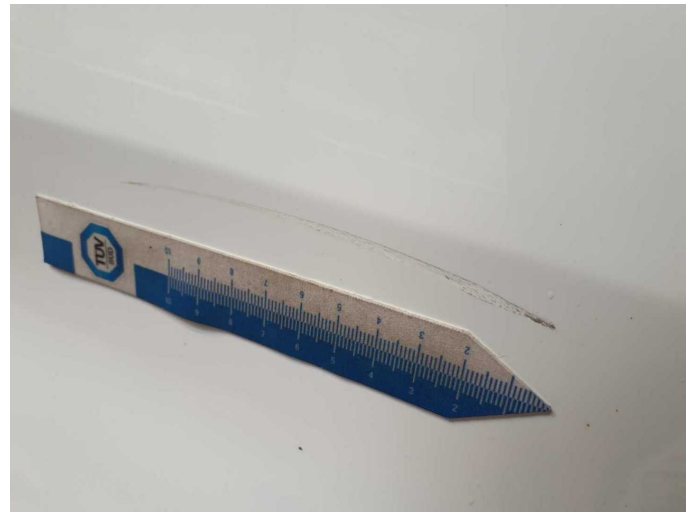
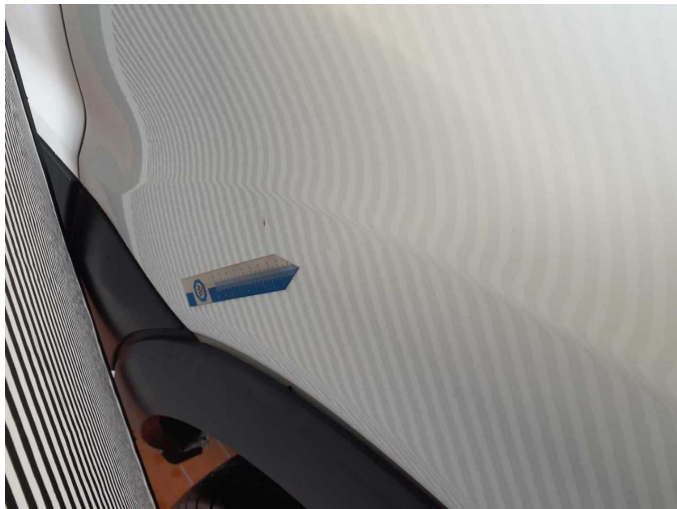
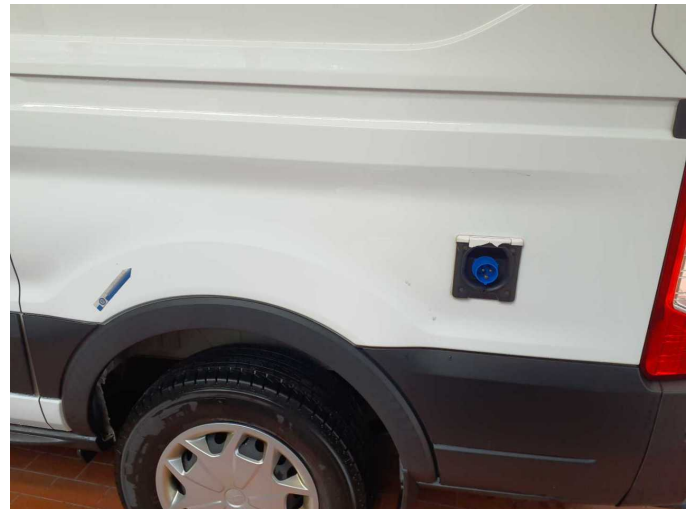
Damage 6: Side panel - rear left side: Side panel - Dent / paintcoat damage - Smart repair

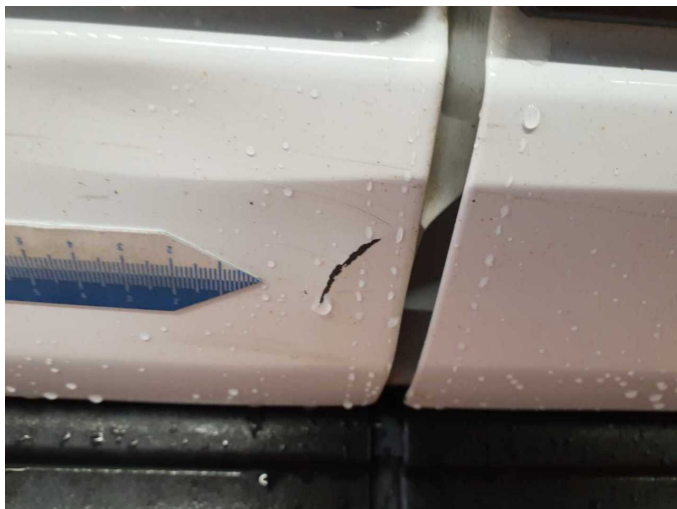
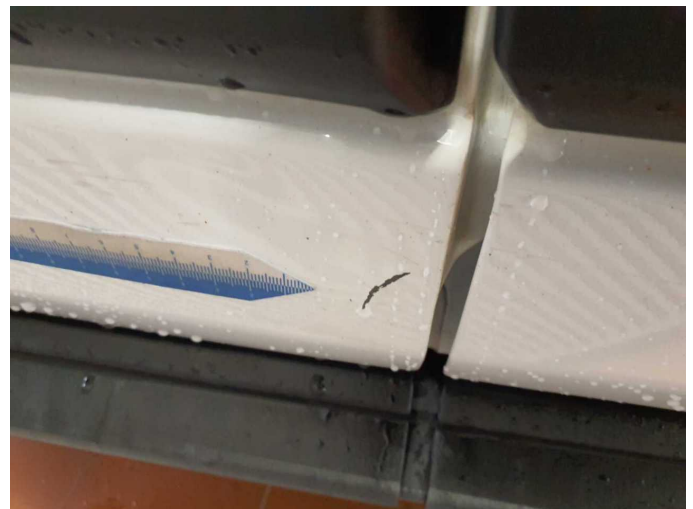
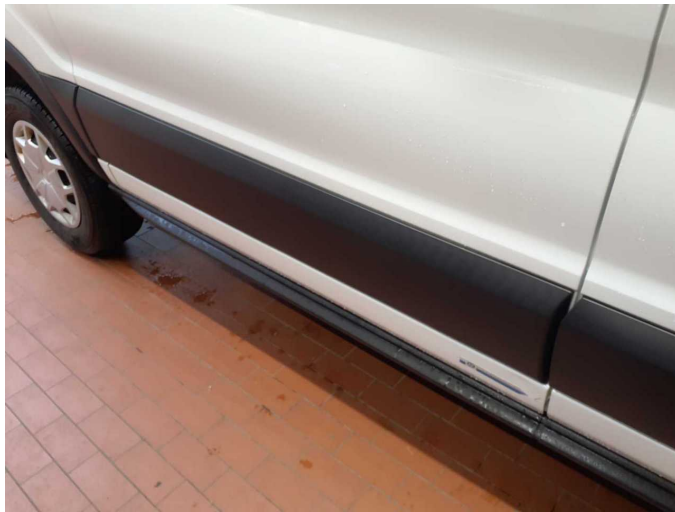
Damage 7: Sliding door, right: Sliding door with glass panel - Dent / paintcoat damage - Smart repair

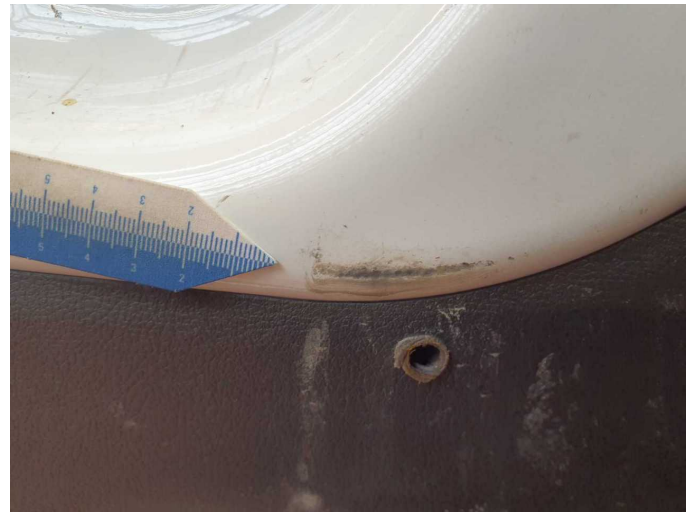
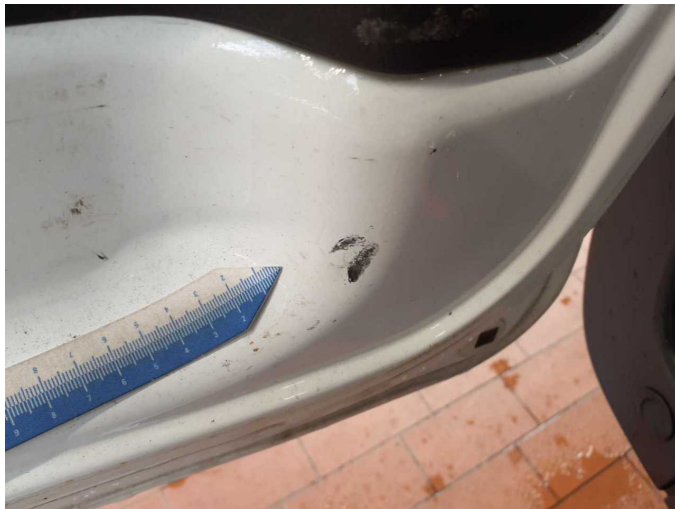
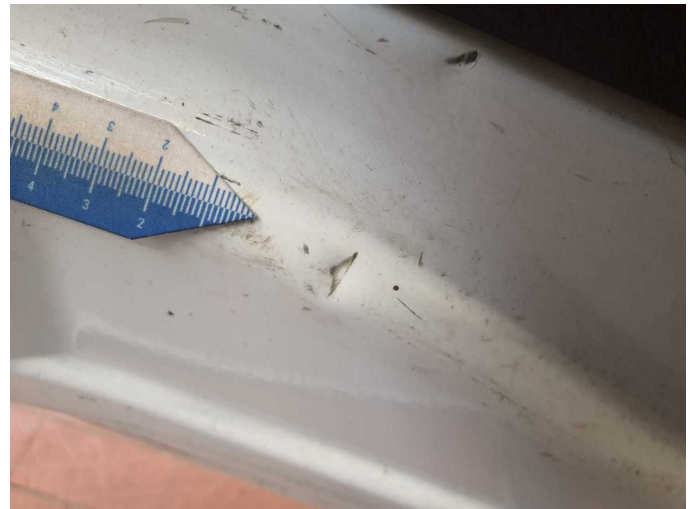
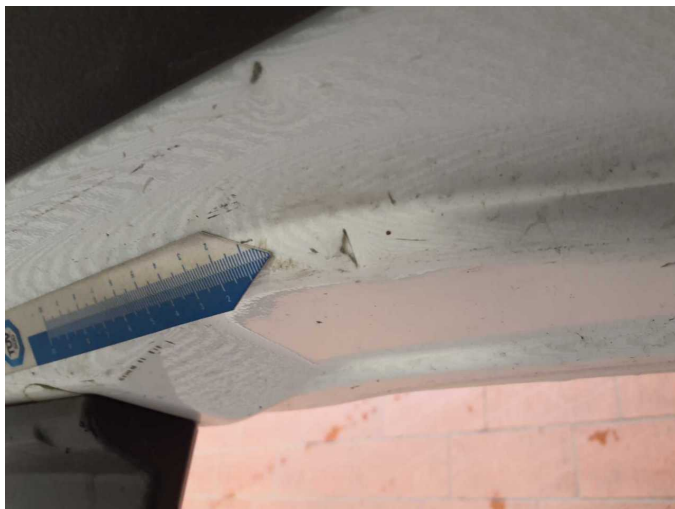
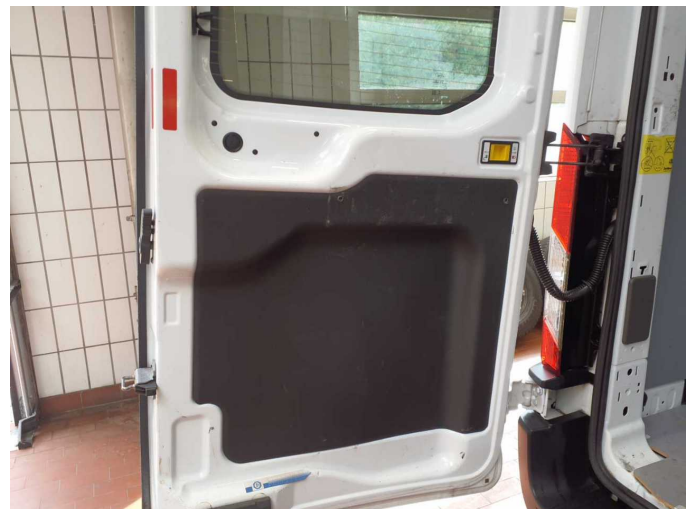
Damage 8: Boot lid / rear door: Rear door - left side - Dent / paintcoat damage - Repair and paint

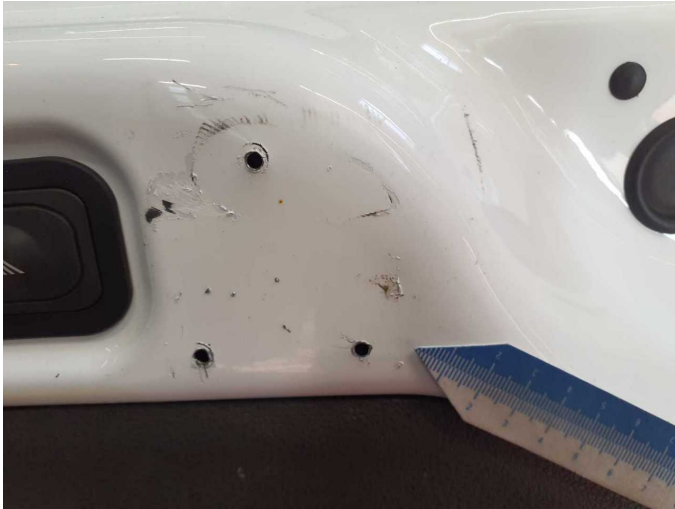
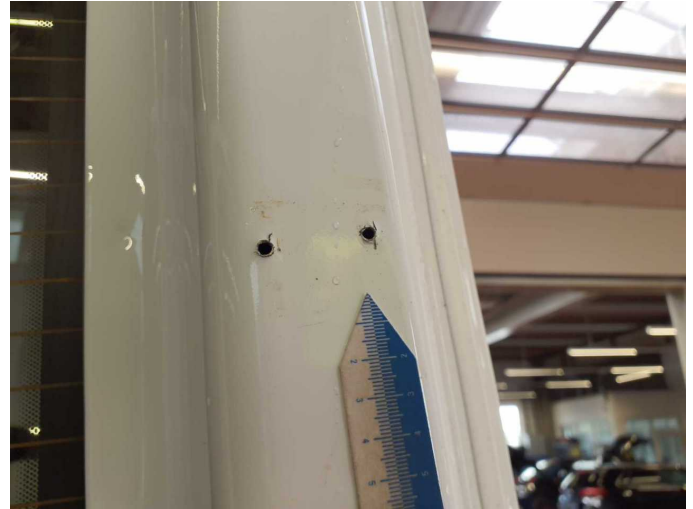
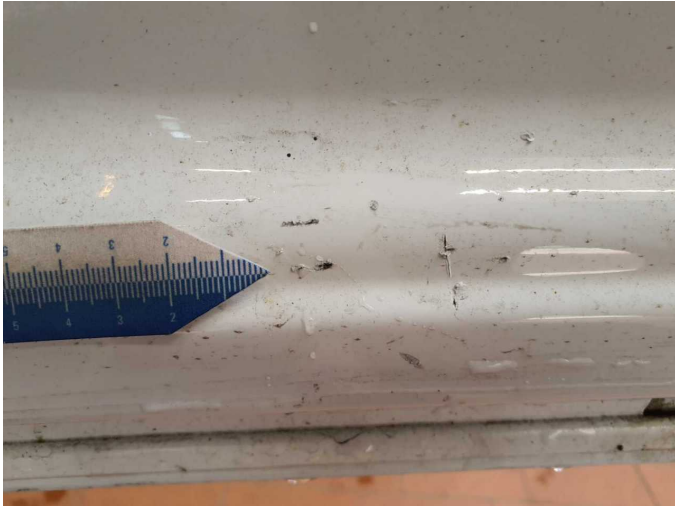
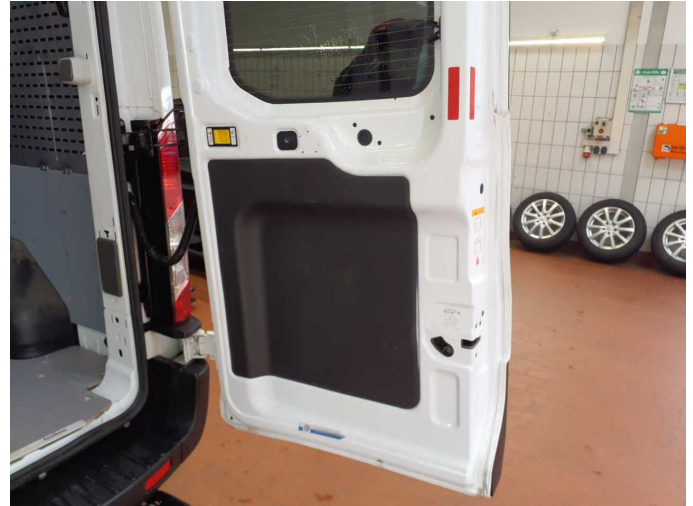
Damage 9: Boot lid / rear door: Rear door - right side (verschließen, lackieren) - Holes - Repair and paint

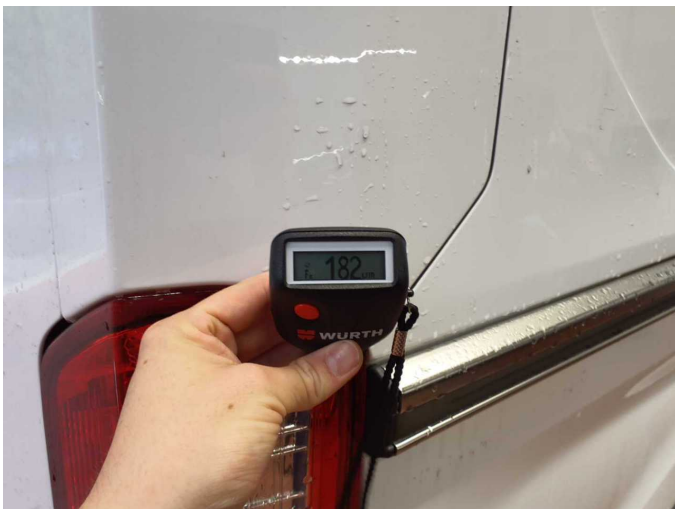
Side panel - rear right side	182 µm
------------------------------	--------

Repainting 1: Side panel - rear right side
