Expertise

Protocol number: 41588096  
Order No. / Reference: 25092359  
Inspection date: 16 Sept 2025

Manufacturer: Ford

Model: Transit 350 L3H3 VA Trend

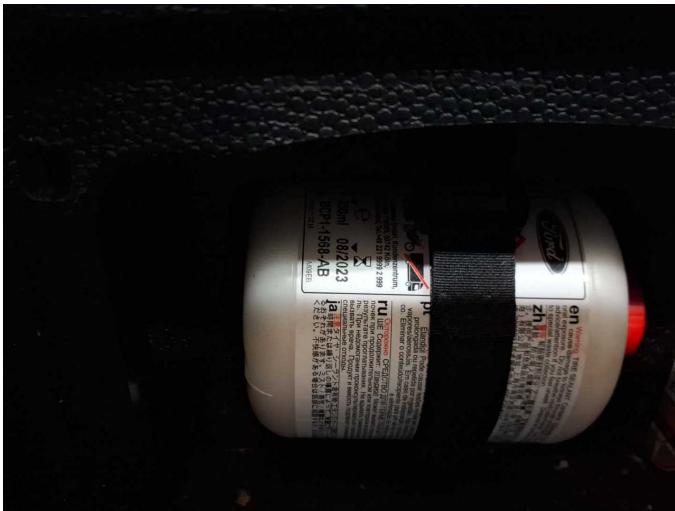
Damage 1: Equipment: Tirefit filler - Expired - Replace

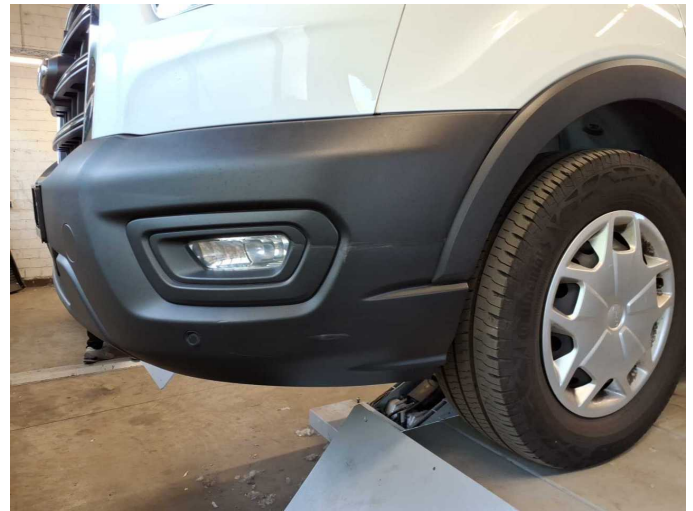
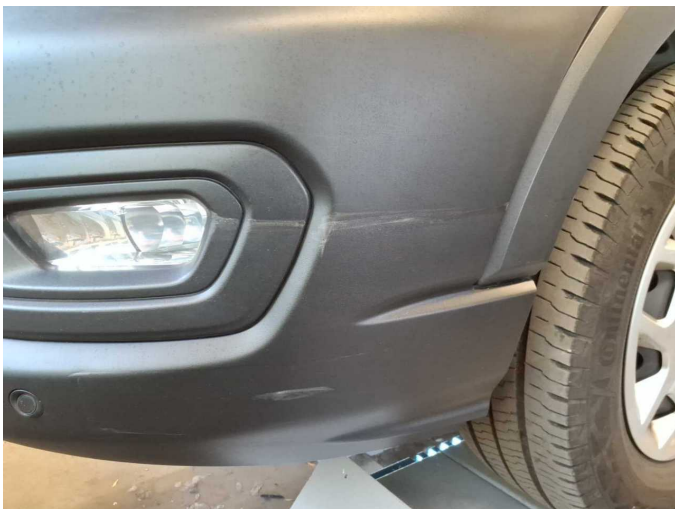
Damage 2: Front bumper: Front bumper (unpainted) - Scratch(es) - Loss in value

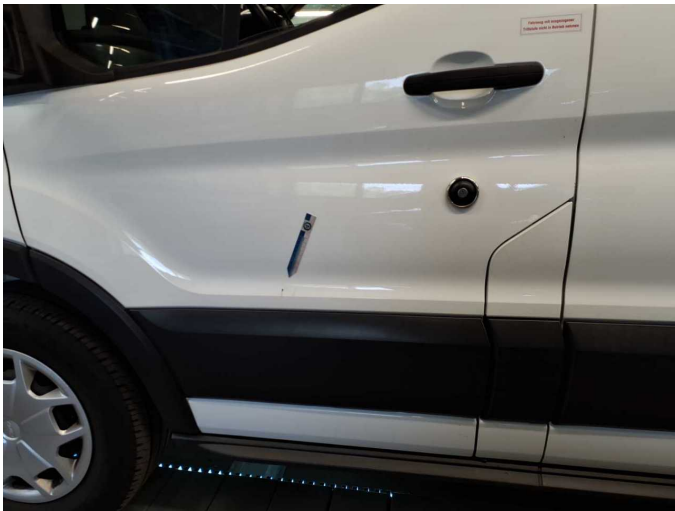
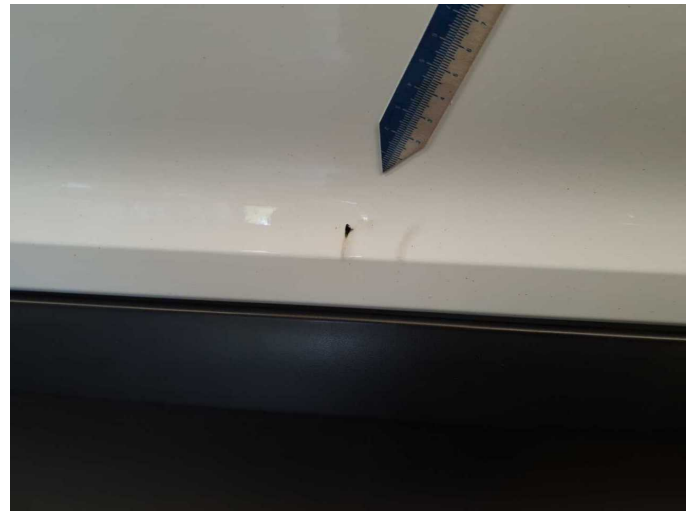
**Damage 4:** Door - front left side: Door - Scratch(es) - Smart repair

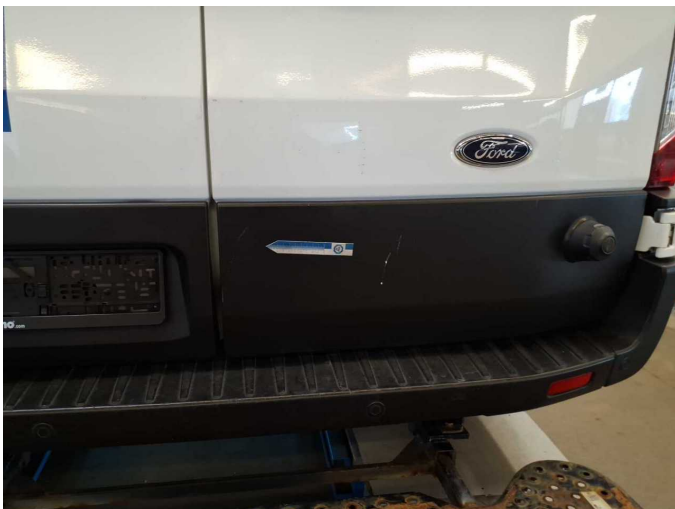
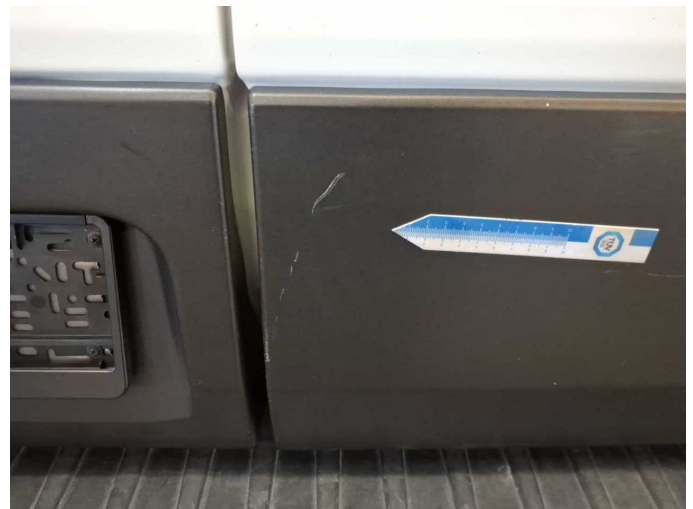
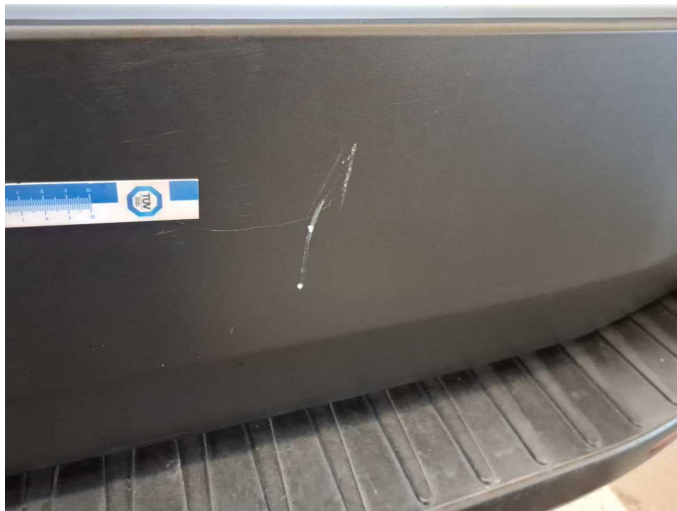
**Damage 5:** Boot lid / rear door: Rear door - right side (Verkleidung Rechts) - Scratch(es) - Replace

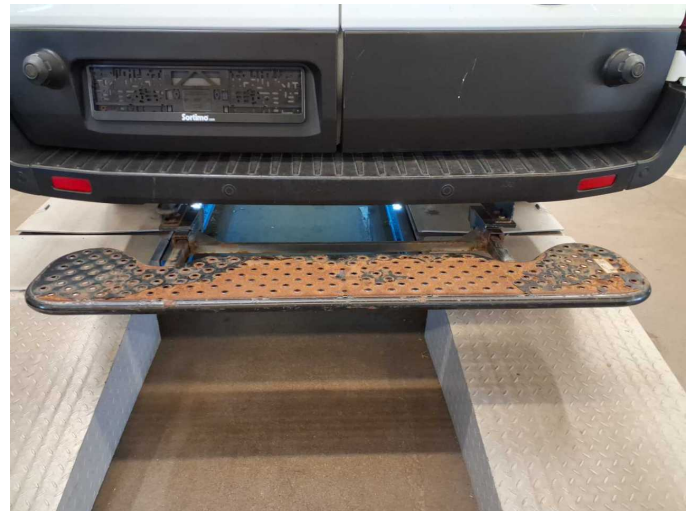
**Damage 6:** Rear of vehicle: Foot plate - Corrosion - Smart repair

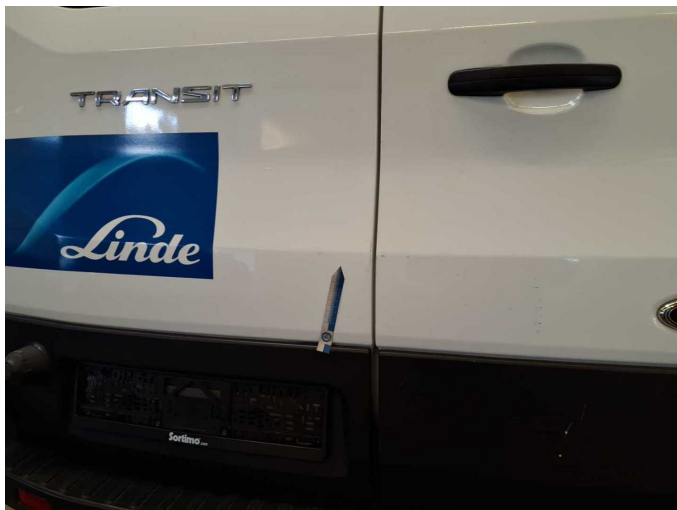
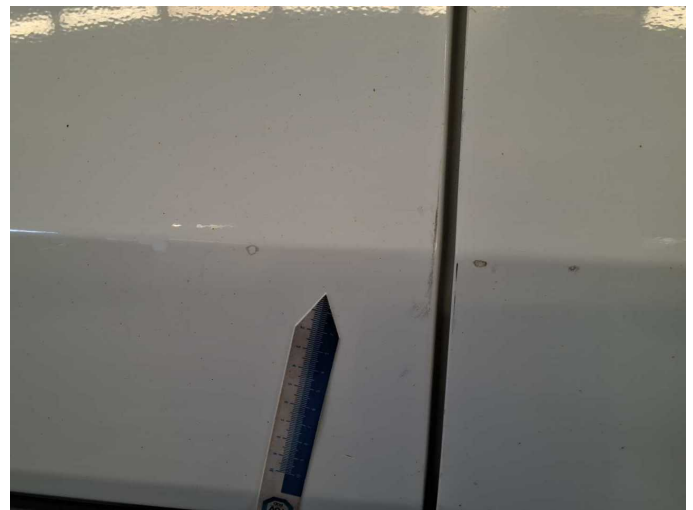
**Damage 7:** Boot lid / rear door: Rear door - left side - Scratch(es) - Smart repair

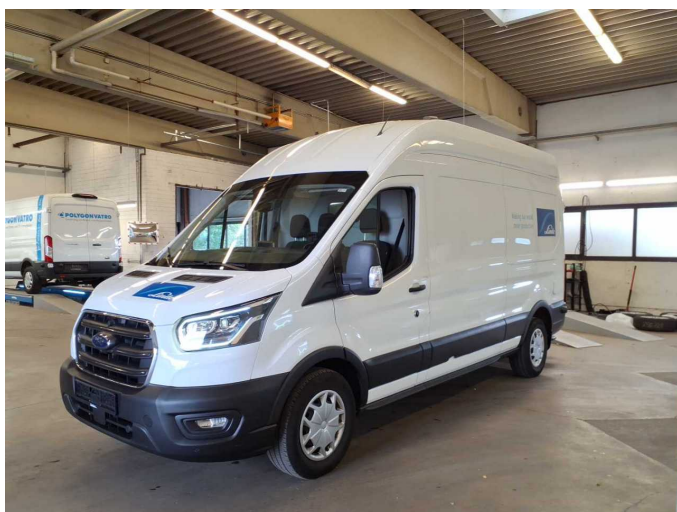
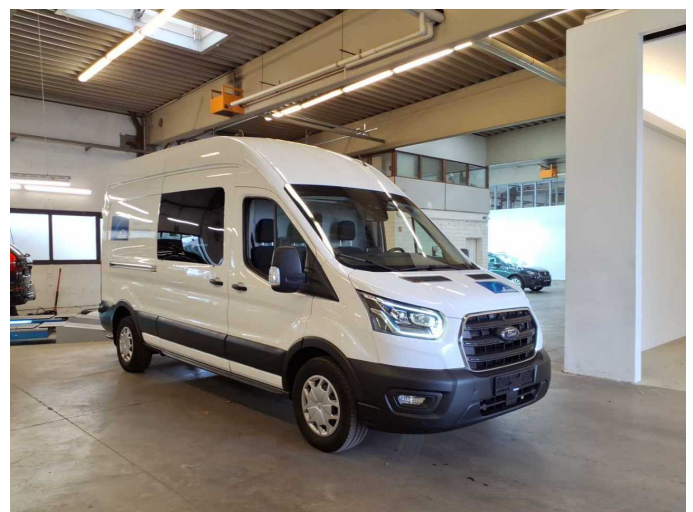
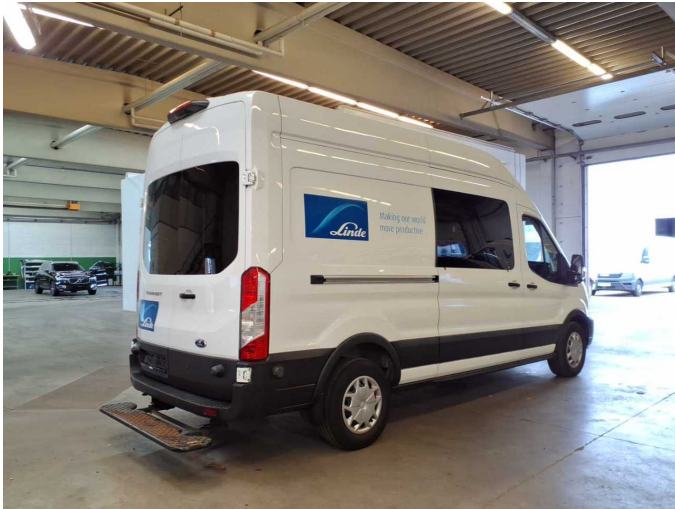
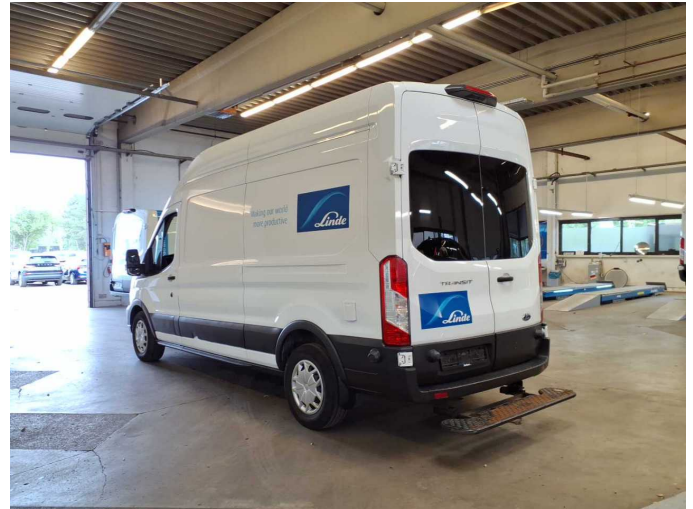
**Damage 8:** Body: Body - Glued / labelled - De-glue / neutralise

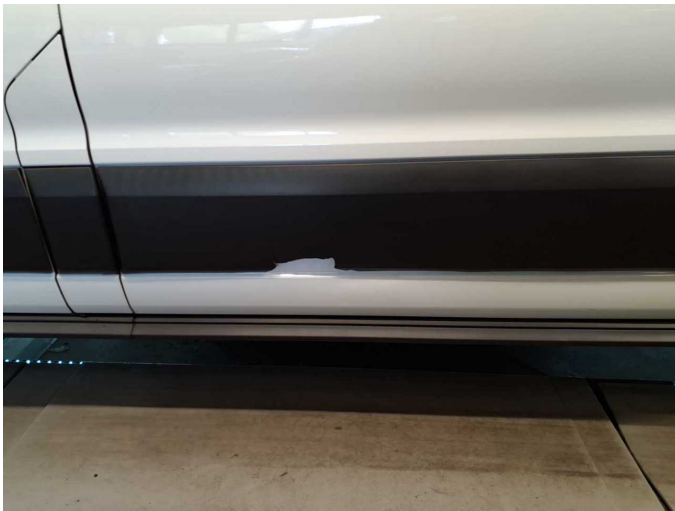
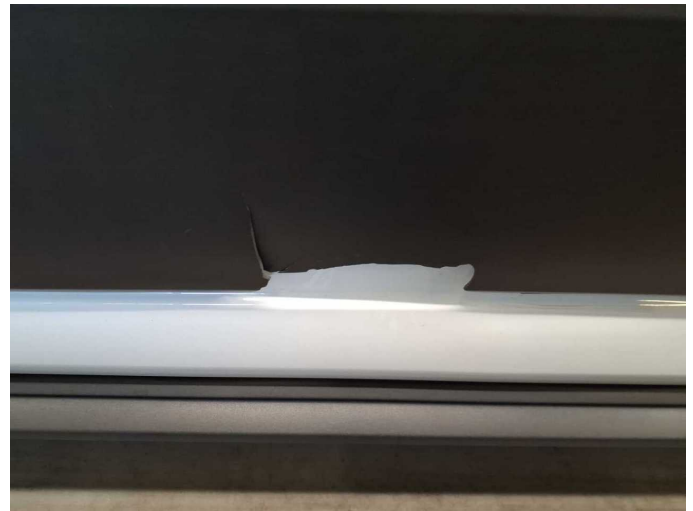
**Damage 9:** Side panel - rear left side: Brightware - Broken / torn - Replace

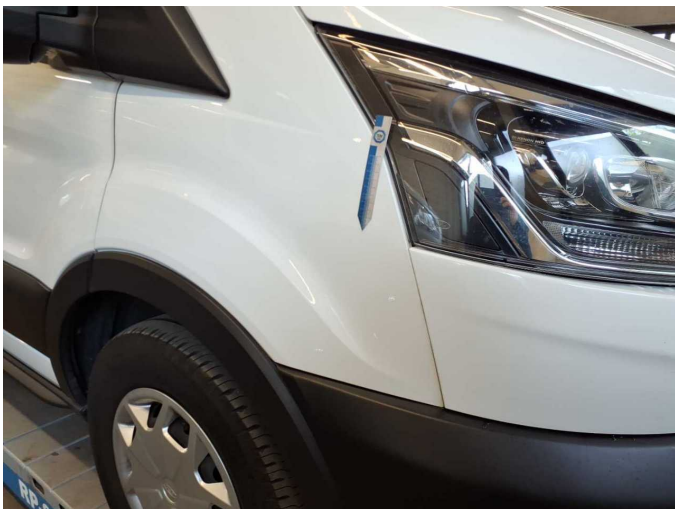
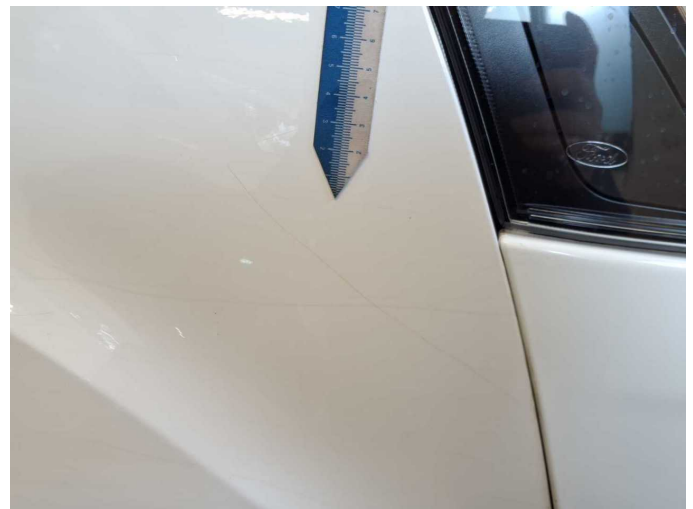
**Damage 10:** Mudguard - right side: Mudguard - right side - Scratch(es) - Paint

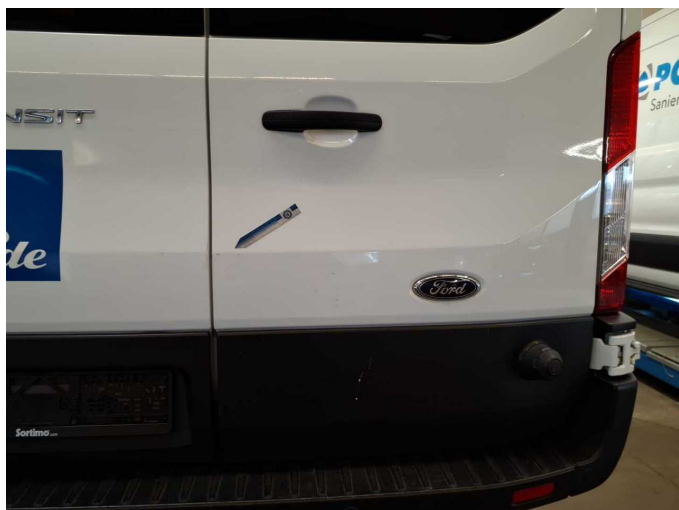
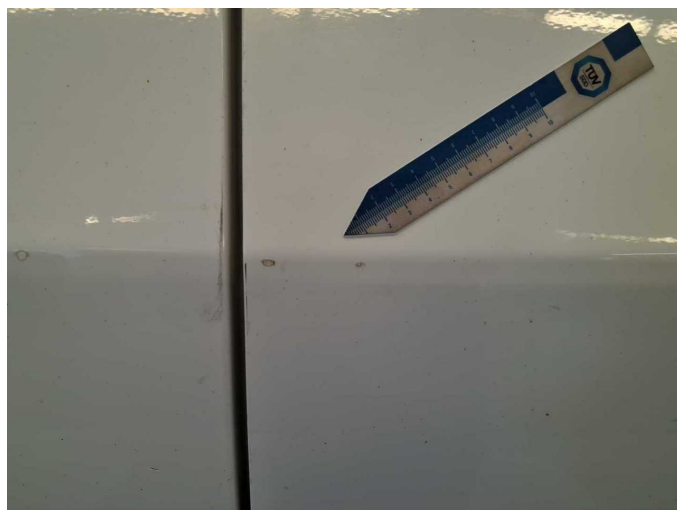
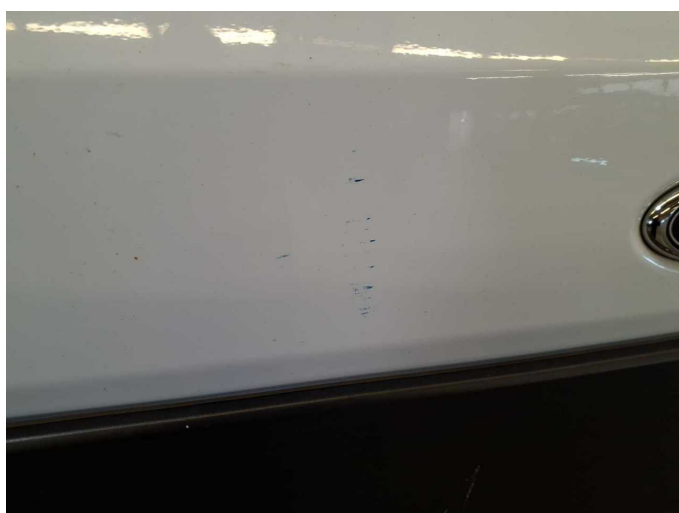
**Damage 11:** Boot lid / rear door: Boot lid (Rechts) - Scratch(es) - Paint

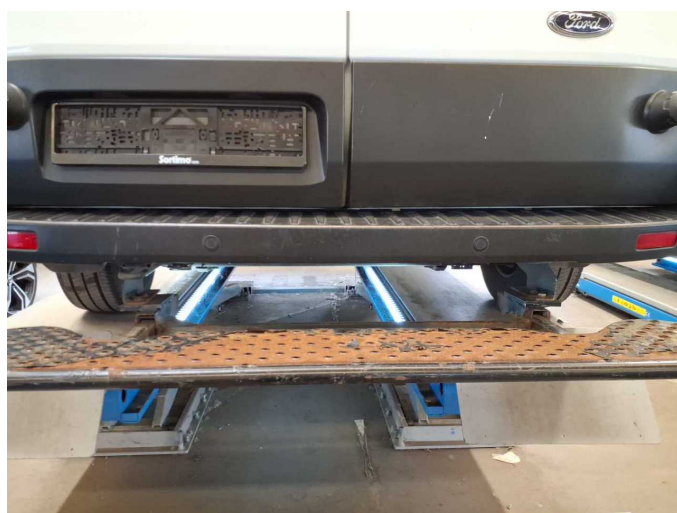
**Missing part 2:** Trailer hitch: Trailer hitch - Missing - Replace

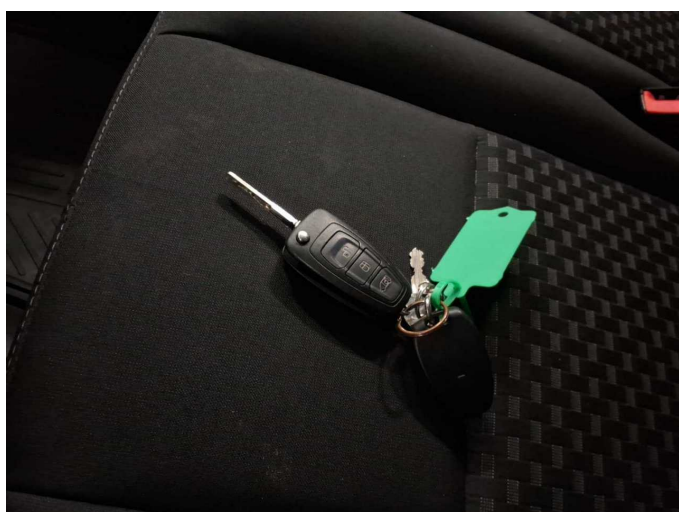
**Missing part 3:** Equipment: Vehicle key - Missing - Replace
