Expertise

Protocol number: 41778046  
Order number / reference: 25180982  
Inspection date: 26 Sept 2025

Manufacturer: Ford

Model: Transit 350 L3H2 Kasten Lkw VA Basis

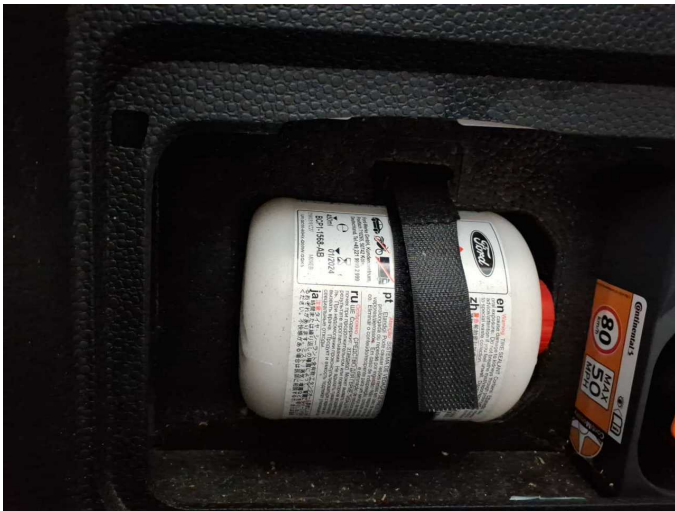
| No. | Component group | Description |
|---|---|---|
| 1 | Equipment | Tirefit filler - Expired - Replace |

Damage 1: Equipment: Tirefit filler - Expired - Replace

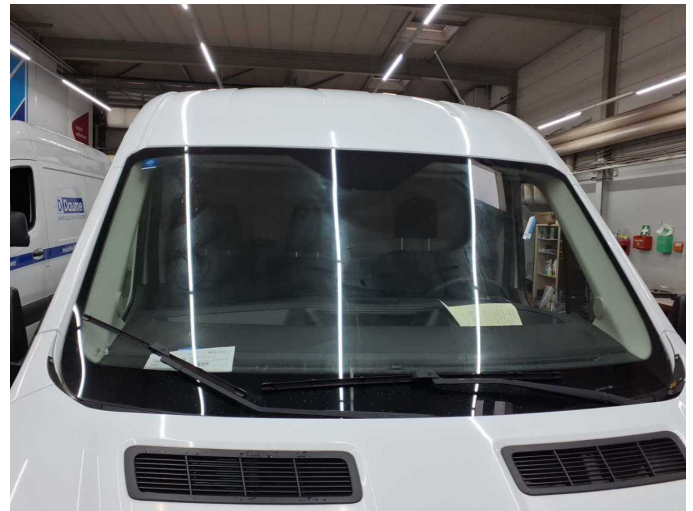
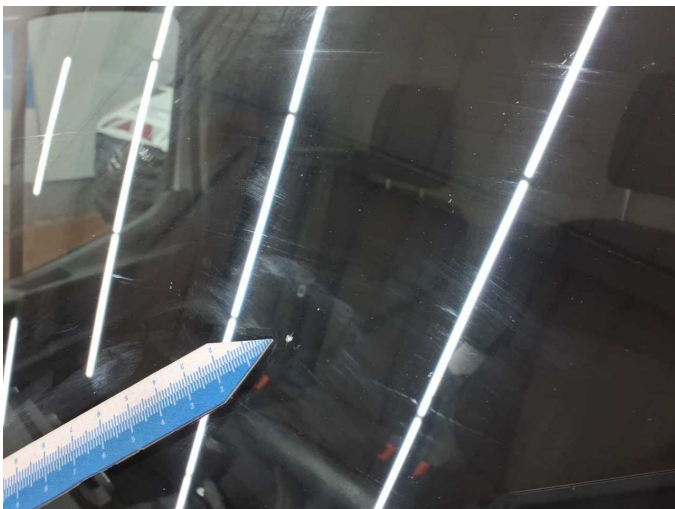
| No. | Component group | Description |
|---|---|---|
| 2 | Vehicle glazing | Windscreen - Stone chips - Replace |

Damage 2: Vehicle glazing: Windscreen - Stone chips - Replace

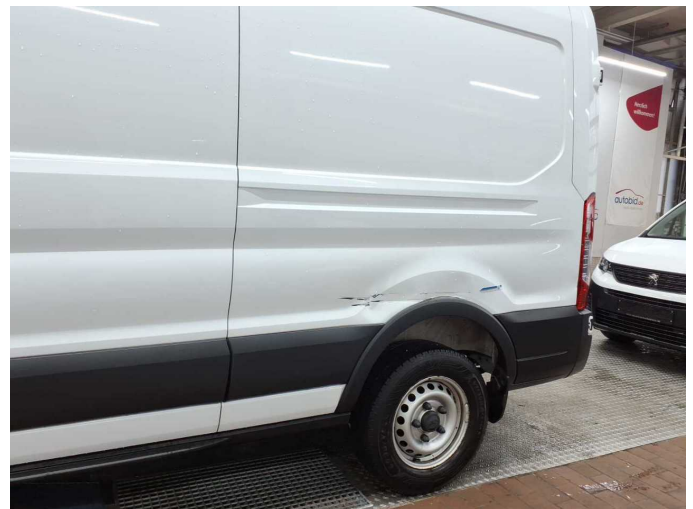
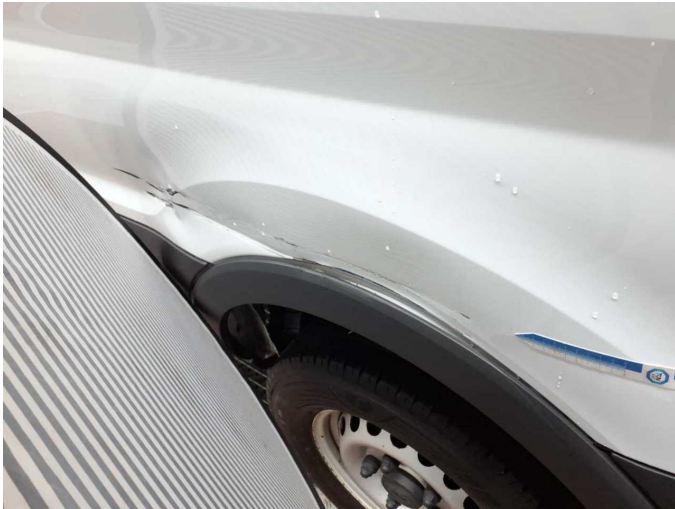
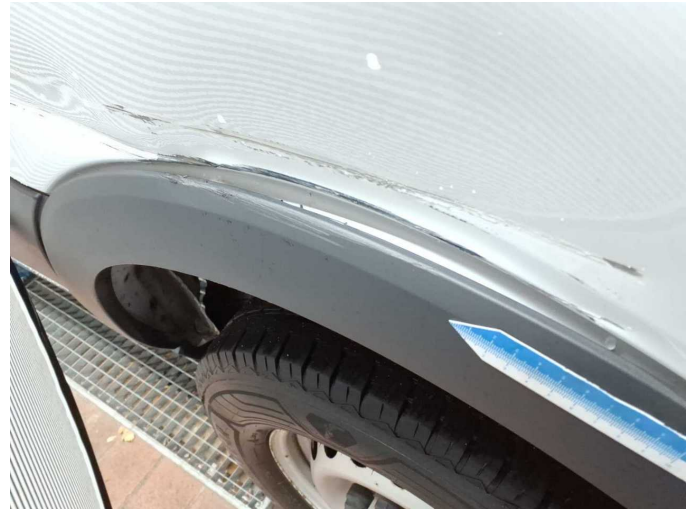
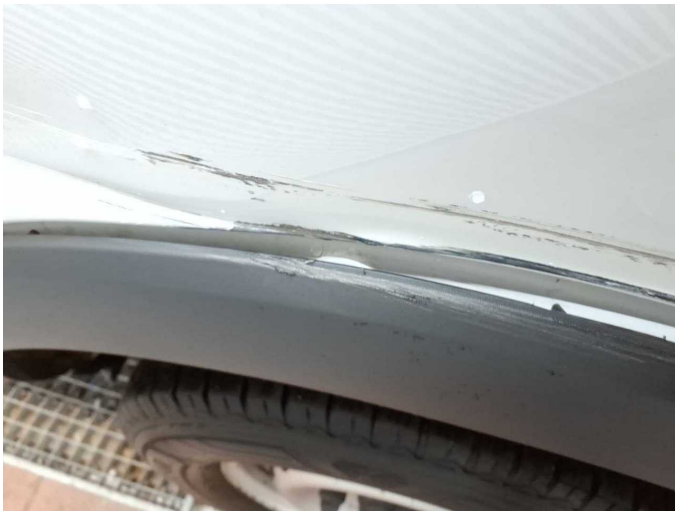
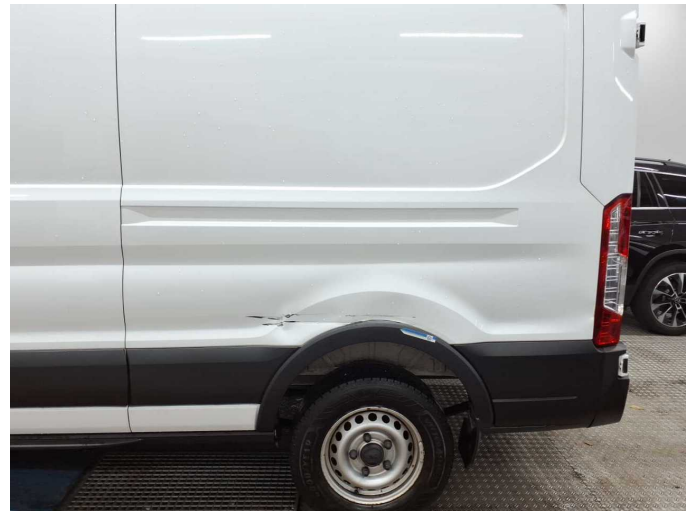
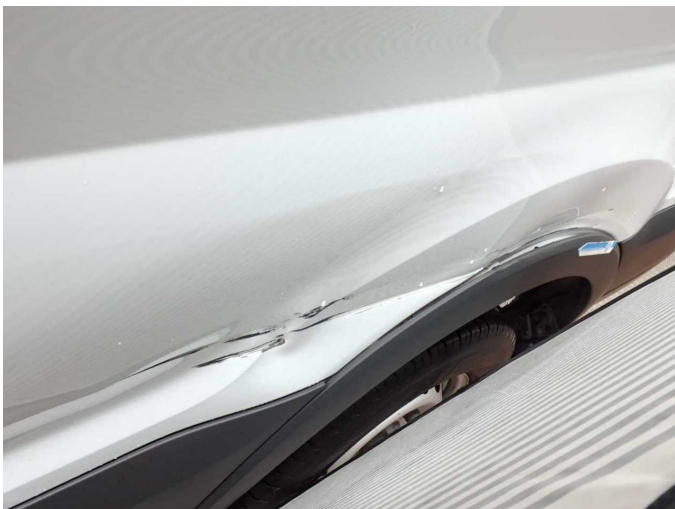
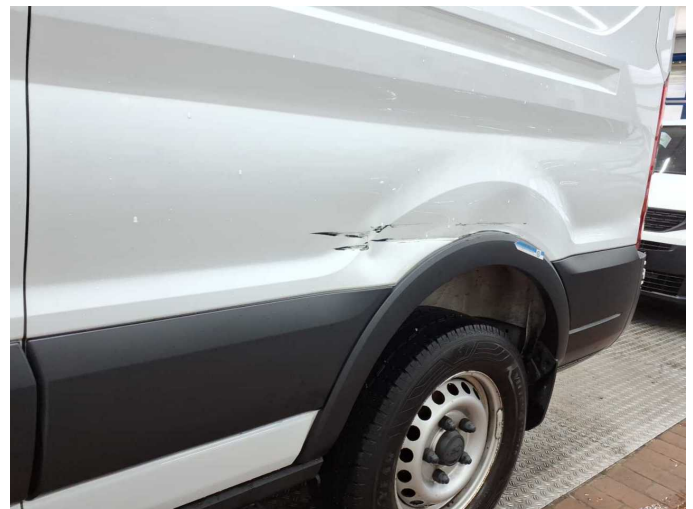
| No. | Accident |
|---|---|
| 1 | Side - left |

Accident 1: Side - left

**Accident 1: Side - left**

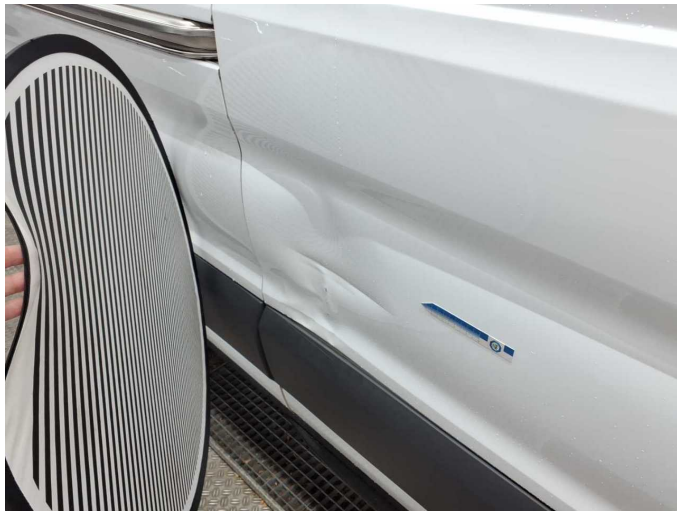
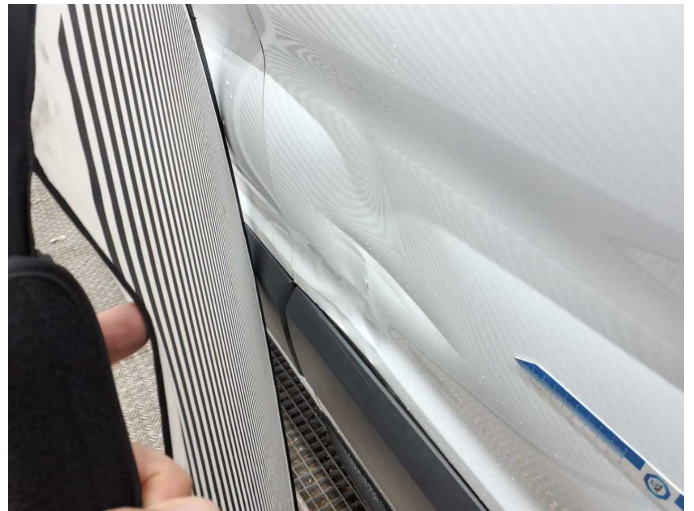
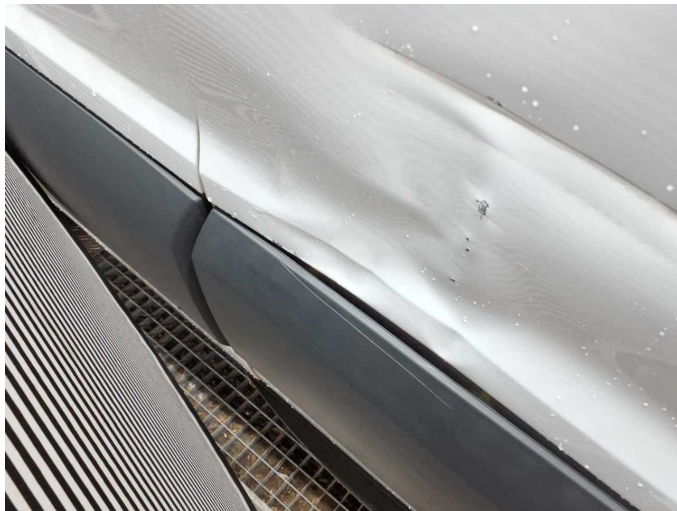
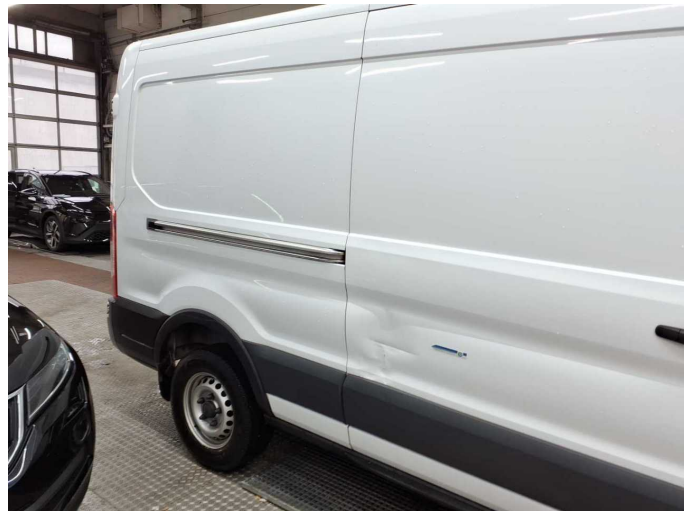
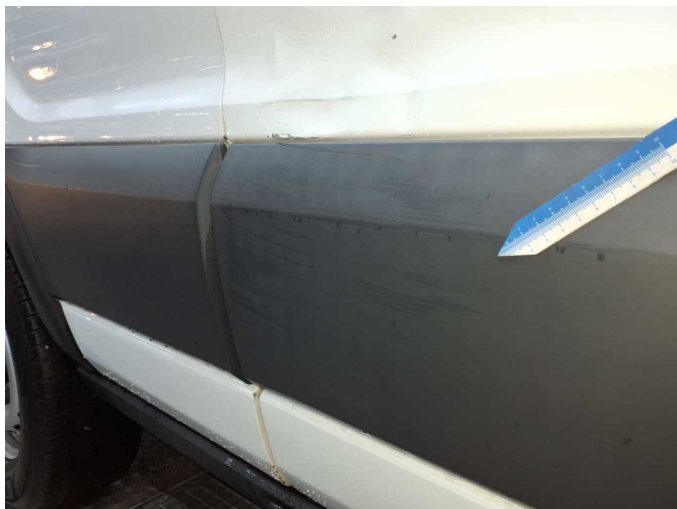
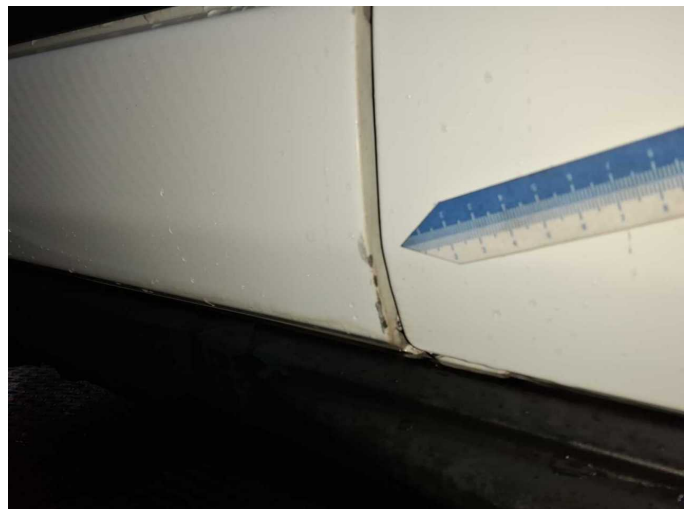
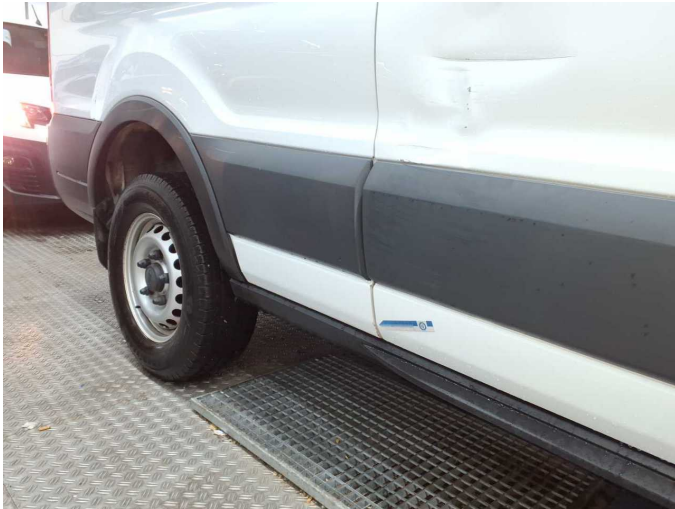
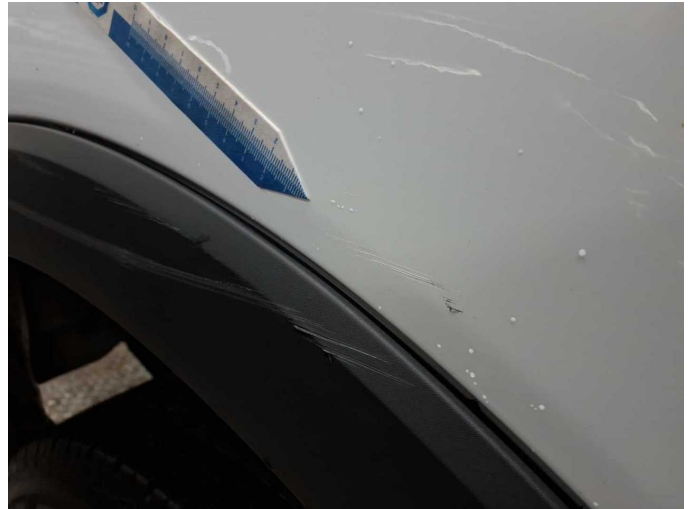
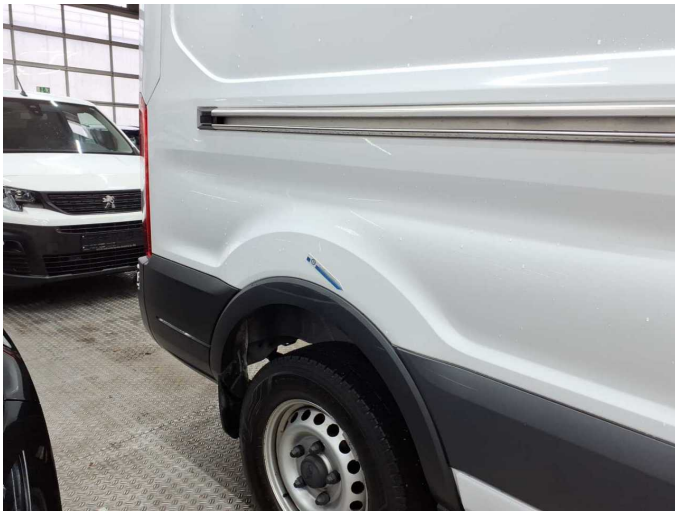
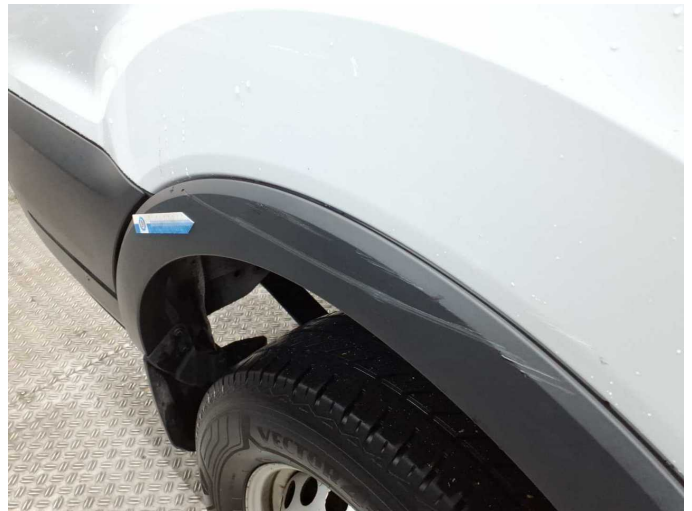
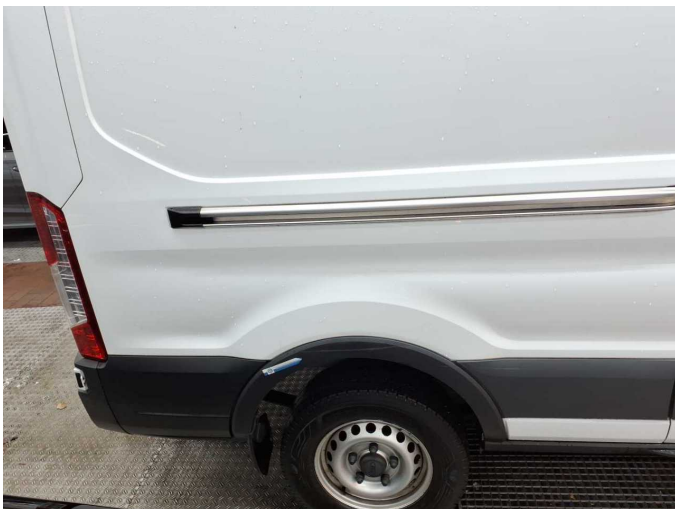
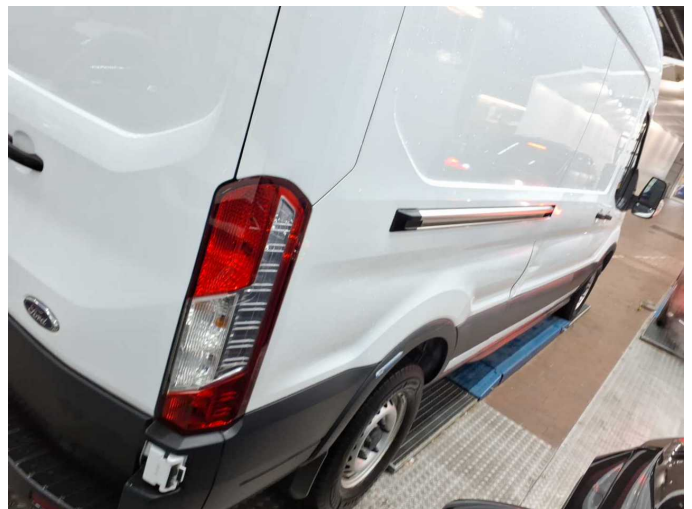
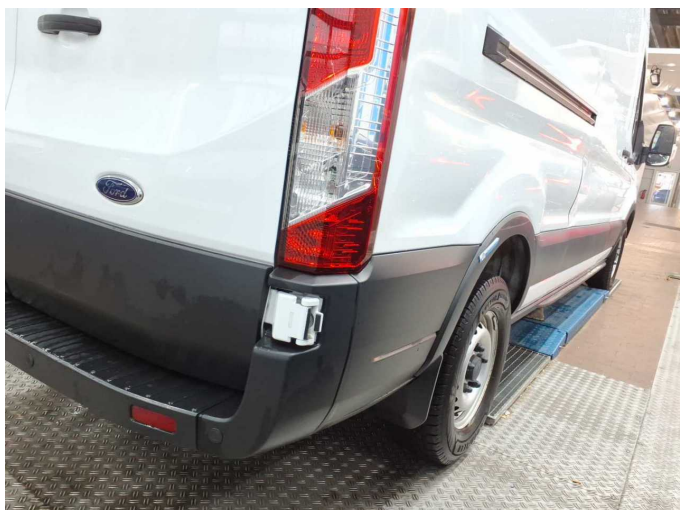
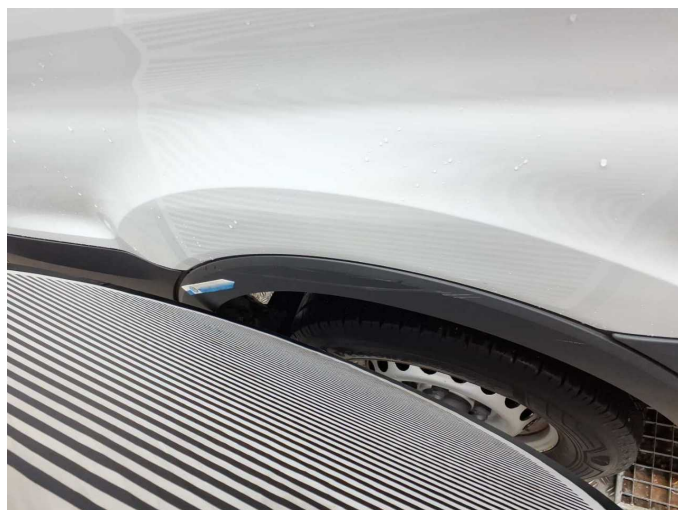
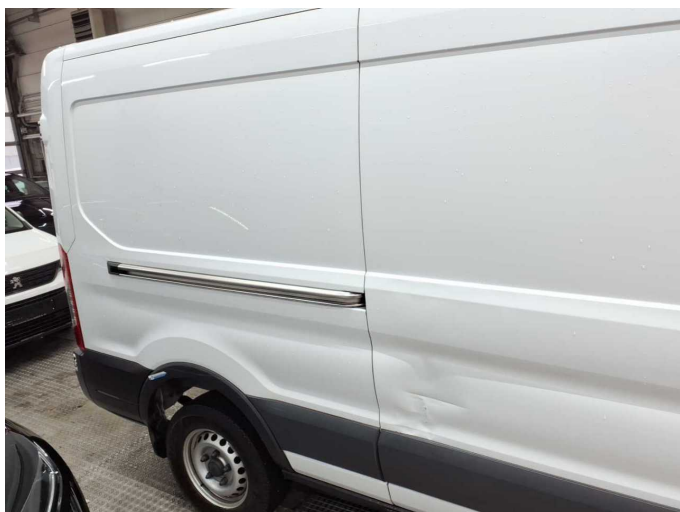
| No. | Accident |
|---|---|
| 2 | Side right |

**Accident 2: Side right**
