Expertise

Protocol number: 41576943
Order No. / Reference: 25137331
Inspection date: 16 Sept 2025

Manufacturer: Ford	Model: Transit 350 Kasten L2H2 Lkw VA Trend
VIN: WF0EXXTTREL41603

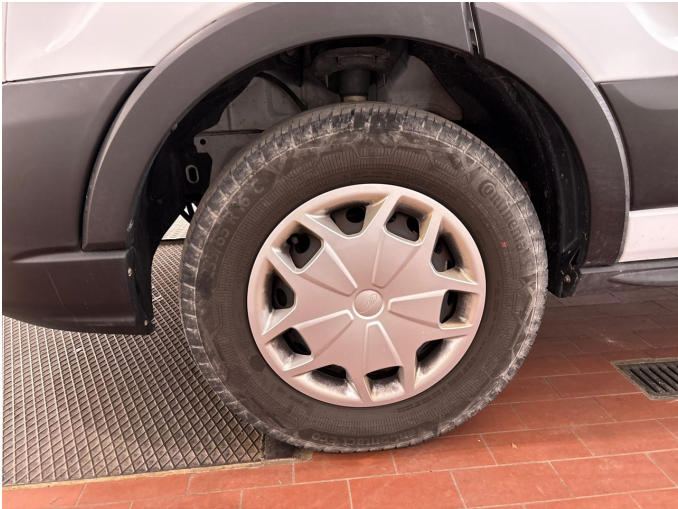
#	Tyre size	Type of tyre	Manufacturer	Tread depth
1)	235/65 R16 115R	Summer tyres on Steel rim with wheel cover	Continental	4mm / 4mm
2)	235/65 R16 115R	Summer tyres on Steel rim with wheel cover	Continental	5mm / 5mm

Figure 12: Mounted tyres

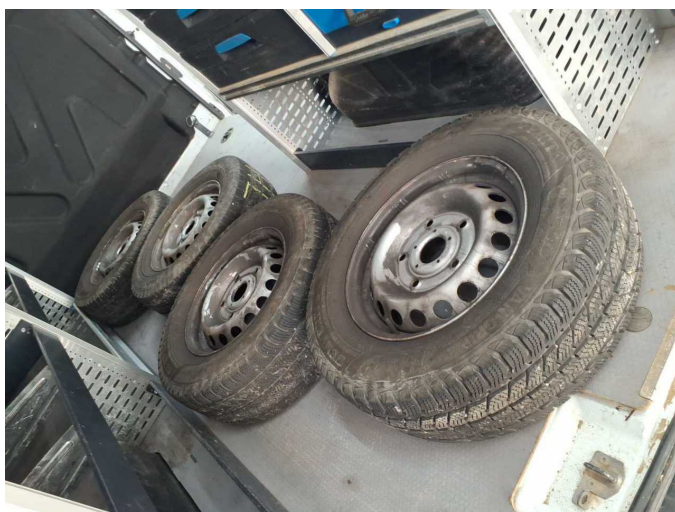
#	Tyre size	Type of tyre	Manufacturer	Tread depth
1)	235/65 R16 115R	Winter tyres on Steel	Semperit	6mm / 6mm
2)	235/65 R16 115R	Winter tyres on Steel	Semperit	6mm / 6mm

Figure 17: Additional tyres

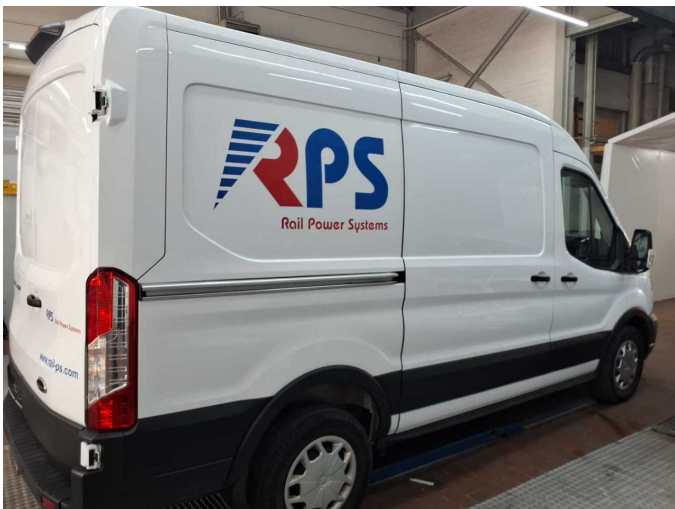
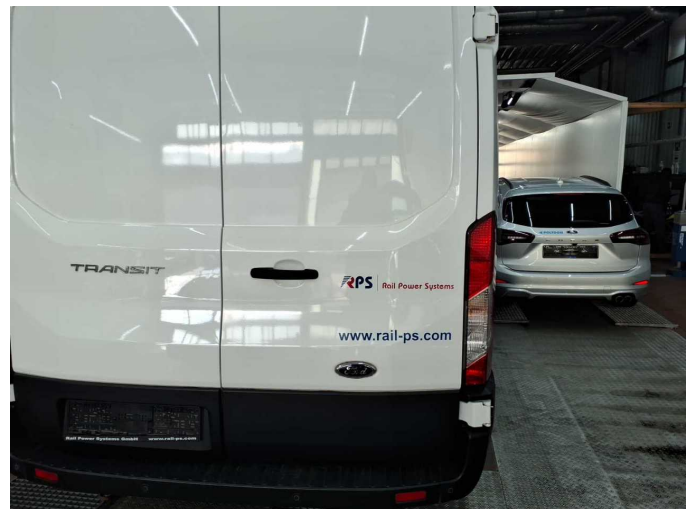
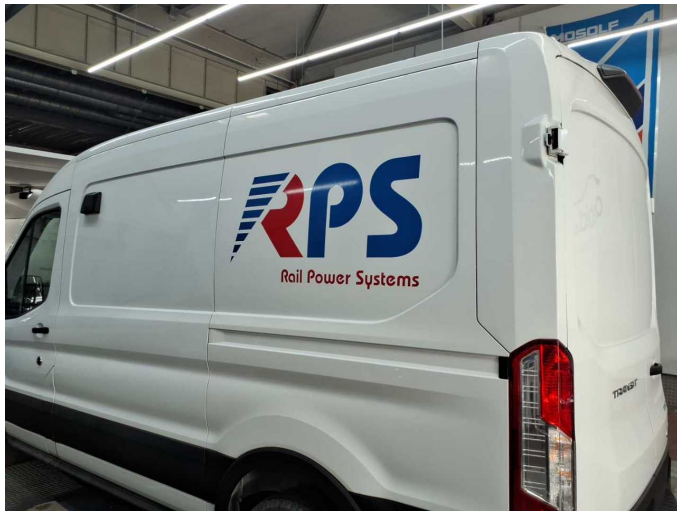
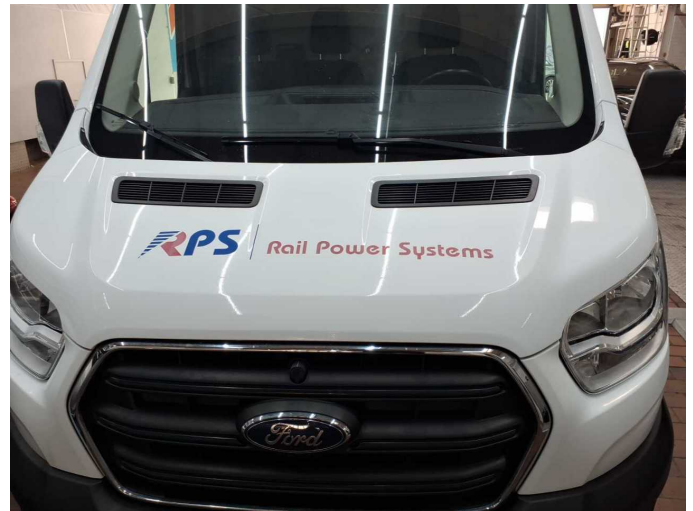
No.	Component group	Description
1	Body	Body - Glued / labelled - De-glue / neutralise
2	Front bumper	Front bumper - Broken / torn - Replace

Damage 1: Body: Body - Glued / labelled - De-glue / neutralise

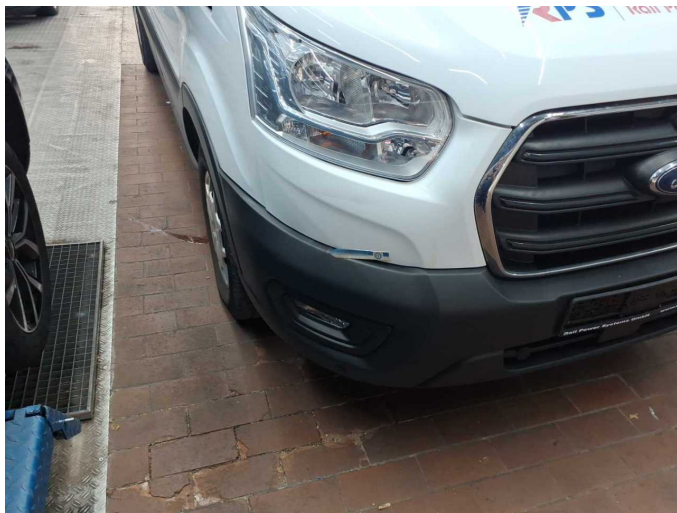
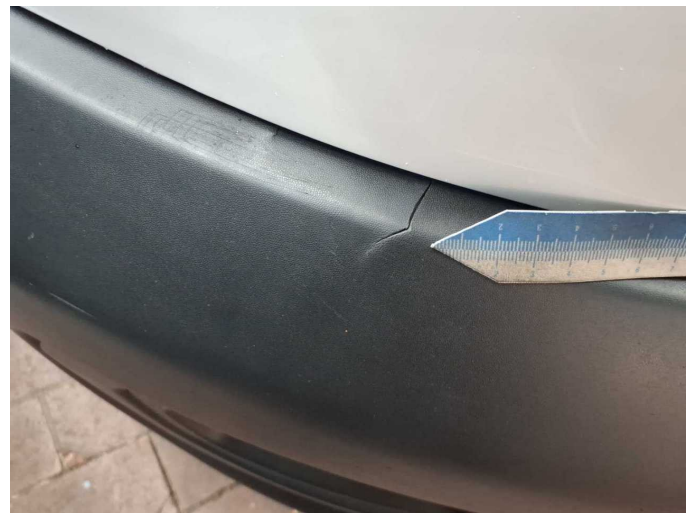
Damage 2: Front bumper: Front bumper - Broken / torn - Replace

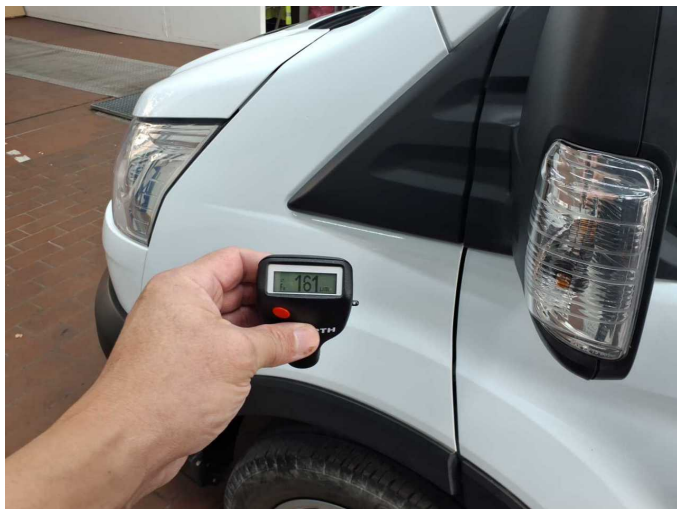
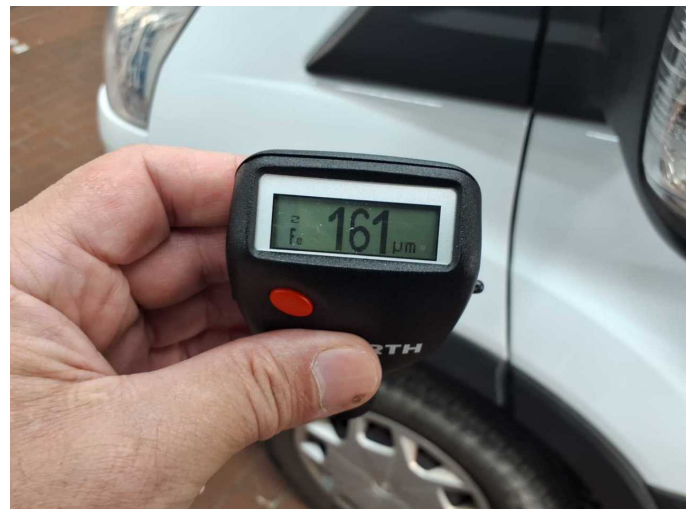
No.	Repainting
1	Mudguard - left side, Professionally carried out, Invoice of repair done Non-existent

Mudguard - left side	161 µm
----------------------	--------

Repainting 1: Mudguard - left side
