Expertise

Protocol number: 41578980
Order No. / Reference: 25196527
Inspection date: 16 Sept 2025

Manufacturer: Ford	Model: Transit 350 L3H2 Lkw VA Trend
VIN: WF0EXXTTREMC80398

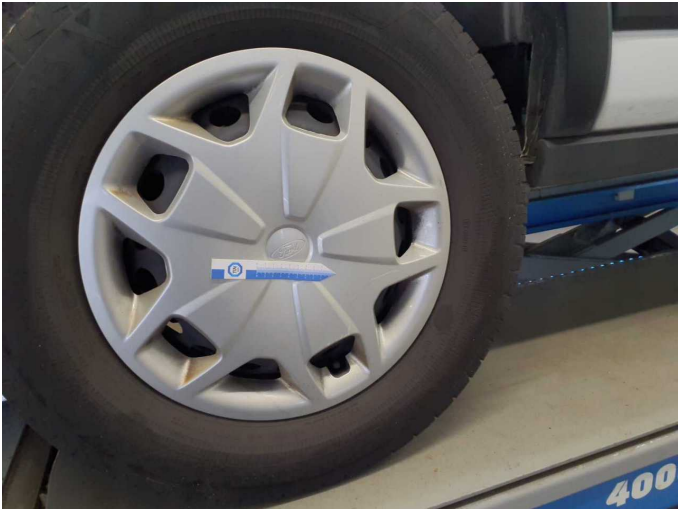
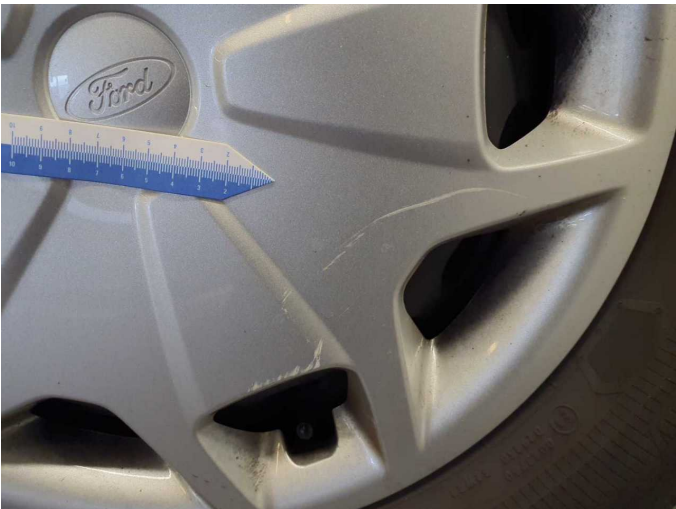
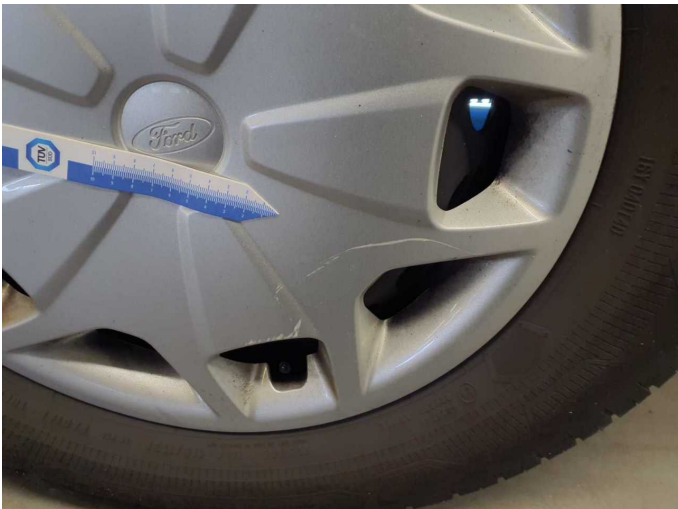
Damage 1: Wheel / tyres: Wheel cover - rear right side - Scratch(es) - Replace

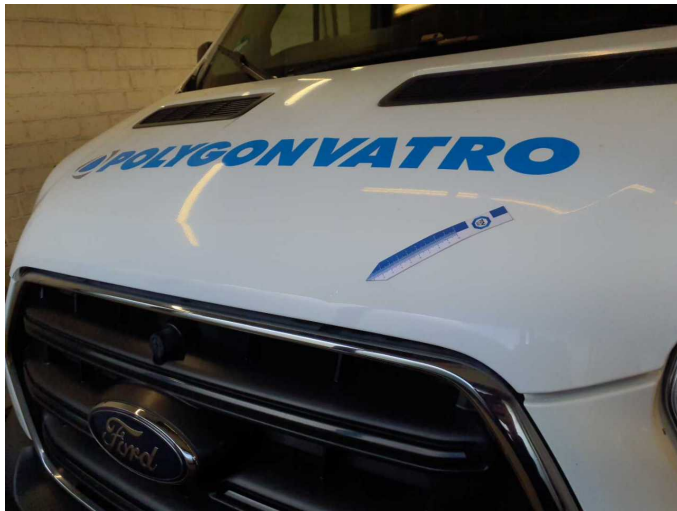
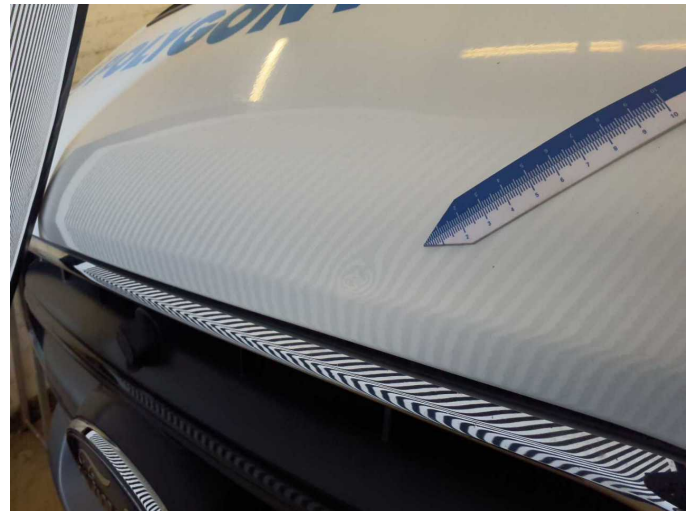
Damage 2: Bonnet: Bonnet (1) - dent(s) - Smart repair

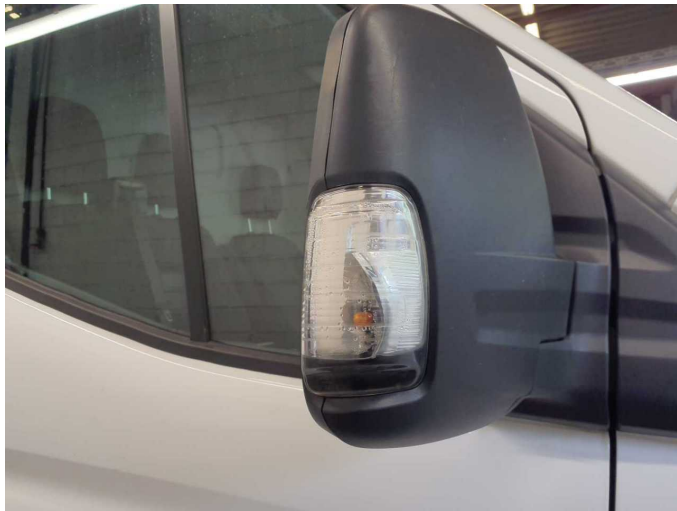
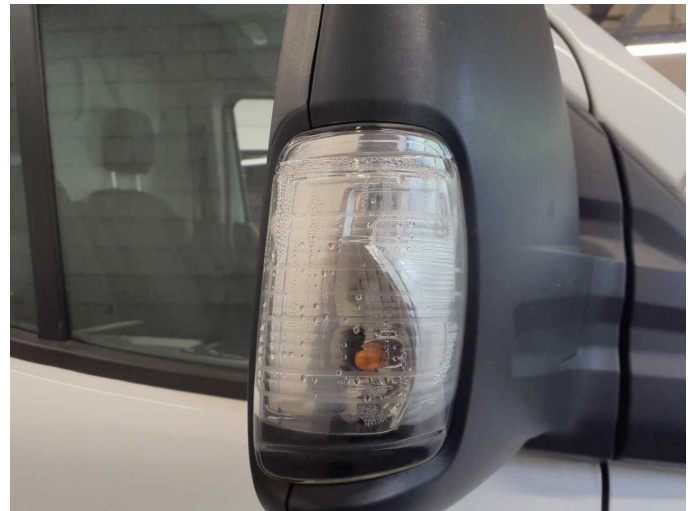
Damage 3: Indicator - front: Mirror - right side - Leaking - Replace

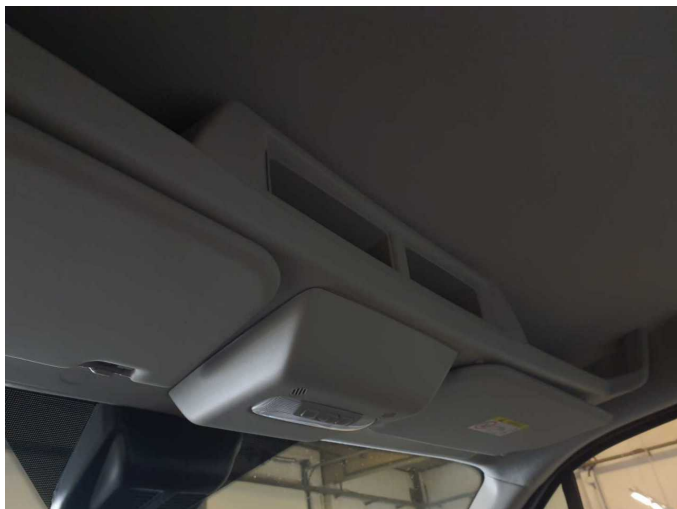
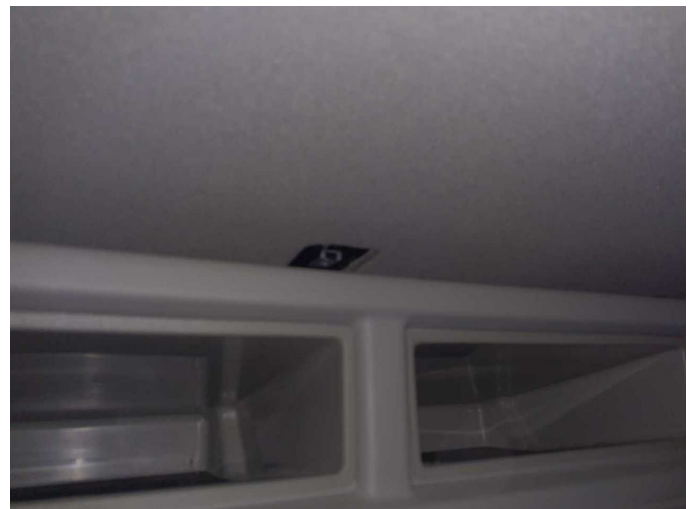
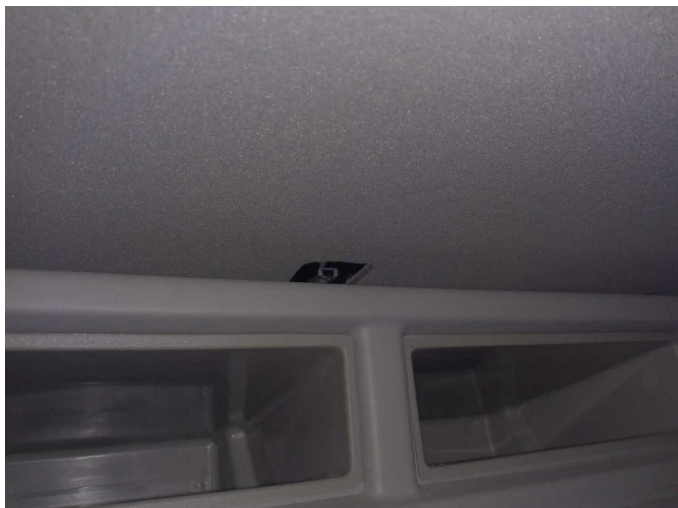
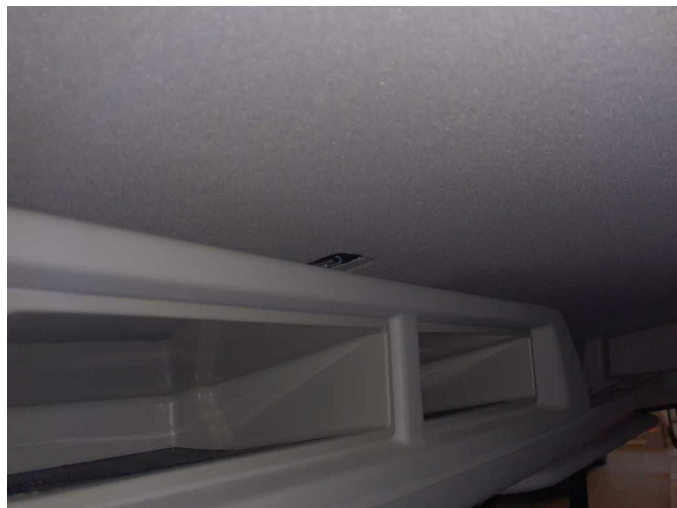
Damage 4: Trim / covers: Roof lining (Dachkonsole/ablage-schraube/ begästigung fehlt) - Loose - Un- / install

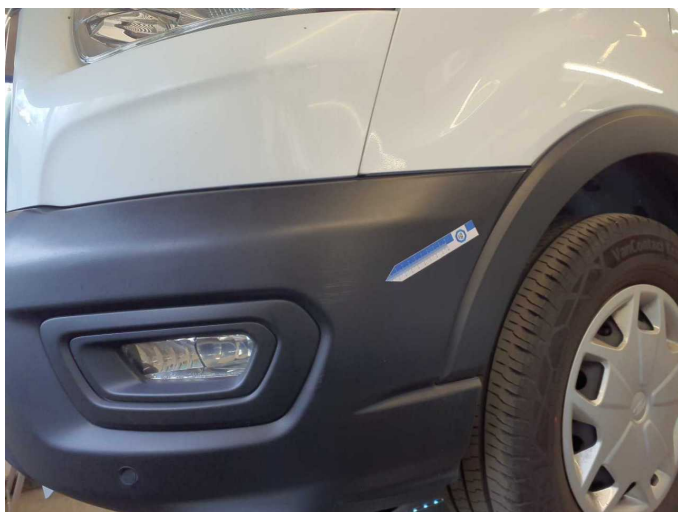
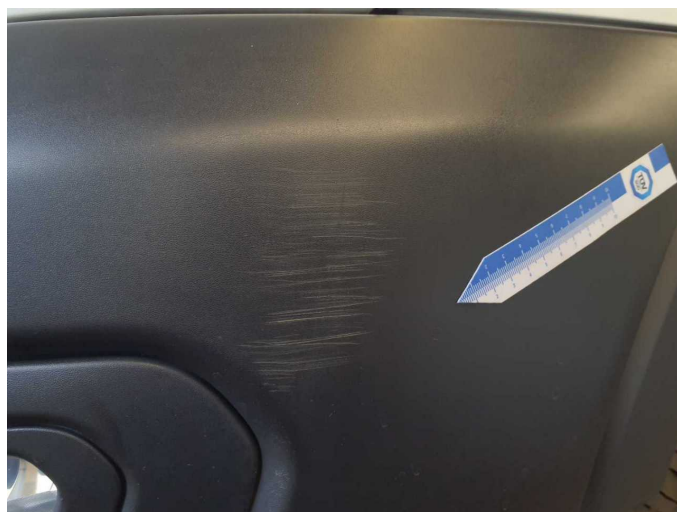
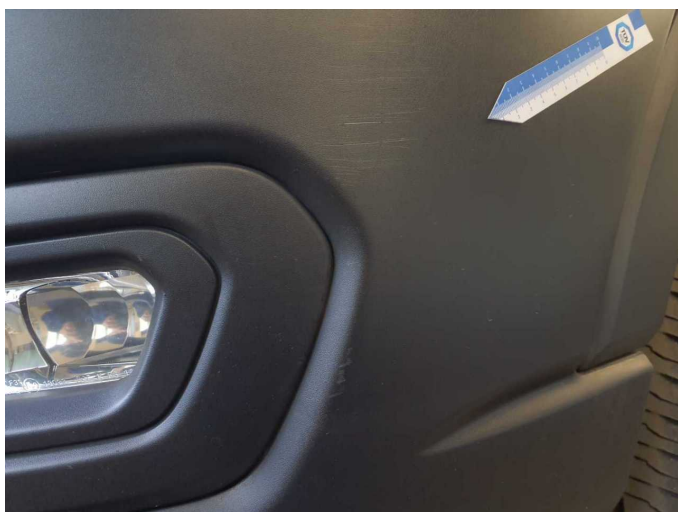
Damage 5: Front bumper: Front bumper - Scratch(es) - Smart repair

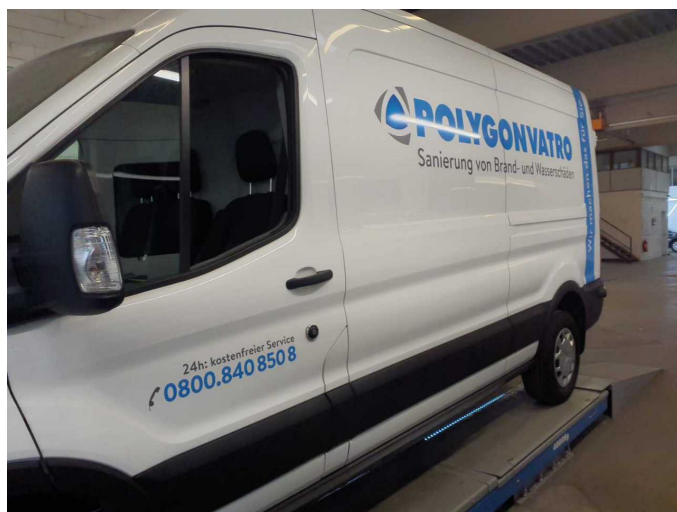
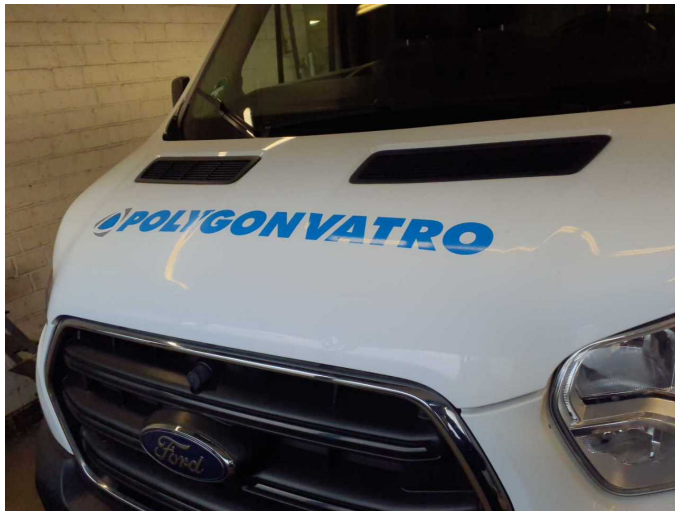
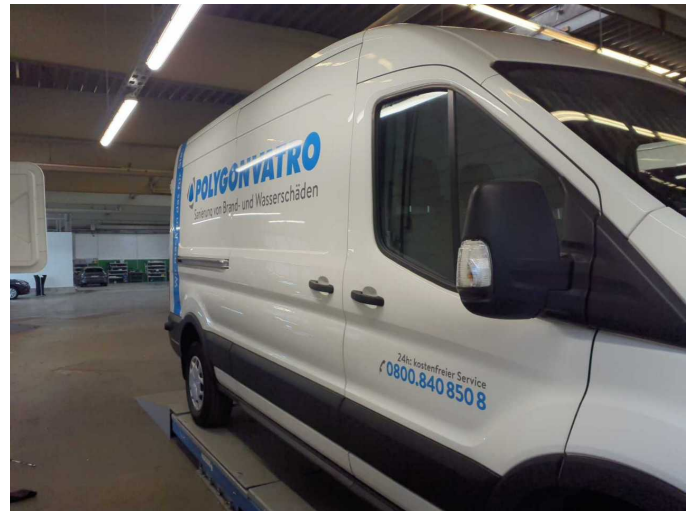
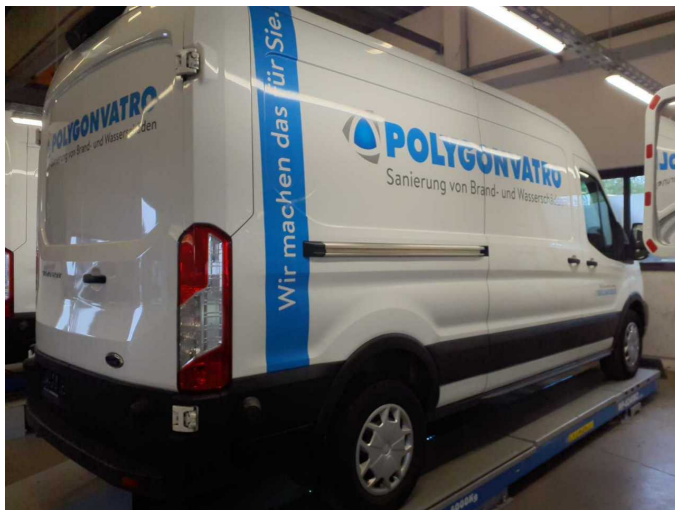
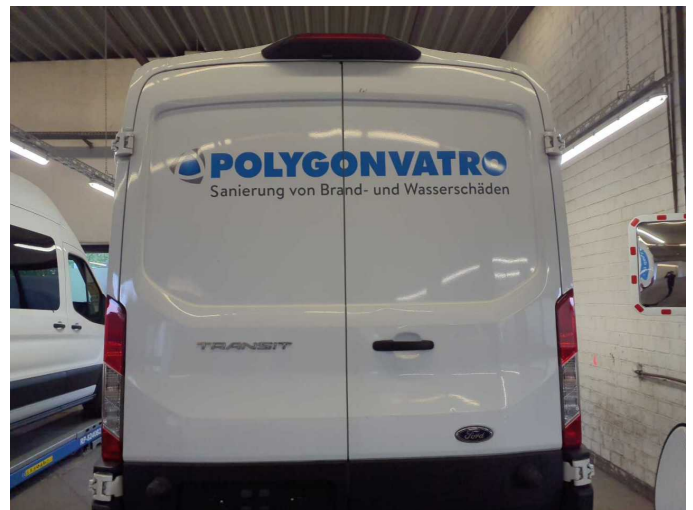
Damage 6: Body: Body - Glued / labelled - De-glue / neutralise

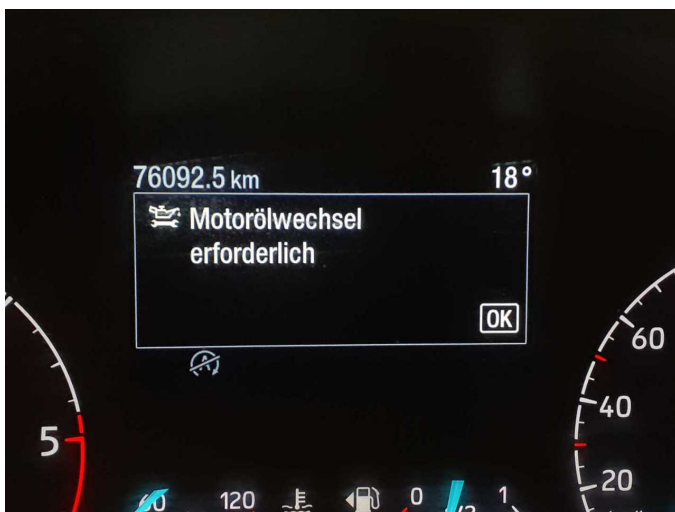
Damage 7: Misc.: Inspection / maintenance - Due - Perform

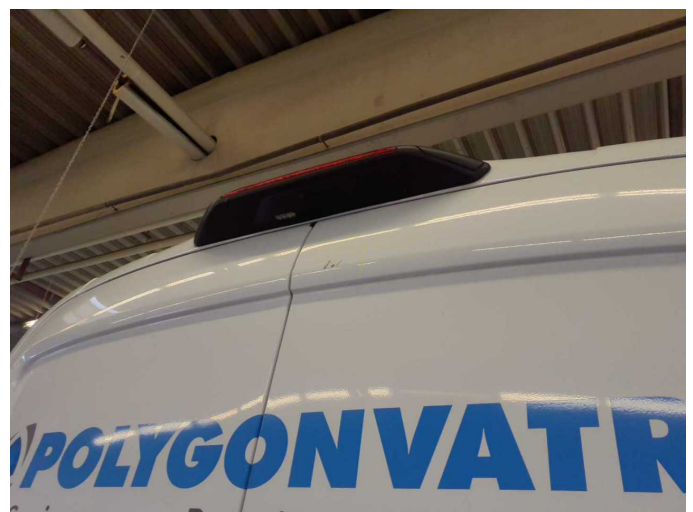
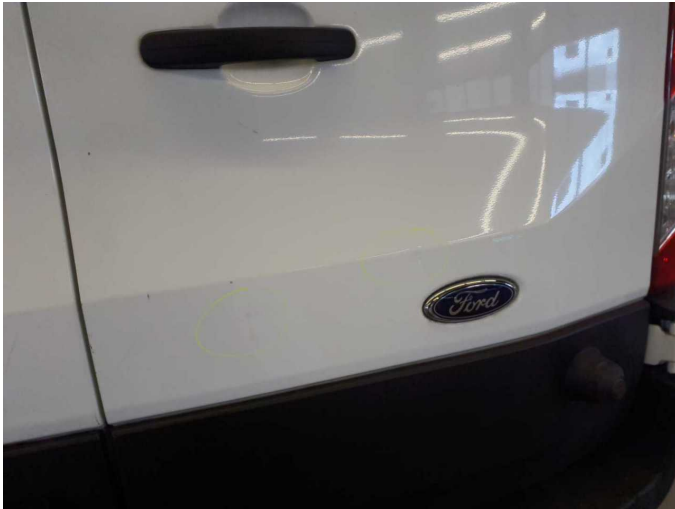
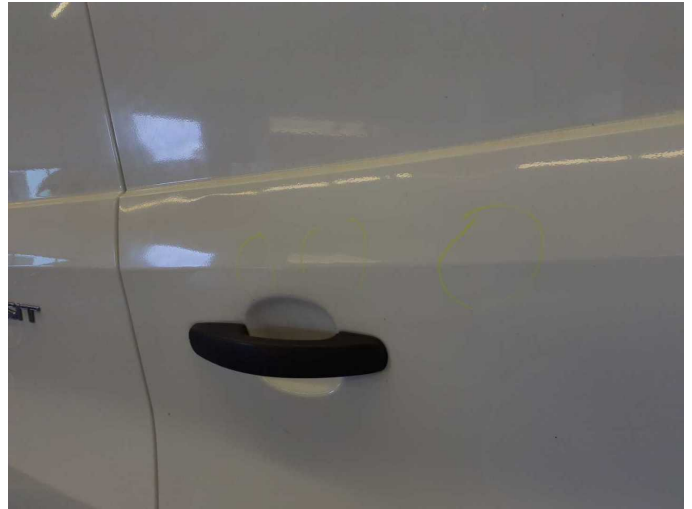
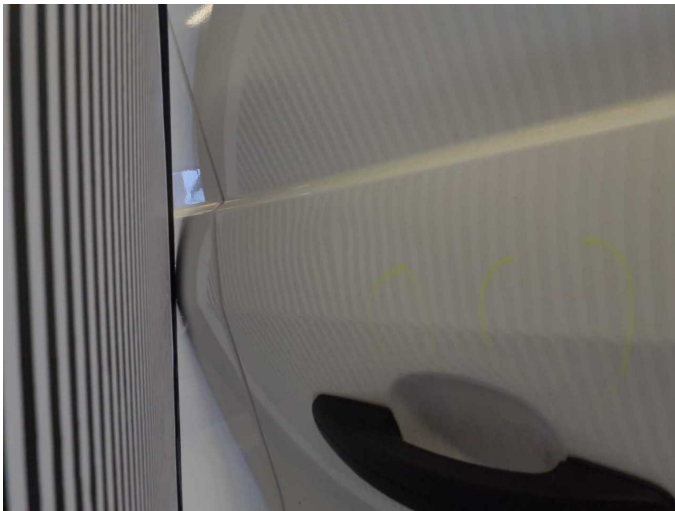
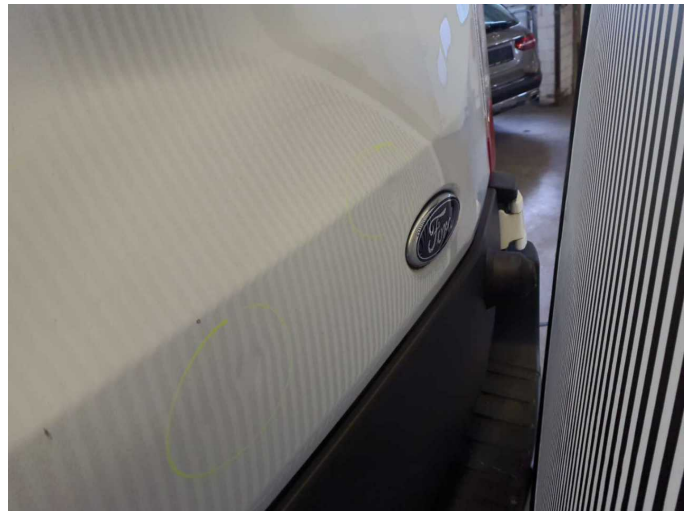
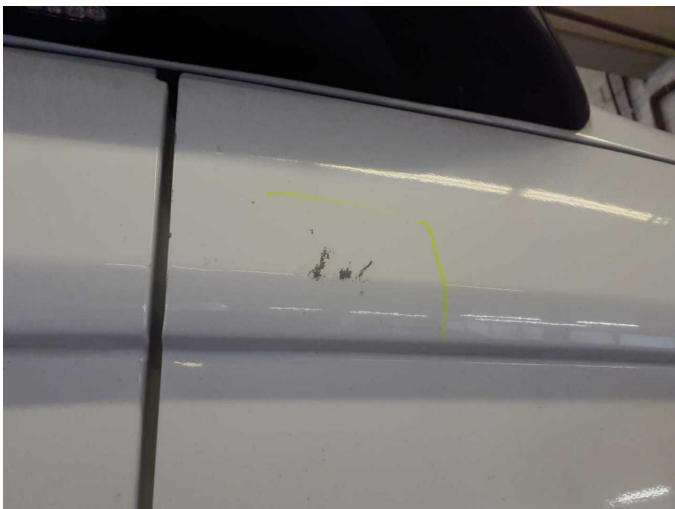
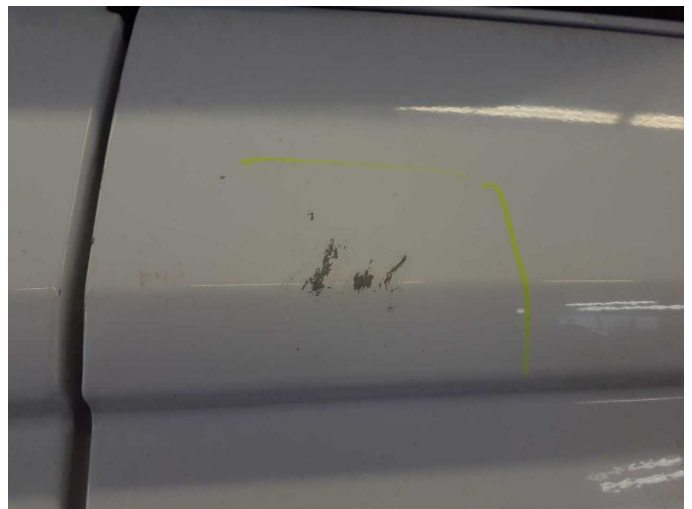
Damage 8: Boot lid / rear door: Rear door - right side (6 Dellen +Kratzer)
- Dent / paintcoat damage - Repair and paint

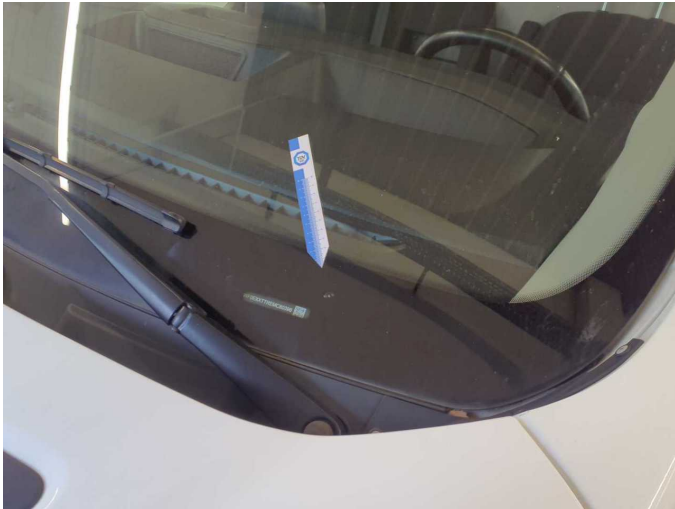
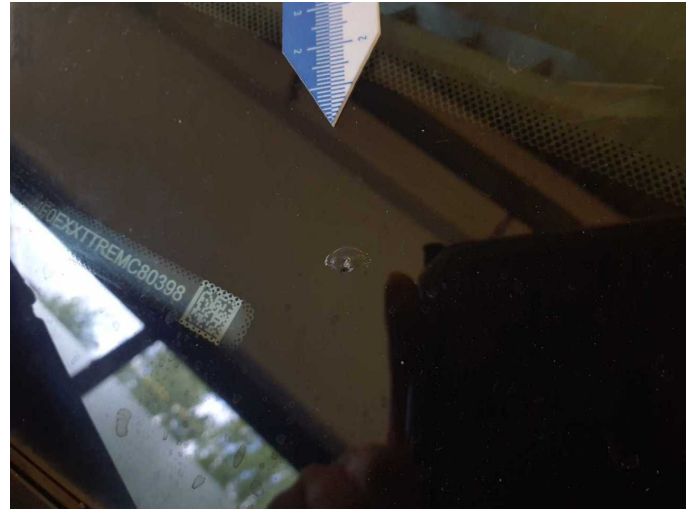
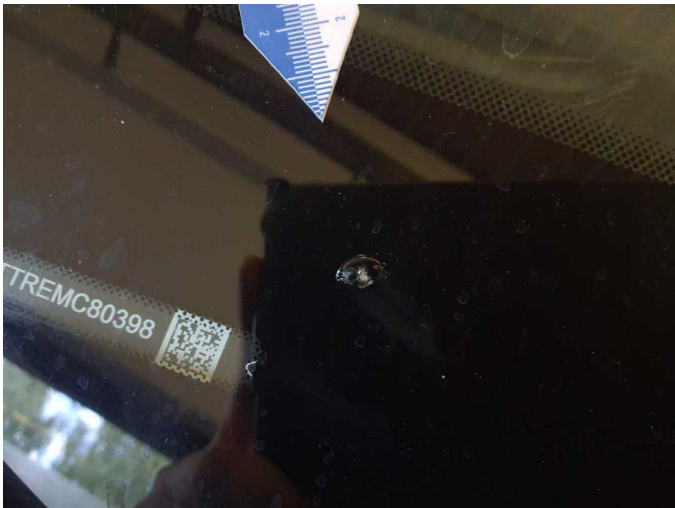
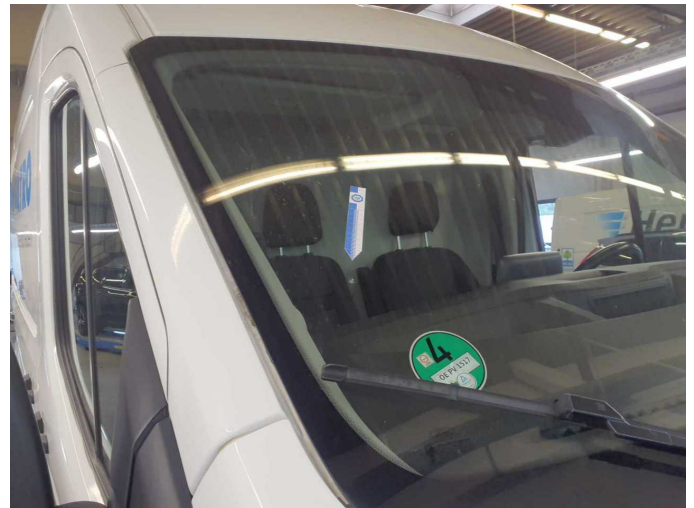
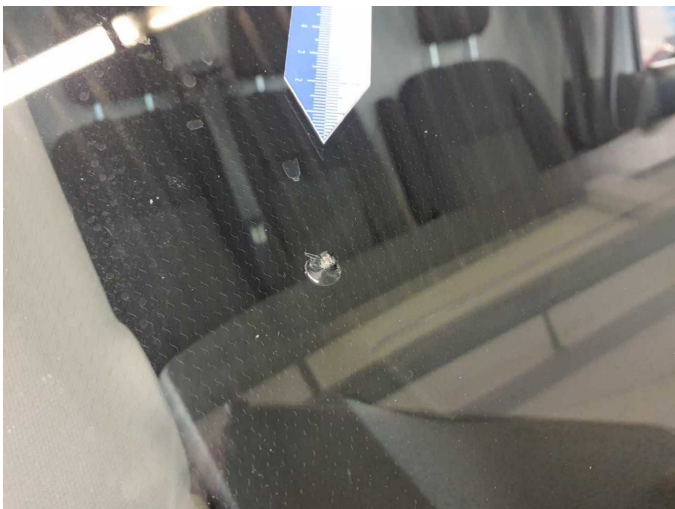
Damage 9: Vehicle glazing: Windscreen - Broken / torn - repair according to calculation

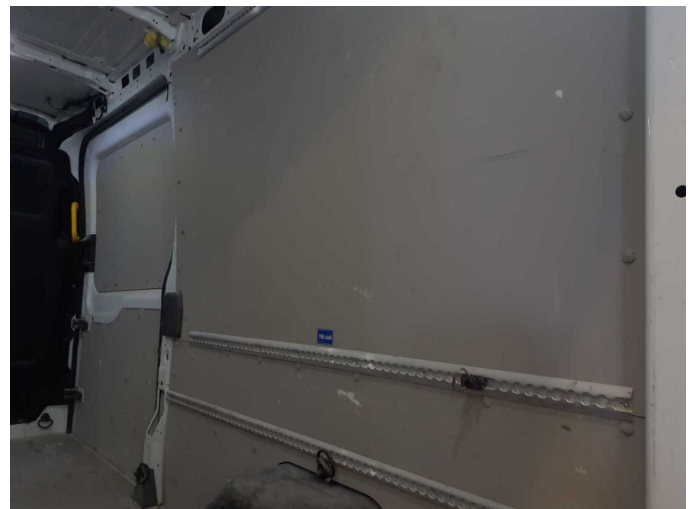
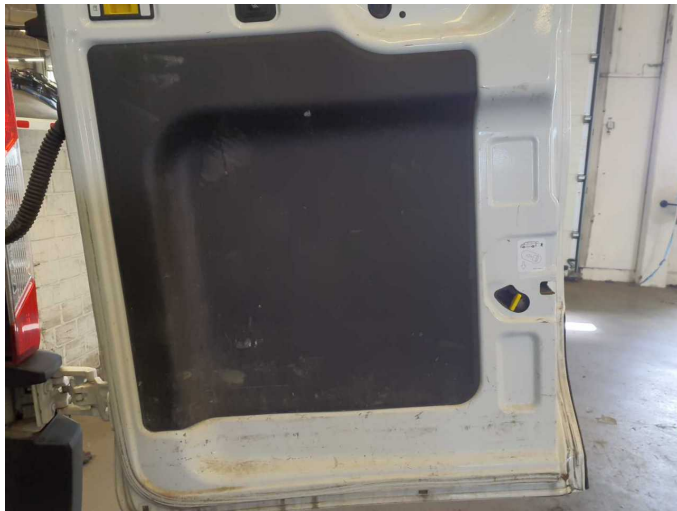
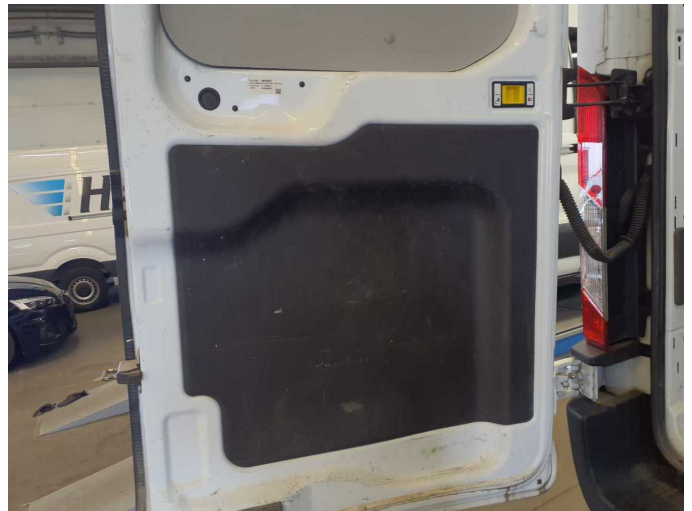
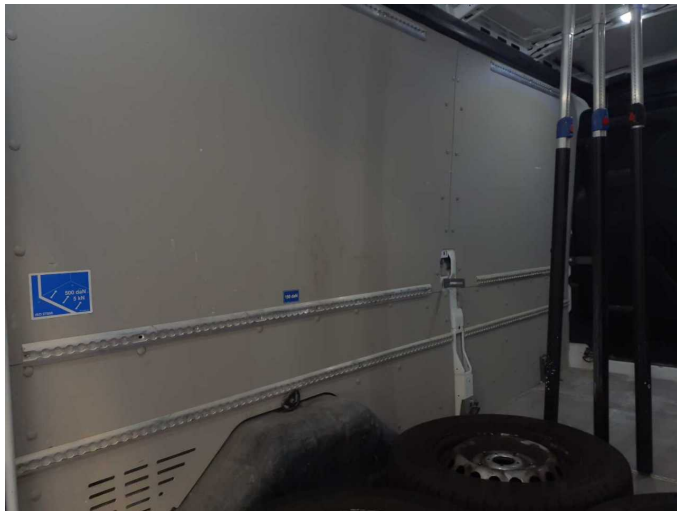
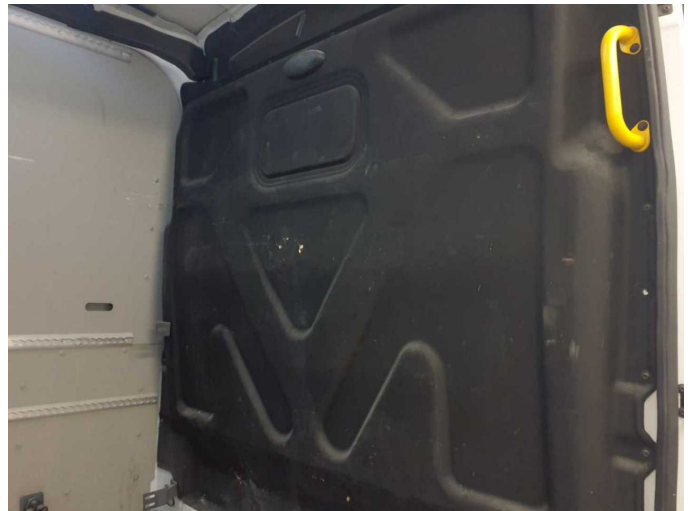
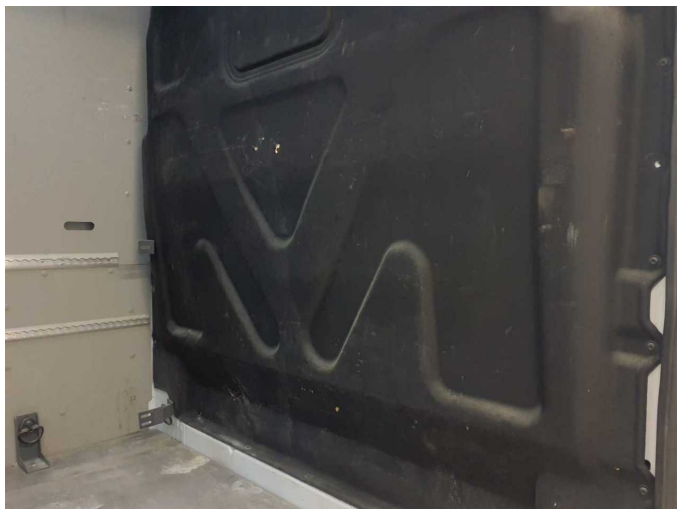
Wear and tear 1: Interior: Cargo space division - Scratch(es) - No deduction

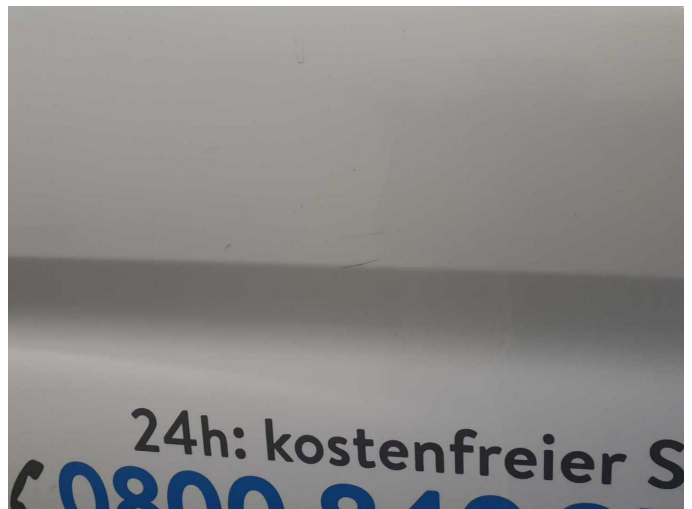
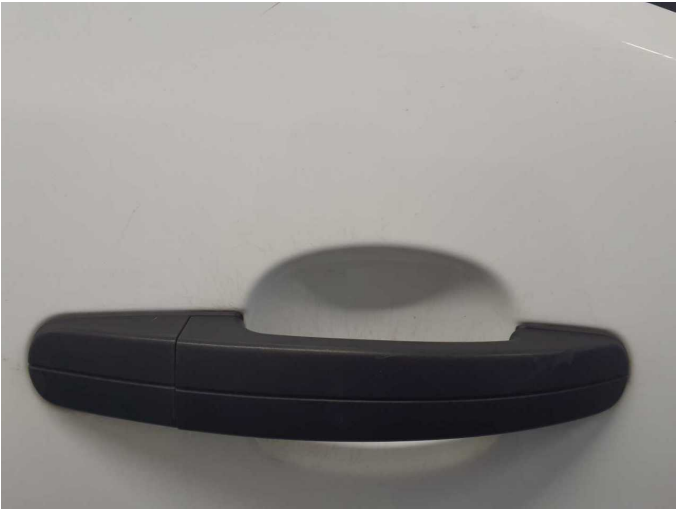
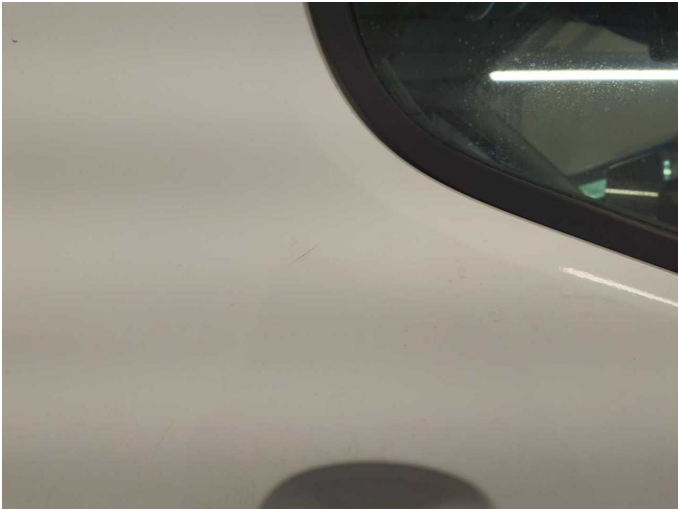
Wear and tear 4: Door - front right side: Door - Scratch(es) - No deduction

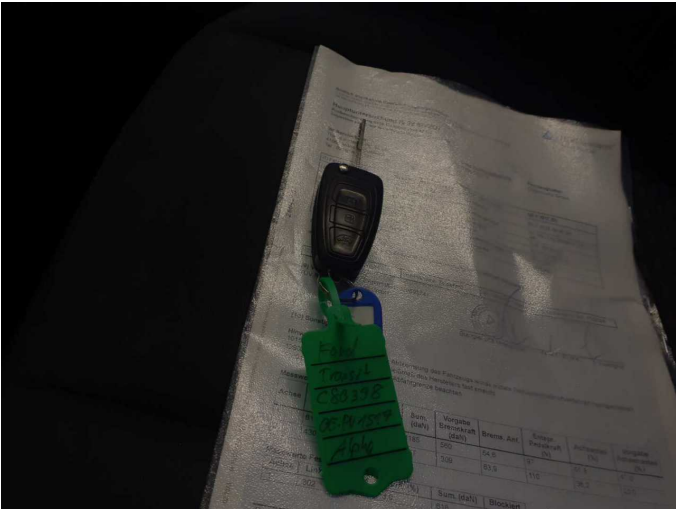
Missing part 2: Equipment: Vehicle key (1 von 2) - Missing - Replace

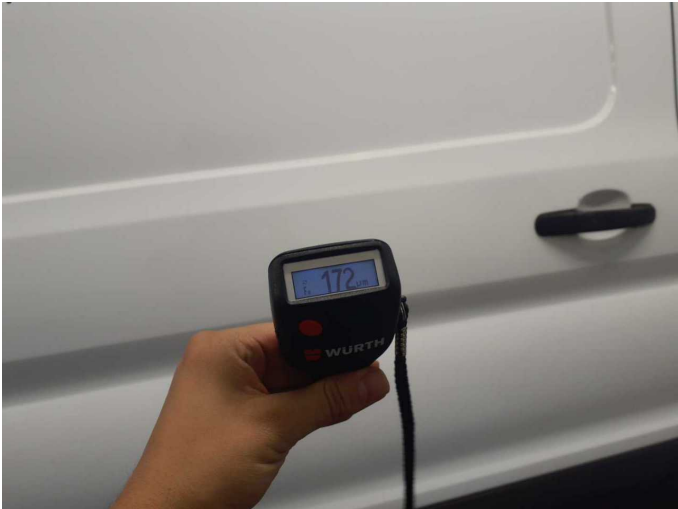
Repainting 1: Door - rear right side

1	Door - rear right side, Professionally carried out, Invoice of repair done Non-existent
---	---

Door - rear right side	172 µm
------------------------	--------
