Expertise

Protocol number: 41812858
Order number / reference: 25237186
Inspection date: 6 Oct 2025

Manufacturer: Ford	Model: Transit 350 L3H2 Lkw VA Trail
VIN: WF0EXXTTREM24382

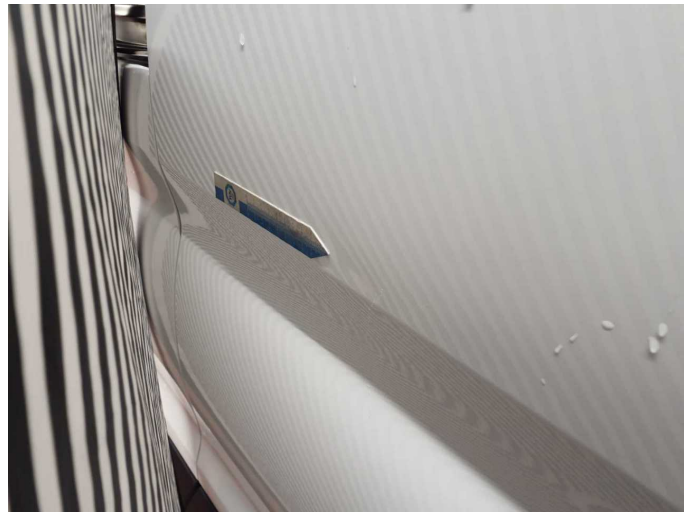
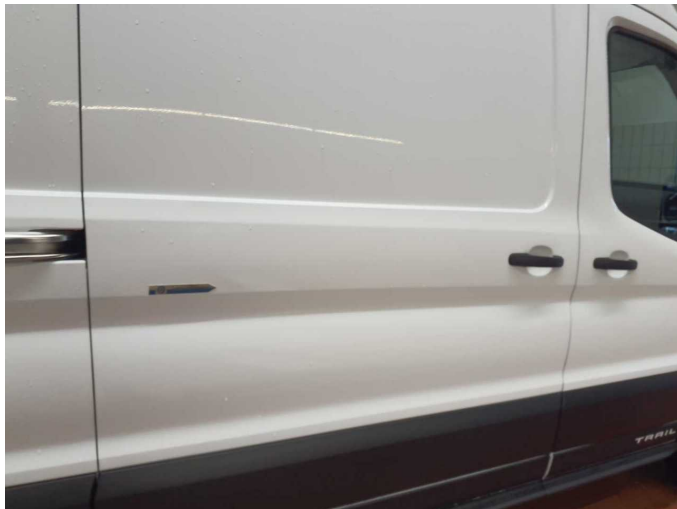
Damage 1: Sliding door, right: Sliding door - dent(s) - Smooth repair work

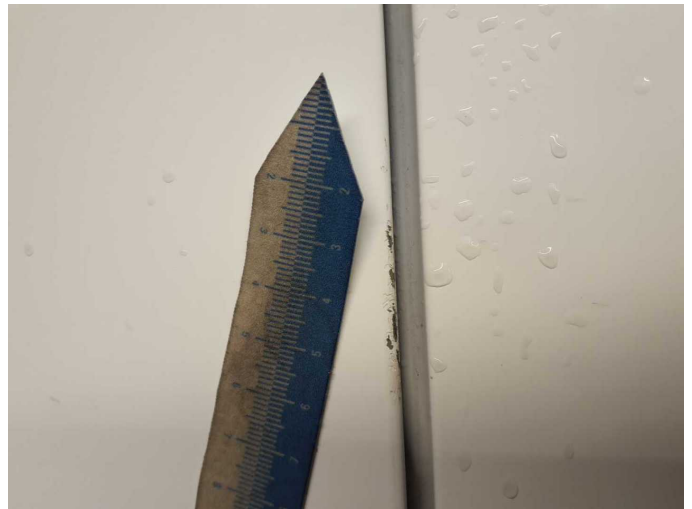
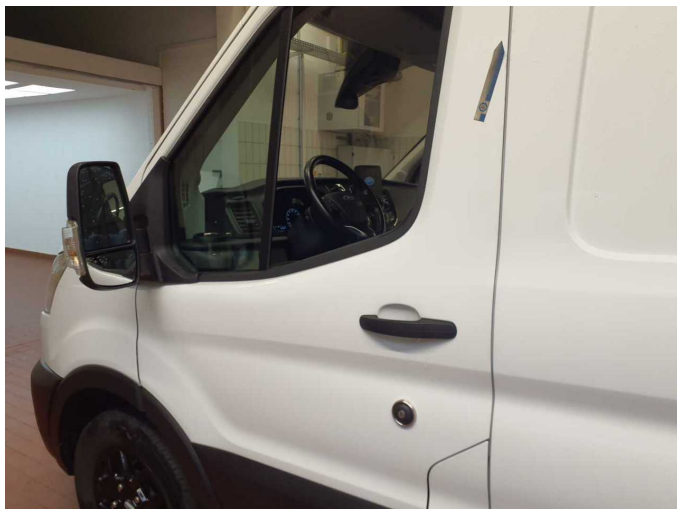
Damage 2: Door - front left side: Door edge - Scratch(es) - Smart repair

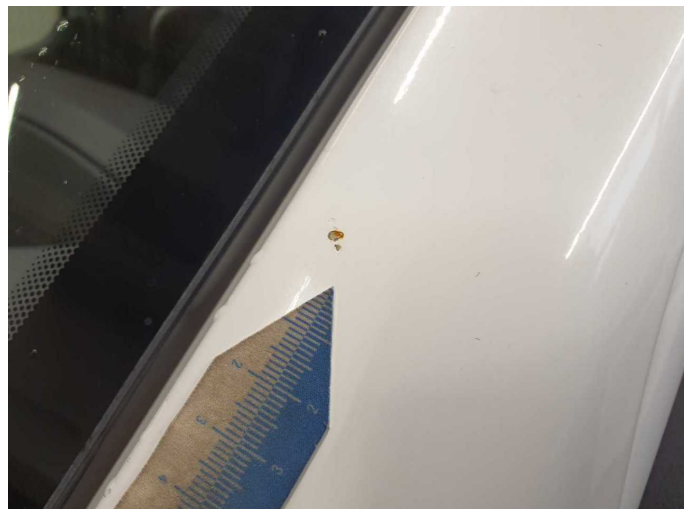
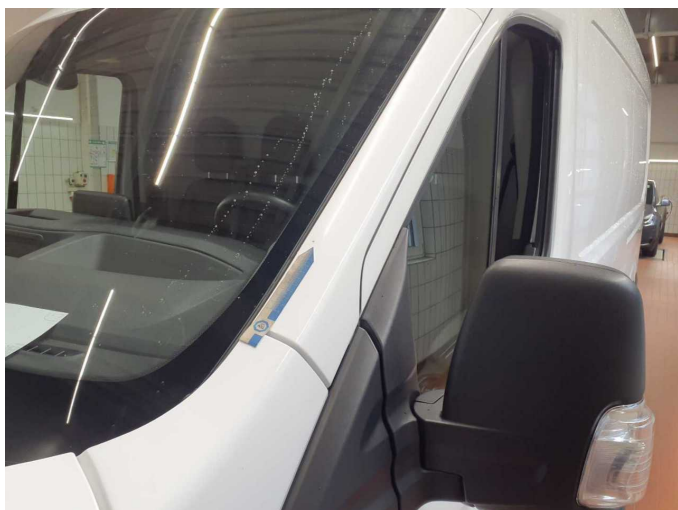
Damage 3: Roof: Roof rail - left side - Stone chips - Smart repair

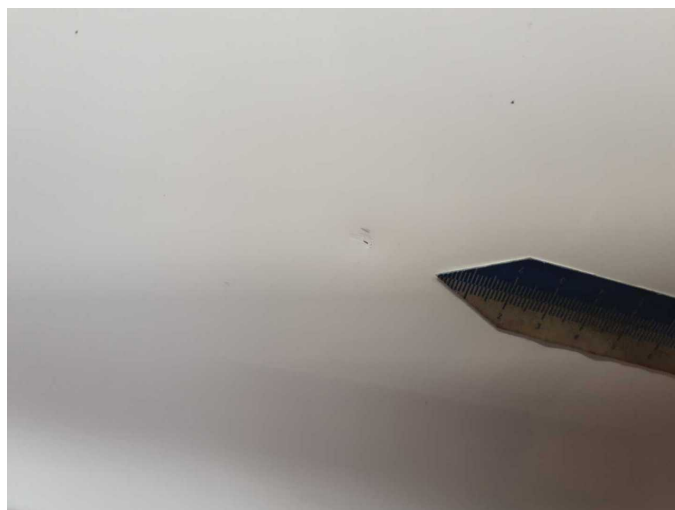
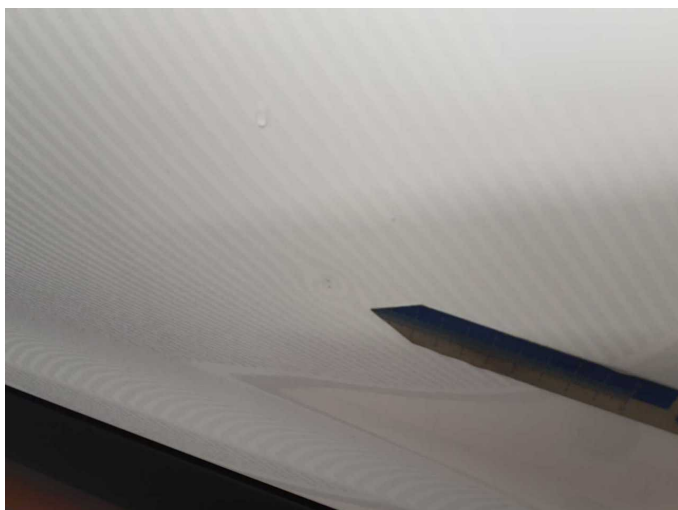
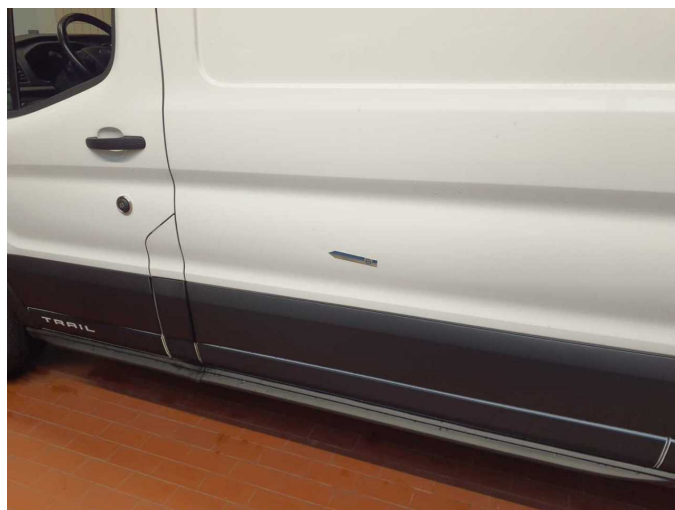
Damage 4: Side panel - rear left side: Side panel - Dent / paintcoat damage - Smart repair

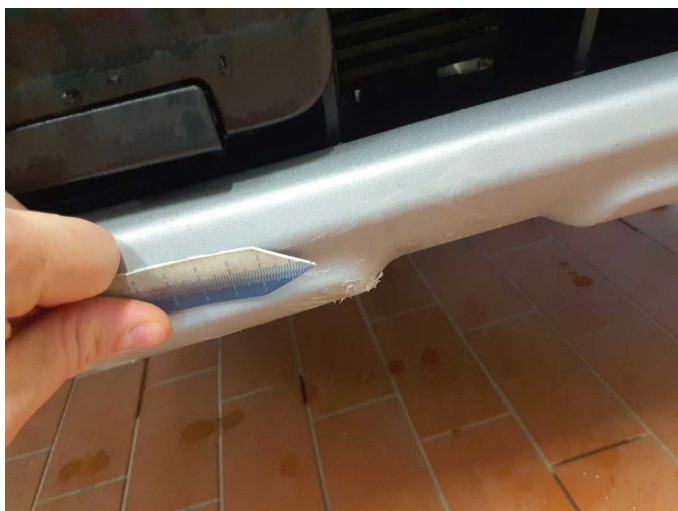
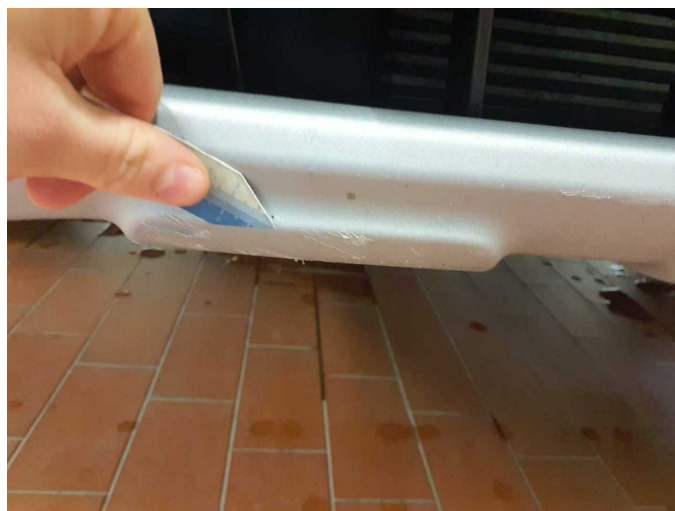
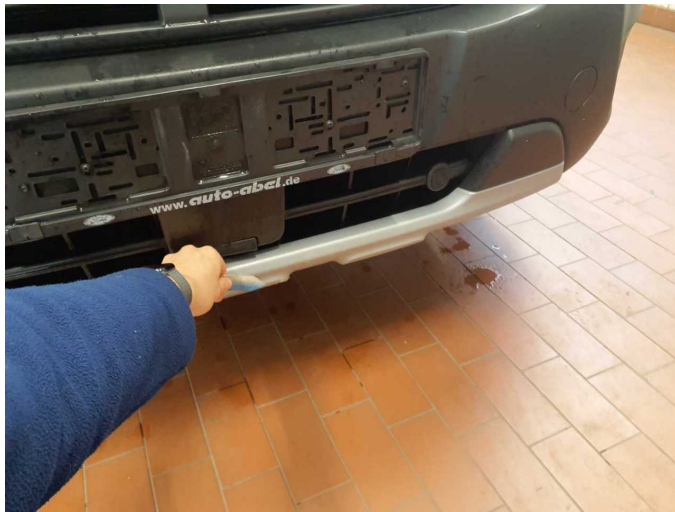
Damage 5: Front bumper: Spoiler - Scratched - Replace

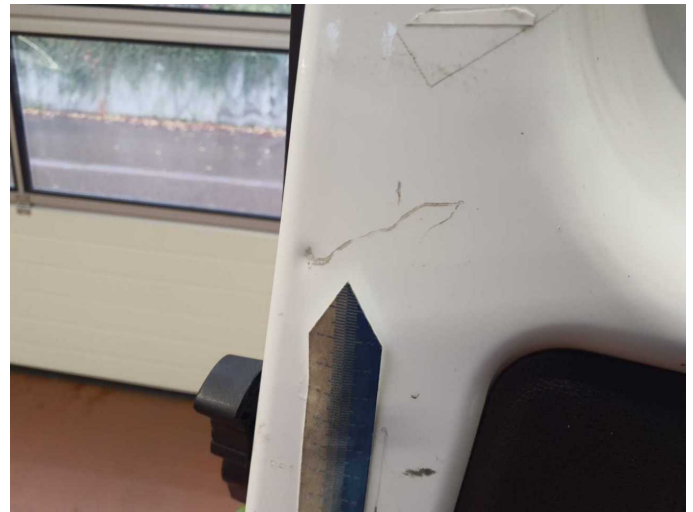
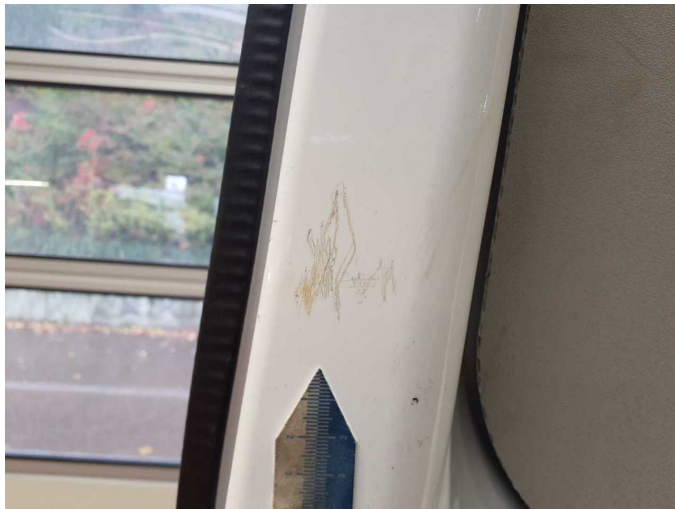
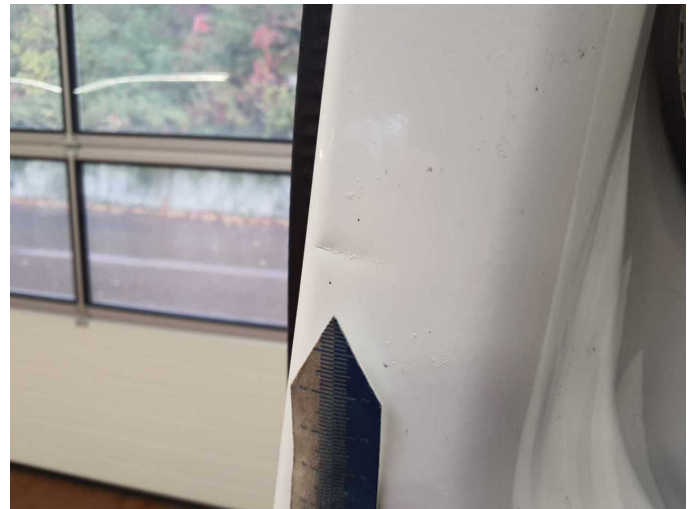
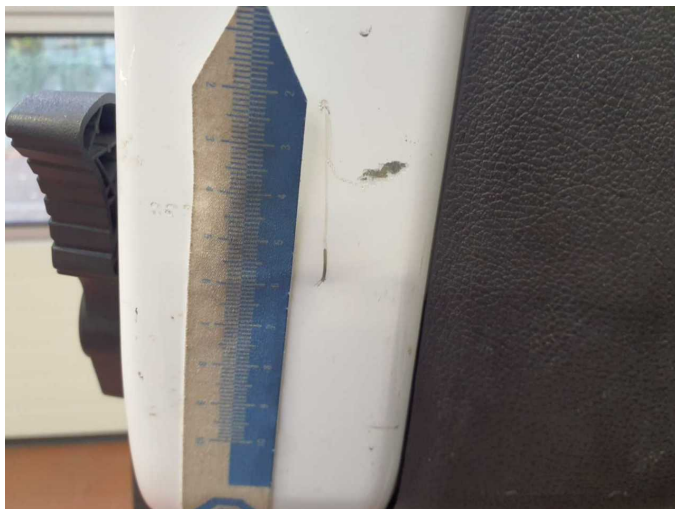
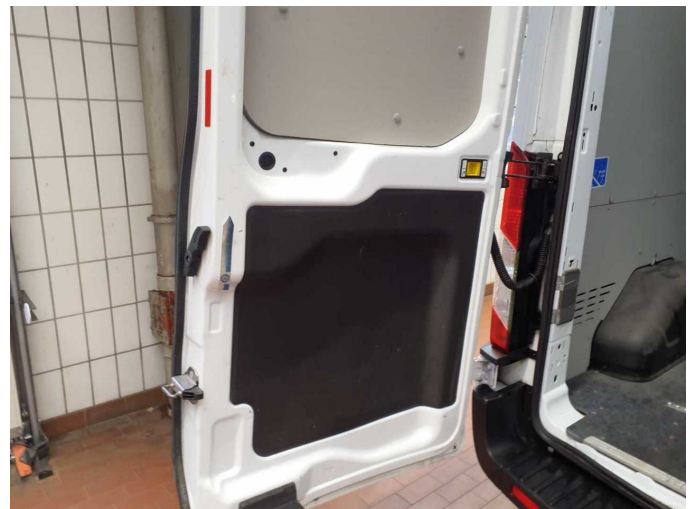
Damage 6: Boot lid / rear door: Rear door - left side - Dent / paintcoat damage - Repair and paint

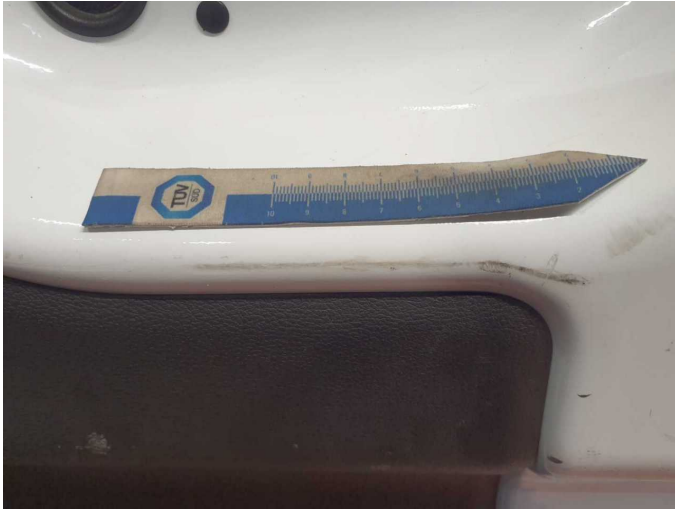
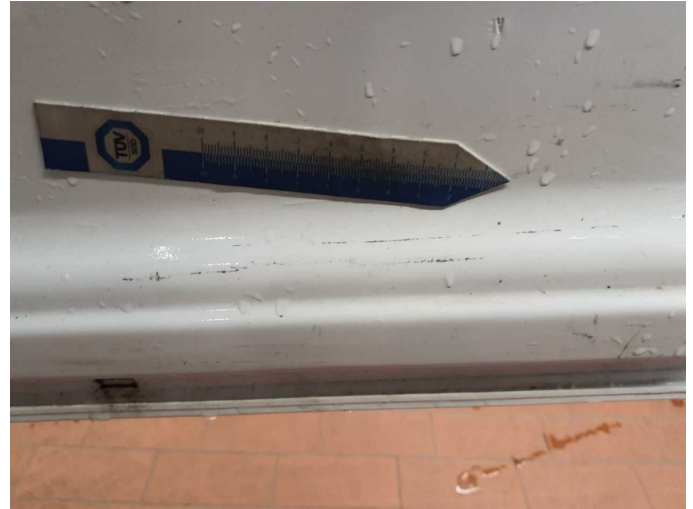
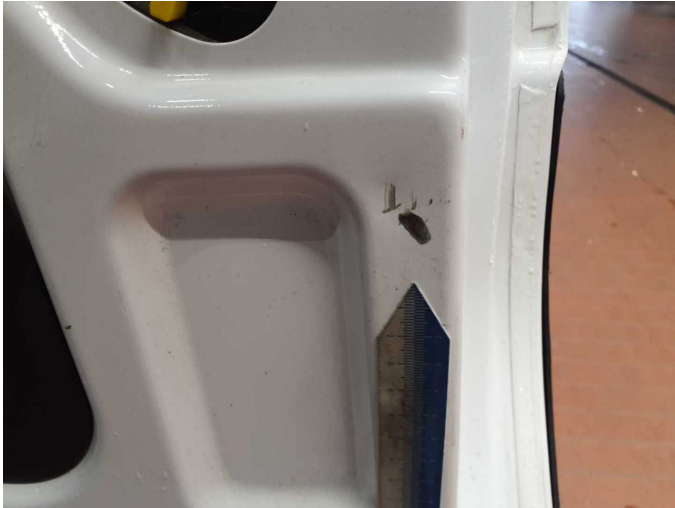
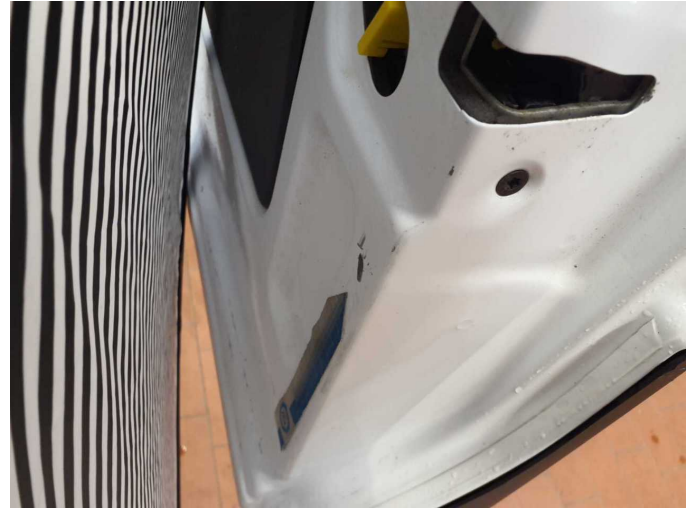
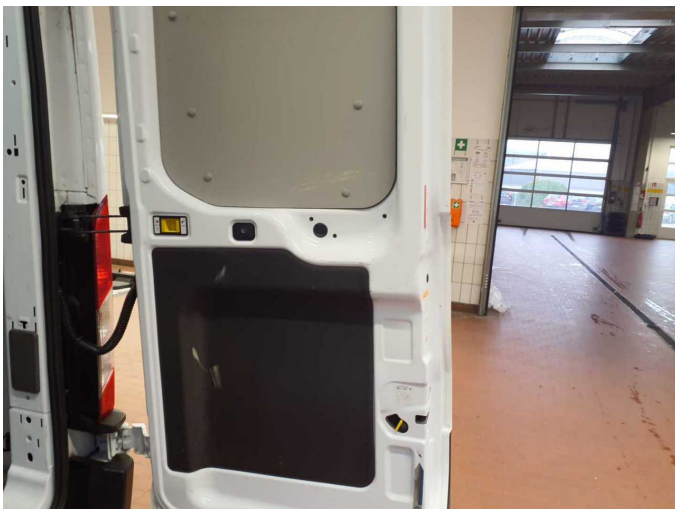
Damage 7: Boot lid / rear door: Rear door - right side - Dent / paintcoat damage - Repair and paint
