Expertise

Protocol number: 41666684
Order No. / Reference: 25228413
Inspection date: 24 Sept 2025

Manufacturer: Ford	Model: Transit 350 L3H2 Lkw VA Trend
VIN: WF0EXXTTREPC35063

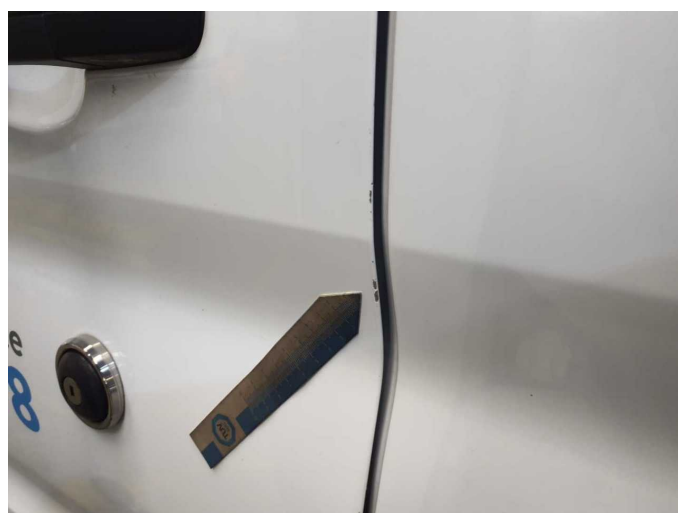
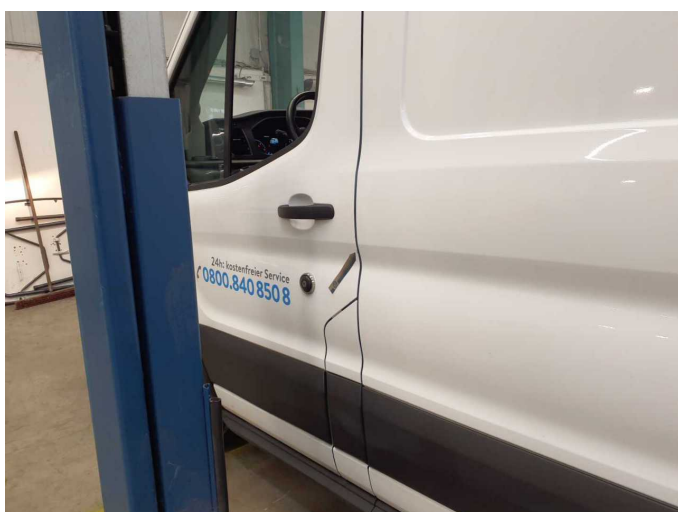
No.	Component group	Description
1	Electrical system	Battery (entladen - Mehrkosten können entstehen) - Electrical fault - Perform diagnosis
2	Door - front left side	Door edge - Scratch(es) - Smart repair
3	Body	Body - Glued / labelled - De-glue / neutralise

Damage 2: Door - front left side: Door edge - Scratch(es) - Smart repair

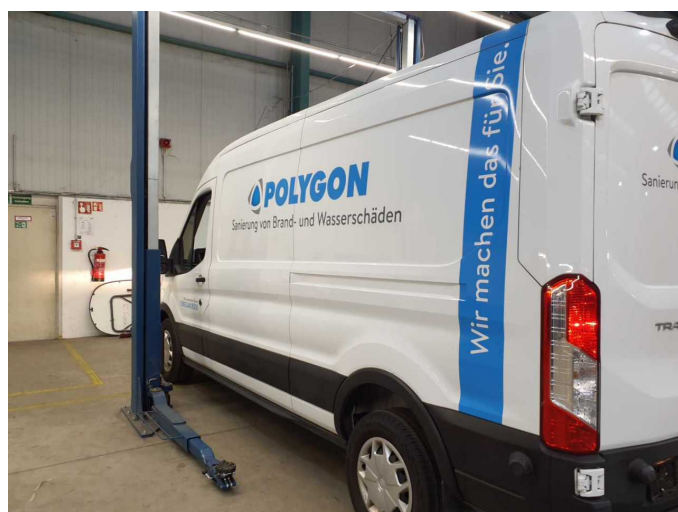
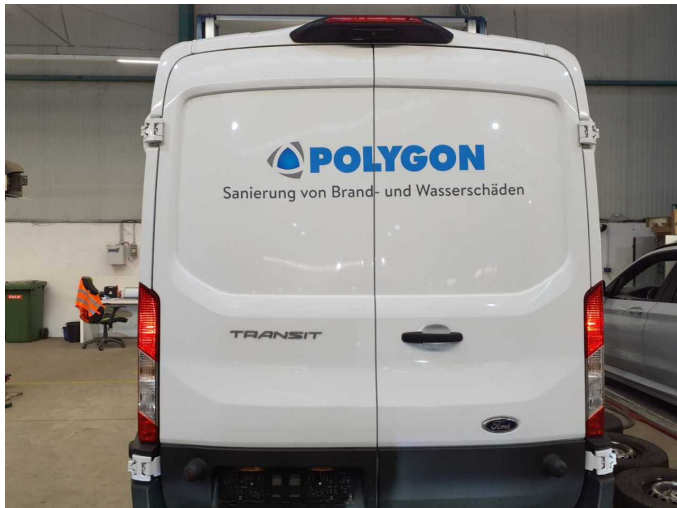
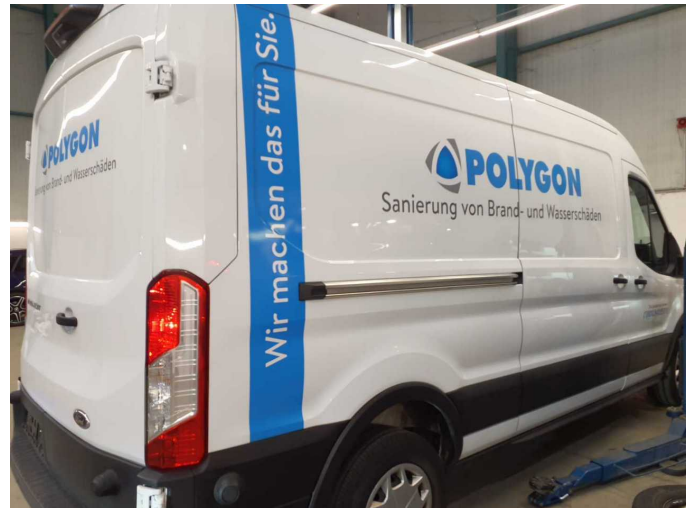
Damage 3: Body: Body - Glued / labelled - De-glue / neutralise

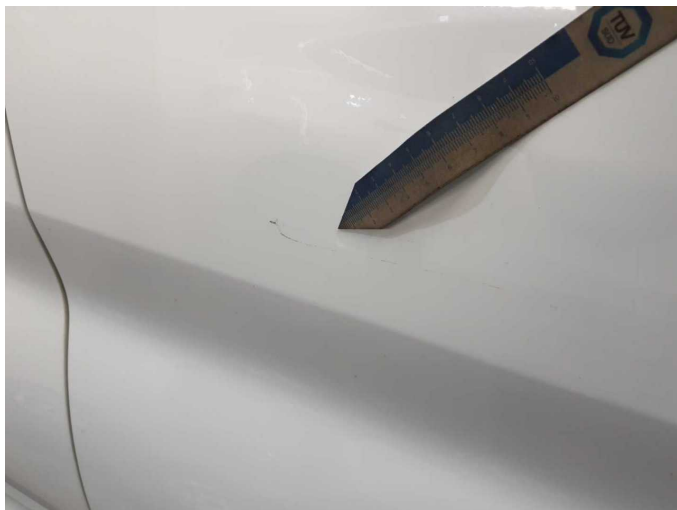
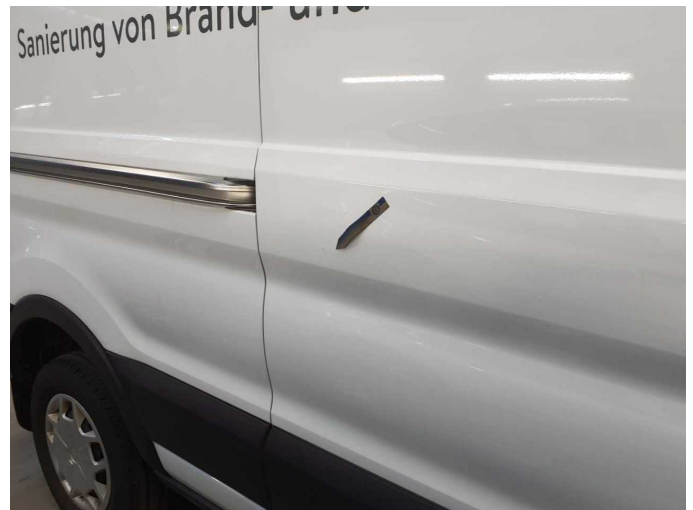
No.	Component group	Description
1	Side panel - rear left side	Side panel - Scratch(es) - No deduction
2	Side panel - rear right side	Side panel - Scratch(es) - No deduction
3	Bonnet	Bonnet - Stone chips - No deduction
4	Vehicle glazing	Windscreen - Stone chips - No deduction
5	Rear bumper	Rear bumper - Scratch(es) - No deduction
6	Front bumper	Front bumper - Stone chips - No deduction
7	Interior	Interior - Scratch(es) - No deduction
8	Door - rear right side	Door - Scratch(es) - No deduction

Wear and tear 8: Door - rear right side: Door - Scratch(es) - No deduction

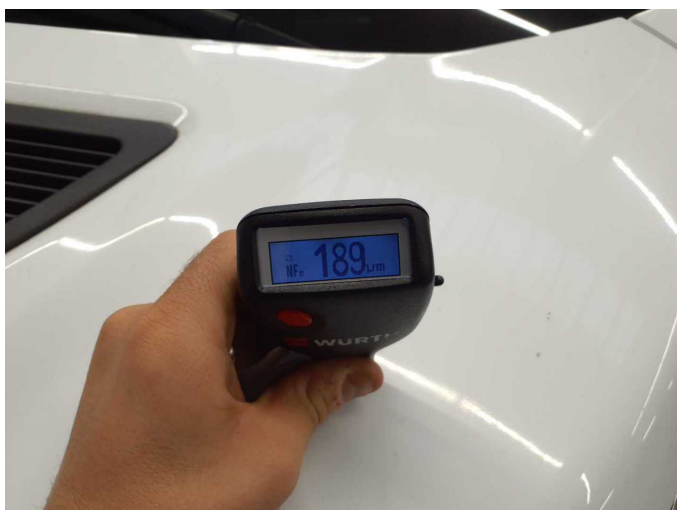
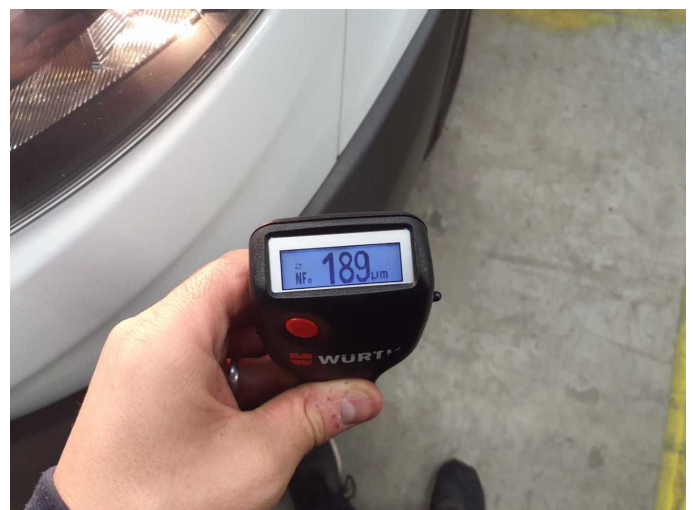
No.	Repainting
1	Bonnet, Professionally carried out, Invoice of repair done Non-existent

Bonnet	189 µm
--------	--------

Repainting 1: Bonnet
