Expertise

Protocol number: 41576068
Order No. / Reference: 25196608
Inspection date: 16 Sept 2025

Manufacturer: Ford	Model: Transit 350 L3H2 Lkw VA Trend
VIN: WF0EXXTTREPP51688

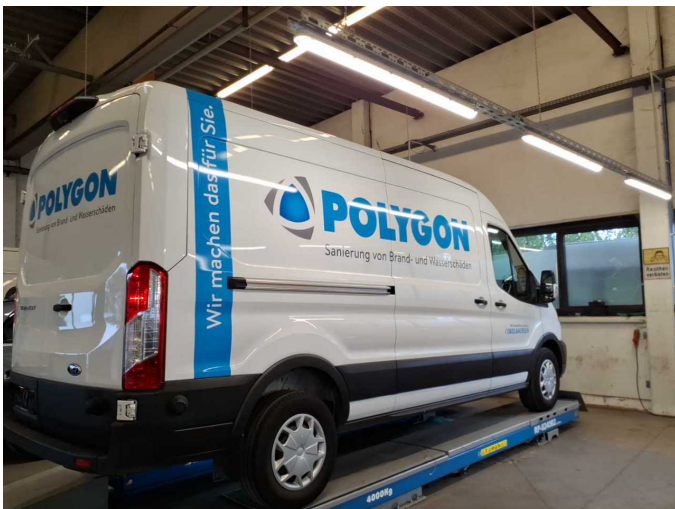
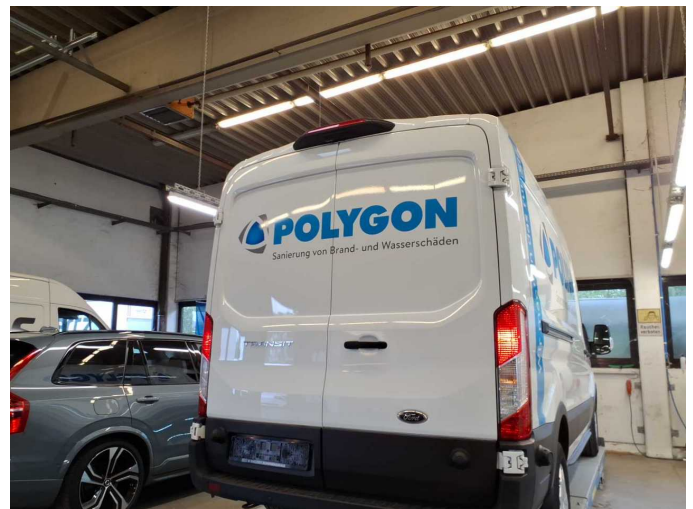
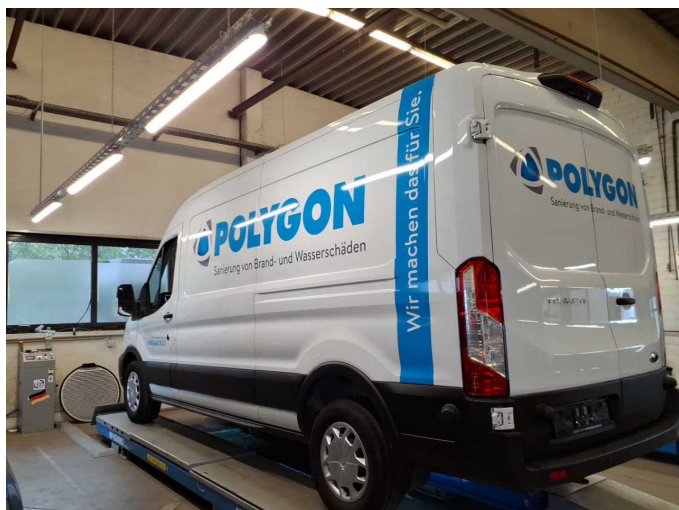
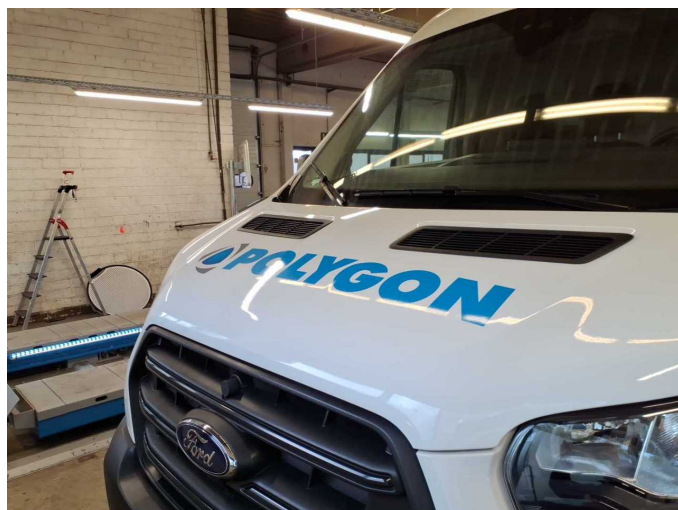
No.	Component group	Description
1	Body	Body - Glued / labelled - De-glue / neutralise

Damage 1: Body: Body - Glued / labelled - De-glue / neutralise
