Expertise

Protocol number: 41620247
Order No. / Reference: 25231735
Inspection date: 18 Sept 2025

Manufacturer: Ford	Model: Transit 350 L3H2 Lkw VA Trend
VIN: WF0EXXTTREPP51969

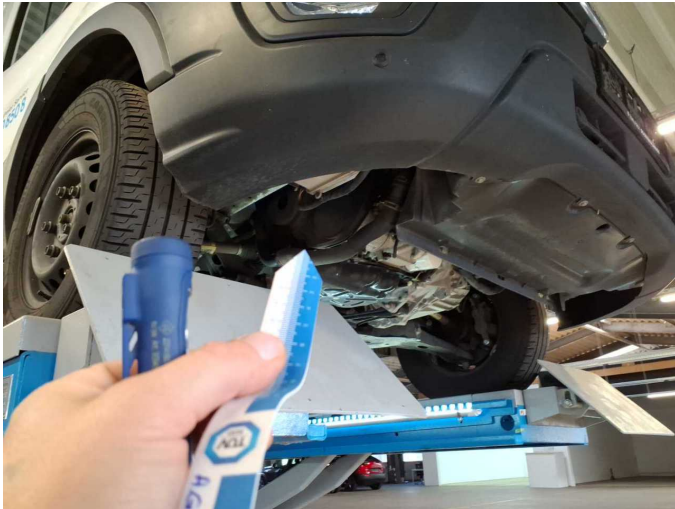
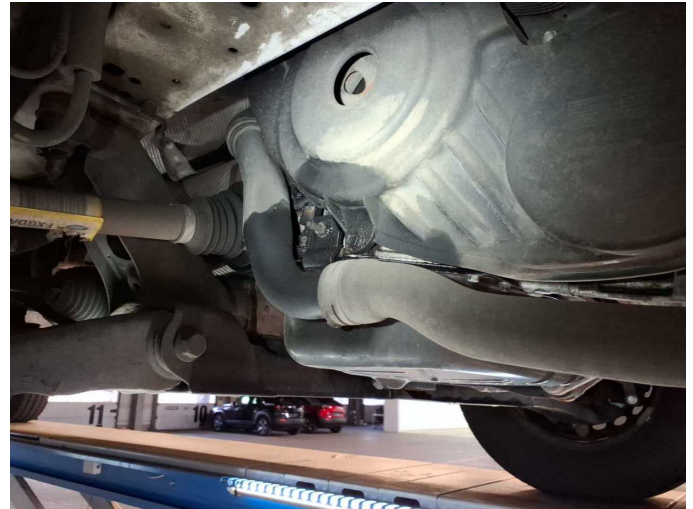
Damage 2: Engine: Engine - Leaking - Perform diagnosis

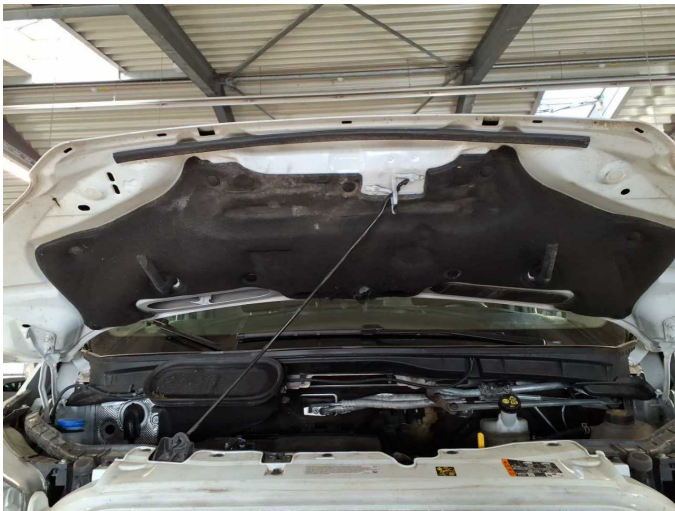
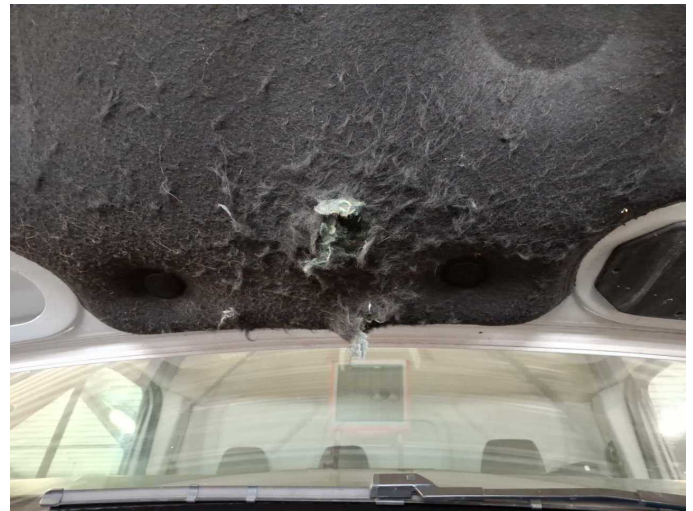
Damage 3: Bonnet: Insulation lining - Broken / torn - Replace

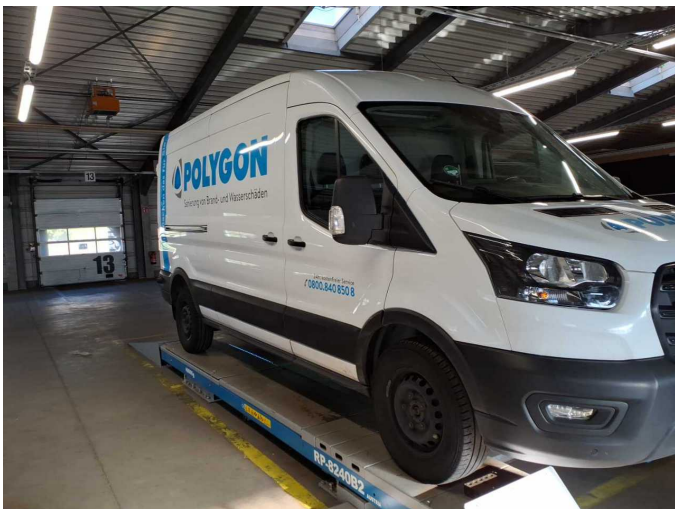
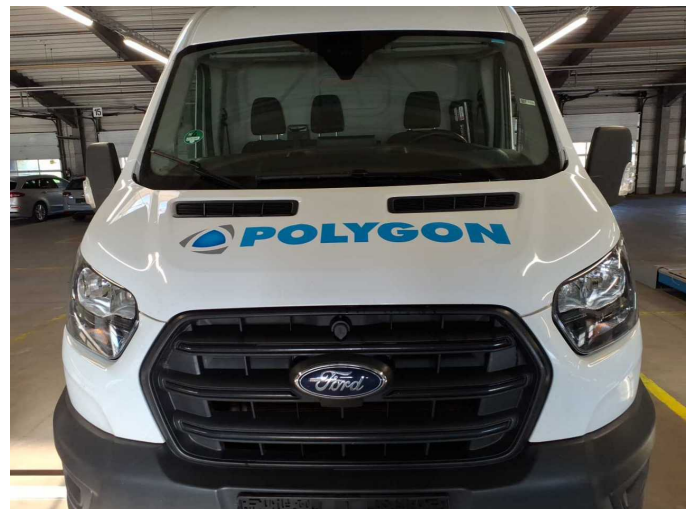
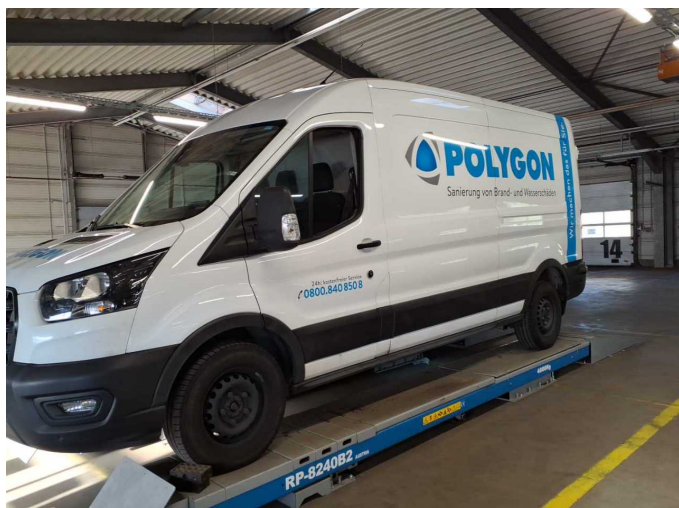
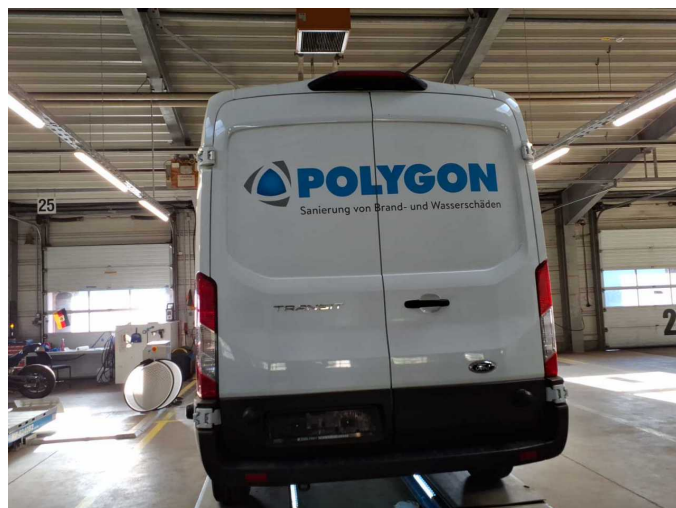
Damage 4: Body: Body - Glued / labelled - De-glue / neutralise

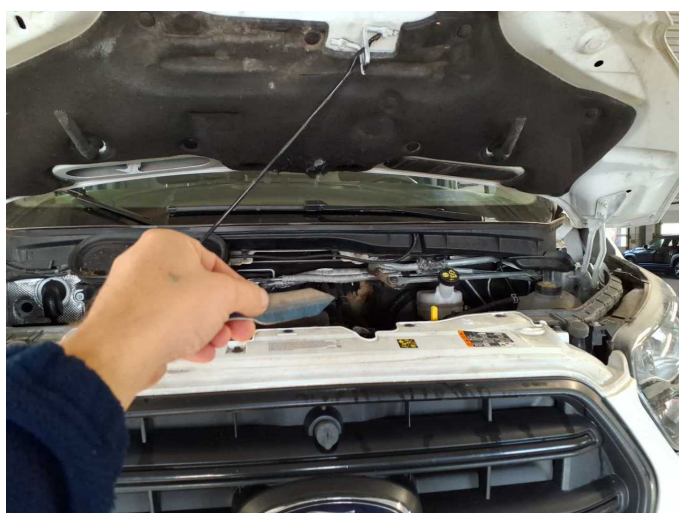
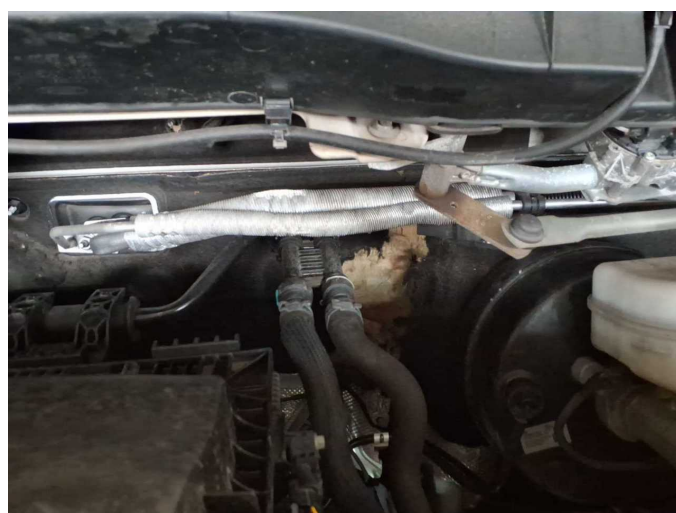
Damage 5: Bonnet: Insulation lining (Spritzwand) - Broken / torn - Replace
