Expertise

Protocol number: 41610343
Order No. / Reference: 25119957
Inspection date: 18 Sept 2025

Manufacturer: Ford

Model: Transit 350 L3H2 Lkw VA Trend

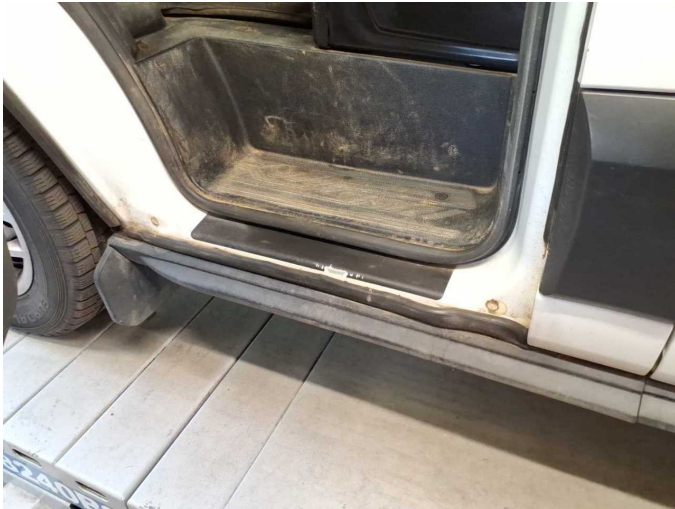
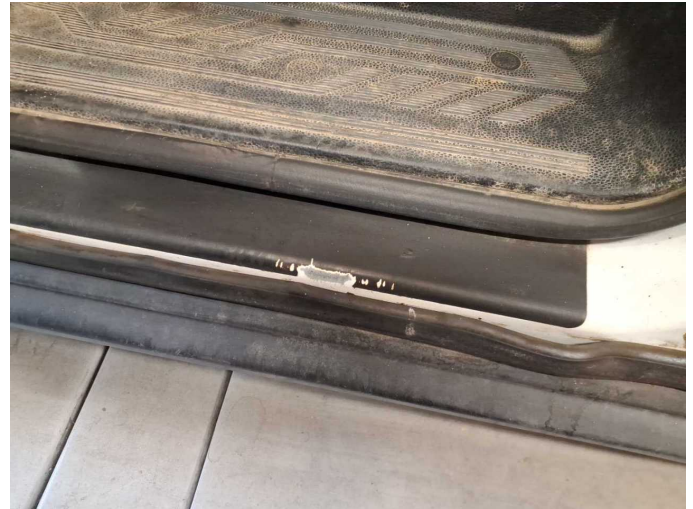
Damage 5: Sill - left side: Sill - Scratch(es) - Smart repair

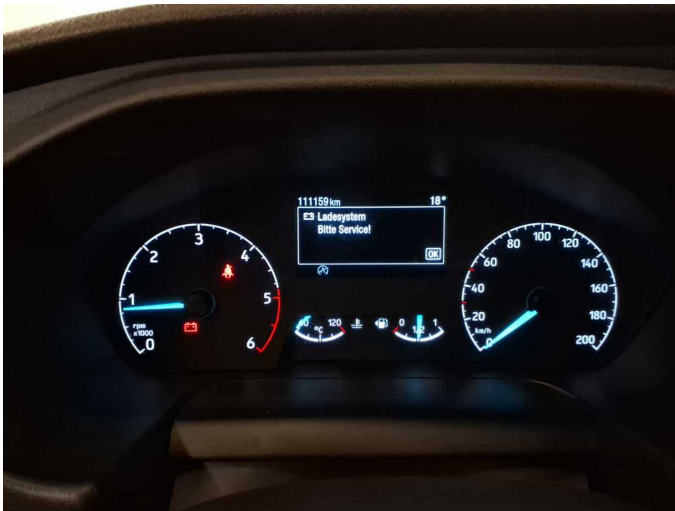
Damage 6: Instrument panel: Indicator light - on - Perform diagnosis

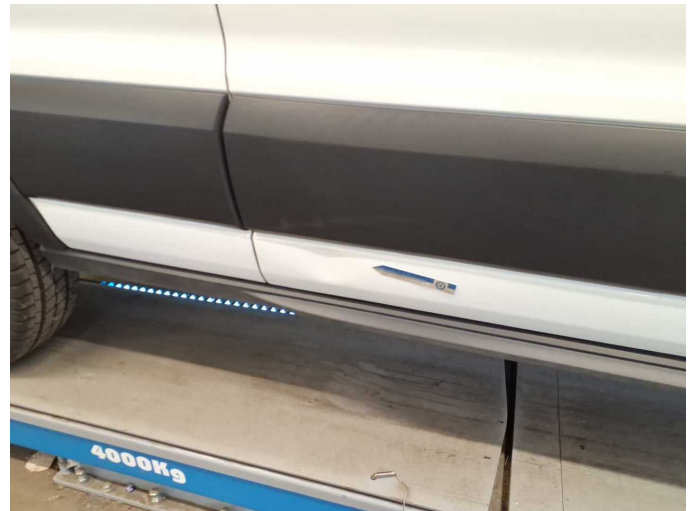
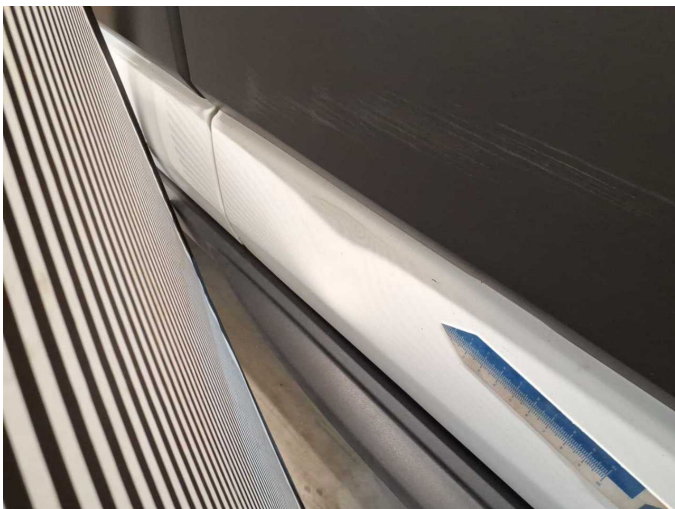
Damage 7: Door - rear right side: Door (Schiebetür) - Deformed - Smart repair

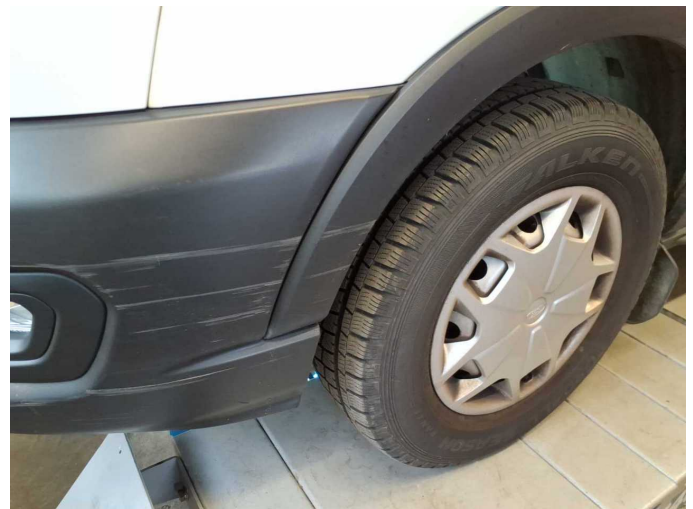
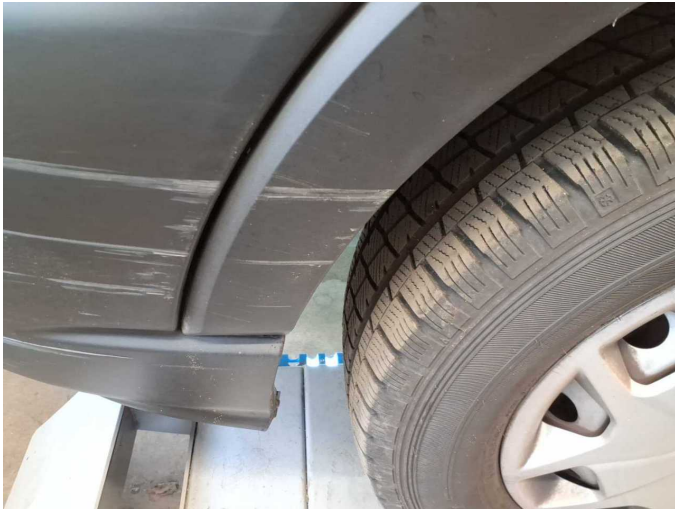
Damage 8: Mudguard - left side: Wheel arch - Scratch(es) - Replace

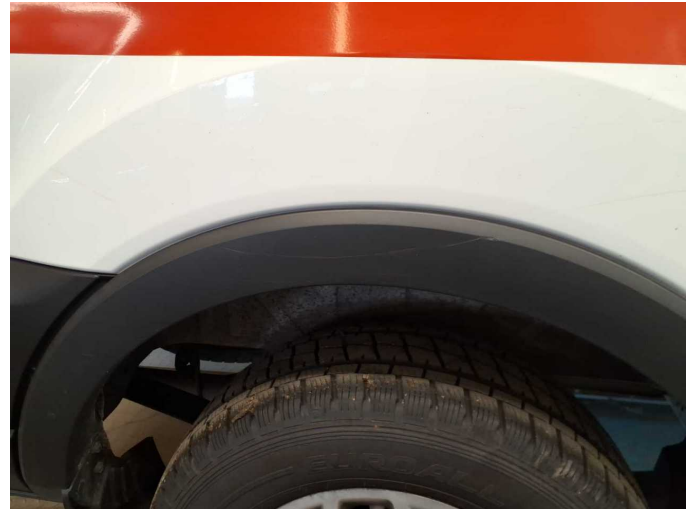
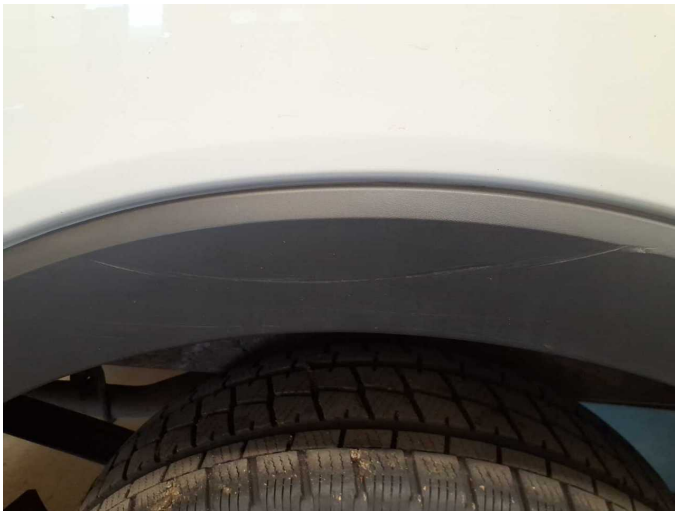
Damage 9: Side panel - rear right side: Wheel arch - Scratch(es) - Replace

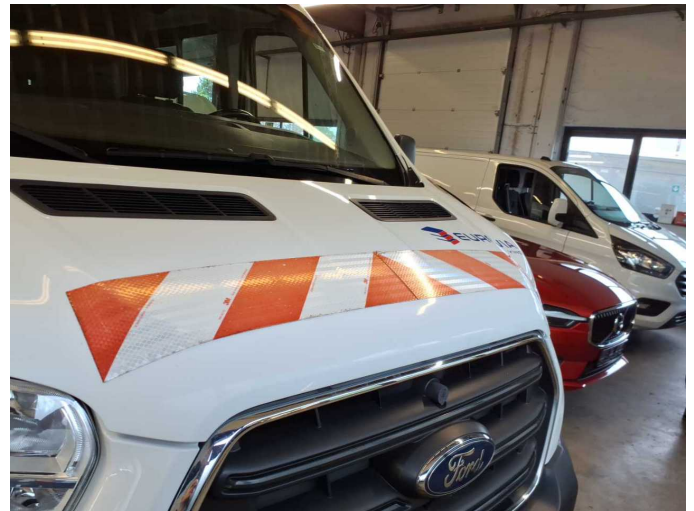
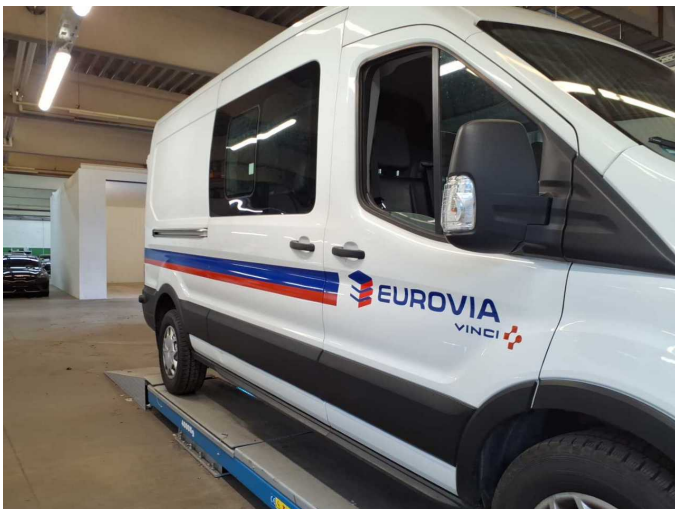
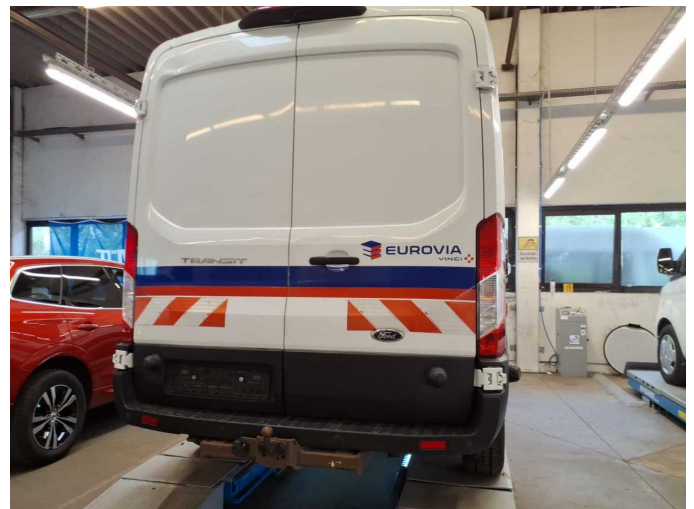
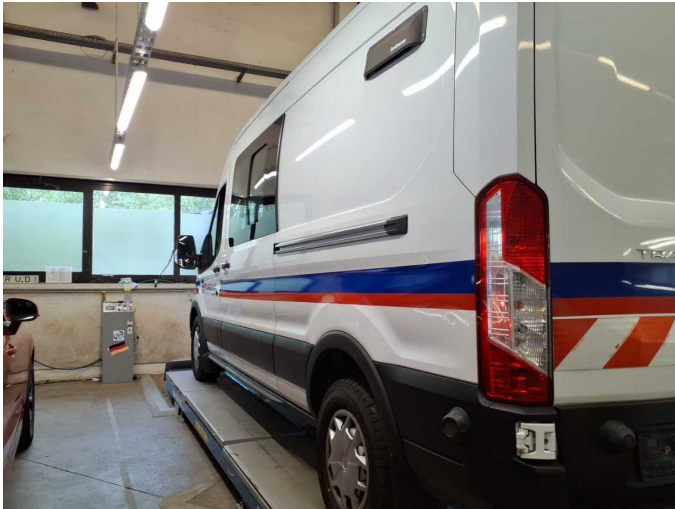
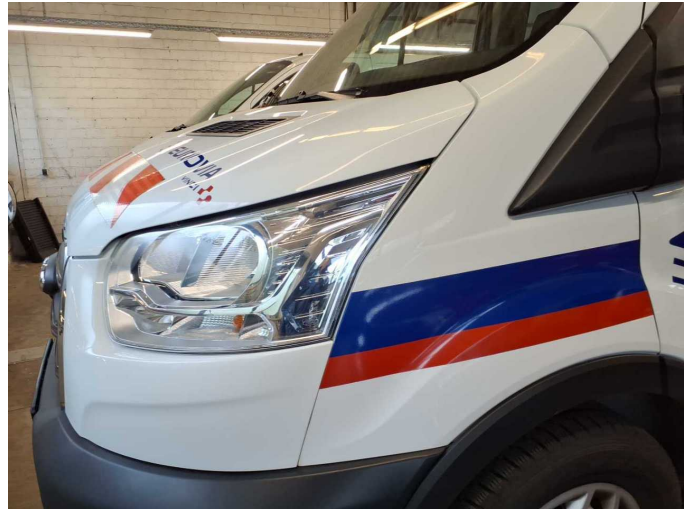
Damage 10: Body: Body - Glued / labelled - De-glue / neutralise

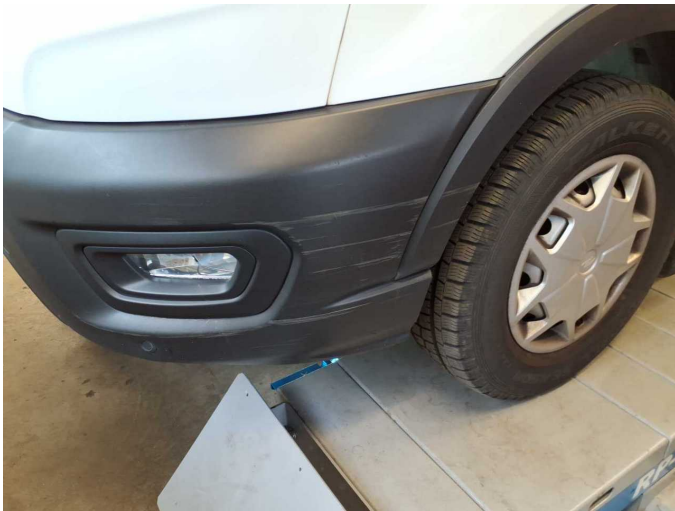
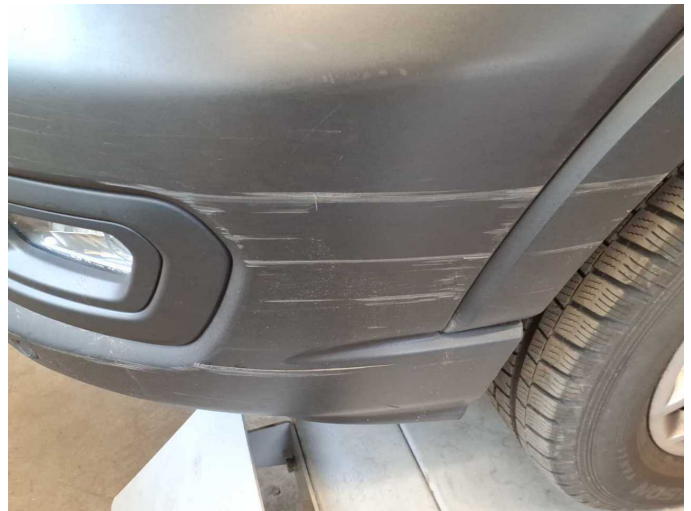
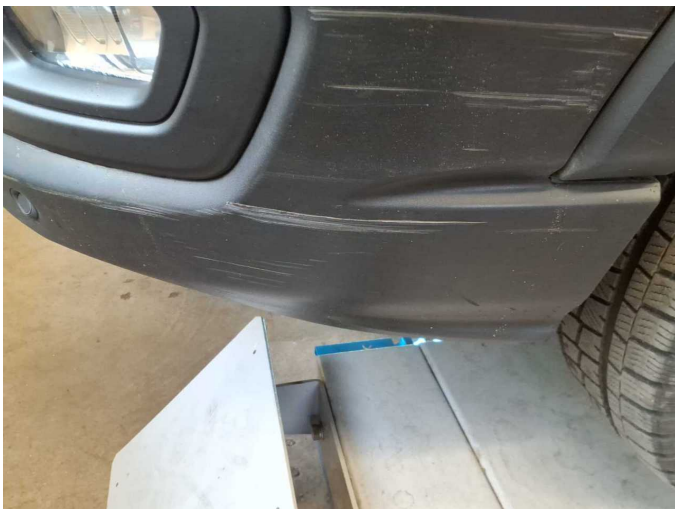
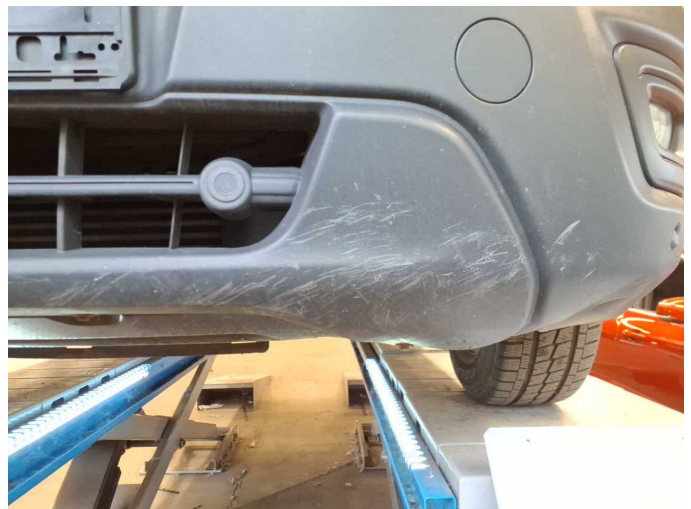
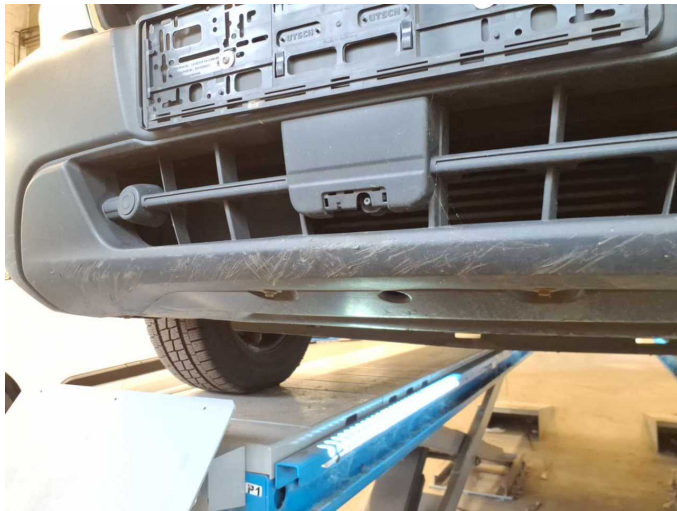
Damage 11: Front bumper: Front bumper (unpainted) - Scratch(es) - Replace

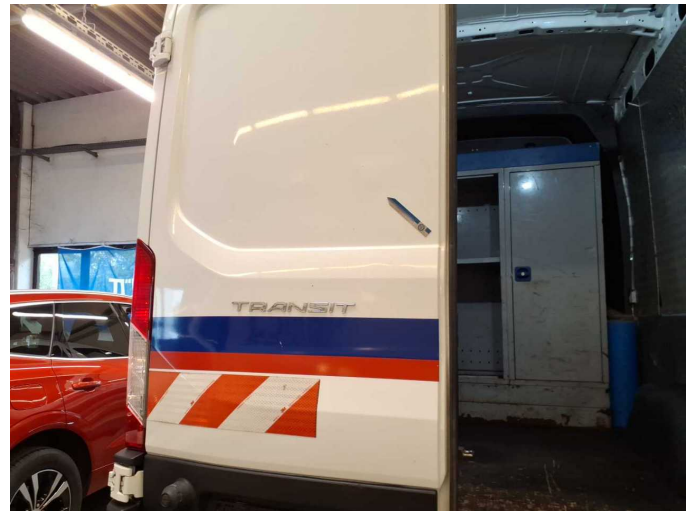
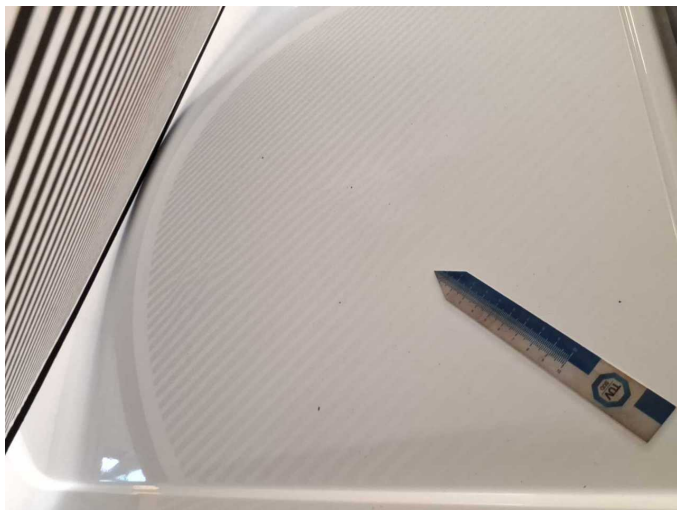
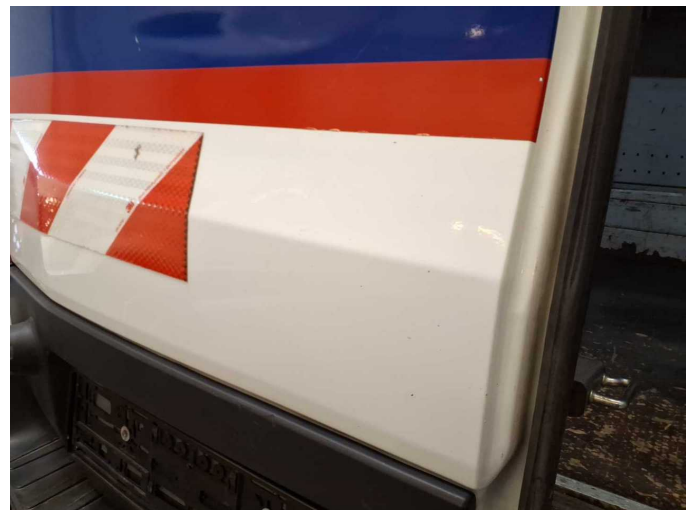
Damage 12: Boot lid / rear door: Boot lid (Links) - Dent / paintcoat damage - Repair and paint

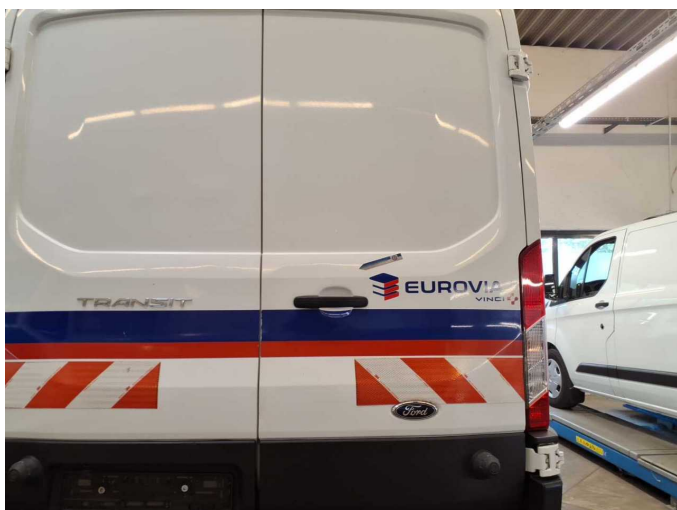
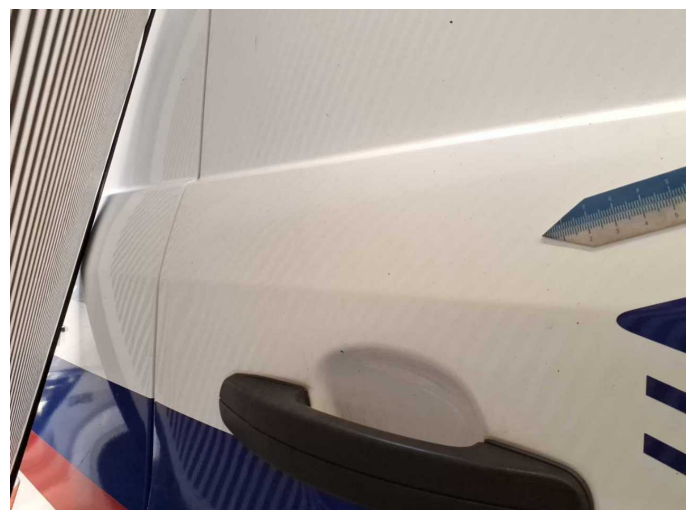
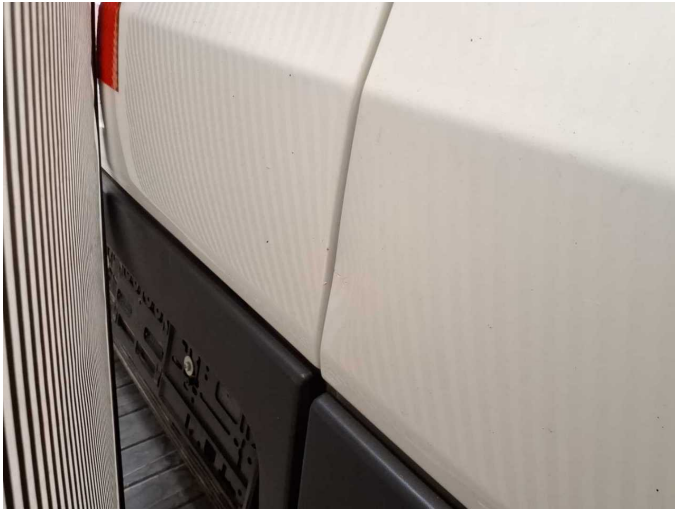
Damage 13: Boot lid / rear door: Boot lid (Rechts) - Dent / paintcoat damage - Repair and paint

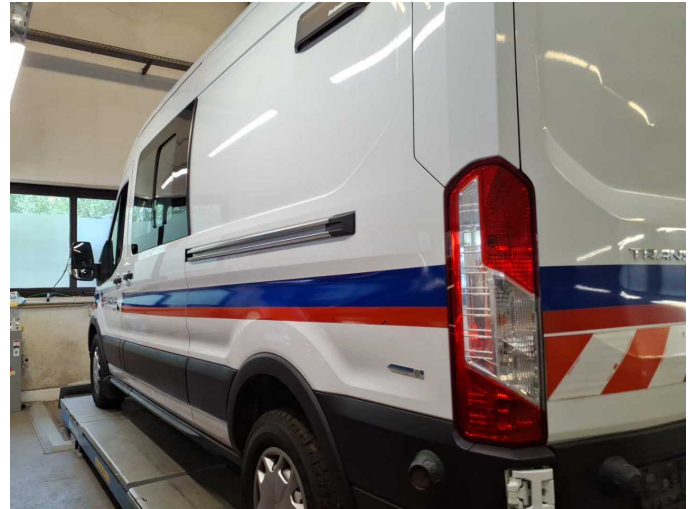
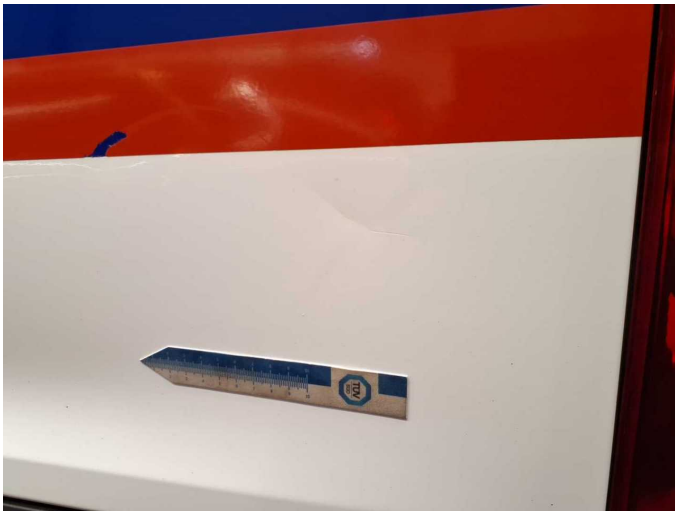
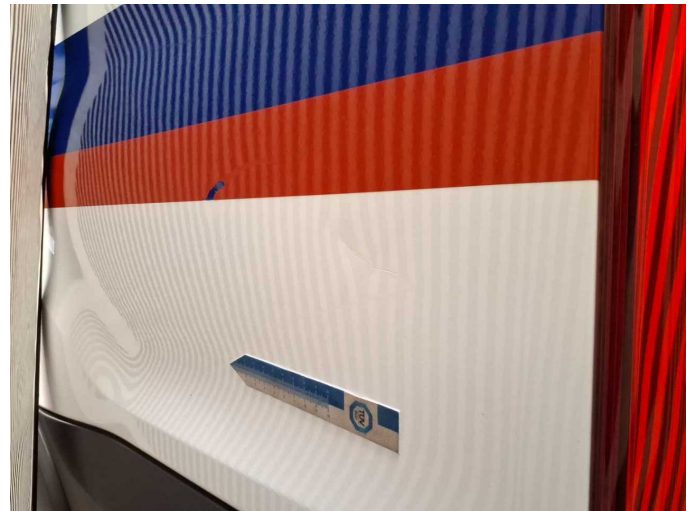
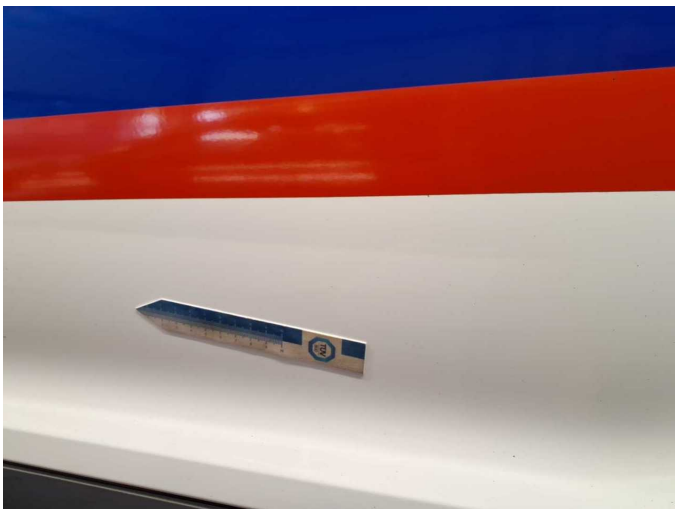
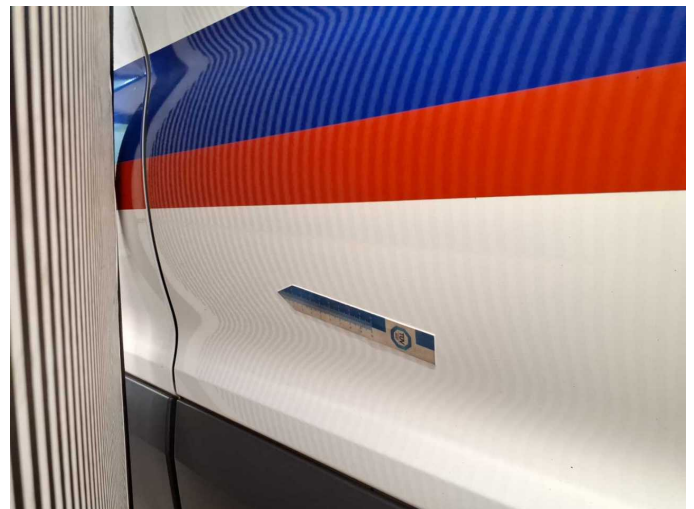
Damage 14: Side panel - rear left side: Side panel (unterhalb) - Dent / paintcoat damage - Repair and paint

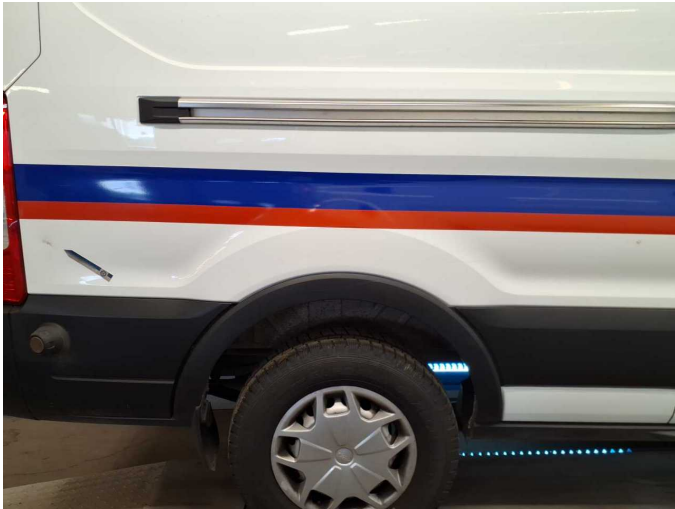
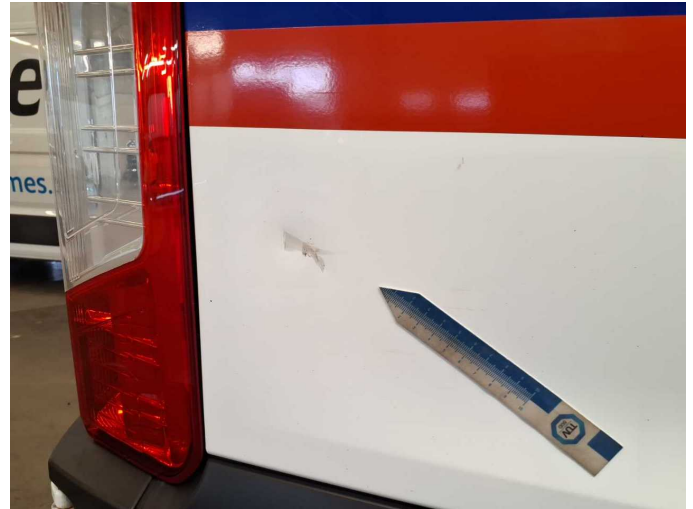
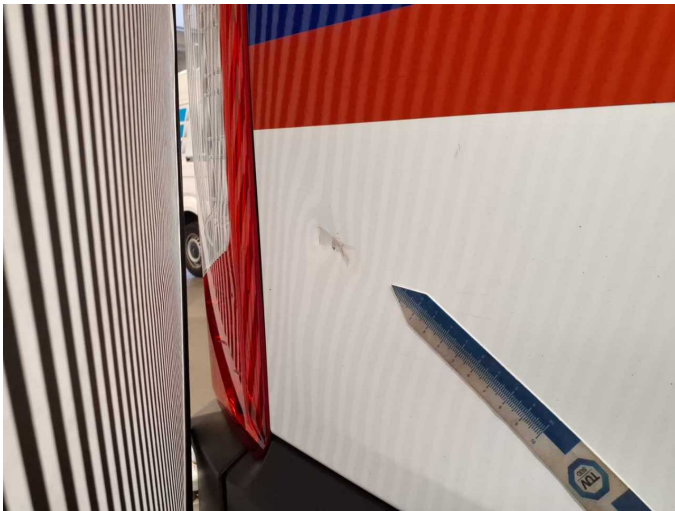
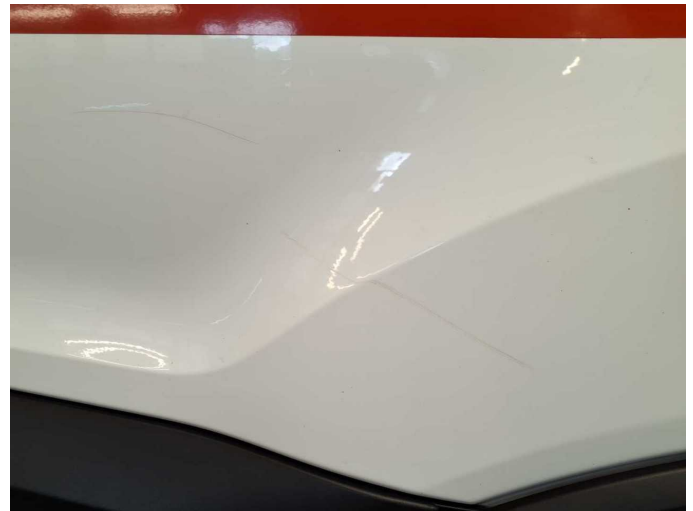
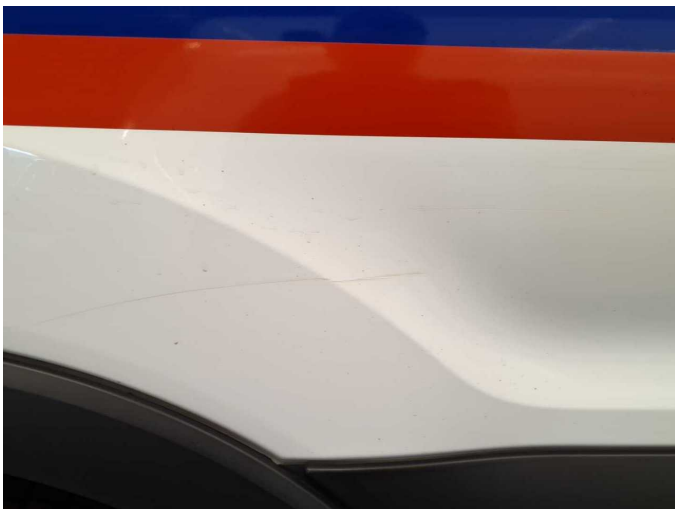
Damage 15: Side panel - rear right side: Side panel (unterhalb) - Dent / paintcoat damage - Repair and paint

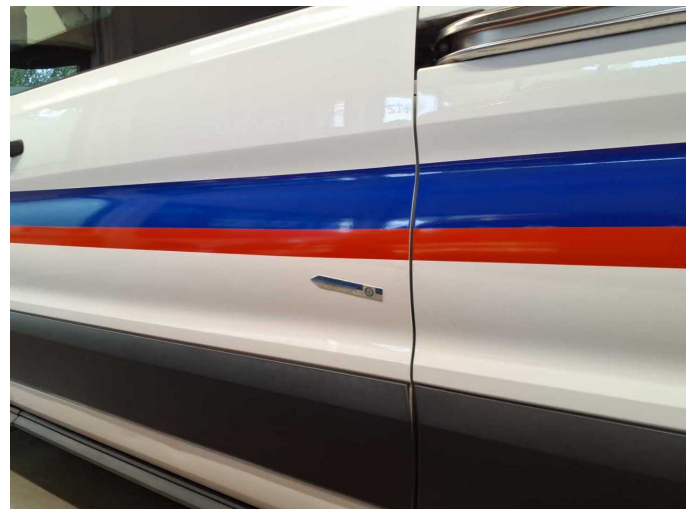
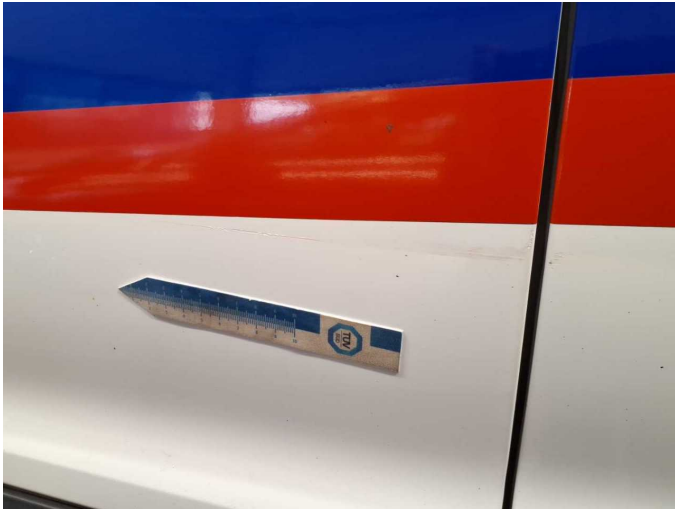
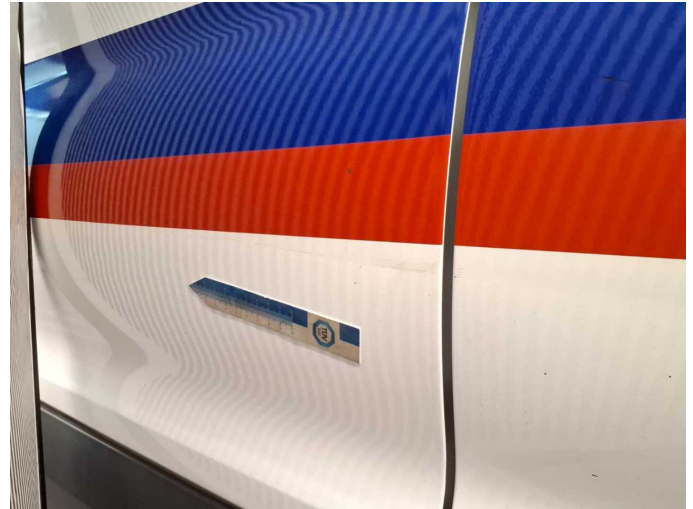
Damage 16: Door - rear left side: Door (Schiebetür) - Dent / paintcoat damage - Repair and paint

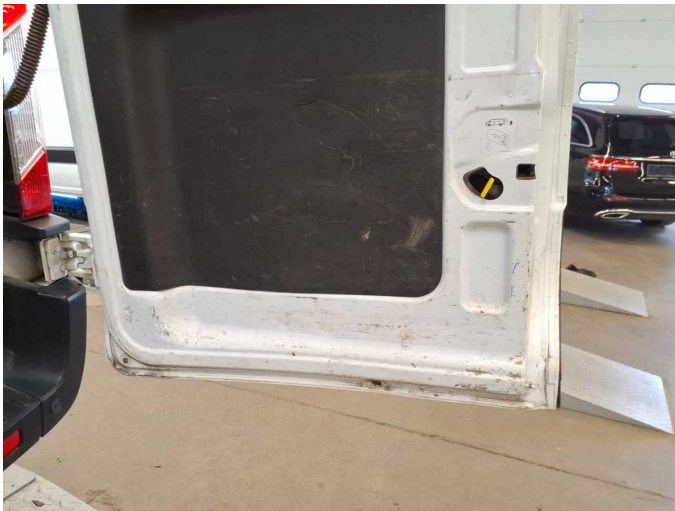
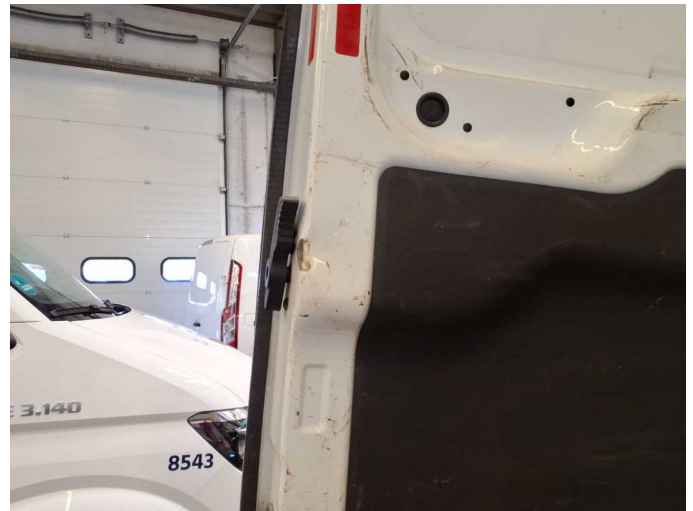
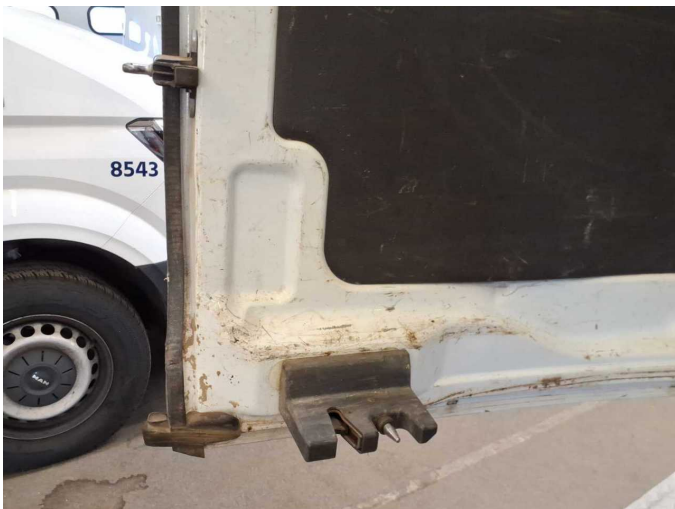
Wear and tear 4: Interior: Cargo area floor (Türen innen, und Dellen) - Scratched - No deduction

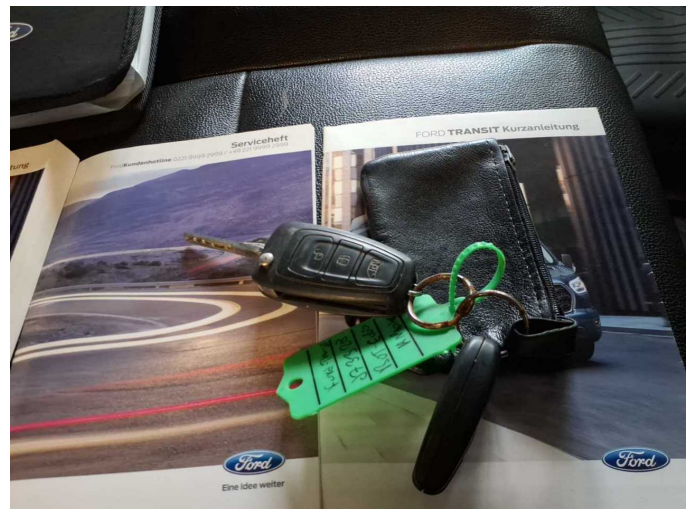
Missing part 1: Equipment: Vehicle key - Missing - Replace
