Expertise

Protocol number: 41619842  
Order No. / Reference: 25172115  
Inspection date: 19 Sept 2025

Manufacturer: Ford

Model: Transit 350 L3H2 Kasten Doka VA Trend

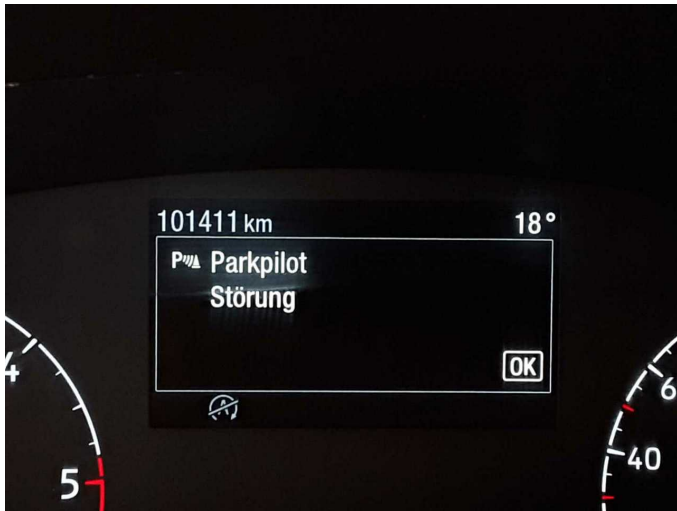
Damage 1: Electronic systems: Parking assistance - Functional / admissibility - Perform diagnosis

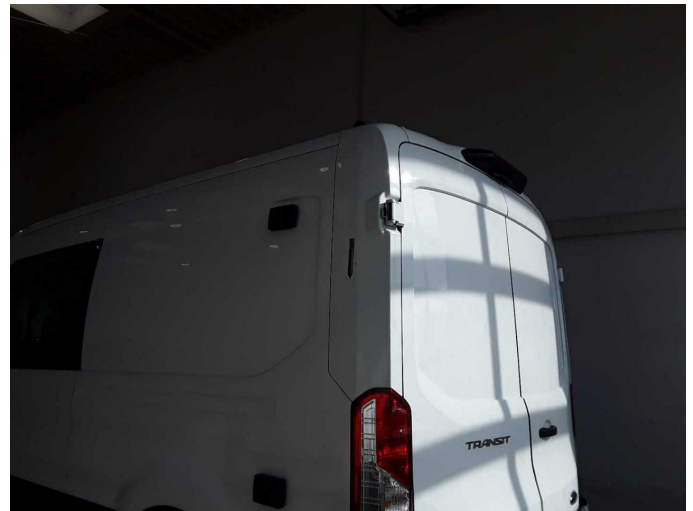
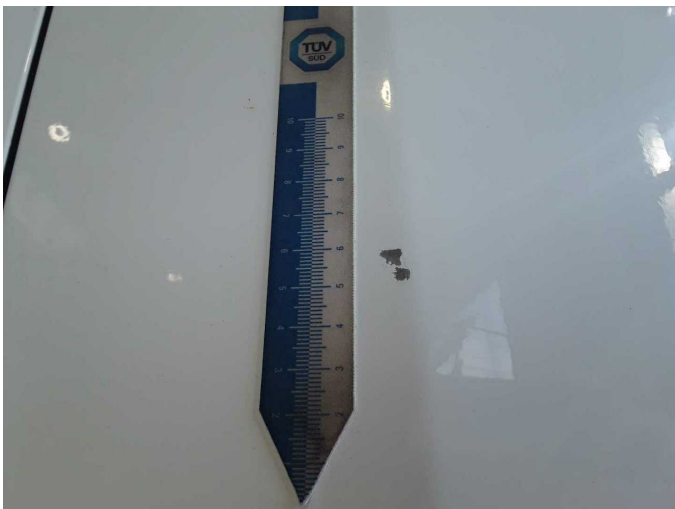
Damage 2: Body: D-pillar - left side - Scratch(es) - Loss in value

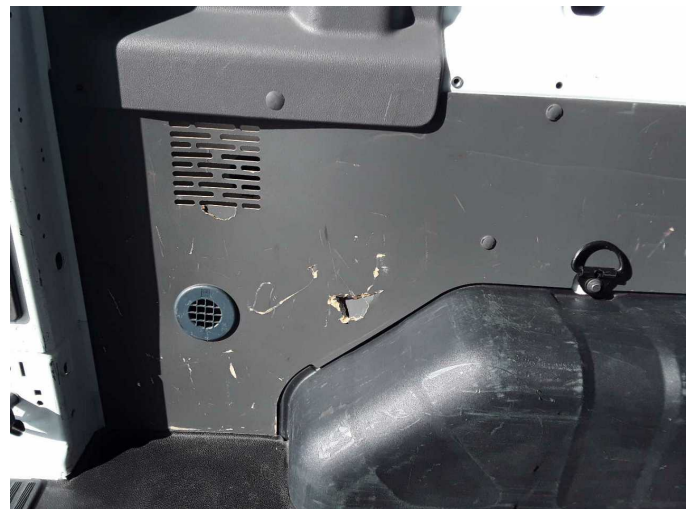
Damage 3: Trim / covers: Cargo area - lining -left side - Damaged - Replace

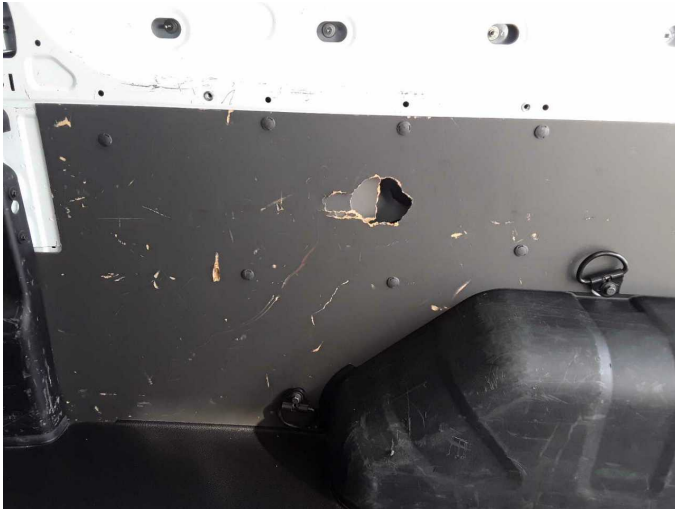
**Damage 4:** Trim / covers: Cargo area - lining - right side - Damaged - Replace

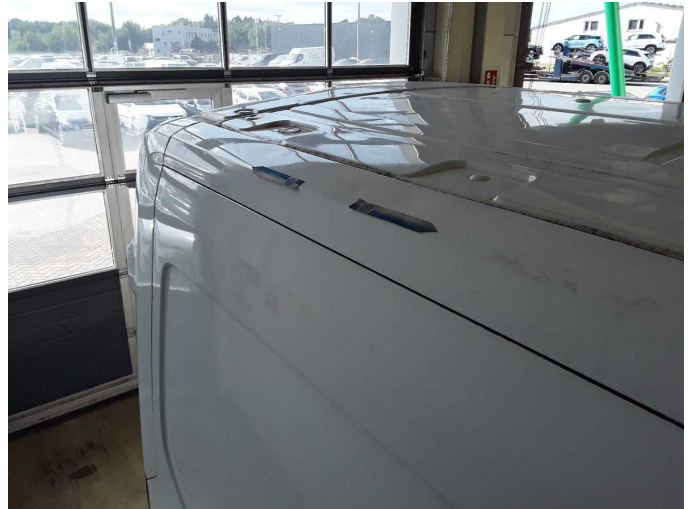
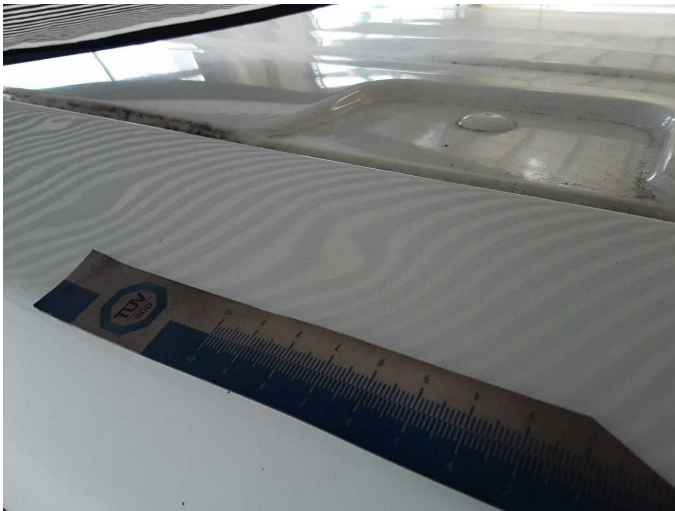
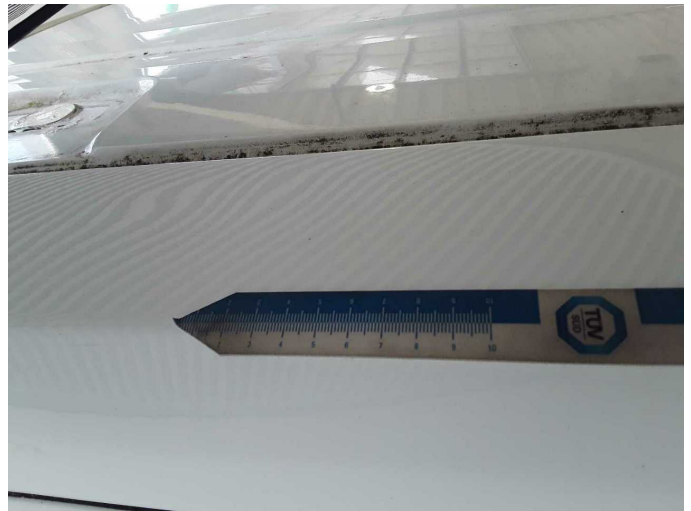
**Damage 5:** Roof: Roof rail - right side - dent(s) - Repair and paint

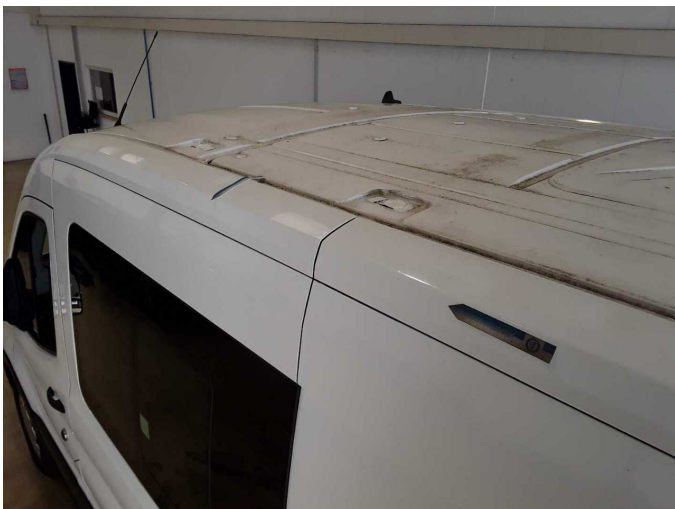
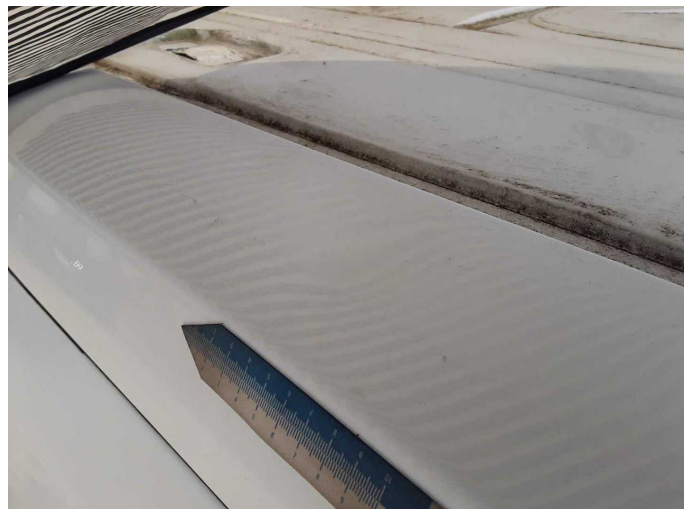
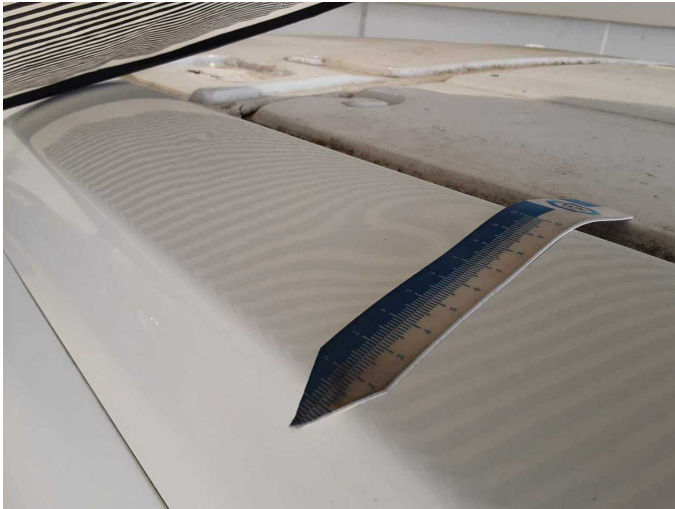
**Damage 6:** Roof: Roof rail - left side - Deformed - Repair and paint

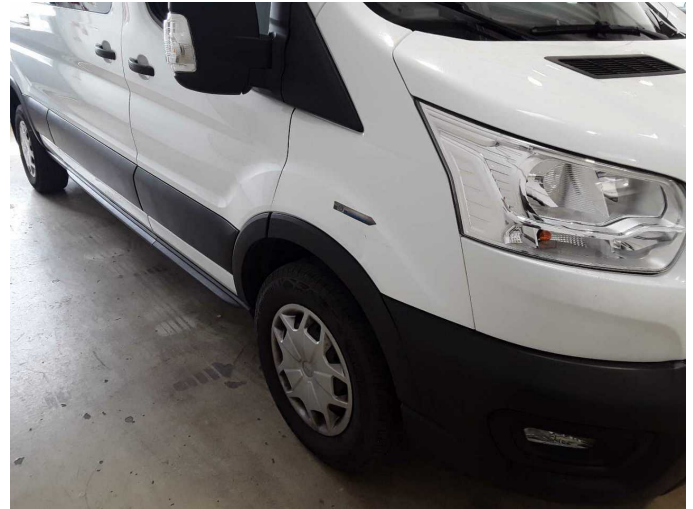
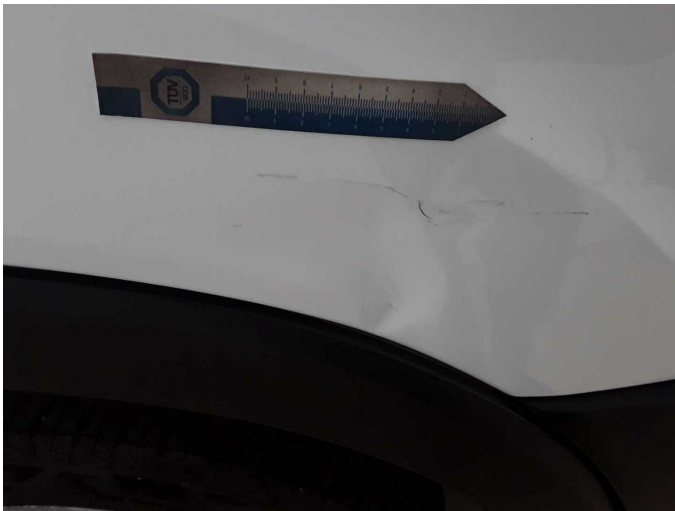
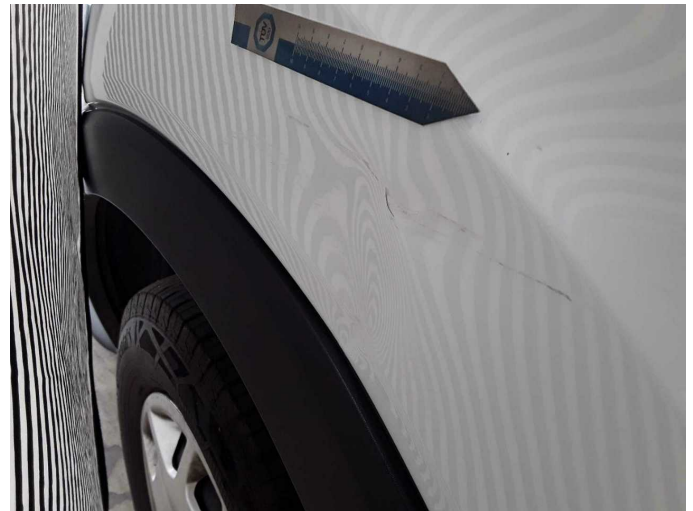
**Damage 7:** Mudguard - right side: Mudguard - right side - Deformed - Repair and paint

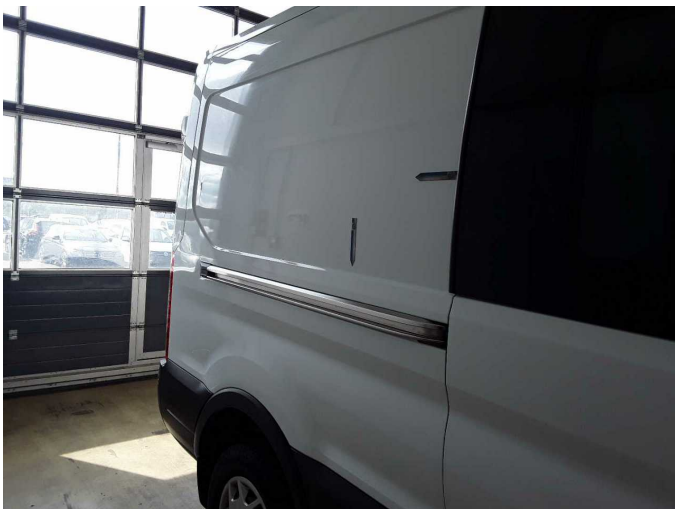
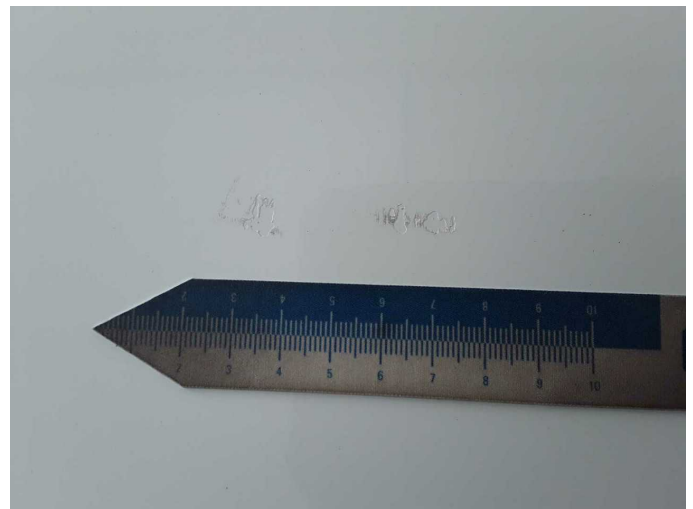
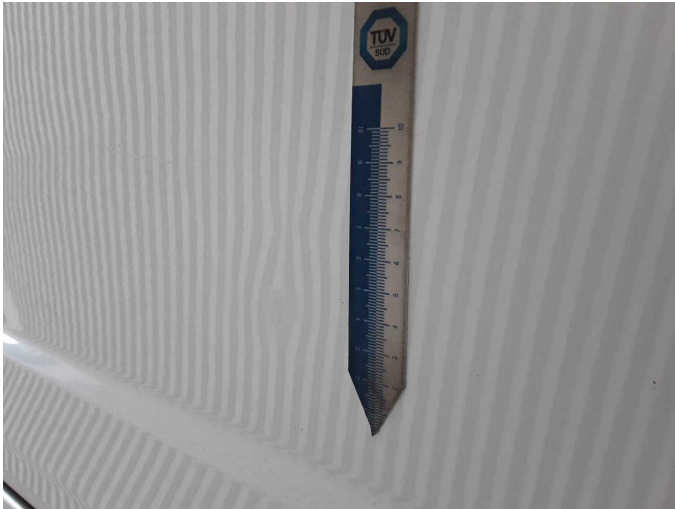
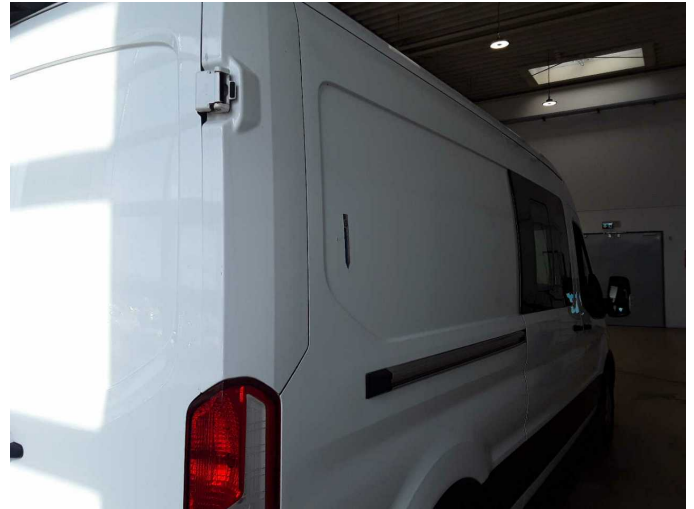
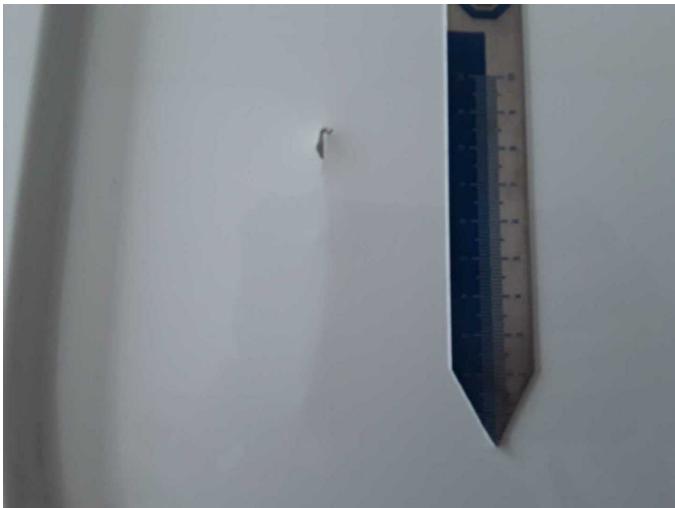
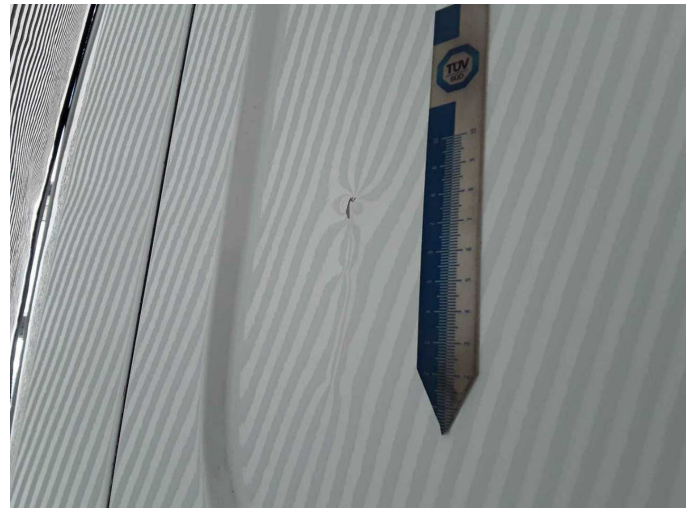
**Damage 8:** Side panel - rear right side: Side panel - Dent / paintcoat damage - Repair and paint

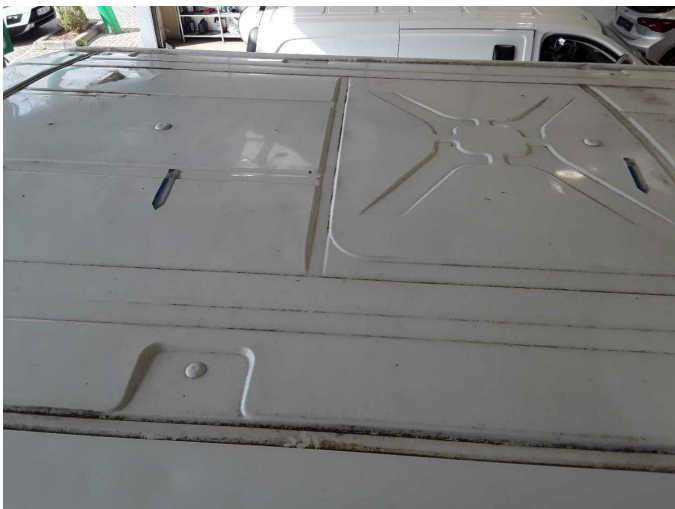
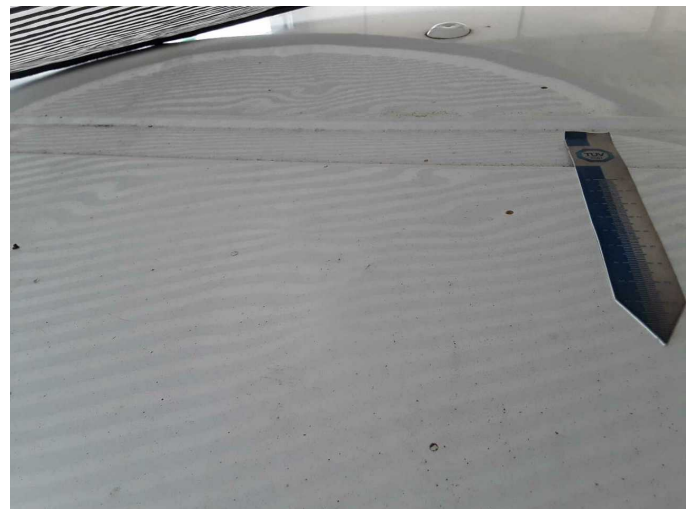
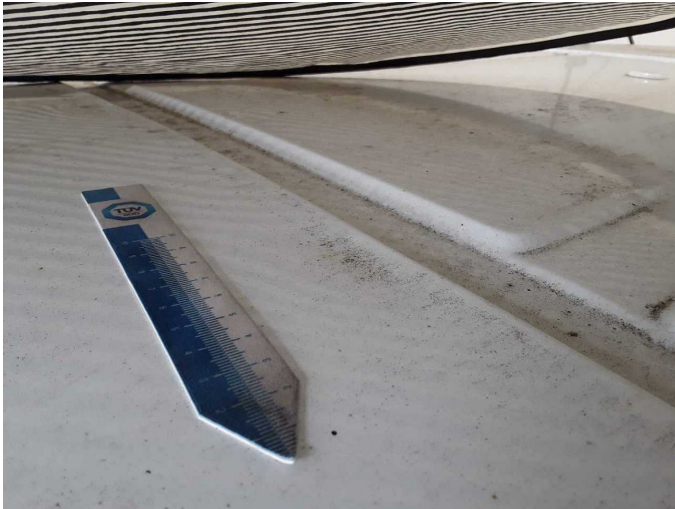
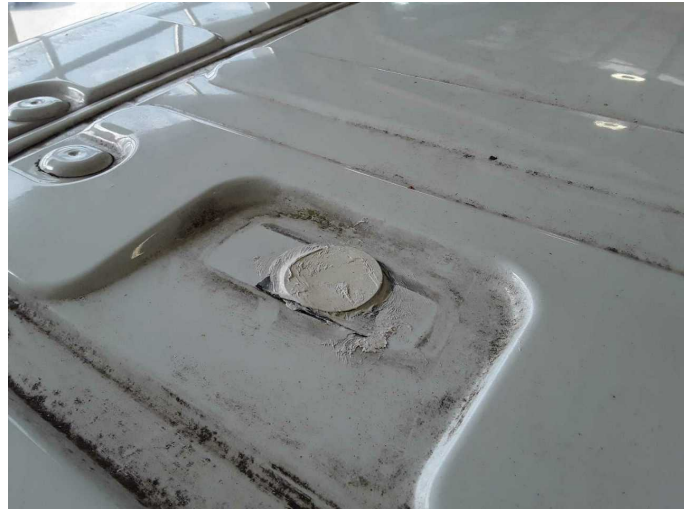
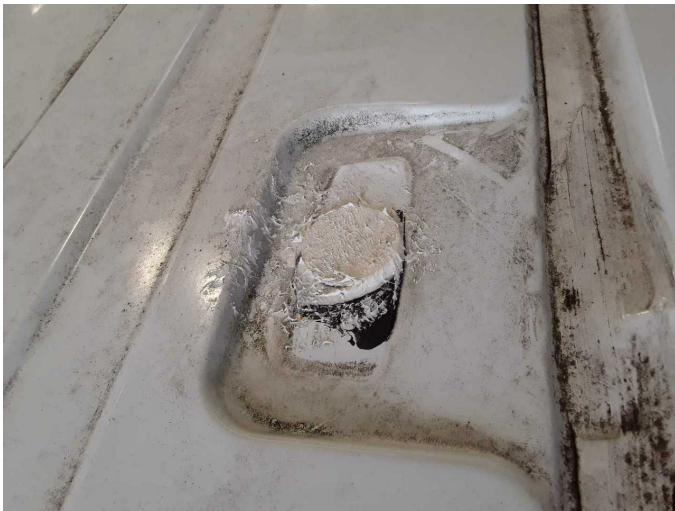
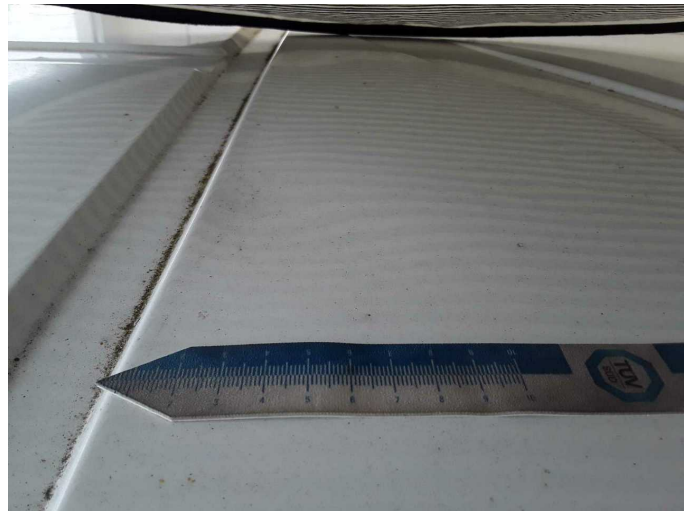
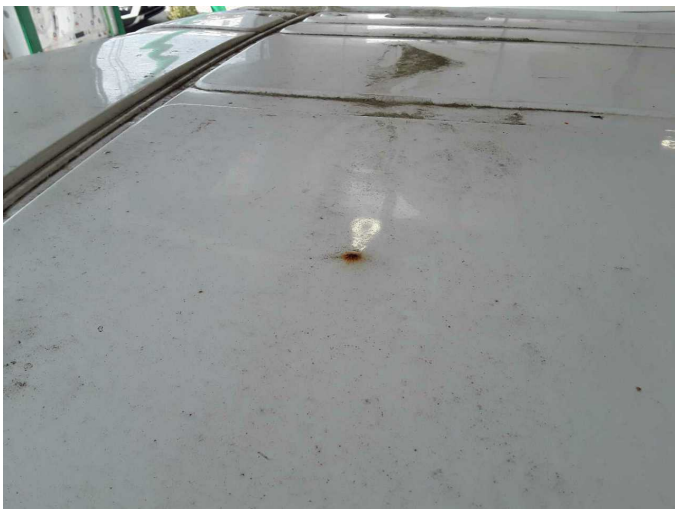
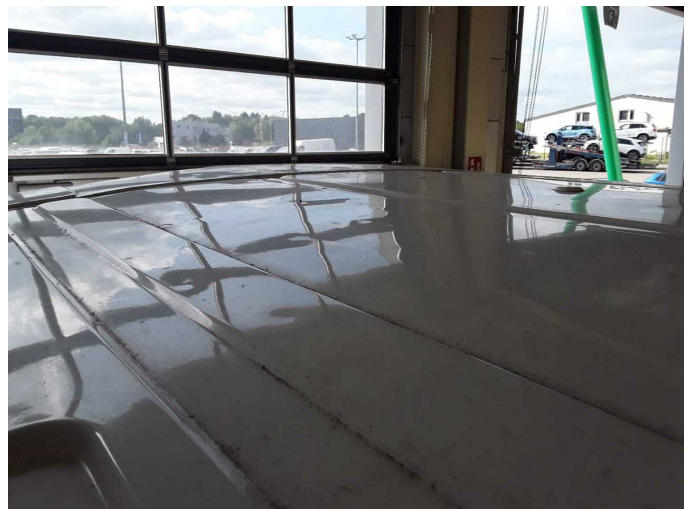
**Damage 9:** Roof: Roof - Deformed - Repair and paint

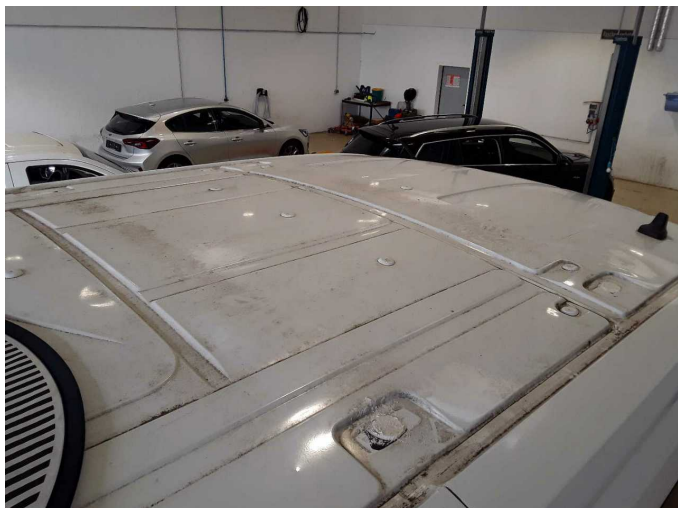
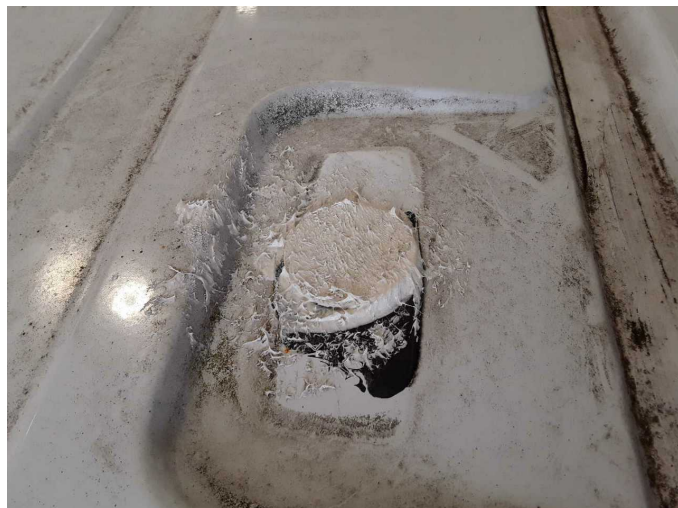
**Missing part 1:** Equipment: Roof rack system - Missing - Replace
