# FORD Mondeo

## Mondeo Turnier 2.0 EcoBoost Start-Stopp Autom.

VIN NO WF0FXXWPCFFD30967  
Registration Number PCFFD30967

### Inspection Report Summary

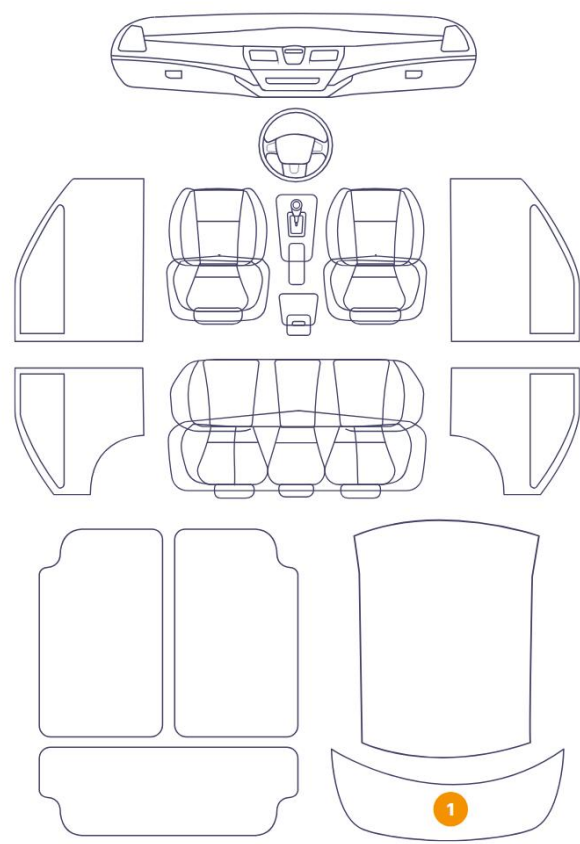
6 Schäden

1 Schäden
