FORD Mondeo

Mondeo Turnier 2.0 EcoBoost Start-Stopp Autom.

VIN NO WF0FXXWPCFFD30967
Registration Number PCFFD30967

Inspection Report Summary

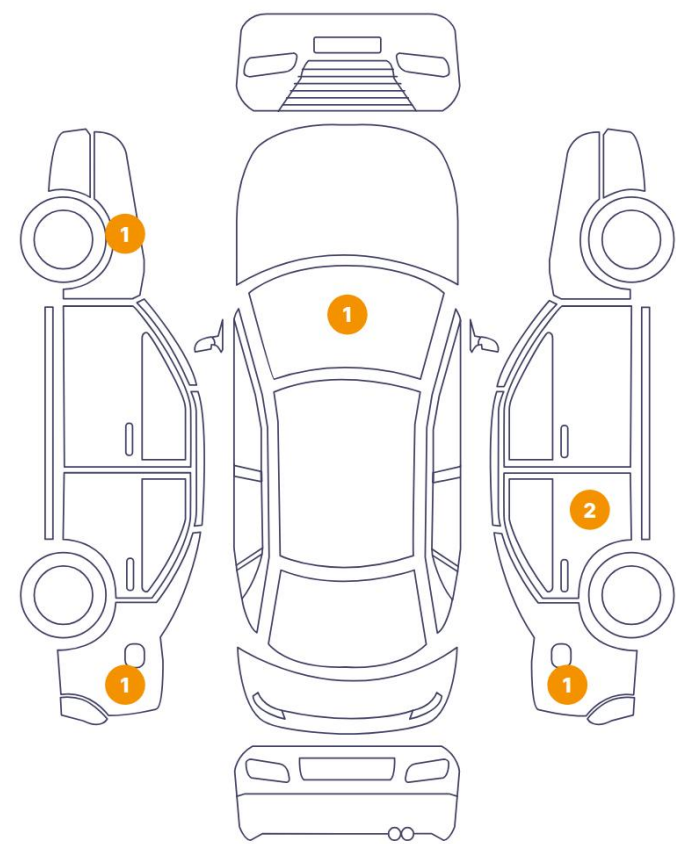
6 Schäden

Component		Damage	Comments
1	Side Panel / Back Left	Paint / Scratch / Scuff	
2	Tailgate Upholstery / Back	Interior / Scratched	
3	Door / Back Right	Bodywork / Dent / Dent	
4	Windshield / Front	Paint / Chipping	
5	Fender / Front Left	Paint / Poor Previous Repair	
6	Side Panel / Back Right	Paint / Poor Previous Repair	
7	Door / Back Right	Paint / Poor Previous Repair

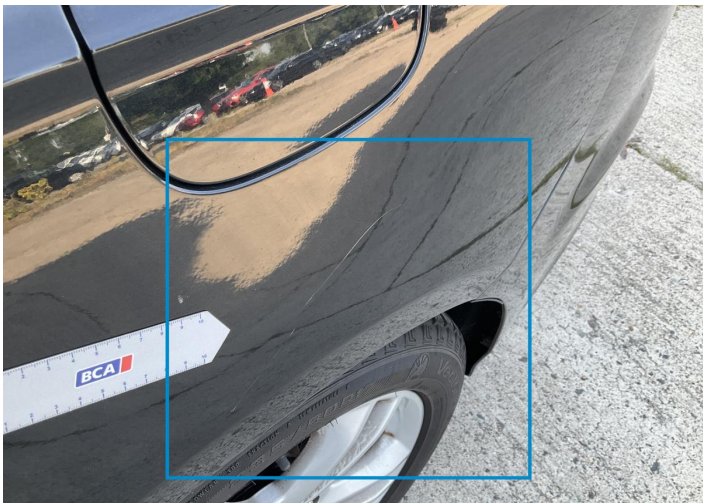
1. Side Panel / Back Left
Paint / Scratch / Scuff -

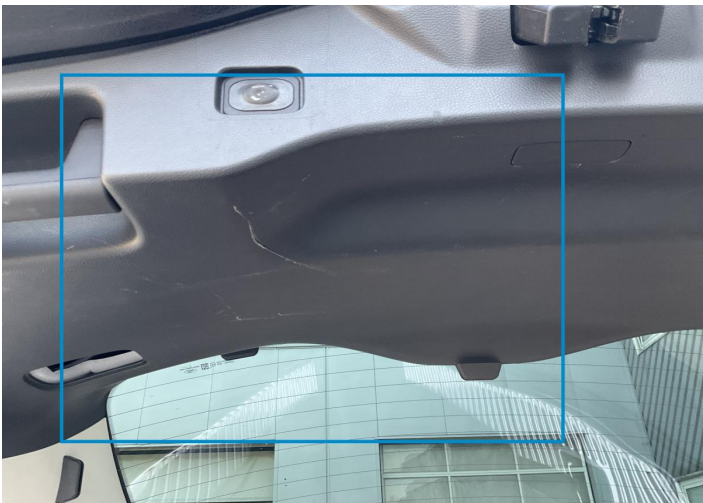
2. Tailgate Upholstery / Back
Interior / Scratched -

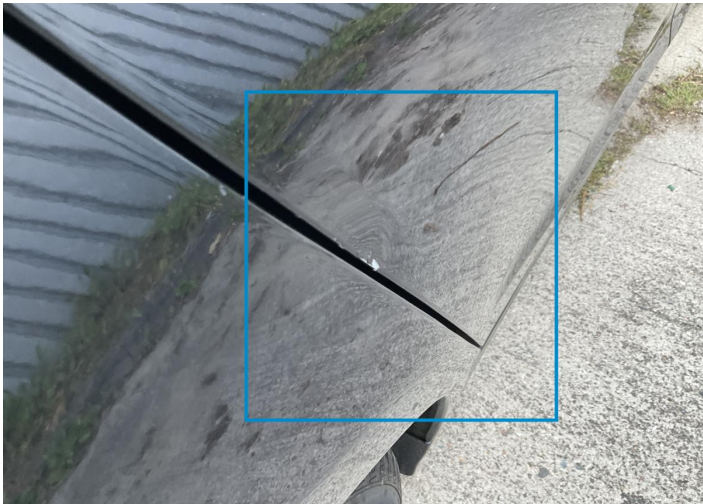
3. Door / Back Right
Bodywork / Dent / Dent -

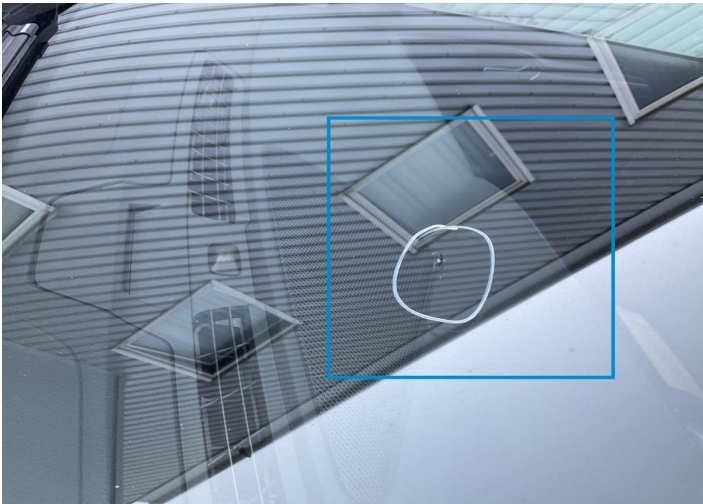
4. Windshield / Front
Paint / Chipping -

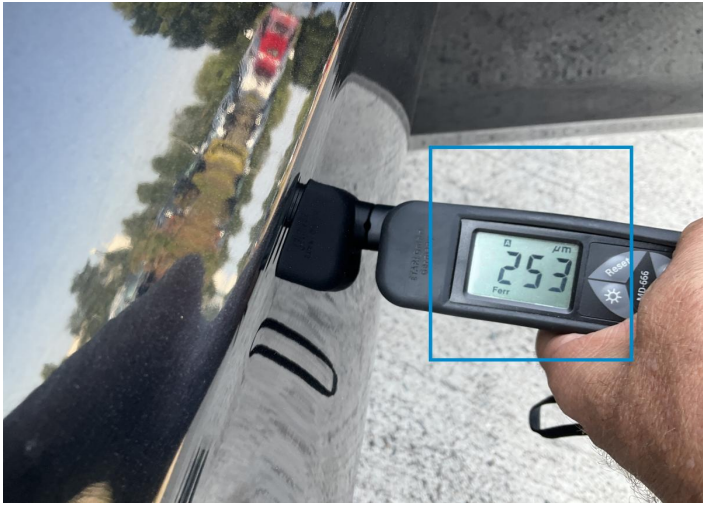
5. Fender / Front Left
Paint / Poor Previous Repair -

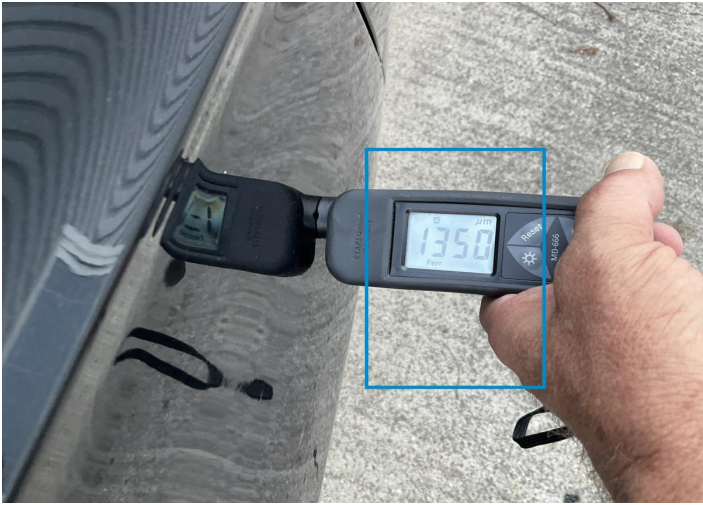
6. Side Panel / Back Right
Paint / Poor Previous Repair -

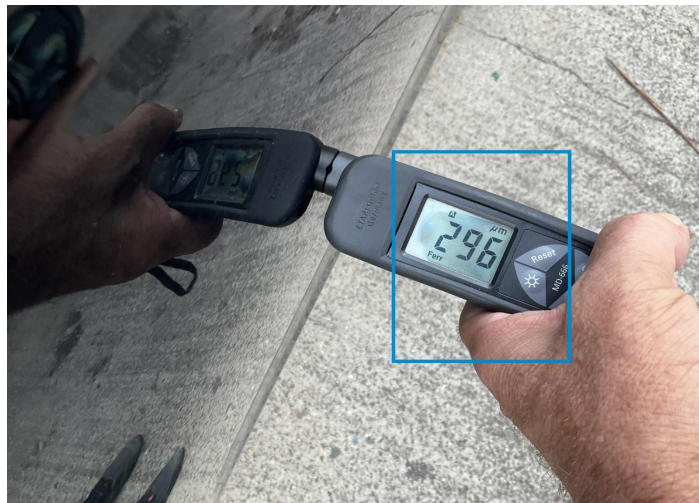
7. Door / Back Right
Paint / Poor Previous Repair -
