## status report

**customer:** BCA Autoauktionen GmbH

#### Ford Mondeo Turnier Business Edition

| Vehicle identification number | <b>WF0FXXWPCFJS38190</b> | mileage read: | <b>125470 km</b> |

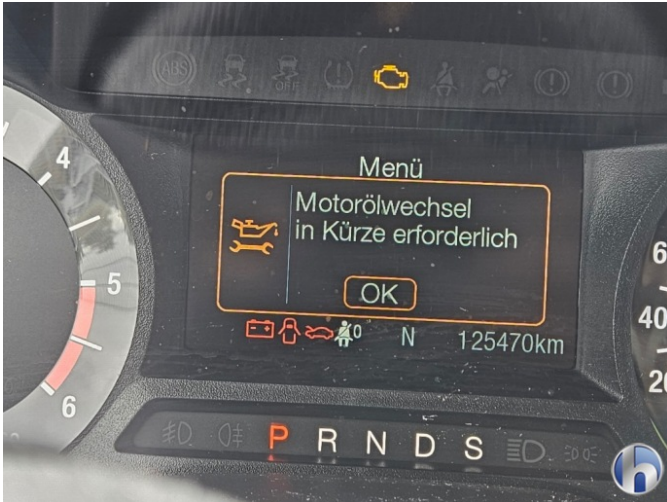
| component | Damage | Rep kind |
|---|---|---|
| 3. Wartung | Due | Replace |

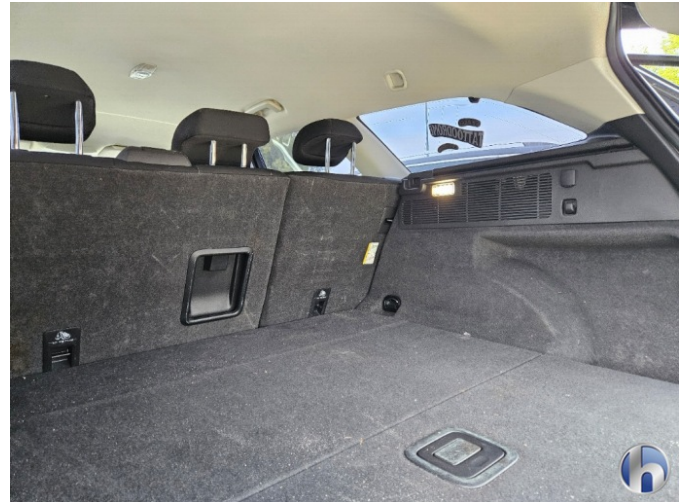
| component | Damage | Rep kind |
|---|---|---|
| 5. Laderaumabdeckung | Missing | Replace |

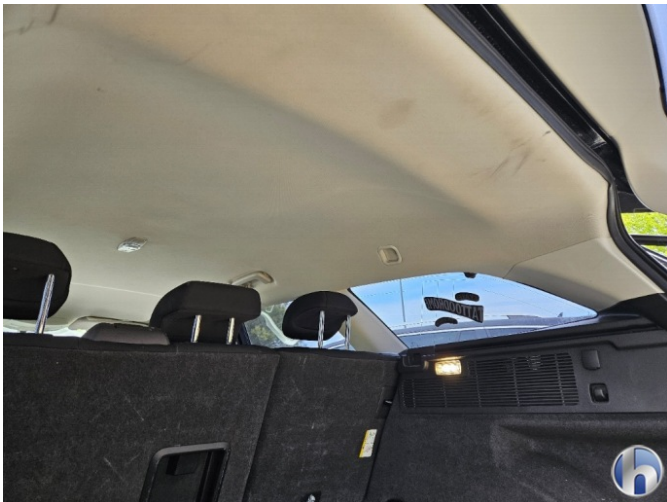
| component | Damage | Rep kind |
|---|---|---|
| 6. Trennnetz | Missing | Replace |

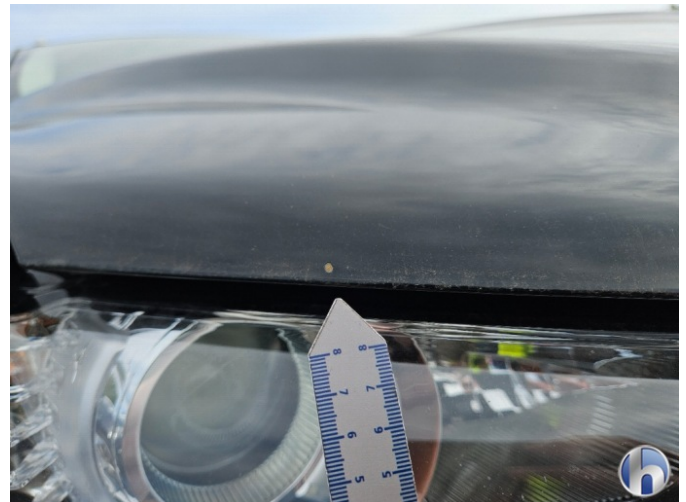
| component | Damage | Rep kind |
|---|---|---|
| 7. hood | Wear and tear | acceptable |

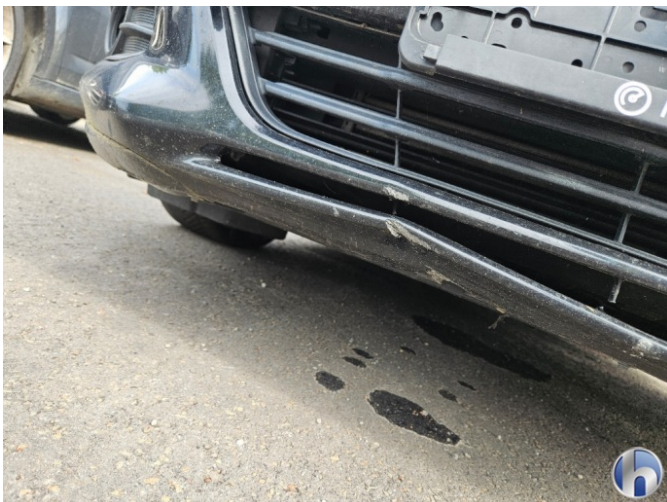
| component | Damage | Rep kind |
|---|---|---|
| 8. Front bumper | Deformed (strongly) | Replace |

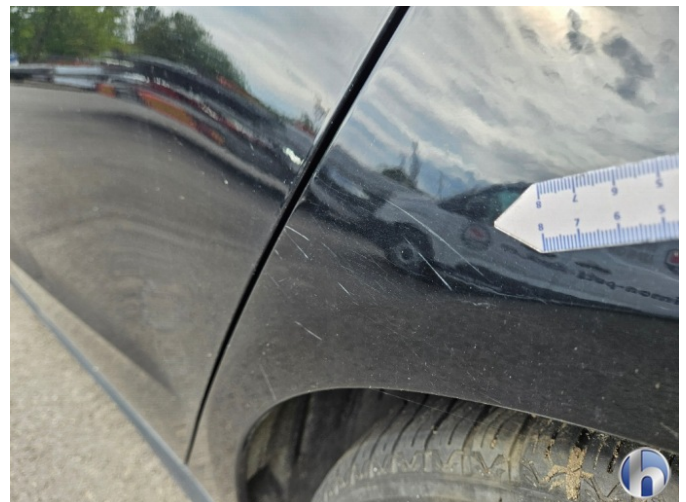
| component | Damage | Rep kind |
|---|---|---|
| 9. Sidewall - Rear - Left | Scratch(es) | Smart repair |

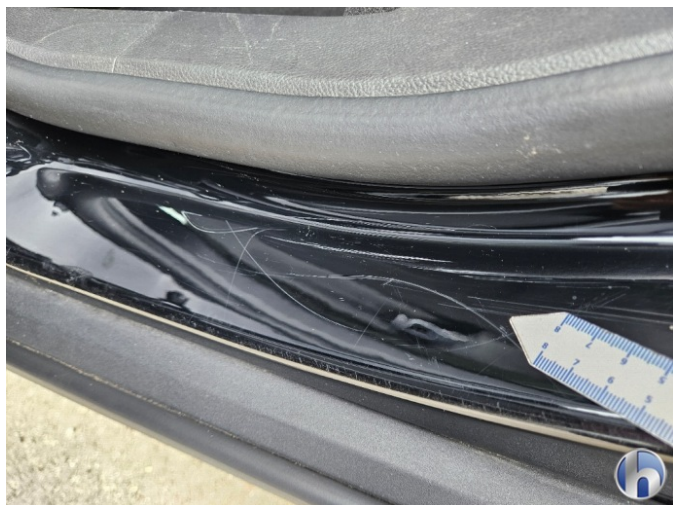
| component | Damage | Rep kind |
|---|---|---|
| 10. Türeinstieg h.l. | Scratch(es) | Paint |

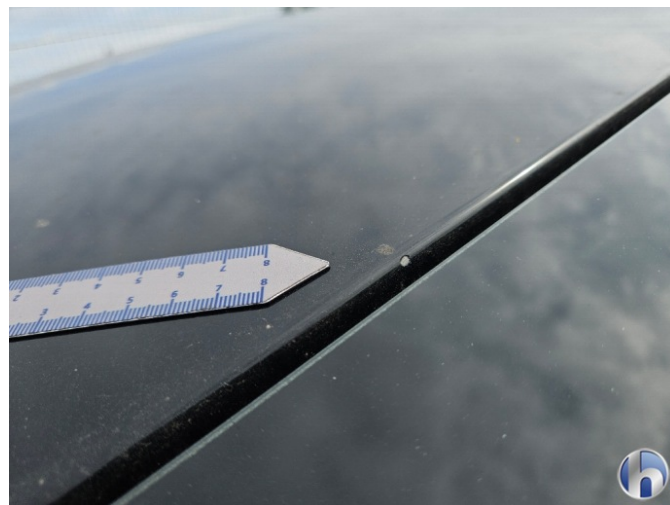
| component | Damage | Rep kind |
|---|---|---|
| 11. roof | Wear and tear | acceptable |

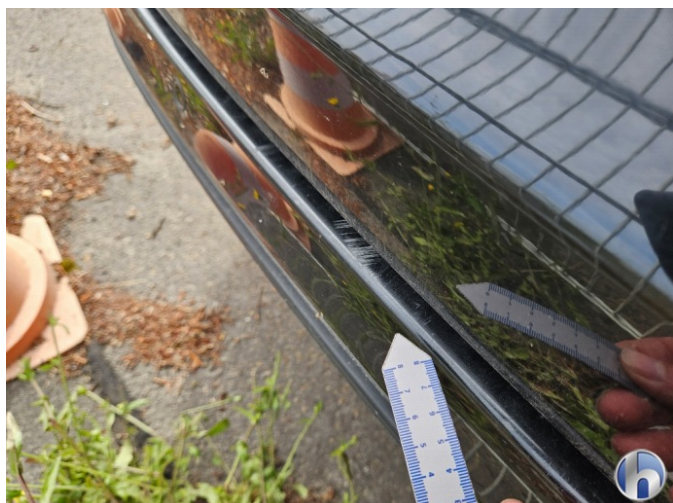
| component | Damage | Rep kind |
|---|---|---|
| 12. Rear bumper | Wear and tear | acceptable |

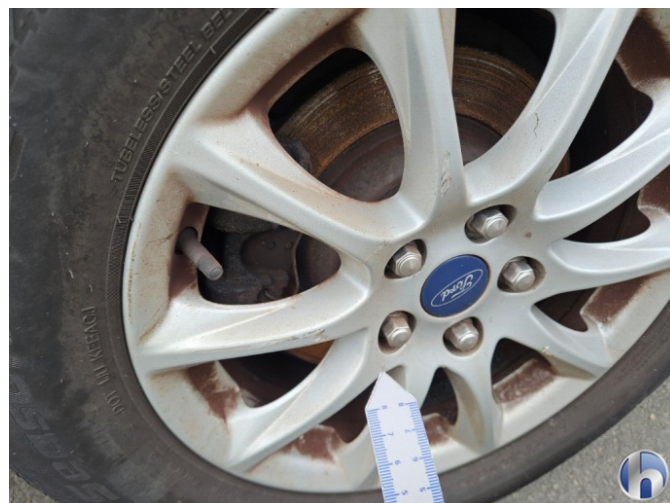
| component | Damage | Rep kind |
|---|---|---|
| 13. Felge h.r. | Scratch(es) | Paint |

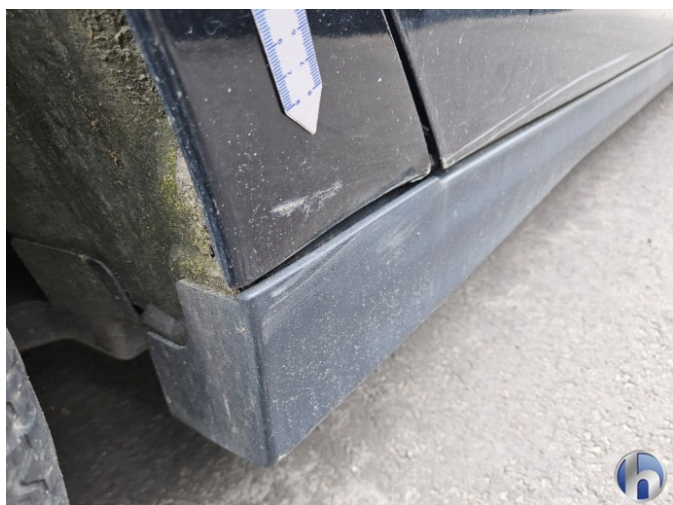
| component | Damage | Rep kind |
|---|---|---|
| 14. Sidewall - Rear - right | Deformed (slightly) | Refurbish and paint |

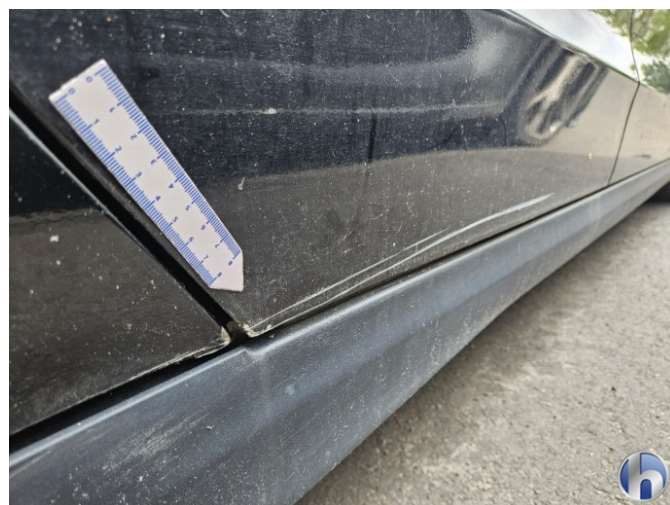
| component | Damage | Rep kind |
|---|---|---|
| 15. Door Rear - right | Scratch(es) | Paint |
