Expertise

Protocol number: 41739045
Order number / reference: 25133207
Inspection date: 29 Sept 2025

Manufacturer: Ford	Model: Mondeo Turnier 2.0 EcoBlue Aut. Titanium
VIN: WF0FXXWPCFLD17524

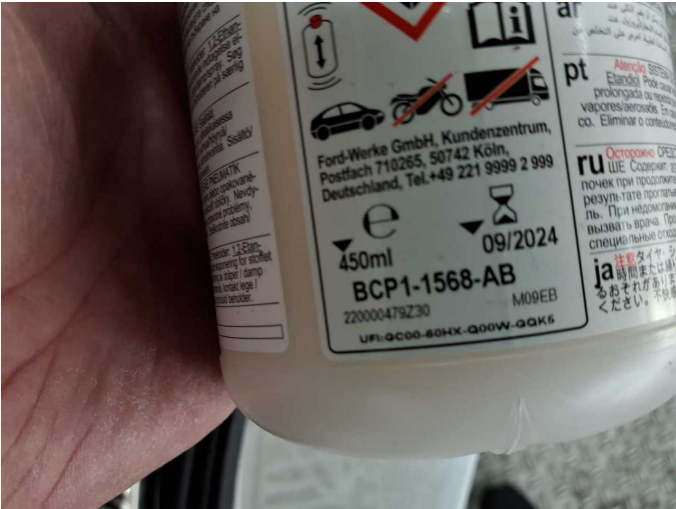
No.	Component group	Description
1	Equipment	Tirefit filler - Expired - Replace

Damage 1: Equipment: Tirefit filler - Expired - Replace

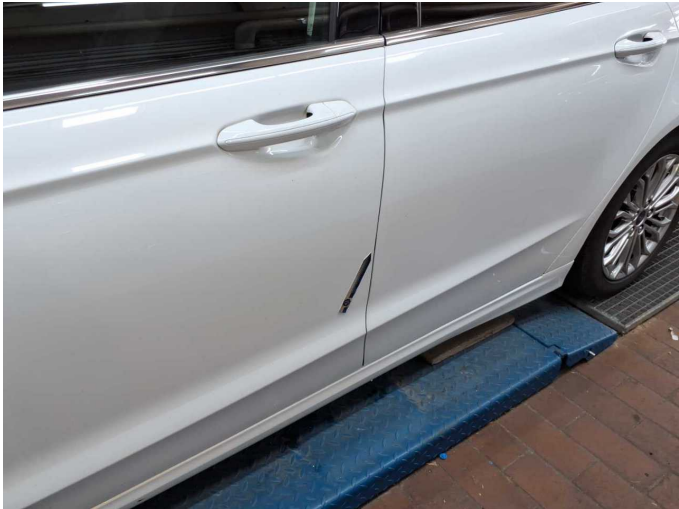
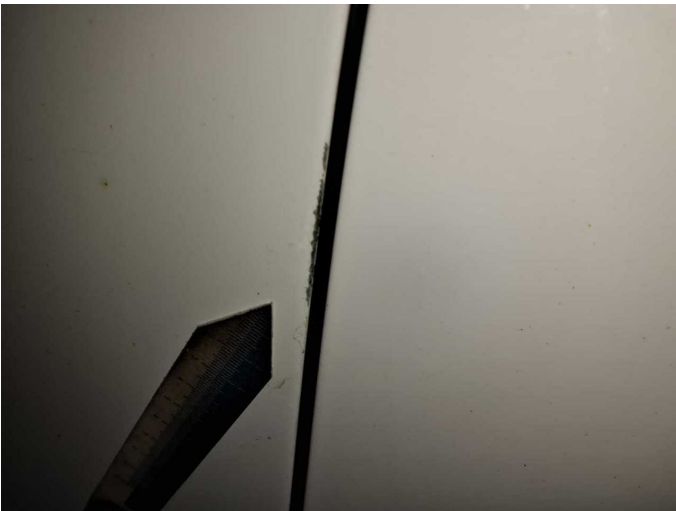
Damage 2: Door - front left side: Door - Scratch(es) - Smart repair

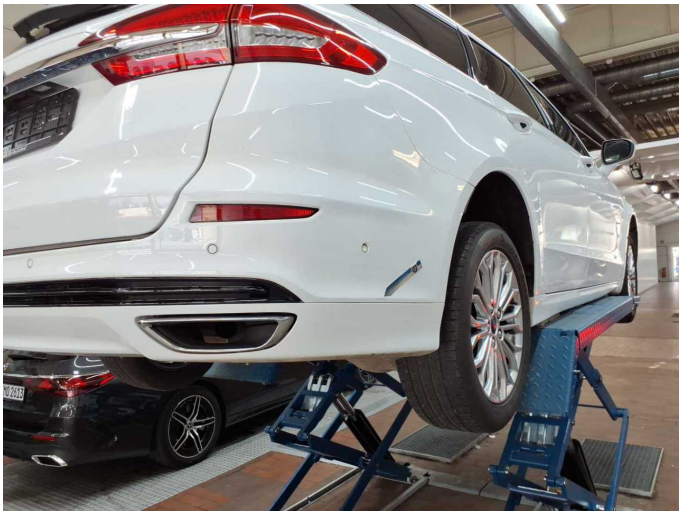
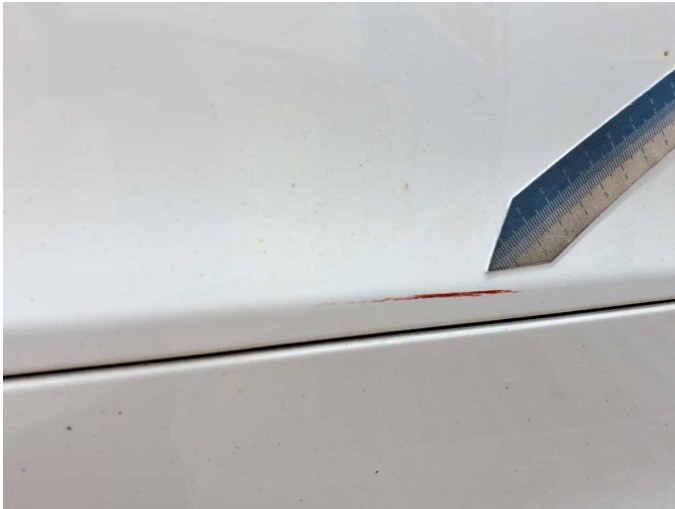
Damage 3: Rear bumper: Rear bumper - Scratch(es) - Smart repair

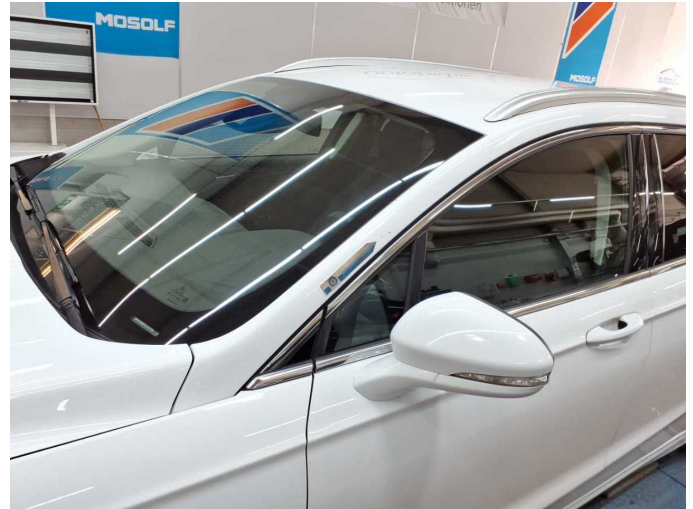
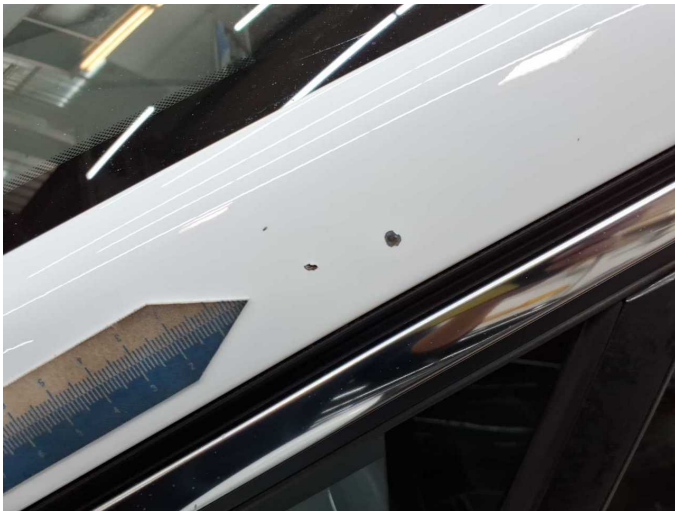
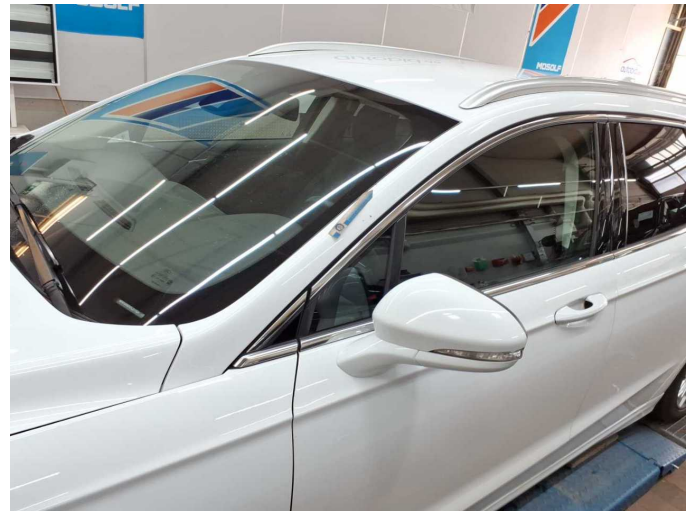
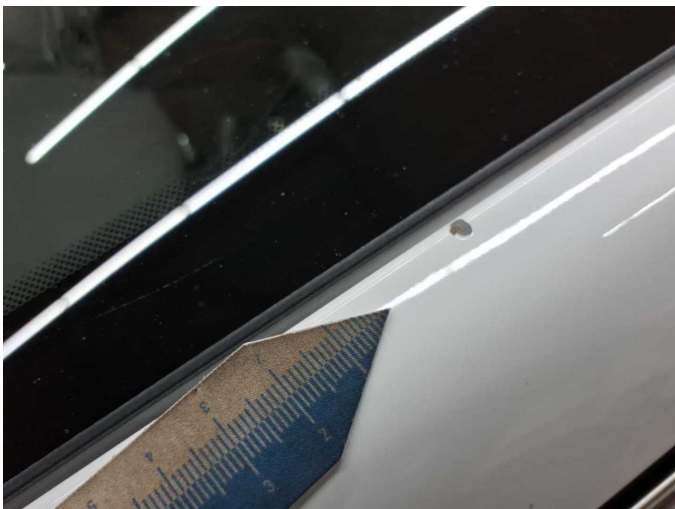
Damage 4: Body: A-pillar - left side - Stone chips - Paint

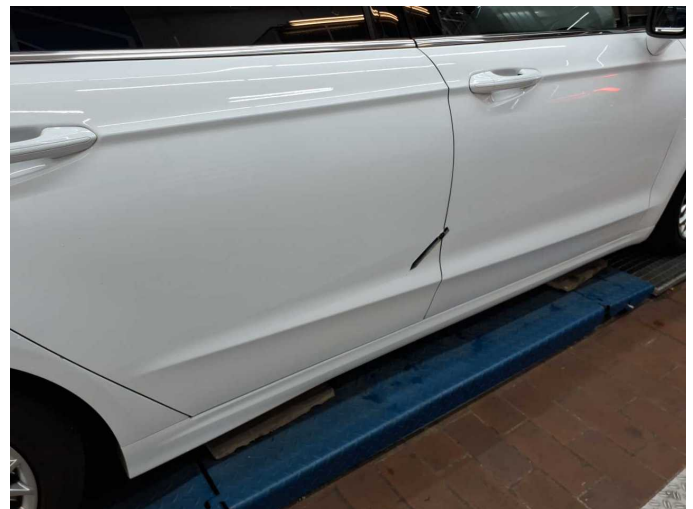
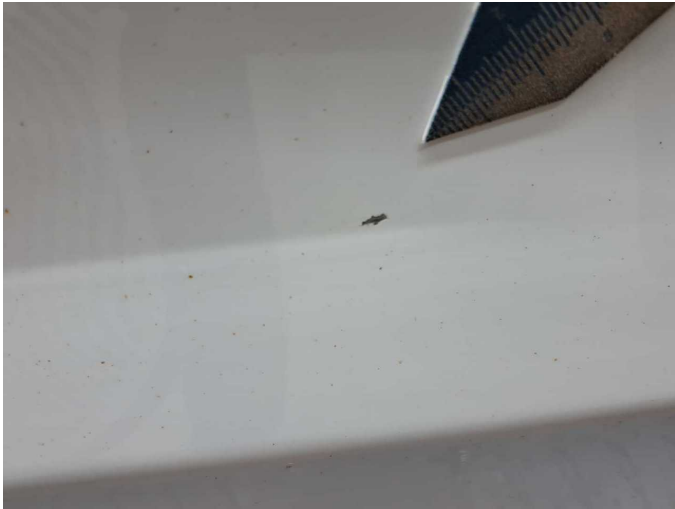
Damage 5: Door - rear right side: Door - Scratch(es) - Paint

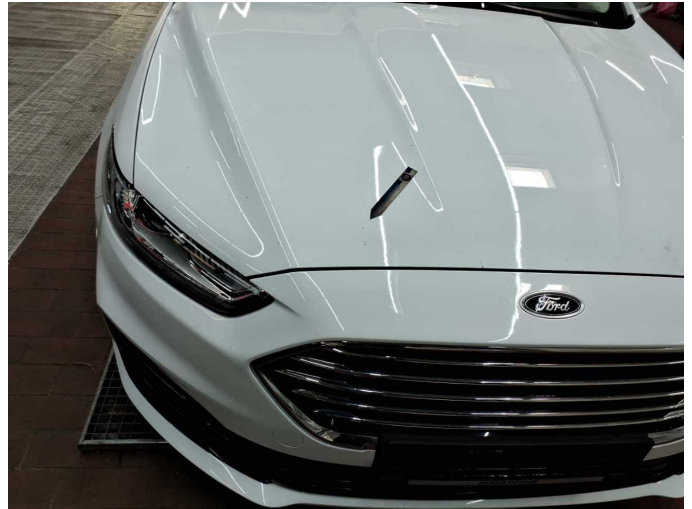
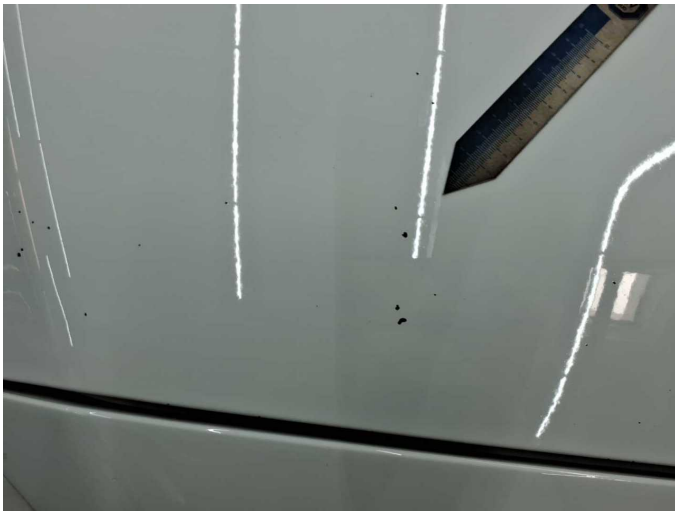
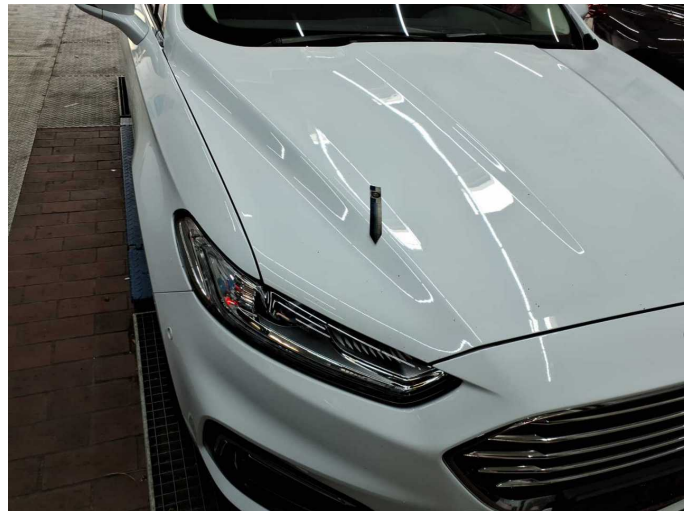
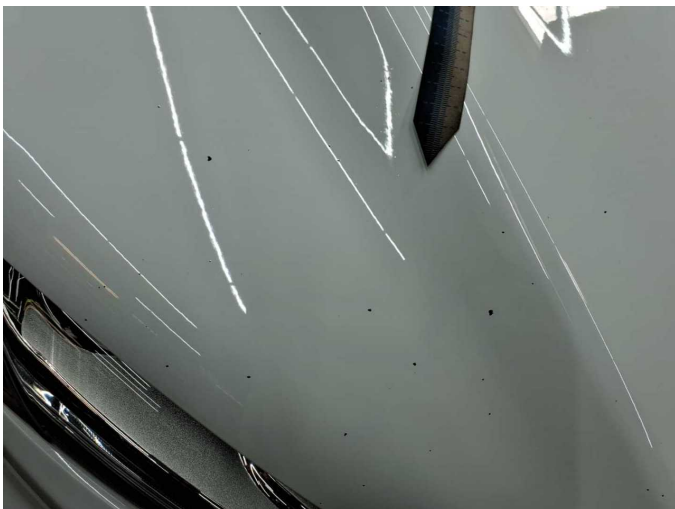
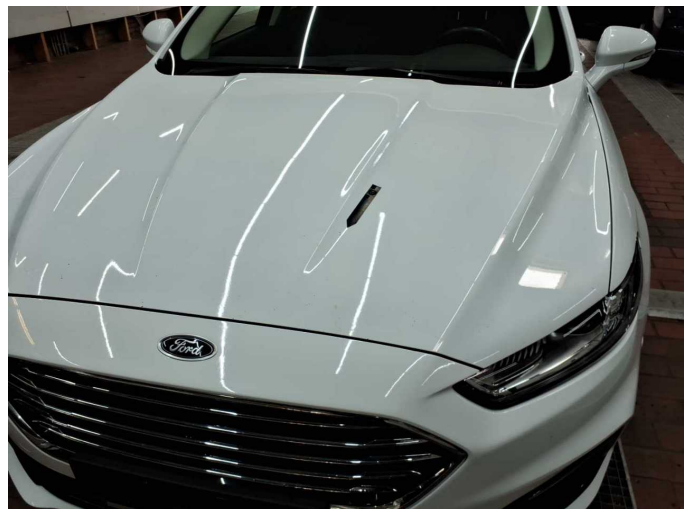
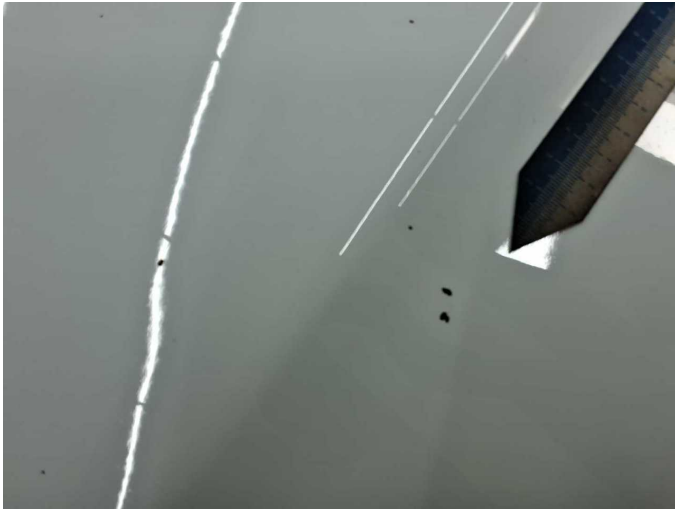
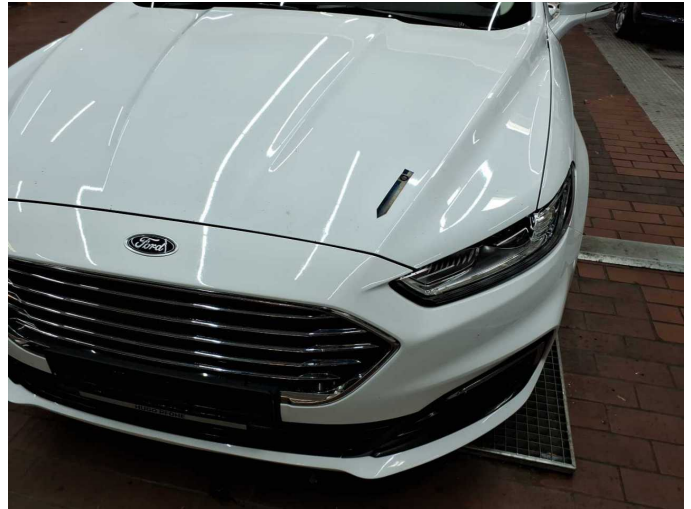
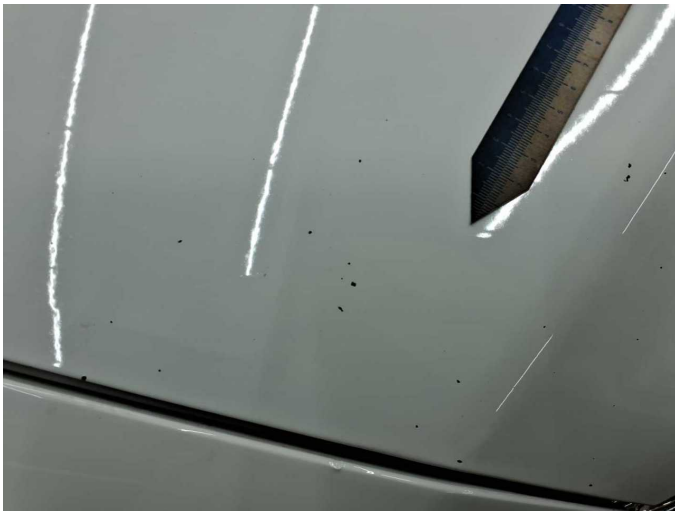
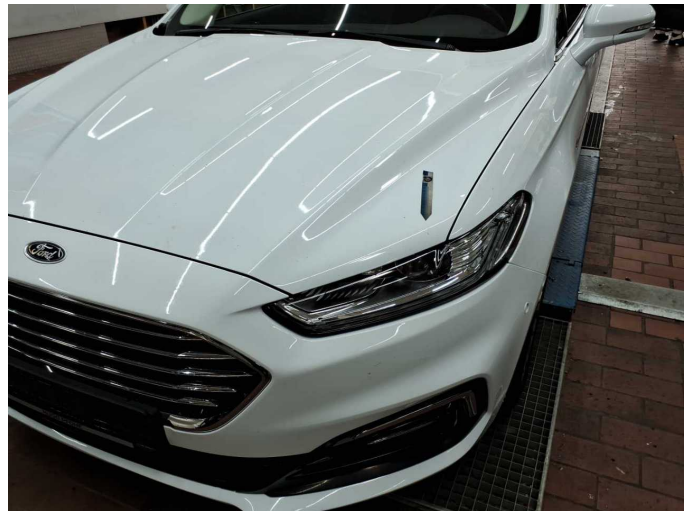
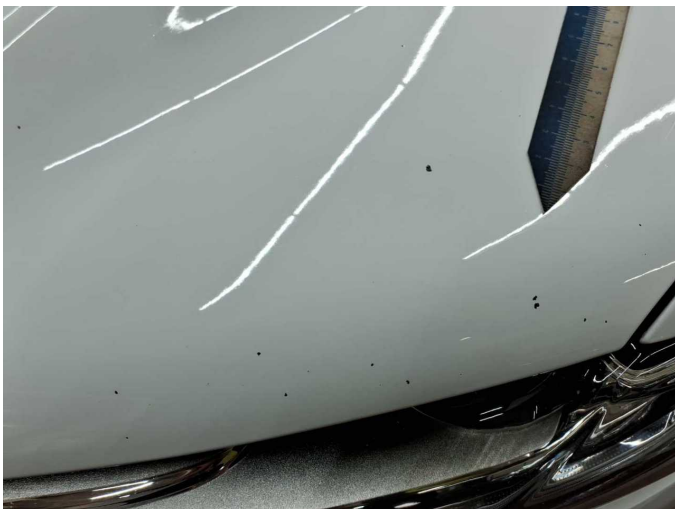
Damage 6: Bonnet: Bonnet - Stone chips - Repair and paint

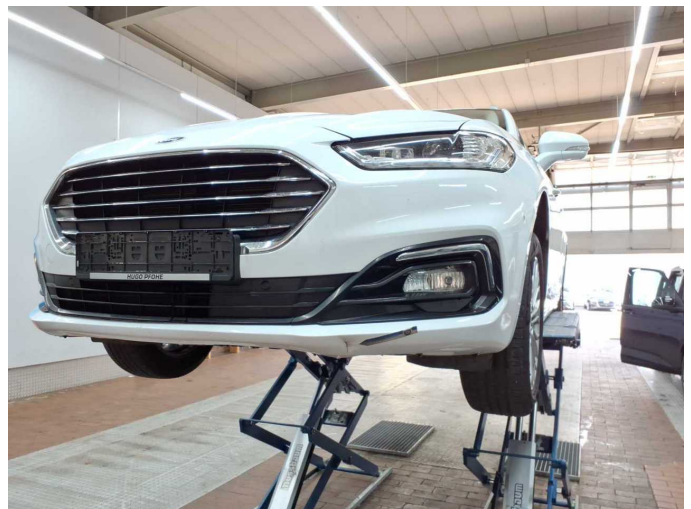
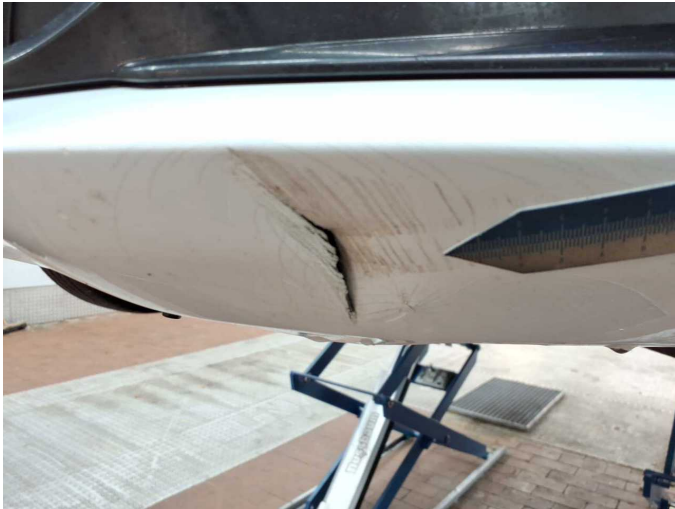
Damage 7: Front bumper: Front bumper - Broken / torn - Replace

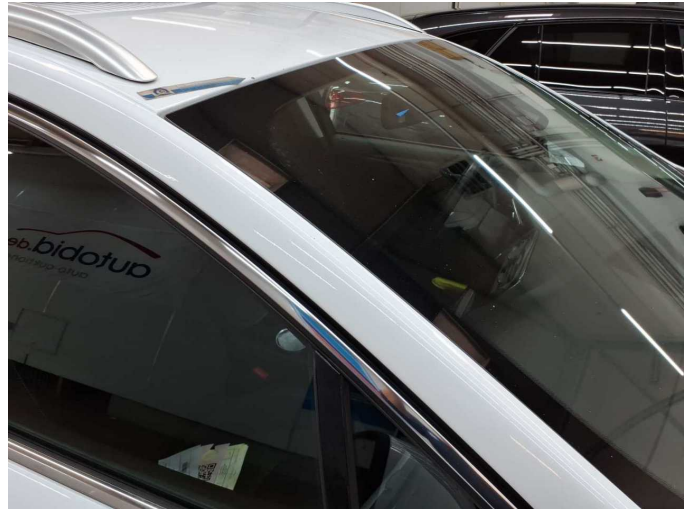
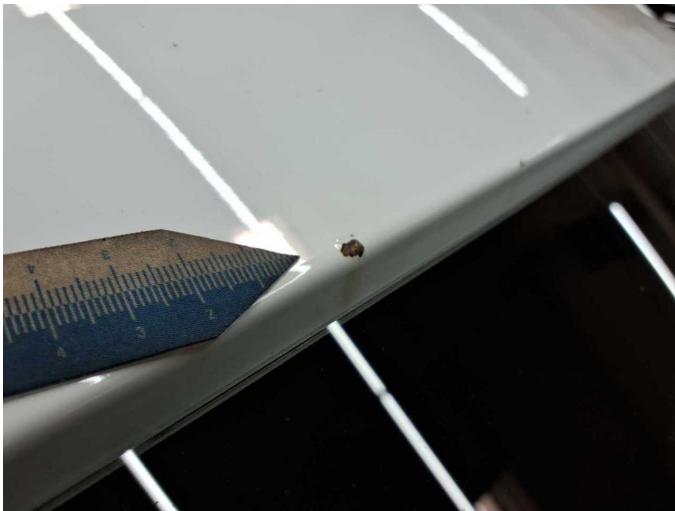
Damage 8: Roof: Roof (Korrosion) - Stone chips - Repair and paint

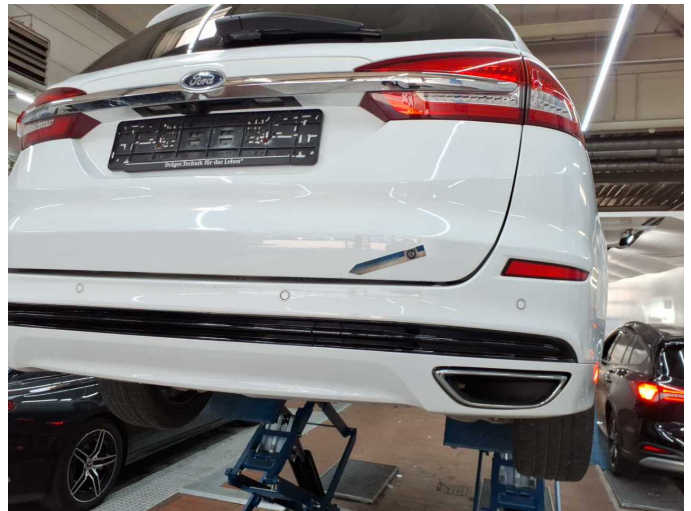
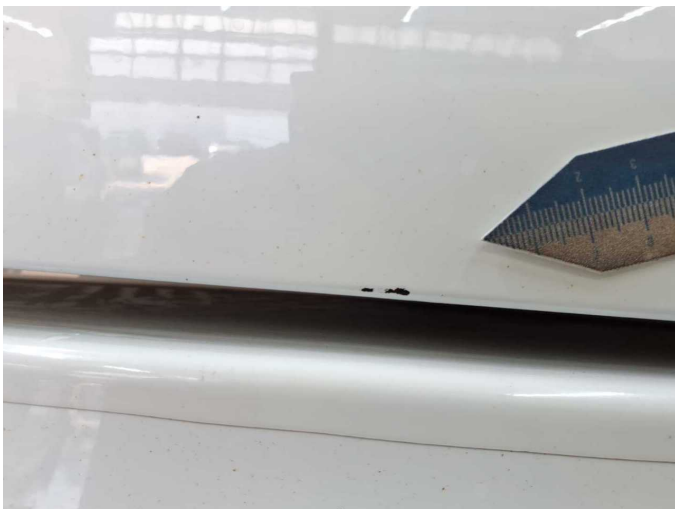
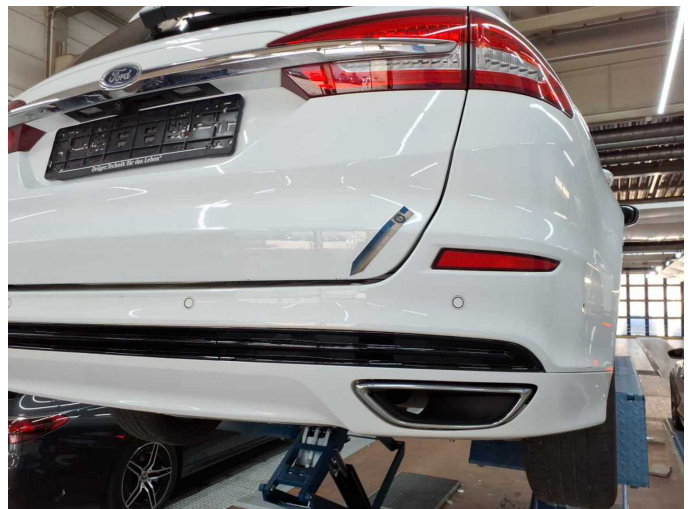
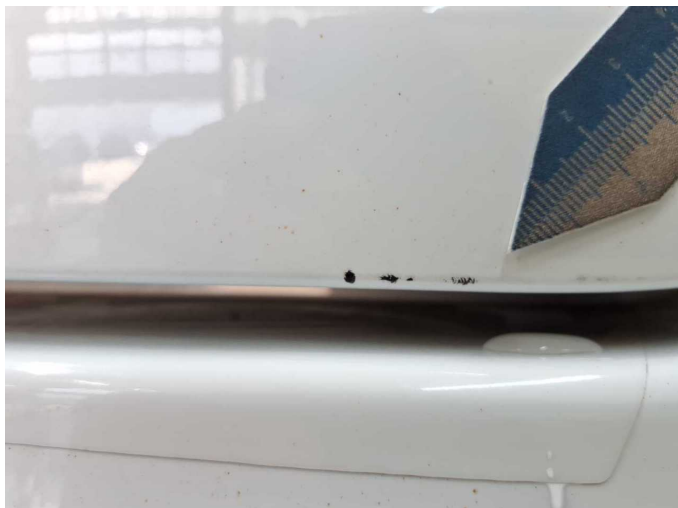
Wear and tear 4: Boot lid / rear door: Boot lid - Scratch(es) - No deduction

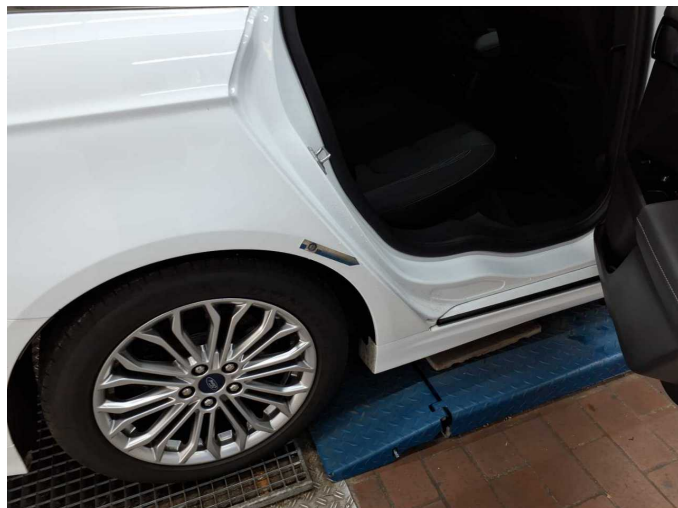
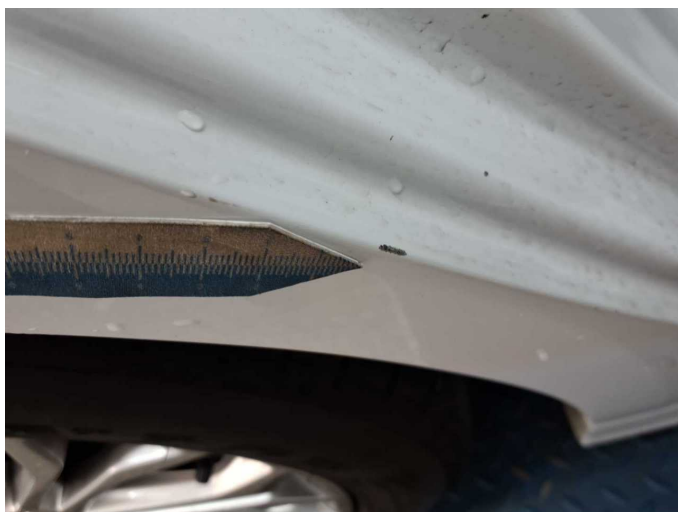
Wear and tear 5: Side panel - rear right side: Elbow - Scratch(es) - No deduction

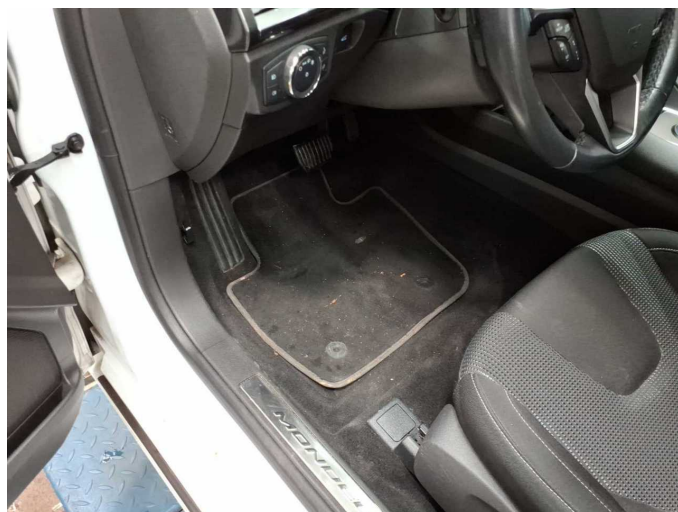
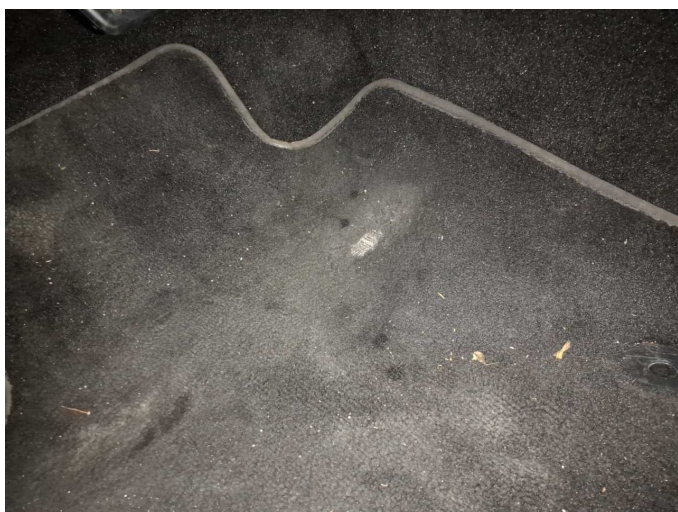
Wear and tear 6: Trim / covers: Floor mats (VI) - Holes - No deduction

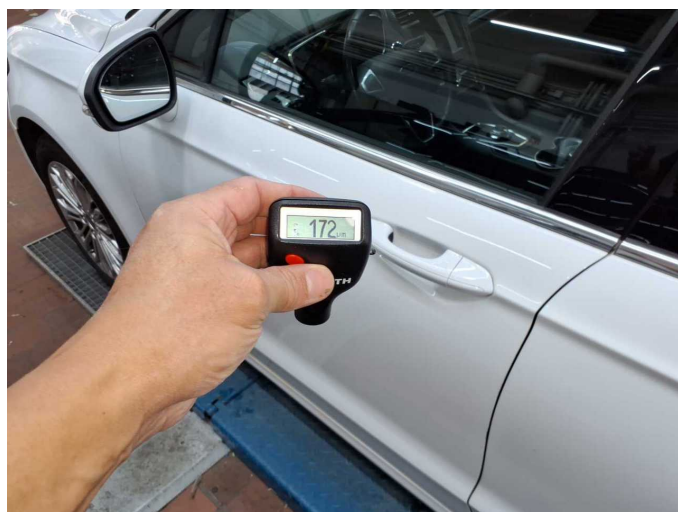
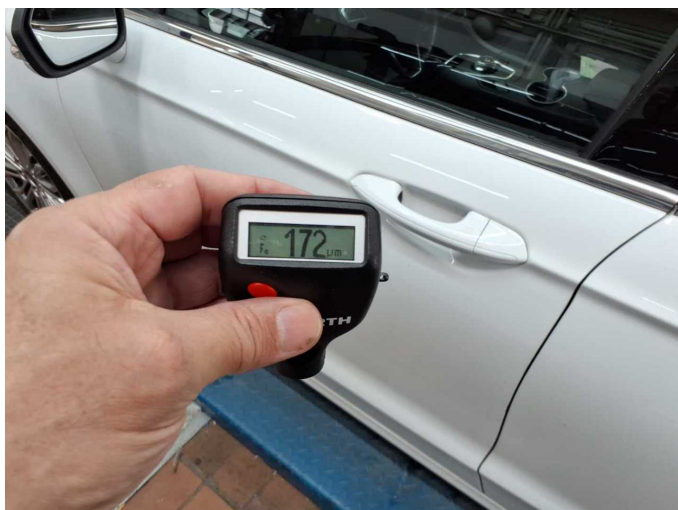
1 Door - front left side, Professionally carried out, Invoice of repair done Non-existent

Door - front left side 172 µm |

Repainting 1: Door - front left side
