Expertise

Protocol number: 41256992
Order No. / Reference: 25026017
Inspection date: 26 Aug 2025

Manufacturer: Ford

Model: Mondeo Turnier 2.0 EcoBlue Aut. VIGNALE

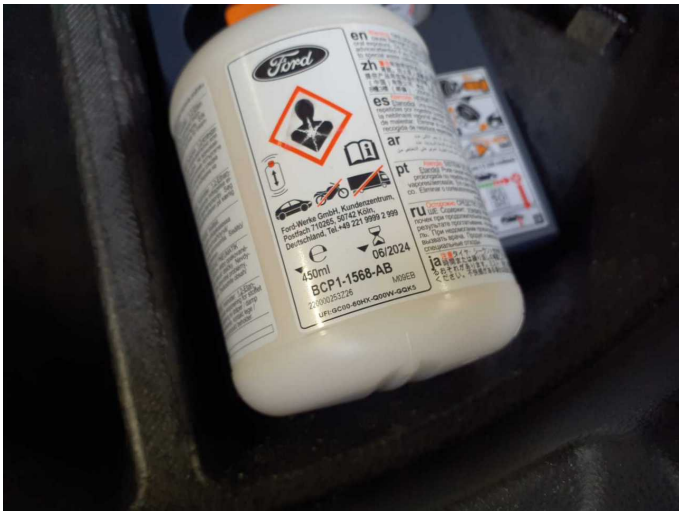
Damage 3: Equipment: Tirefit filler - Expired - Replace

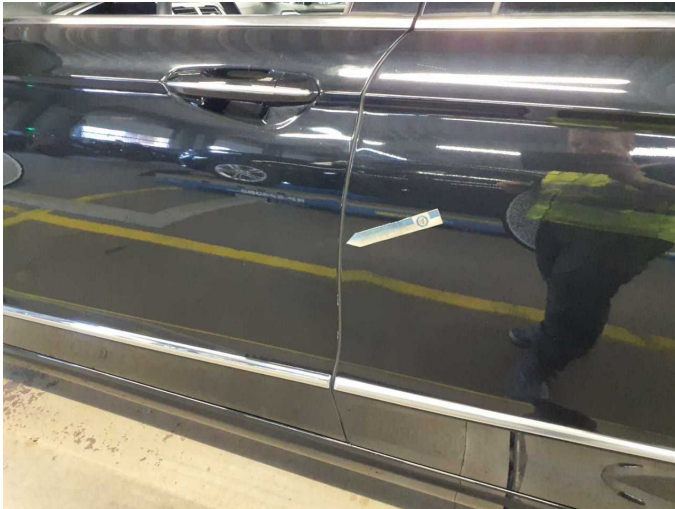
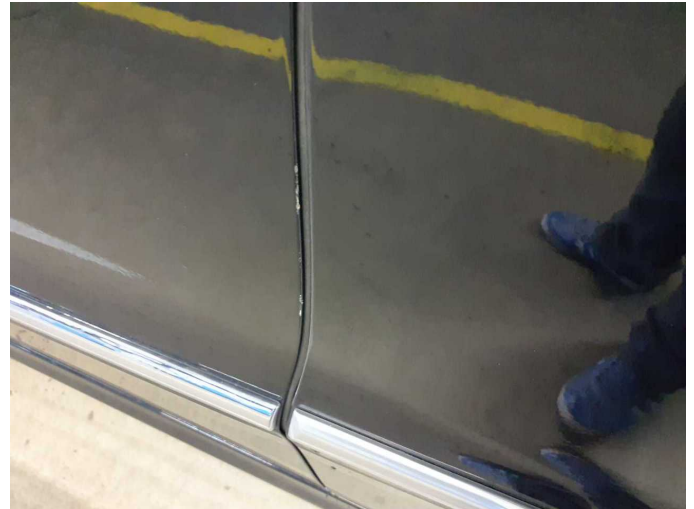
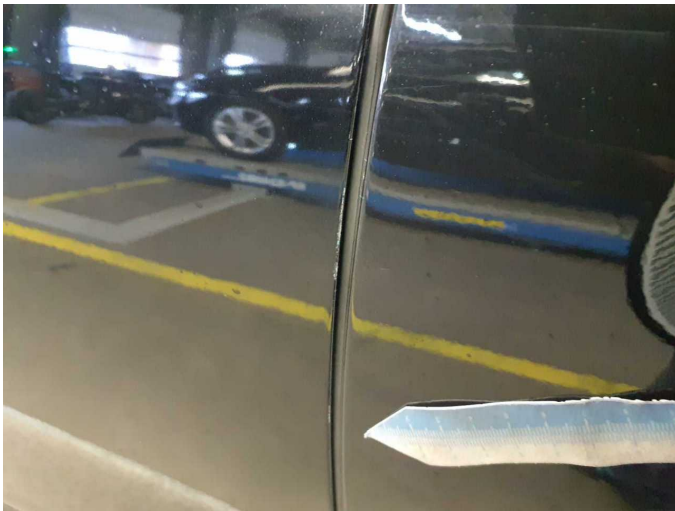
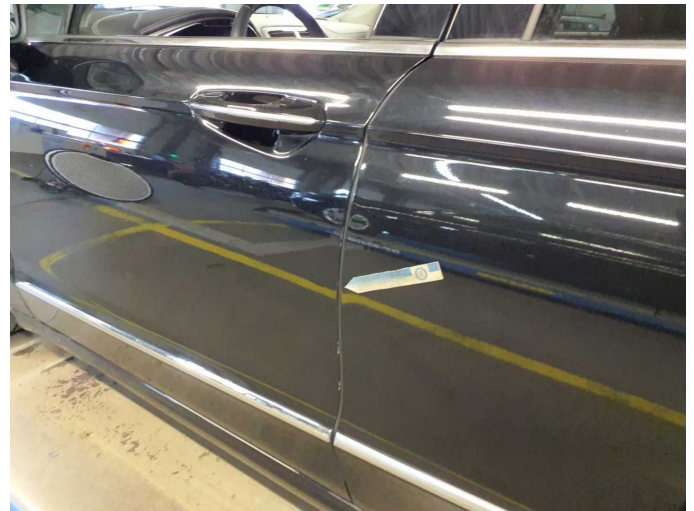
Damage 4: Door - front left side: Door edge - Scratch(es) - Smart repair

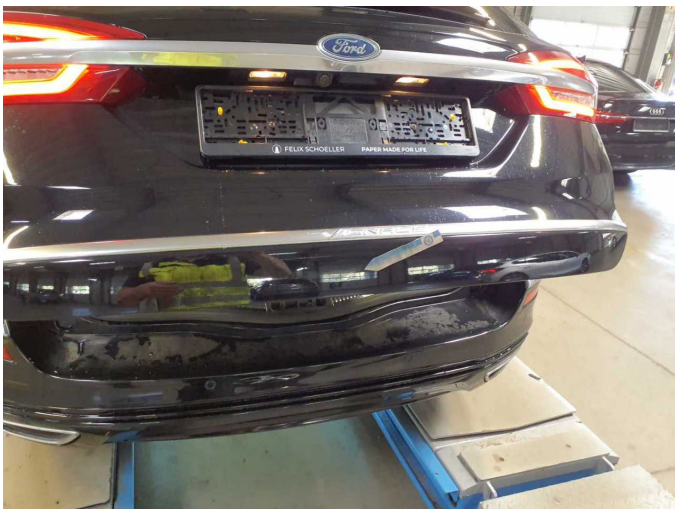
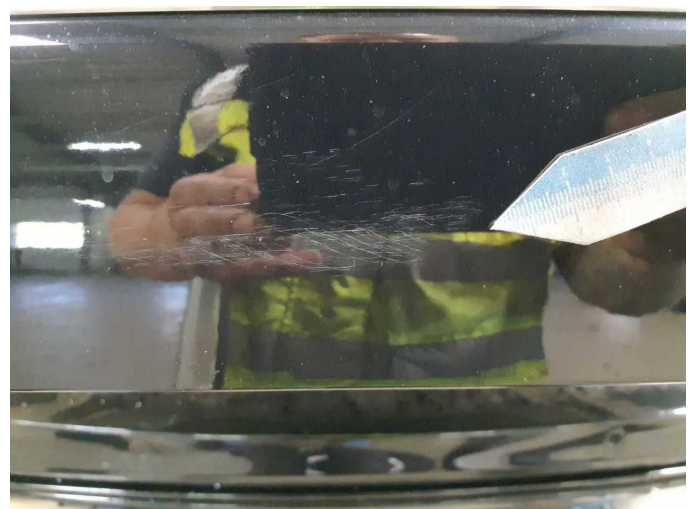
Damage 5: Boot lid / rear door: Boot lid - Scratch(es) - Smart repair

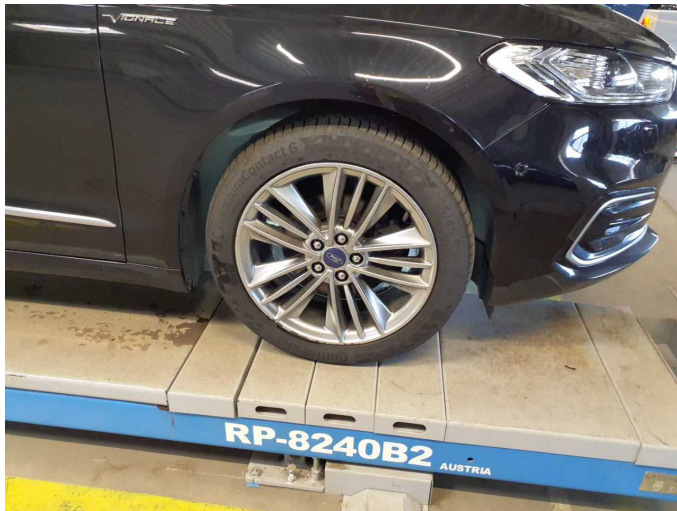
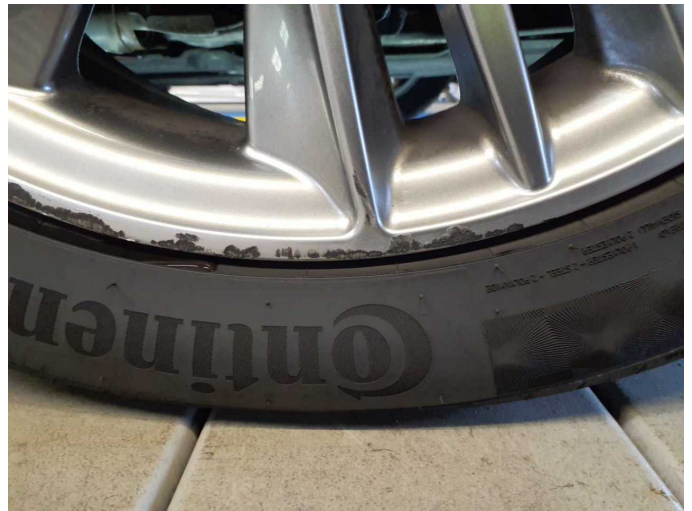
Damage 6: Wheel / tyres: Alloy rim - front right side - Scratch(es) - Smart repair

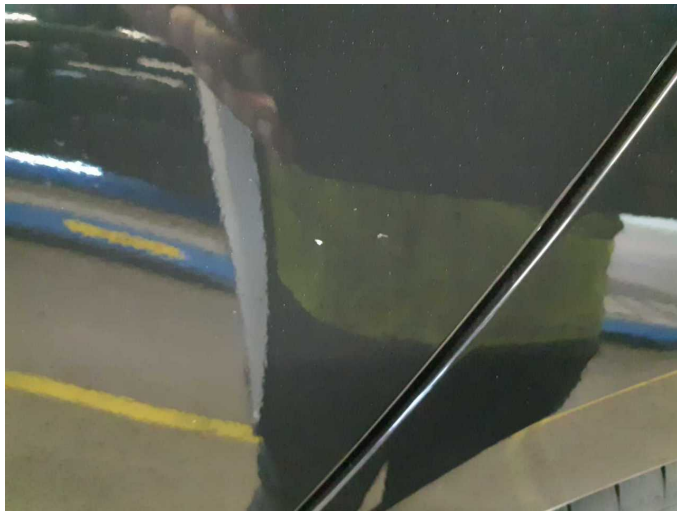
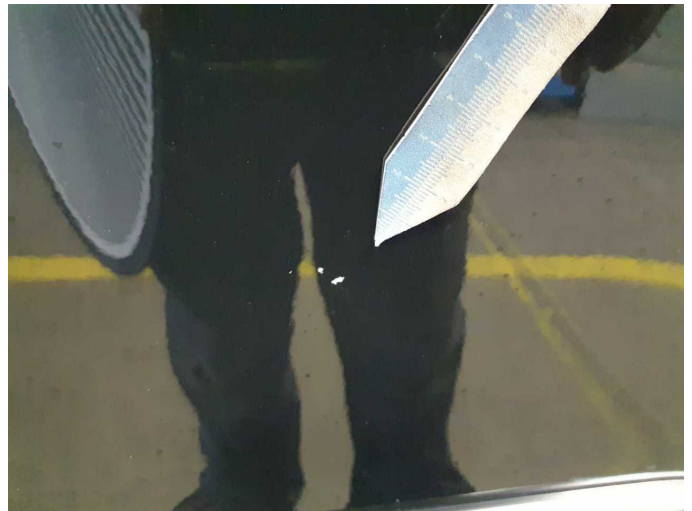
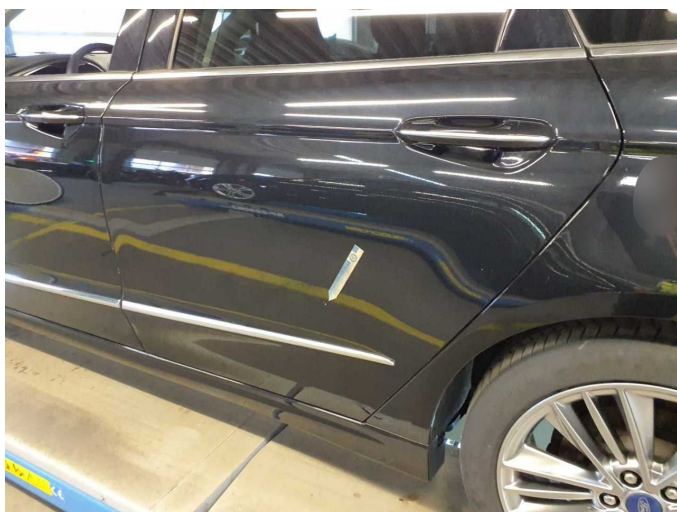
Damage 7: Door - rear left side: Door - Scratched - Paint

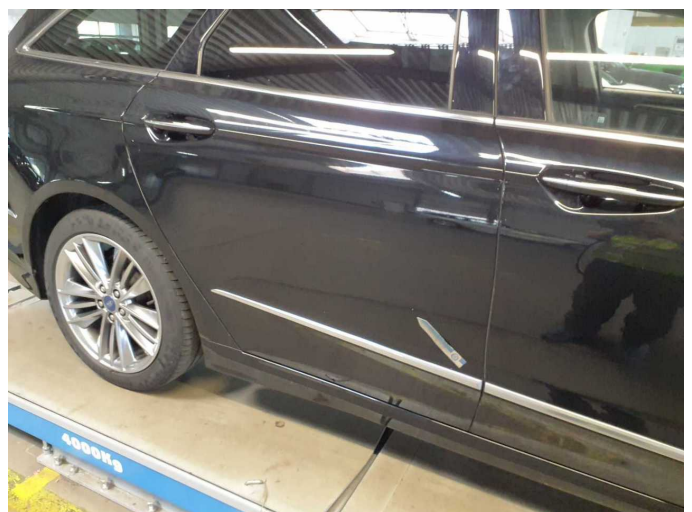
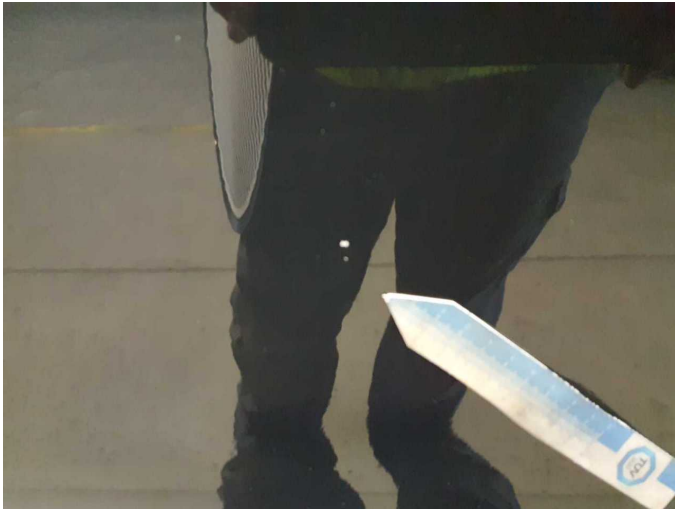
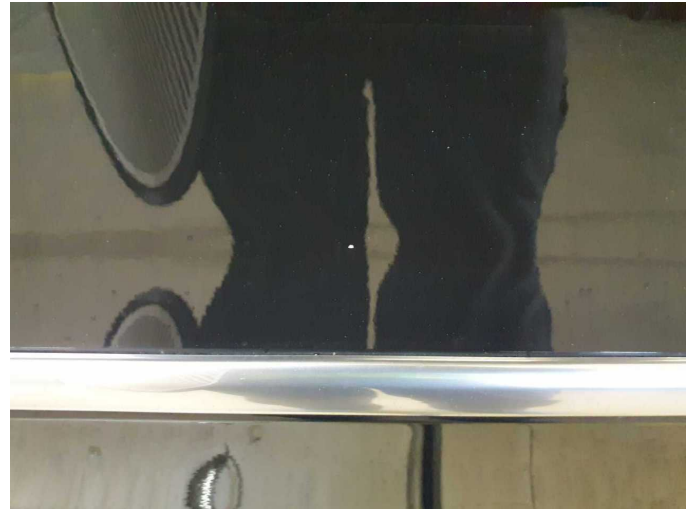
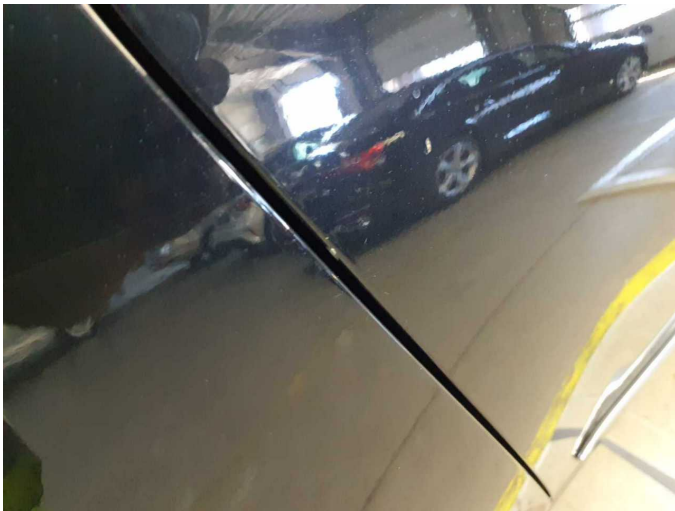
Damage 8: Door - rear right side: Door - Scratch(es) - Paint

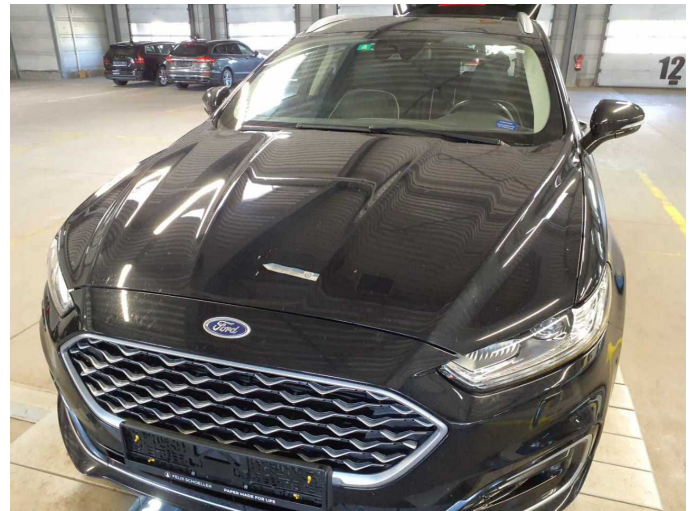
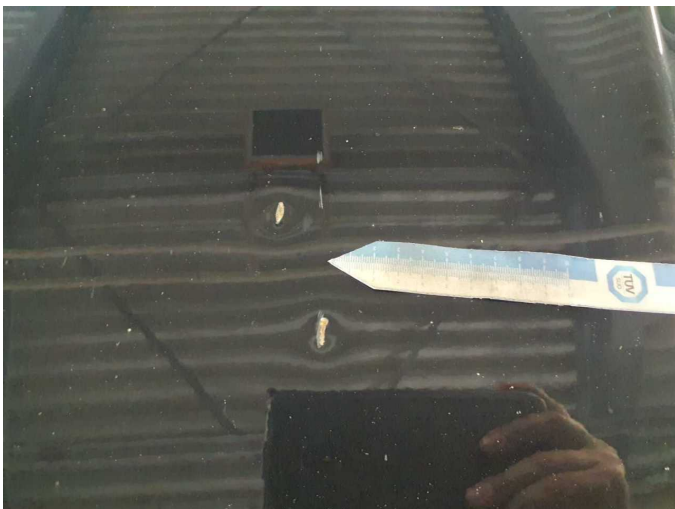
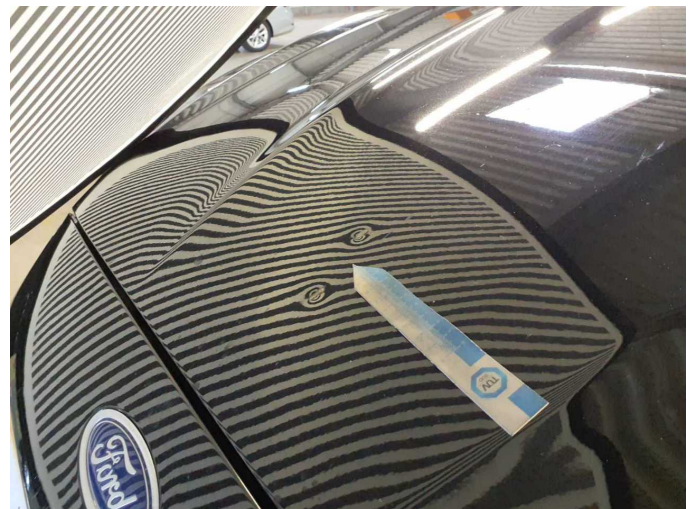
Damage 9: Bonnet: Bonnet - Dent / paintcoat damage - Repair and paint

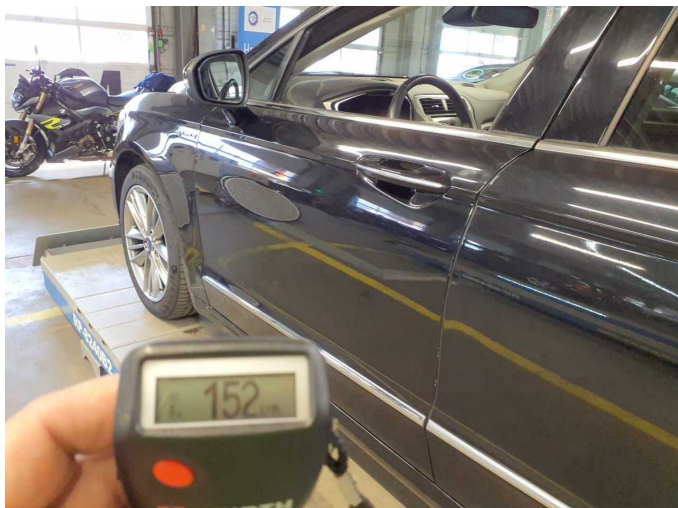
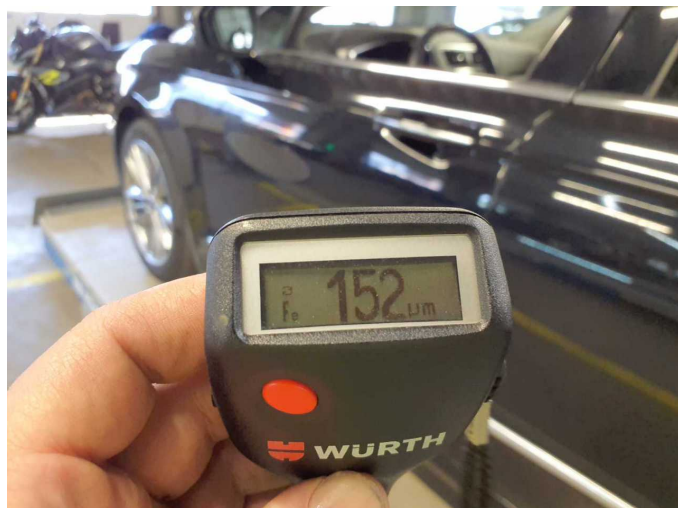
- 1 Door - front left side, Professionally carried out, Invoice of repair done Non-existent

Door - front left side 152 µm

Repainting 1: Door - front left side
