Expertise

Protocol number: 41642388
Order No. / Reference: 25216630
Inspection date: 22 Sept 2025

Manufacturer: Ford

Model: Mondeo Turnier 2.0 EcoBlue Titanium

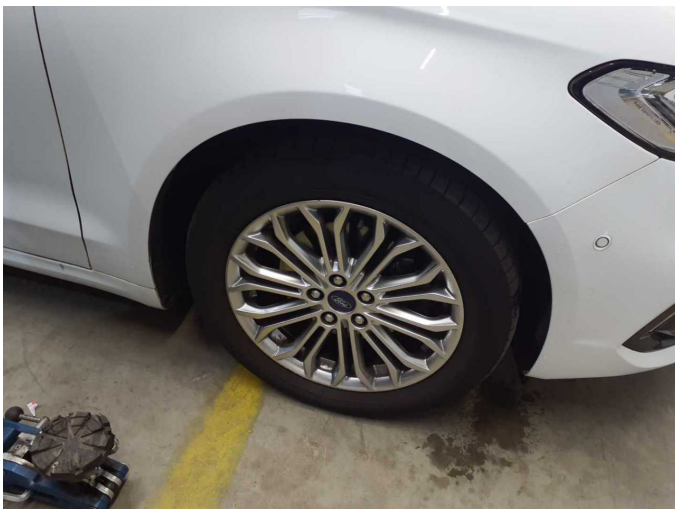
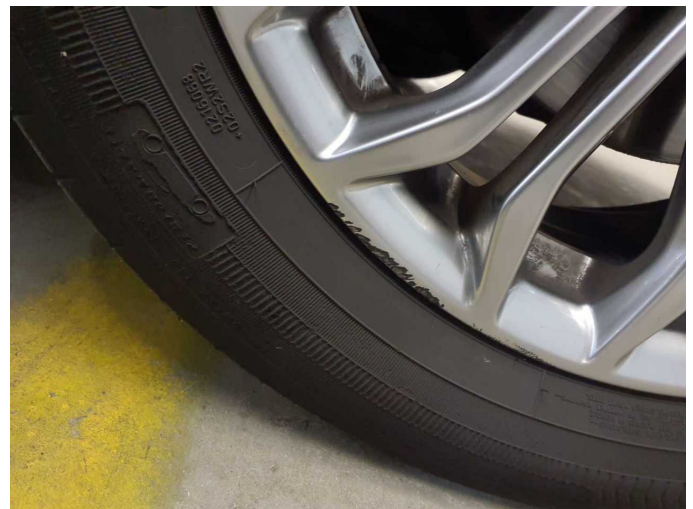
Damage 1: Wheel / tyres: Alloy rim - front right side - Scratch(es) - Smart repair

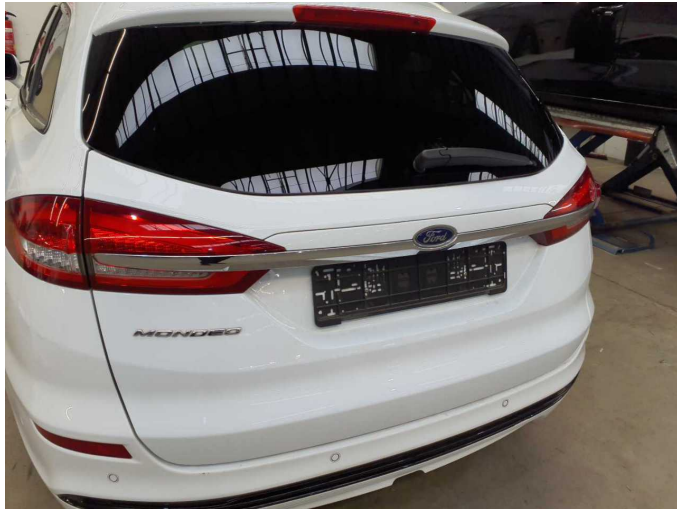
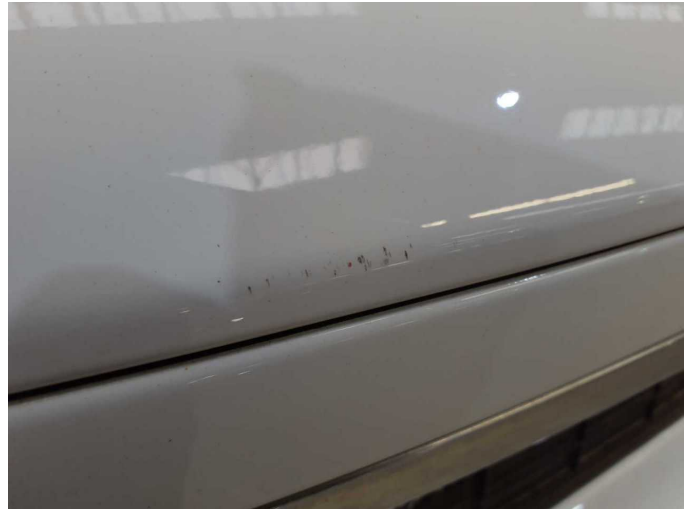
Damage 2: Boot lid / rear door: Boot lid - Scratch(es) - Paint

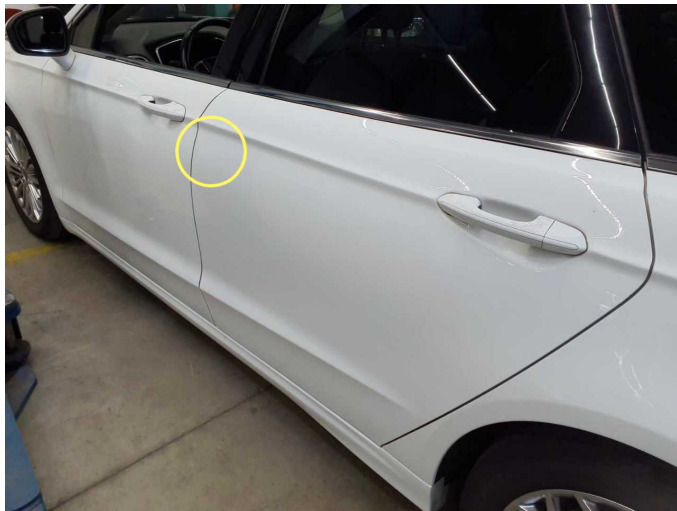
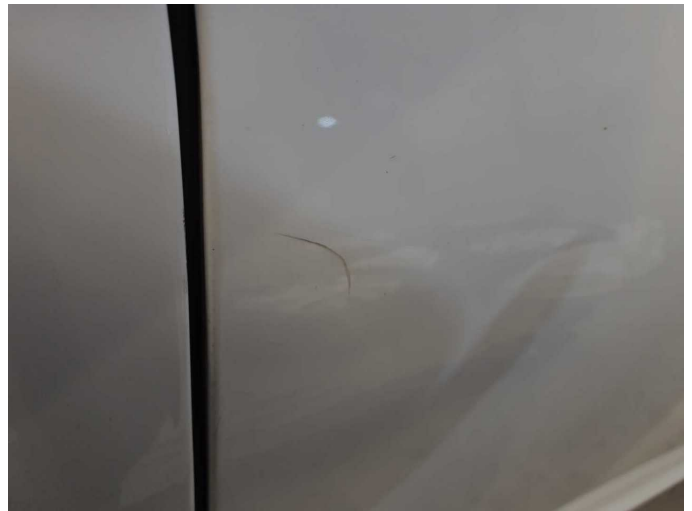
Damage 3: Door - rear left side: Door - Scratch(es) - Paint

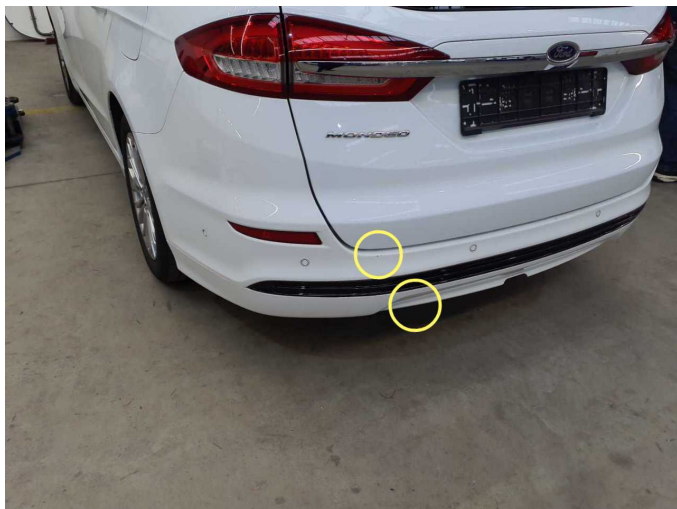
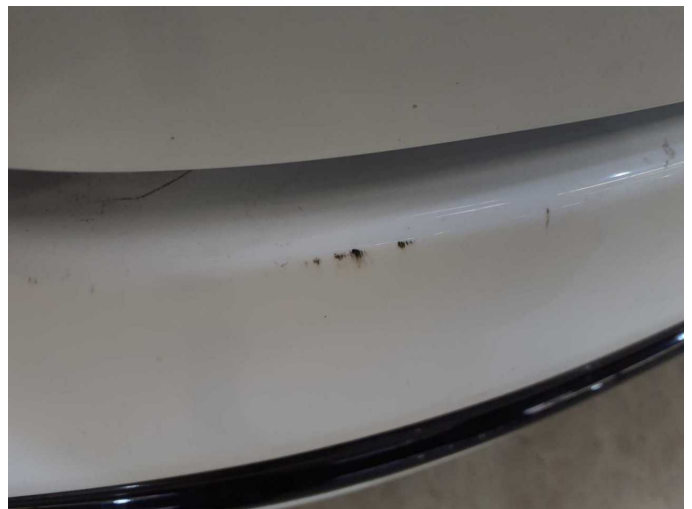
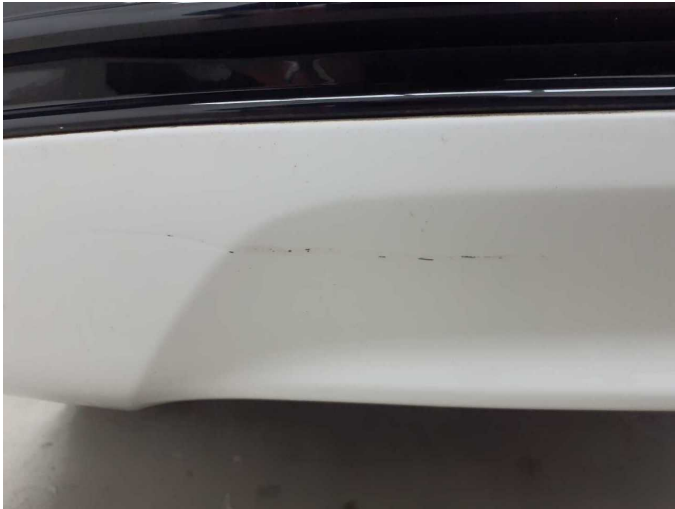
Damage 4: Rear bumper: Rear bumper - Scratch(es) - Paint
