Expertise

Protocol number: 41338979
Order No. / Reference: 24998258
Inspection date: 1 Sept 2025

Manufacturer: Ford

Model: Mondeo Turnier 2.0 EcoBlue Aut. Titanium

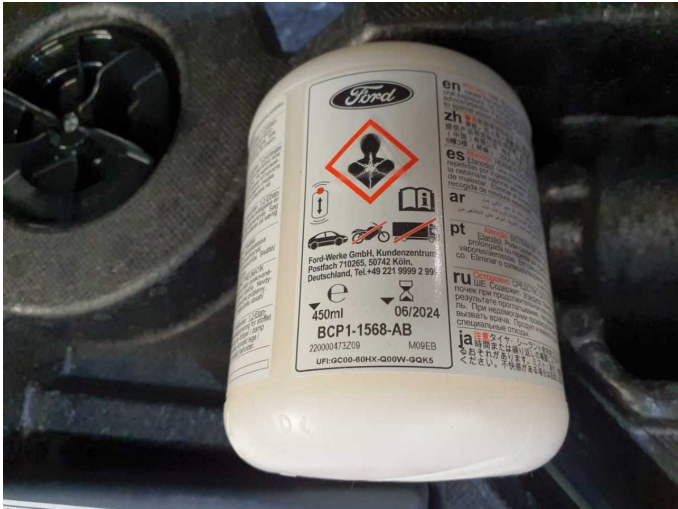
Damage 1: Equipment: Tirefit filler - Expired - Replace

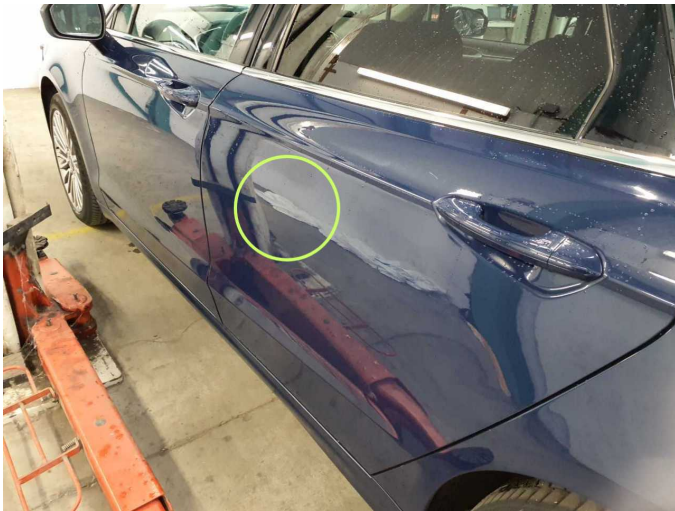
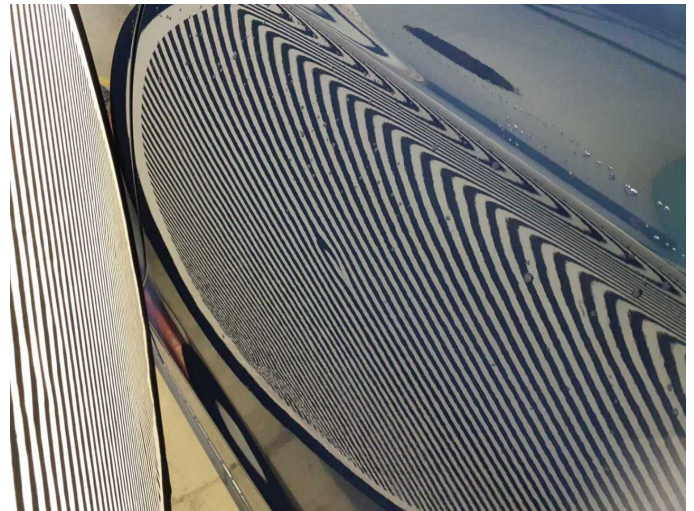
Damage 2: Door - rear left side: Door - dent(s) - Smooth repair work

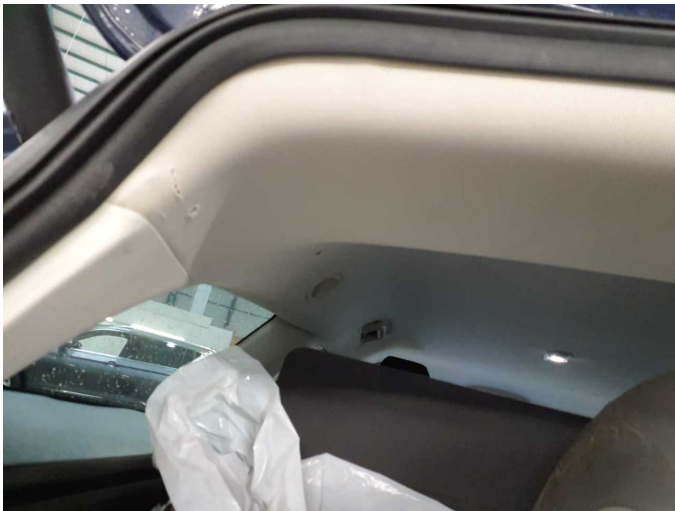
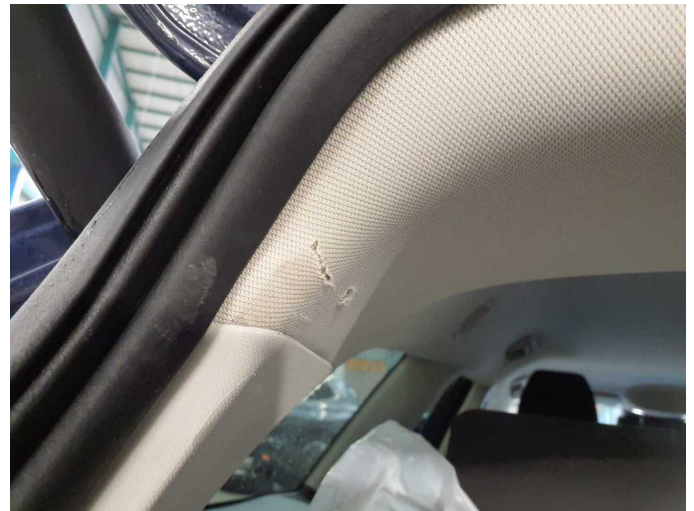
Damage 3: Trim / covers: Roof lining - Broken / torn - Loss in value

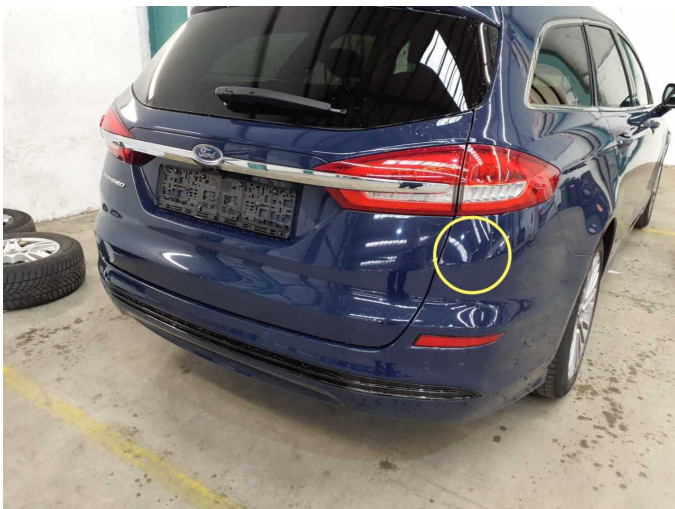
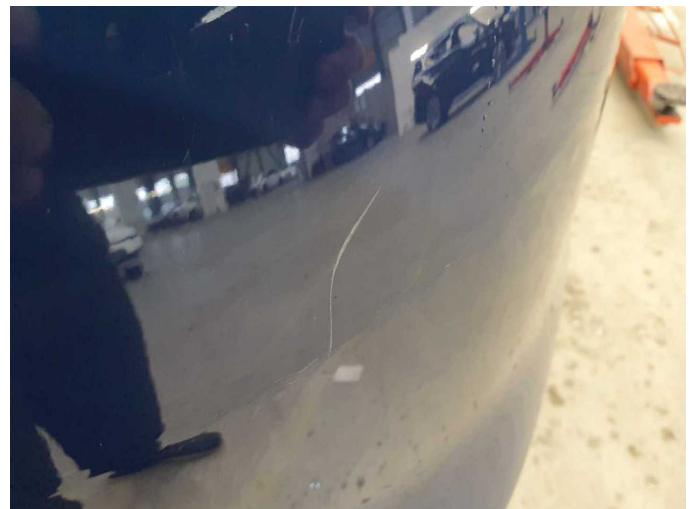
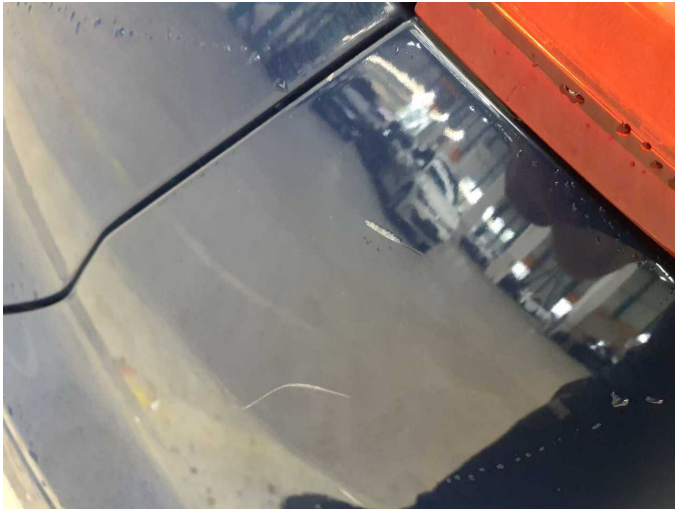
Damage 4: Rear bumper: Rear bumper - Scratch(es) - Paint

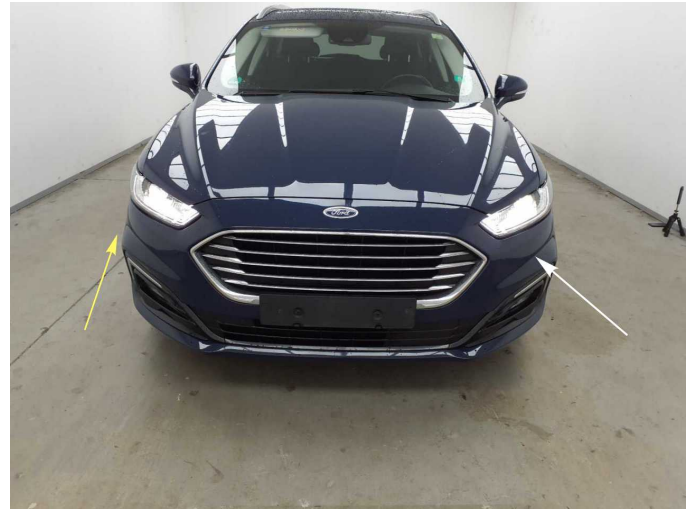
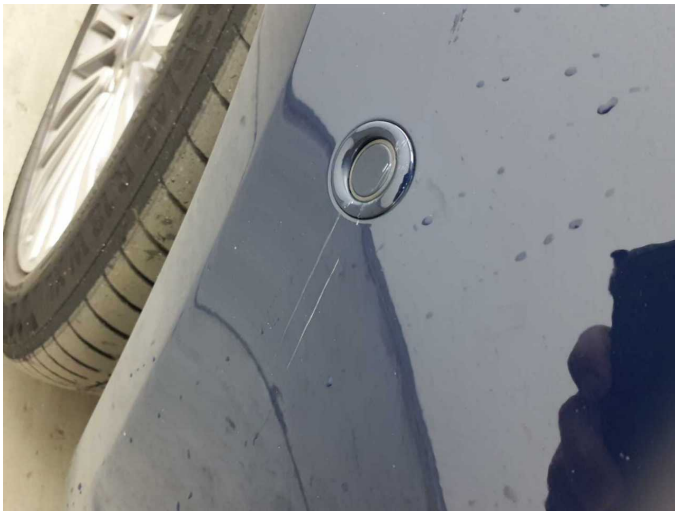
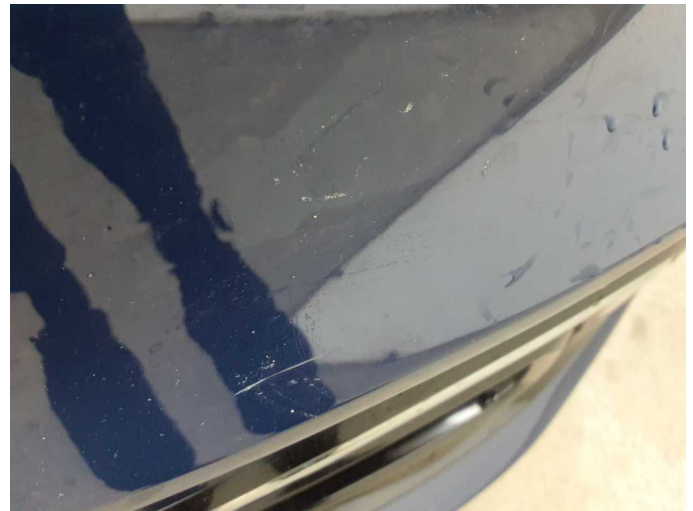
Damage 5: Front bumper: Front bumper - Scratch(es) - Paint

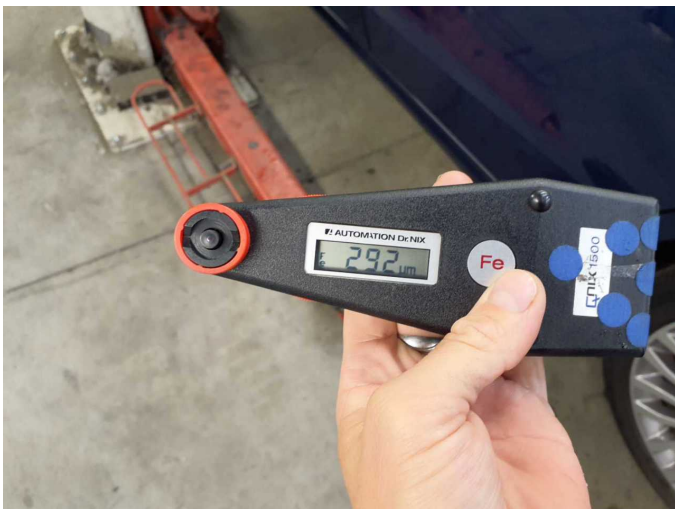
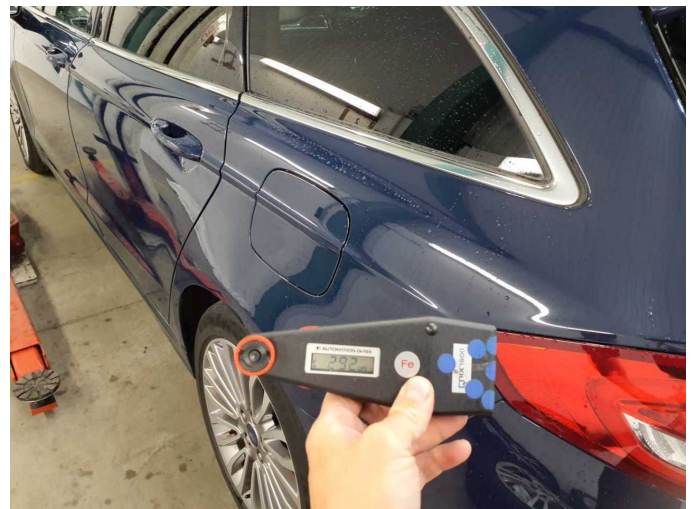
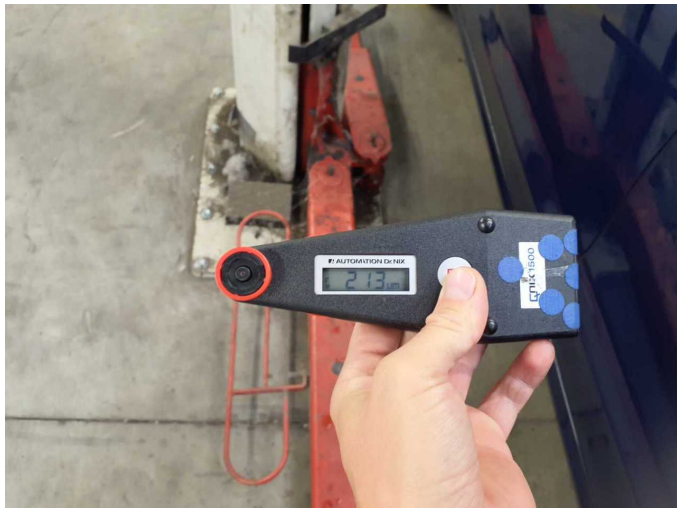
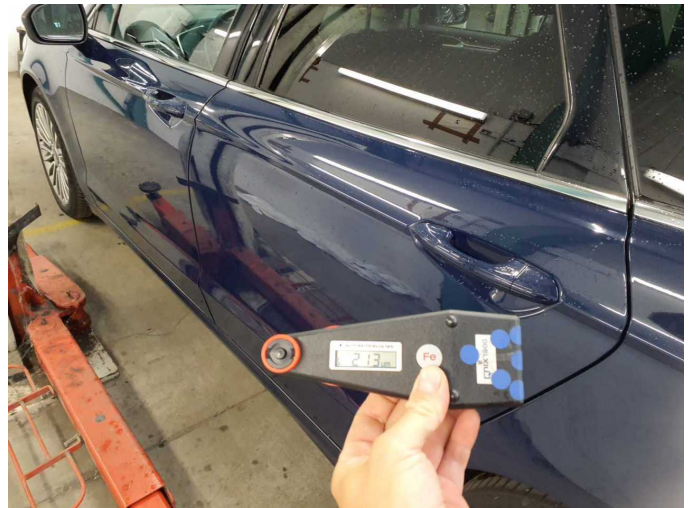
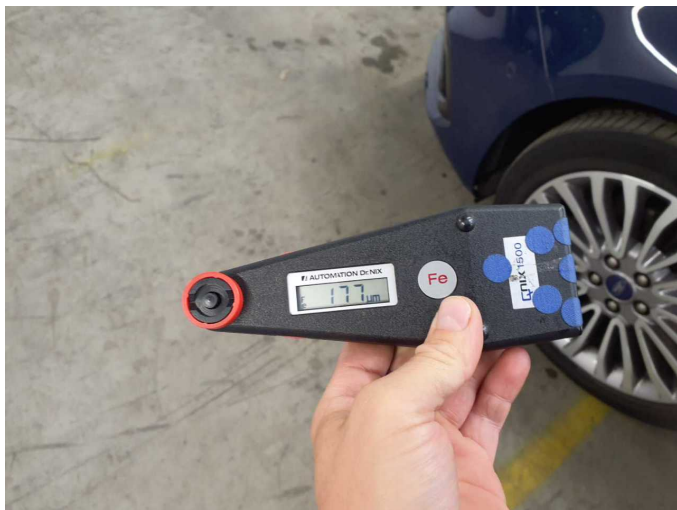
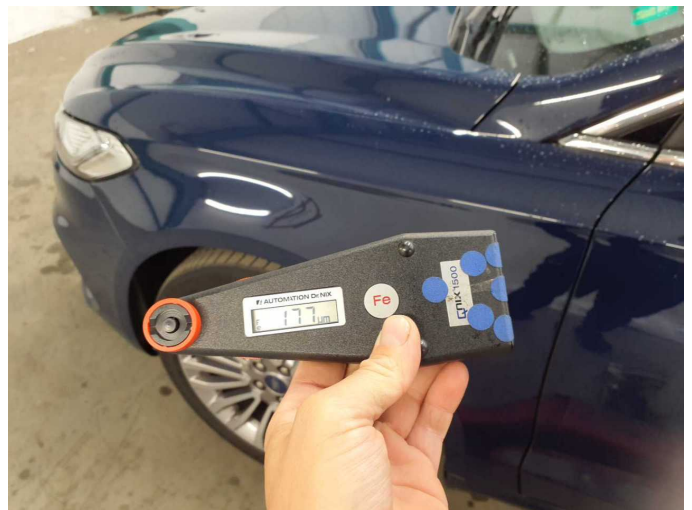
No.	Repainting
1	Mudguard - left side, Side panel - rear left side, Door - rear left side, Professionally carried out, Invoice of repair done Non-existent

Mudguard - left side	177 µm	Side panel - rear left side	292 µm
Door - rear left side	213 µm

Repainting 1: Mudguard - left side, Side panel - rear left side, Door - rear left side
