Expertise

Protocol number: 41617635
Order No. / Reference: 25185717
Inspection date: 18 Sept 2025

Manufacturer: Ford	Model: Mondeo Turnier 2.0 EcoBlue ST-Line
VIN: WF0FXXWPCFNS70496

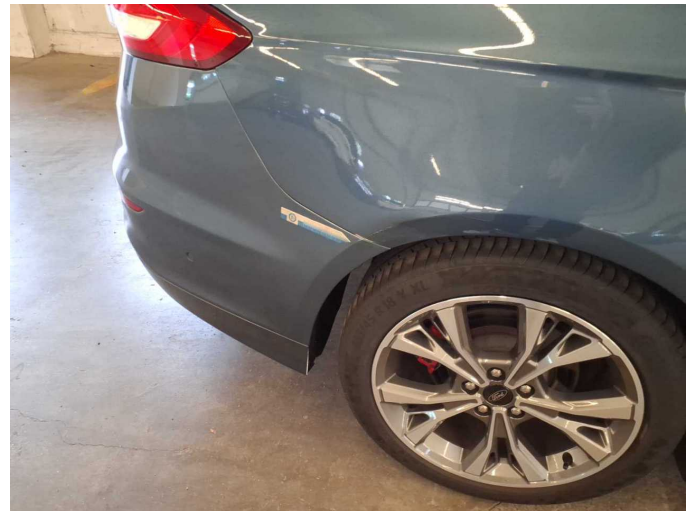
Damage 1: Rear bumper: Rear bumper (wurde im Unfall berücksichtigt.)
- Deformed - repair according to calculation

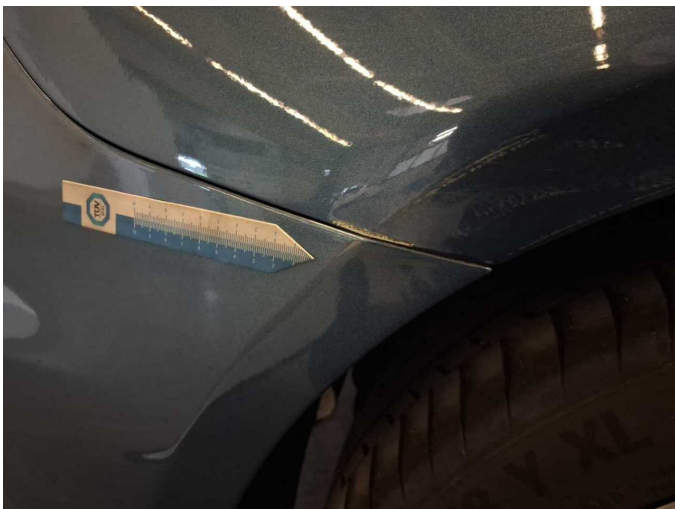
Damage 1: Rear bumper: Rear bumper (wurde im Unfall berücksichtigt.)
- Deformed - repair according to calculation

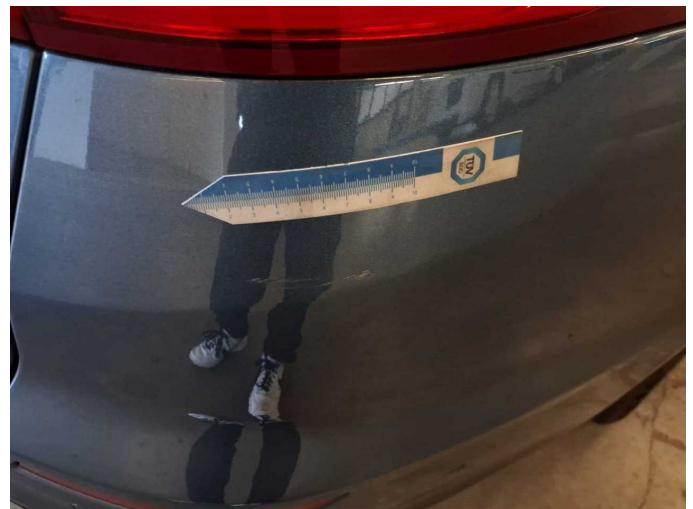
Damage 1: Rear bumper: Rear bumper (wurde im Unfall berücksichtigt.)
- Deformed - repair according to calculation

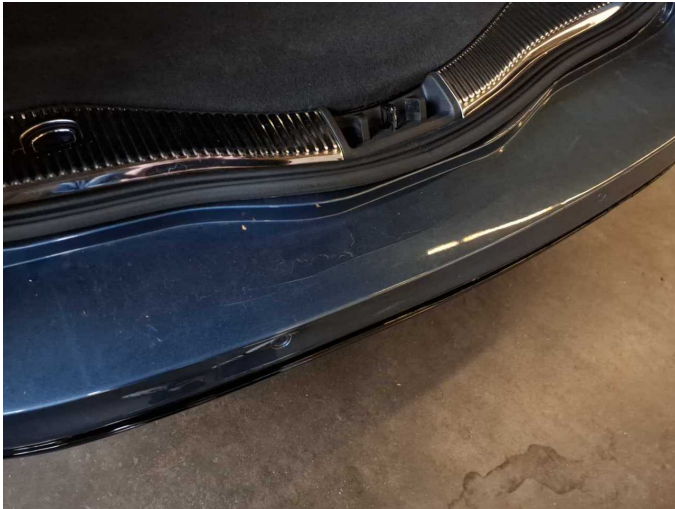
Damage 1: Rear bumper: Rear bumper (wurde im Unfall berücksichtigt.)
- Deformed - repair according to calculation

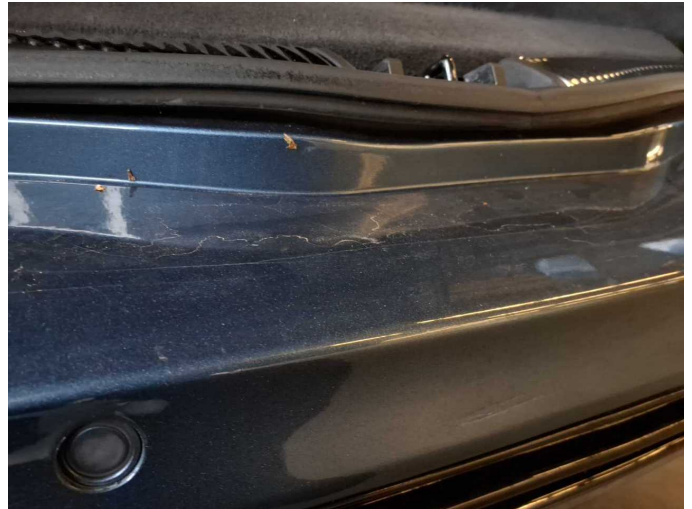
Damage 1: Rear bumper: Rear bumper (wurde im Unfall berücksichtigt.)
- Deformed - repair according to calculation

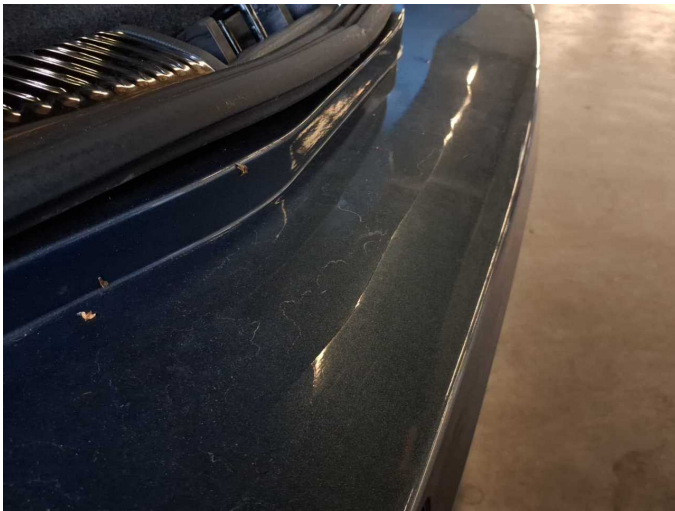
Damage 1: Rear bumper: Rear bumper (wurde im Unfall berücksichtigt.)
- Deformed - repair according to calculation

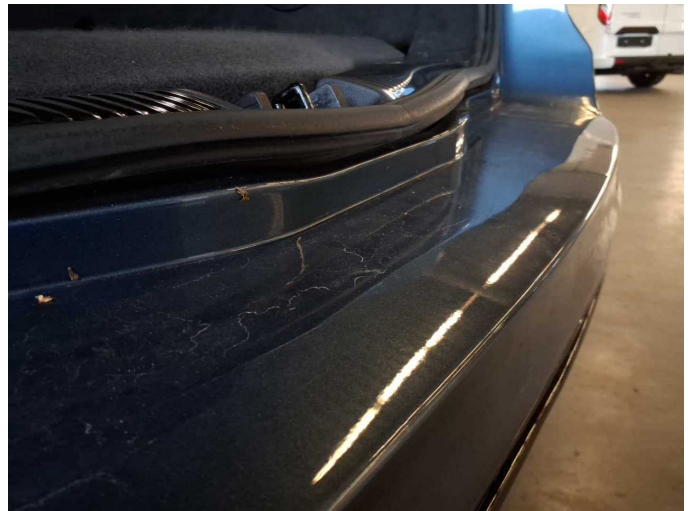
Damage 1: Rear bumper: Rear bumper (wurde im Unfall berücksichtigt.)
- Deformed - repair according to calculation

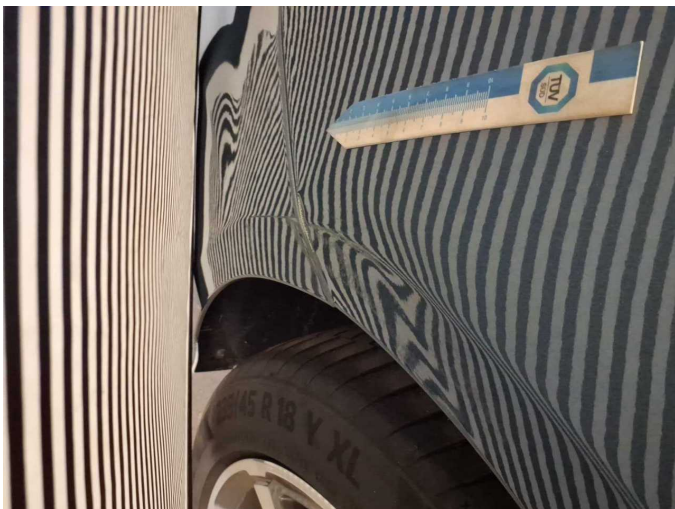
Damage 1: Rear bumper: Rear bumper (wurde im Unfall berücksichtigt.)
- Deformed - repair according to calculation

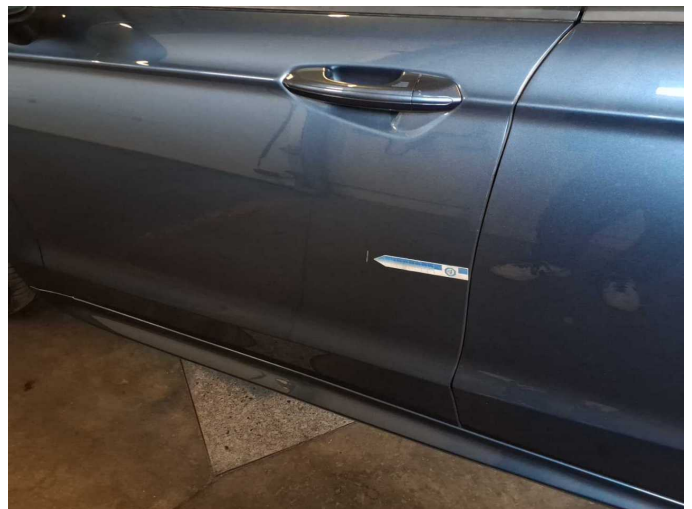
Damage 3: Door - front left side: Door - Scratch(es) - Smart repair

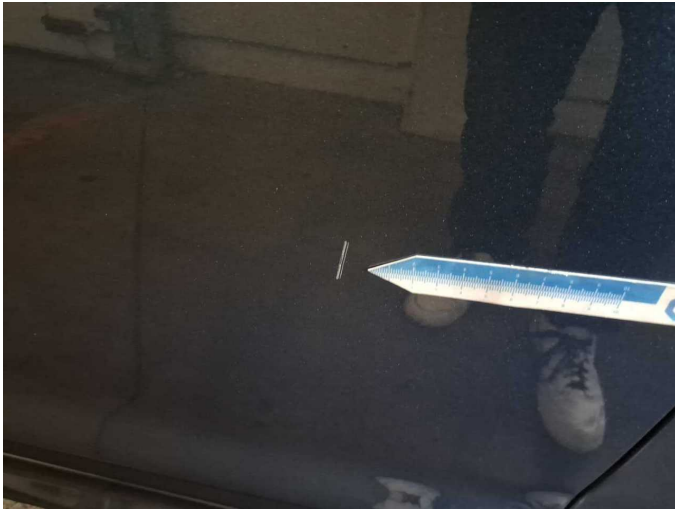
Damage 3: Door - front left side: Door - Scratch(es) - Smart repair

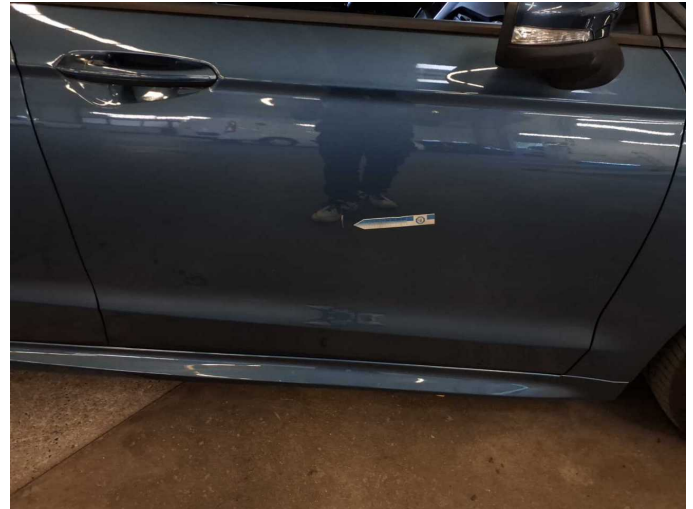
Damage 4: Door - front right side: Door - Scratch(es) - Smart repair

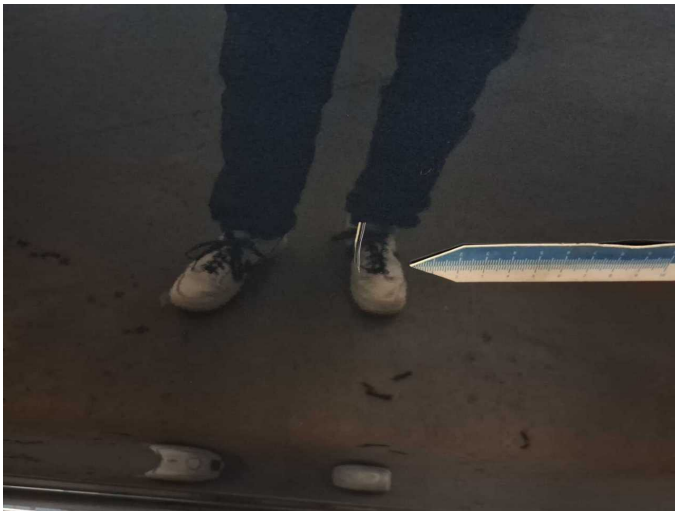
Damage 4: Door - front right side: Door - Scratch(es) - Smart repair

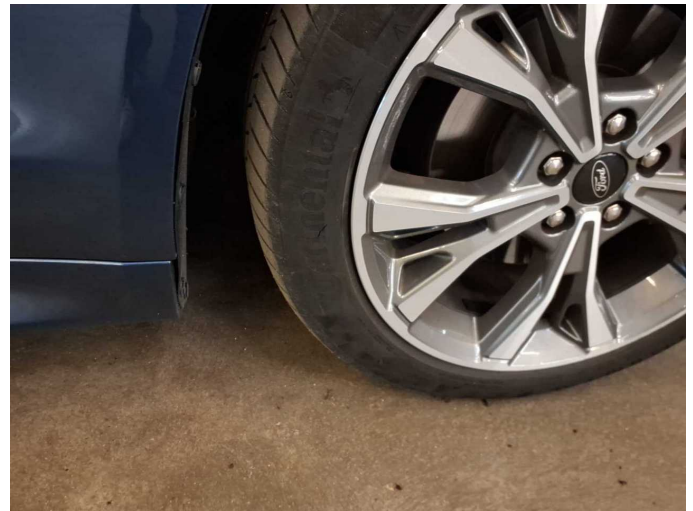
Damage 5: Wheel / tyres: Tyre - front right side (nicht fahrbereit) - Broken / torn - Replace

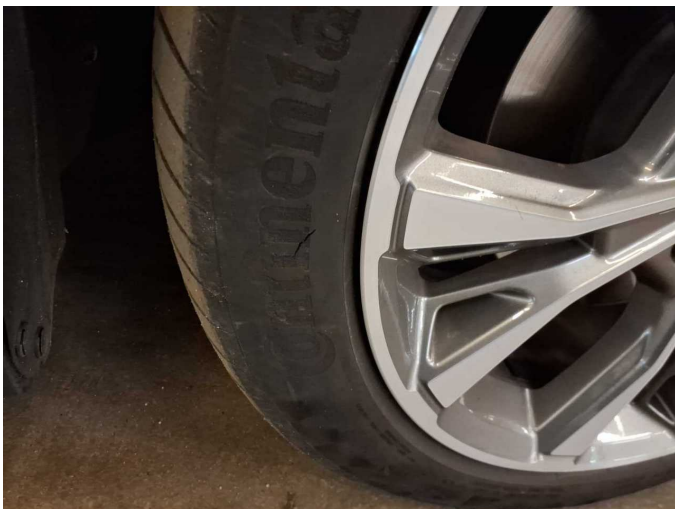
Damage 5: Wheel / tyres: Tyre - front right side (nicht fahrbereit) - Broken / torn - Replace

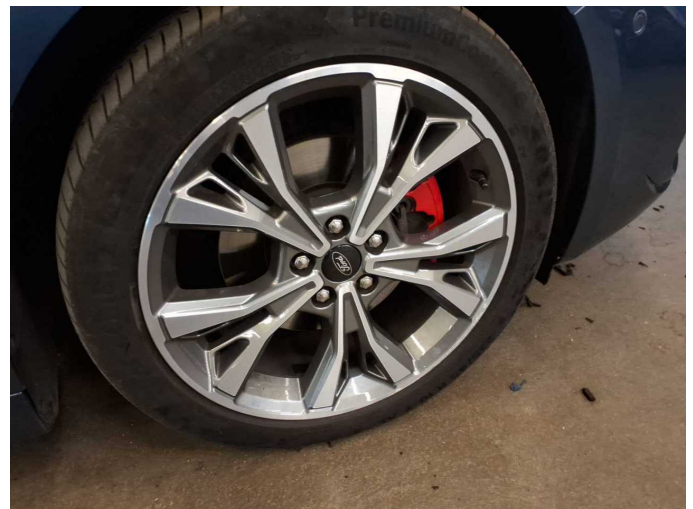
Damage 6: Wheel / tyres: Alloy rim - front right side - Scratch(es) - Loss in value

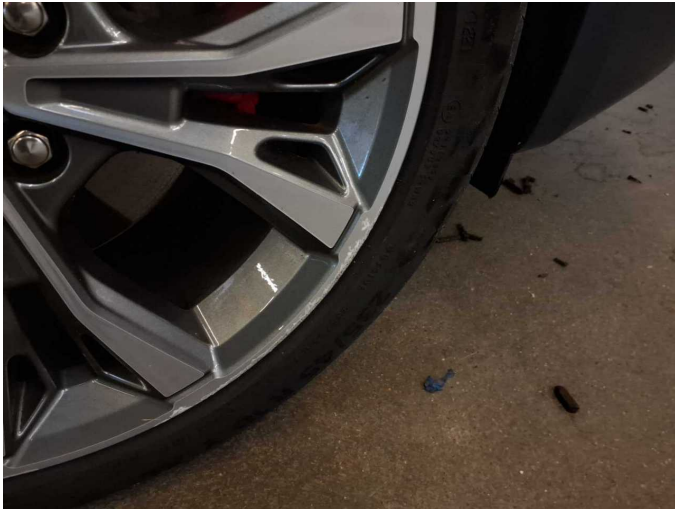
Damage 6: Wheel / tyres: Alloy rim - front right side - Scratch(es) - Loss in value

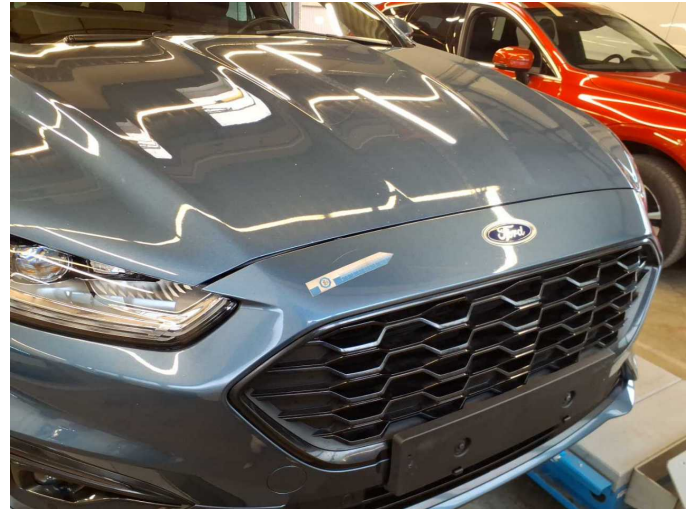
Damage 7: Front bumper: Front bumper - Scratch(es) - Paint

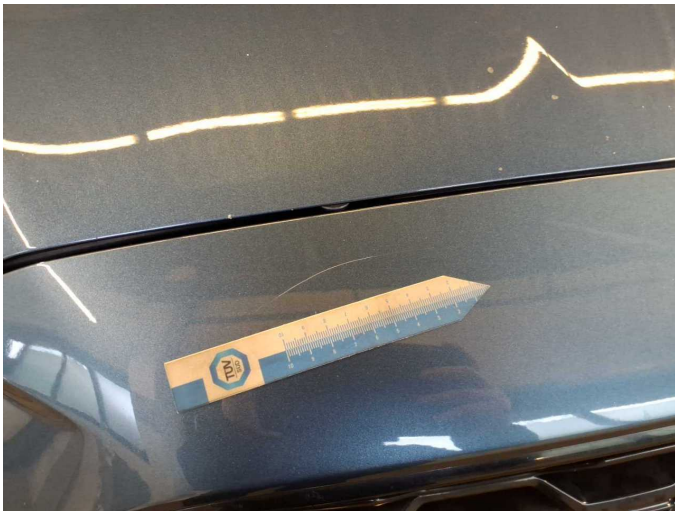
Damage 7: Front bumper: Front bumper - Scratch(es) - Paint

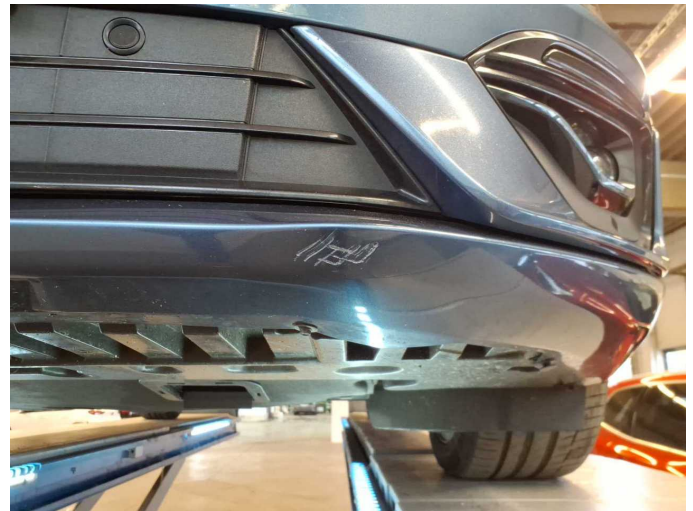
Damage 7: Front bumper: Front bumper - Scratch(es) - Paint

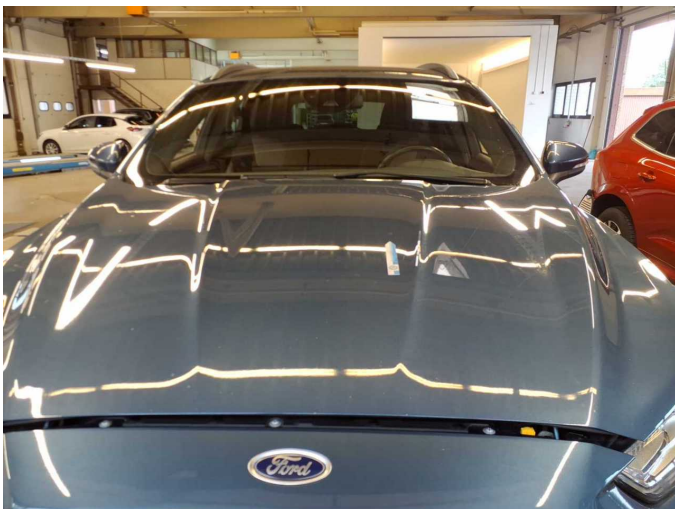
Damage 8: Bonnet: Bonnet (Vogelkotverätzung + Steinschläge) - Paint defect - Paint

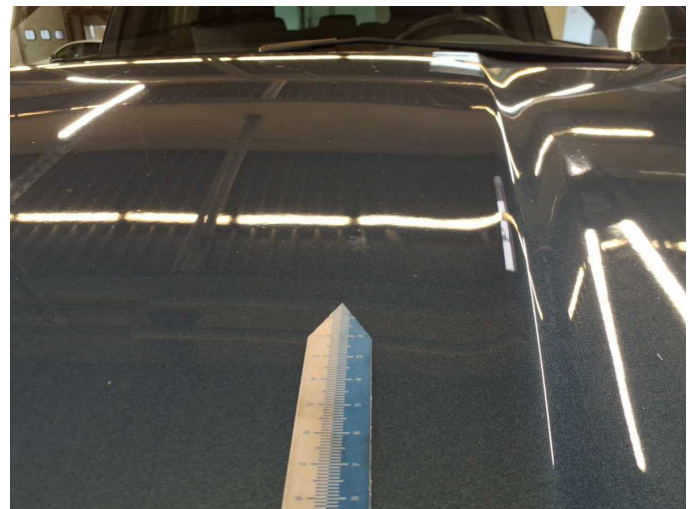
Damage 8: Bonnet: Bonnet (Vogelkotverätzung + Steinschläge) - Paint defect - Paint

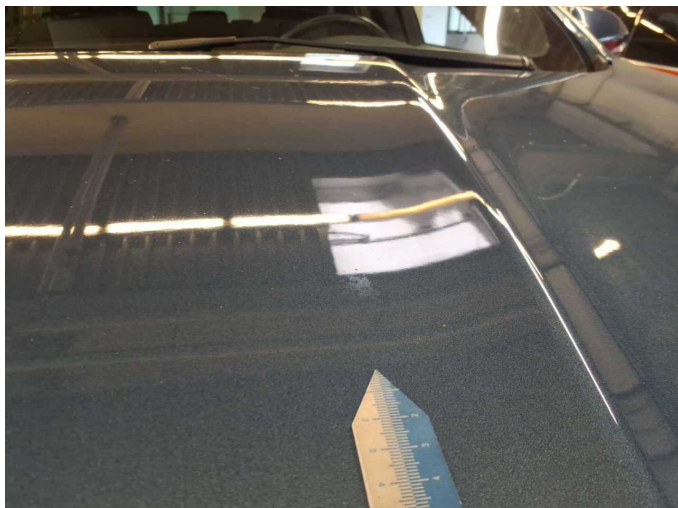
Damage 8: Bonnet: Bonnet (Vogelkotverätzung + Steinschläge) - Paint defect - Paint

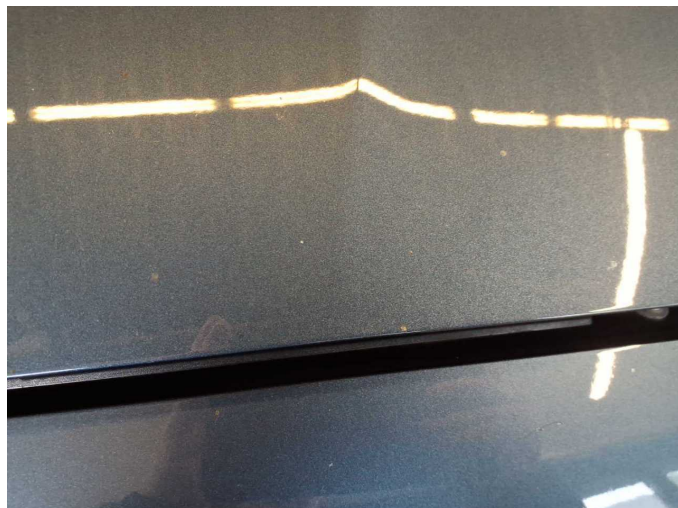
Damage 8: Bonnet: Bonnet (Vogelkotverätzung + Steinschläge) - Paint defect - Paint

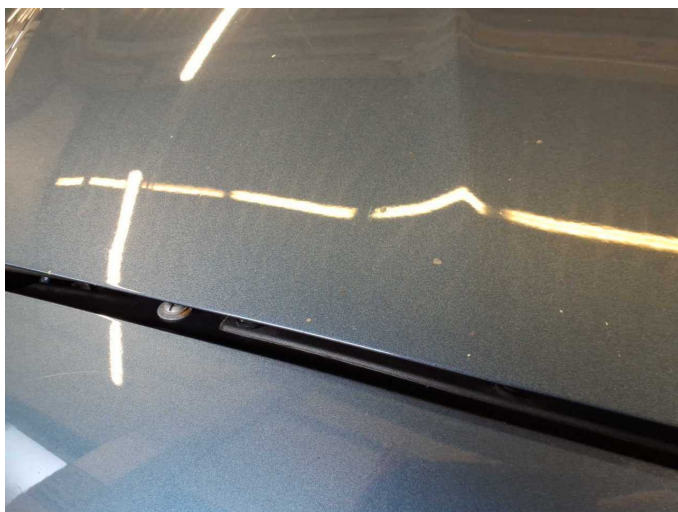
Damage 8: Bonnet: Bonnet (Vogelkotverätzung + Steinschläge) - Paint defect - Paint

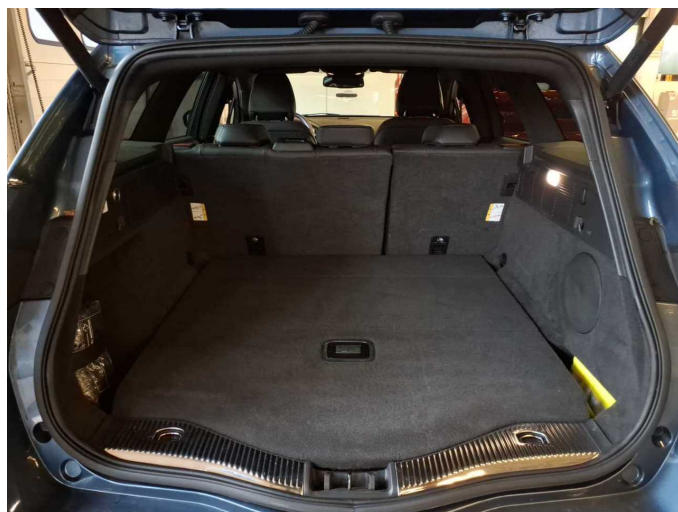
Missing part 1: Interior: Boot cover / roller cover - Missing - Replace

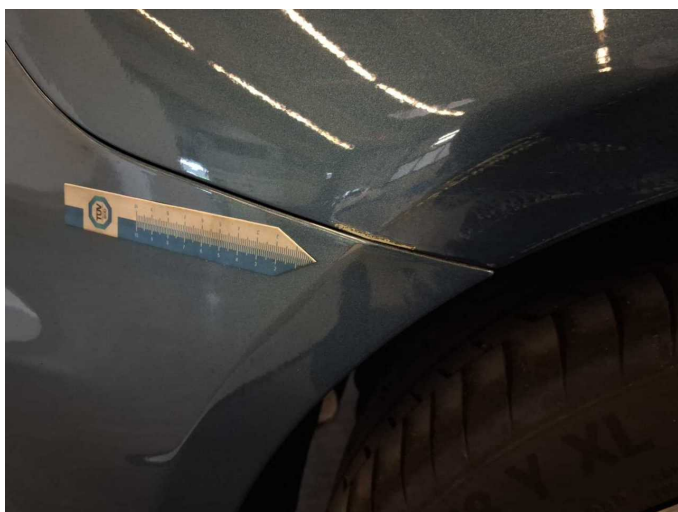
Accident 1: Rear, Side right

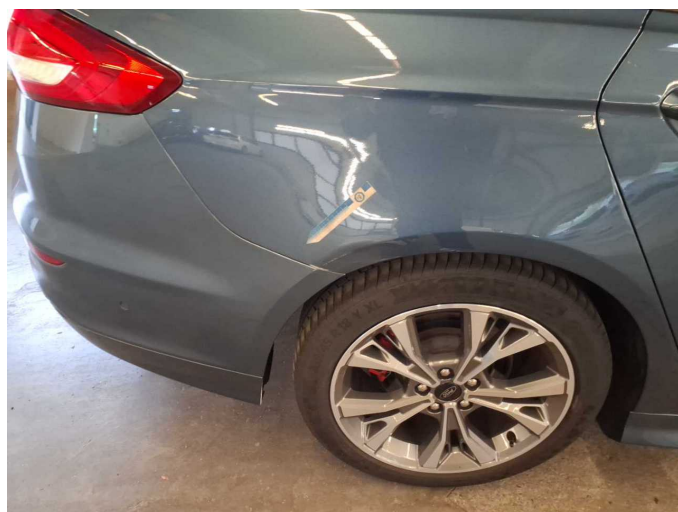
Accident 1: Rear, Side right

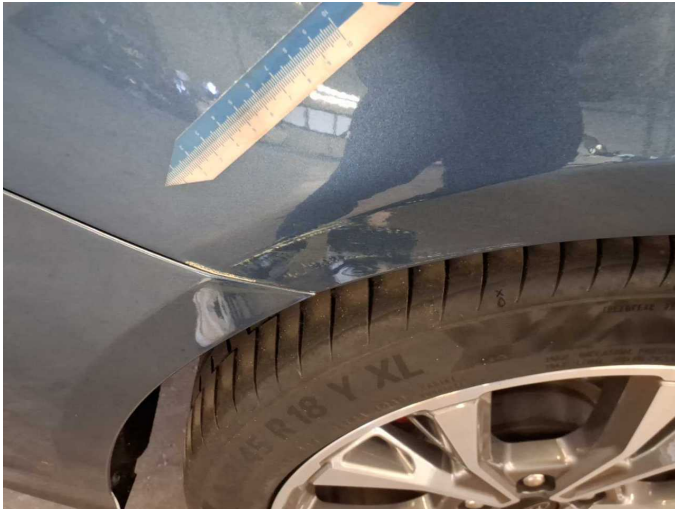
Accident 1: Rear, Side right

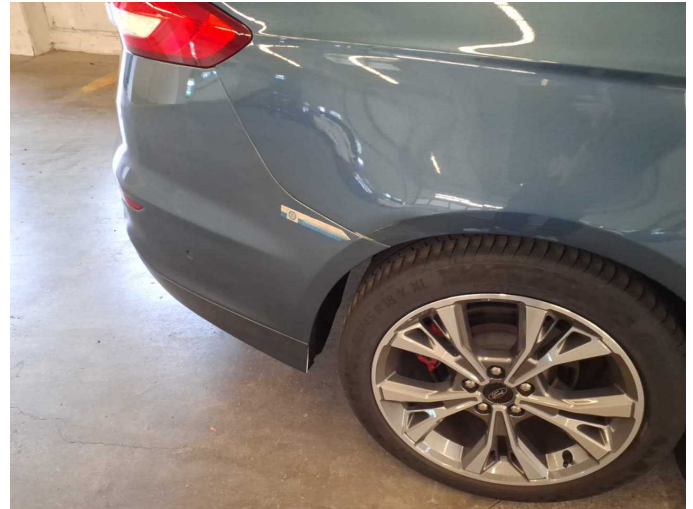
Accident 1: Rear, Side right

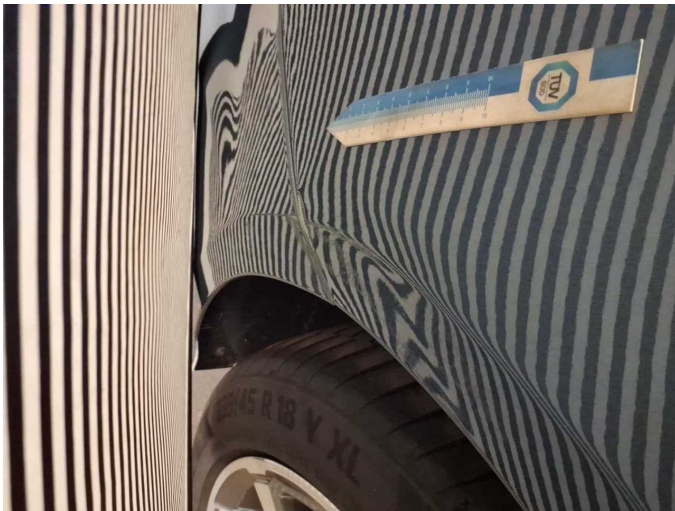
Accident 1: Rear, Side right

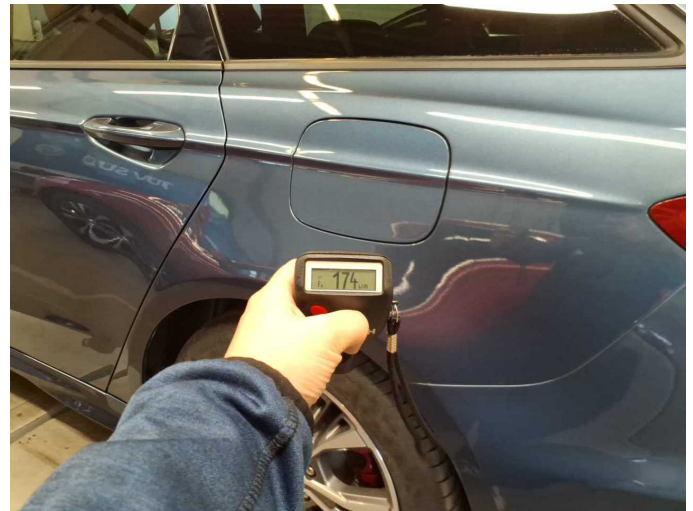
Mudguard - left side	205 µm	Side panel - rear left side	174 µm
Door - rear left side	198 µm	Door - front left side	197 µm

Repainting 1: Mudguard - left side, Side panel - rear left side, Door - rear left side, Door - front left side

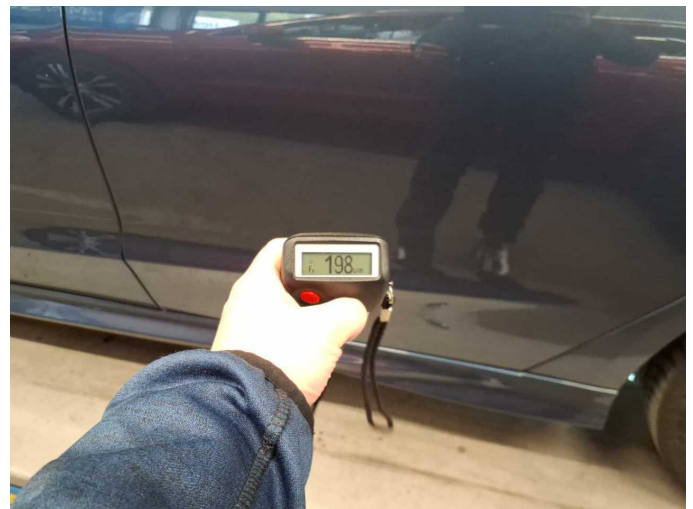
Repainting 1: Mudguard - left side, Side panel - rear left side, Door - rear left side, Door - front left side

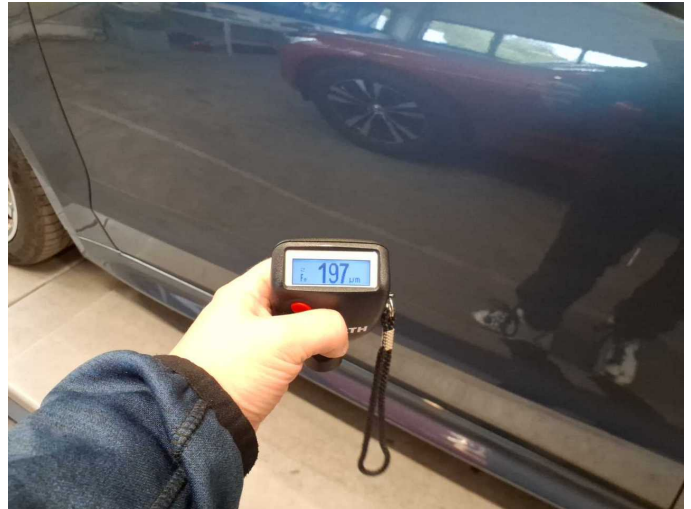
Repainting 1: Mudguard - left side, Side panel - rear left side, Door - rear left side, Door - front left side

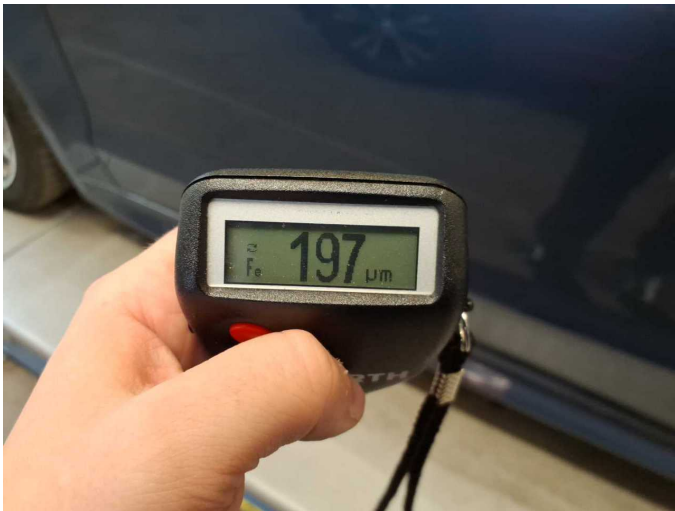
Repainting 1: Mudguard - left side, Side panel - rear left side, Door - rear left side, Door - front left side

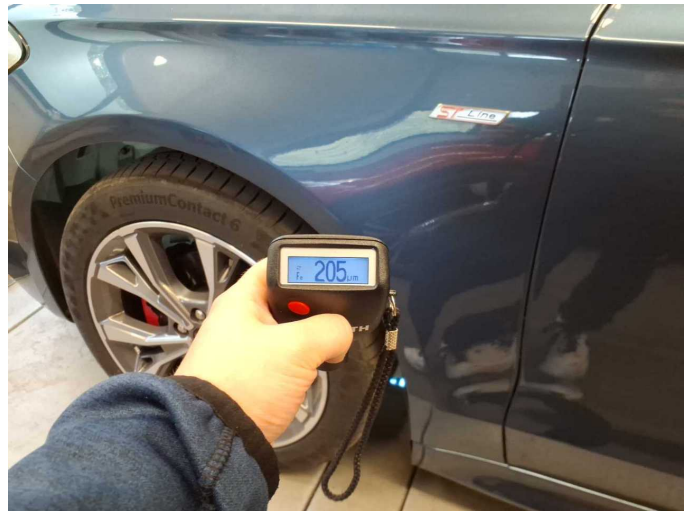
Repainting 1: Mudguard - left side, Side panel - rear left side, Door - rear left side, Door - front left side
