Expertise

Protocol number: 40712616  
Order No. / Reference: 24903101  
Inspection date: 23 Jul 2025

Manufacturer: Ford	Model: Kuga 2.0 EcoBlue 4x4 Aut. ST-LINE
VIN: WF0FXXWPMFMM02256

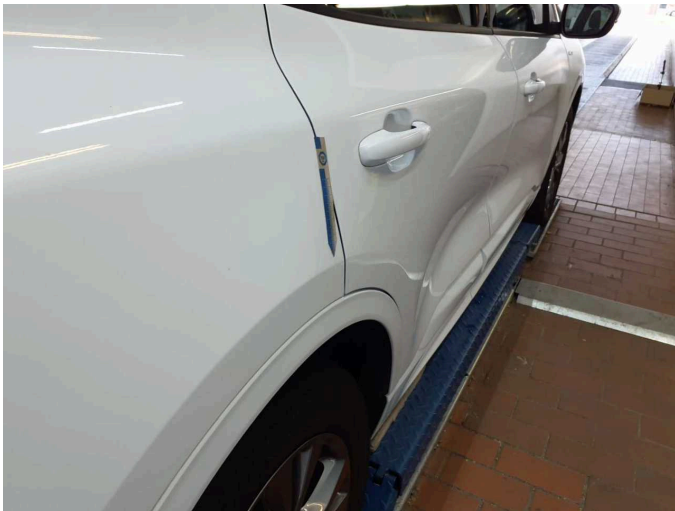
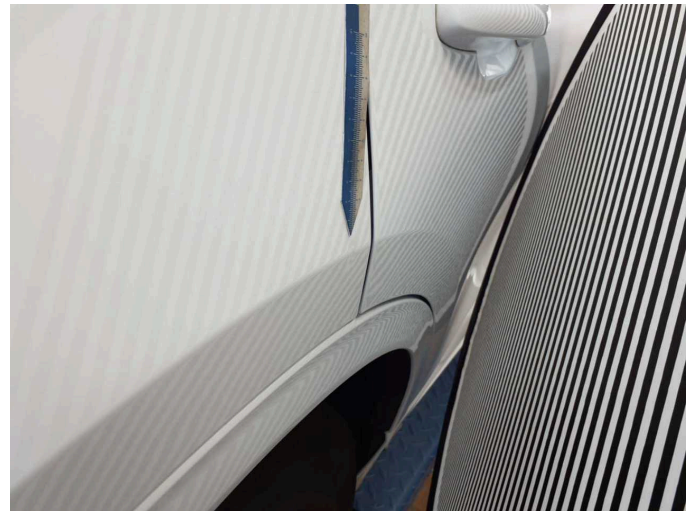
No.	Component group	Description
1	Side panel - rear right side	Side panel - dent(s) - Smart repair
2	Boot lid / rear door	Boot lid - Scratch(es) - Smart repair
3	Wheel / tyres	Alloy rim - rear right side - Scratched - Loss in value

**Damage 1:** Side panel - rear right side: Side panel - dent(s) - Smart repair

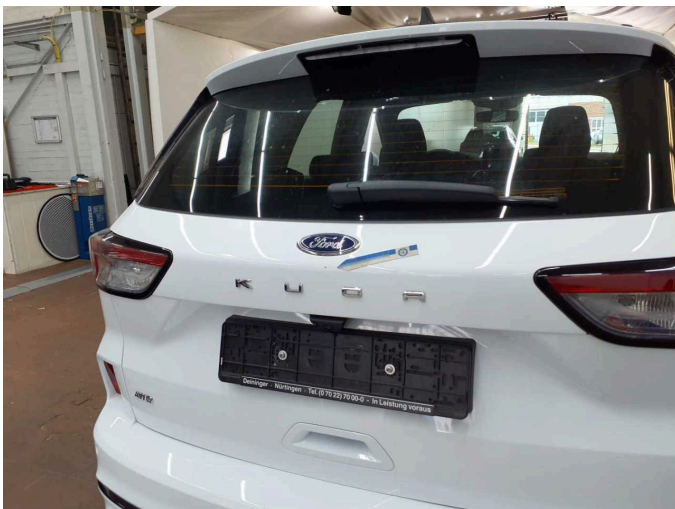
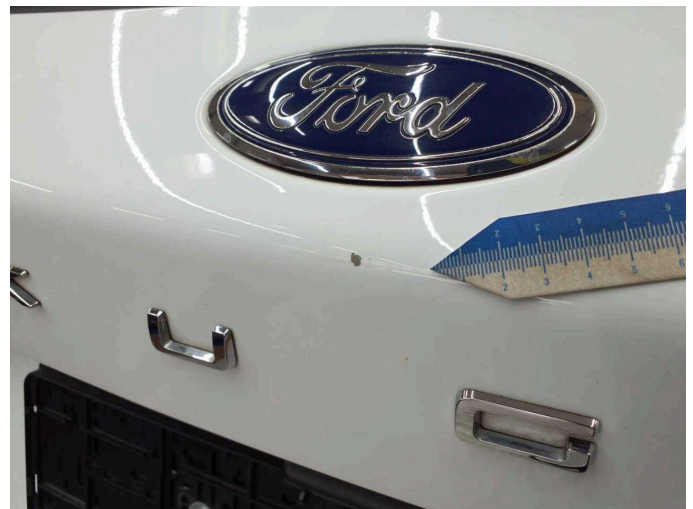
**Damage 2:** Boot lid / rear door: Boot lid - Scratch(es) - Smart repair

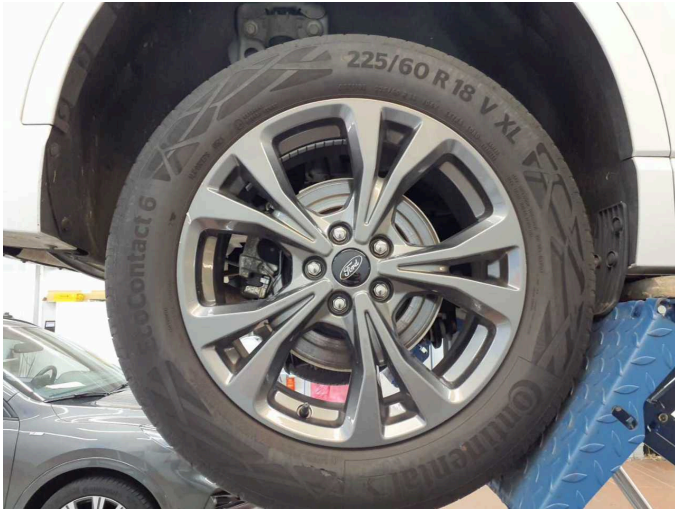
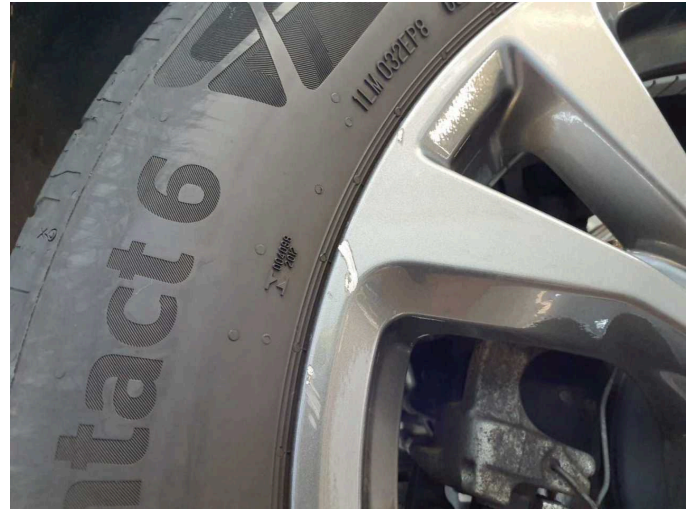
**Damage 3:** Wheel / tyres: Alloy rim - rear right side - Scratched - Loss in value

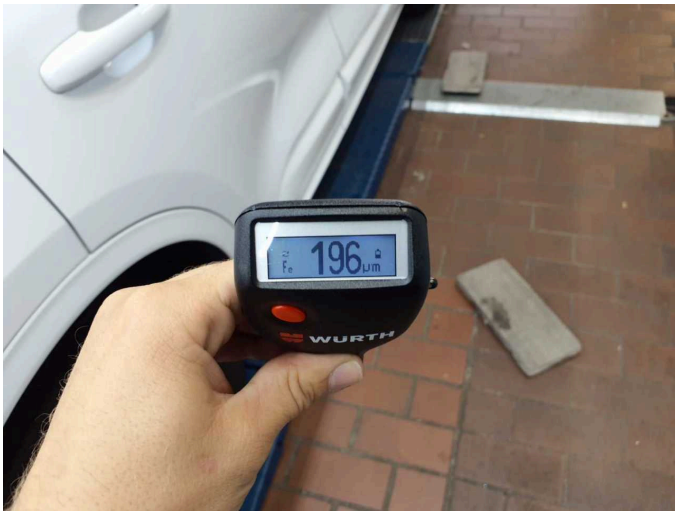
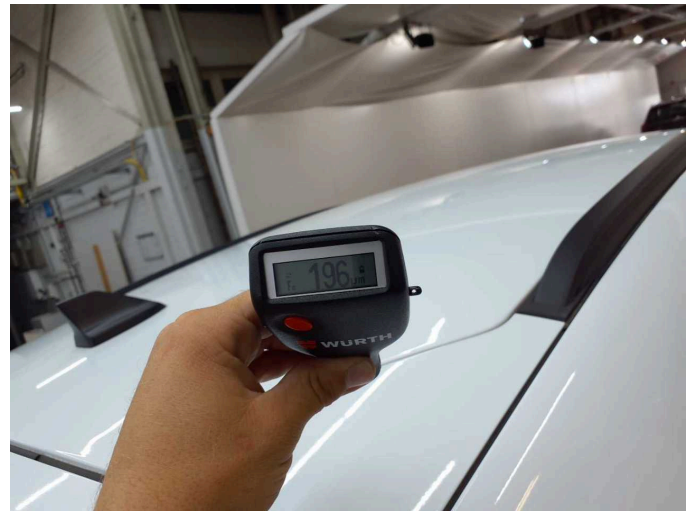
1 Roof, Professionally carried out, Invoice of repair done Non-existent

Roof 196  $\mu\text{m}$  |

**Repainting 1:** Roof
