Expertise

Protocol number: 41602155
Order No. / Reference: 25180928
Inspection date: 18 Sept 2025

Model: Kuga 2.0 EcoBlue Aut. 4x4 TITANIUM

VIN: WF0FXXWPMFNU67172

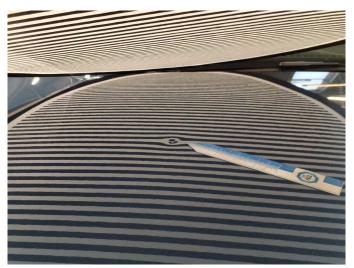
Damage 1: Bonnet: Bonnet - dent(s) - Smooth repair work

No.	Component group	Description
1	Bonnet	Bonnet - dent(s) - Smooth repair work
2	Wing mirror - right side	Can - Scratch(es) - Smart renair

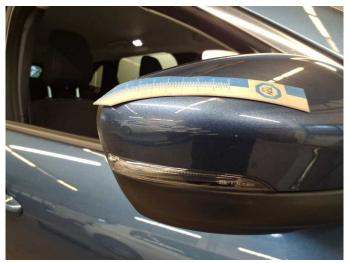
Damage 2: Wing mirror - right side: Cap - Scratch(es) - Smart repair
