Expertise

Protocol number: 41277808
Order No. / Reference: 25140068
Inspection date: 27 Aug 2025

Manufacturer: Ford	Model: Kuga 2.5 Duratec PHEV ST-LINE X
VIN: WF0FXXWPMHMP13476

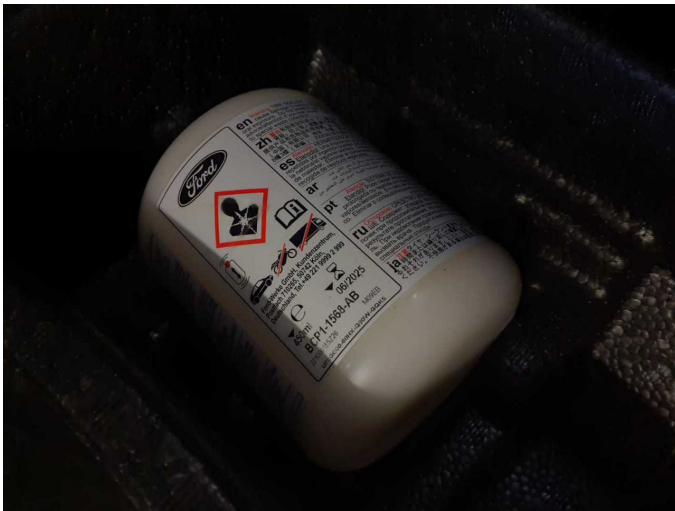
Damage 1: Equipment: Tirefit filler - Expired - Replace

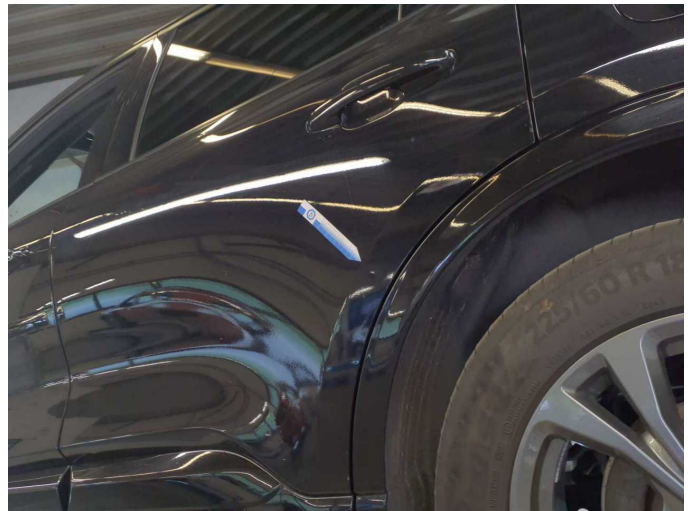
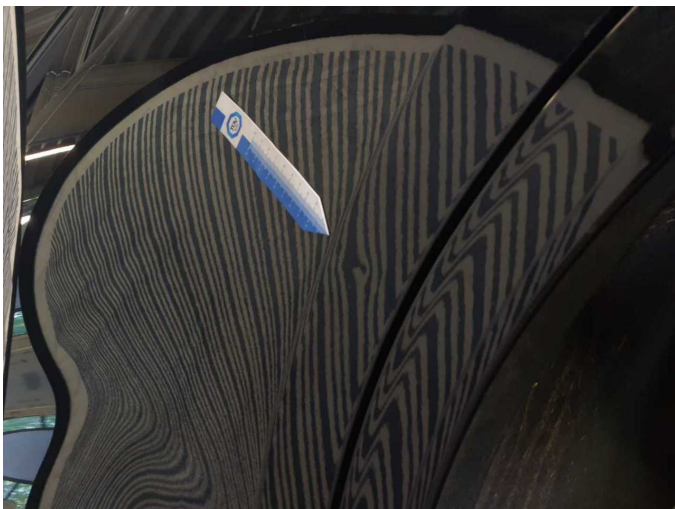
Damage 2: Door - rear left side: Door (die Kratzer sind Gebrauchsspuren) - dent(s) - Smart repair

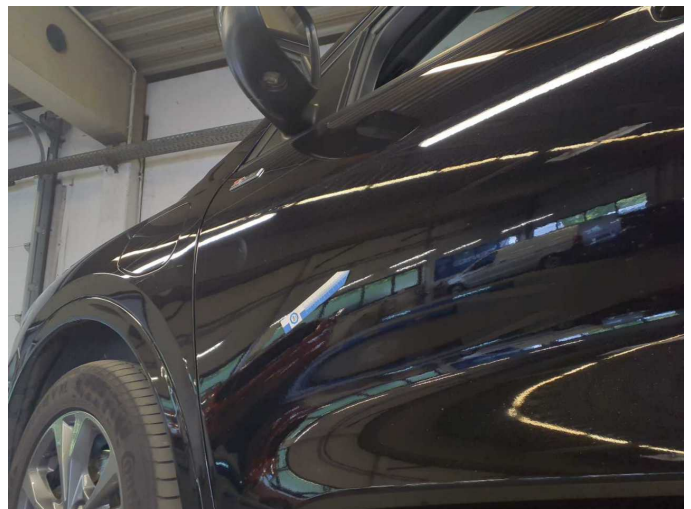
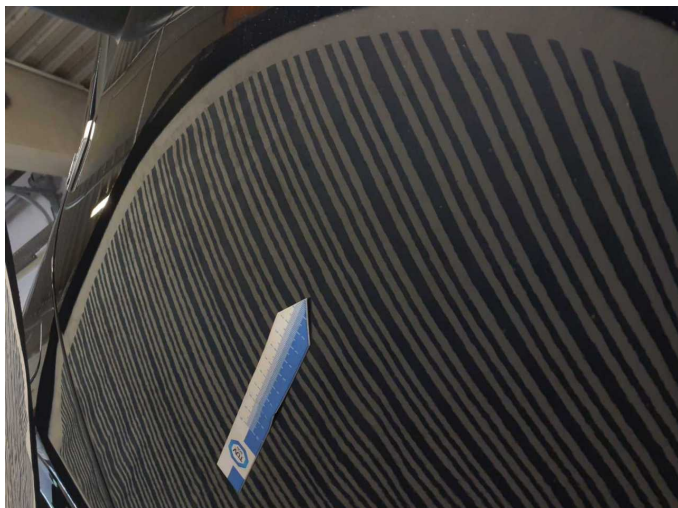
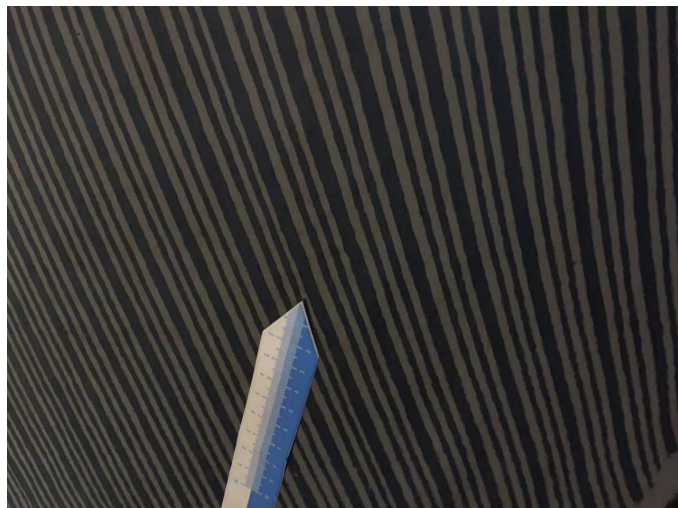
Damage 3: Door - front left side: Door (Lackpickel) - dent(s) - Smart repair

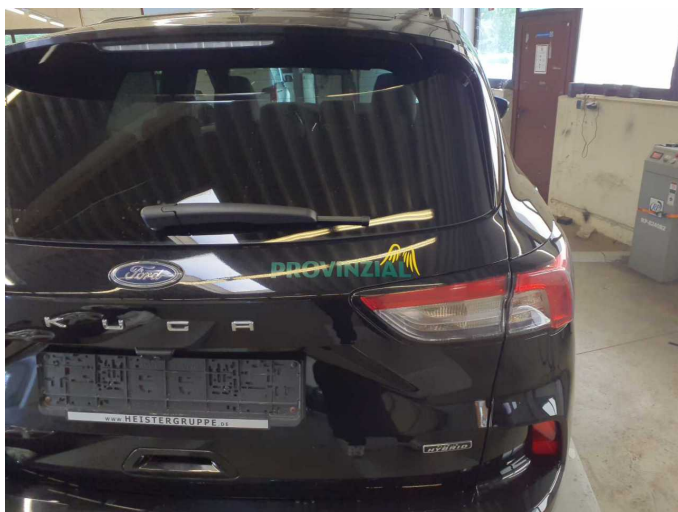
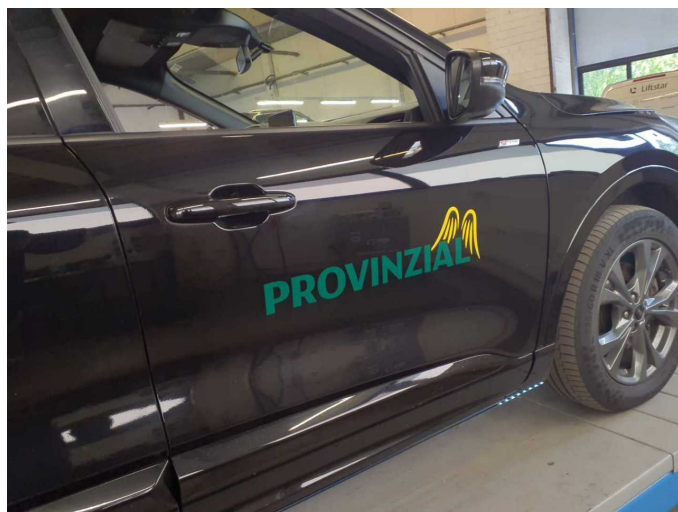
Damage 4: Body: Body - Glued / labelled - De-glue / neutralise

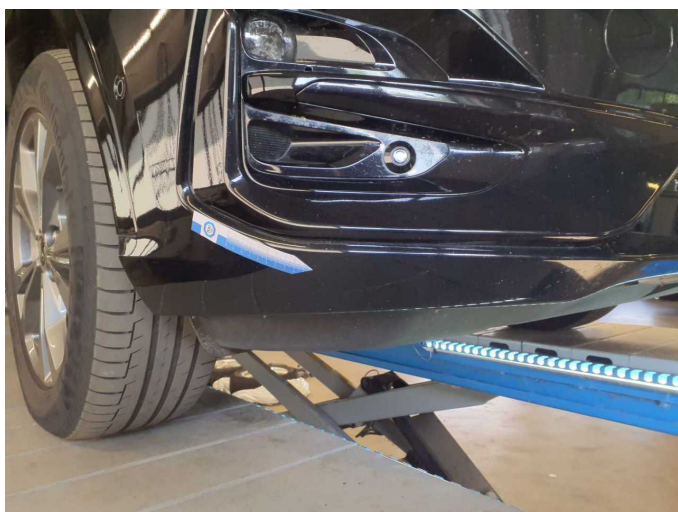
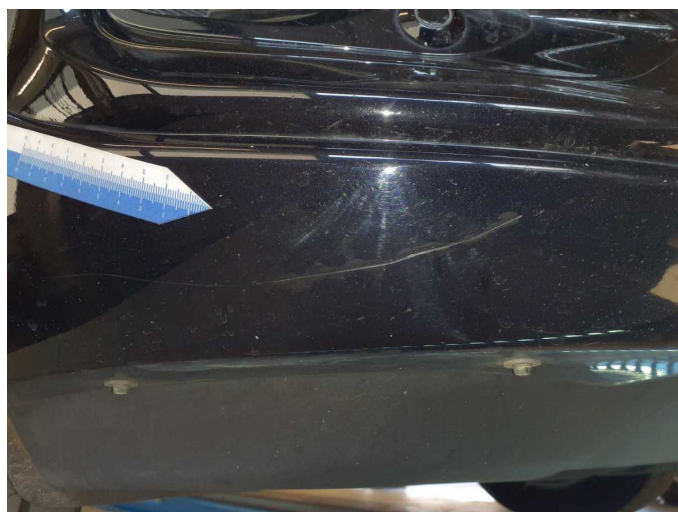
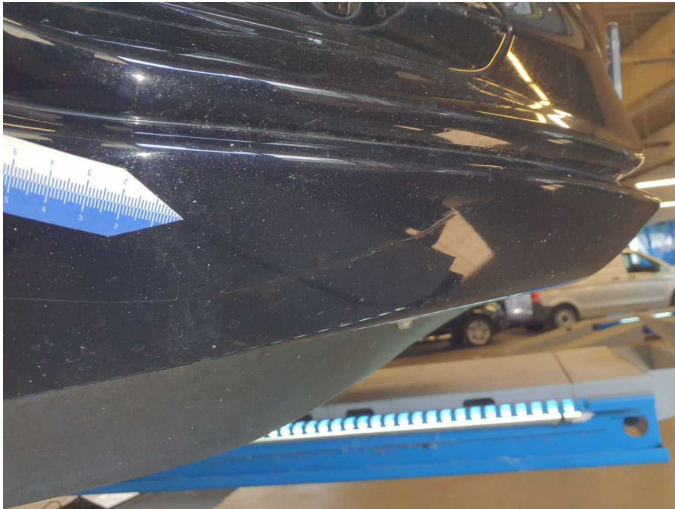
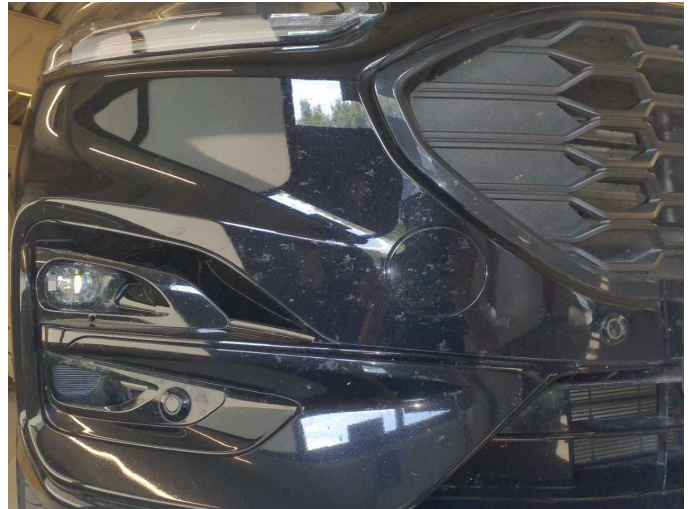
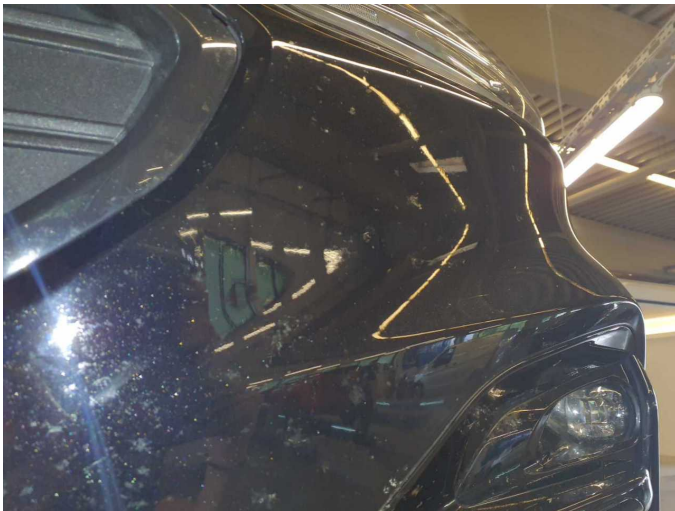
Damage 5: Front bumper: Front bumper (+Sandstrahleffekt) - Scratched - Repair and paint

Damage 5: Front bumper: Front bumper (+Sandstrahleffekt) - Scratched
- Repair and paint

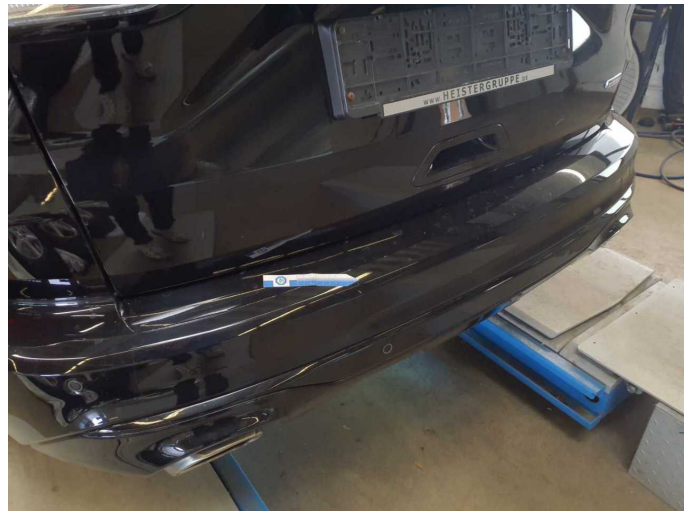
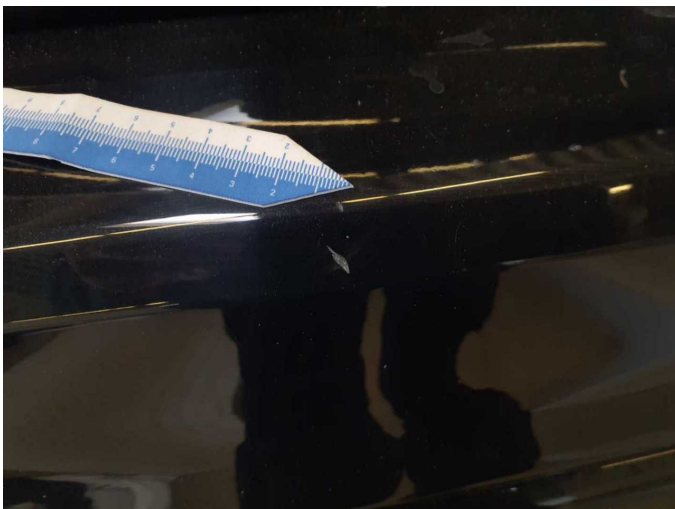
Wear and tear 1: Rear bumper: Rear bumper - Scratch(es) - No deduction

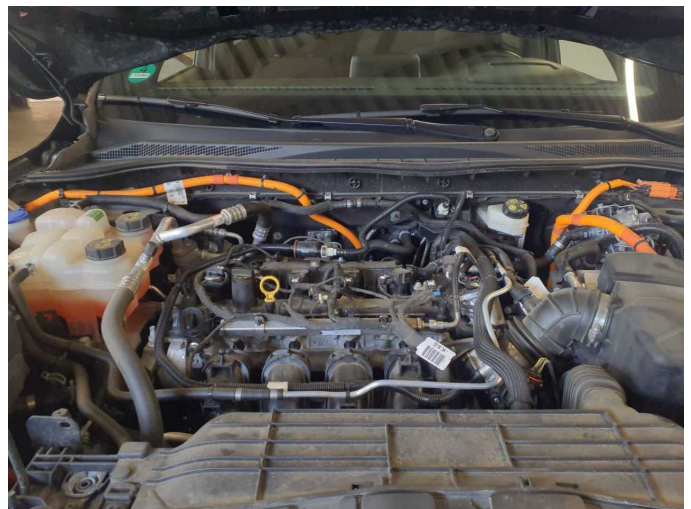
Missing part 1: Engine: Engine cover - Missing - Replace

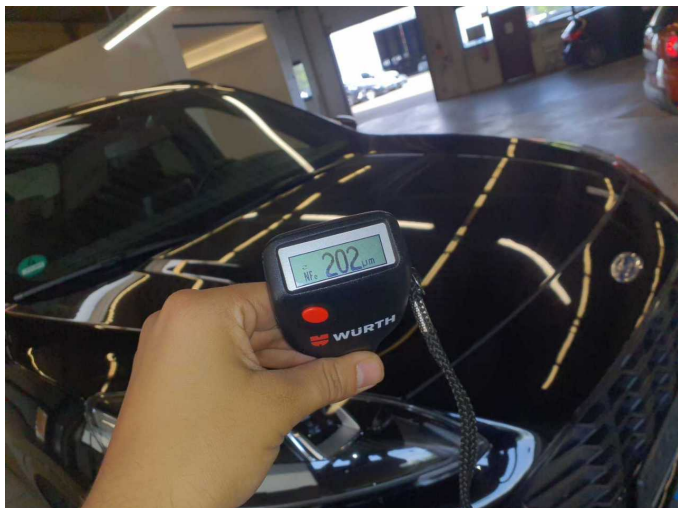
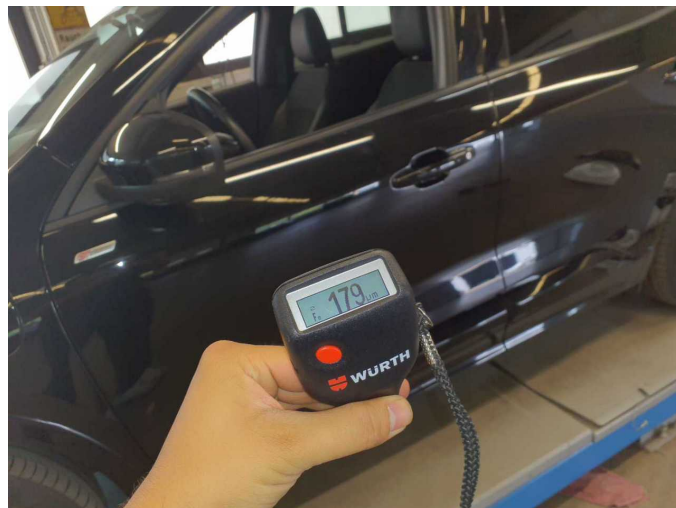
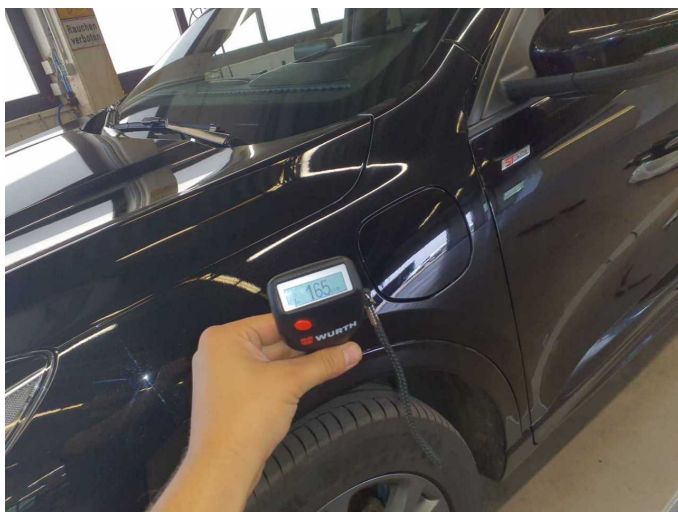
- 1 Mudguard - left side, Bonnet, Door - front left side, Professionally carried out, Invoice of repair done Non-existent

Mudguard - left side	165 µm	Bonnet	202 µm
Door - front left side	179 µm

Repainting 1: Mudguard - left side, Bonnet, Door - front left side
