# FORD S-Max

## S-Max 2.0 EcoBlue Aut.

### Inspection Report Summary

Customer	BCA Online	Report Number	P20250922110306
Inspection Date / Place	2025-09-22 / ARS Altmann AG Riedstadt	Cosmetic Grade	3

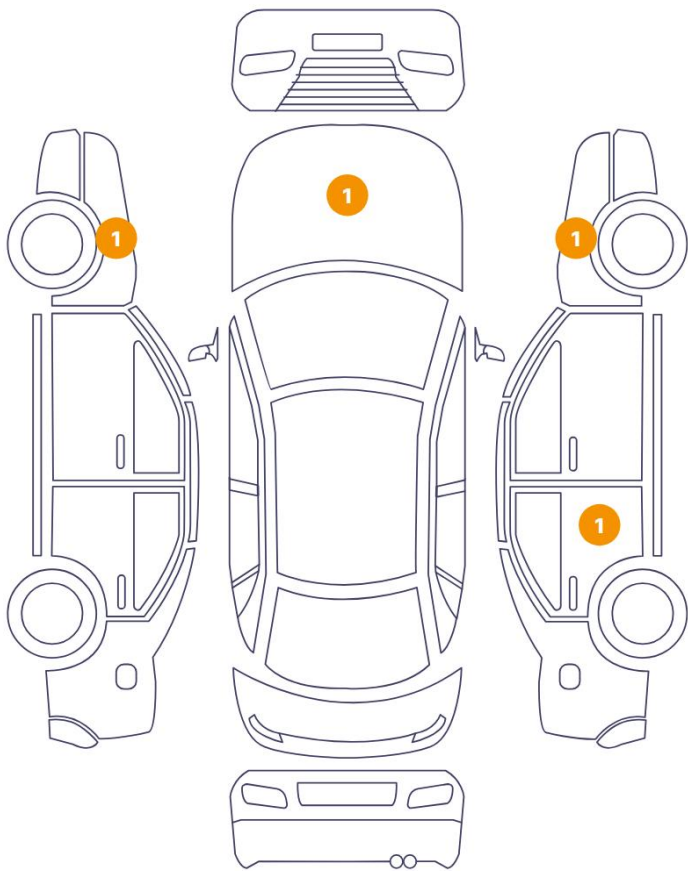
4 Schäden

Component		Damage	Comments
1	Hood	Paint / Stone Chip	
2	Fender / Front Right	Paint / Poor Previous Repair	
3	Door / Back Right	Paint / Scratch / Scuff	
4	Fender / Front Left	Paint / Scratch / Scuff

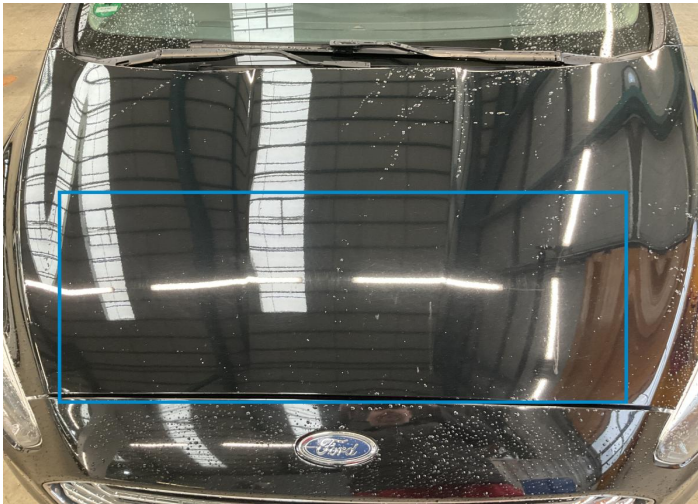
1. Hood  
Paint / Stone Chip -

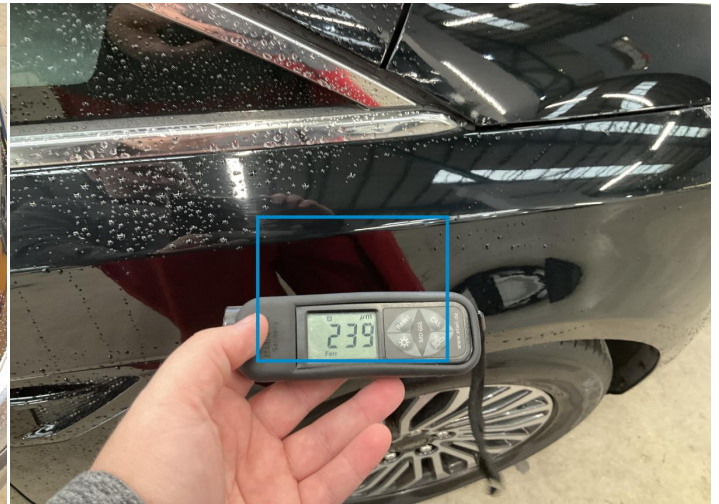
2. Fender / Front Right  
Paint / Poor Previous Repair -

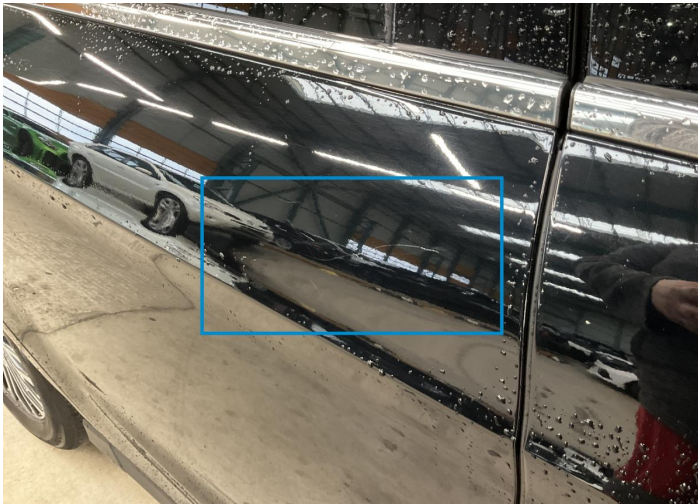
3. Door / Back Right  
Paint / Scratch / Scuff -

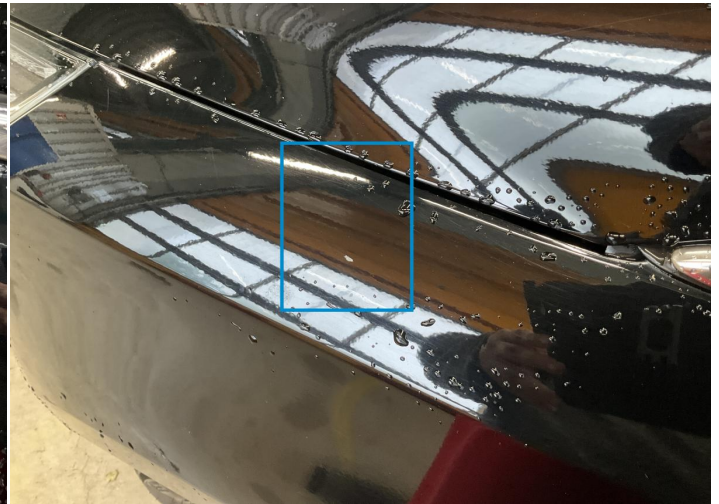
4. Fender / Front Left  
Paint / Scratch / Scuff -
