## status report

**customer:** Bank 11, Neuss  
**contract number:** 1121995530  
**reference:**

#### Ford S-MAX Vignale

| Vehicle identification number | <b>WF0JXXWPCJKE00355</b> | mileage read: | <b>138750 km</b> |

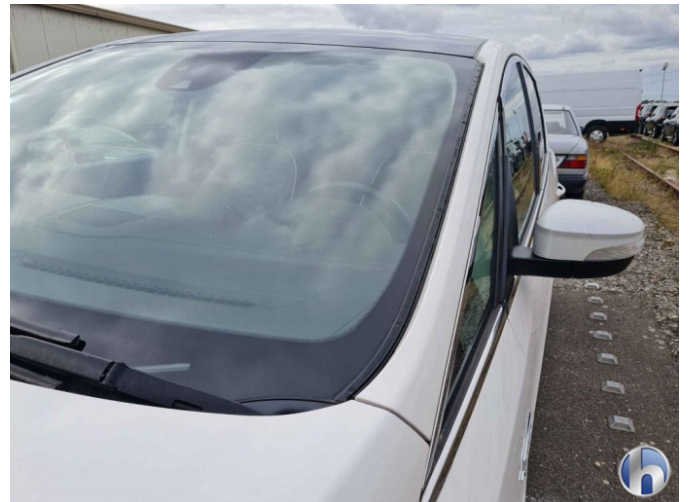
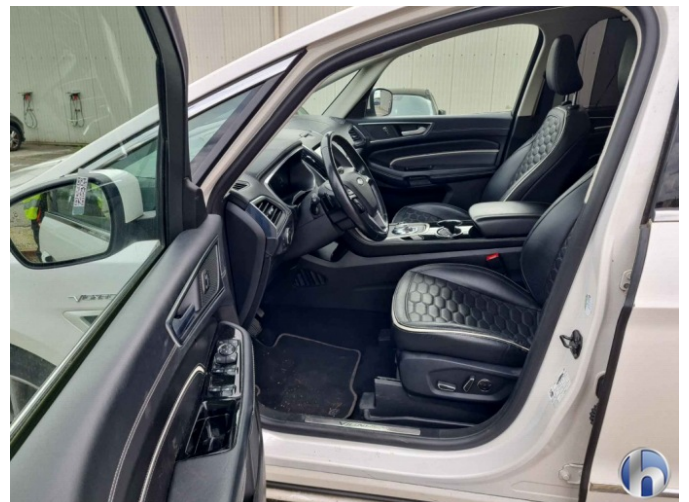
| component | Damage | Rep kind |
|---|---|---|
| 2. Frontscheibenleiste links und rechts | Missing | Replace |

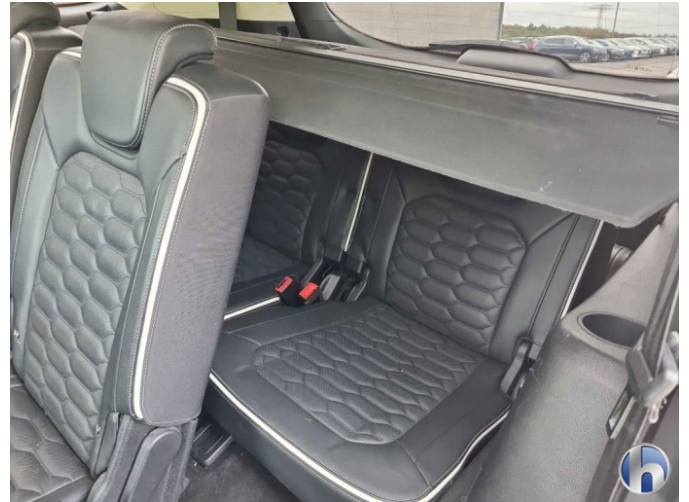
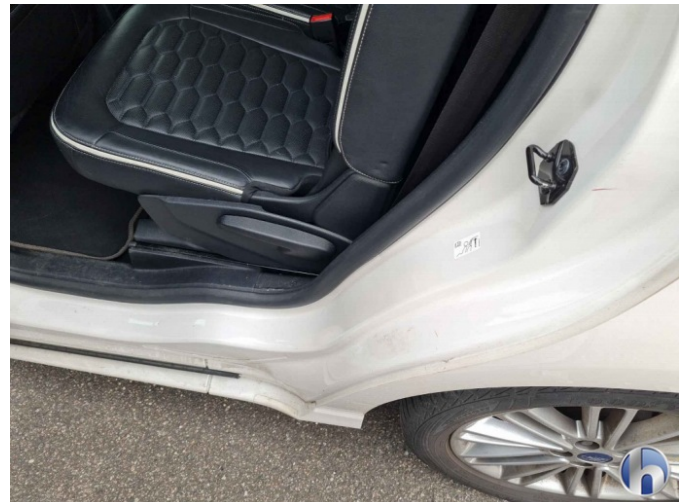
| component | Damage | Rep kind |
|---|---|---|
| 3. Kofferraum und Innenraum | Wear and tear | acceptable |

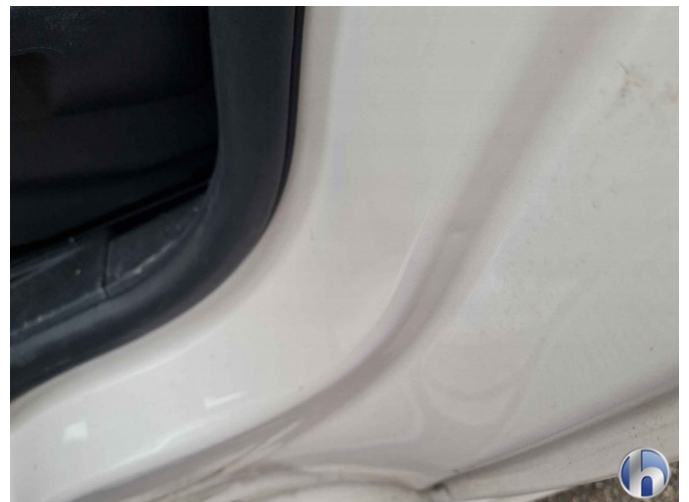
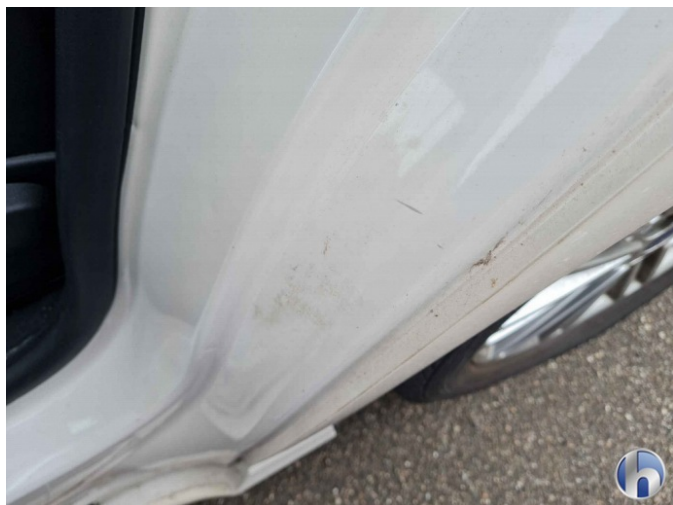
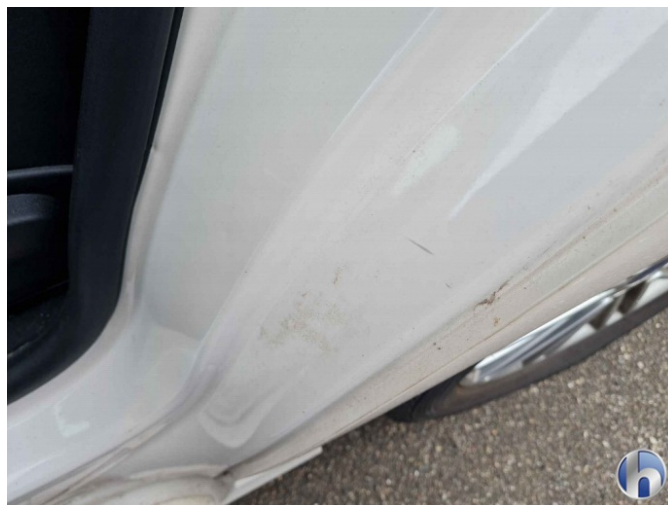
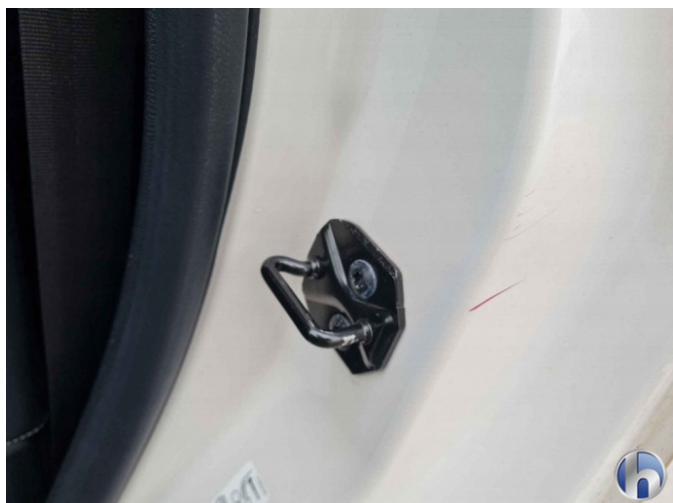
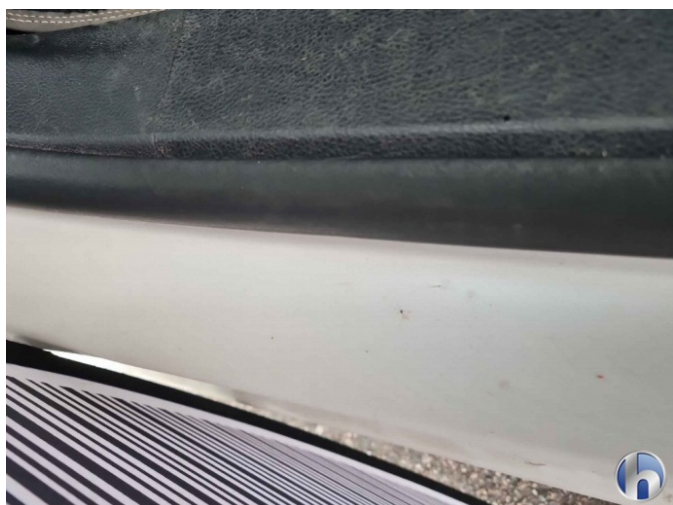
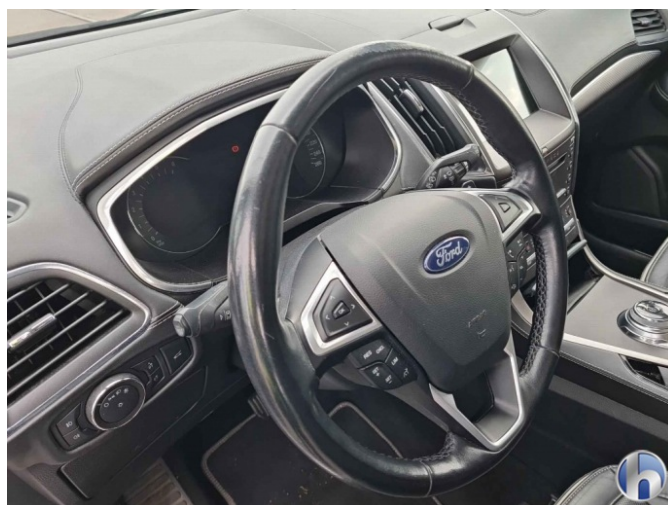
| component | Damage | Rep kind |
|---|---|---|
| 4. Türeinstieg Hinten - Links | Damaged | Refurbish and paint |

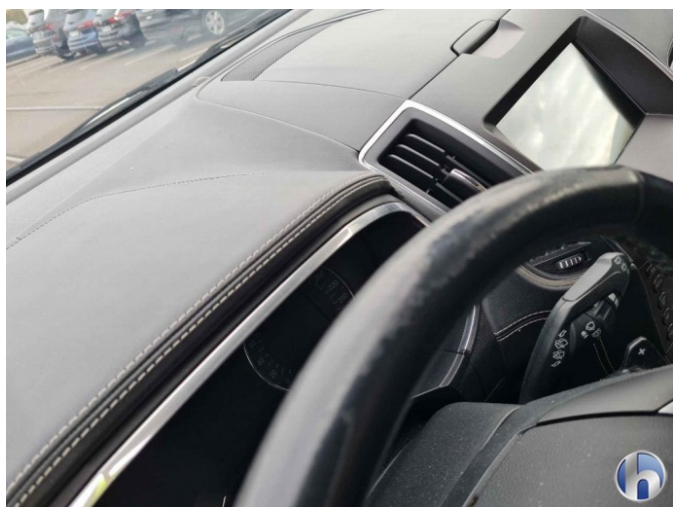
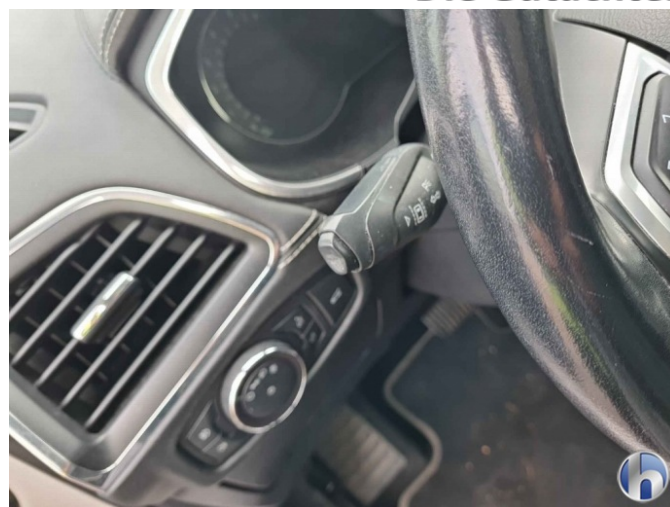
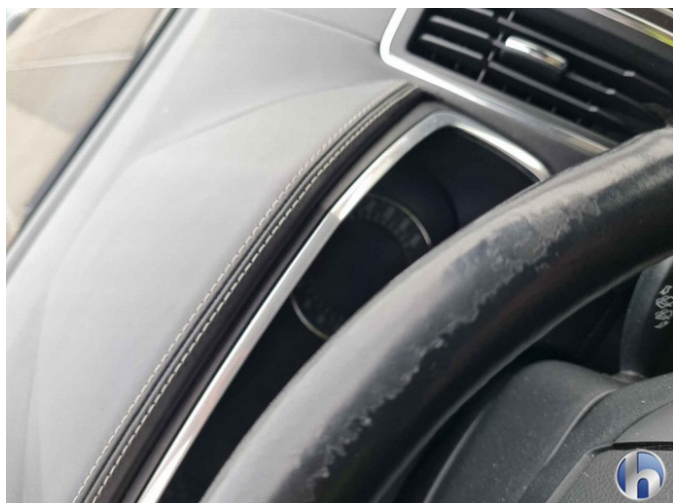
| component | Damage | Rep kind |
|---|---|---|
| 5. Lenkrad | Material wear | Replace |

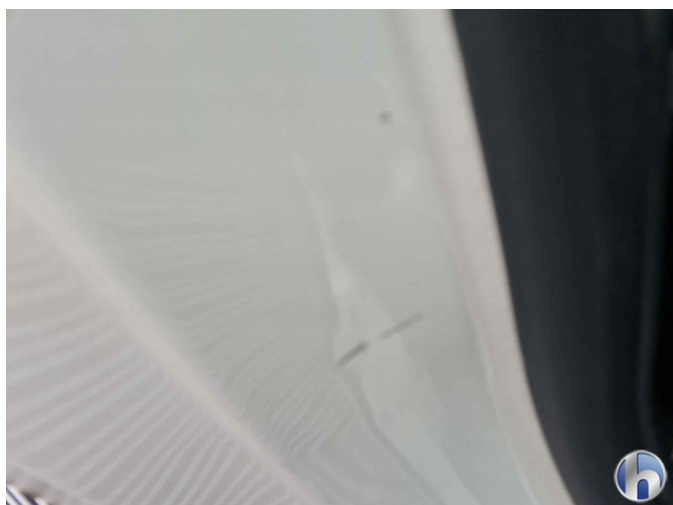
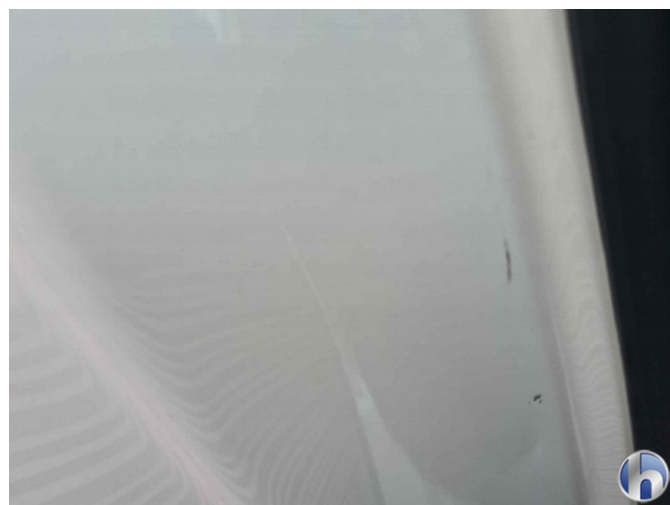
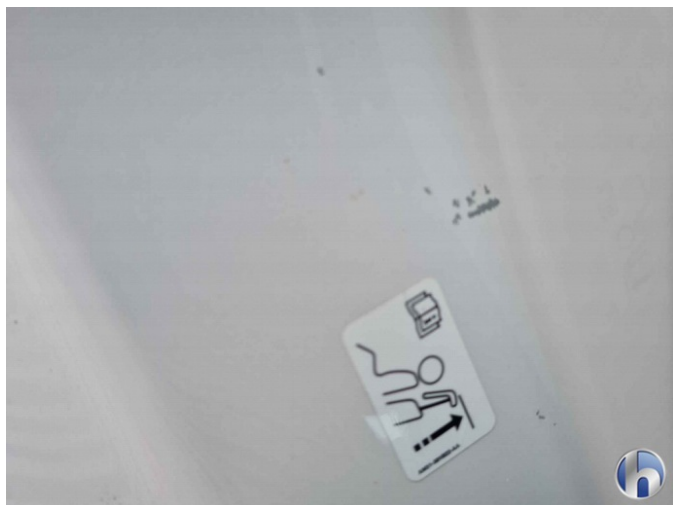
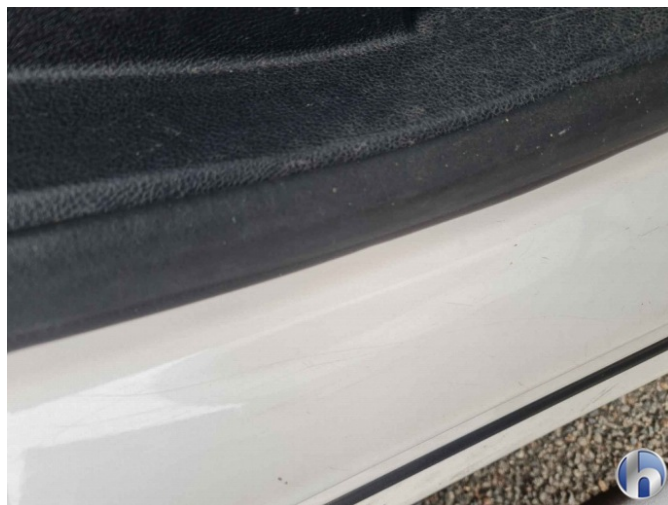
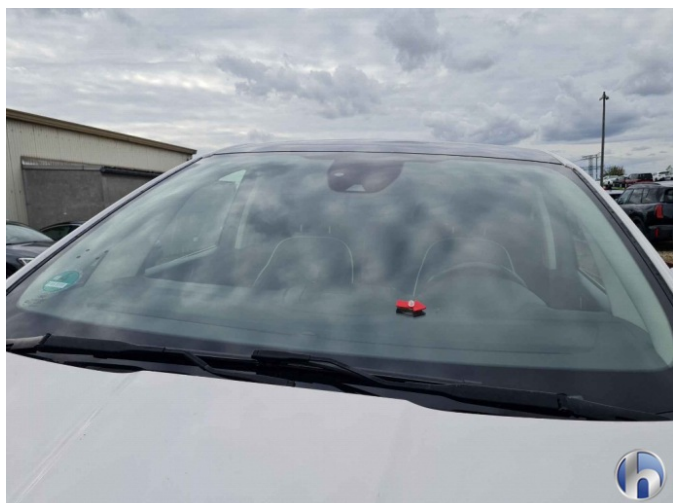
| component | Damage | Rep kind |
|---|---|---|
| 6. Türeinstieg Hinten - Rechts | Damaged | Refurbish and paint |

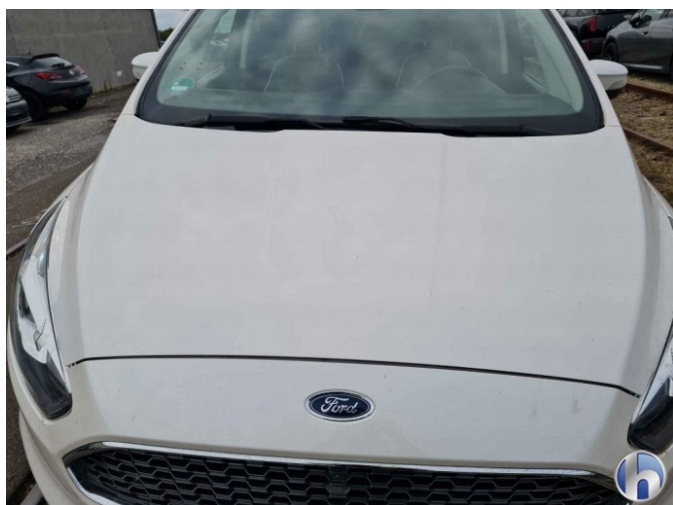
**Note Road Safe:** Frontscheibe Steinschlag, Bremse verschlissen/nicht in Ordnung

| component | Damage | Rep kind |
|---|---|---|
| 7. | Chipping from stones | Replace |

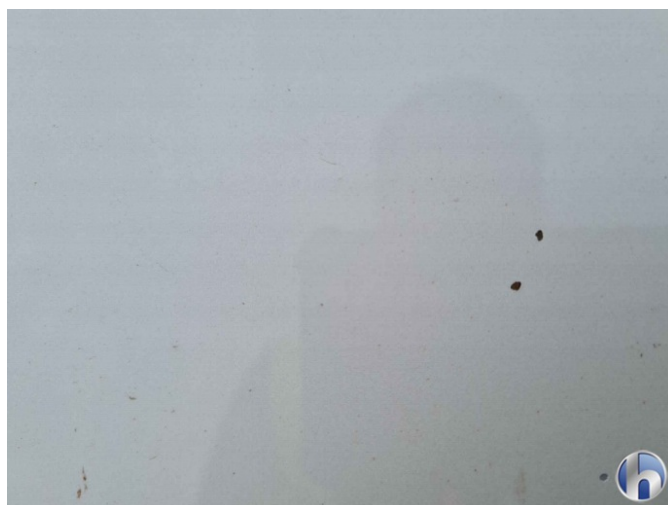
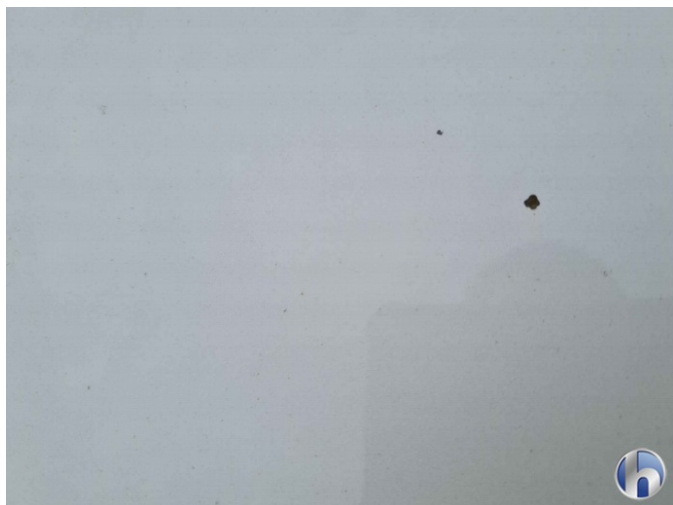
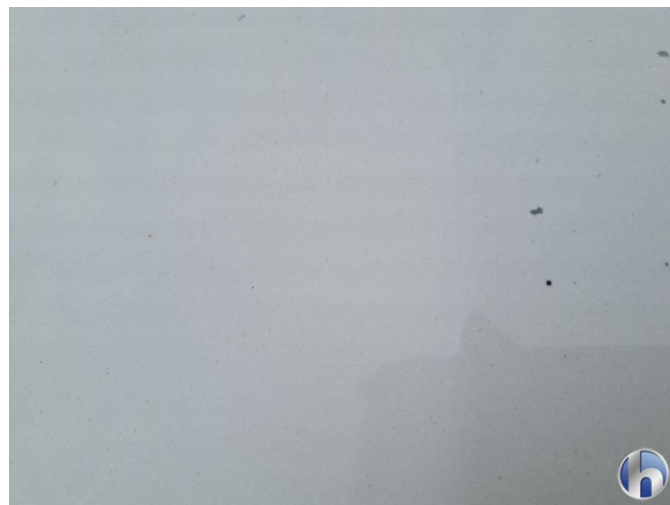
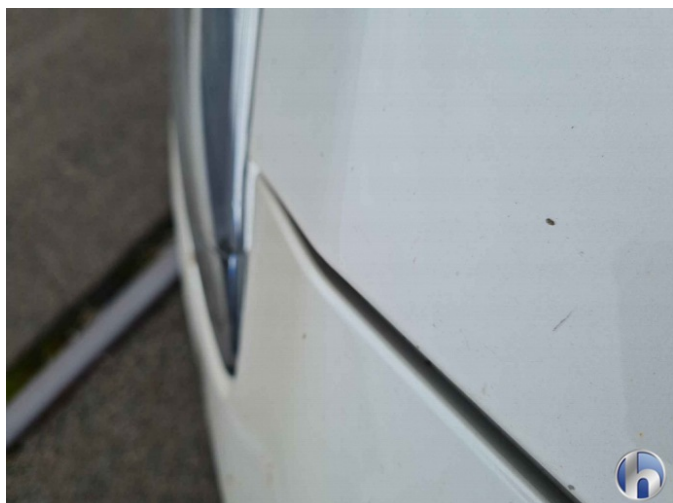
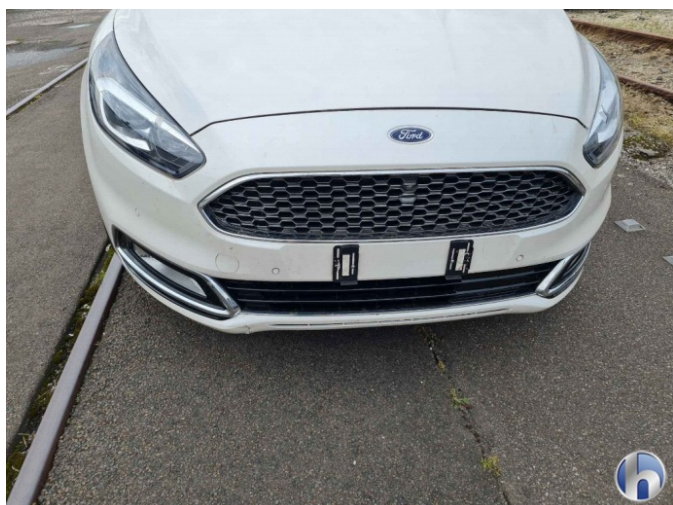
| component | Damage | Rep kind |
|---|---|---|
| 8. hood | Rust | Paint |

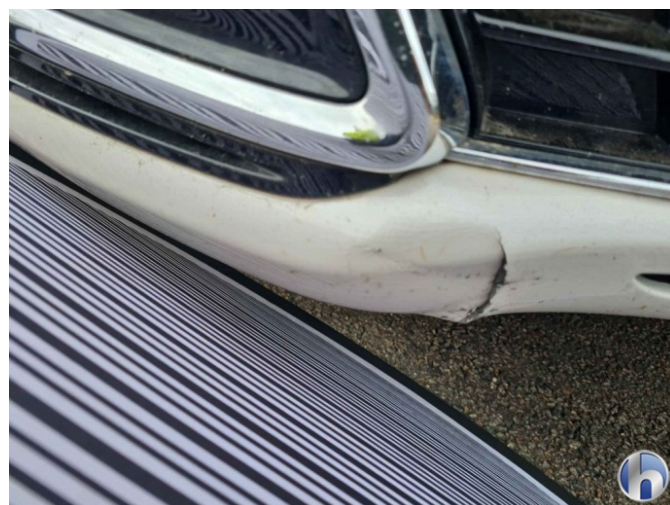
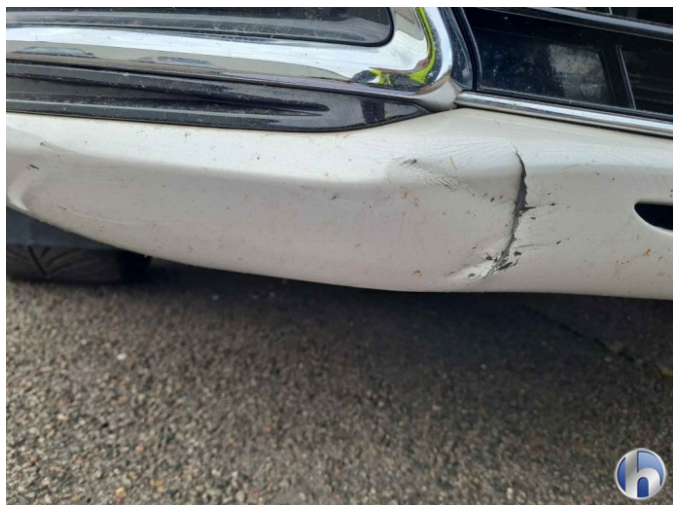
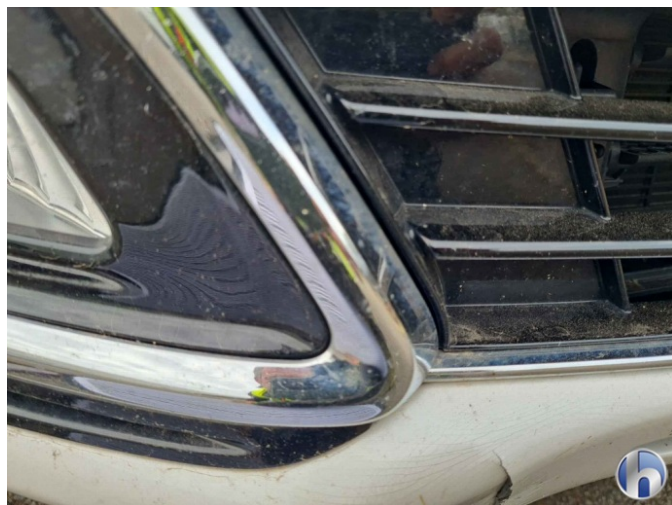
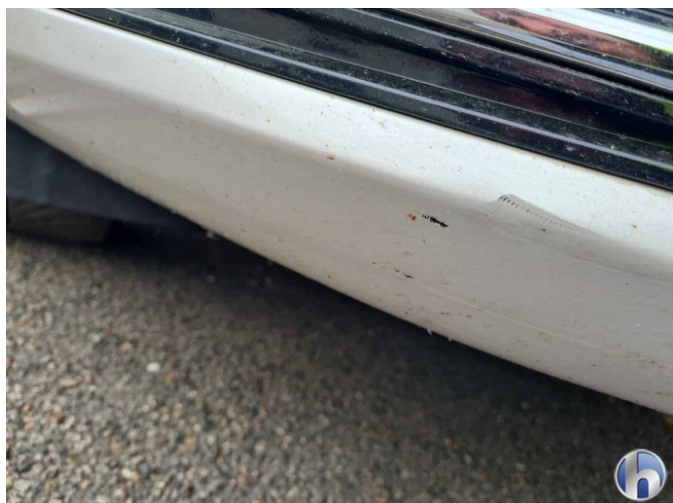
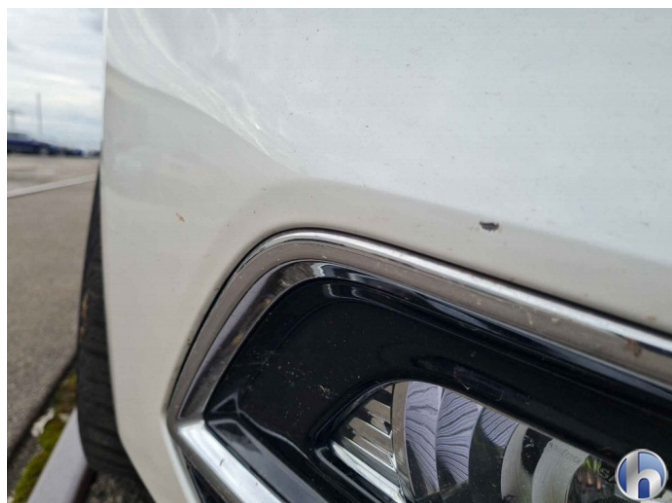
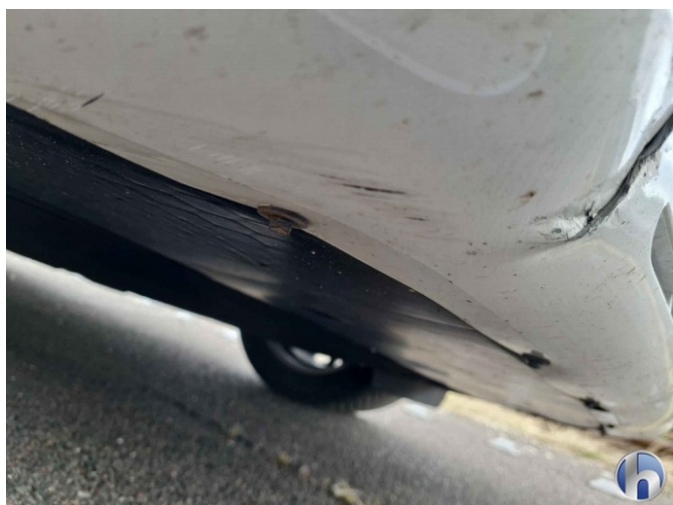
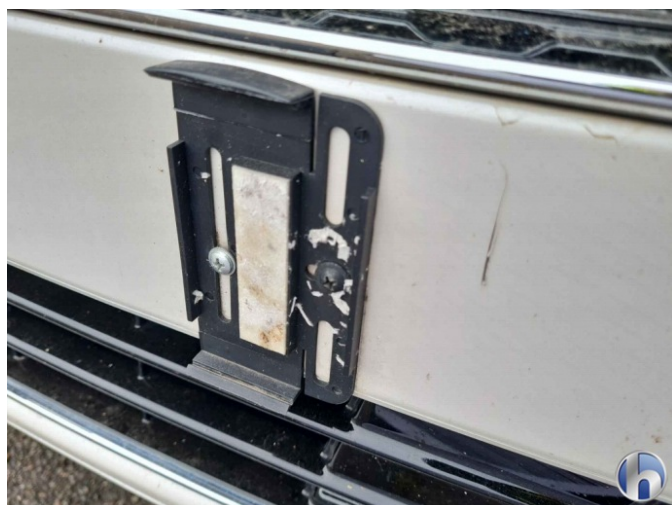
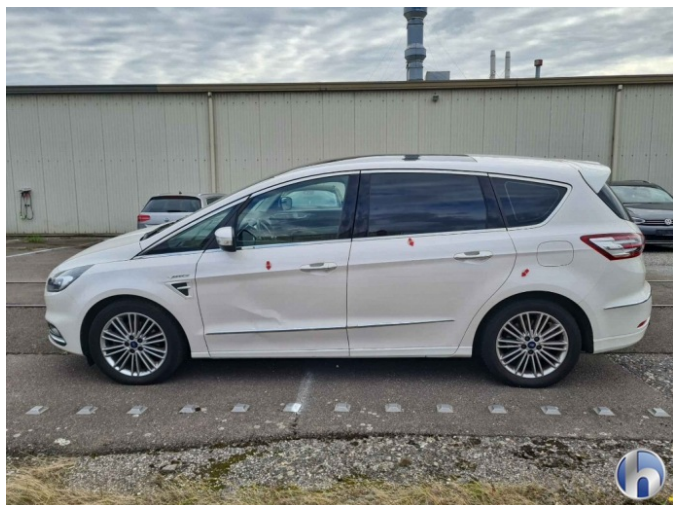
At the unrepaired vehicle accident damage were observed on visual examination on the body skin .

Fahrzeug mit bestehenden Unfallschaden, zur Schadensermittlung wurden keine Demontagearbeiten durchgeführt, verborgen gebliebene Schäden können nicht ausgeschlossen werden. Unfallschaden Kosten wurden überschlägig Kalkuliert, Kostenerweiterung möglich.

| component | Damage | Rep kind |
|---|---|---|
| 9. Fahrzeug vorn | Accident damage | Replace |

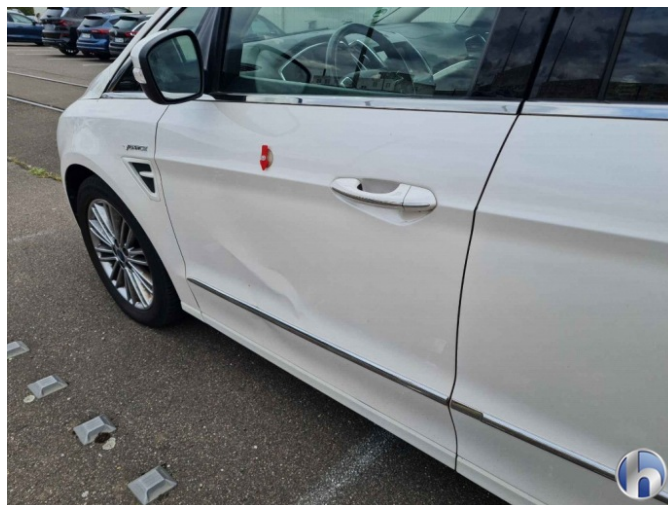
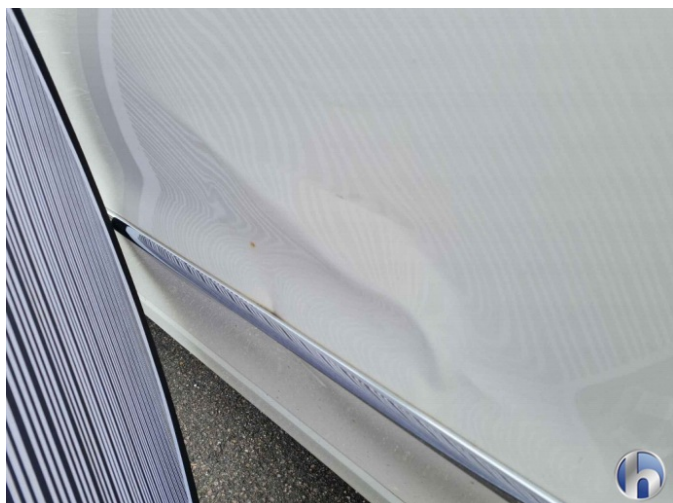
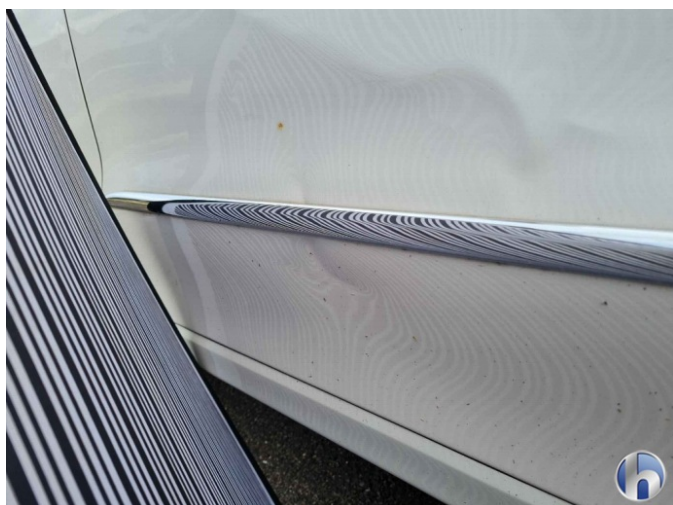
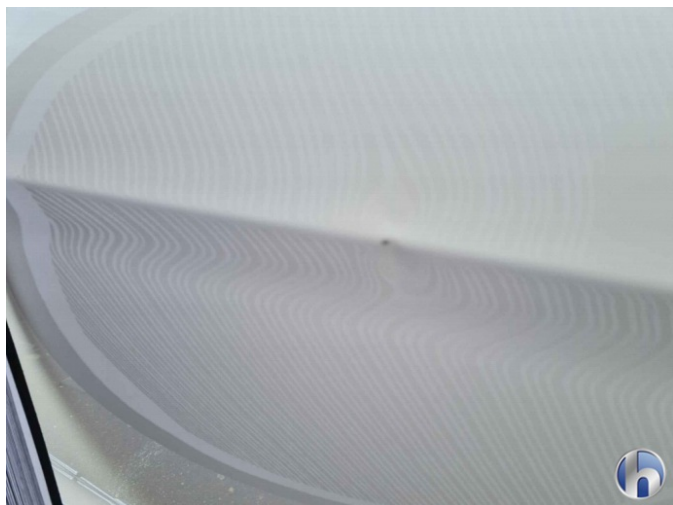
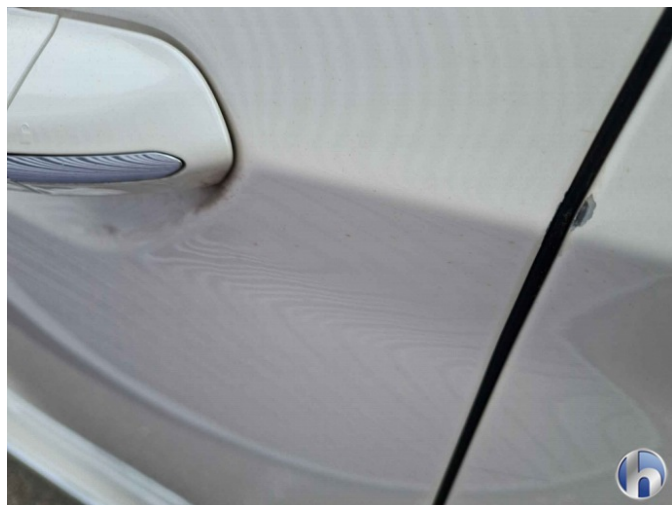
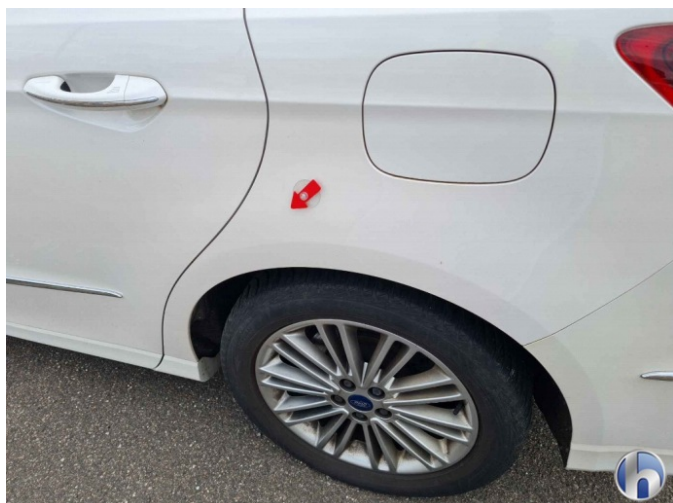
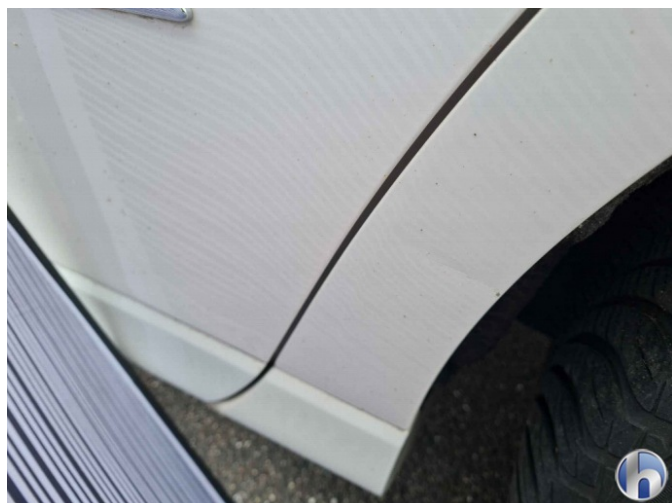
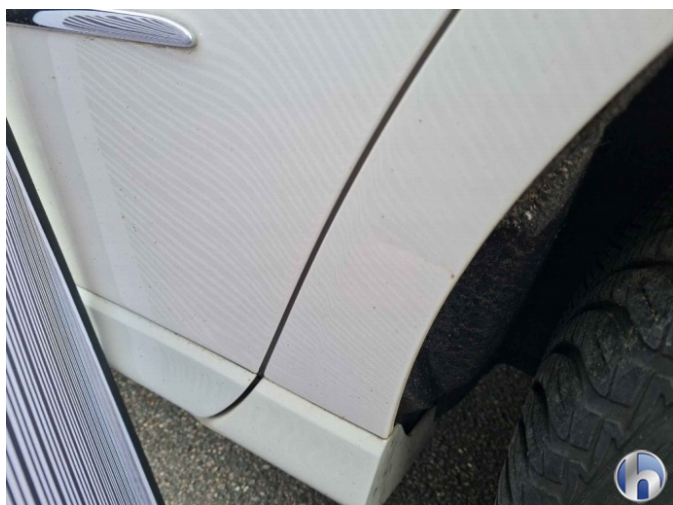
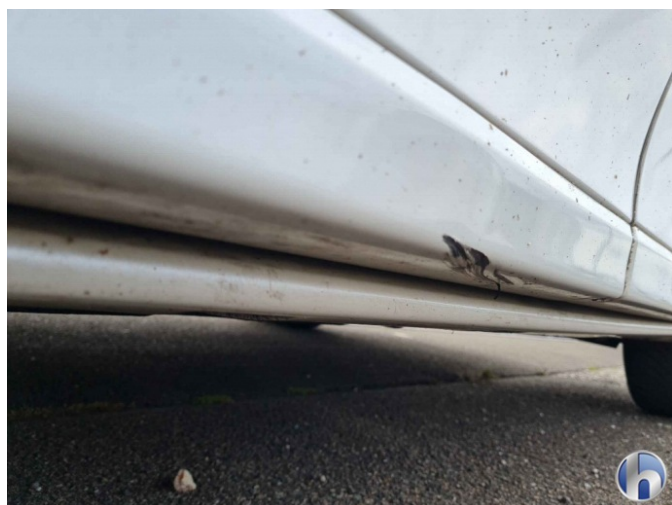
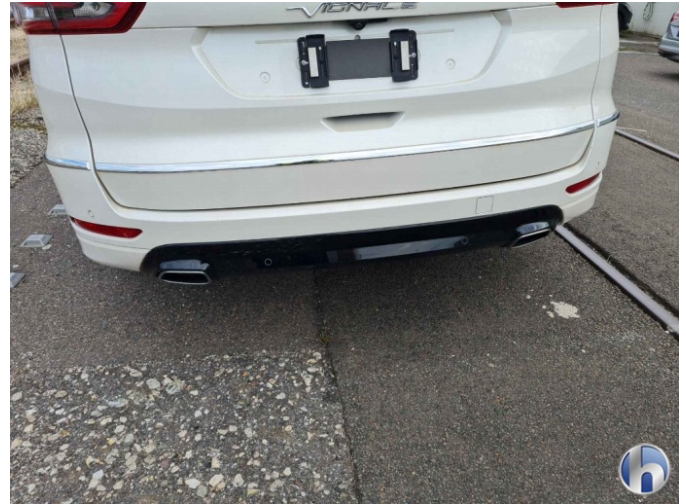
| component | Damage | Rep kind |
|---|---|---|
| 10. Fahrzeug links | Accident damage | Replace |

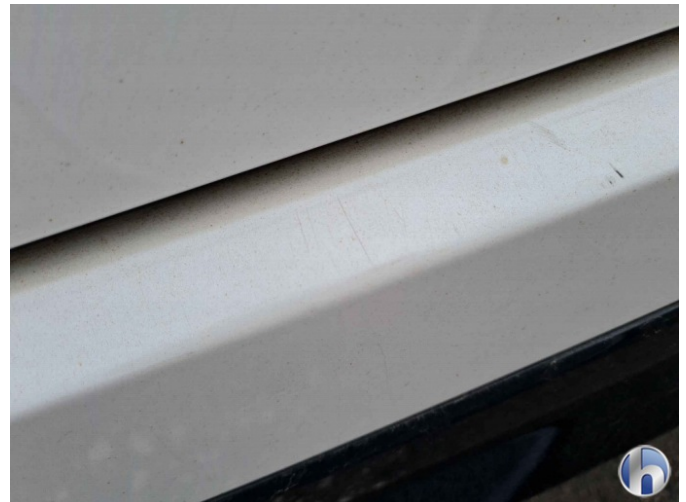
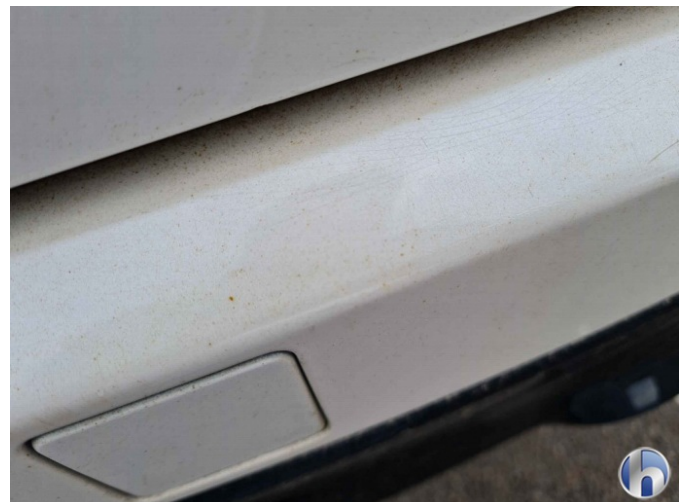
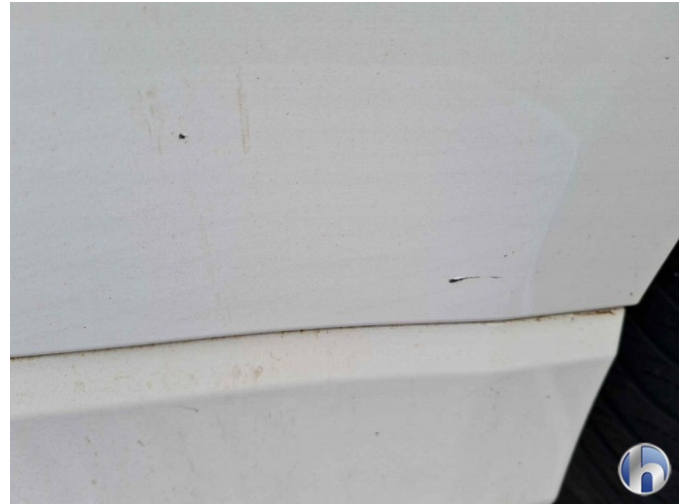
| component | Damage | Rep kind |
|---|---|---|
| 11. Rear bumper | Scrape | Refurbish and paint |

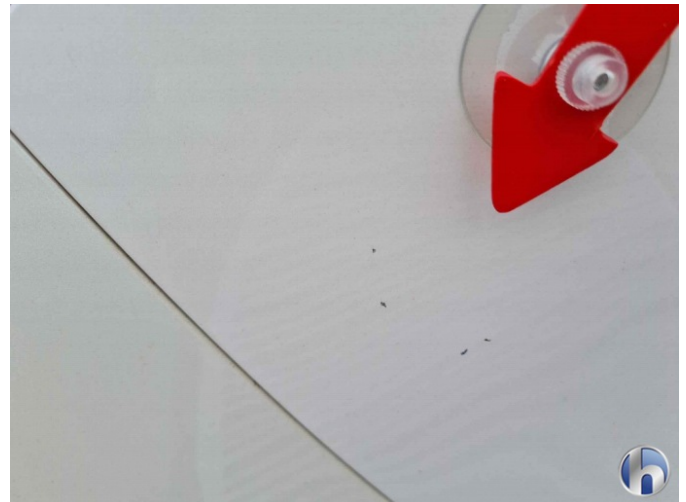
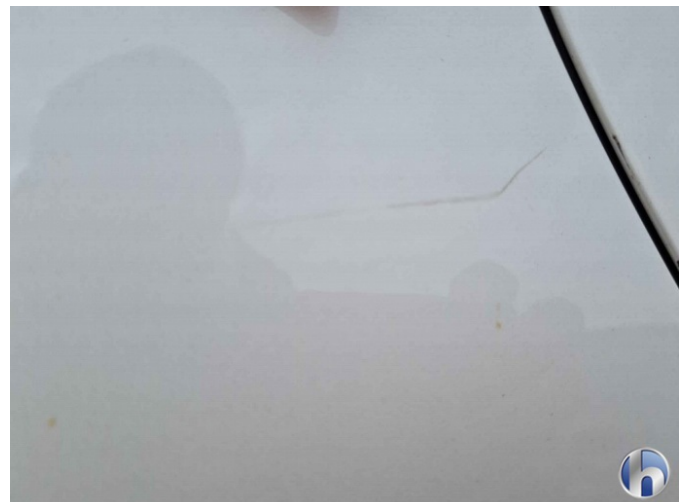
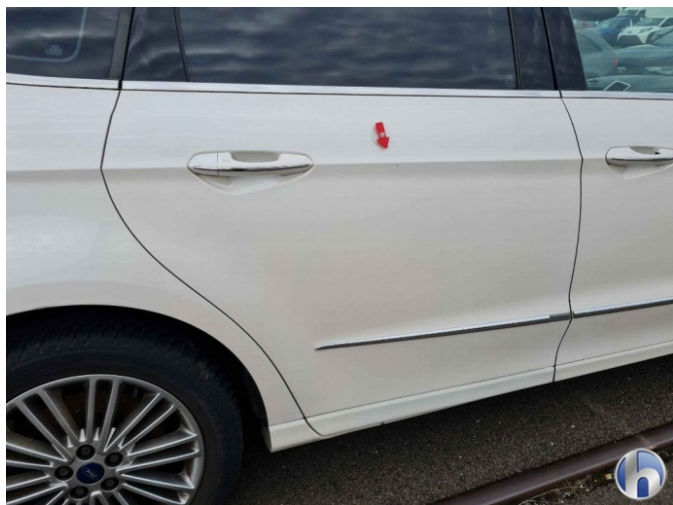
| component | Damage | Rep kind |
|---|---|---|
| 12. Sidewall - Rear - right | Scratch(es) | Paint |

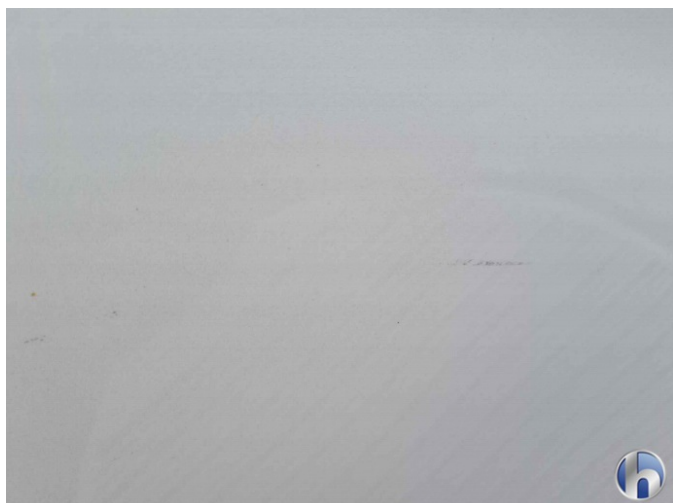
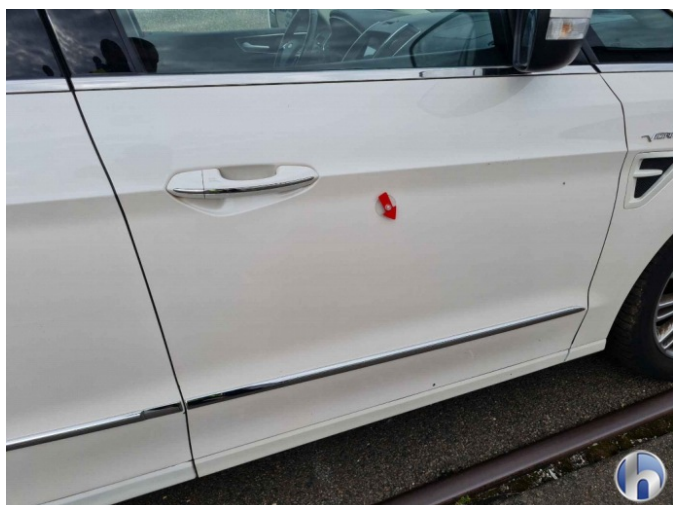
| component | Damage | Rep kind |
|---|---|---|
| 13. Door Rear - right | Scrape | Paint |

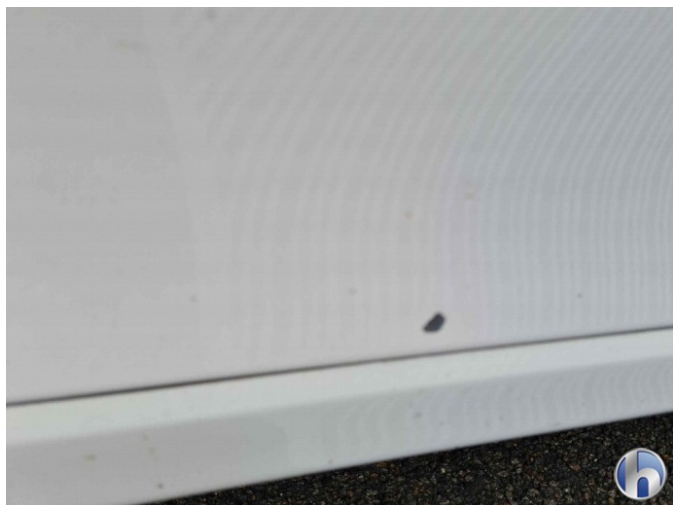
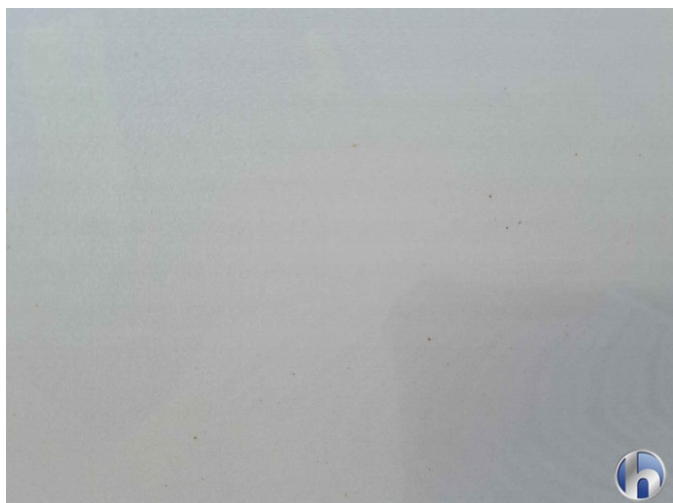
| component | Damage | Rep kind |
|---|---|---|
| 14. Front door - right | chipped paint | Paint |

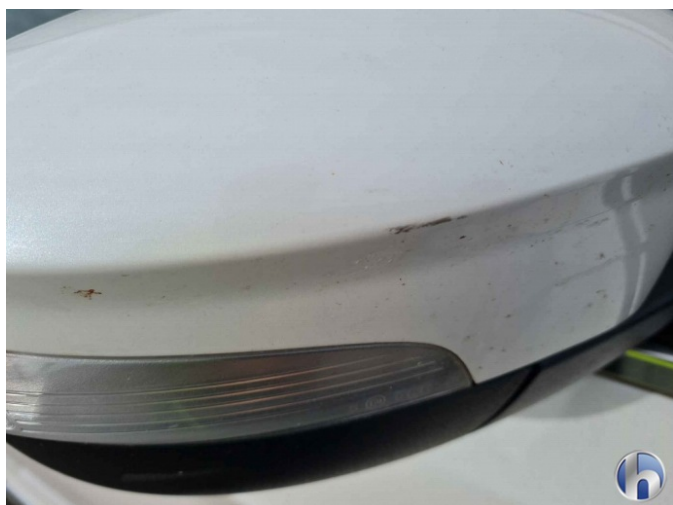
| component | Damage | Rep kind |
|---|---|---|
| 15. Outside mirror - right | Scrape | Paint |

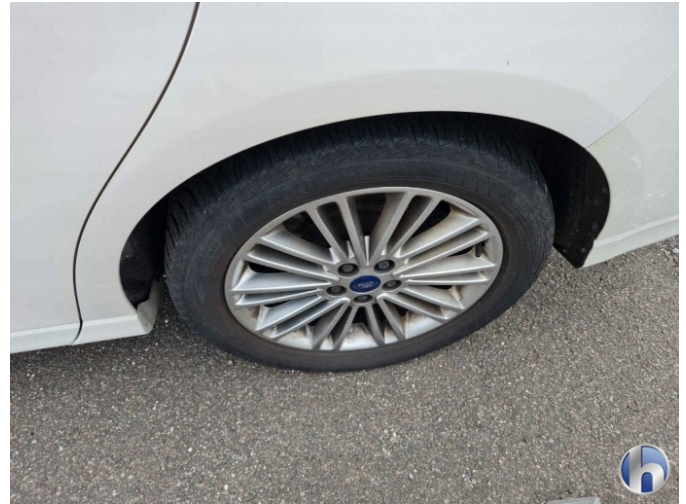
| component | Damage | Rep kind |
|---|---|---|
| 16. | Scrape | Paint |

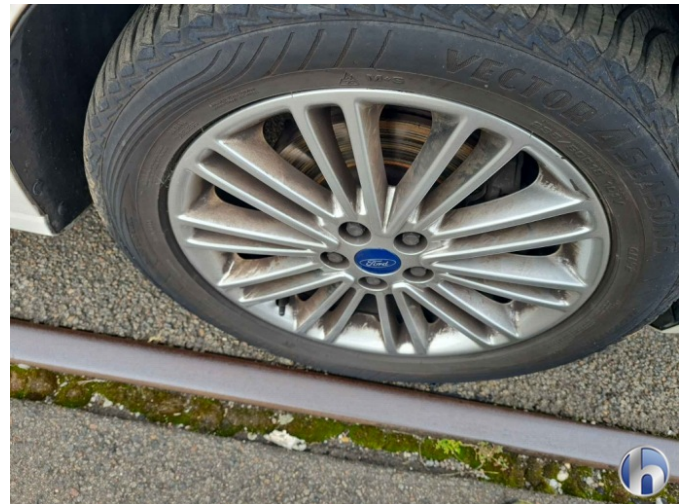
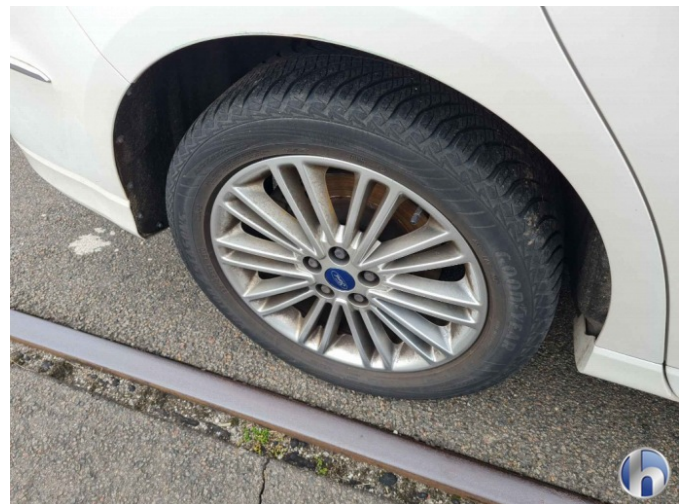
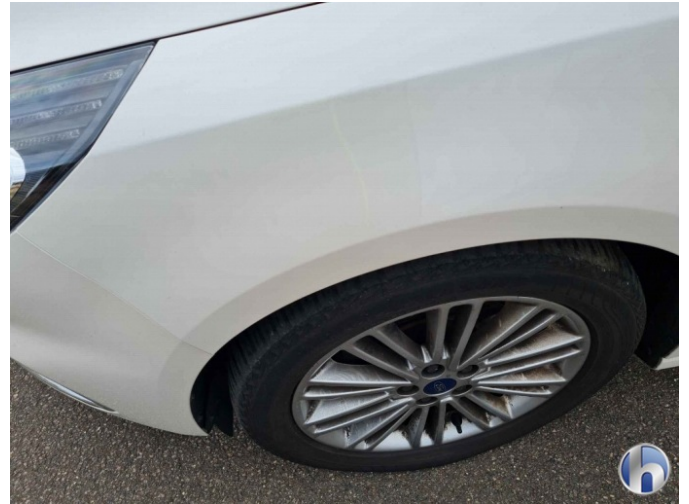
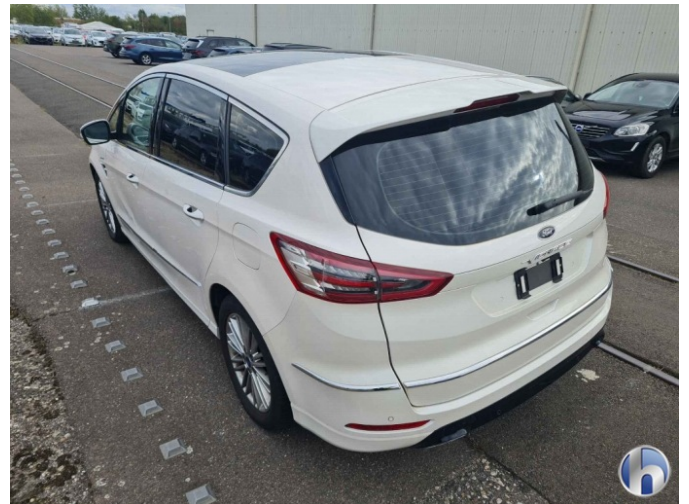
| component | Damage | Rep kind |
|---|---|---|
| 17. brake system | Not okay | Replace |

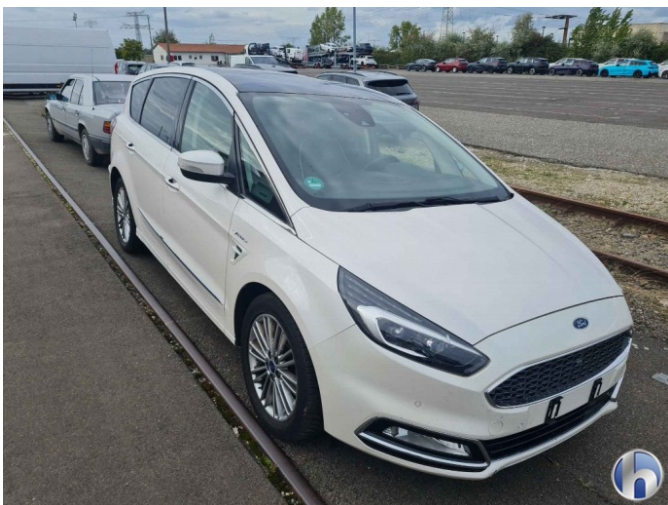
18. Fahrzeug (Kratzer, Harz-/Säureeinwirkung, Flugrost, Verschmutzungen)

| component | Damage | Rep kind |
|---|---|---|
| 18. Fahrzeug (Kratzer,<br>Harz-/Säureeinwirkung, Flugrost,<br>Verschmutzungen) | Not okay | |
