Expertise

Protocol number: 39469385
Order No. / Reference: 24690044
Inspection date: 23 Apr 2025

Manufacturer: Ford	Model: S-Max 2.0 EcoBlue Aut. TITANIUM
VIN: WF0JXXWPCJLA25908

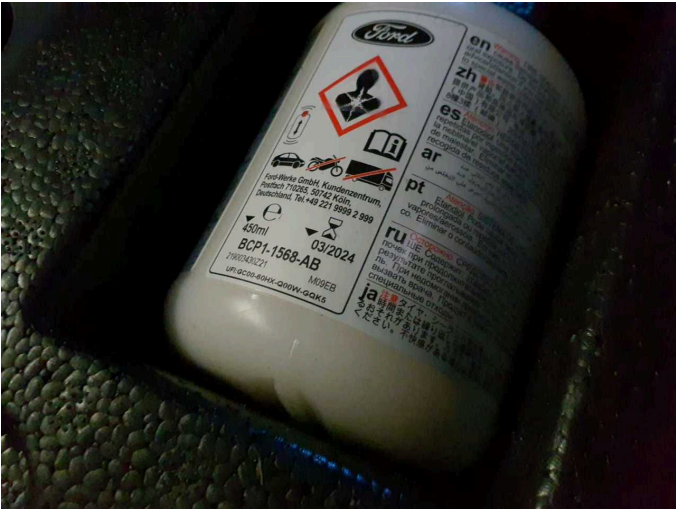
Damage 2: Equipment: Tirefit filler - Expired - Replace

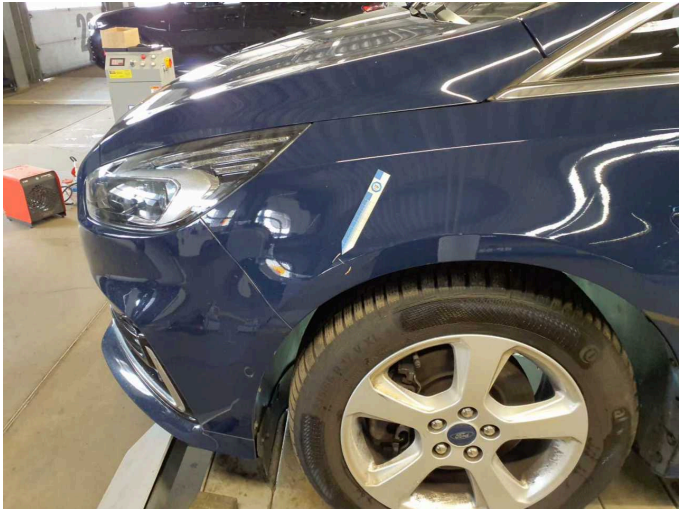
Damage 3: Mudguard - left side: Mudguard - left side - Scratch(es) - Smart repair

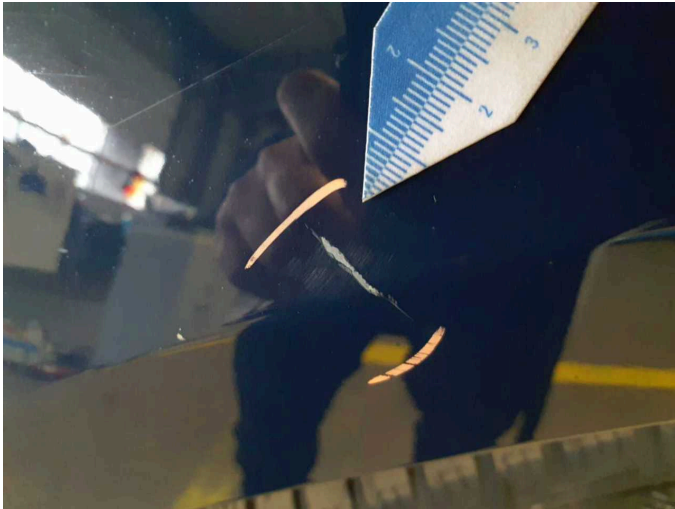
Damage 3: Mudguard - left side: Mudguard - left side - Scratch(es) - Smart repair

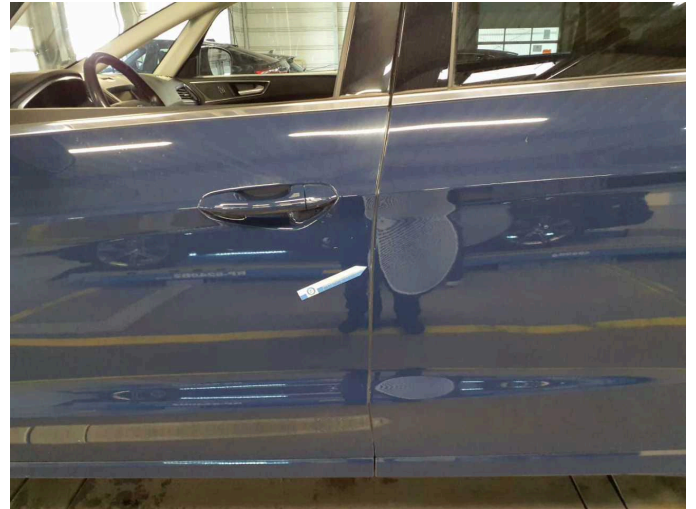
Damage 4: Door - front left side: Door edge - Scratch(es) - Smart repair

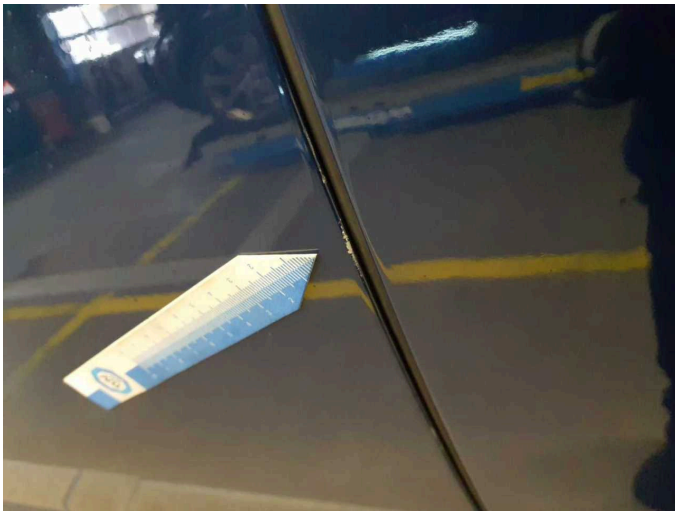
Damage 4: Door - front left side: Door edge - Scratch(es) - Smart repair

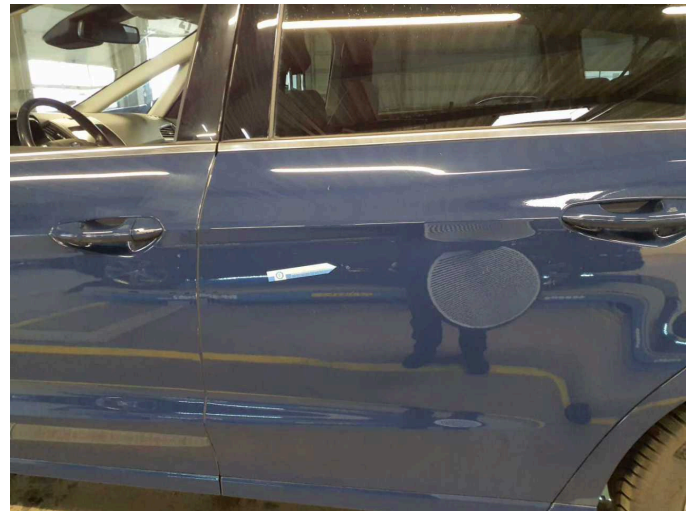
Damage 6: Door - rear left side: Door - Scratch(es) - Paint

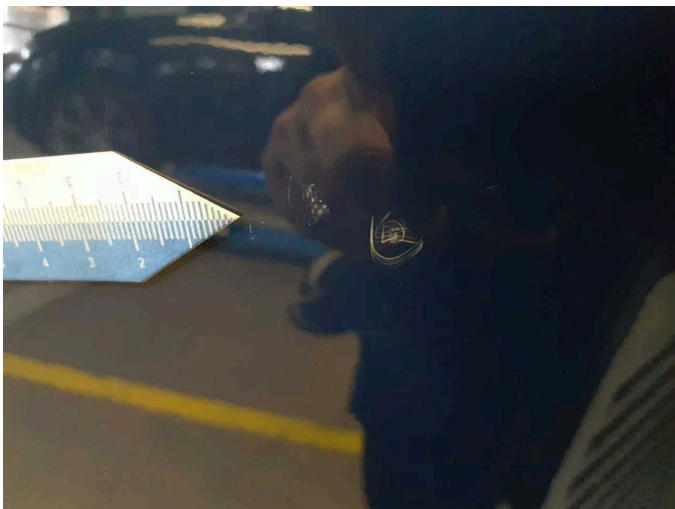
Damage 6: Door - rear left side: Door - Scratch(es) - Paint

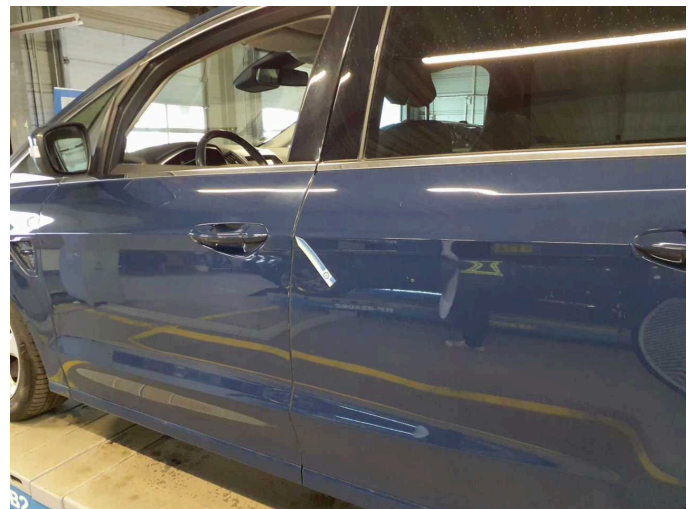
Damage 6: Door - rear left side: Door - Scratch(es) - Paint

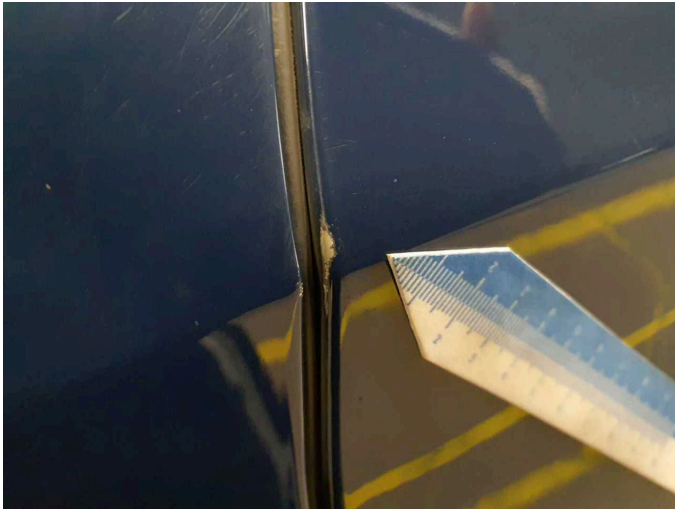
Damage 6: Door - rear left side: Door - Scratch(es) - Paint

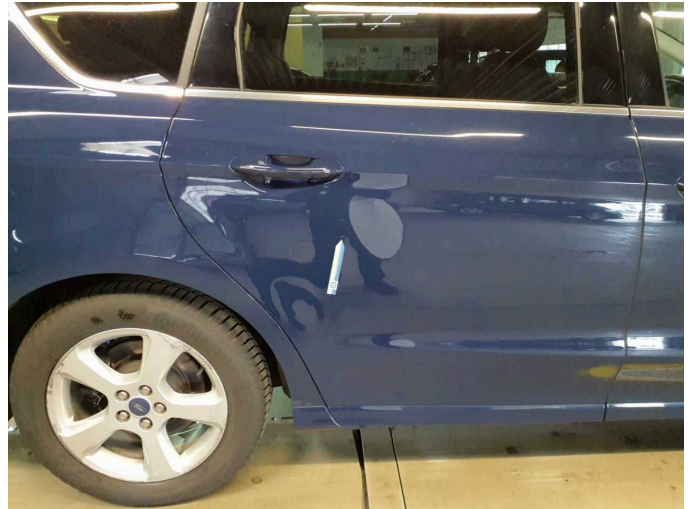
Damage 7: Door - rear right side: Door - Dent / paintcoat damage - Repair and paint

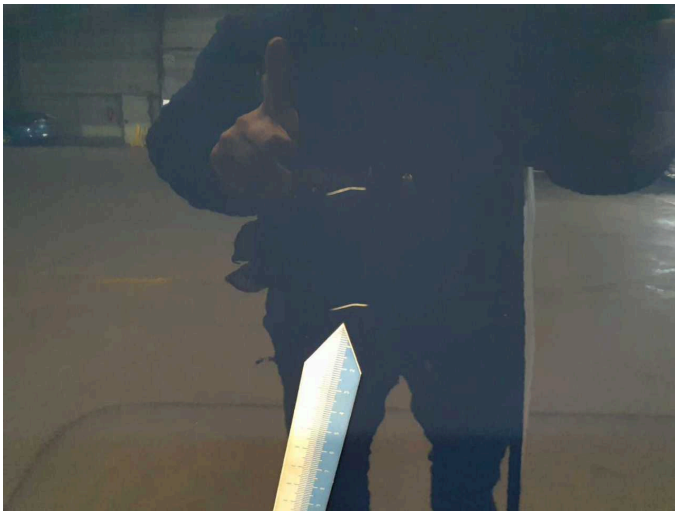
Damage 7: Door - rear right side: Door - Dent / paintcoat damage - Repair and paint

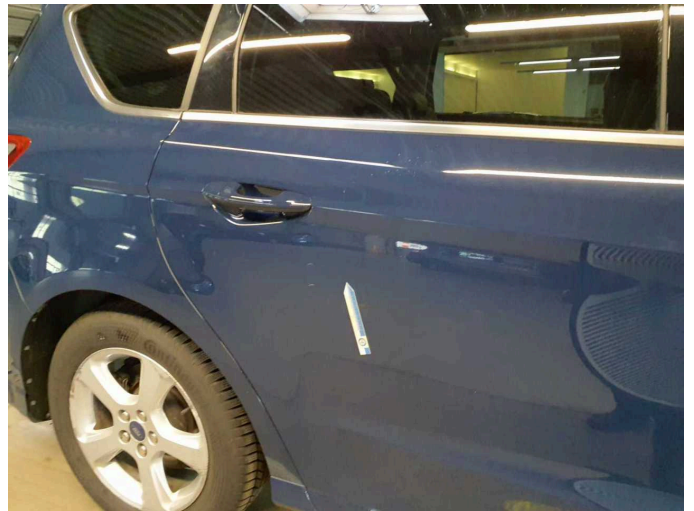
Damage 7: Door - rear right side: Door - Dent / paintcoat damage - Repair and paint

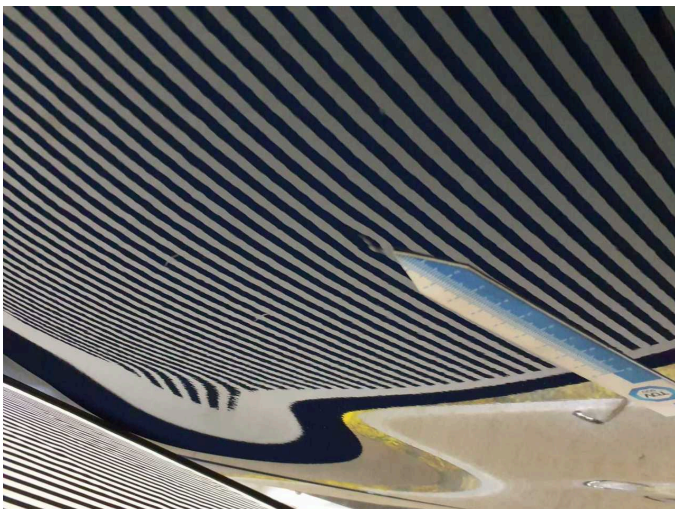
Damage 7: Door - rear right side: Door - Dent / paintcoat damage - Repair and paint

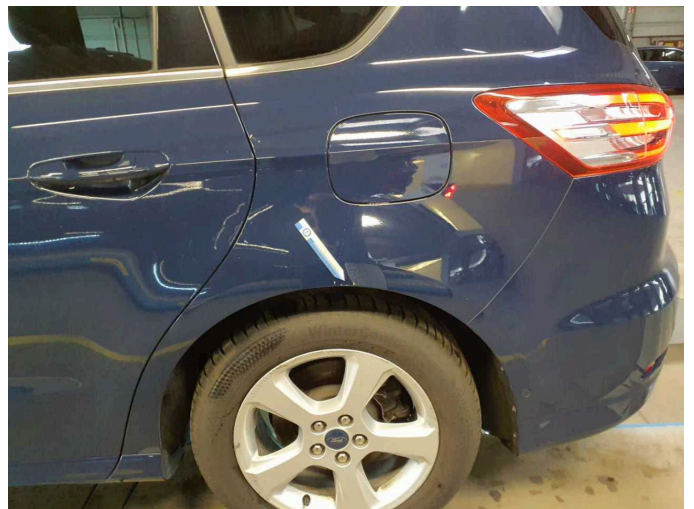
Damage 8: Side panel - rear left side: Side panel - Dent / paintcoat damage - Repair and paint

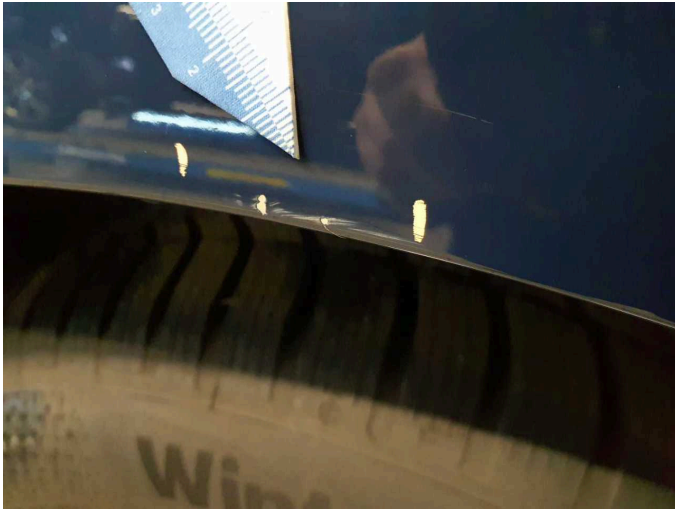
Damage 8: Side panel - rear left side: Side panel - Dent / paintcoat damage - Repair and paint

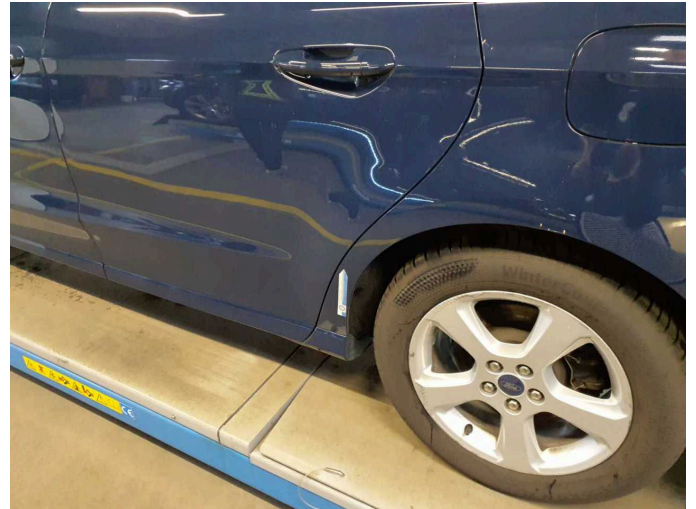
Damage 8: Side panel - rear left side: Side panel - Dent / paintcoat damage - Repair and paint

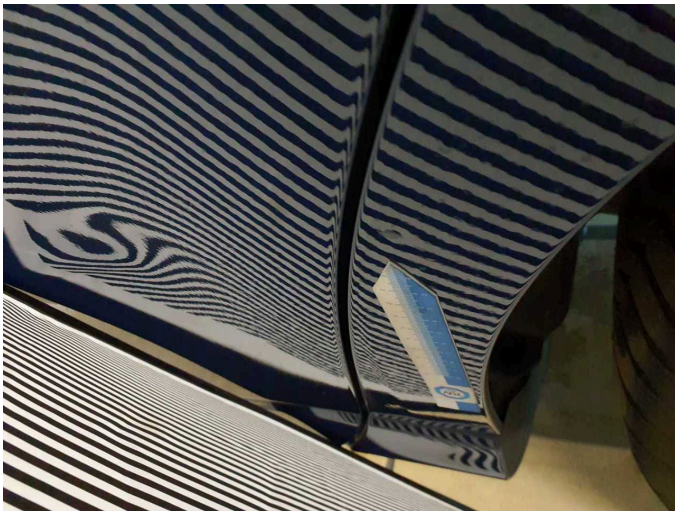
Damage 8: Side panel - rear left side: Side panel - Dent / paintcoat damage - Repair and paint

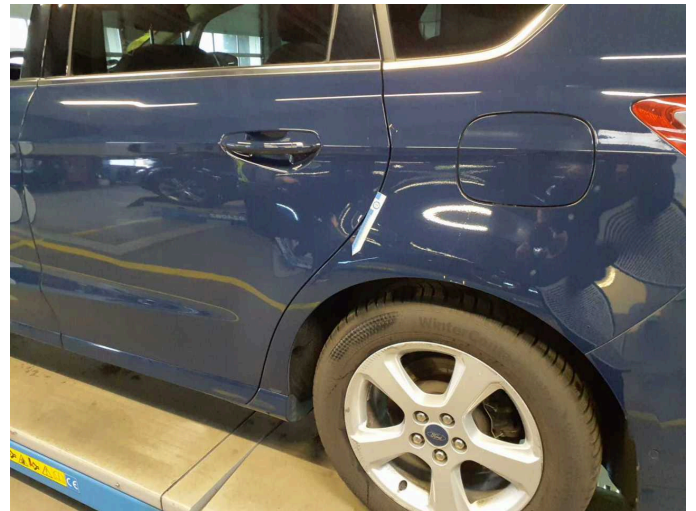
Damage 8: Side panel - rear left side: Side panel - Dent / paintcoat damage - Repair and paint

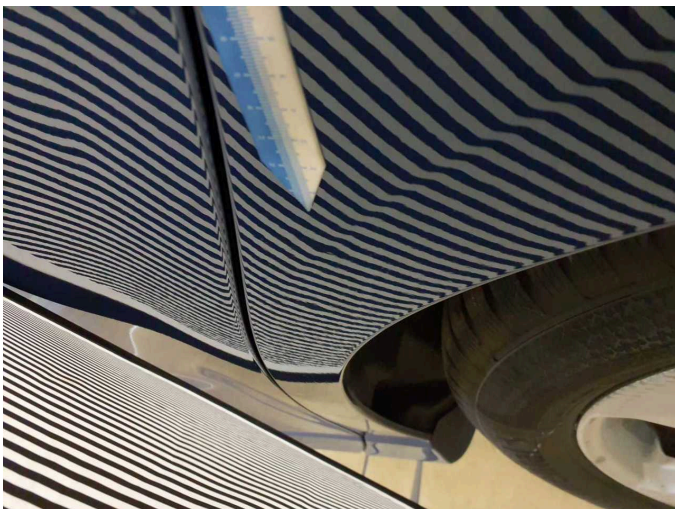
Damage 8: Side panel - rear left side: Side panel - Dent / paintcoat damage - Repair and paint

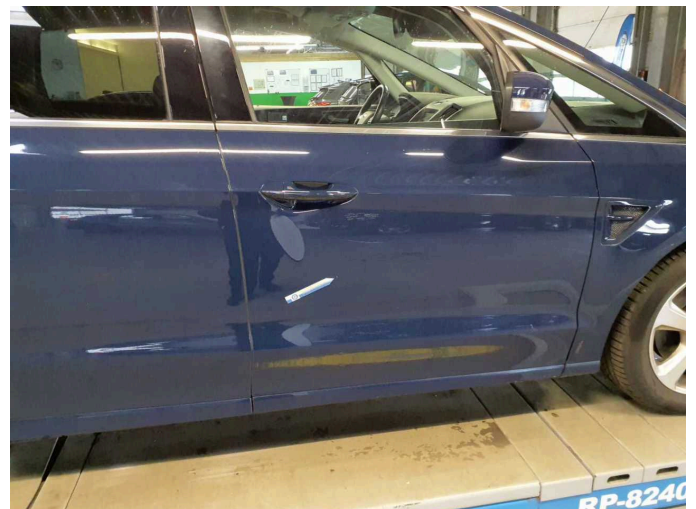
Damage 9: Door - front right side: Door - Scratch(es) - Paint

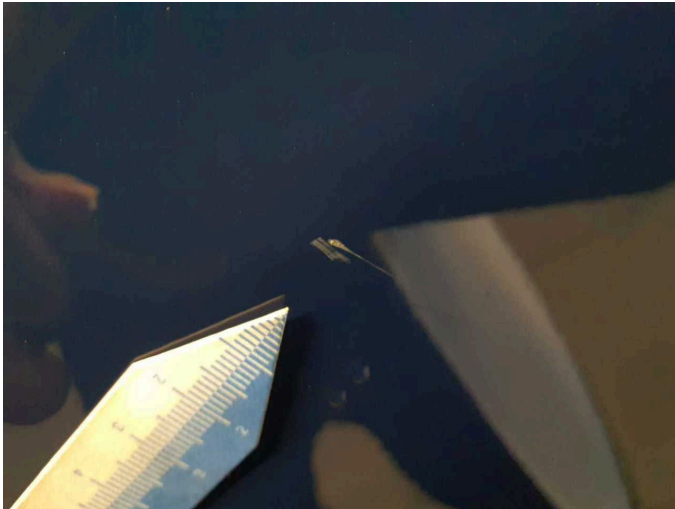
Damage 9: Door - front right side: Door - Scratch(es) - Paint

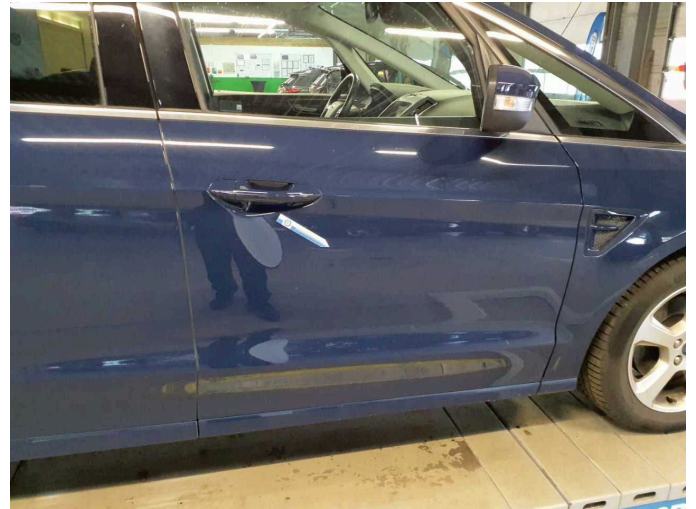
Damage 9: Door - front right side: Door - Scratch(es) - Paint

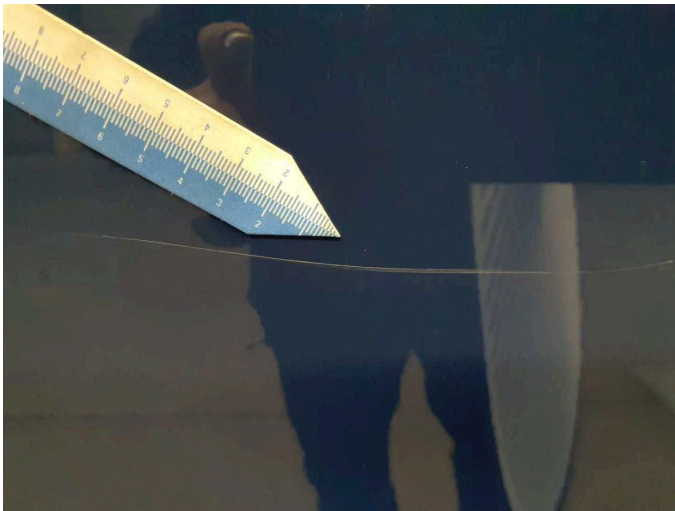
Damage 9: Door - front right side: Door - Scratch(es) - Paint

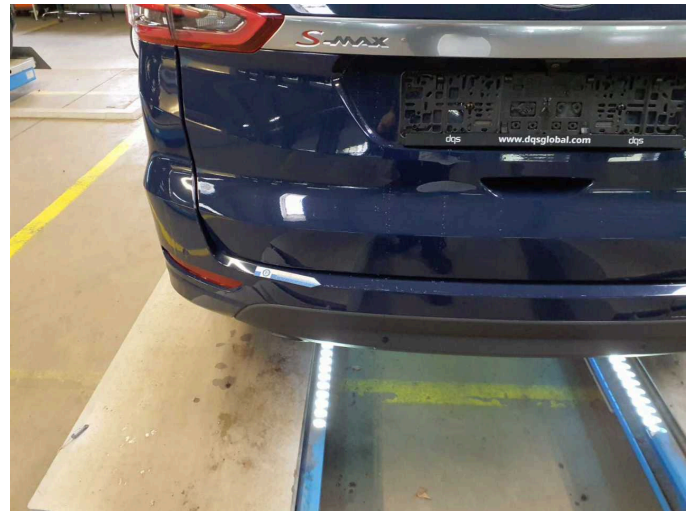
Damage 10: Rear bumper: Rear bumper - Scratched - Paint

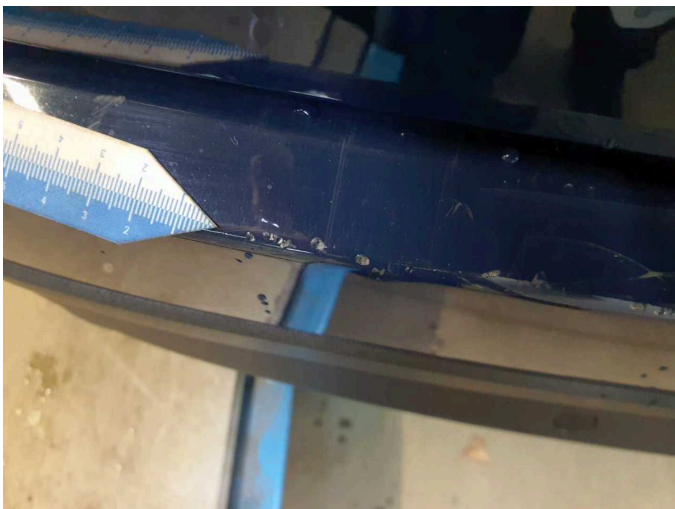
Damage 10: Rear bumper: Rear bumper - Scratched - Paint

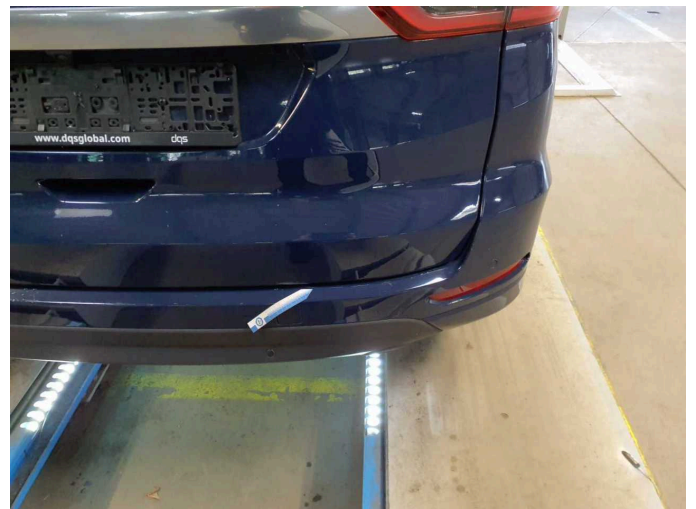
Damage 10: Rear bumper: Rear bumper - Scratched - Paint

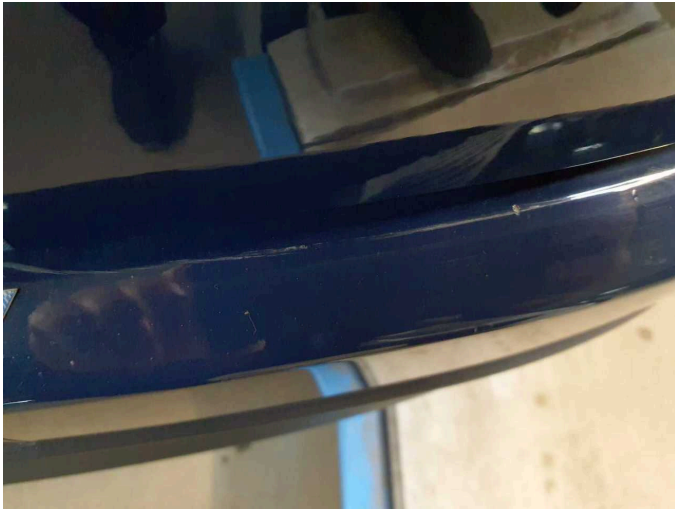
Damage 10: Rear bumper: Rear bumper - Scratched - Paint

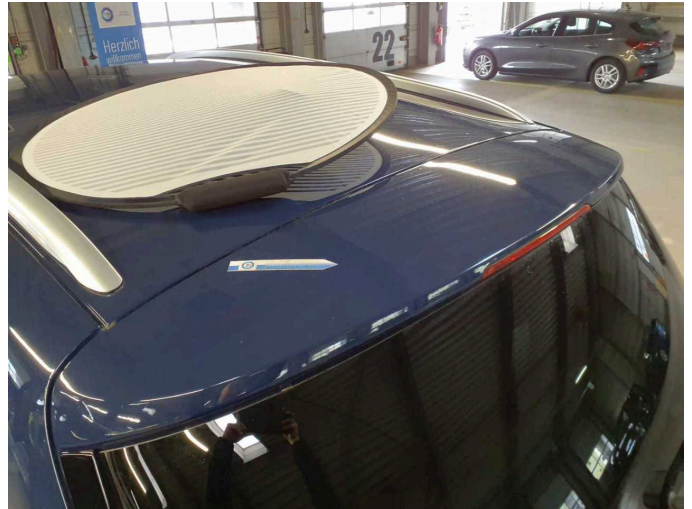
Damage 11: Boot lid / rear door: Rear spoiler - Deformed - Repair and paint

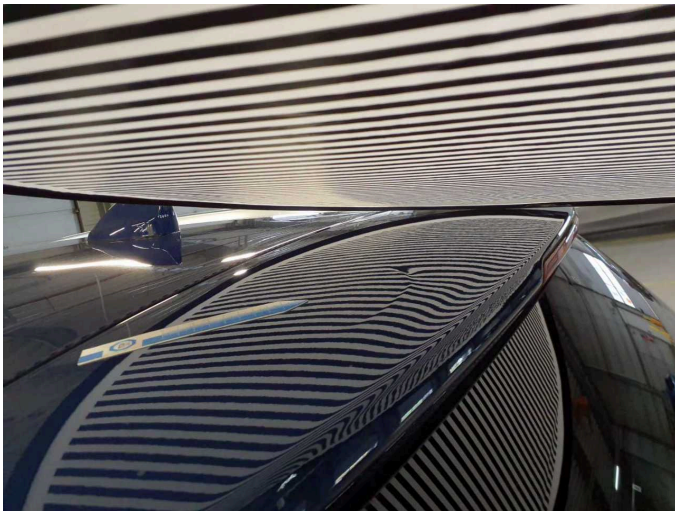
Damage 11: Boot lid / rear door: Rear spoiler - Deformed - Repair and paint

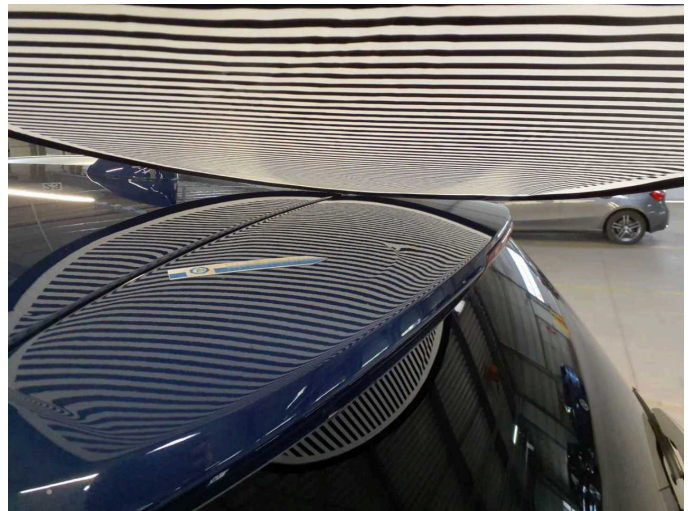
Damage 11: Boot lid / rear door: Rear spoiler - Deformed - Repair and paint
