Expertise

Protocol number: 41440583
Order No. / Reference: 25137291-1
Inspection date: 5 Sept 2025

Manufacturer: Ford	Model: S-Max 2.0 EcoBlue Aut. TITANIUM
VIN: WF0JXXWPCJLY81489

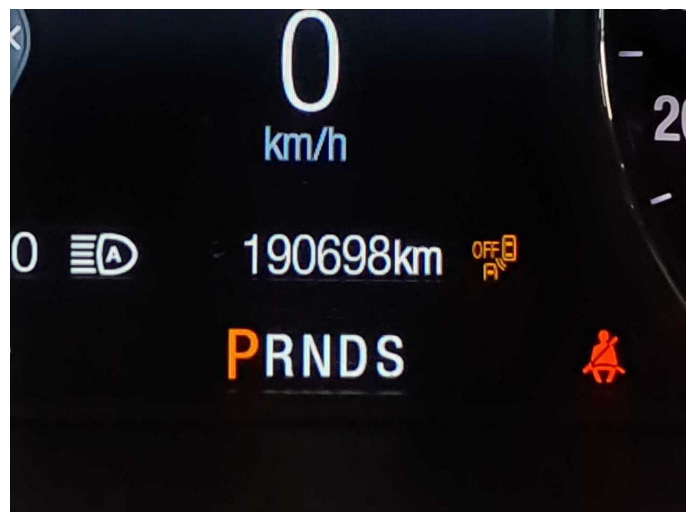
Damage 1: Misc.: Inspection / maintenance - No evidence - No deduction

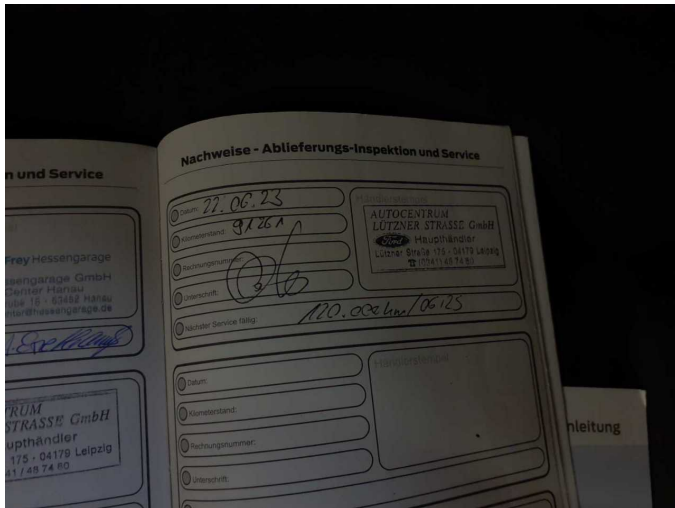
Damage 1: Misc.: Inspection / maintenance - No evidence - No deduction

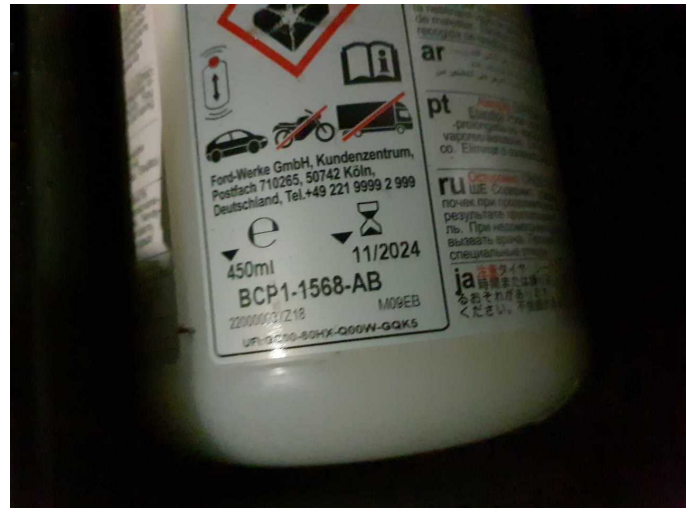
Damage 3: Equipment: Tirefit filler - Expired - Replace

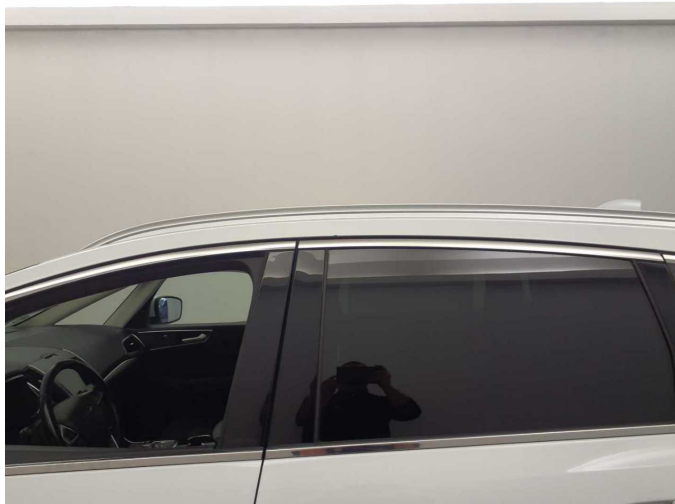
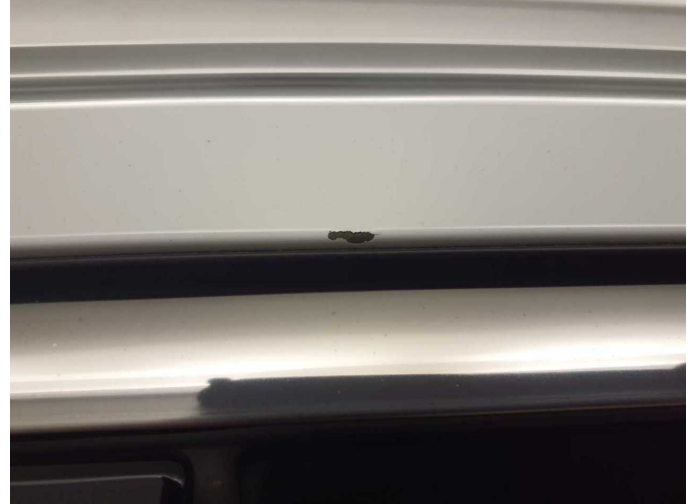
Damage 4: Roof: Roof rail - left side - Scratch(es) - Smart repair

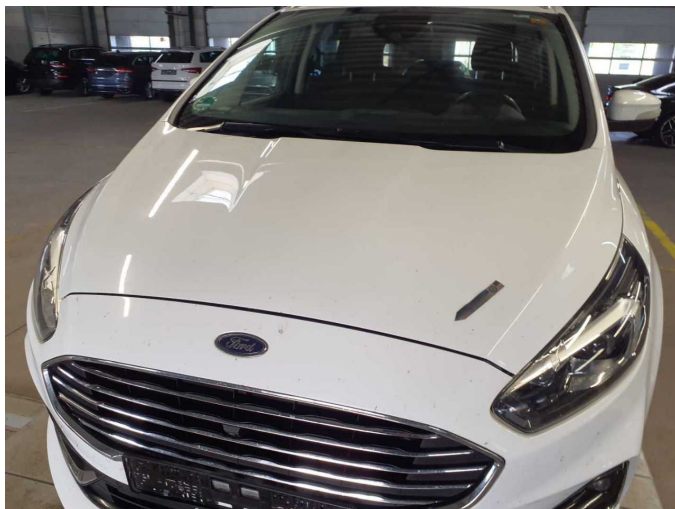
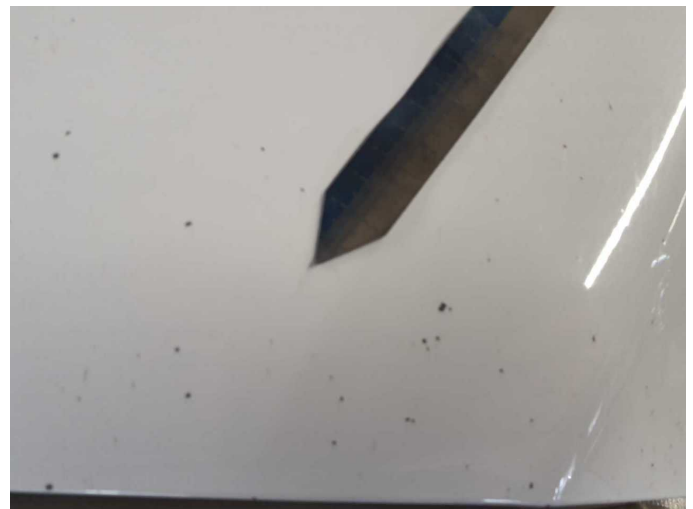
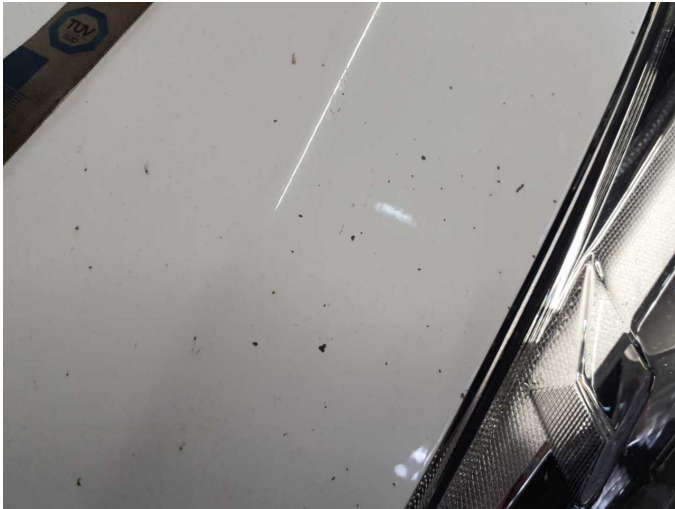
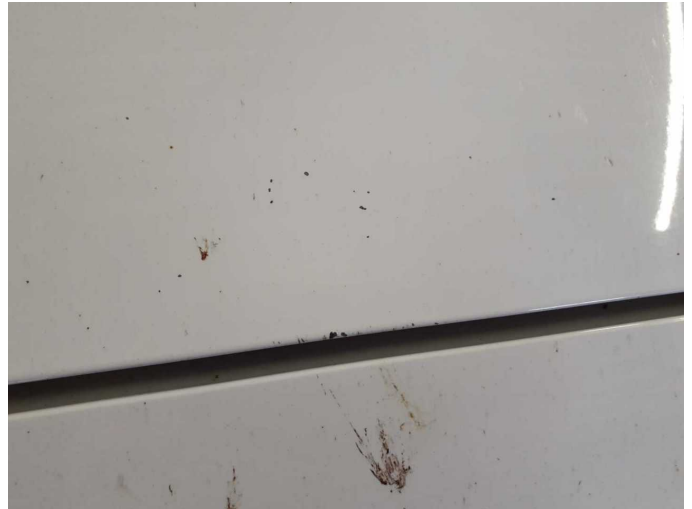
Damage 5: Bonnet: Bonnet - Stone chips - Paint

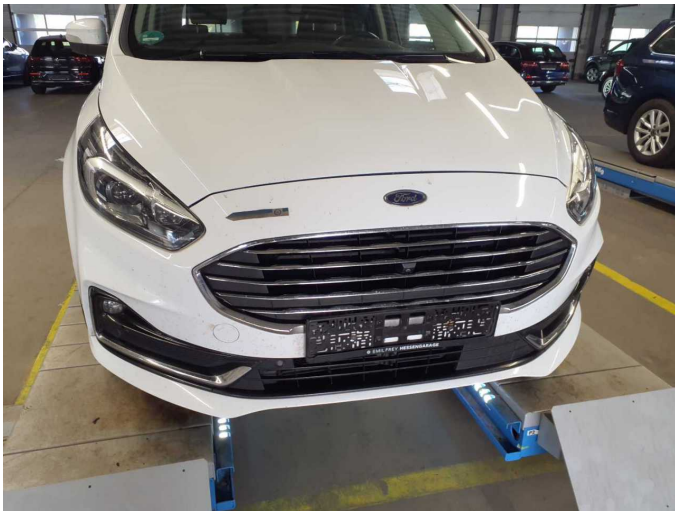
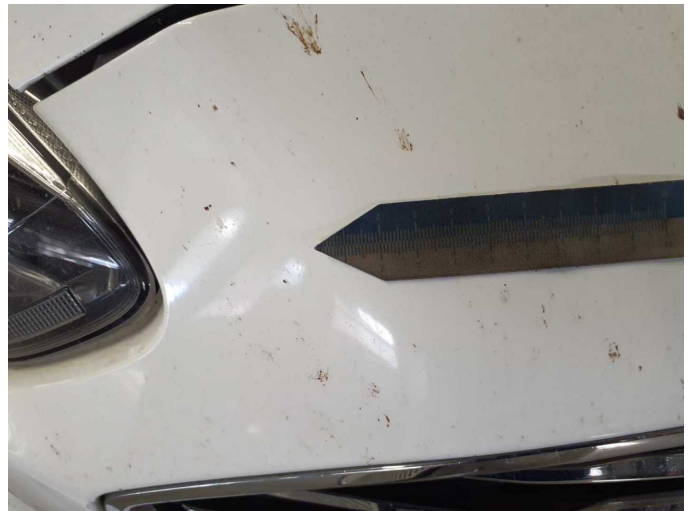
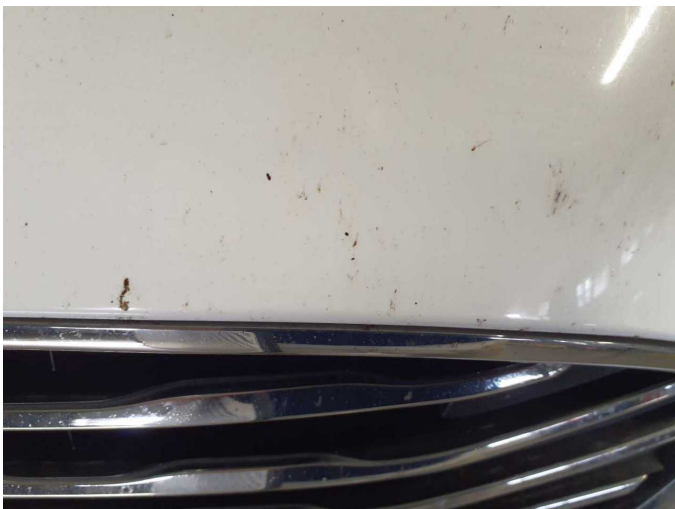
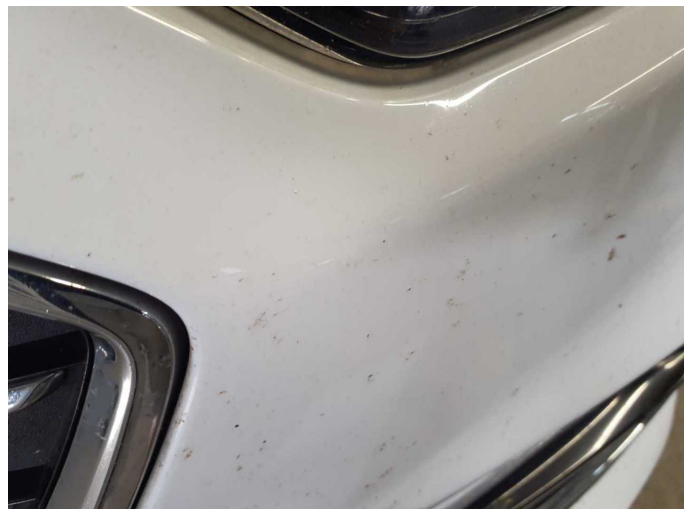
Damage 6: Front bumper: Front bumper - Stone chips - Paint

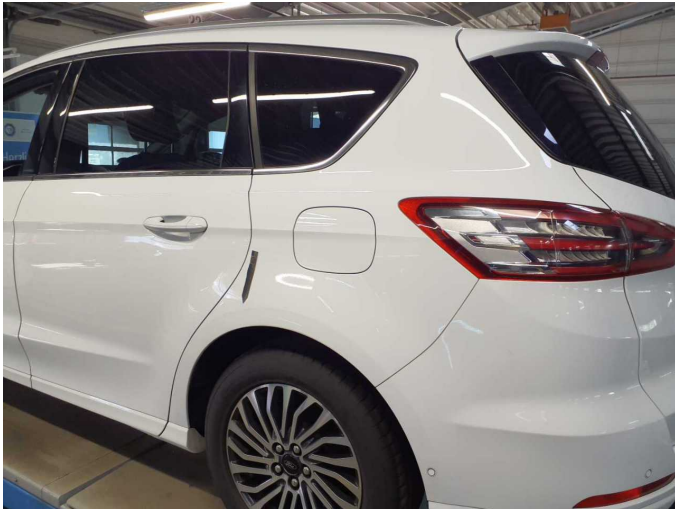
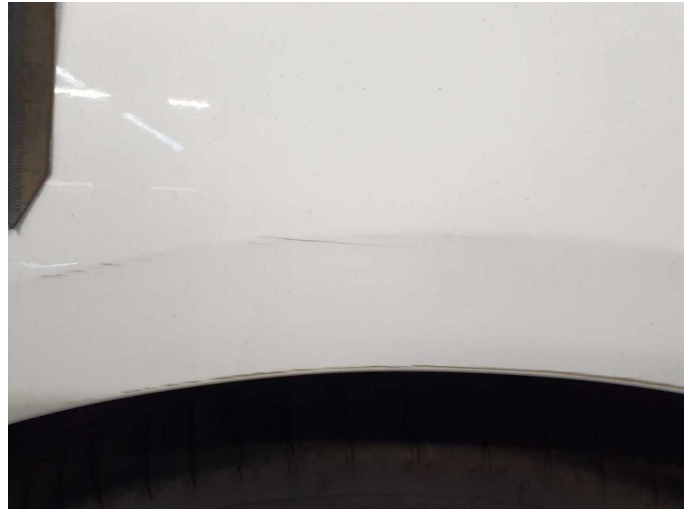
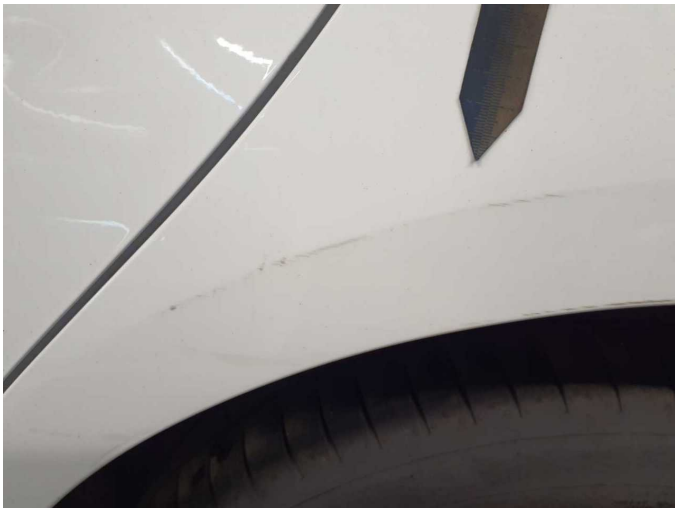
Damage 7: Side panel - rear left side: Side panel - Scratched - Paint

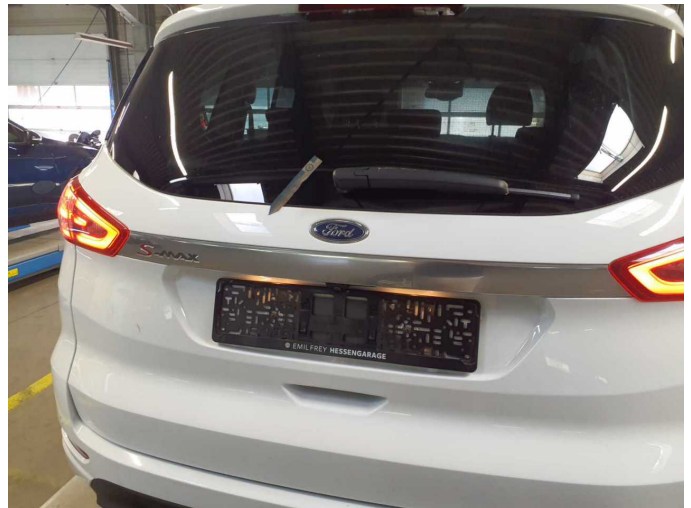
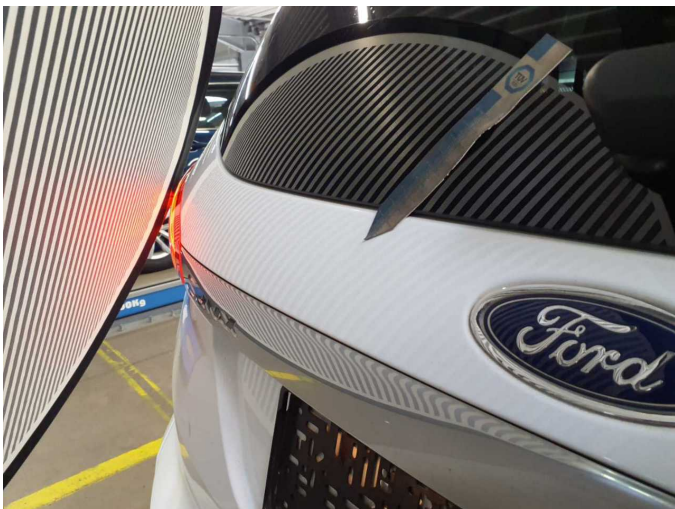
Wear and tear 2: Boot lid / rear door: Boot lid - dent(s) - Smooth repair work

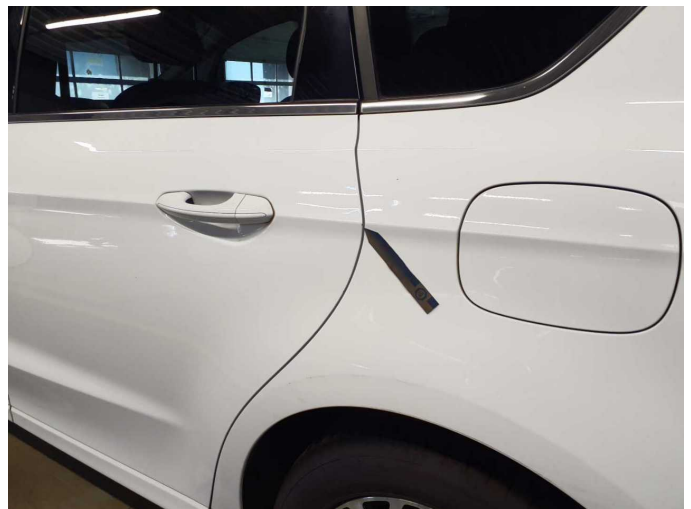
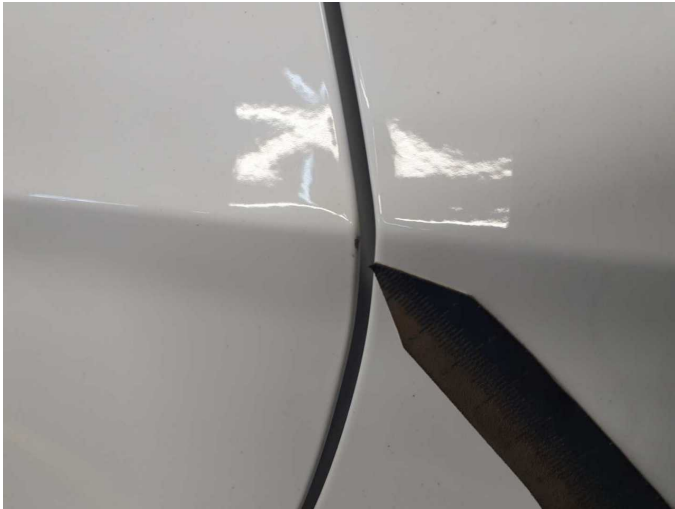
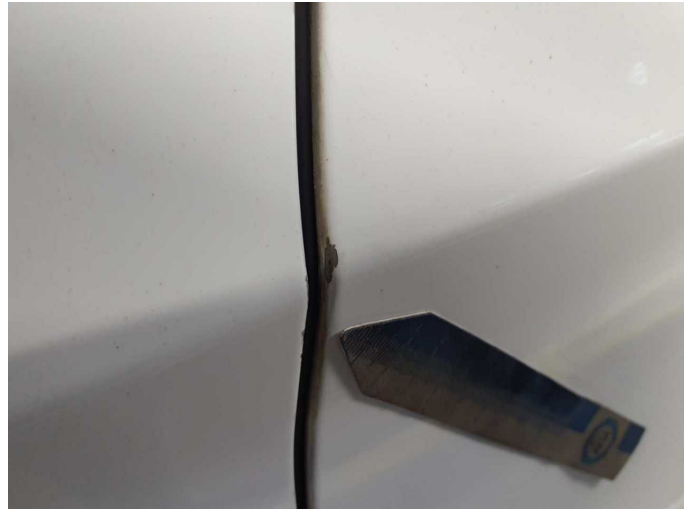
Wear and tear 3: Door - rear left side: Door edge - Scratch(es) - Smart repair

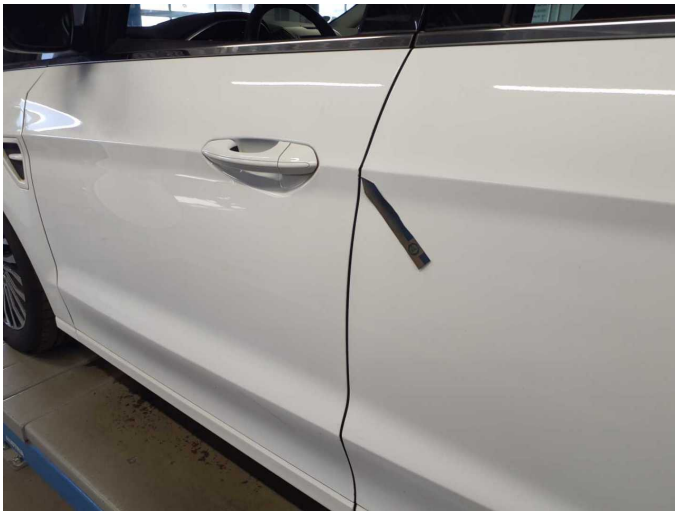
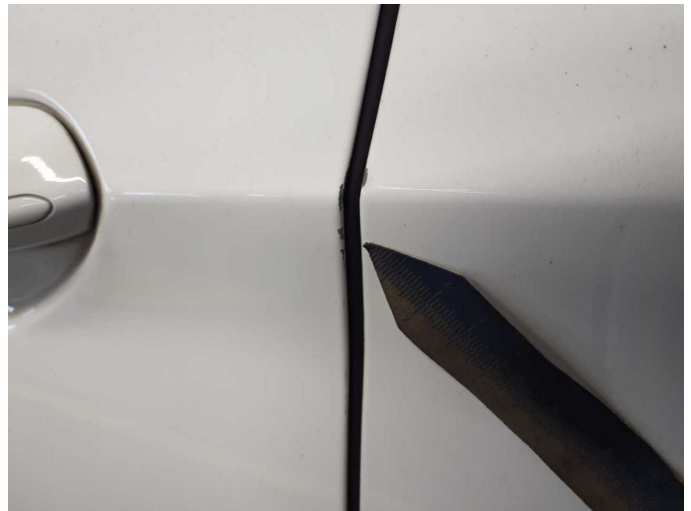
Wear and tear 4: Door - front left side: Door edge - Scratch(es) - Smart repair

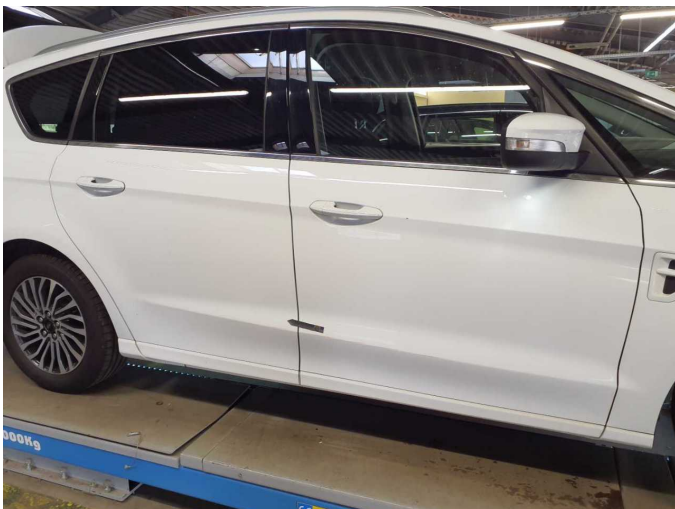
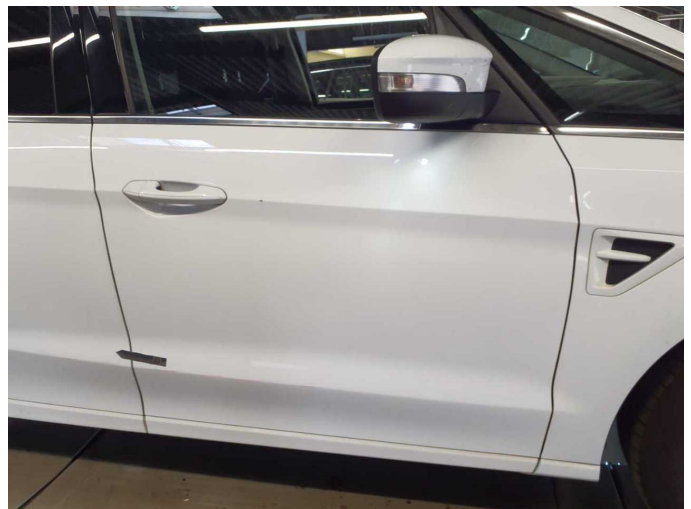
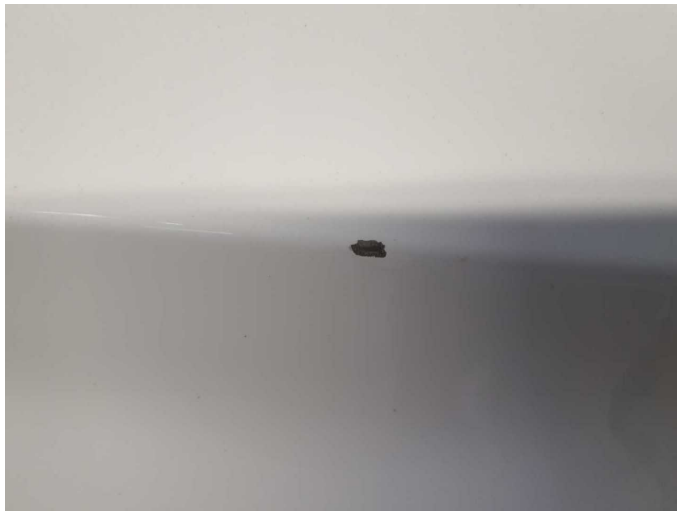
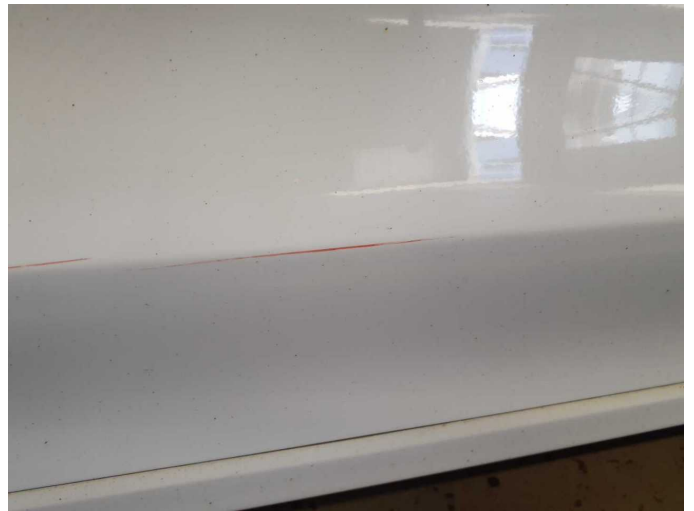
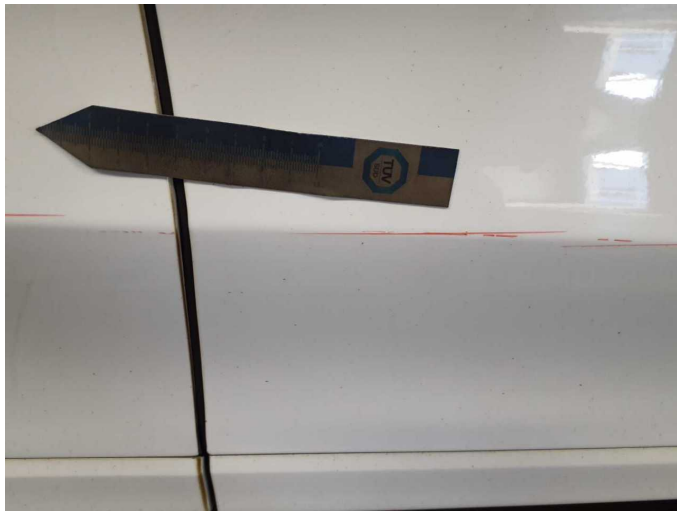
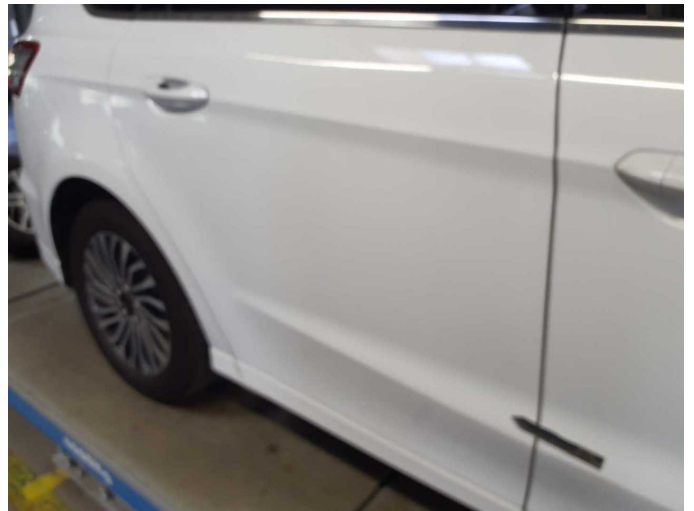
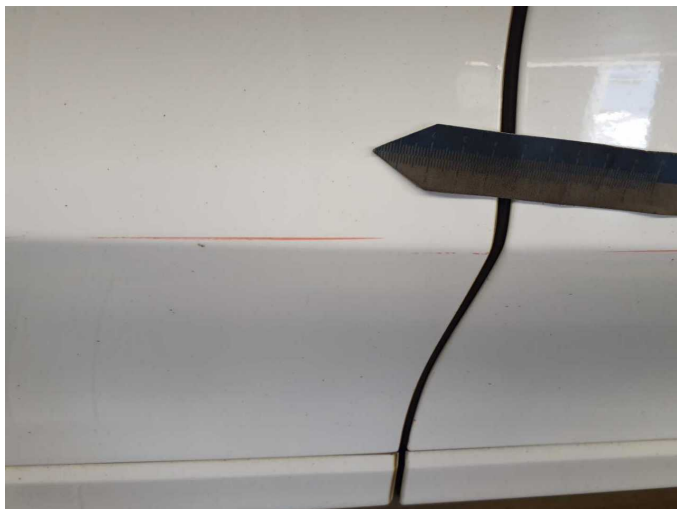
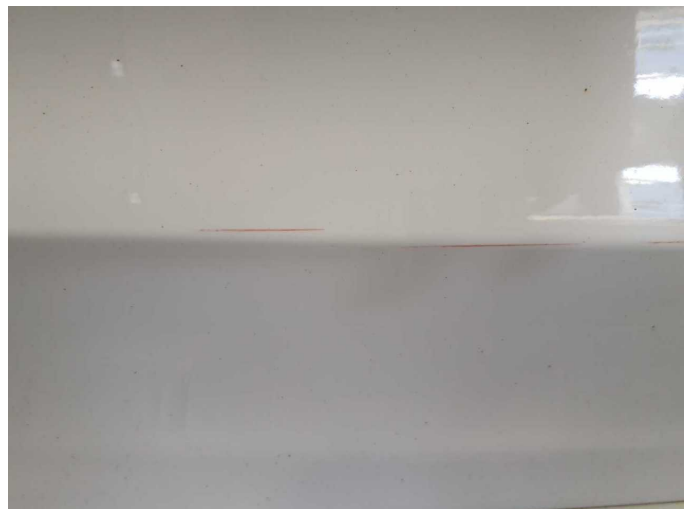
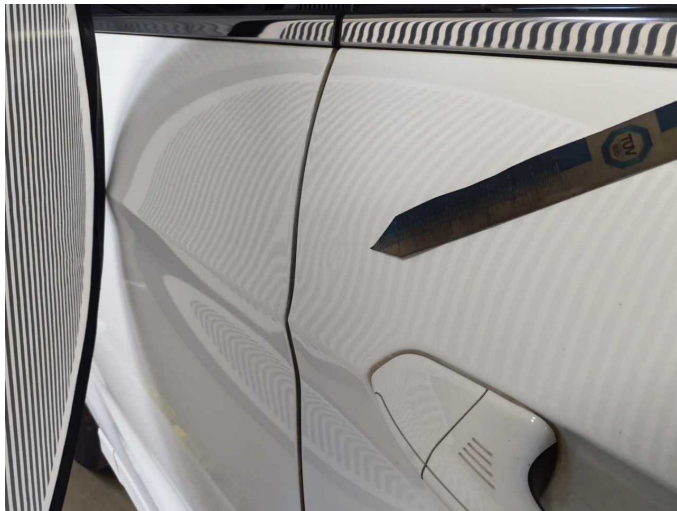
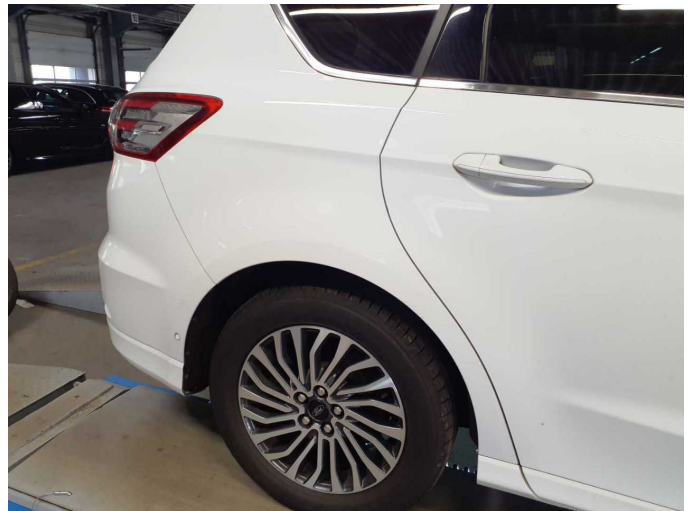
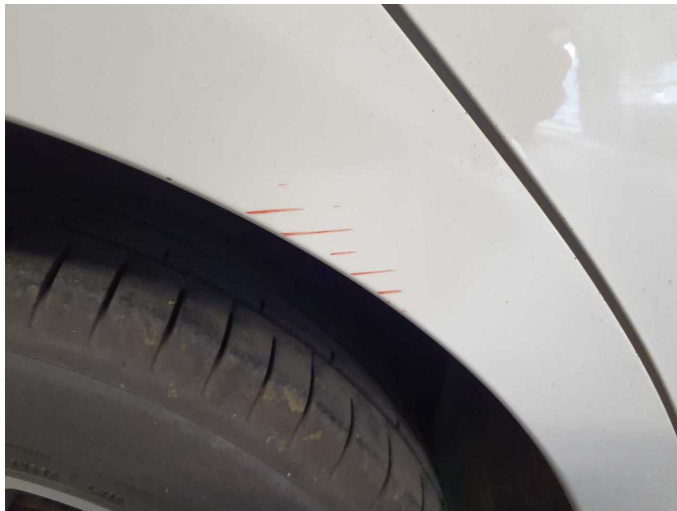
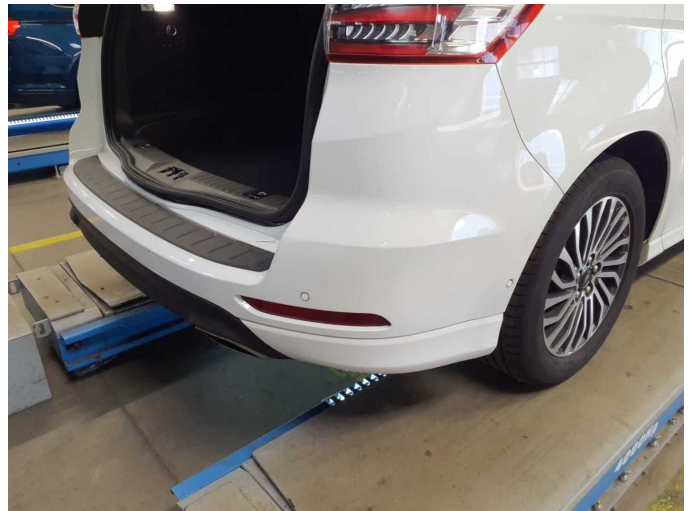
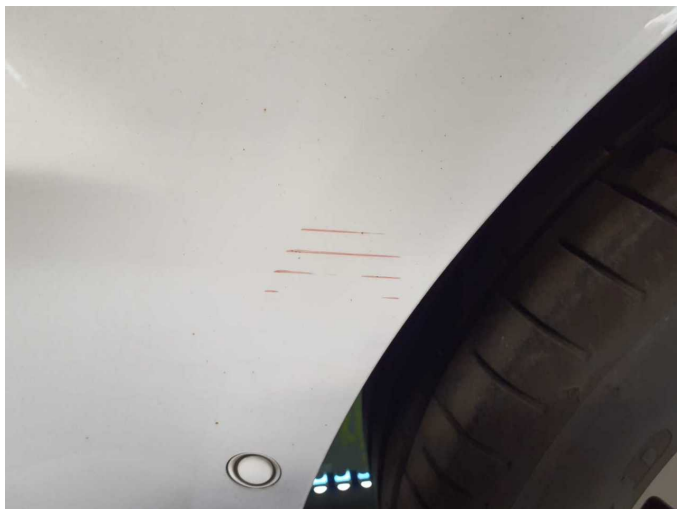
Non-repaired previous damages were found at the vehicle. The necessary repair costs are listed in the expert report or if necessary, are listed in detail in a separately enclosed repair cost calculation.

Accident 1: Side right
