Expertise

Protocol number: 41346061
Order No. / Reference: 25096691
Inspection date: 28 Aug 2025

Manufacturer: Ford	Model: S-Max 2.0 EcoBlue Aut. TITANIUM
VIN: WF0JXXWPCJMR33593

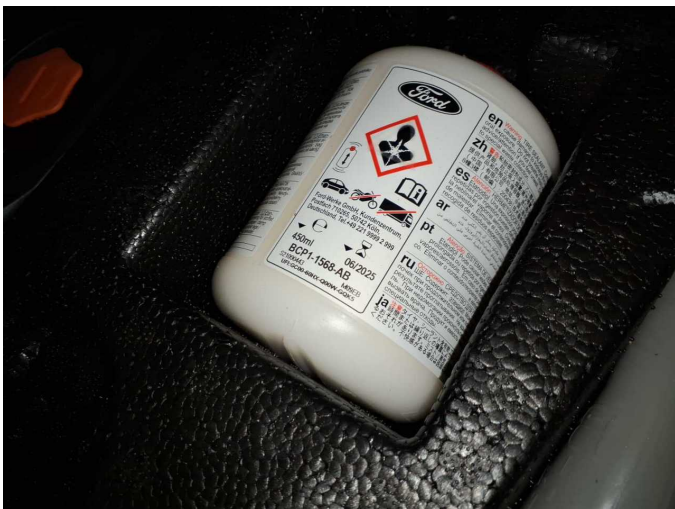
Damage 2: Equipment: Tirefit filler - Expired - Replace

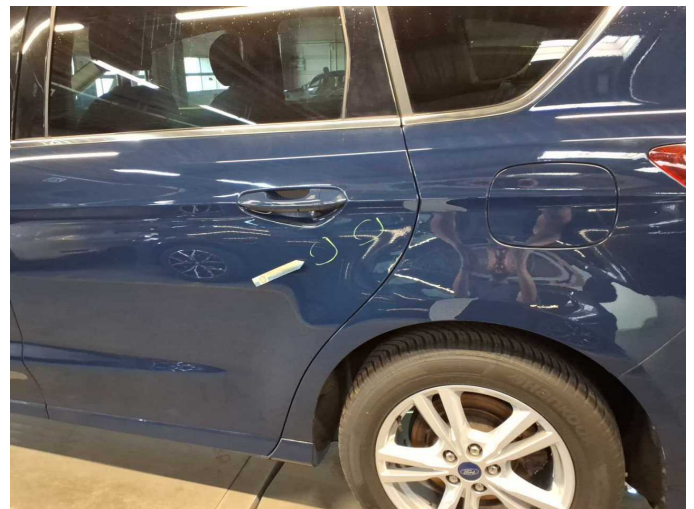
Damage 3: Door - rear left side: Door - dent(s) - Smooth repair work

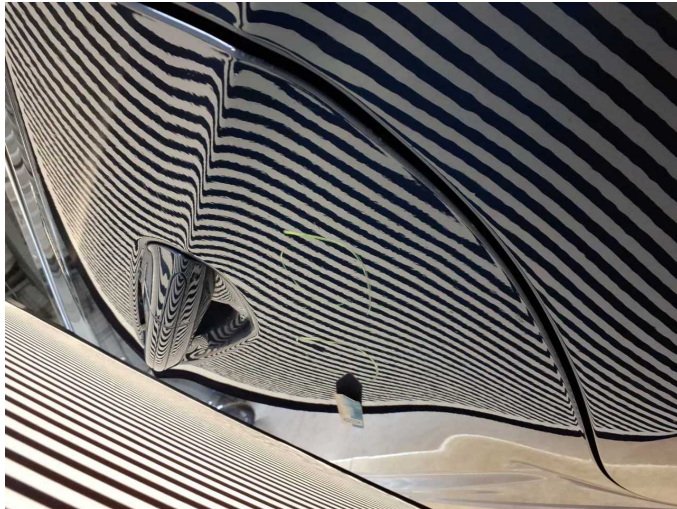
Damage 3: Door - rear left side: Door - dent(s) - Smooth repair work

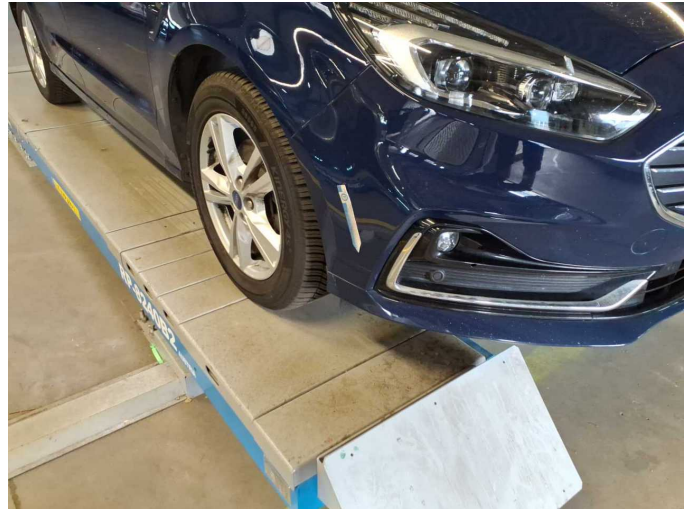
Damage 4: Front bumper: Front bumper - Scratch(es) - Smart repair

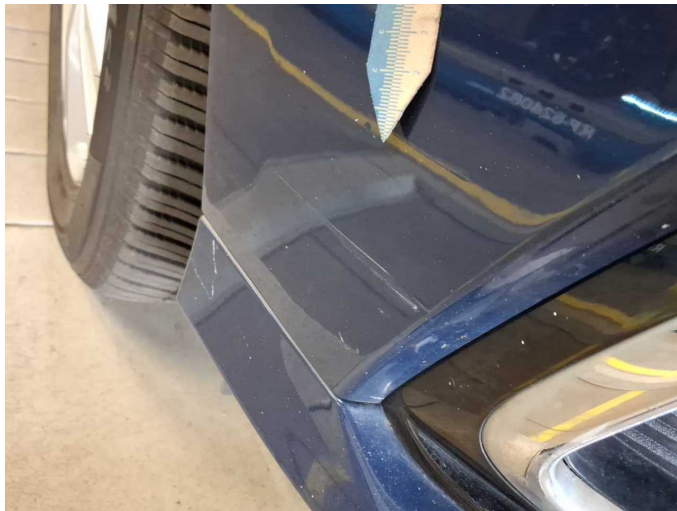
Damage 4: Front bumper: Front bumper - Scratch(es) - Smart repair

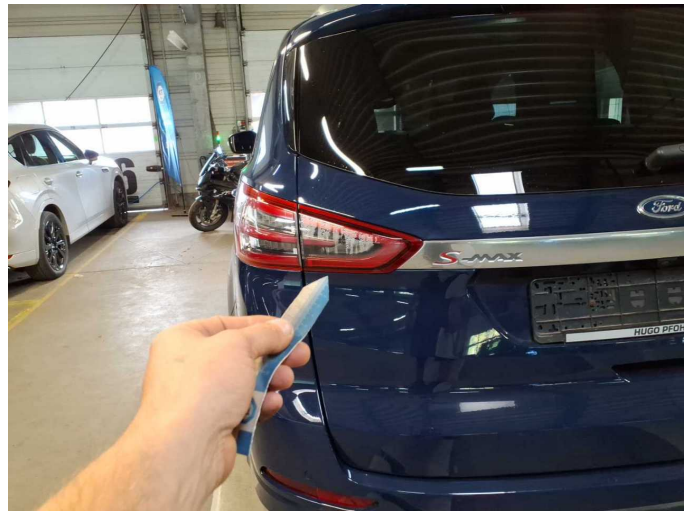
Damage 5: Tail light: Tail lamp - left side - Leaking - Replace

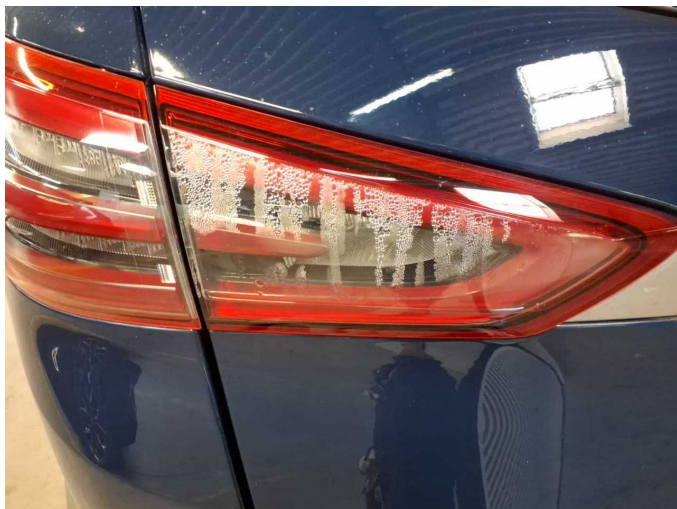
Damage 5: Tail light: Tail lamp - left side - Leaking - Replace

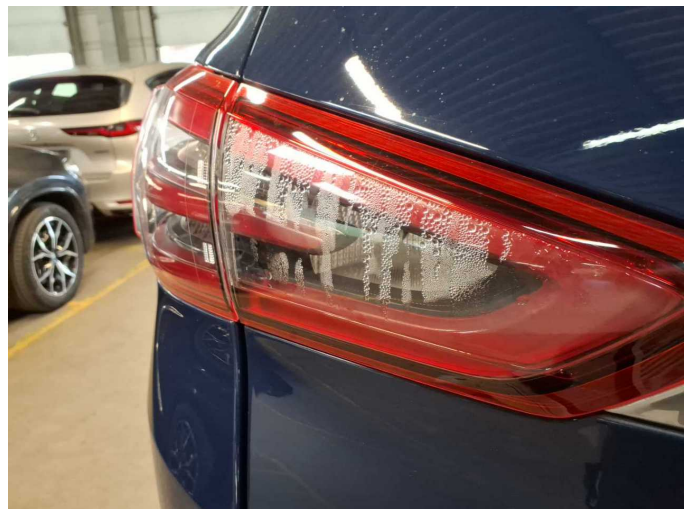
Damage 5: Tail light: Tail lamp - left side - Leaking - Replace

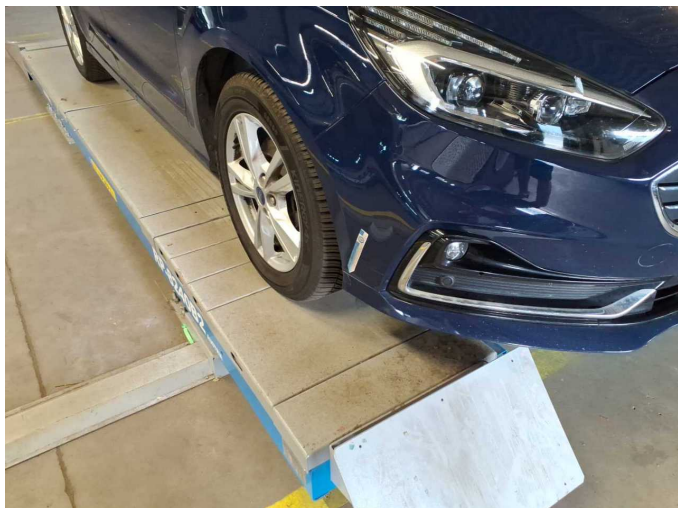
Damage 6: Front bumper: Spoiler (Lackmangel) - Stone chips - Paint

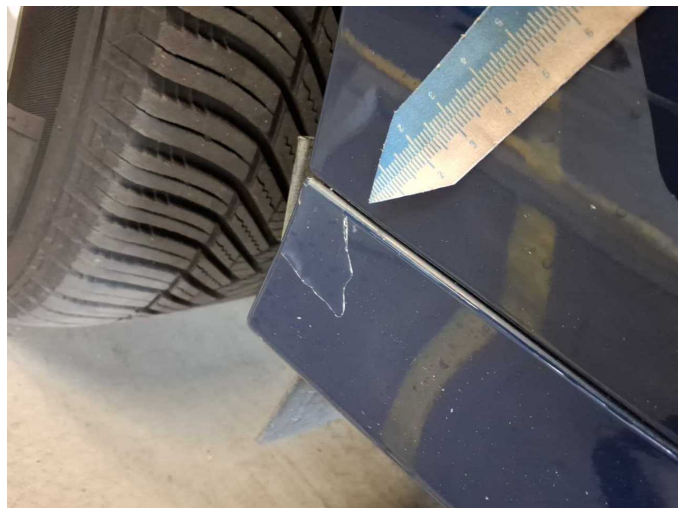
Damage 6: Front bumper: Spoiler (Lackmangel) - Stone chips - Paint

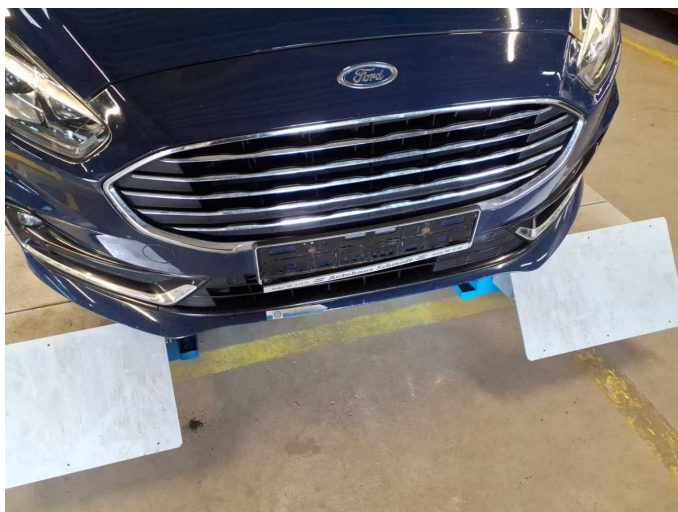
Damage 6: Front bumper: Spoiler (Lackmangel) - Stone chips - Paint

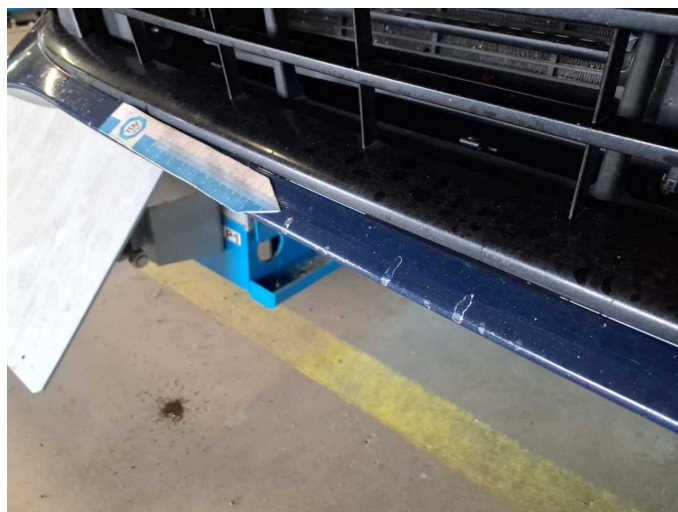
Damage 6: Front bumper: Spoiler (Lackmangel) - Stone chips - Paint

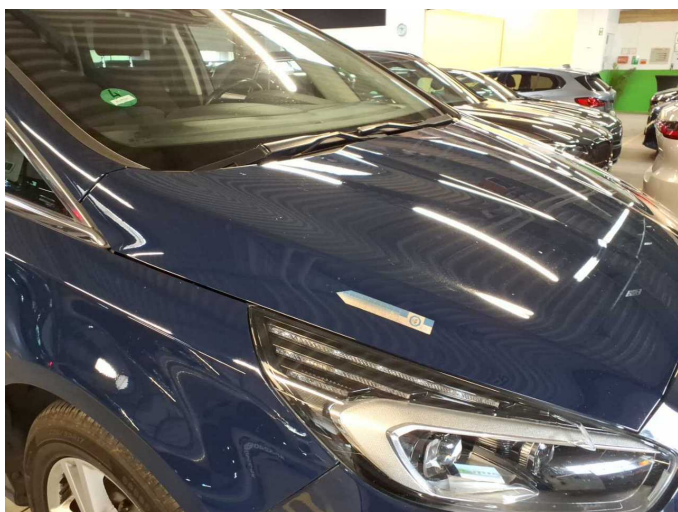
Damage 7: Bonnet: Bonnet (Steinschlag, Lackstift) - Unprofessionally repaired - Paint

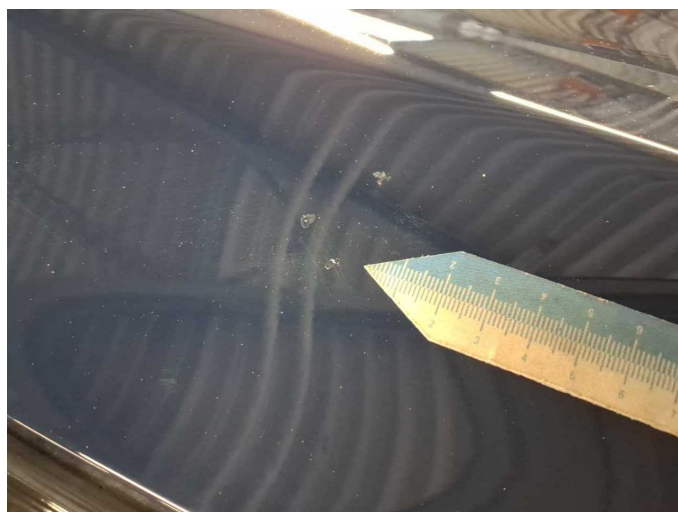
Damage 7: Bonnet: Bonnet (Steinschlag, Lackstift) - Unprofessionally repaired - Paint

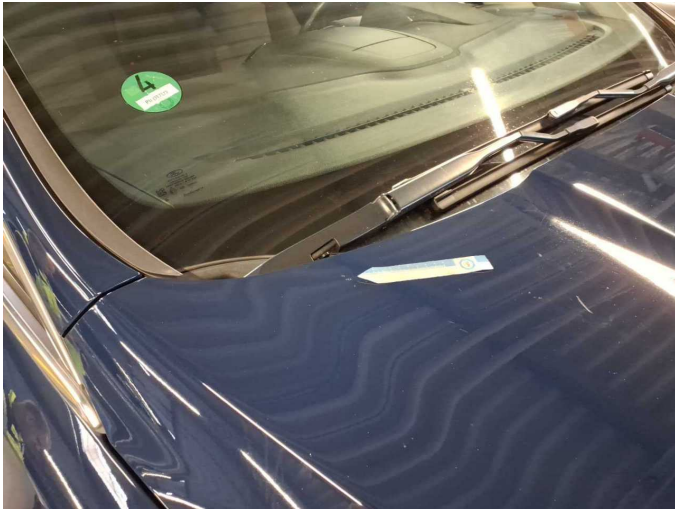
Damage 7: Bonnet: Bonnet (Steinschlag, Lackstift) - Unprofessionally repaired - Paint

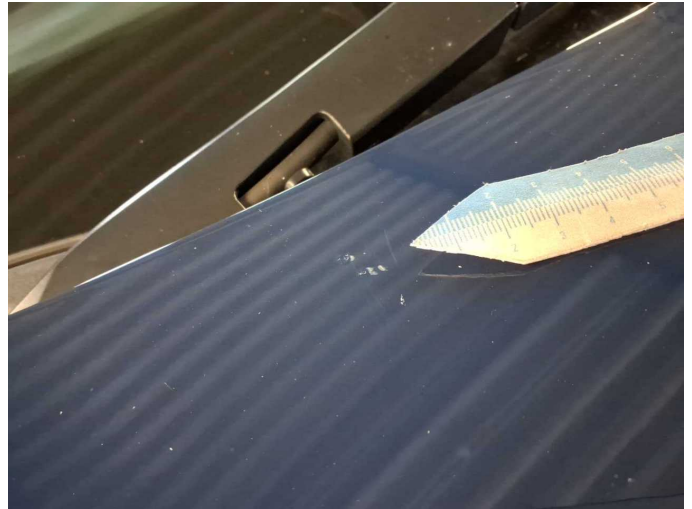
Damage 7: Bonnet: Bonnet (Steinschlag, Lackstift) - Unprofessionally repaired - Paint

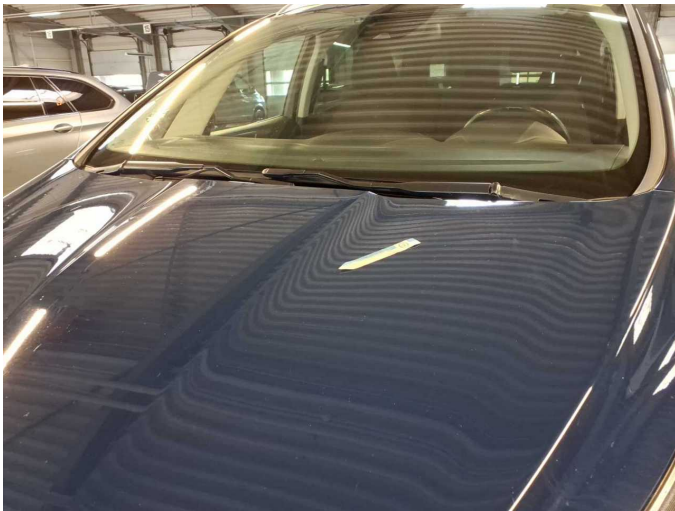
Damage 7: Bonnet: Bonnet (Steinschlag, Lackstift) - Unprofessionally repaired - Paint

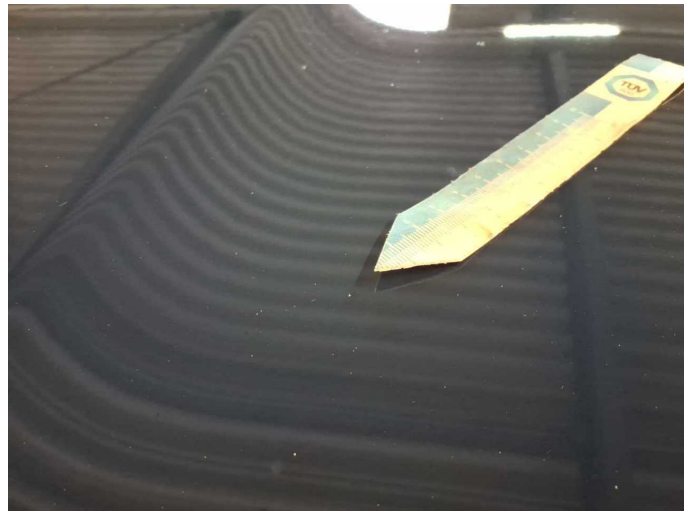
Damage 7: Bonnet: Bonnet (Steinschlag, Lackstift) - Unprofessionally repaired - Paint

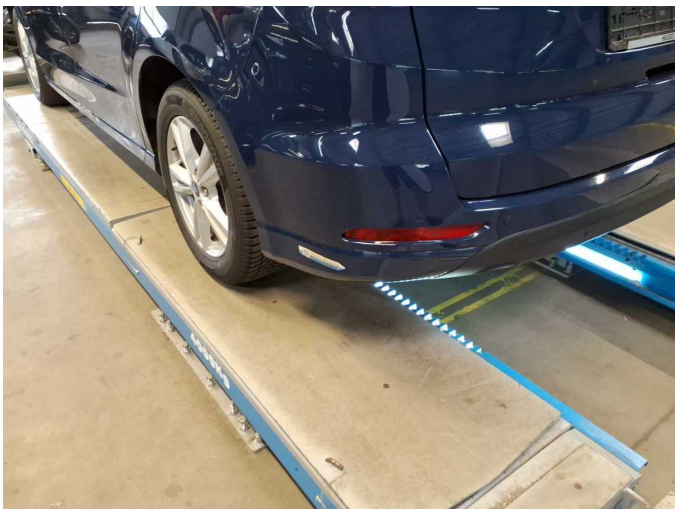
Damage 8: Rear bumper: Rear bumper - Scratch(es) - Paint

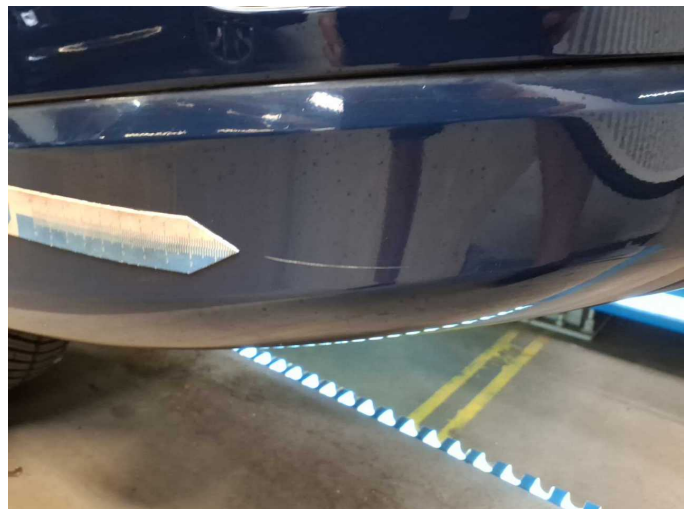
Damage 8: Rear bumper: Rear bumper - Scratch(es) - Paint

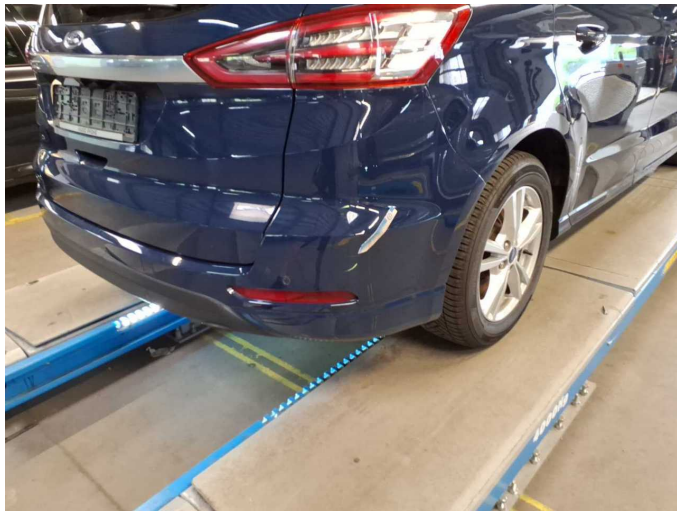
Damage 8: Rear bumper: Rear bumper - Scratch(es) - Paint

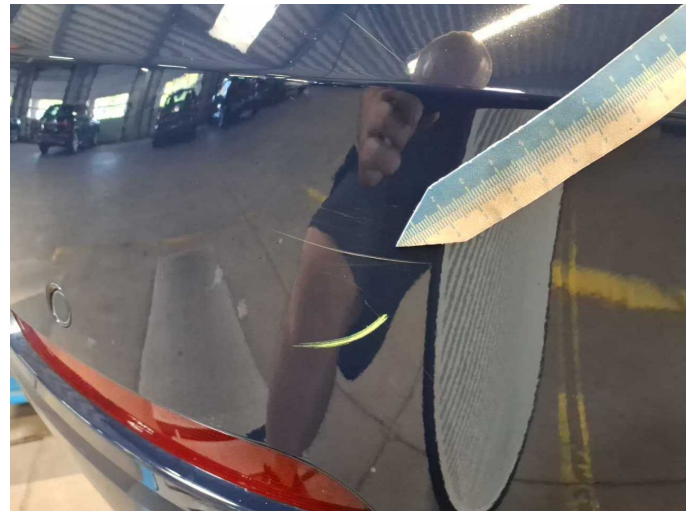
Damage 8: Rear bumper: Rear bumper - Scratch(es) - Paint

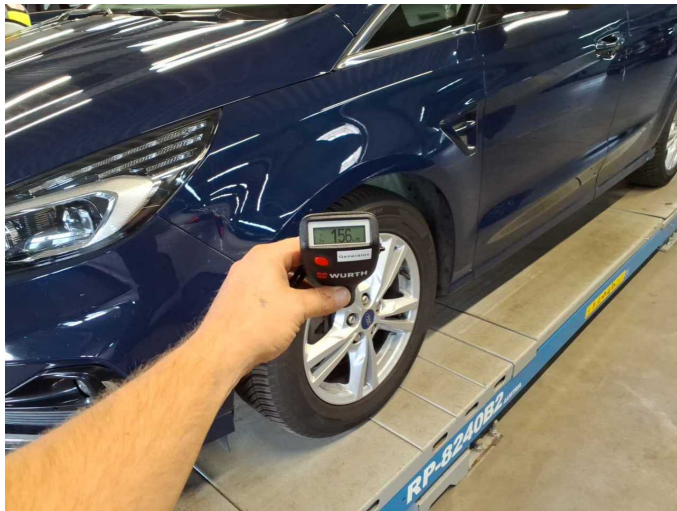
Repainting 1: Mudguard - left side

- 1 Mudguard - left side, Professionally carried out, Invoice of repair done Non-existent
- 2 Side panel - rear left side, Professionally carried out, Invoice of repair done Non-existent
- 3 Side panel - rear right side, Professionally carried out, Invoice of repair done Non-existent
- 4 Door - rear right side, Professionally carried out, Invoice of repair done Non-existent

Mudguard - left side	156 µm	Side panel - rear left side	163 µm
Side panel - rear right side	171 µm	Door - rear right side	220 µm
