Expertise

Protocol number: 41493102  
Order No. / Reference: 25210376  
Inspection date: 11 Sept 2025

Manufacturer: Ford	Model: S-Max 2.0 EcoBlue Aut. Titanium
VIN: WF0JXXWPCJNS05424

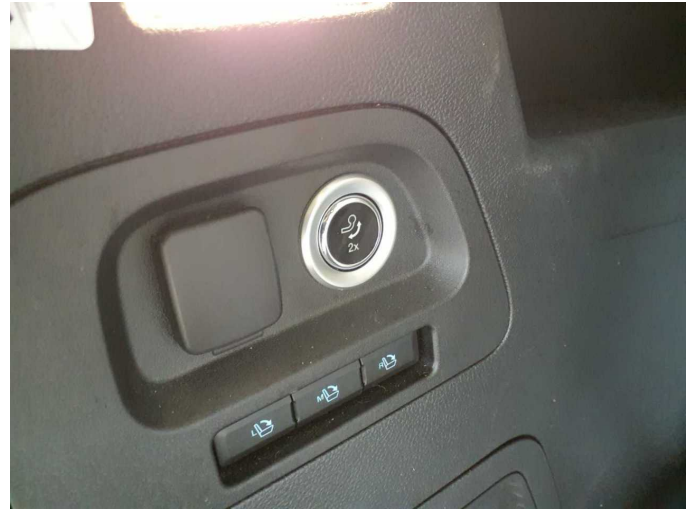
**Damage 1:** Rear of vehicle: Trailer hitch - Non-operational - Diagnosed and repair if necessary

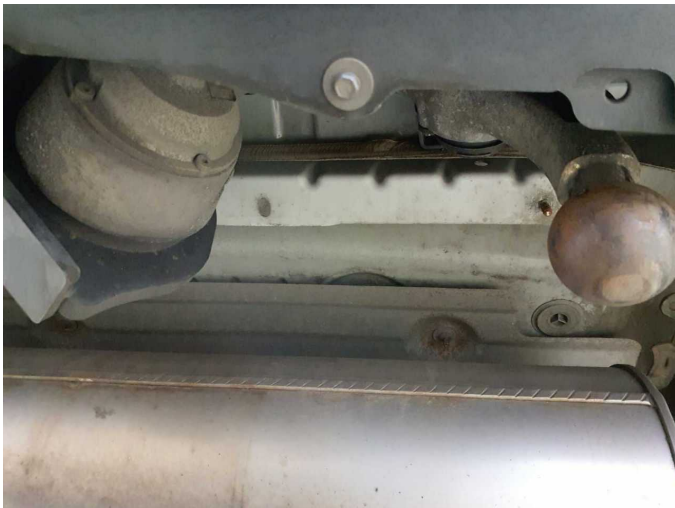
**Damage 1:** Rear of vehicle: Trailer hitch - Non-operational - Diagnosed and repair if necessary

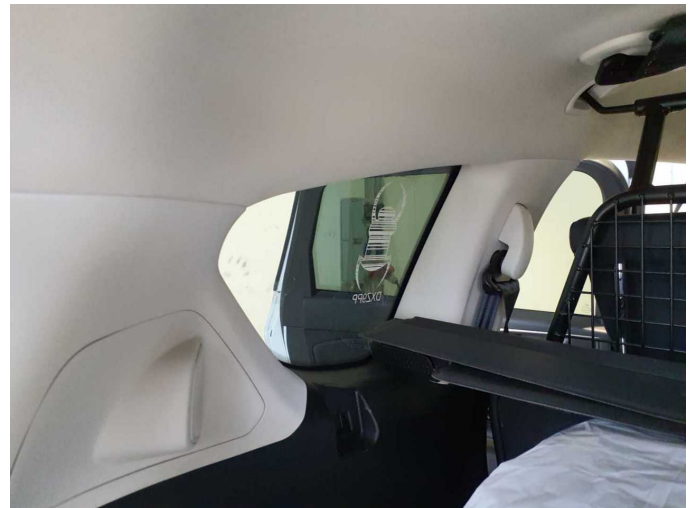
**Damage 2:** Vehicle glazing: Side window - rear left side - Glued / labelled - De-glue / neutralise

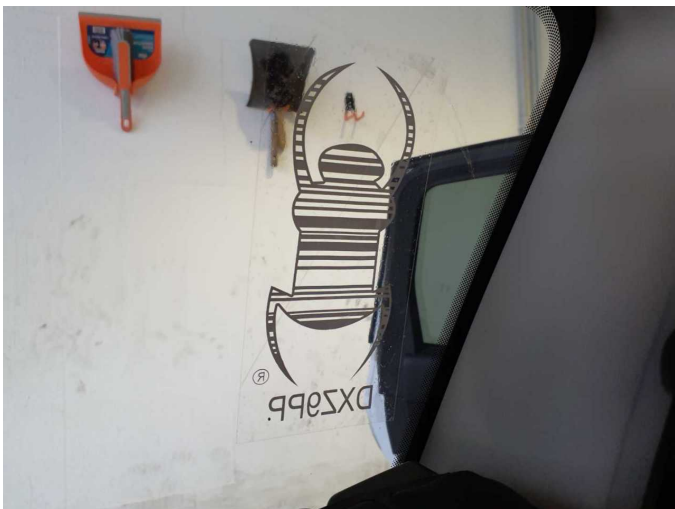
**Damage 2:** Vehicle glazing: Side window - rear left side - Glued / labelled - De-glue / neutralise

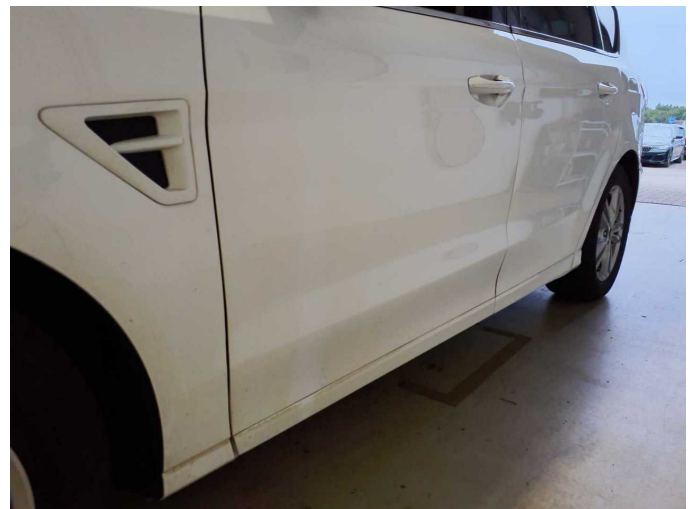
**Damage 3:** Body: Body (Flugrost) - Soiled - Clean

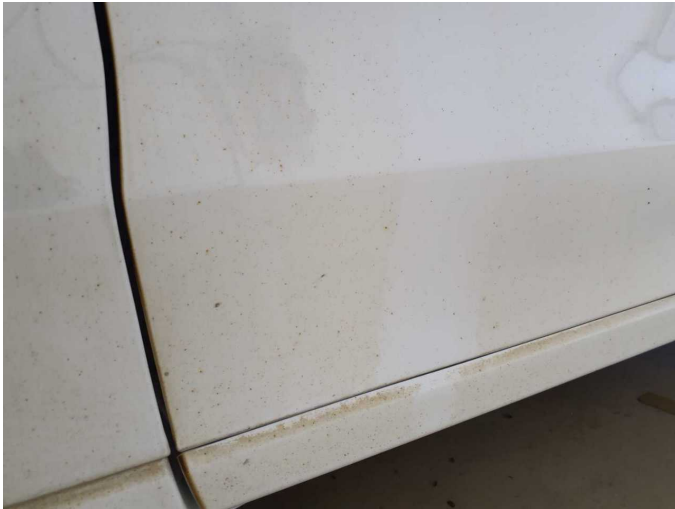
**Damage 3:** Body: Body (Flugrost) - Soiled - Clean

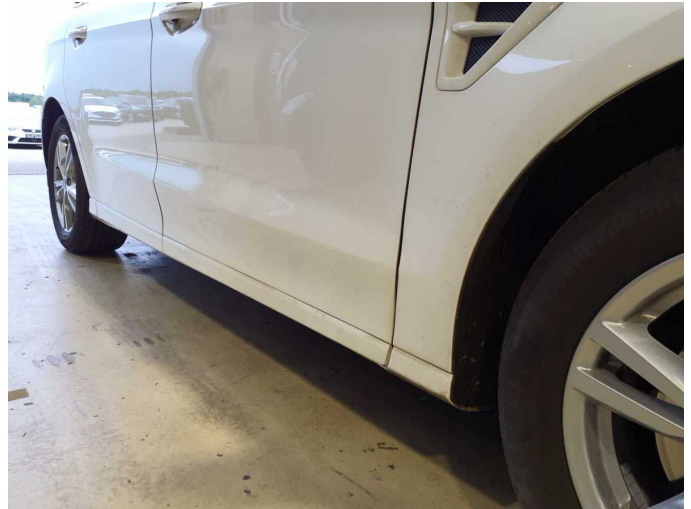
**Damage 3:** Body: Body (Flugrost) - Soiled - Clean

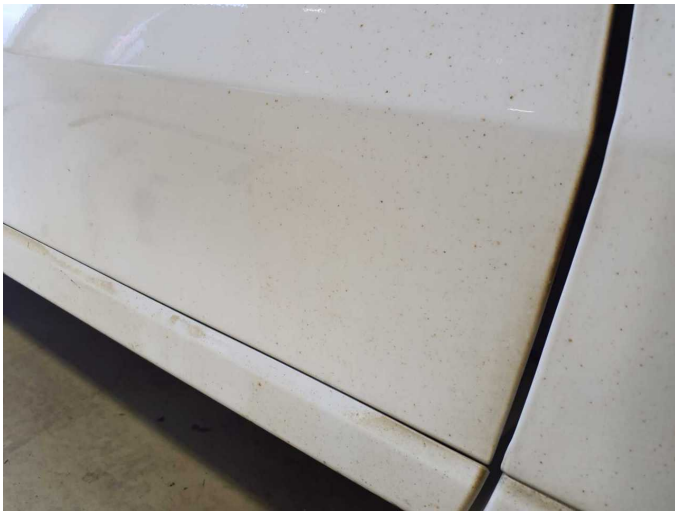
**Damage 3:** Body: Body (Flugrost) - Soiled - Clean

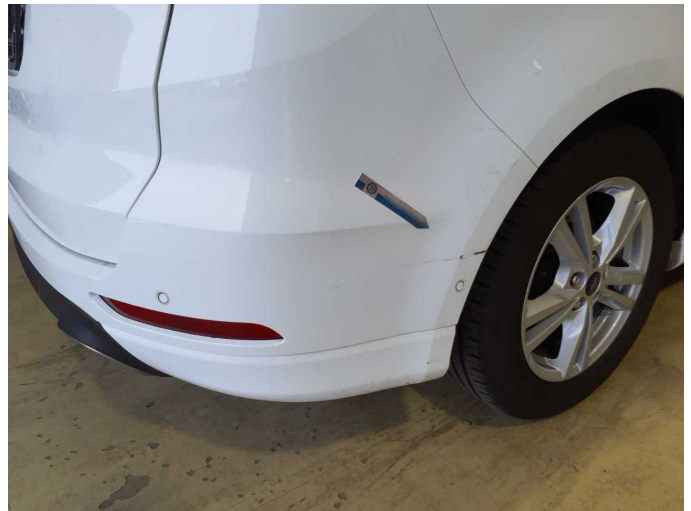
**Damage 4:** Rear bumper: Rear bumper - Scratch(es) - Paint

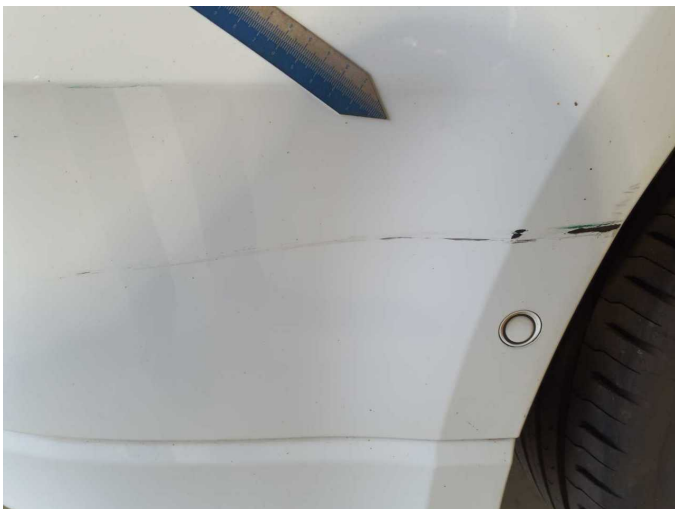
**Damage 4:** Rear bumper: Rear bumper - Scratch(es) - Paint

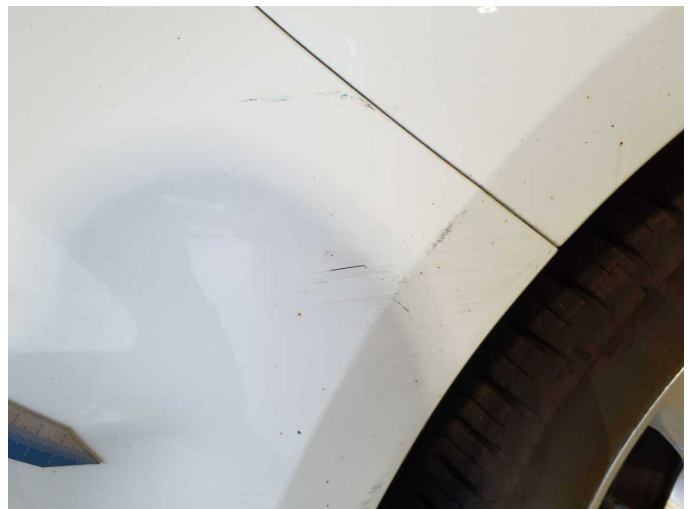
**Damage 4:** Rear bumper: Rear bumper - Scratch(es) - Paint

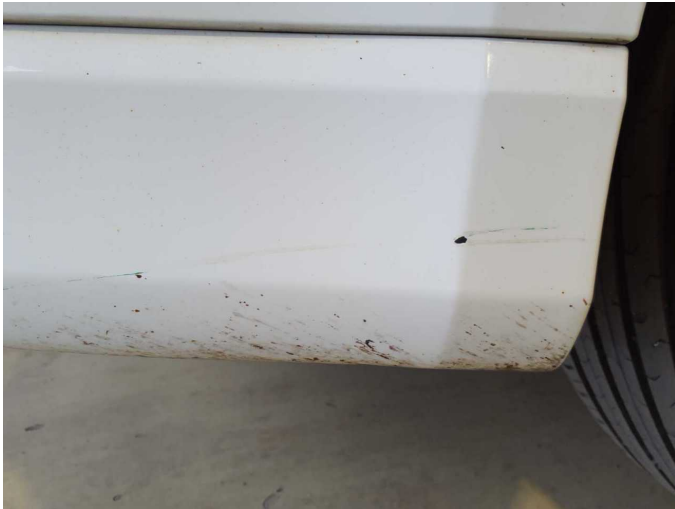
**Damage 4:** Rear bumper: Rear bumper - Scratch(es) - Paint

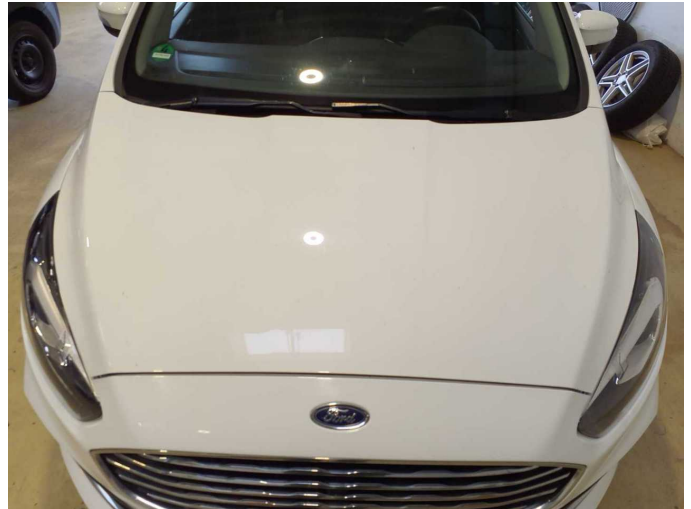
**Damage 5:** Bonnet: Bonnet - Stone chips - Paint

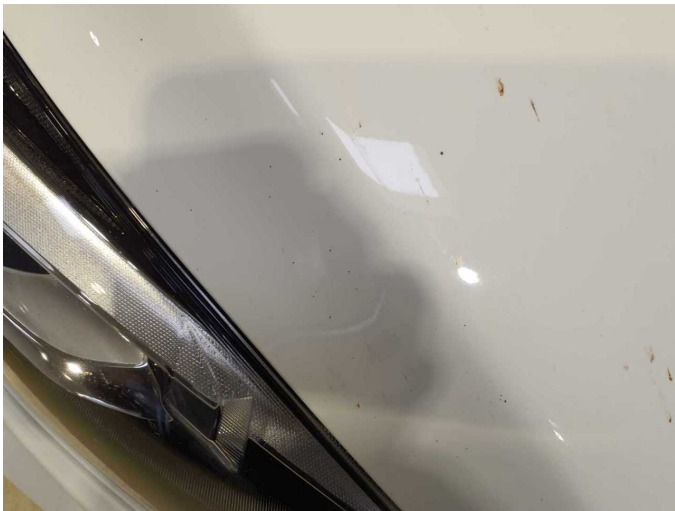
**Damage 5:** Bonnet: Bonnet - Stone chips - Paint

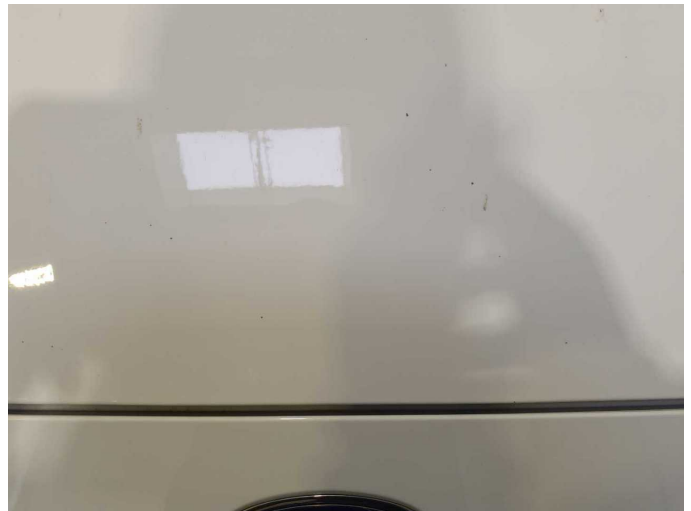
**Damage 5:** Bonnet: Bonnet - Stone chips - Paint

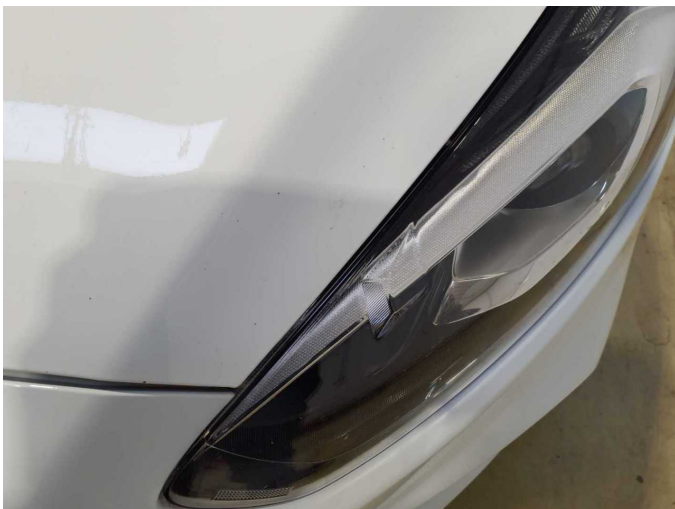
**Damage 5:** Bonnet: Bonnet - Stone chips - Paint

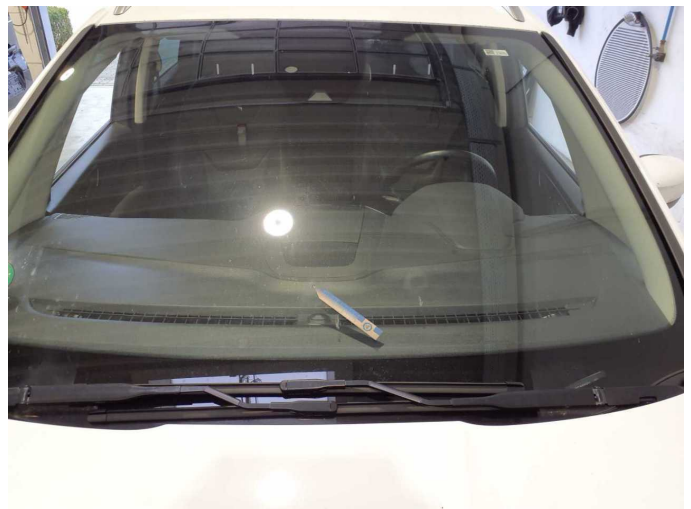
**Damage 6:** Vehicle glazing: Windscreen with rain sensor - Stone chips - Replace

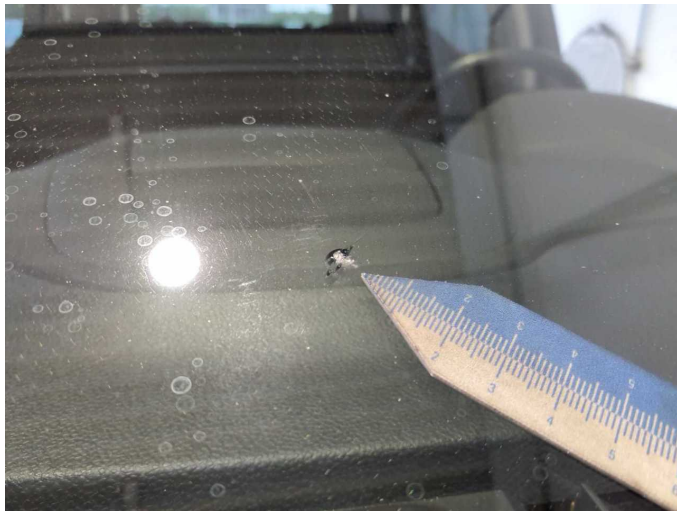
**Damage 6:** Vehicle glazing: Windscreen with rain sensor - Stone chips - Replace

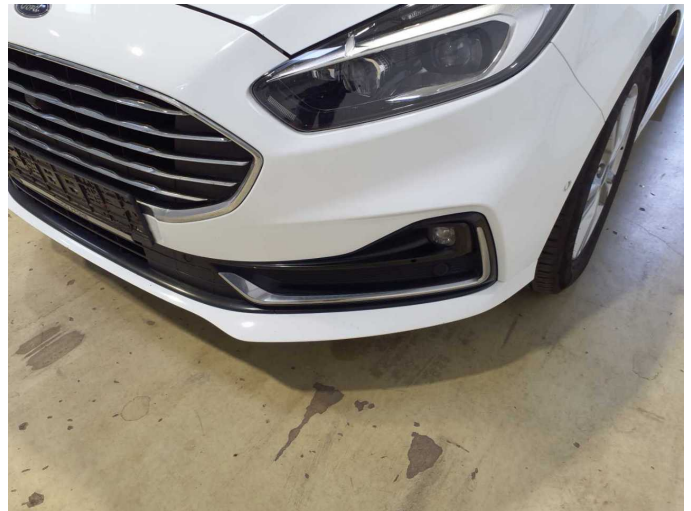
**Wear and tear 1:** Front bumper: Front bumper - Stone chips - No deduction

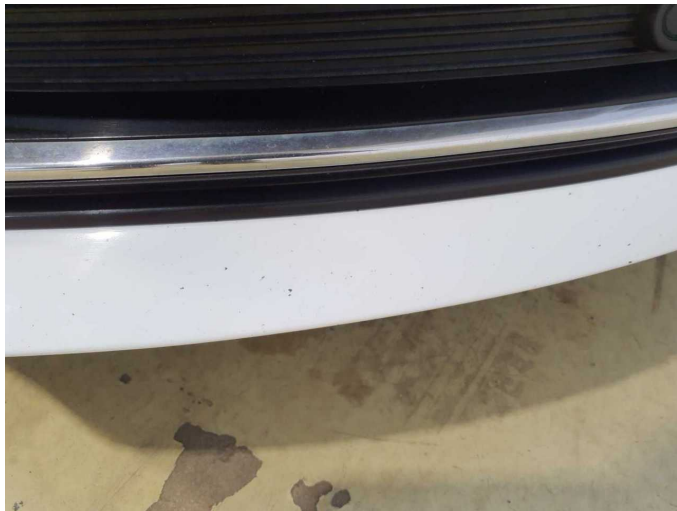
**Wear and tear 1:** Front bumper: Front bumper - Stone chips - No deduction

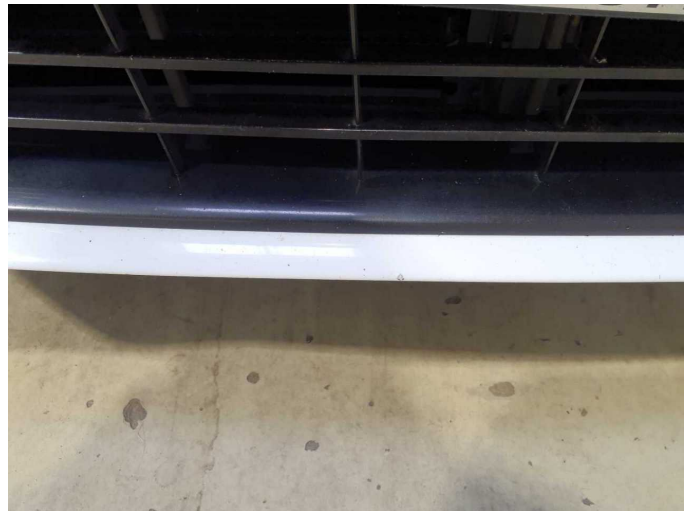
**Wear and tear 1:** Front bumper: Front bumper - Stone chips - No deduction

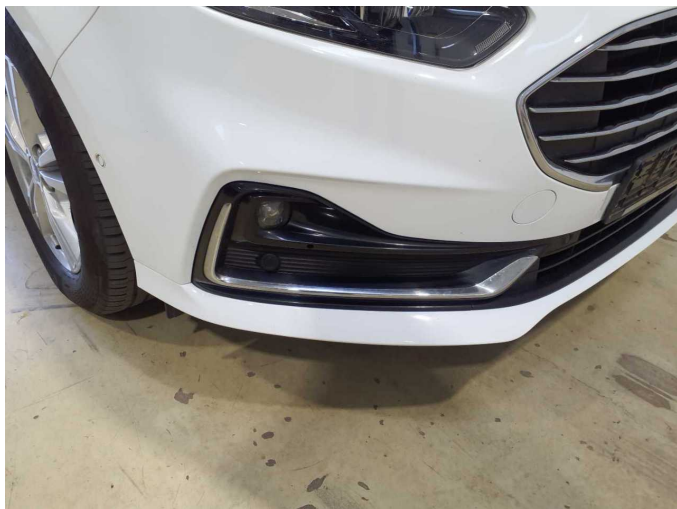
**Wear and tear 1:** Front bumper: Front bumper - Stone chips - No deduction

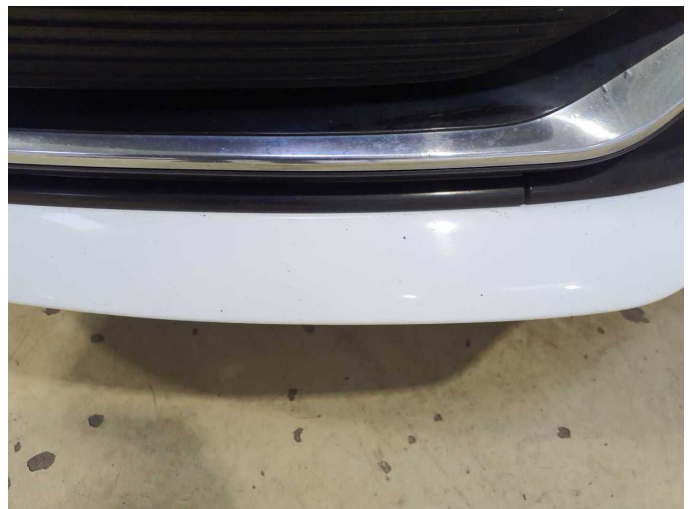
**Wear and tear 1:** Front bumper: Front bumper - Stone chips - No deduction

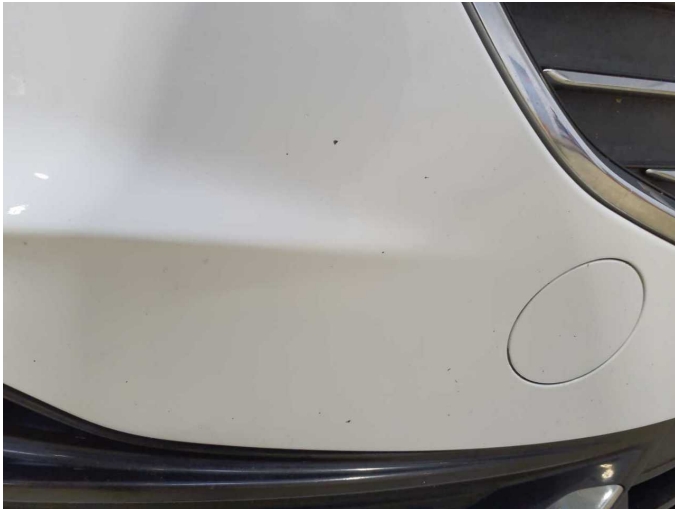
**Wear and tear 1:** Front bumper: Front bumper - Stone chips - No deduction
