## status report

**customer:** BCA Autoauktionen GmbH

#### Ford Tourneo Courier Titanium

| Vehicle identification number | <b>WF0LXXTACLHC42051</b> | mileage read: | <b>61568 km</b> |

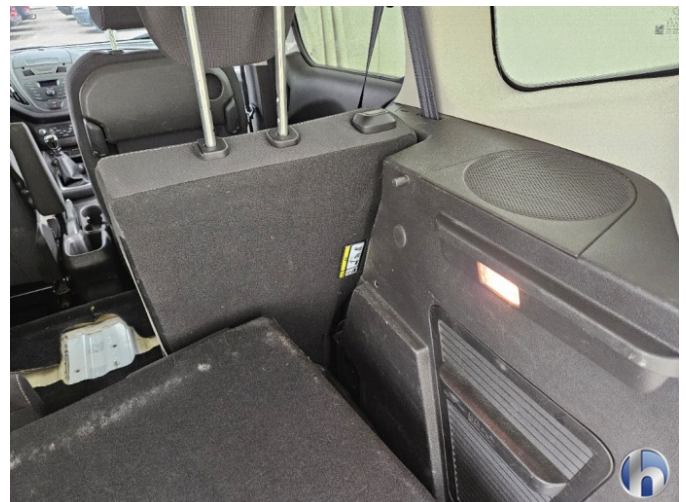
| component | Damage | Rep kind |
|---|---|---|
| 2. Cargo cover | Missing | Replace |

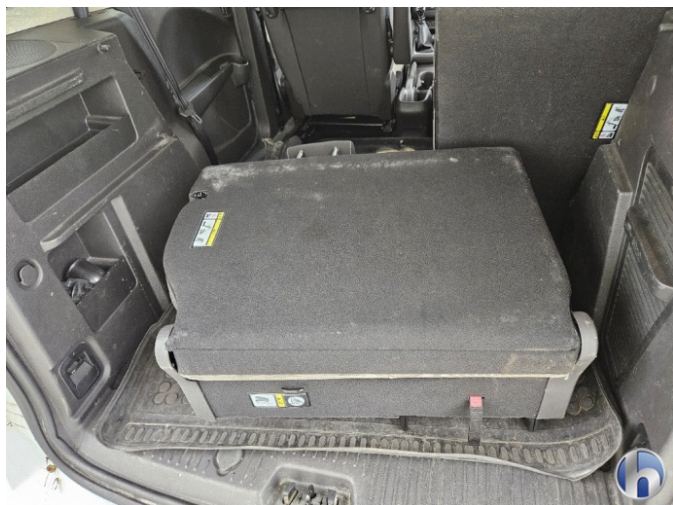
| component | Damage | Rep kind |
|---|---|---|
| 3. Sitzbank | Not possible | acceptable |

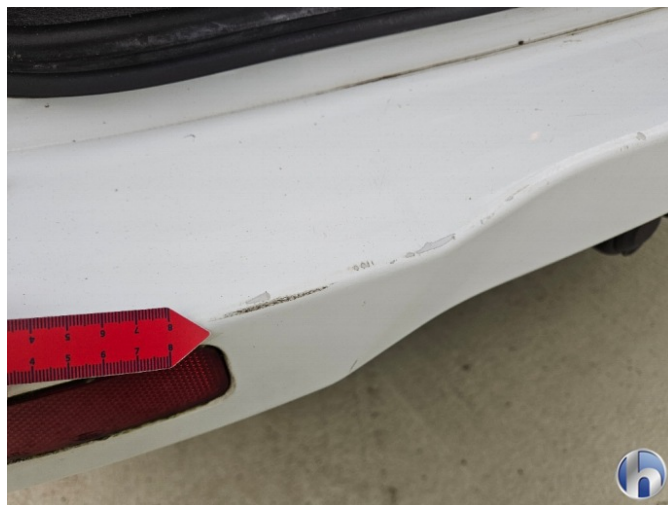
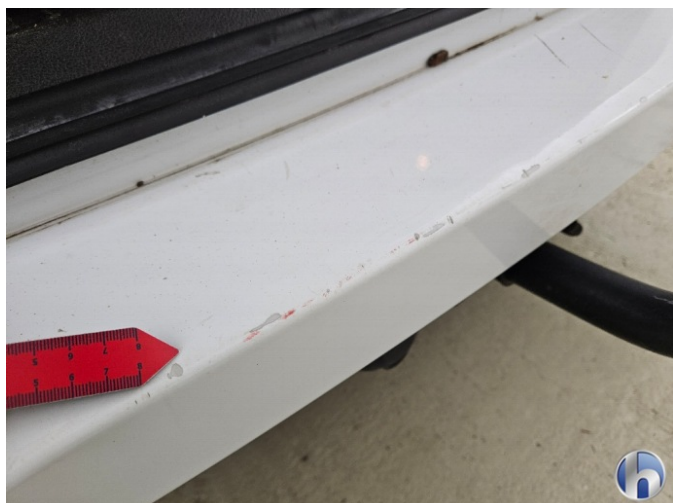
| component | Damage | Rep kind |
|---|---|---|
| 4. Rear bumper | Scratch(es) | Paint |

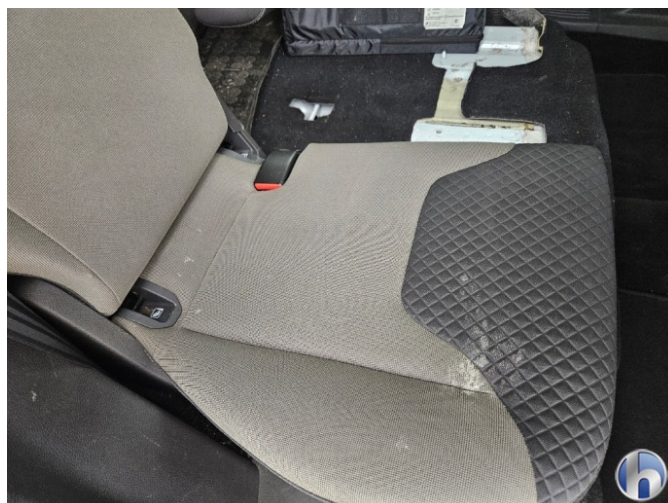
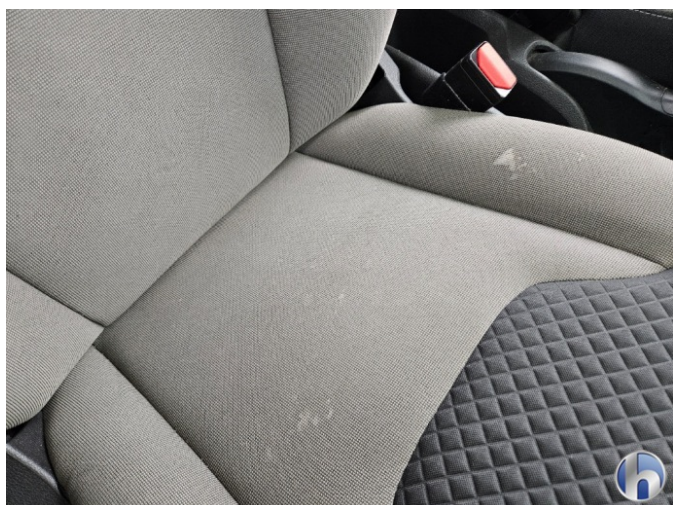
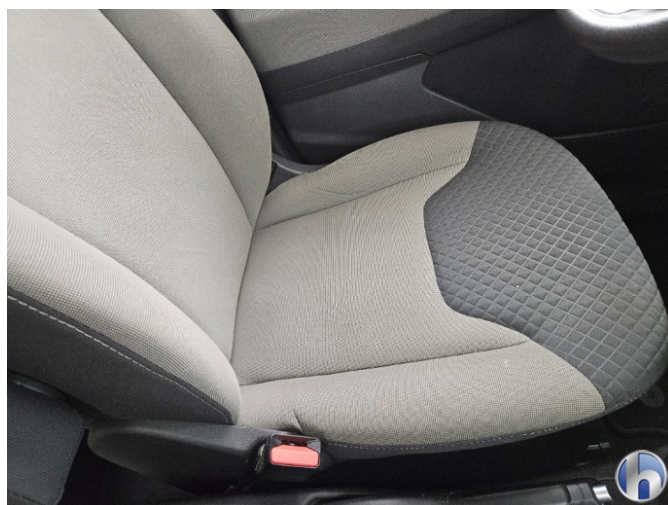
| component | Damage | Rep kind |
|---|---|---|
| 5. | Dirty | |

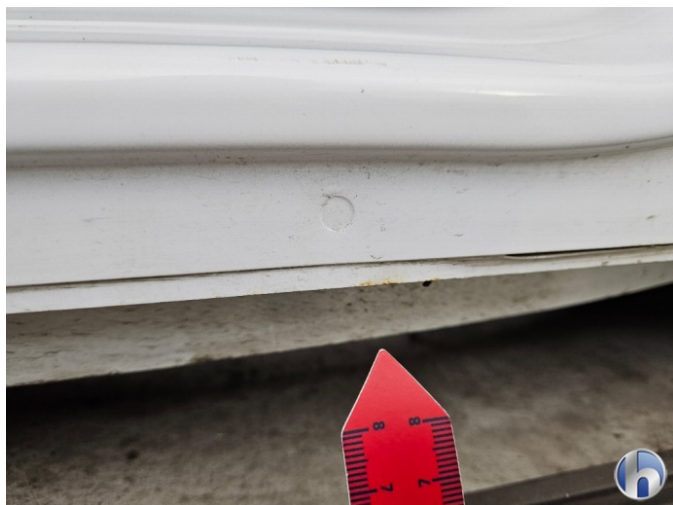
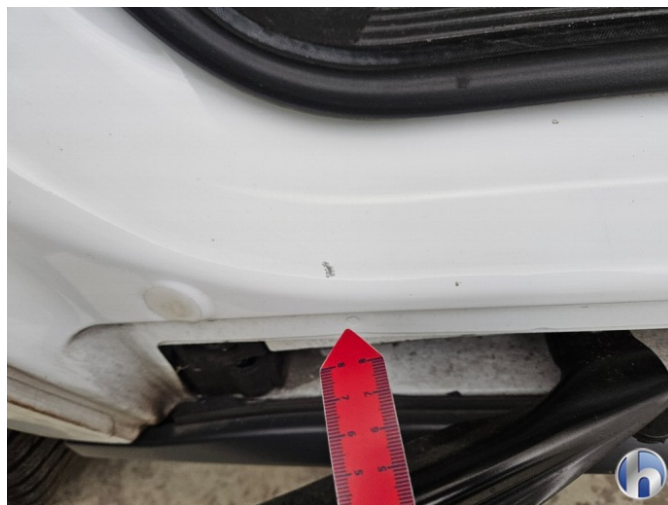
| component | Damage | Rep kind |
|---|---|---|
| 6. Türeinstieg Hinten - Rechts | Corroded | Paint |

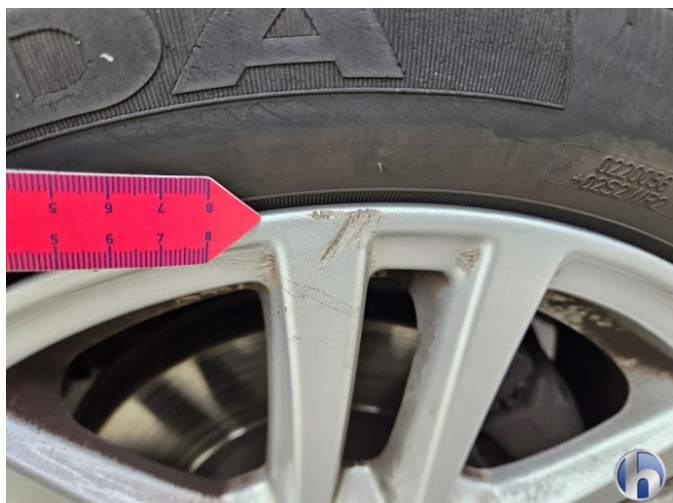
| component | Damage | Rep kind |
|---|---|---|
| 7. | Scratch(es) | Smart repair |

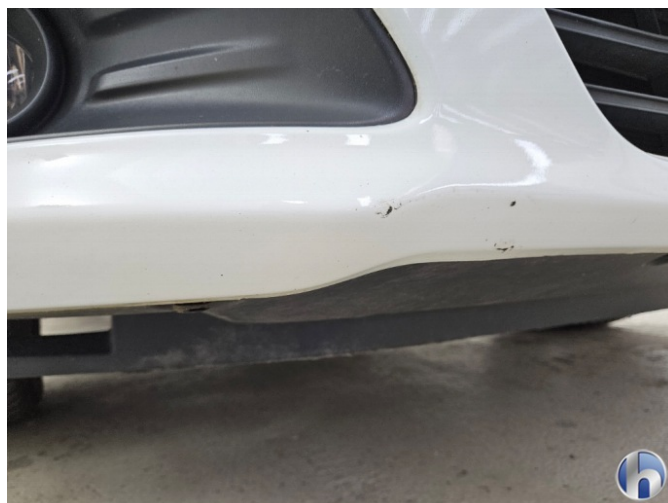
| component | Damage | Rep kind |
|---|---|---|
| 8. Front bumper | Wear and tear | acceptable |

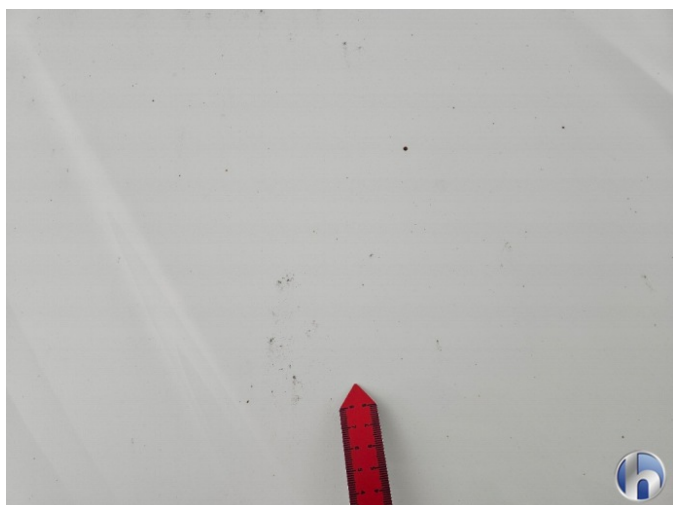
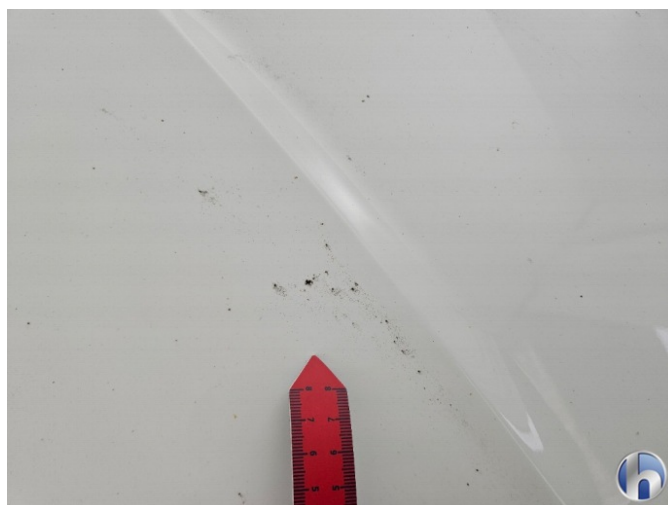
| component | Damage | Rep kind |
|---|---|---|
| 9. hood | Wear and tear | acceptable |

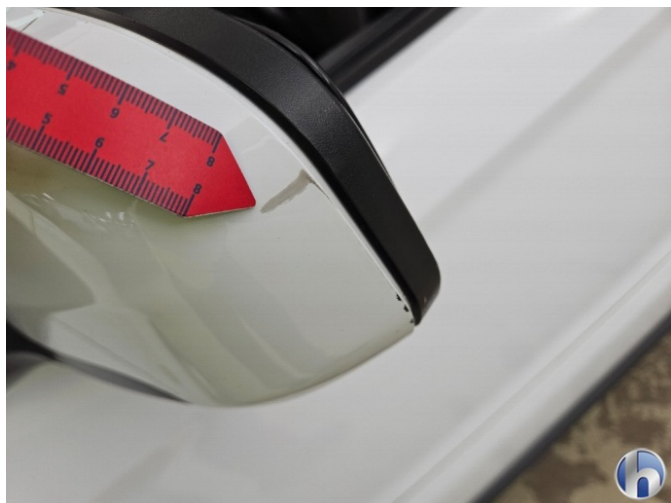
| component | Damage | Rep kind |
|---|---|---|
| 10. | Wear and tear | acceptable |

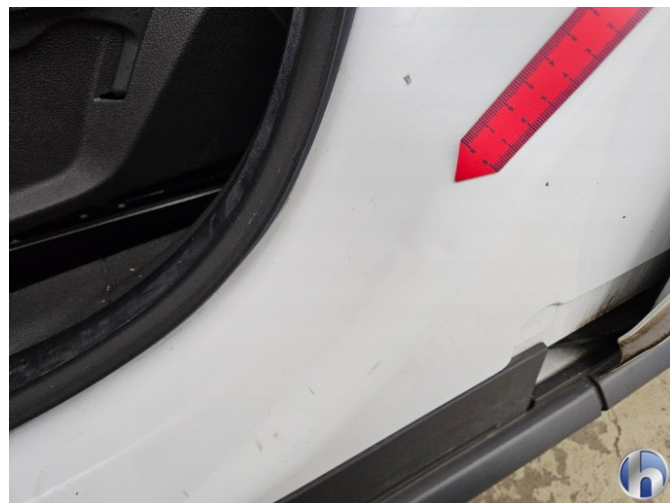
| component | Damage | Rep kind |
|---|---|---|
| 11. Türeinstieg Vorne - Links | Wear and tear | acceptable |

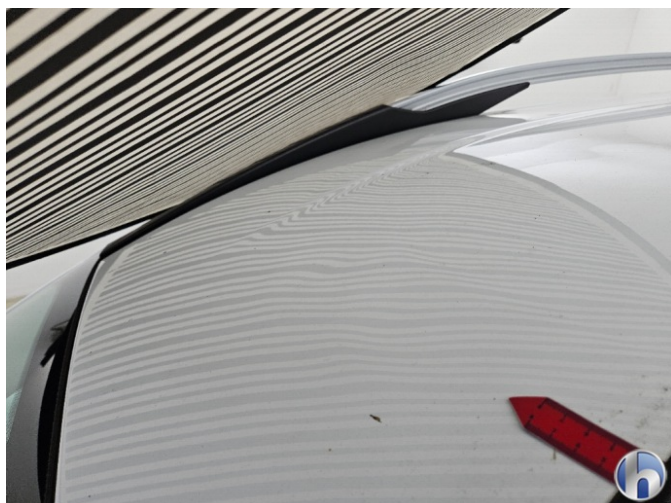
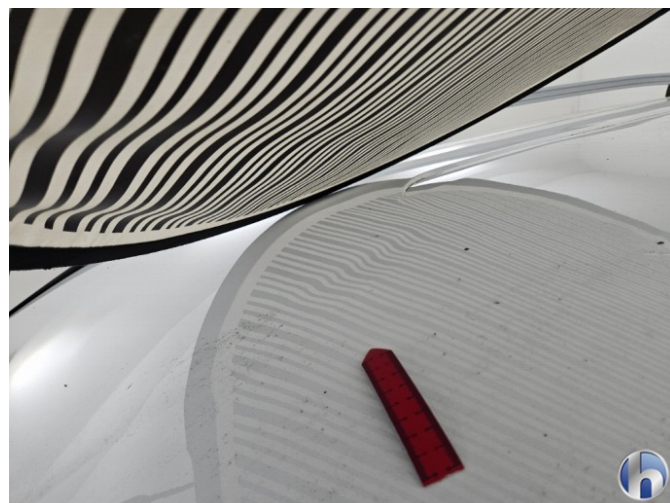
| component | Damage | Rep kind |
|---|---|---|
| 12. roof | Deformed | Refurbish and paint |

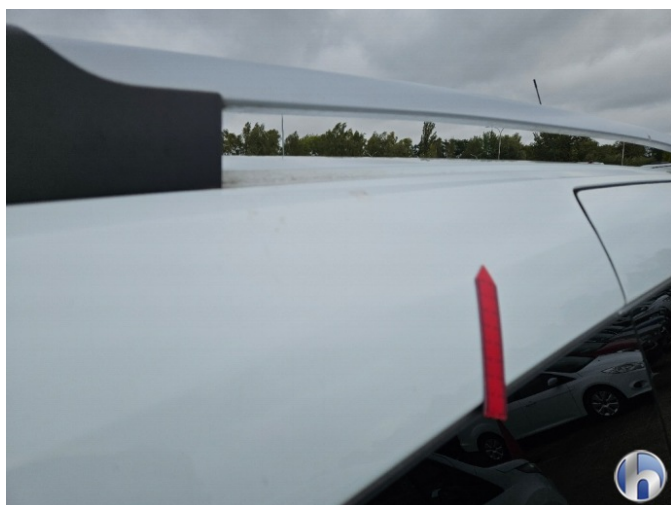
| component | Damage | Rep kind |
|---|---|---|
| 13. Roof frame - right | Wear and tear | acceptable |
