Expertise

Protocol number: 40963223
Order No. / Reference: 25025505
Inspection date: 4 Aug 2025

Manufacturer: Ford

Model: Focus 1.0 EcoBoost Start-Stopp-System COOL&CONNECT

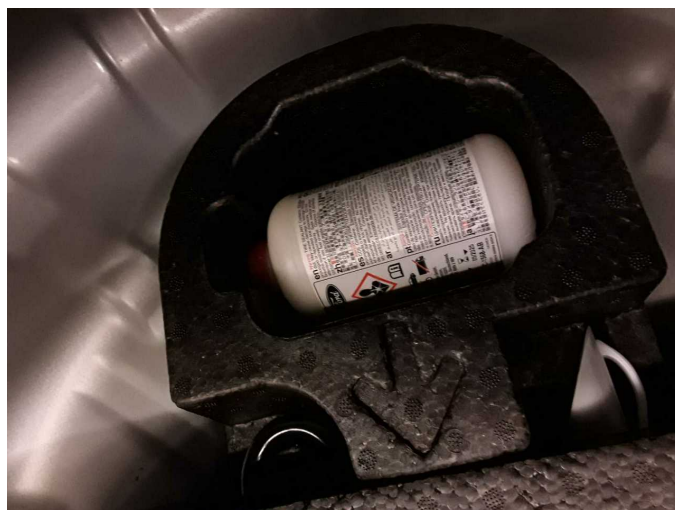
Damage 1: Equipment: Tirefit filler - Expired - Replace

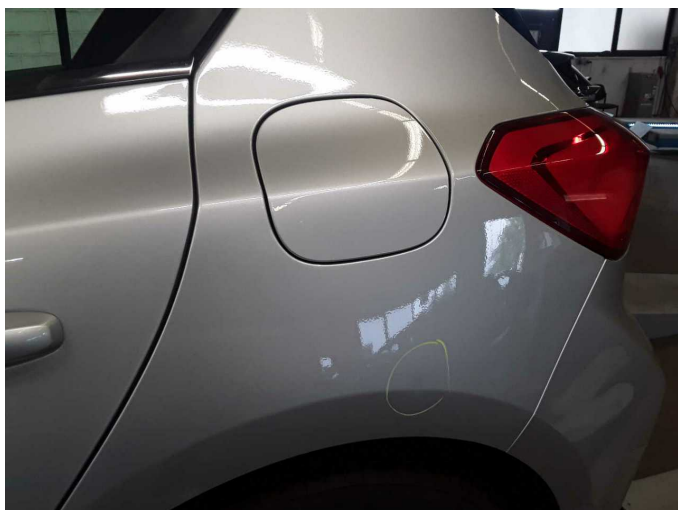
Damage 2: Side panel - rear left side: Side panel - dent(s) - Smooth repair work

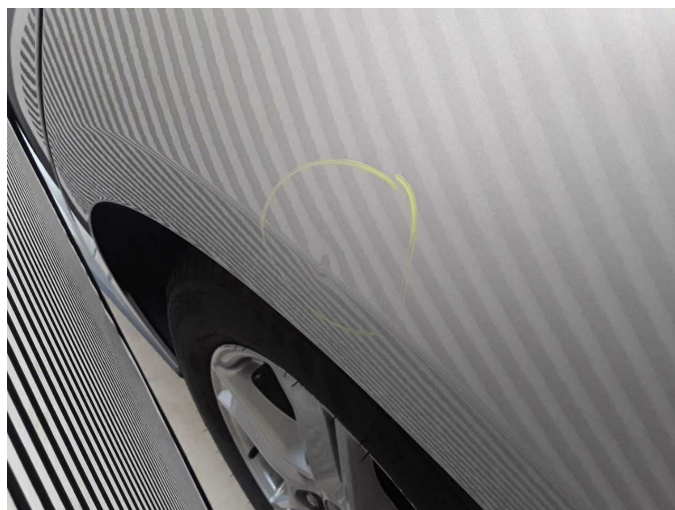
Damage 2: Side panel - rear left side: Side panel - dent(s) - Smooth repair work

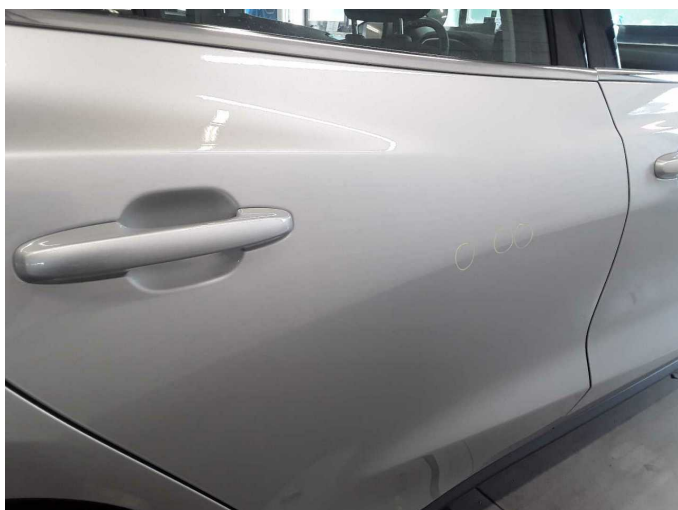
Damage 3: Door - rear right side: Door - Scratch(es) - Smart repair

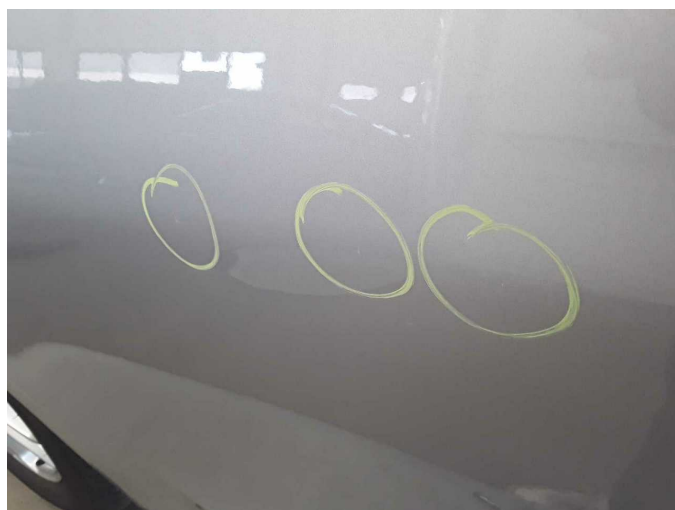
Damage 3: Door - rear right side: Door - Scratch(es) - Smart repair

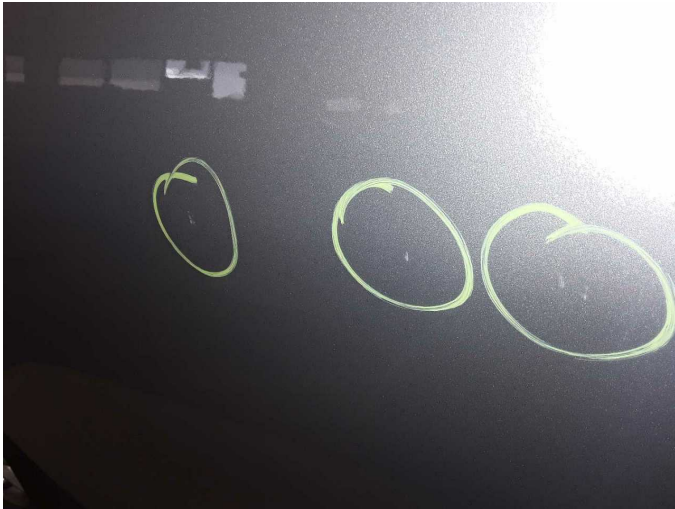
Damage 3: Door - rear right side: Door - Scratch(es) - Smart repair

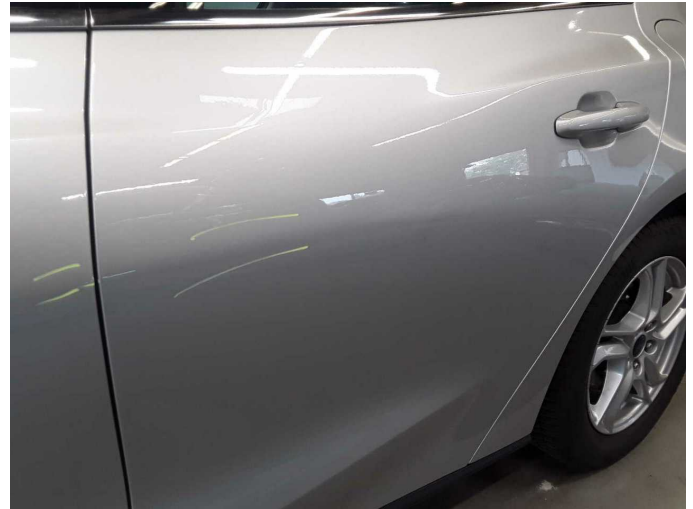
Damage 4: Door - rear left side: Door - Scratch(es) - Smart repair

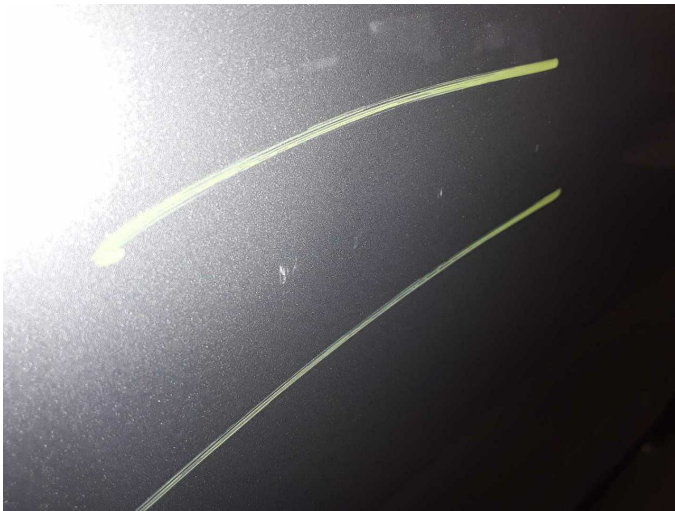
Damage 4: Door - rear left side: Door - Scratch(es) - Smart repair

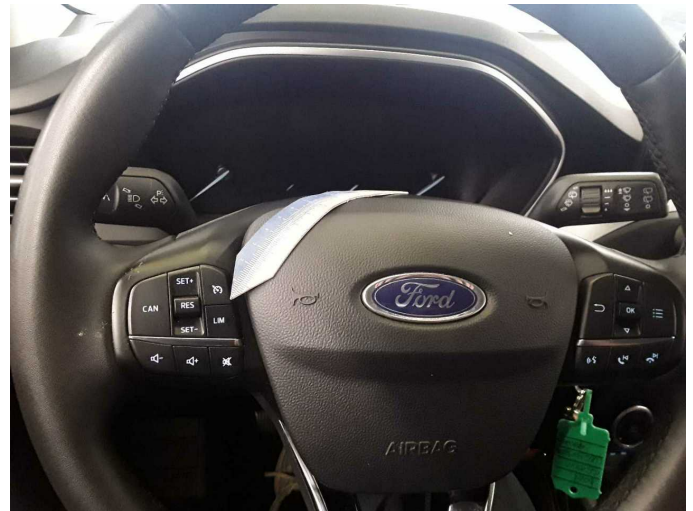
Damage 5: Steering system: Steering wheel - Scratch(es) - Loss in value

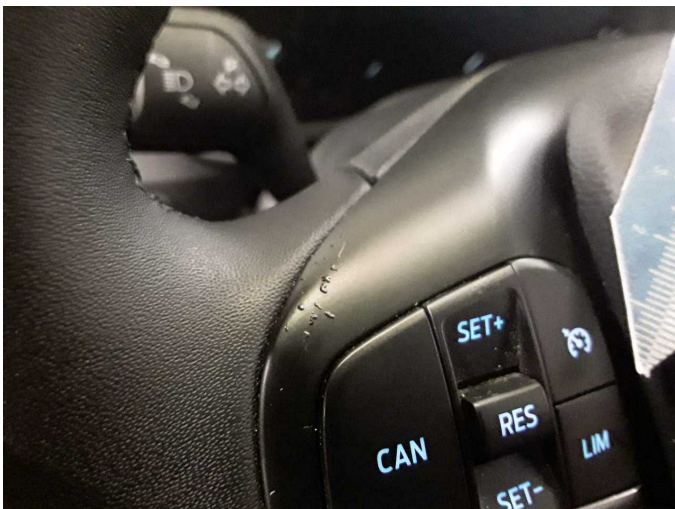
Damage 5: Steering system: Steering wheel - Scratch(es) - Loss in value

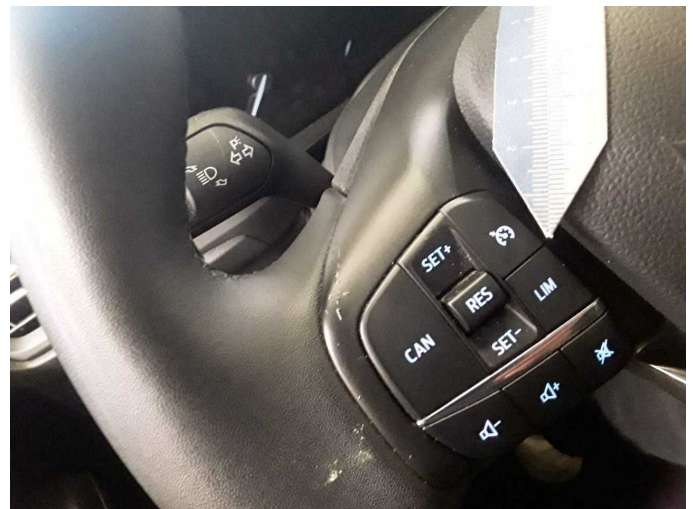
Damage 5: Steering system: Steering wheel - Scratch(es) - Loss in value

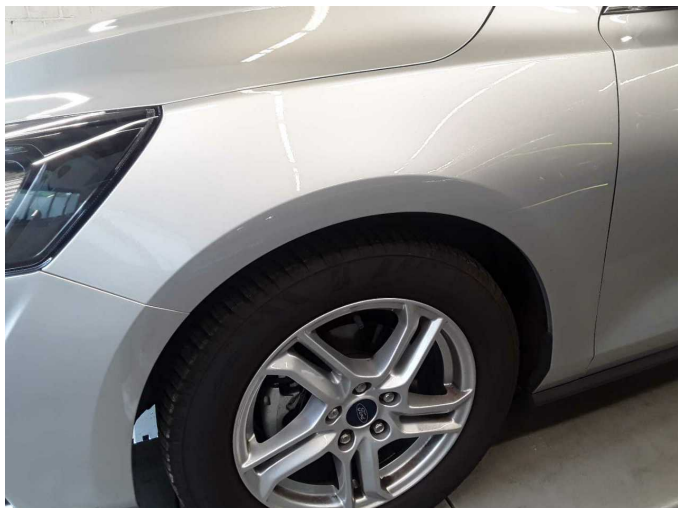
Damage 6: Mudguard - left side: Mudguard - left side - Scratch(es) - Paint

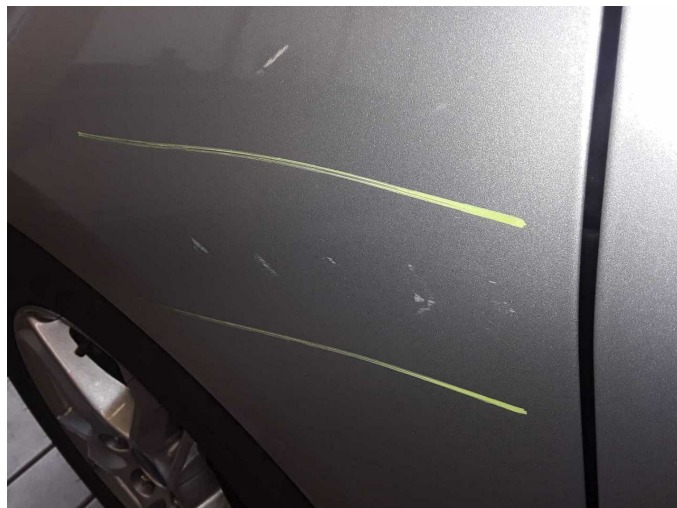
Damage 6: Mudguard - left side: Mudguard - left side - Scratch(es) - Paint

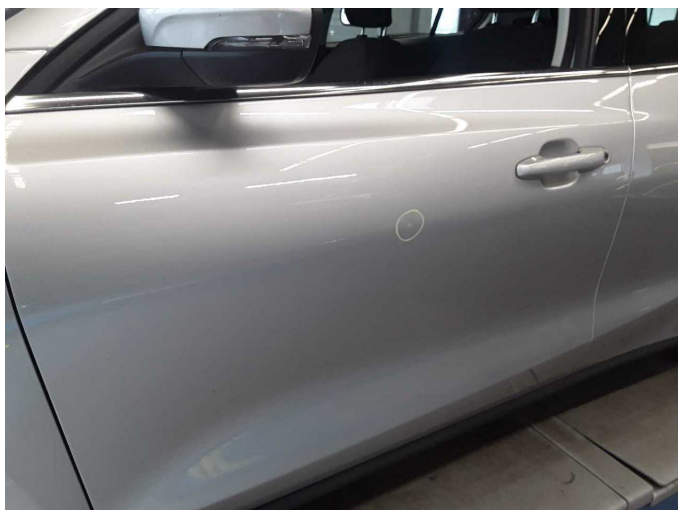
Damage 7: Door - front left side: Door - Scratch(es) - Paint

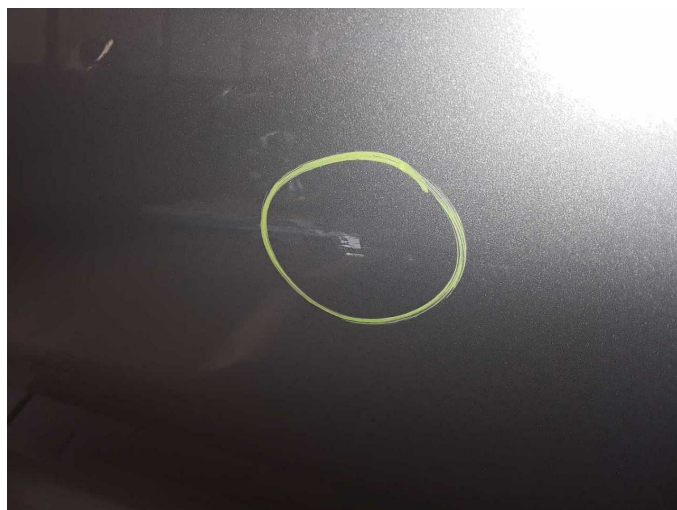
Damage 7: Door - front left side: Door - Scratch(es) - Paint

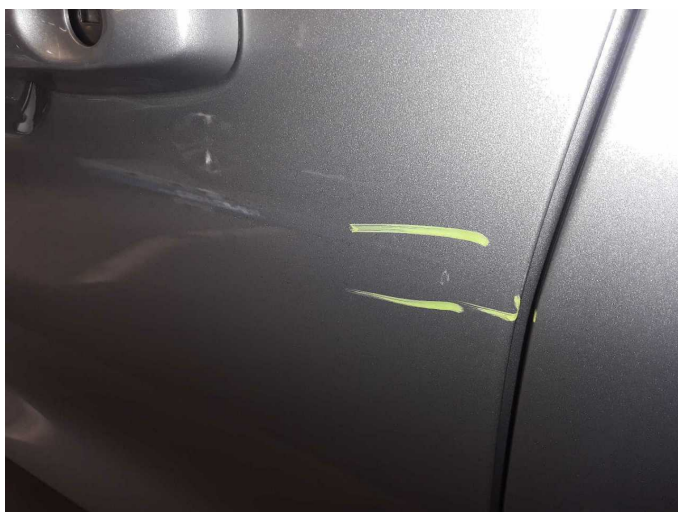
Damage 7: Door - front left side: Door - Scratch(es) - Paint

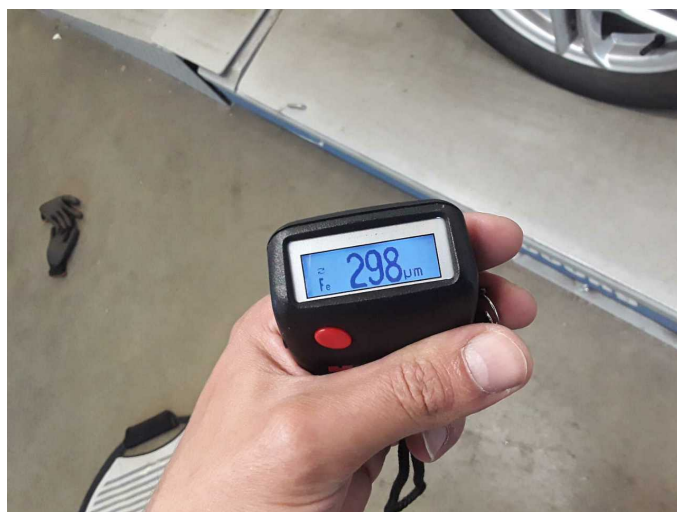
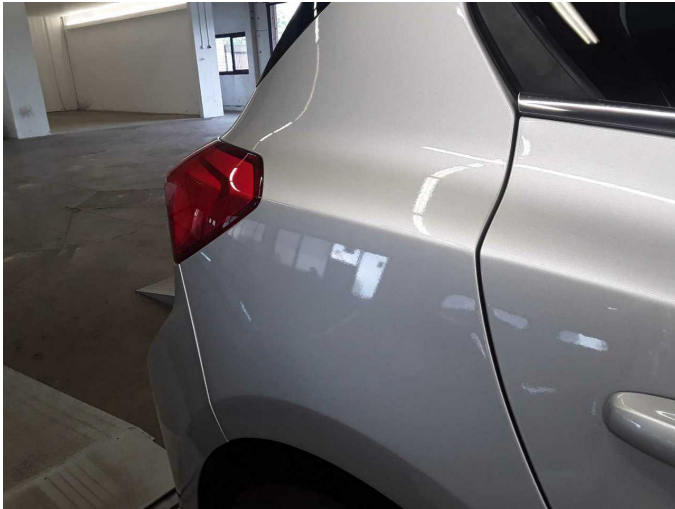
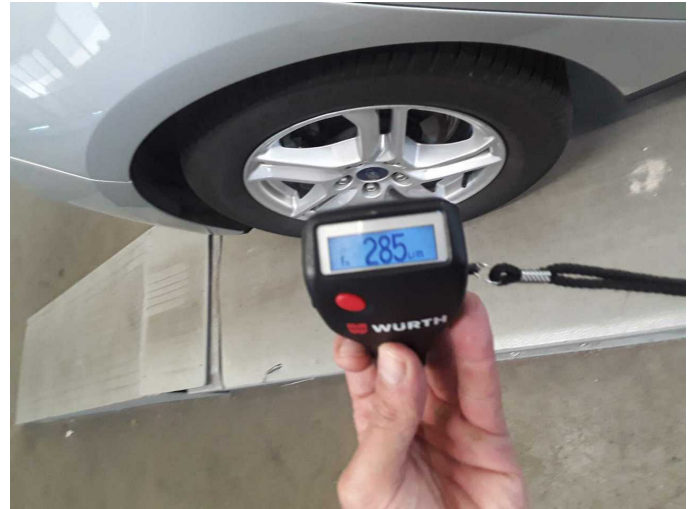
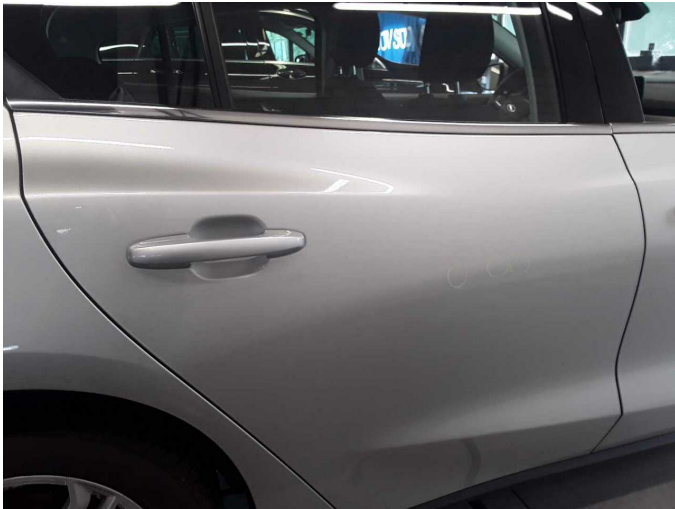
1	Side panel - rear right side, Door - rear right side, Professionally carried out, Invoice of repair done Non-existent
---	---

Side panel - rear right side	298 µm	Door - rear right side	285 µm
------------------------------	--------	------------------------	--------

Repainting 1: Side panel - rear right side, Door - rear right side
